# Power Quality Study

**Voltage Sags (Dips) in Distribution System and  
Residual Current Circuit Breaker (RCCB)  
Nuisance Tripping at Distribution Board  
ISTANA BUDAYA**

**JKR – UiTM**

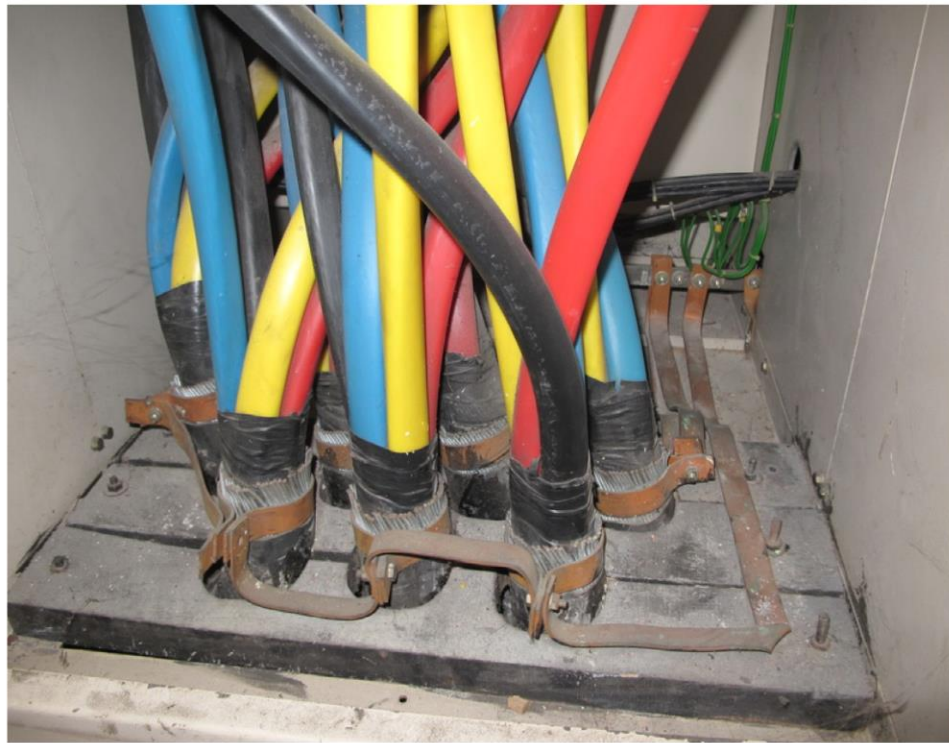
The sub-main cables connected from MSB to Understage Machinery Switchboard are of type XLPE armoured cables. The steel wire armoured were not terminated properly

- i. Check the wiring installation of the electrical system and correct all the wiring errors such as intermittent single line-to-ground fault and improper cable joint.
- ii. Check for loose neutral connections.
- iii. Inspect the wiring for other equipment, light fittings etc. for loose joints and terminations.

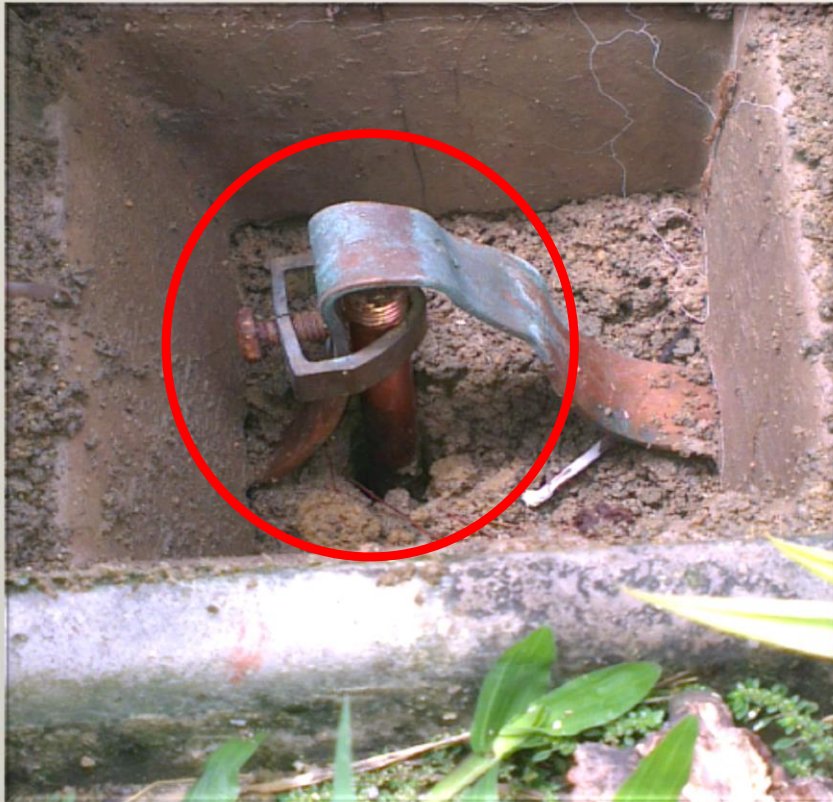
The grounding conductor is not fastened securely to the ground electrode. Clamp is used to connect ground electrode and copper tape (grounding conductor)

- i. Use exothermic welding connection between grounding conductor to the ground electrode.

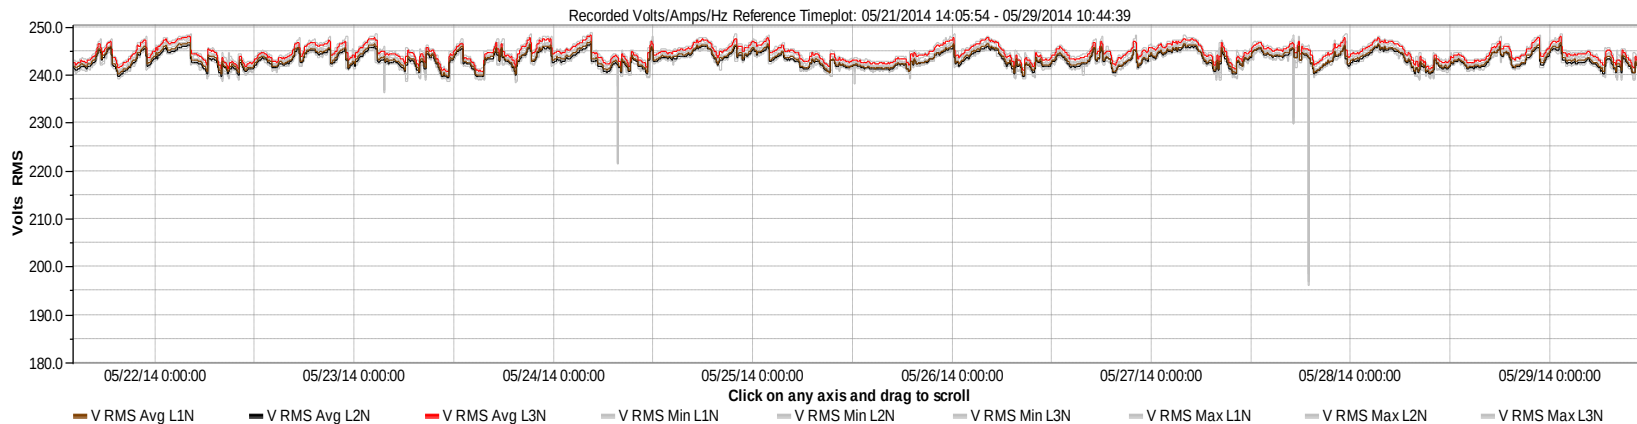
## 10 minutes trend data of MSB-D

10 minutes trend data average RMS Voltage at MSB-D is within limits (230 V +10%, -6%) (216 V to 253 V )

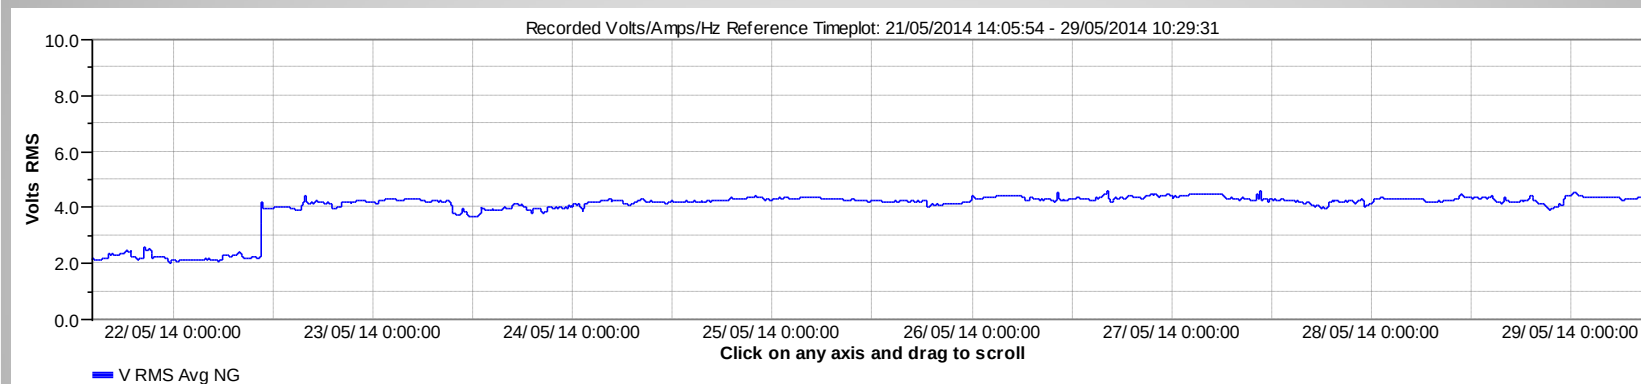
10 minutes trend data of MSB-D

Maximum steady state neutral-to-ground Voltage at MSB-D=4.61V

**Indicate that there is poor termination of earthing conductor and earth electrode**

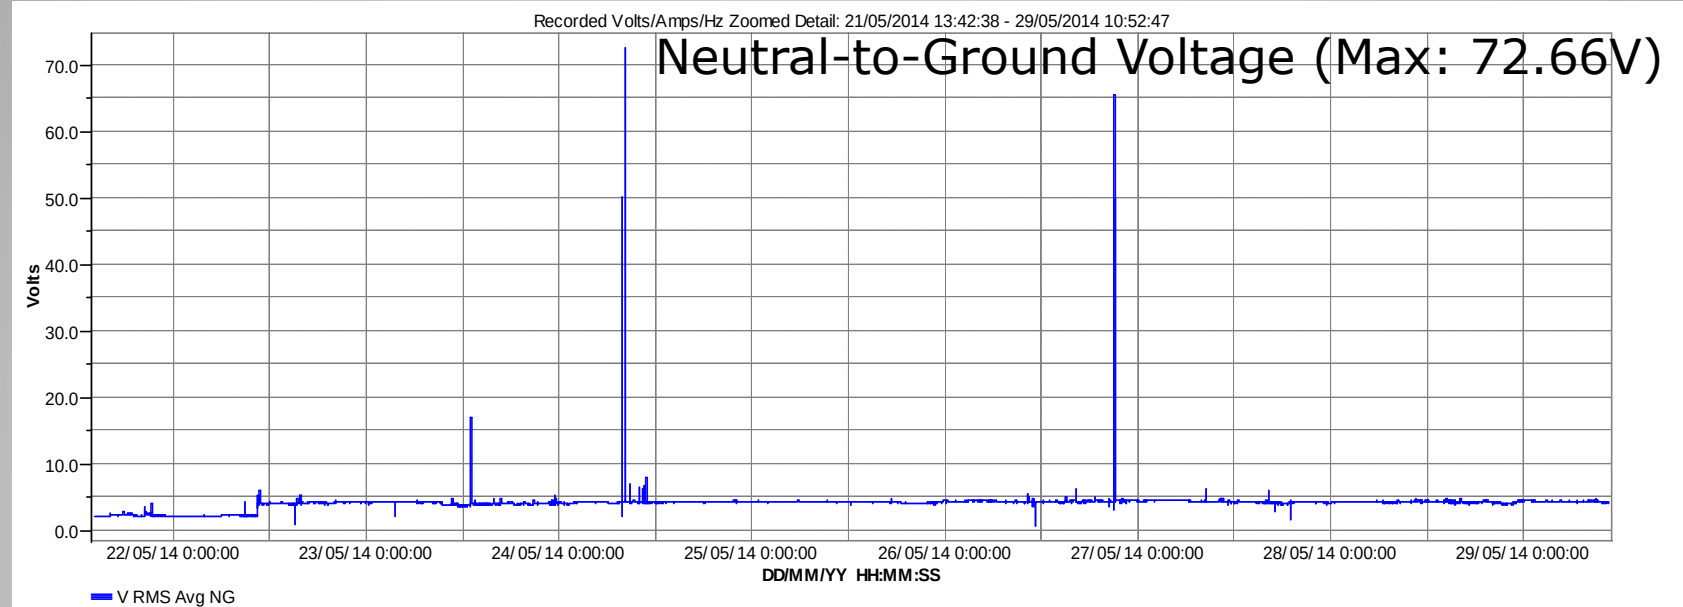
## Neutral to Ground Voltage( $V_{NG}$ ) at MSB-D (Detailed View Data)

Indicates 'Intermittent Single Line-to-Ground Fault (SLG)' within electrical supply distribution system

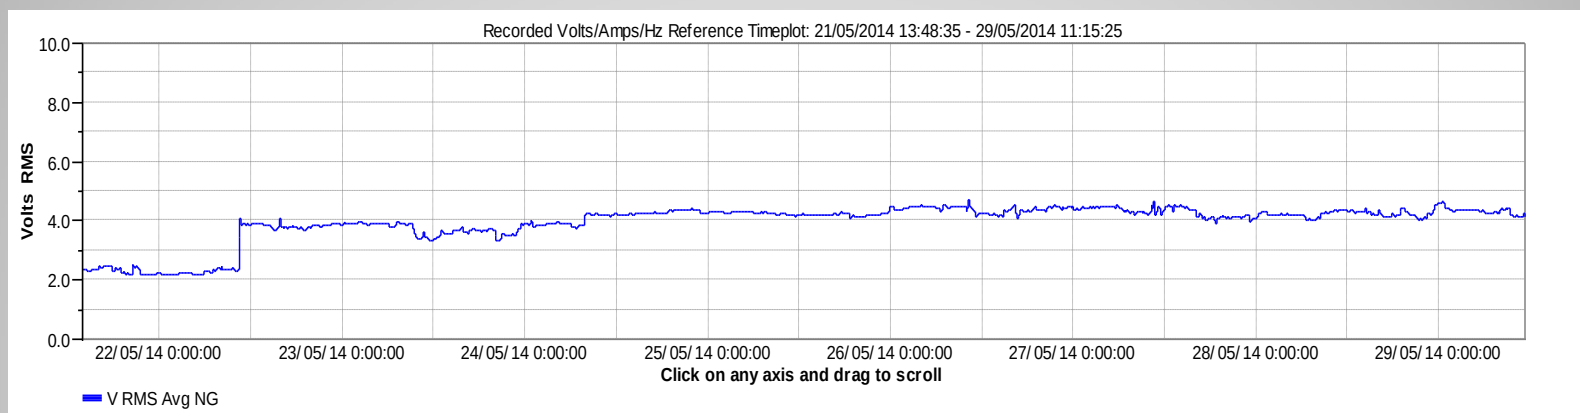
10 minutes trend data of DB/ELP/3F-ALR-1

Maximum steady state neutral-to-ground Voltage at DB/ELP/3F-ALR-1=4.73V

**Value is higher than at MSB D (4.61V) < DB (4.73V)**

**Indicate loose termination at location between MSB and DB**

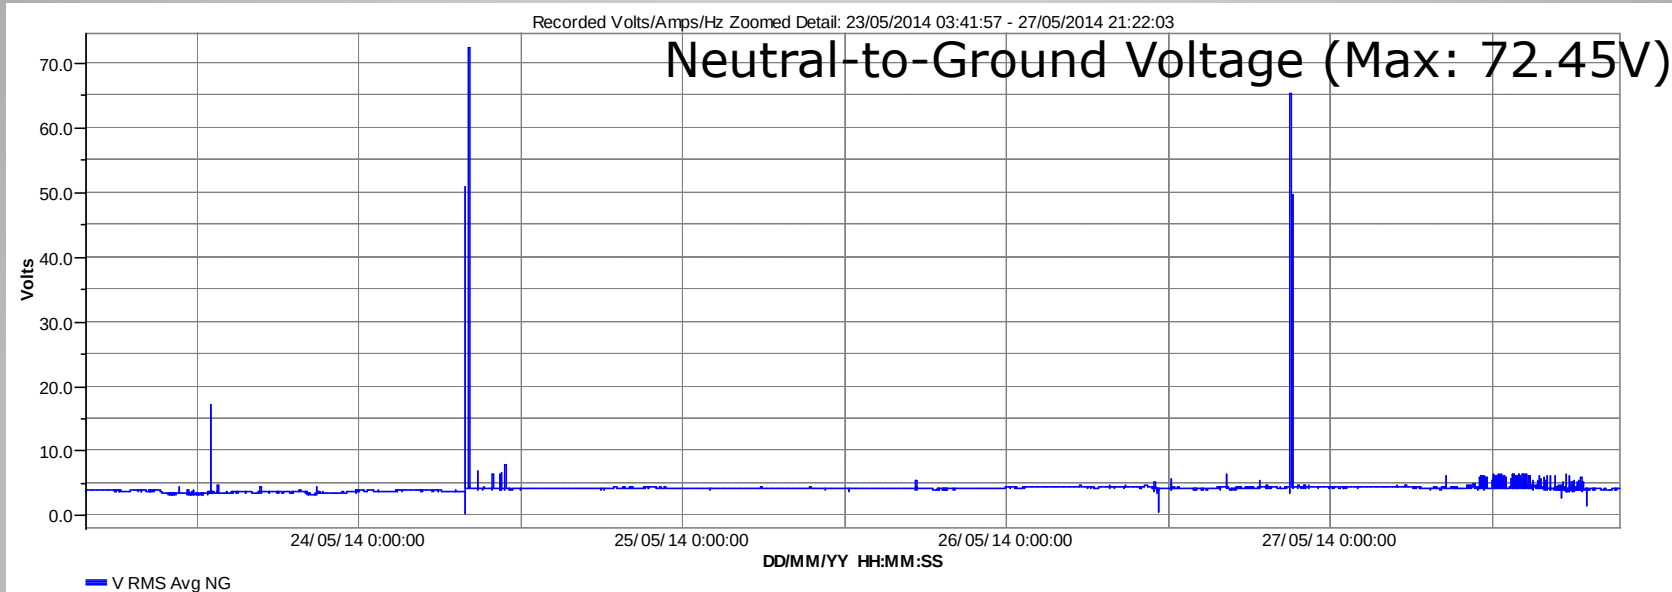
Neutral to Ground Voltage (VNG) at DB/ELP/3F-ALR-1 (Detailed View Data)

- Indicates 'Intermittent Single Line-to-Ground Fault (SLG)' within electrical supply distribution system.
- Can cause damage to electronic equipment and nuisance tripping of RCCB.

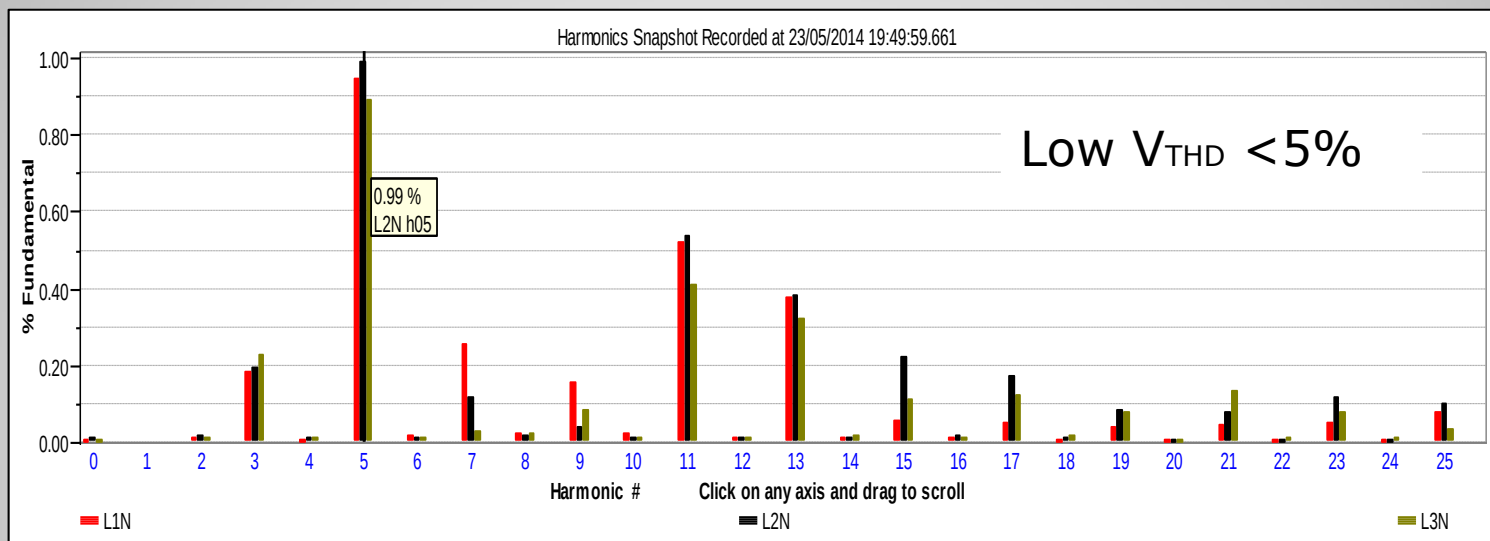
## MSB- D Harmonics at High Load

- Since the voltage THD at the MSB-D is low ( $< 5\%$ ), therefore the electrical harmonics will not cause any problems to electrical supply system.
- The voltage sags that occurred at MSB-D came from upstream (supply side).
- The voltage sag that occurred at TNB INCOMER HT2 came from upstream (i.e. Electricity Supply Authority)
- High neutral to ground voltage impulses have led to the damage and malfunction of the electronic loads and nuisance tripping of the RCCB.
- The high neutral to ground voltage impulses are due with an inadequate wiring installation, improper termination and improper grounding configuration

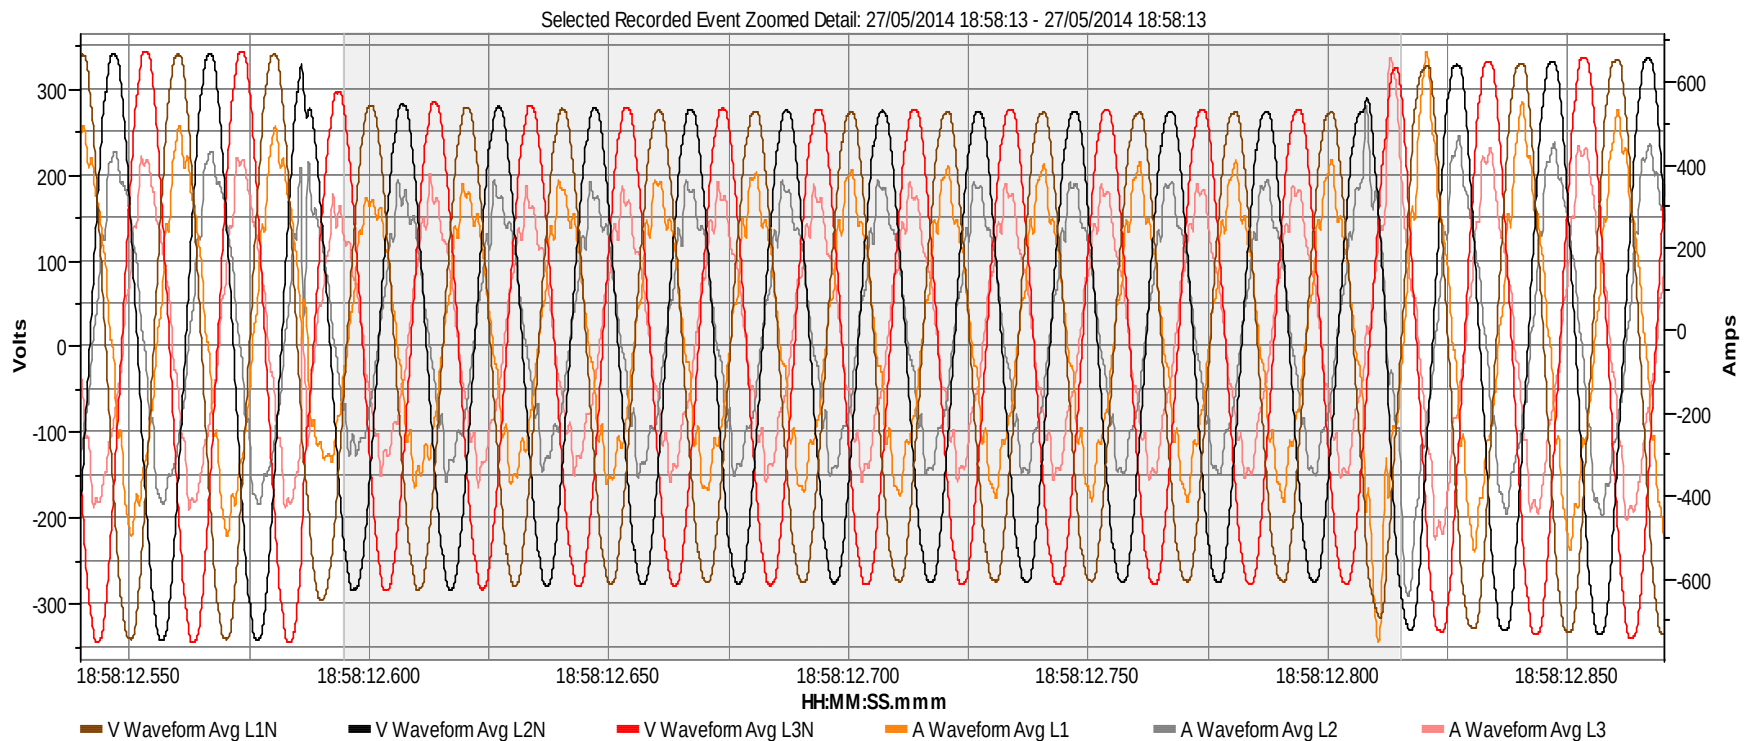
## Voltage Sag at MSB-D

Voltage Sag of 195.38 V

Duration : 220 ms

No Increase in Current:  
**Voltage Sag Originates  
from the upstream\***

- i. Make a complaint to the Electricity Supply Authority.

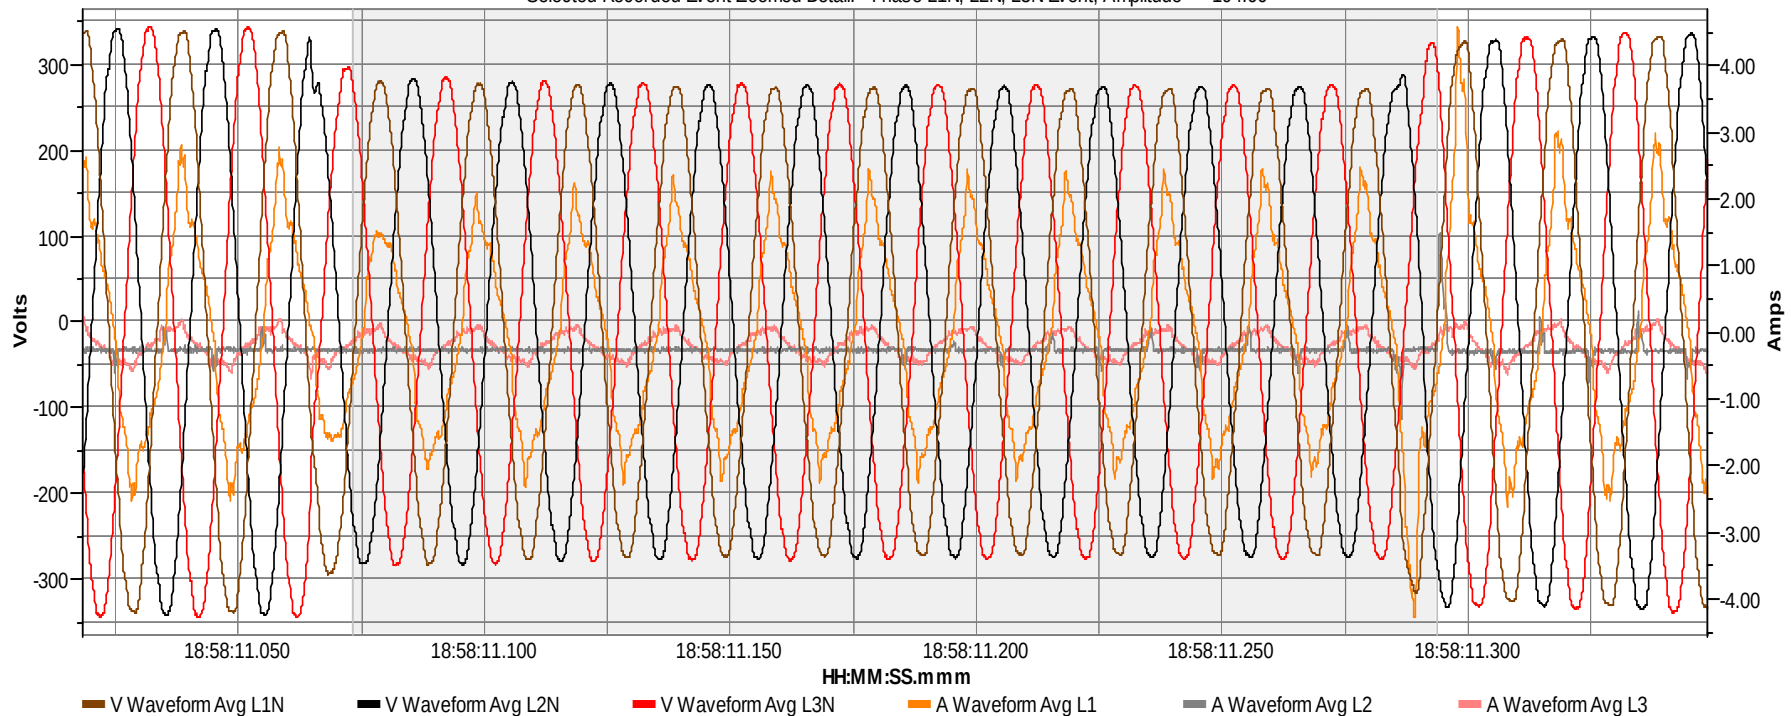
Voltage Sag at DB/ELP/3F-ALR-1

Voltage Sag of 194.65 V

Duration : 220 ms

No Increase in Current:

**Voltage Sag Originates  
from the upstream \***

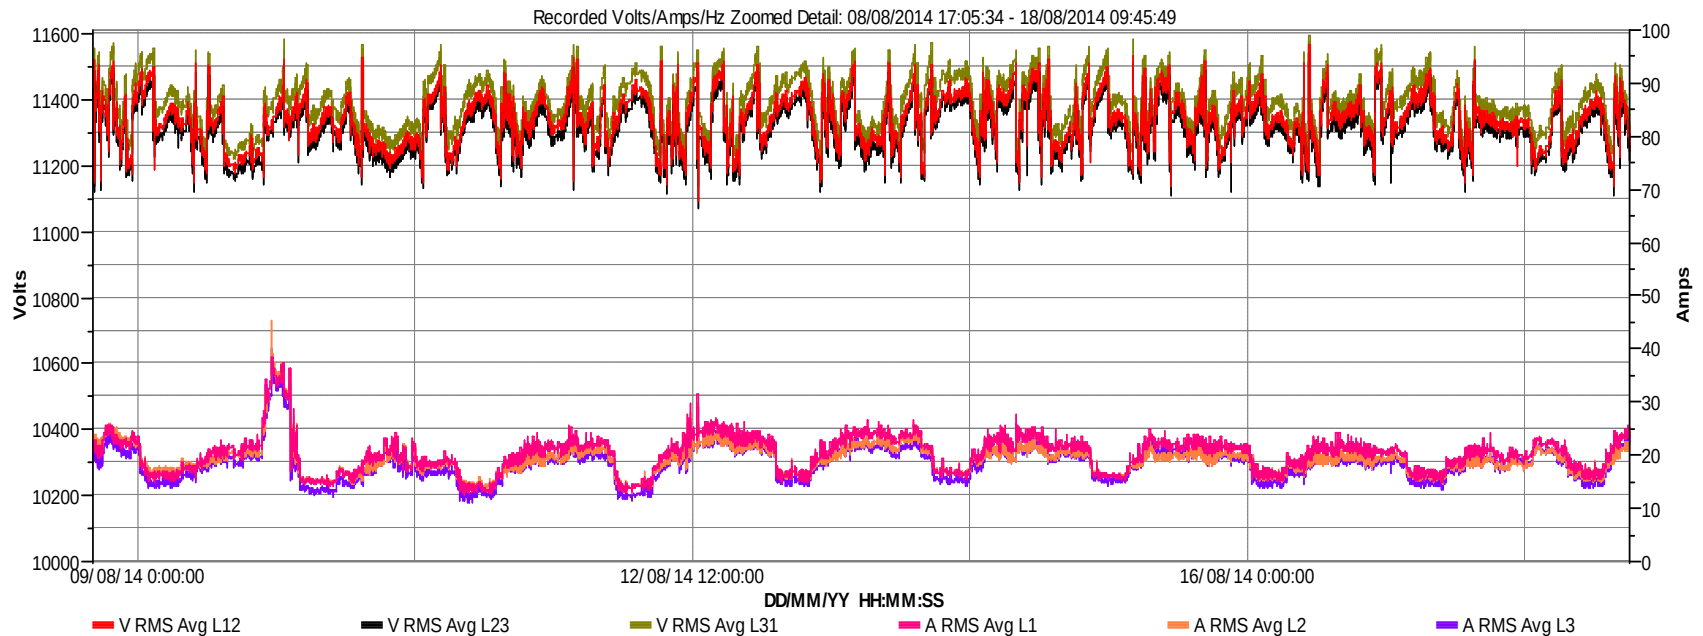
No voltage sags recorded at the TNB INCOMER HT1

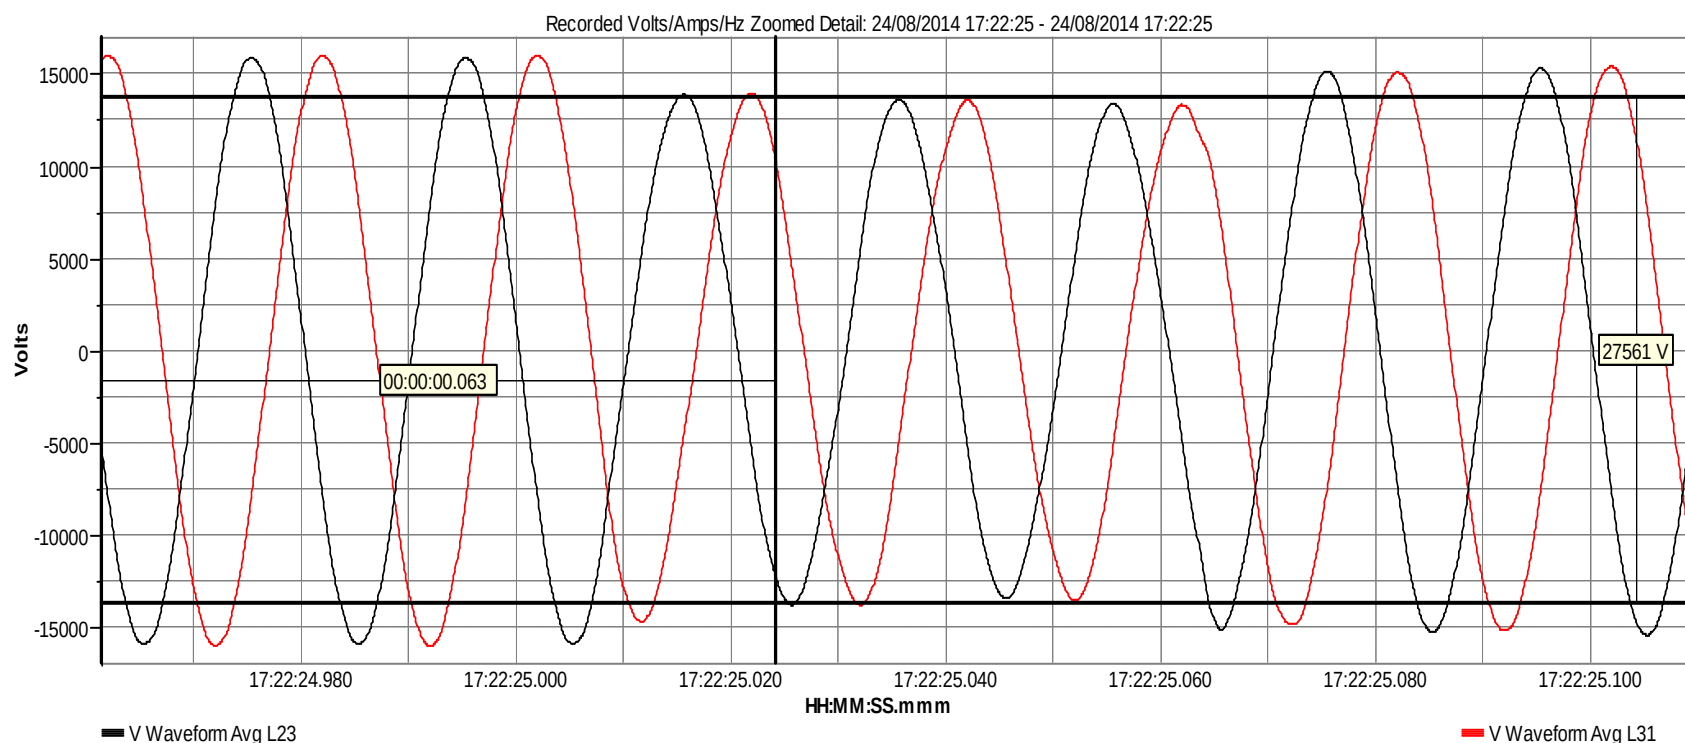
TNB INCOMER HT2 shows a voltage sag for duration of 3 cycle (60 ms) of phase L23 and L31 occur on 24th August 2014

Voltage Sag Values : 9464.6 V(L23) and 9520.0V (L31)

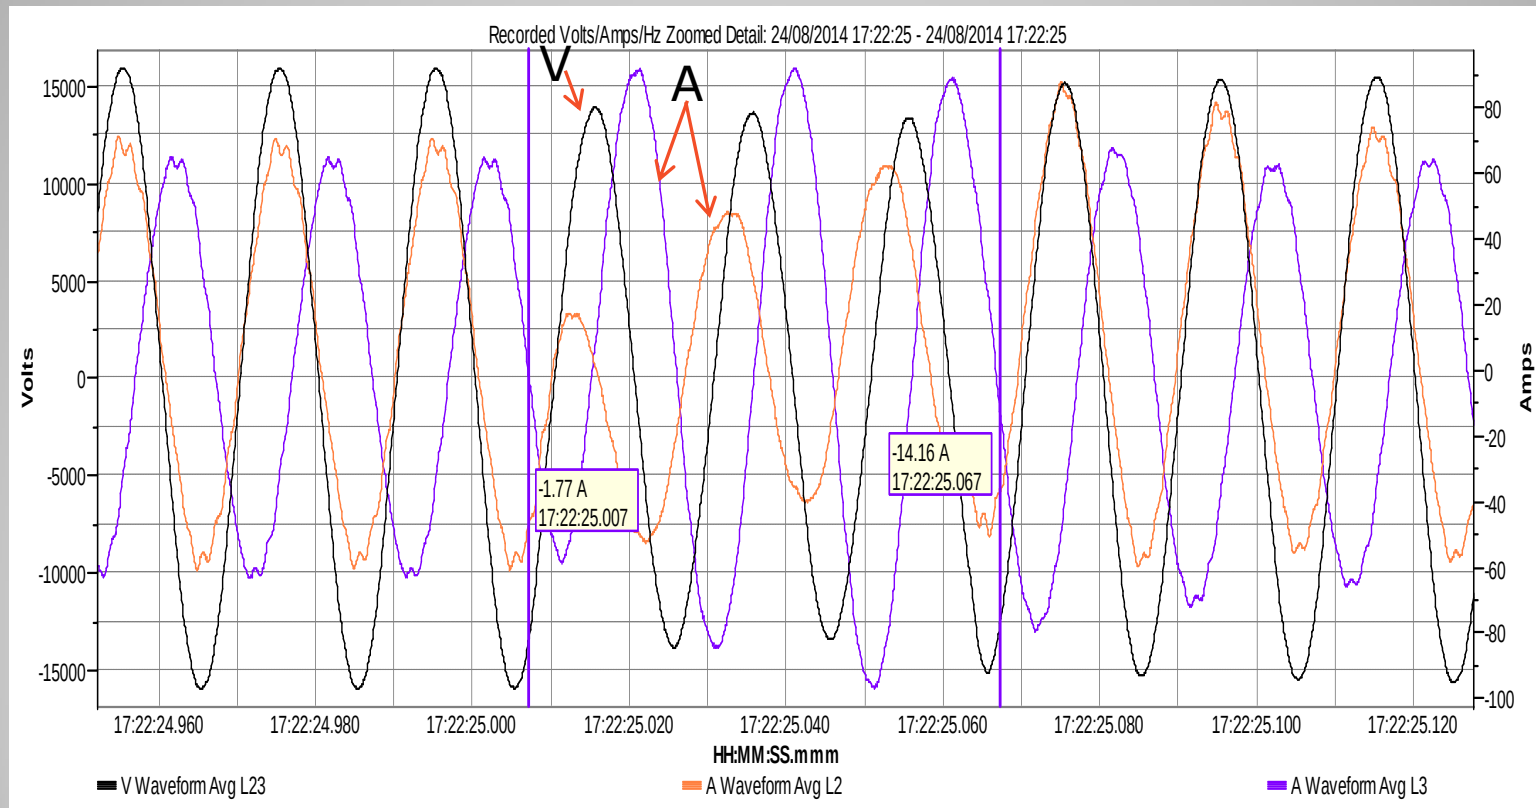
Since there is no sudden increase in the current magnitudes, the voltage sag is originated upstream of the measurement point

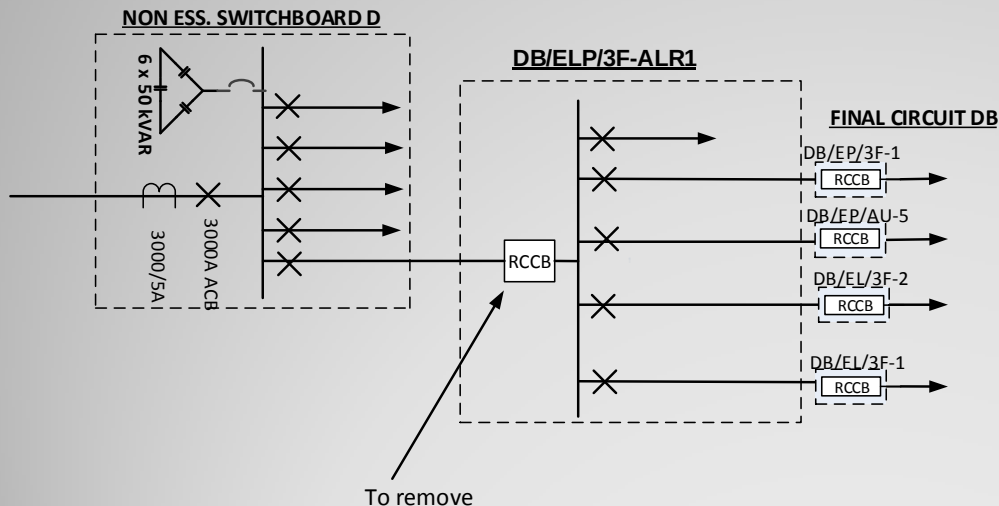
If there is any earth leakage at the final circuit DB, these RCCBs would see the same fault, and both would trip at the same time thus disrupting the electrical supply to the other area. Also, if there is any neutral-to-ground voltage disturbance occurs, RCCB located at the DB/ELP/3F-ALR-1 will trip first since the total leakage current at DB/ELP/3F-ALR-1 is higher than at the final circuit DBs.

- iv. Remove the RCCB located at DB/ELP/3F-ALR-1 and replace with circuit breaker
