INDOOR ENVIRONMENTAL QUALITY (IEQ)

Jawatan Kuasa Kerja Pengurusan Persekutaran Dalaman (JKKPPD)
Pembangunan Lestari JKR Malaysia

CAWANGAN KERJA PENDIDIKAN DAN PENGAJIAN TINGGI
MAJU TOWER 13-15 OKTOBER 2015

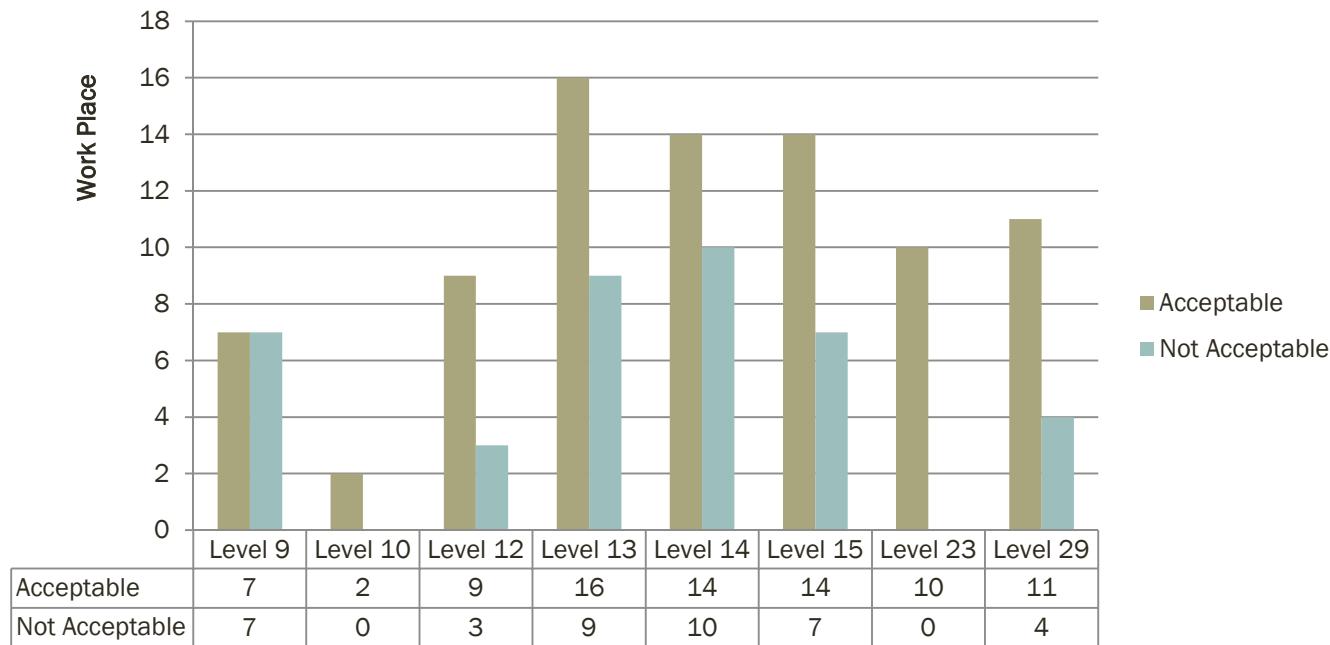
Illumination Level at Caw. Pendidikan & Pengajian Tinggi JKR

Illumination level at 40 workplaces (32.52 %) has not achieved the minimum illumination level recommended by MS 1525:2014 and Panduan Teknik Rekabentuk Elektrik CKE 2008: Edisi 4

- It is strongly advisable to the Building Management to up keep and maintains the indoor environmental quality within the building areas as specified in the Industry Code of Practice 2010 by DOSH. As overall finding indicated that the indoor environmental quality is satisfactory but certain issues should be taken with necessary actions.
 - High Level of Relative Humidity
 - MVAC Maintenance
 - Bacterial and Fungal Count
 - sound insulation is provided within the AHU room
 - conduct robotic duct inspection at the MVAC ducting
 - improve the illumination level

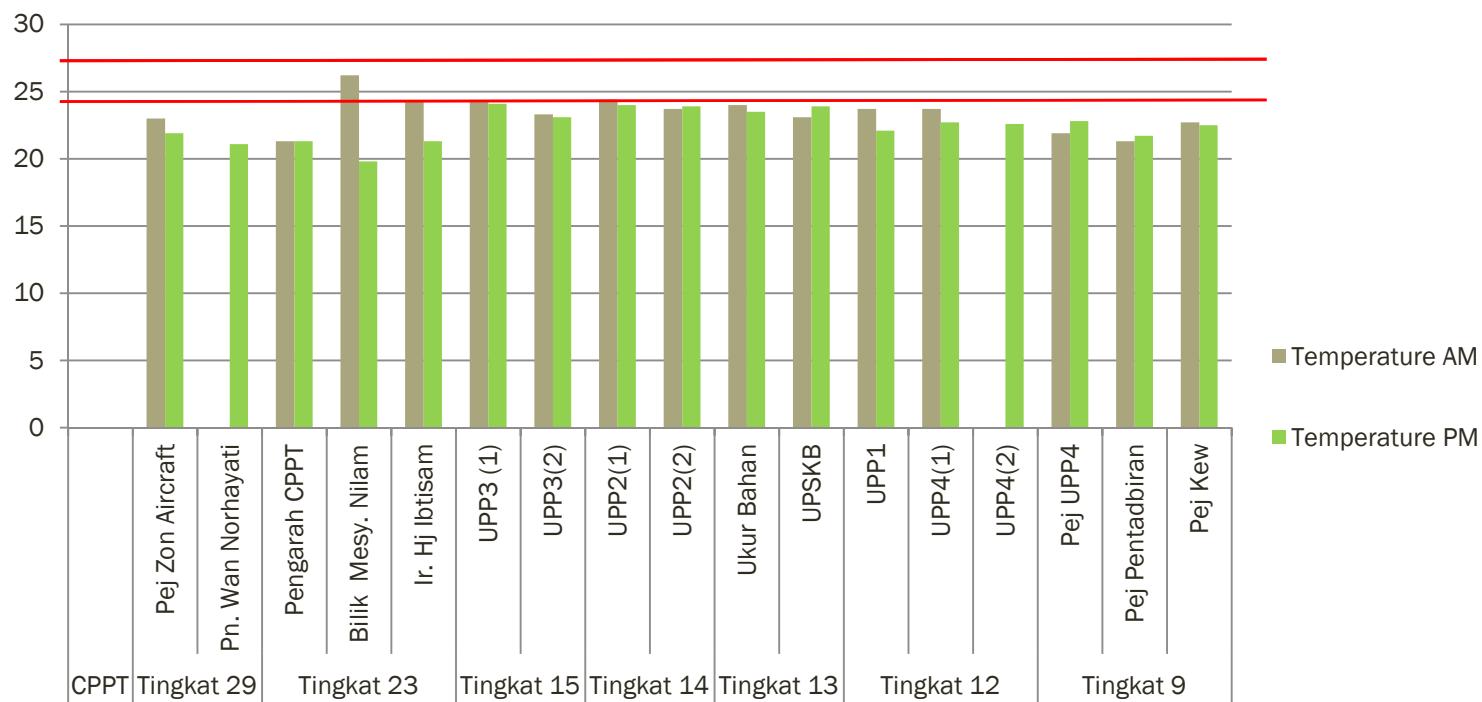
- Temperature ($^{\circ}\text{C}$)

Most of the workplace are **below acceptable limit** which is Temperature of $23^{\circ}\text{C} - 26^{\circ}\text{C}$
According to ICOP by DOSH and JKR IEQ Guidelines 2013

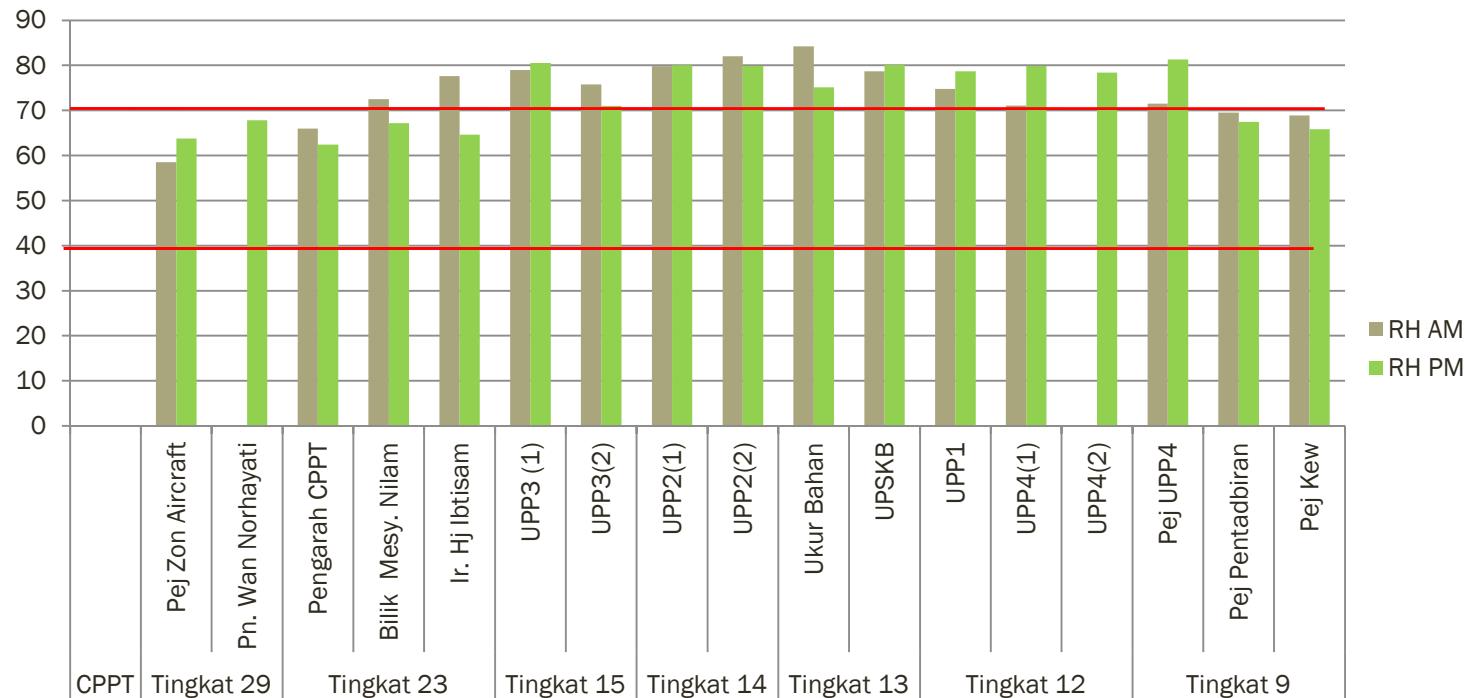
- Relative Humidity (%)

Most of the work places are **above acceptable limit**. Recommended RH comfort range is between 40%-70% for an office building

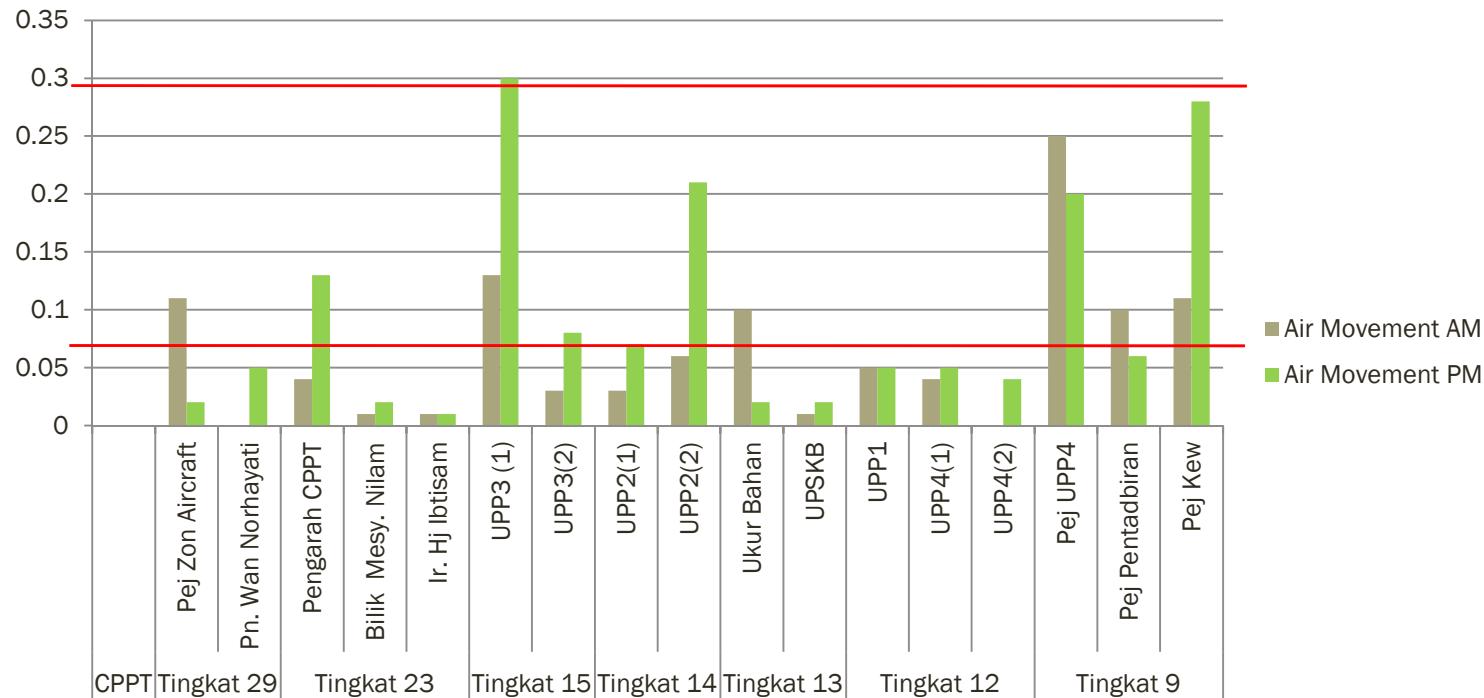
- Air Movement (m/s)

The indoor air movement at most of the sample points were **below** acceptable limit. Allowable limit is between 0.15m/s-0.5m/s at the work place.

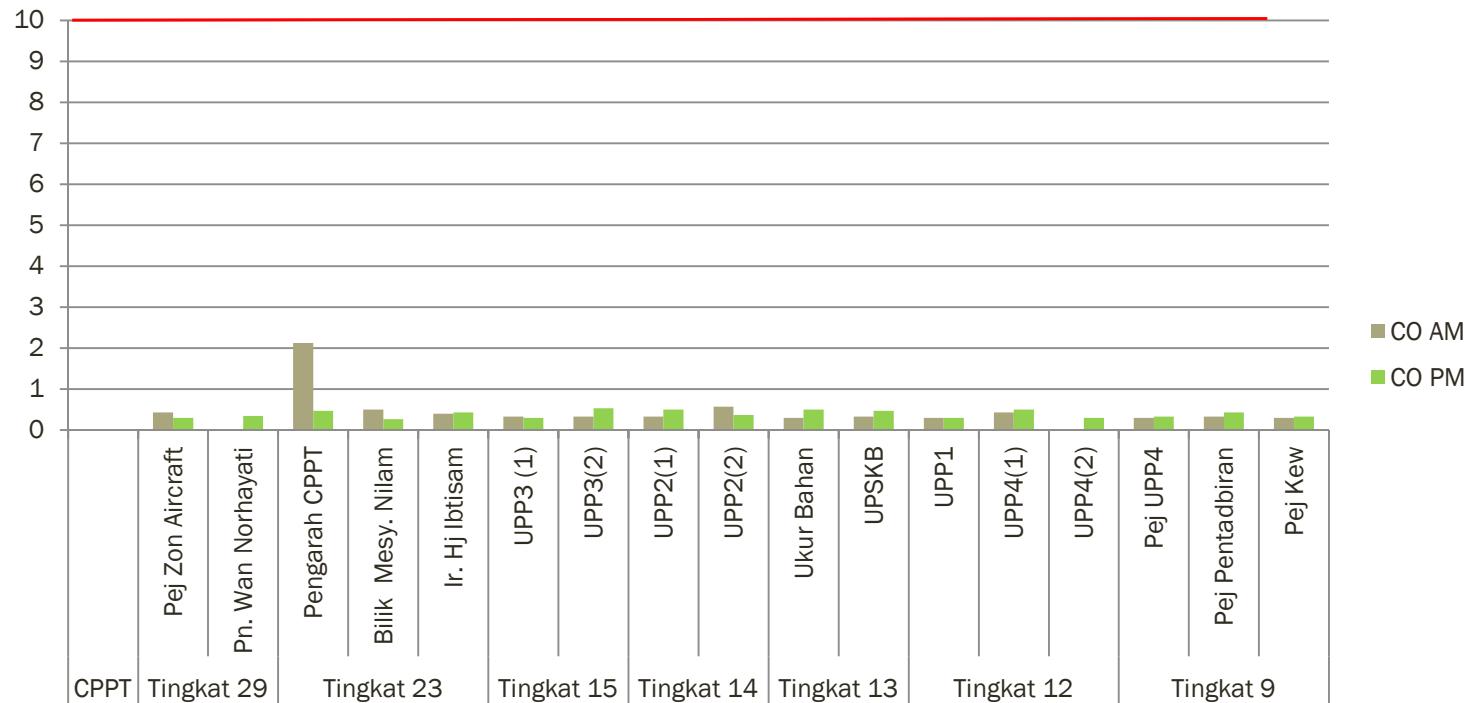
- CO (ppm)

CO level is below acceptable limit which refer to ICOP and JKR IEQ Guidelines stipulate that CO level is 10ppm

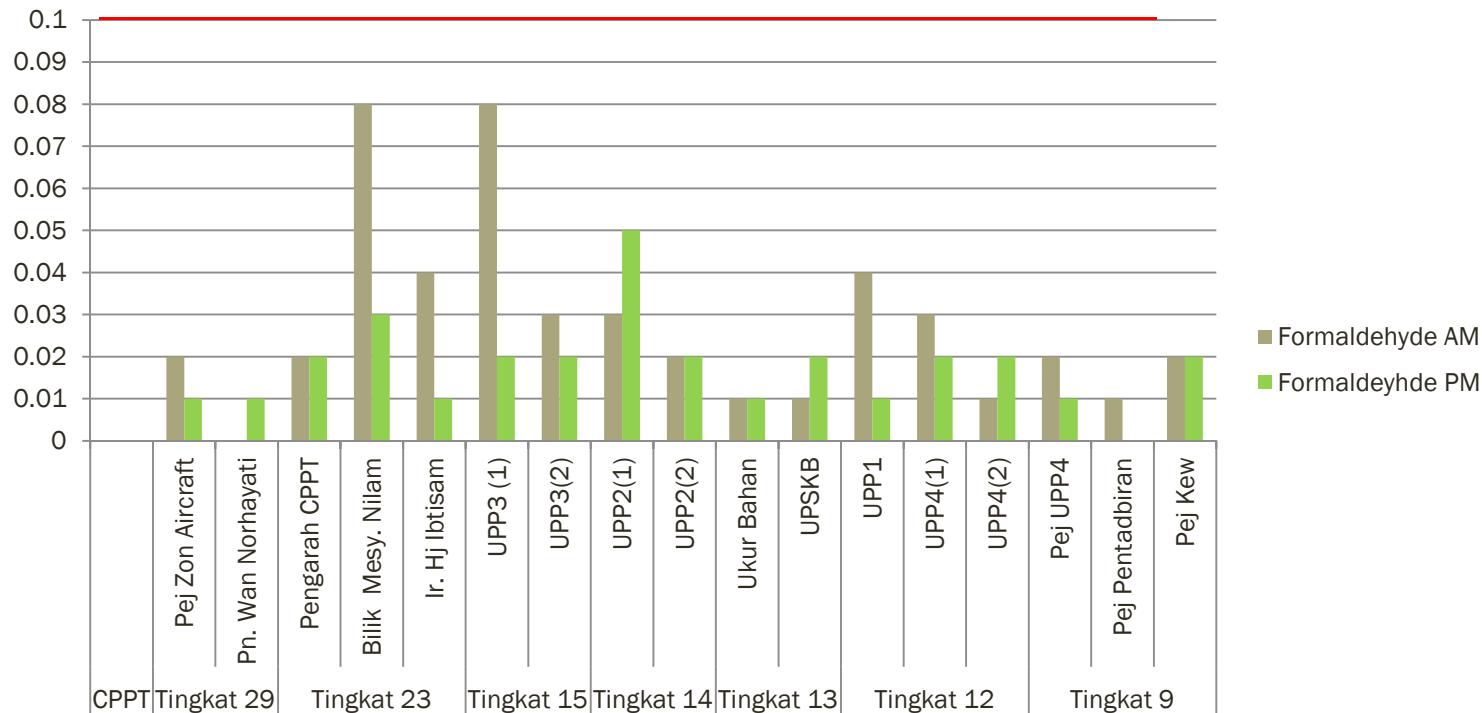
- Formaldehyde (ppm)

Formaldehyde level is below acceptable limit of 0.1ppm set by ICOP and JKR IEQ Guidelines

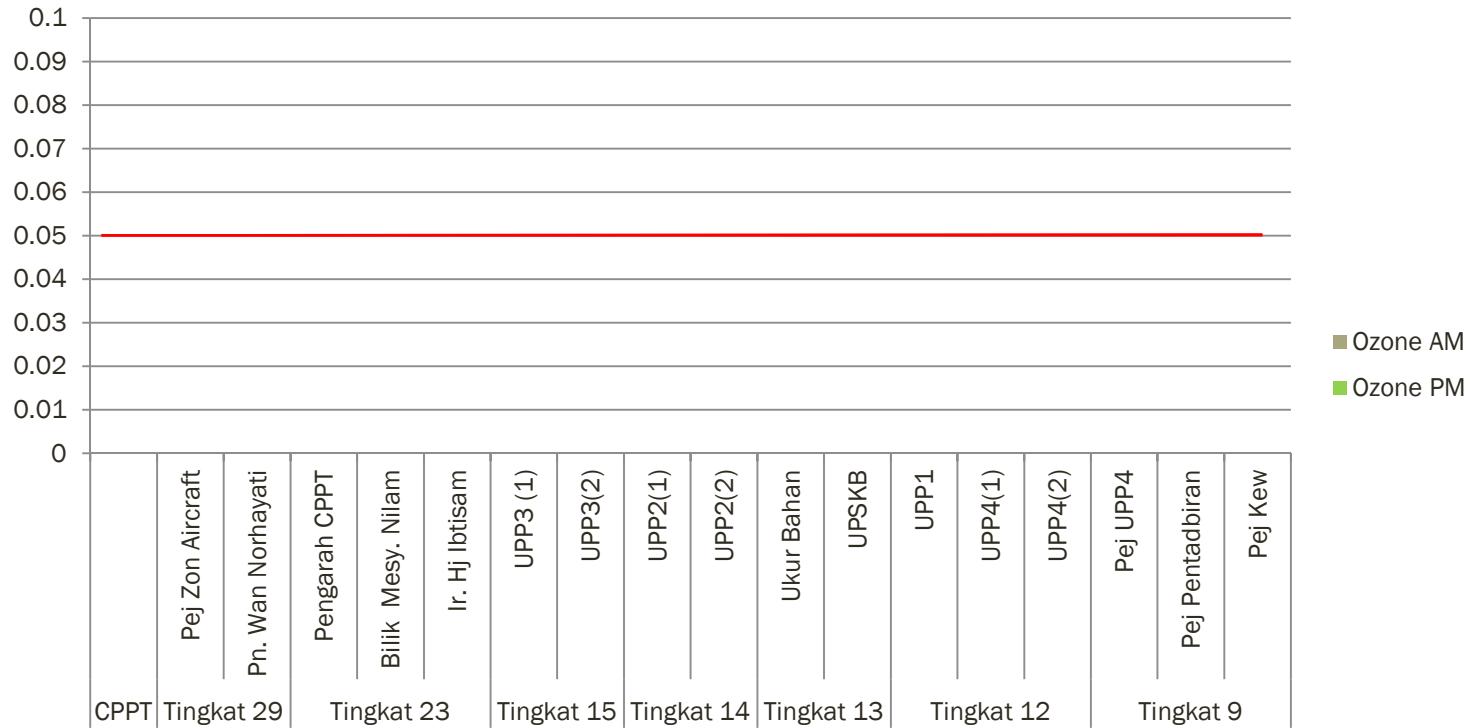
- Ozone (ppm)

Ozone level is below acceptable limit 0.05ppm recommended by ICOP and JKR IEQ Guidelines

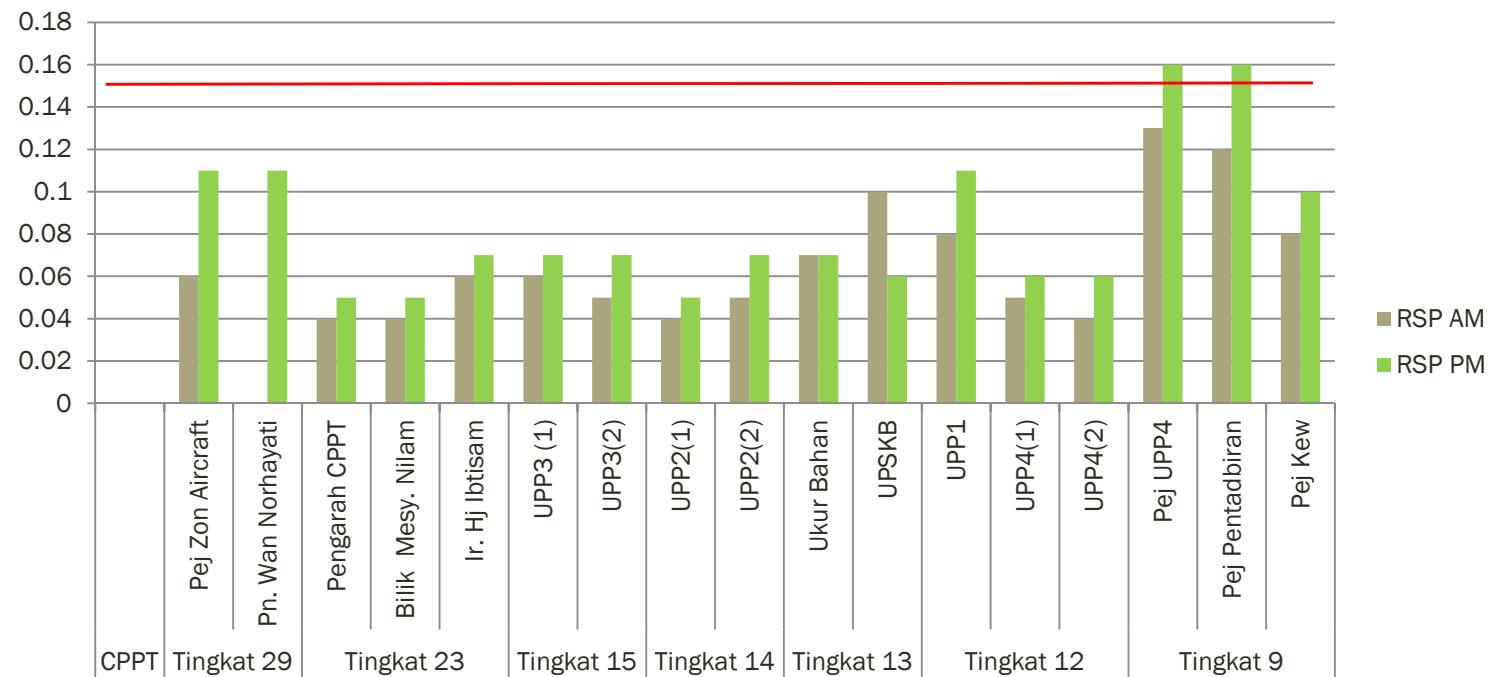
- Respirable Particulates (ppm)

Respirable particulate are still within acceptable limits 0.15mg/m³ recommended by ICOP and JKR IEQ Guidelines

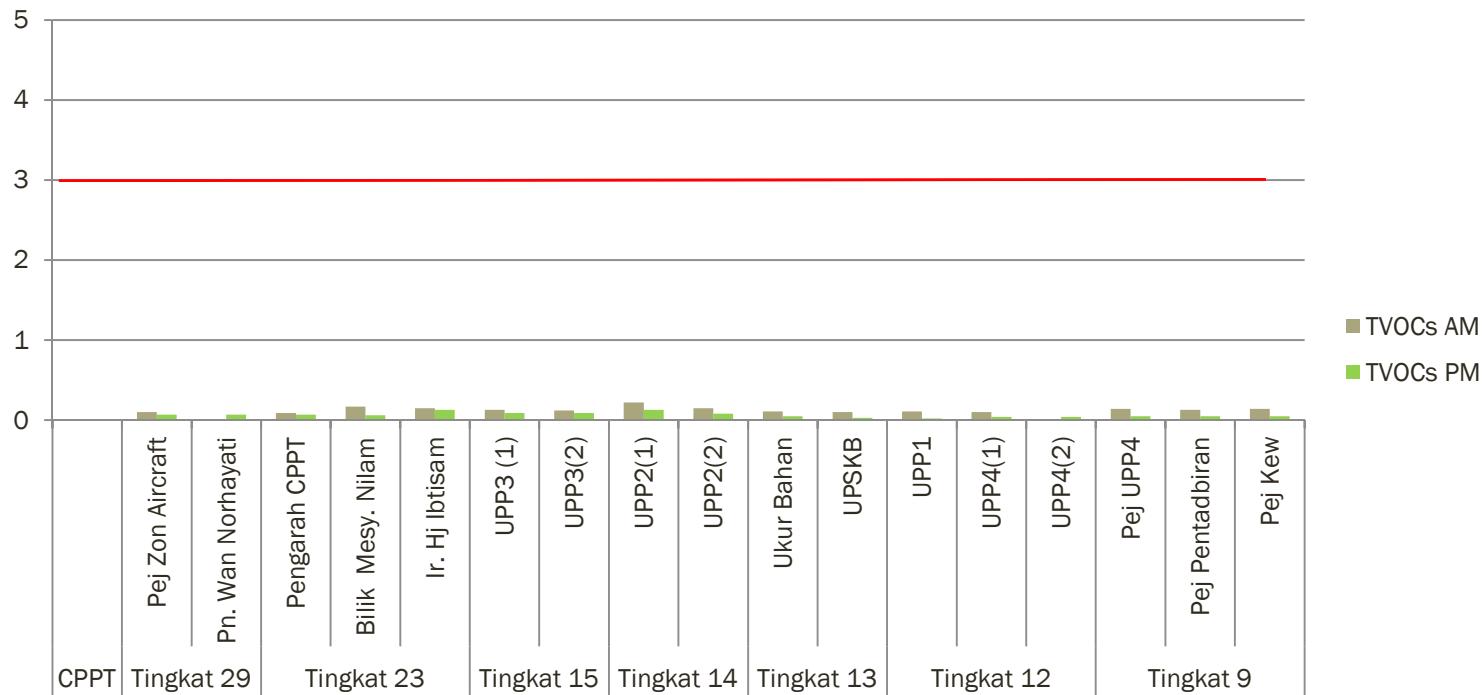
- Total VOC (ppm)

Total VOC level is below acceptable limit compliance with ICOP and JKR IEQ Guidelines is 3ppm

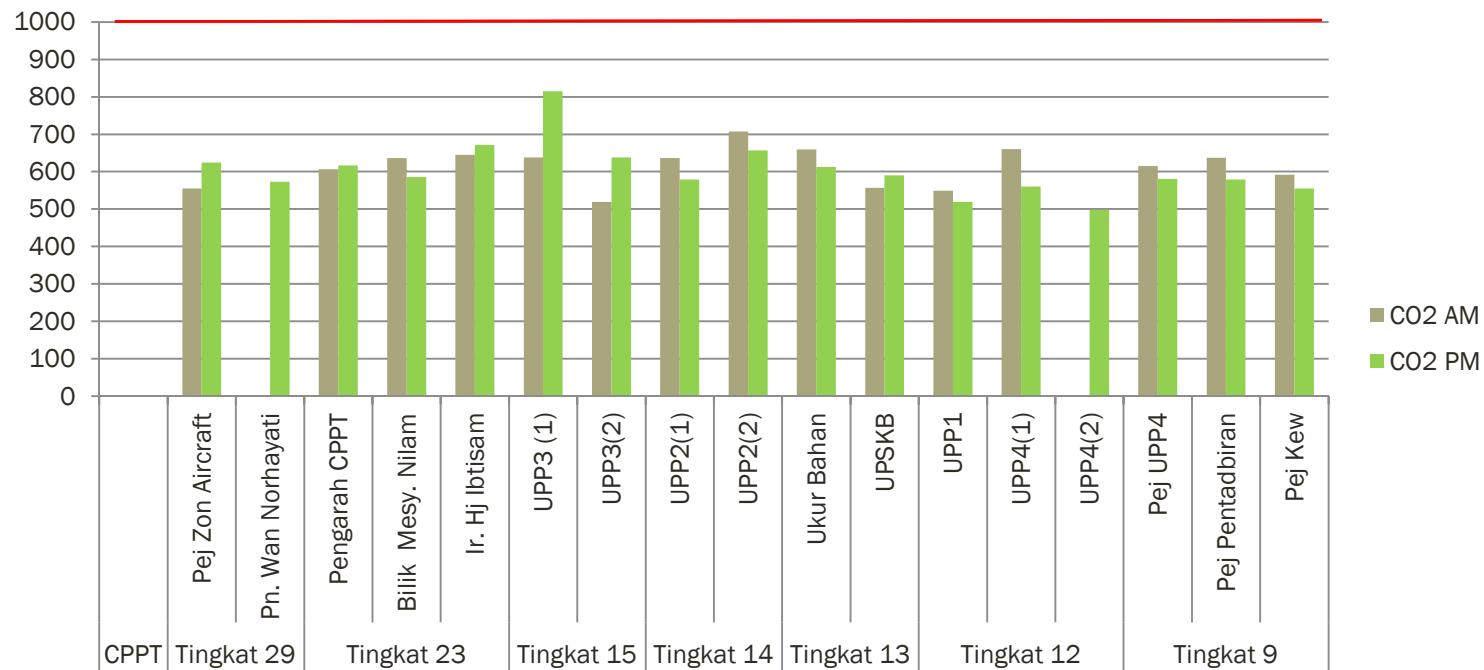
- CO₂ (ppm)

CO₂ level inside this building were within the ceiling limit of 1000ppm as recommended by ICOP and JKR IEQ Guidelines

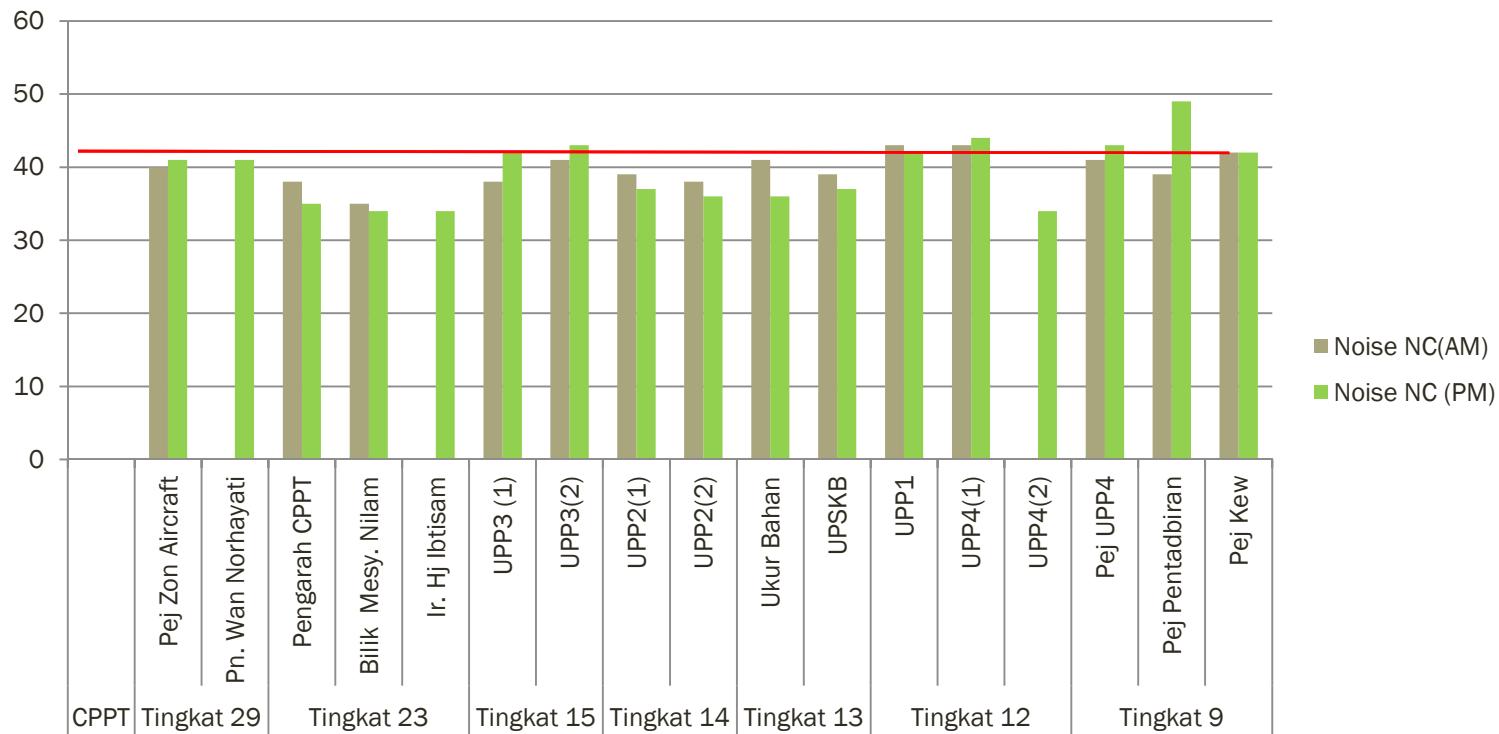
- Noise (NC)

Noise level in CPPT, Maju Tower is unsatisfactory. Certain workplaces are at beyond the acceptable limit range ICOP and JKR IEQ Guidelines which 40NC
