SLOPE FAILURES IN TROPICAL RESIDUAL SOILS

Presented by:
Ir. Liew Shaw Shong

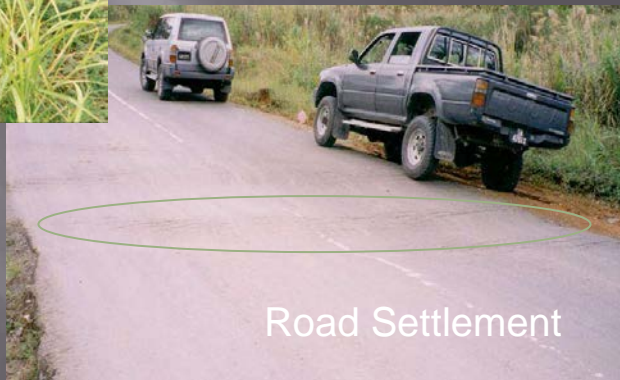
Road Settlement

- Damage of road pavement and drains.
- Tension cracks, settlement and lateral movement.
- Investigation of root causes.

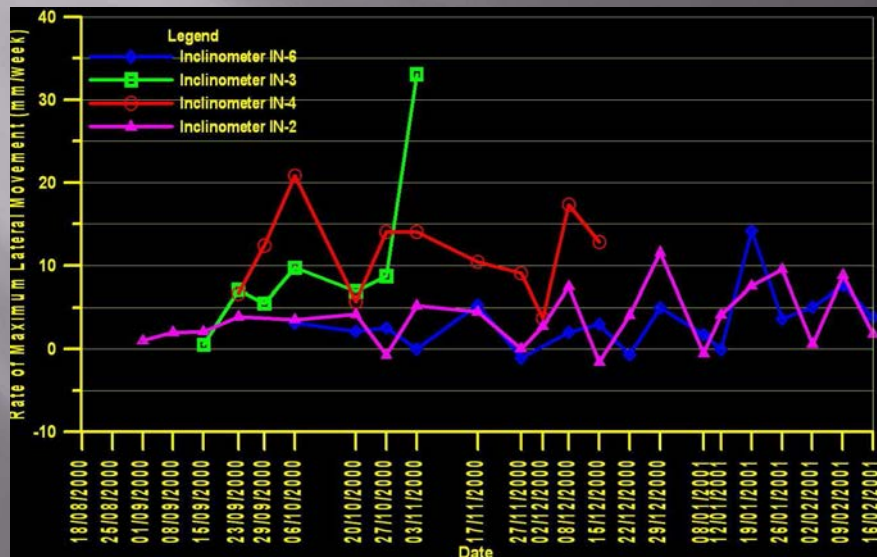
Inclinometer Movement Rate

- ▣ Inclinometers detected slip surface.
- ▣ Lateral Movement:
- ▣ Direction : $225^\circ \sim 250^\circ$
- ▣ Max. Movement : 140mm (IN-4)
- ▣ Rate of Movement : 2~14mm/week
(Max. 21mm/week)

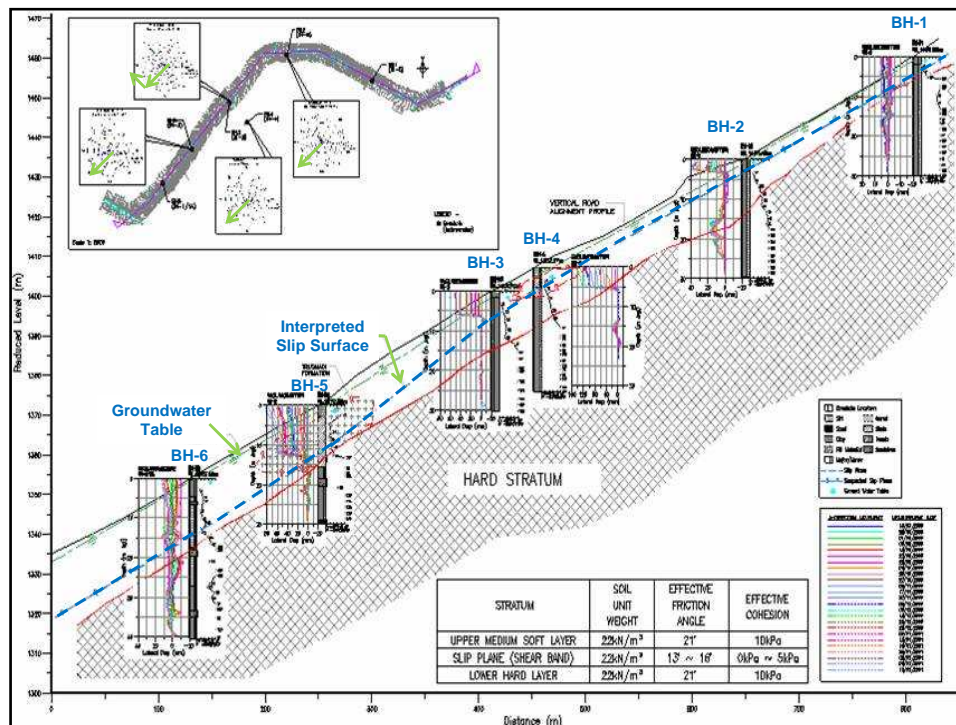
- Interpreted laboratory shear strength parameters are too high to cause instability.
- Back-analysis shear strength parameters:
 $\phi' = 13^\circ \sim 16^\circ$, $c' = 0 \sim 5 \text{ kPa}$

- ❑ Slip Surface : 6m (higher ground) to 15m (lower ground).
- ❑ Movement Direction: almost parallel to road alignment, towards river.
- ❑ Back-analysed shear strength < Interpreted laboratory test results.

- ▣ Carry out **continuous sampling** at identified shear surface for observing **slicken-sided surface** and direct shear testing.
- ▣ Carry out **ring shear test** and/or **multiple reversal direct shear box test** to determine **residual strength**.

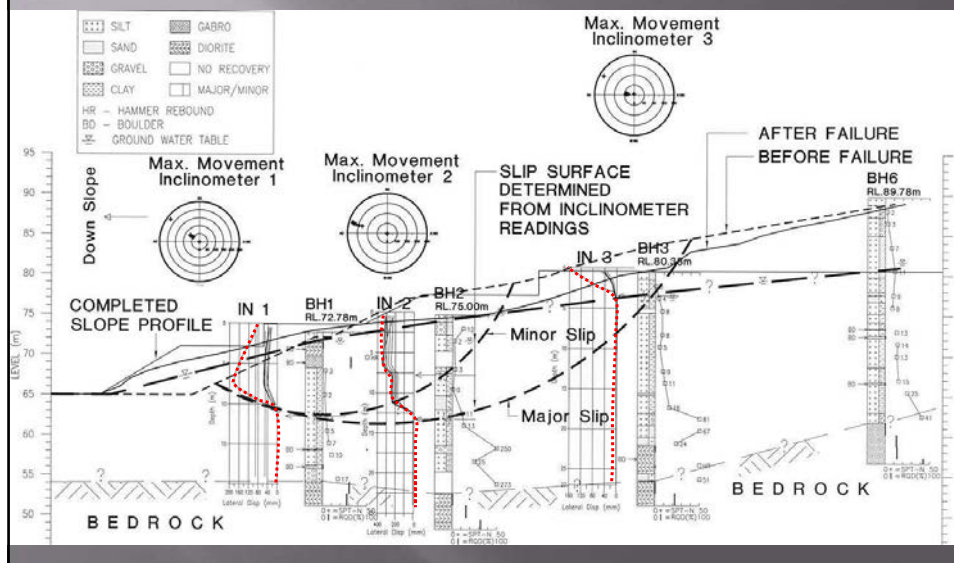
Interpreted Slip Surfaces

- IN-1 and IN-2 were sheared off at 10.5m and 12.0m below ground.
- IN-3 sheared off at 2.5m below ground.
- Observation wells were also sheared off.

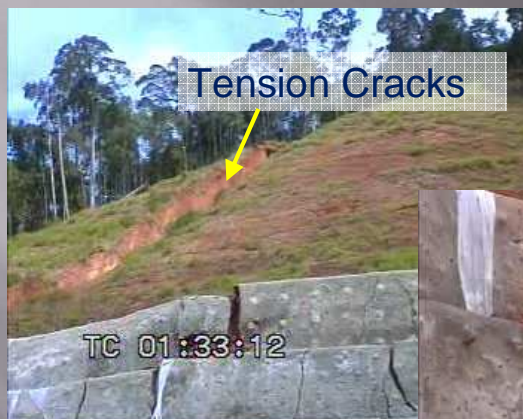
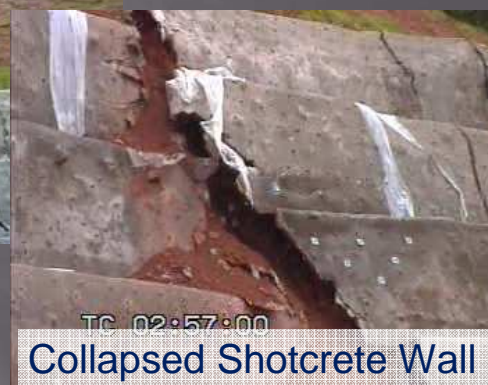
Site Observations

- RL210m to RL330m.
- 7 Upper berms of 1V:1H Cut Slope & 5 Lower berms of 4V:1H Soil Nailed Slope
- Soil Nail : 12m with spacing of 1m(V):1m (H)
- Geology : Shale Facies in Gua Musang Formation (mainly consists of Mudstone & Sandstone)
- A massive slope failure occurred before soil nails were installed at the lowest berm.

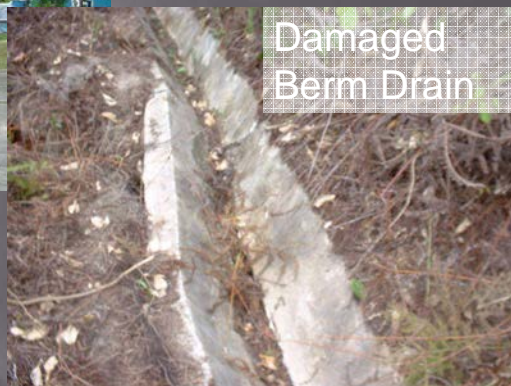
Damaged
Berm Drain

- The cut slope with 6 berms was formed in 90s
- Slope gradient varies from 1V:1.72H (lowest berm) to 1V:1H (highest berm)
- RL75m to RL110m.
- Geology: Granite formation.
- Slope movement was detected in Nov 2002 and obvious tension cracks were found at the lowest three berms.

- ❑ Installation of Soil Nails (12m, 18m and 27m).
- ❑ Installation of horizontal drains.
- ❑ Repairing and re-construction of berm drains.

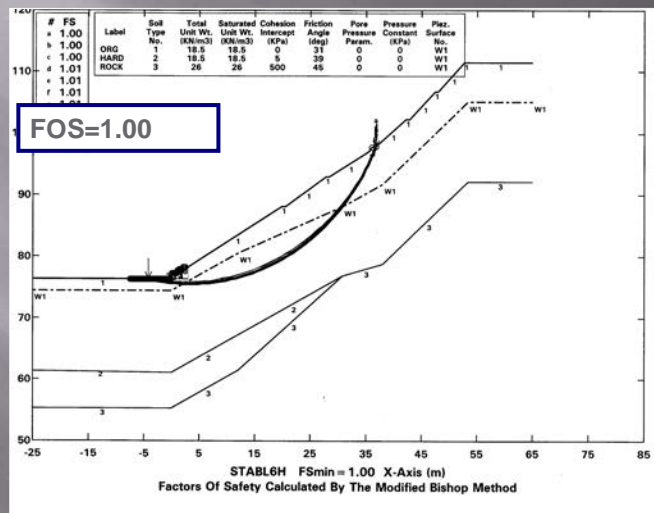
Slope Stability Analyses

- ▣ Max lateral movement (IN. 1)
~ 8mm with the depth of shear surface of about 7m tallies with stability analyses.

- ▣ The gradient of the cut slope is steep and is not stable in long term
- ▣ Slope strengthening works with installation of soil nails and subsoil drainage system have proven an effective solution to stabilise the distressed slope.

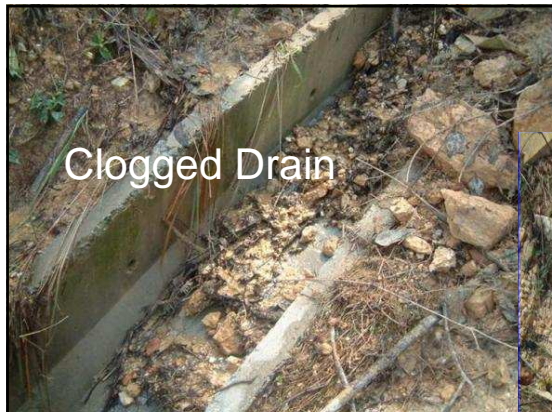
Clogged Drain

- ▣ The platform of pipeline was saturated.
- ▣ Concrete drains were clogged.
- ▣ Debris, tree trunks and vegetations indicated surface runoff overflowed the platform and traveled downslope to valley.
- ▣ Failed mass traveled more than 120m downhill along valley.

- Fill embankment over valley.
- Fill embankment comprises of :
rock toe and seven berm slope (1V:2H).
- Provision of extensive subsoil drainage :
French drain and drainage blanket.
- Upgrading and construction of new drainage system.

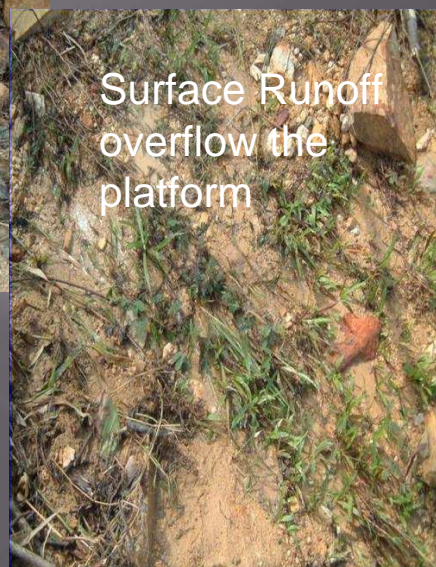
Surface Runoff
overflow the
platform

- Valley terrain (Channelised runoff).
- Steep fill slope gradient – steepest gradient of 1V:1H.
- Marginal FOS when groundwater level rises near to ground surface.
- Poor drainage system lead to saturation and erosion.

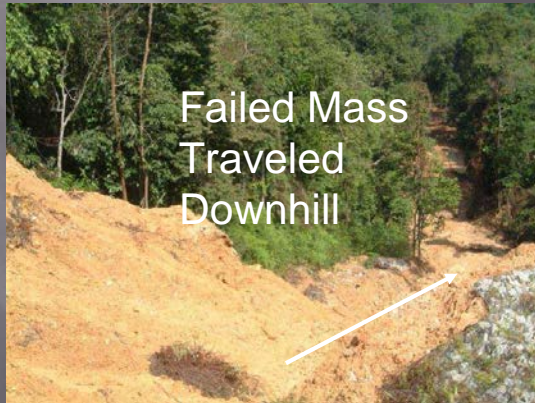
- ▣ Bedrock was observed at certain parts, indicating the failure resembles a slide along the bedrock surface.

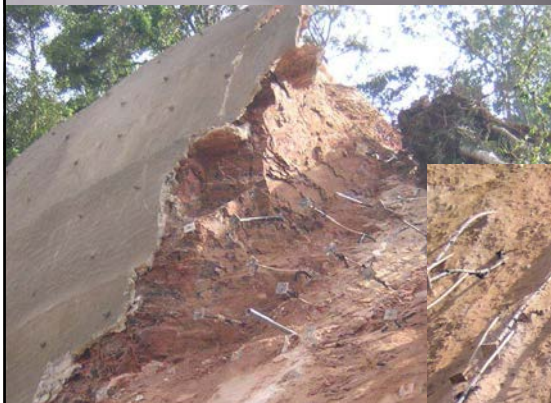
**Soil nails hanging
on failed slope**

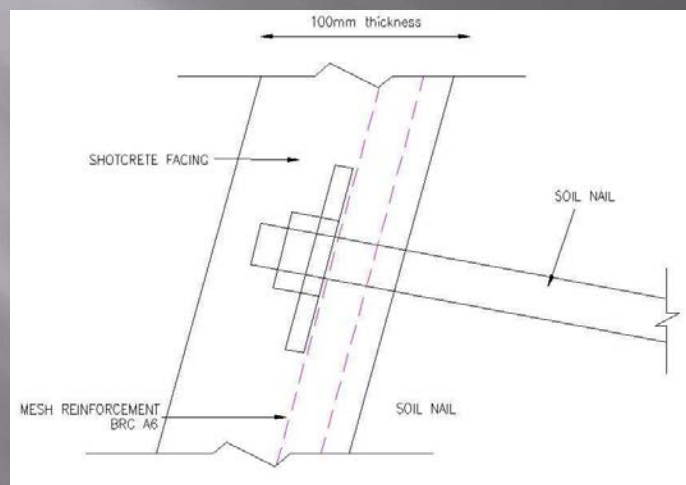
Shotcrete Facing as Constructed at Site

- ▣ Inadequate design of shotcrete facing of soil nailed slope.
- ▣ FOS against overall failure is inadequate and marginally stable.
- ▣ Rainfall/ groundwater is not a triggering cause to failure.

- ▣ 4 Failure modes (nail tendon failure, nail pull-out failure, facing failure) & overall failure shall be checked. **Facing failure check** is usually neglected.
- ▣ Facing design is critical especially when soil nailed slope is **steep and high**.
- ▣ **Hoek-Brown failure criterion** is appropriate for establishing engineering parameters of weathered rock mass of different formation in Malaysia.

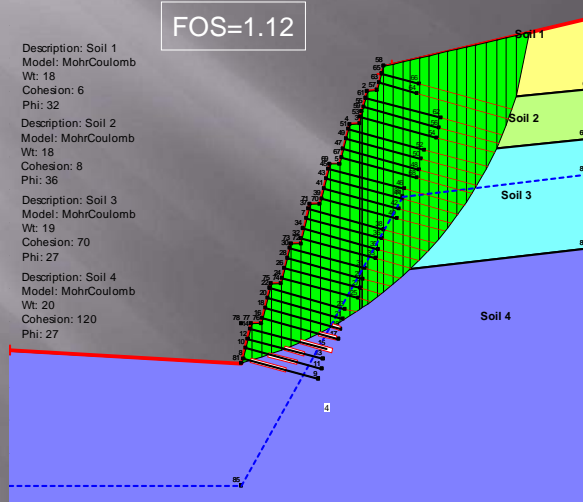
Slope Stability Analysis

FOS=1.12
