# **POWER QUALITY STUDY**

## **MOULDED CASED CIRCUIT BREAKER (MCCB) TRIPPING AT COMPUTER LABORATORY SUB-SWITCHBOARD**

Politeknik Seberang Perai P.Pinang

**Moulded Case Circuit Breaker  
(MCCB) tripping at the Sub-  
Switchboard (SSB 'CL') for  
Computer Laboratory Block**

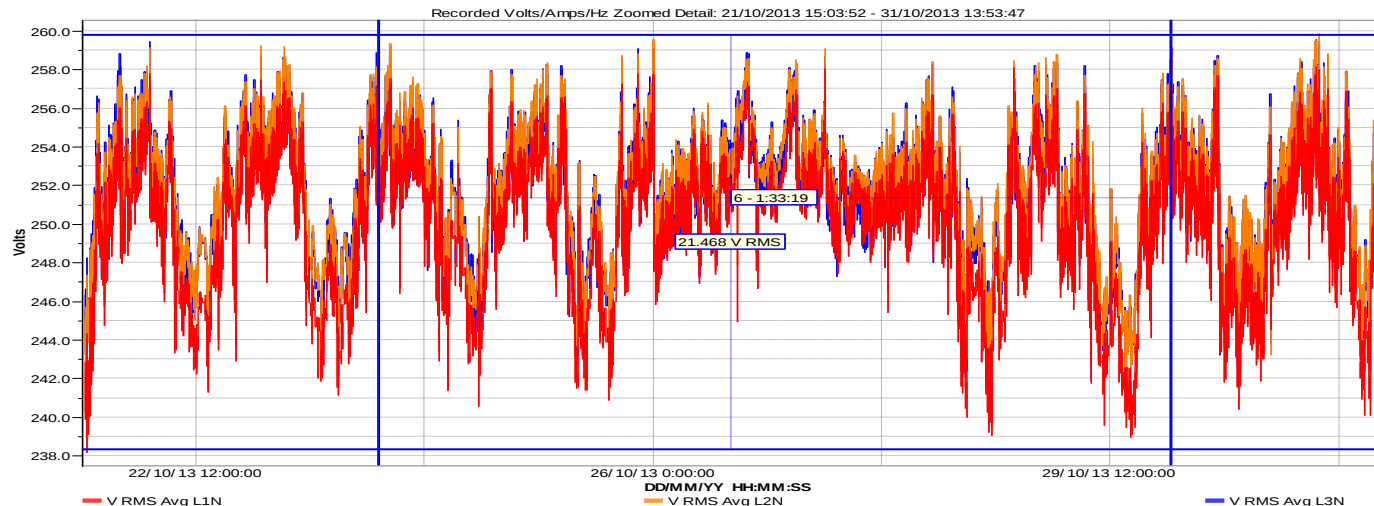
*\*These average RMS voltages are exceed +10% limit of the nominal voltage.*

Figure below shows the voltage fluctuation is 21V (9.3%) are considered high (above 6% of nominal voltage, i.e.>13.8V)

- **Immediate Action to be taken**
  1. Redistribute final circuit loads to improve balance of the three phases. The maximum unbalance current should be below the earth fault relay pick up current.
  2. Reduce the supply voltage to the nominal value by changing the position of the tap-changer of the transformer.

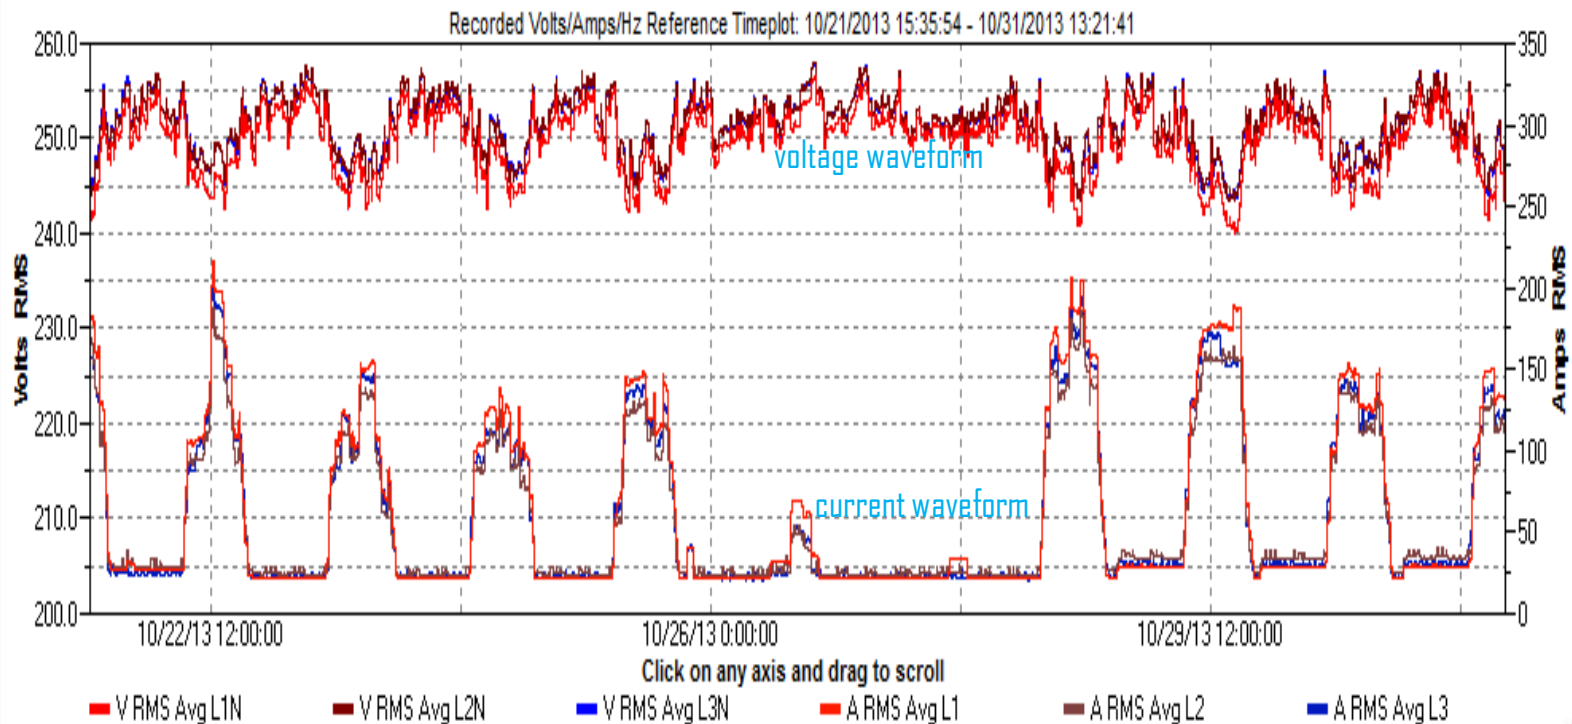
Recorded data shows that, when the current increase and the voltage drop significantly (or vice versa) shows that the electrical distribution system for SSB'CL' has high system impedance.

| | Event recorded | Caused by | Effect to the system |
|---|---|---|---|
| 2 | <b>Significant Voltage drop &amp; Current increase</b> (or vice versa) | <u>Loose or defective wiring</u> , such as insufficiently tightened screws connection on power conductors or corroded connections | Electrical distribution system SSB'CL' has high system impedance |

1. Check the wiring installation of the electrical system and correct all the wiring errors such as improper neutral-to-ground bond, intermittent single line-to-ground fault and improper cable joint.
2. Check for loose neutral connections.
3. Inspect the wiring for other equipment, light fittings etc. for loose joints and terminations.

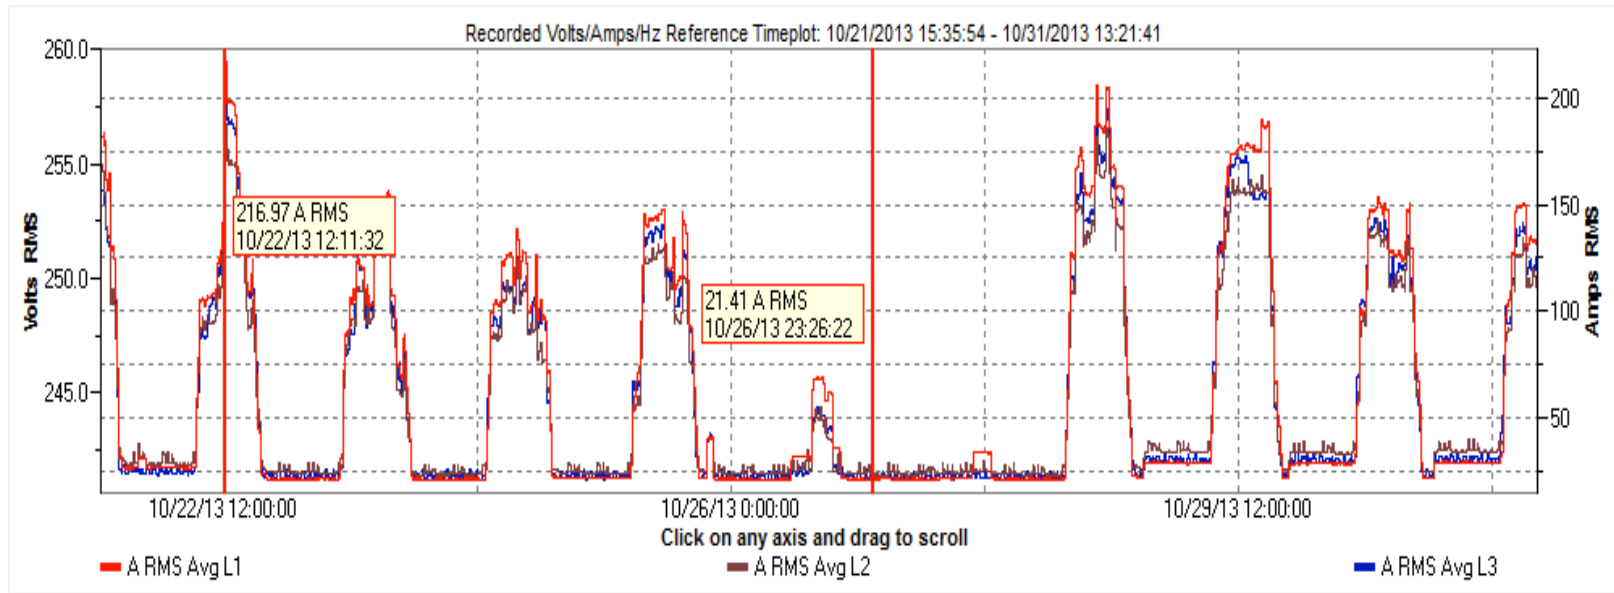
| | 10 minutes trend data average RMS | | | Detail view data average RMS | | |
|---|---|---|---|---|---|---|
| Current | 216.97A | 188.08A | 205.09A | 259.13A | 220.55A | 239.77A |

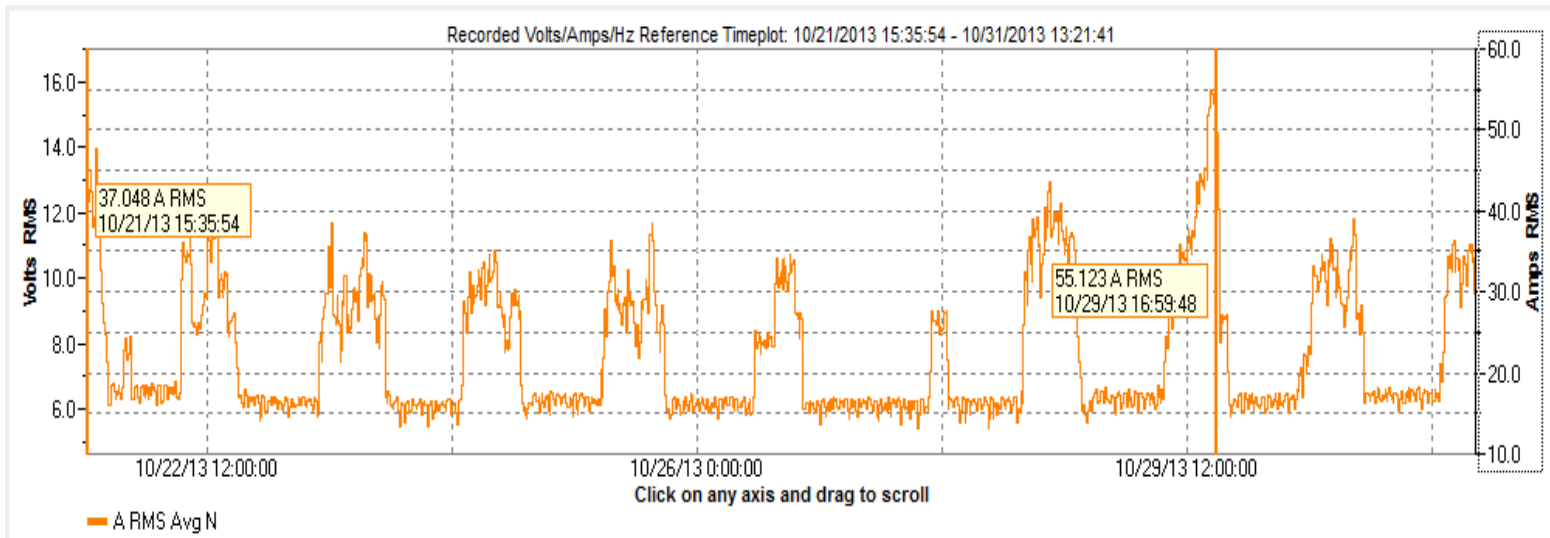
| Data | Unbalance Neutral Current, $I_N$ | Indicator | Effect to the system |
|---|---|---|---|
| 10 minutes trend data average RMS | 55.12 A | > the earth fault relay pick up current (i.e 50 A) | nuisance tripping to the MCCB |
| Maximum current unbalance (%) | 23.41% | | |

| | Event recorded | Caused by | Effect to the system |
|---|---|---|---|
| 3 | <b>Unbalance Neutral Current, <math>I_N</math></b> | $I_N >$ the earth fault relay pick up current i.e 50 A (for this SSB 'CL') | Nuisance tripping to the MCCB |

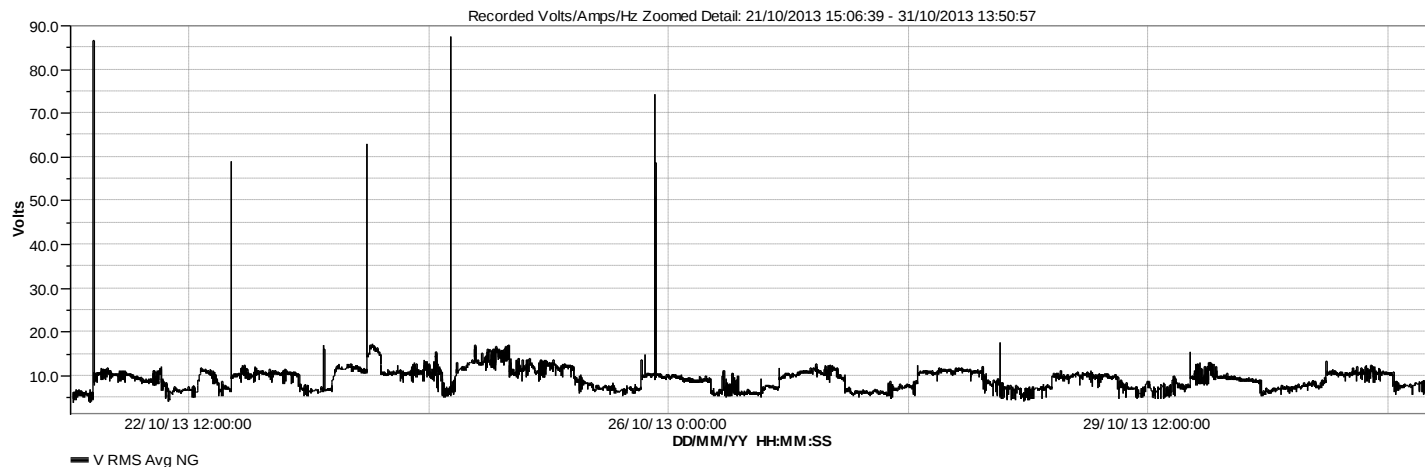
*The neutral to ground impulses :*

| Data | $V_{NG}$ | Indicator | Caused by | Effect to the system |
|---|---|---|---|---|
| Detail view data average RMS | 87.47V (impulse) | <i>The magnitude of <math>V_{NG}</math> is <b>high</b> (values above 4.3% (&gt; 10V) of the nominal voltage)</i> | Neutral to ground impulses indicate that there are <u>wiring errors</u> in the electrical wiring installation (intermittent single line-to-ground fault) | Neutral to ground impulses can result in <u>equipment damage</u> over time and also can cause <u>nuisance tripping</u> of Residual Current Circuit Breaker (RCCB) |

| | Event recorded | Caused by | Effect to the system |
|---|---|---|---|
| 5 | <b>Neutral to ground impulse</b> | Neutral to ground impulses indicate that there are <u>wiring errors</u> in the electrical wiring installation (intermittent single line-to-ground fault) | Neutral to ground impulses can result in equipment damage over time and also can cause nuisance tripping of Residual Current Circuit Breaker (RCCB) |

4. To mitigate high neutral-to-ground voltage, it is recommended to install an isolation transformer connected as separately derived system. The transformer should be placed near to the load.

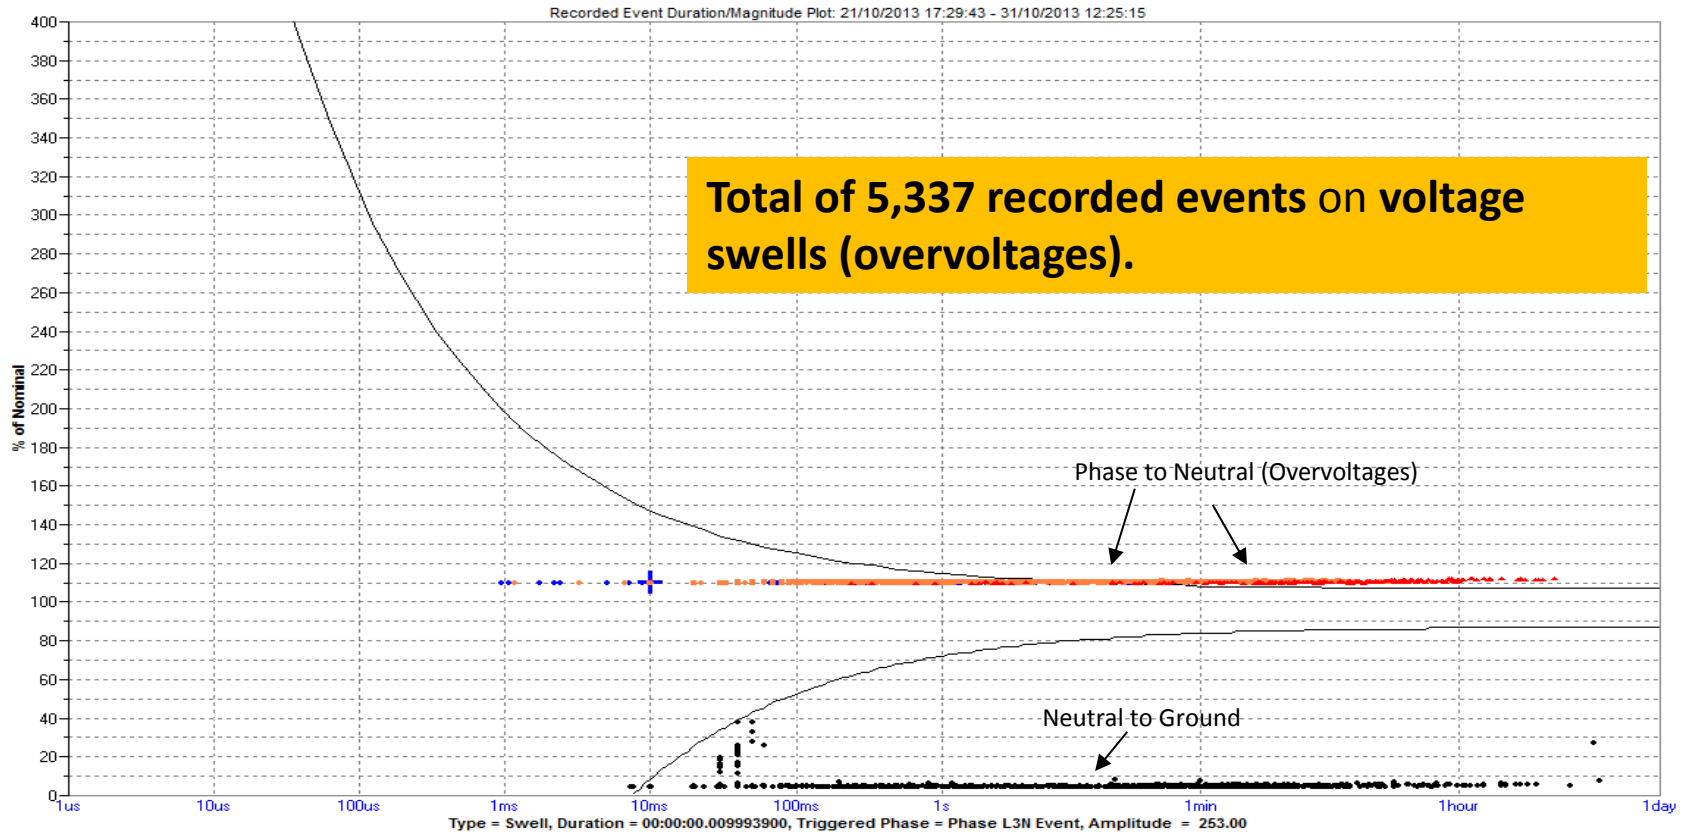
Plot of events on a CBEMA voltage tolerance curve

During the measurement period, there was **no tripping incident** but there were **events on voltage swells** (overvoltages) which recorded 5,337 times.
