# **Structural Monitoring of the Akashi Kaikyo Bridge**

**Kiyohiro Imai**

**Honshu Shikoku Bridge Expressway Co. Ltd.**

# Arrangement of Monitoring Sensors on the Akashi Kaikyo Br.

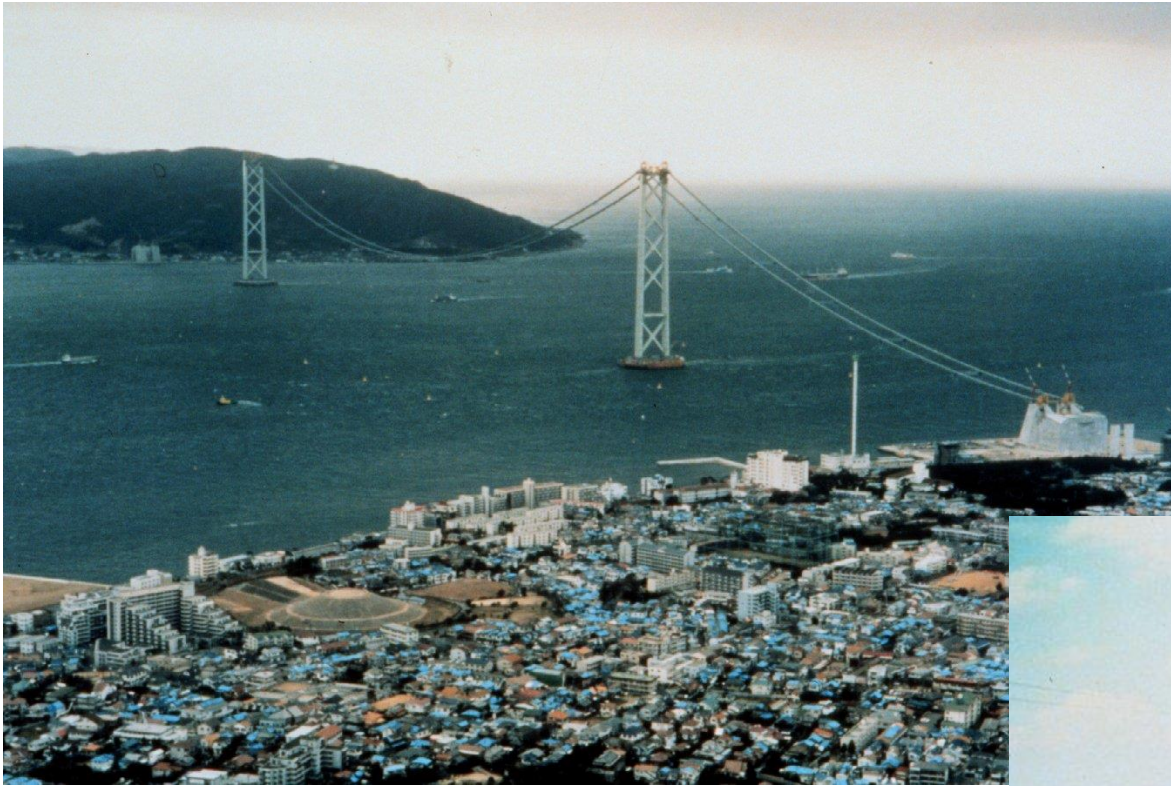
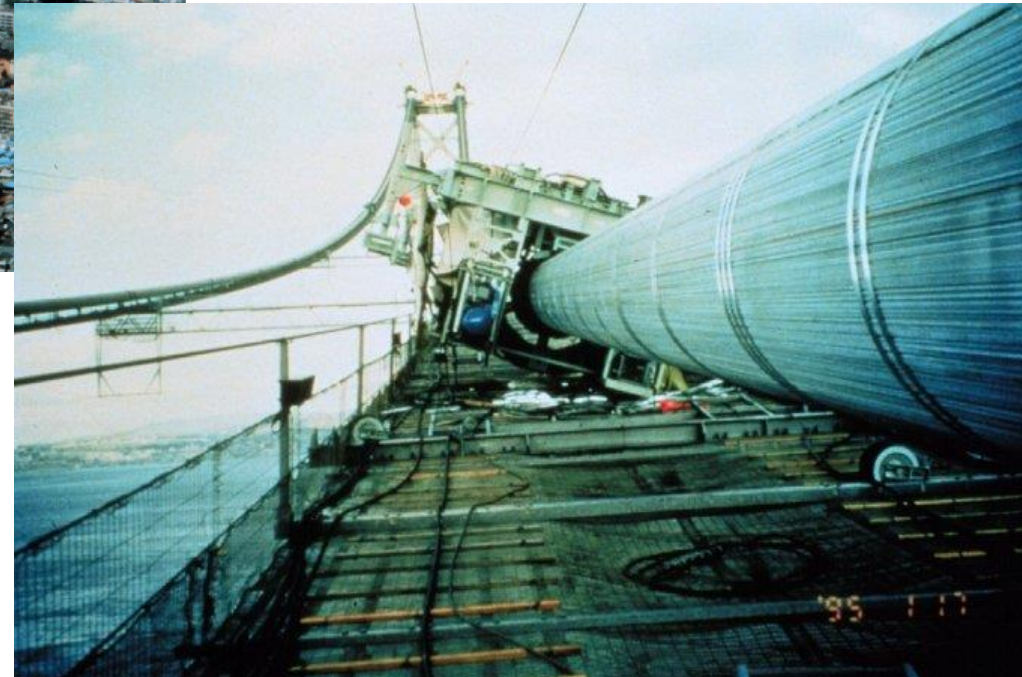
# Akashi Kaikyo Bridge just after the Earthquake (January 23, 1995)

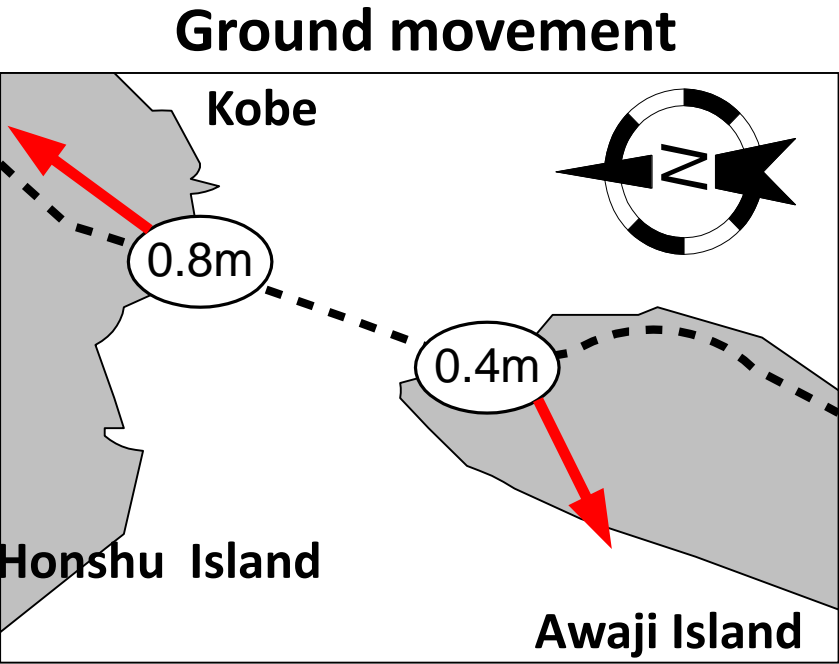
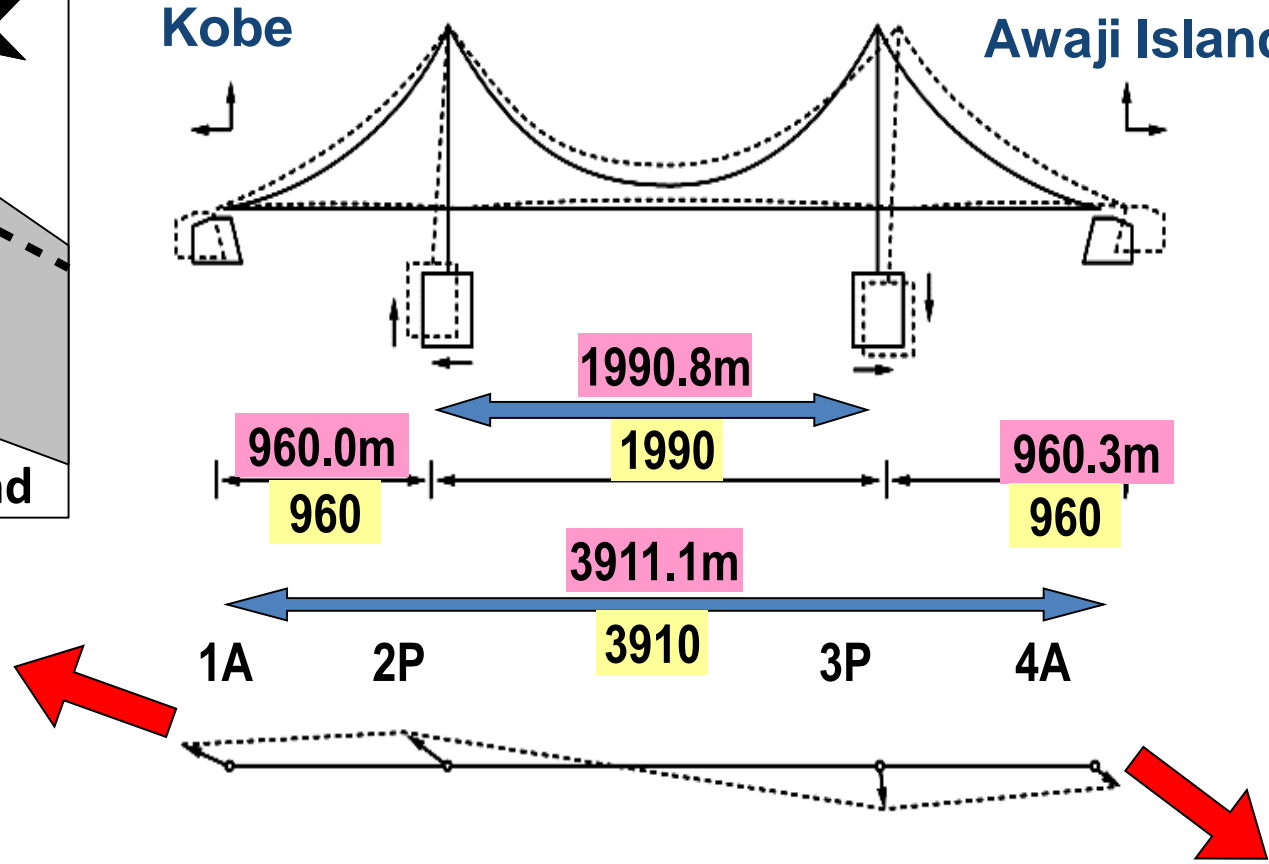
Effects of Kobe earthquake on

the Akashi Kaikyo Bridge

Relative deformation of bridge

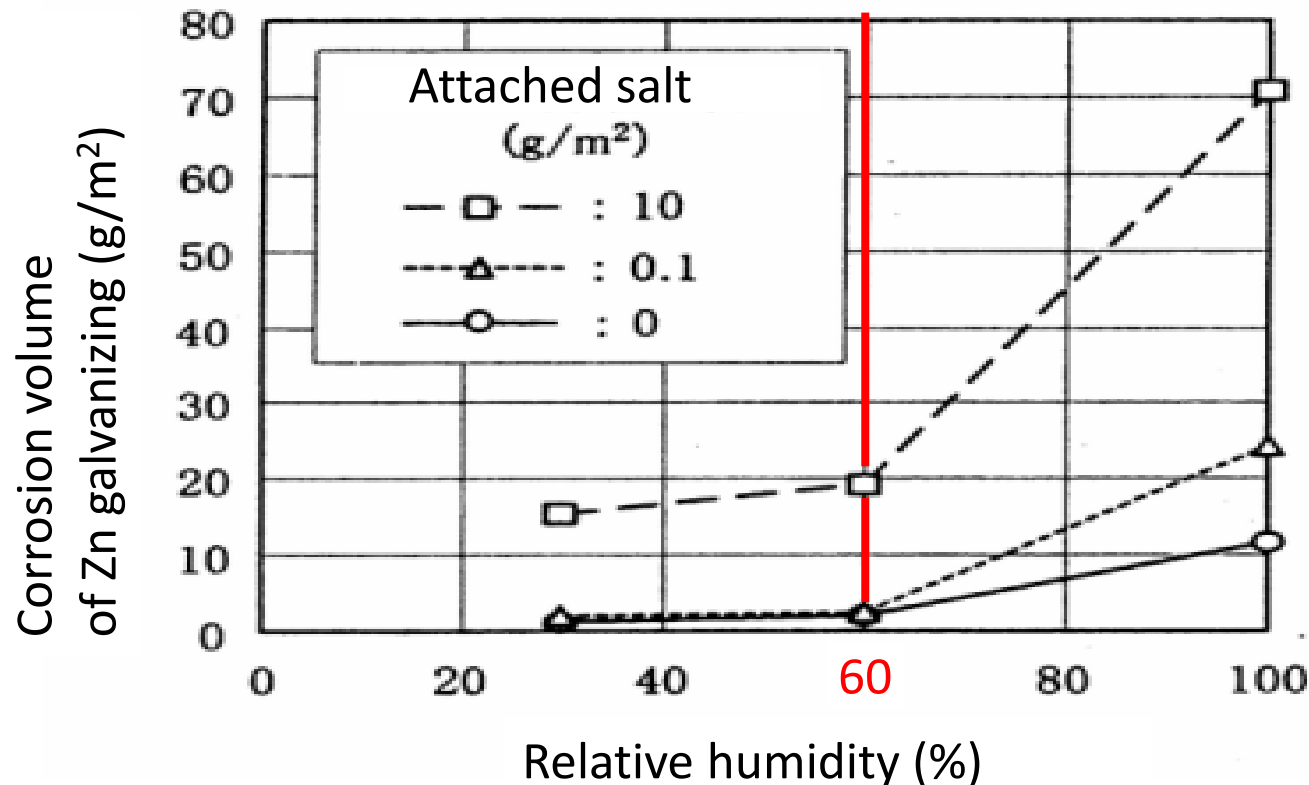
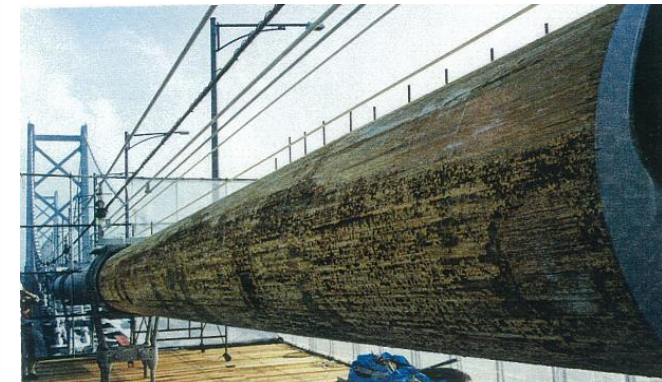
- Keep relative humidity in the cables less than 60%, and the cable can be protected from corrosion.
- Dry-air injection system was introduced to keep relative humidity less than 40% in the cables.

Corrosion of a main cable

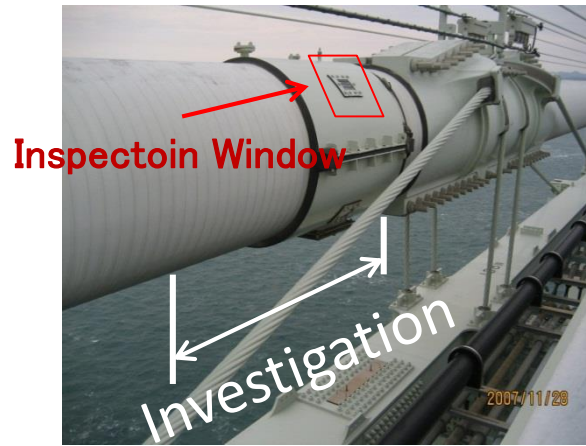
February, 2008 (9 year)

## 9 and 20 years after Completion

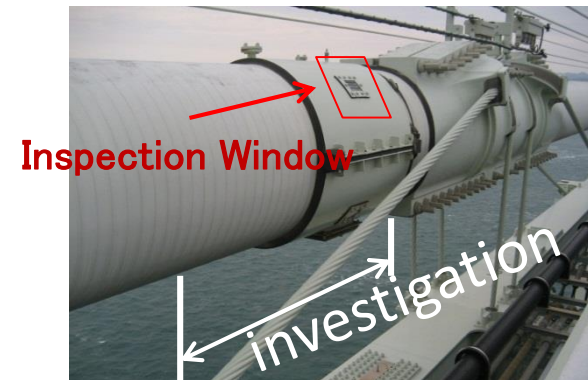
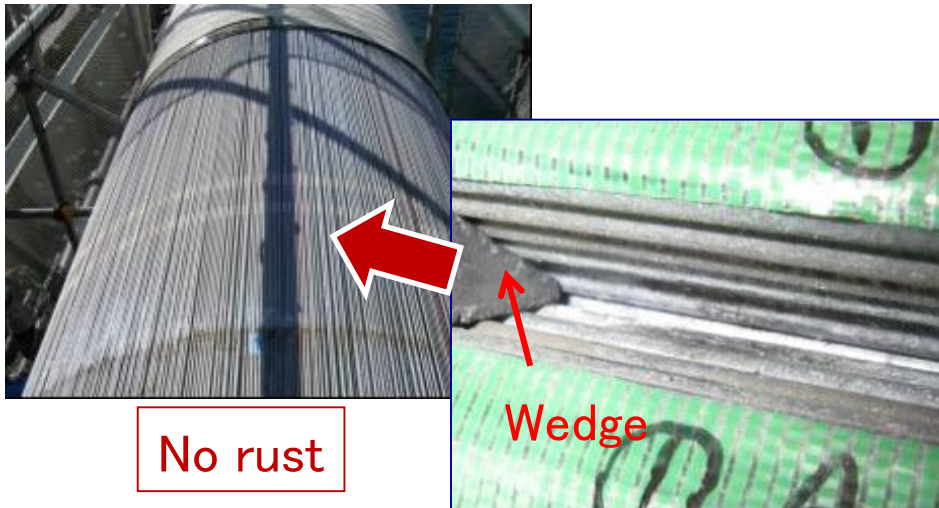
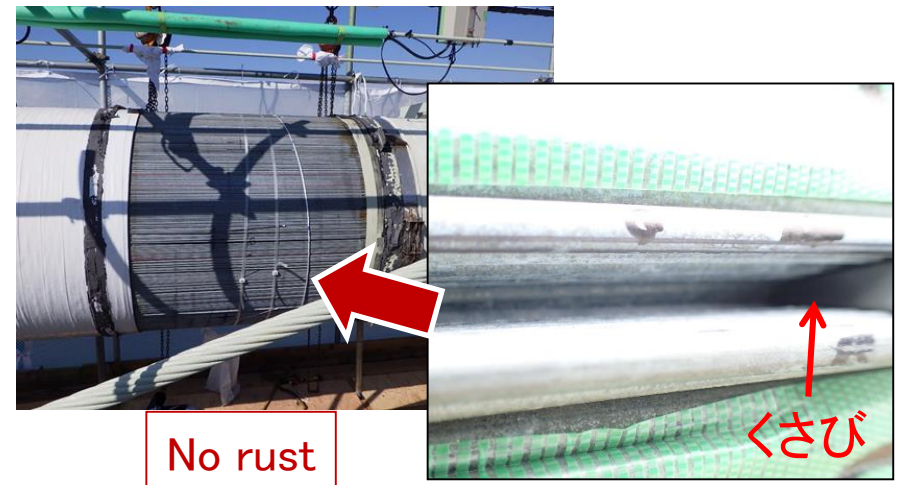
November, 2018 (20 years)

- Dynamic monitoring has been conducted on major Honshu Shikoku Bridges
- It was confirmed that original design of the bridges is appropriate and proved to be conservative.
- Main Cables have been protected against corrosion by the Dry-air Injection System.
- It was confirmed that main cables are in proper condition.
- In order to improve the Dry-air injection system, more efficient operation has been currently investigated and introduced. (Reduction of operation units, reduction of air pressure, installation of pre-cooling units, etc.)
