FORENSIC ENGINEERING FOR GEOTECHNICAL ENGINEERS

4.0 Circumstances Leading to Geotechnical Failure - 1

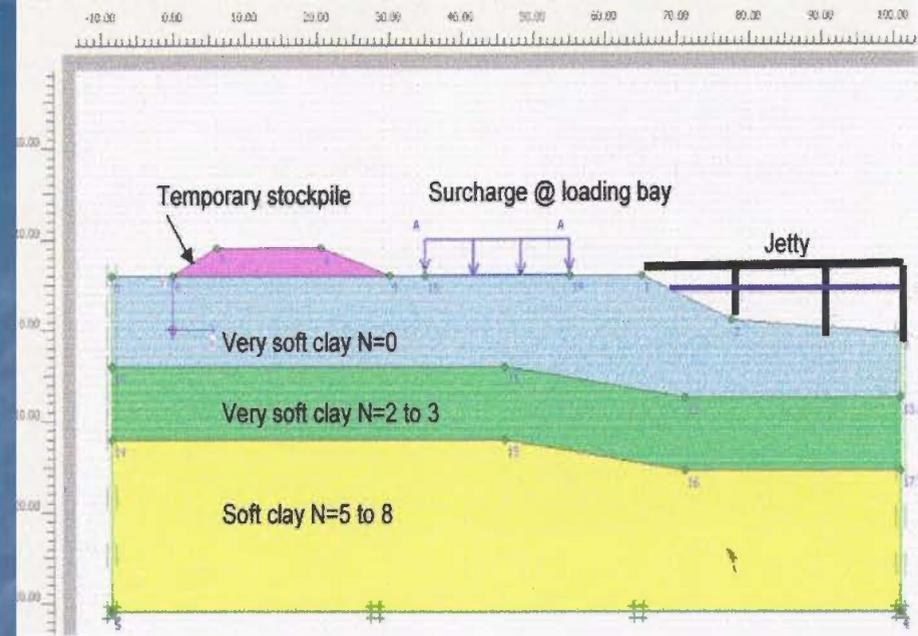
Plan of Stockpile & Jetty Area

- Excessive surcharge load
- Large stockpile on soft grd

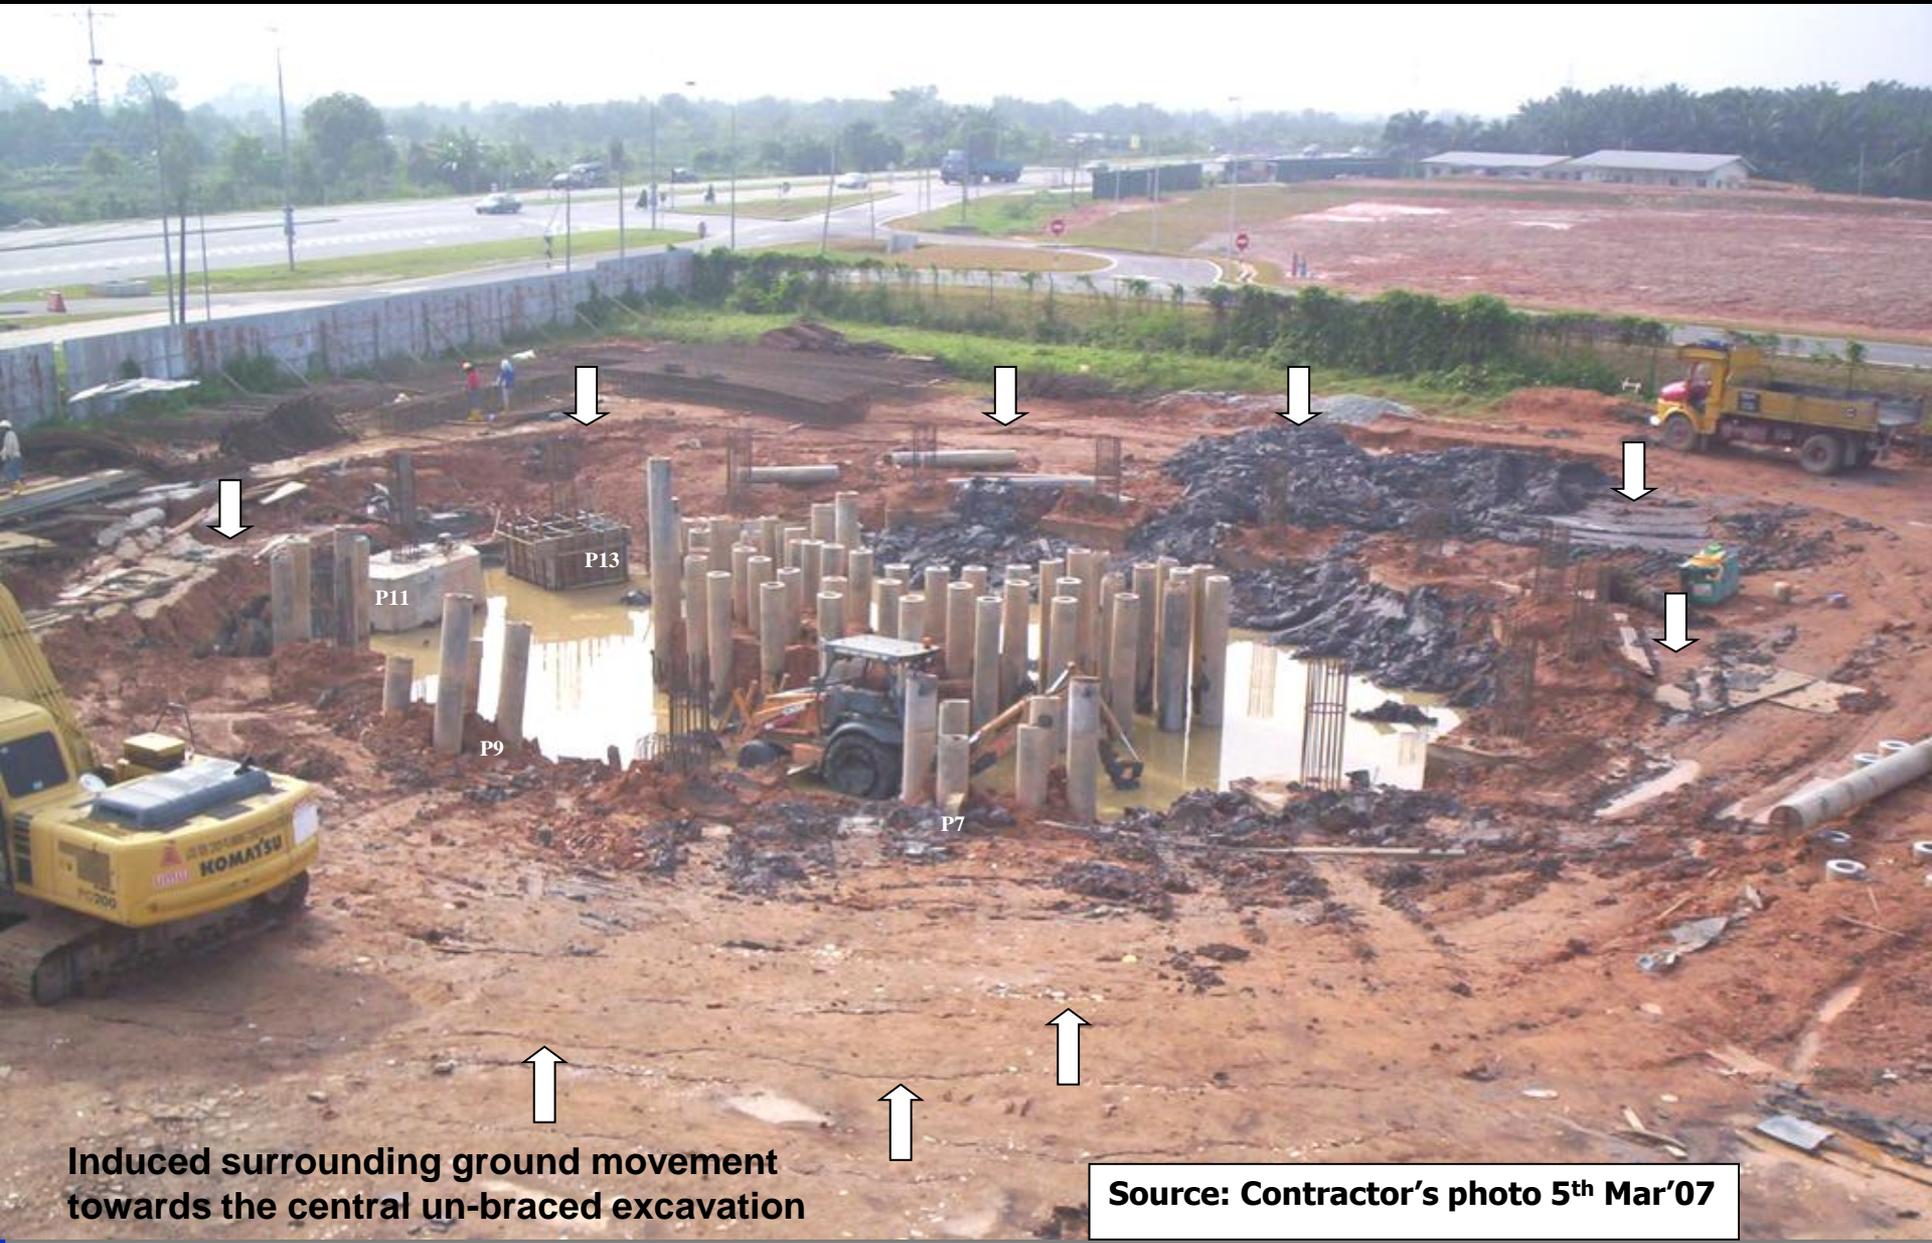
Induced surrounding ground movement towards the central un-braced excavation

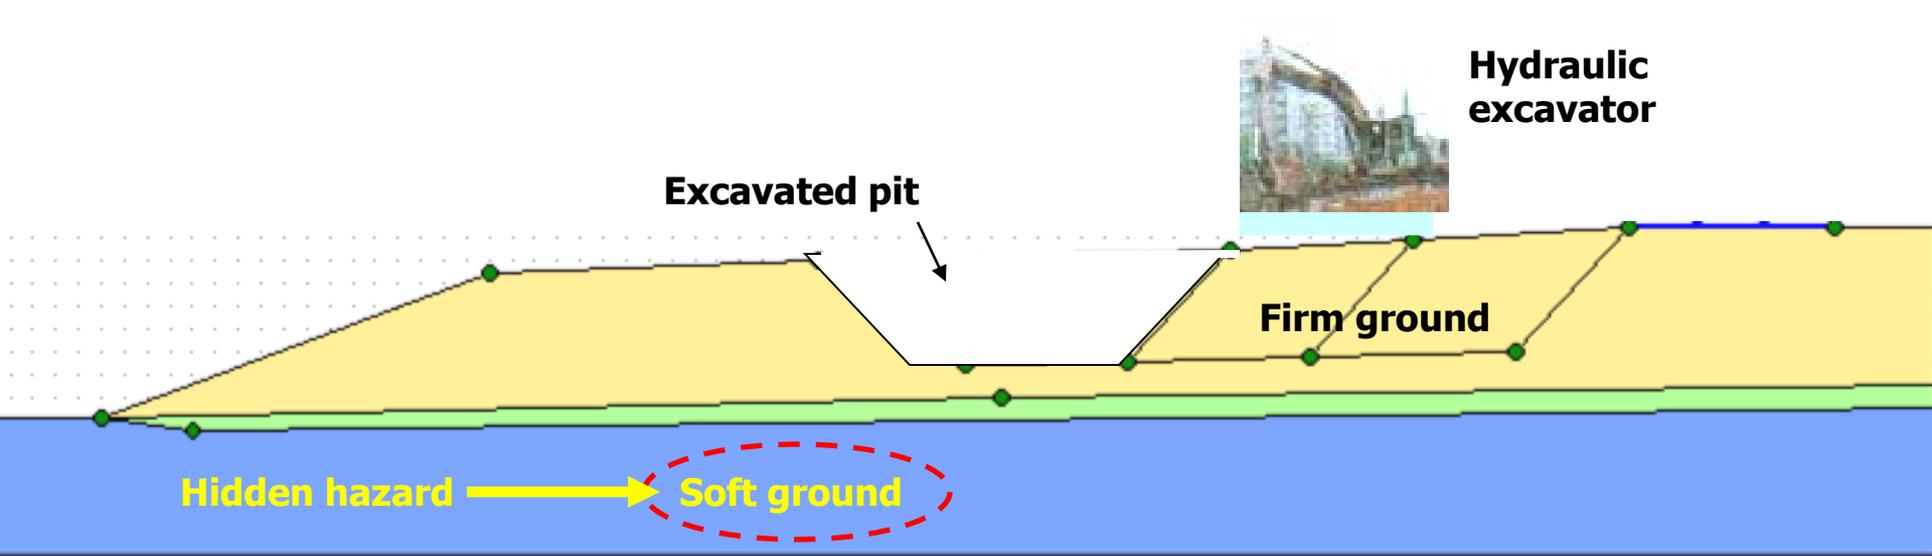
Illustration on the hidden hazard below excavation level

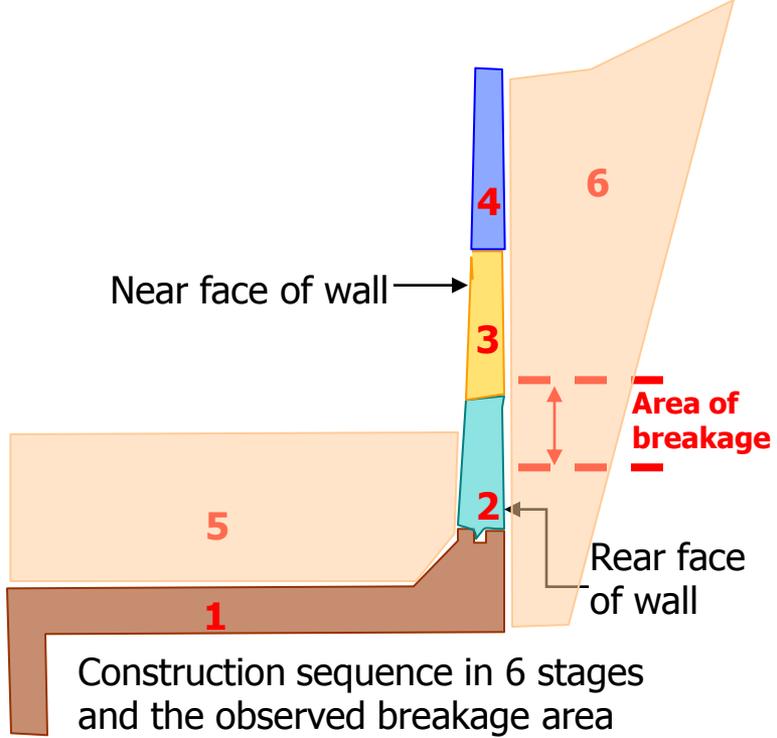
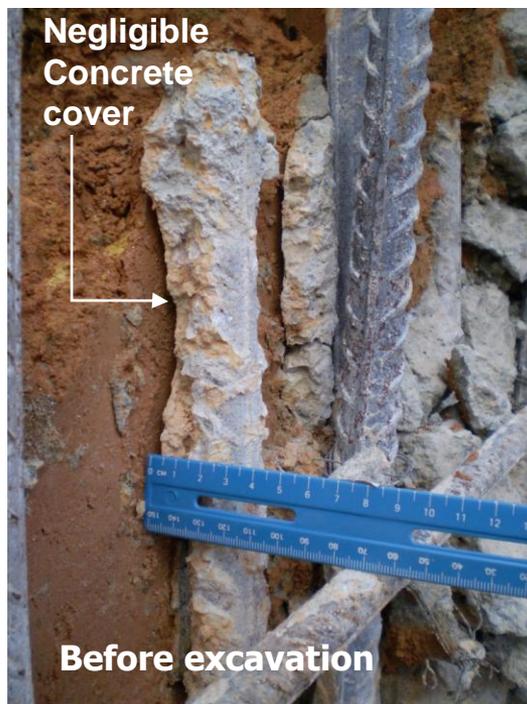
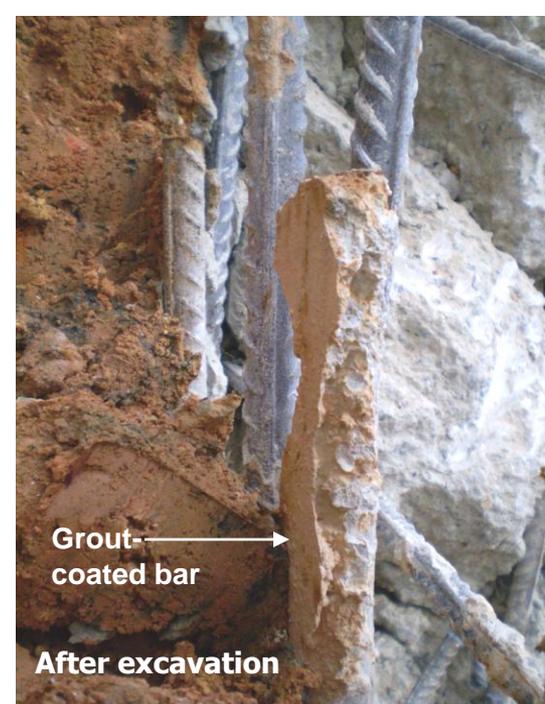
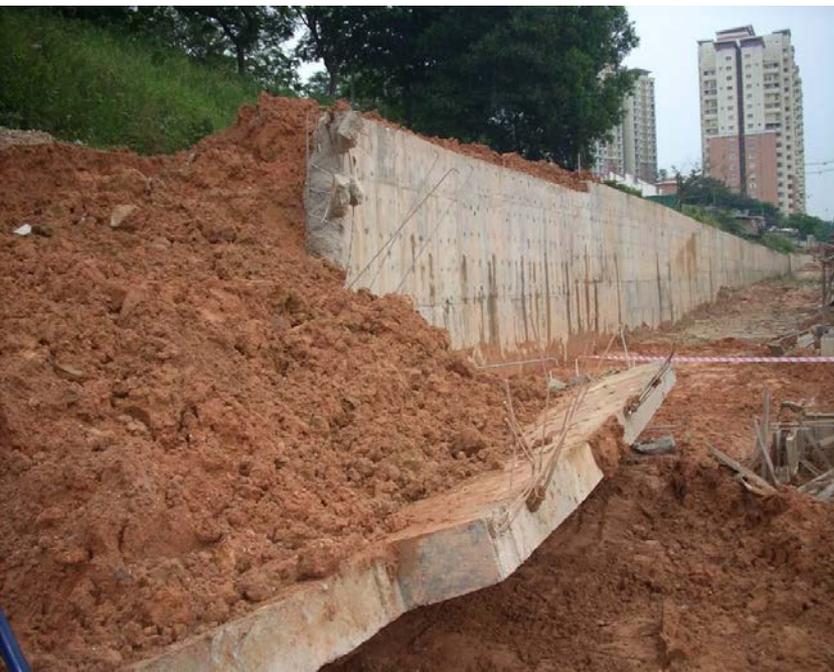
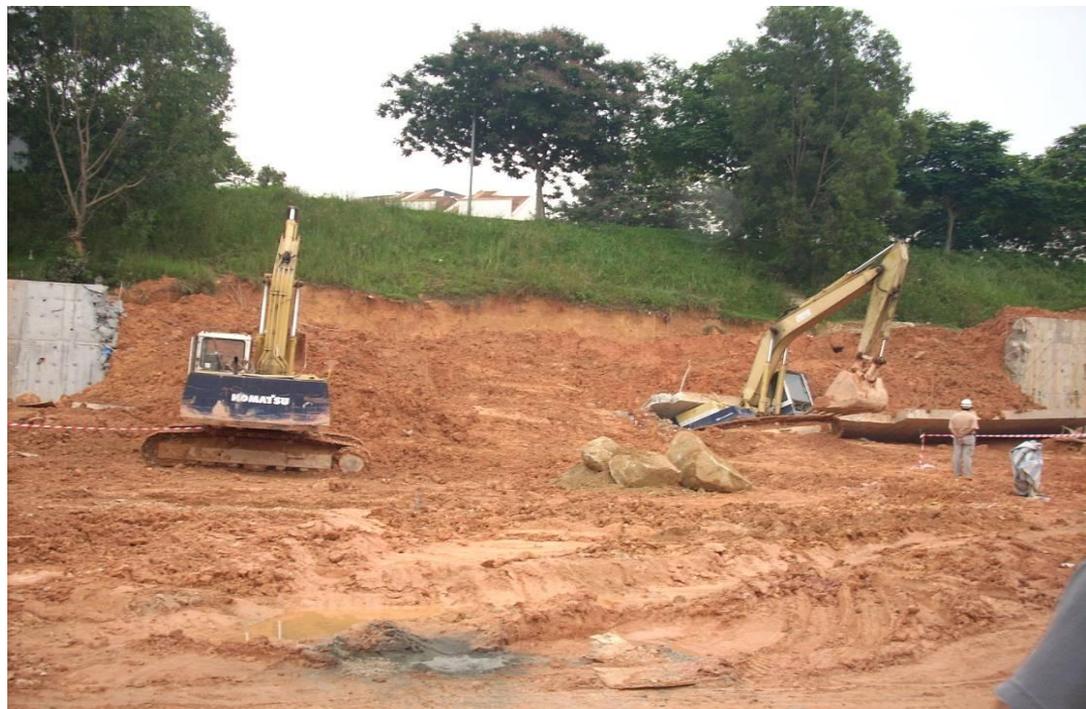
- Poor workmanship
- Inadequate concrete cover
- Movement of formwork

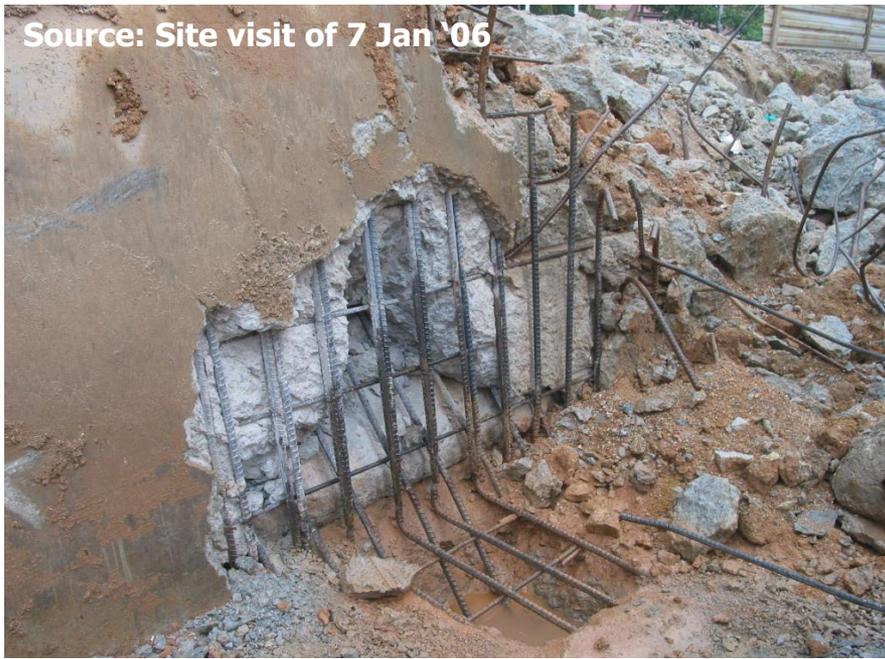
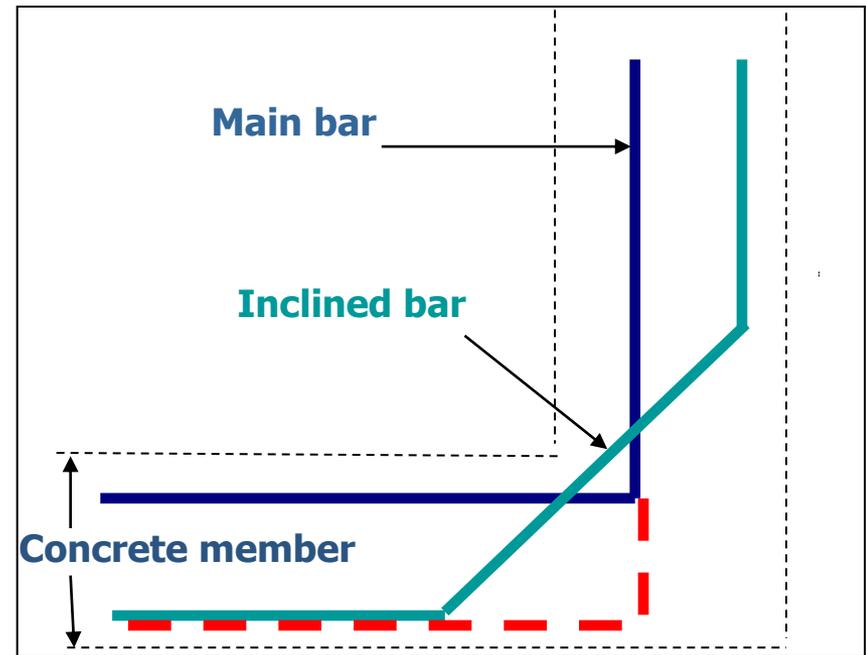
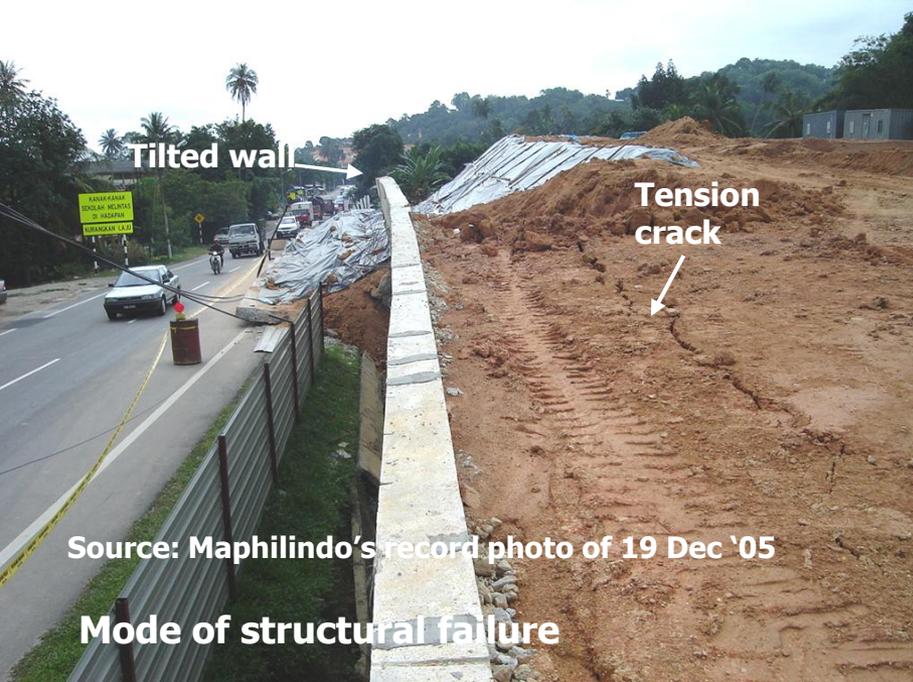
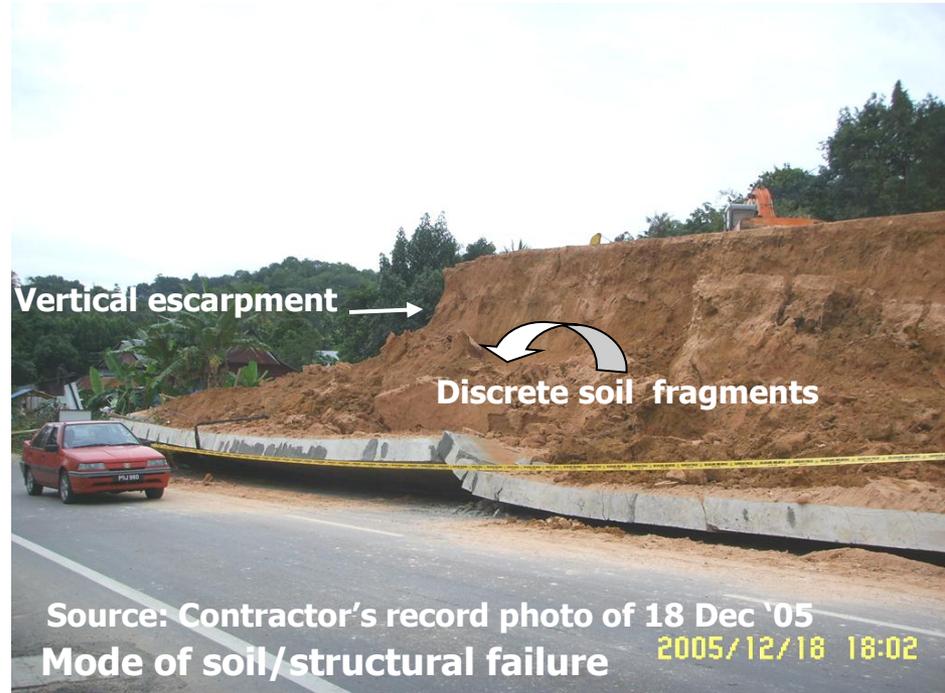
Source: Site visit of 7 Jan '06

- Unclear detailing in critical areas
- Misconception of redundant bars
- Symmetrical structure but different loading
- Unchecked drafting works

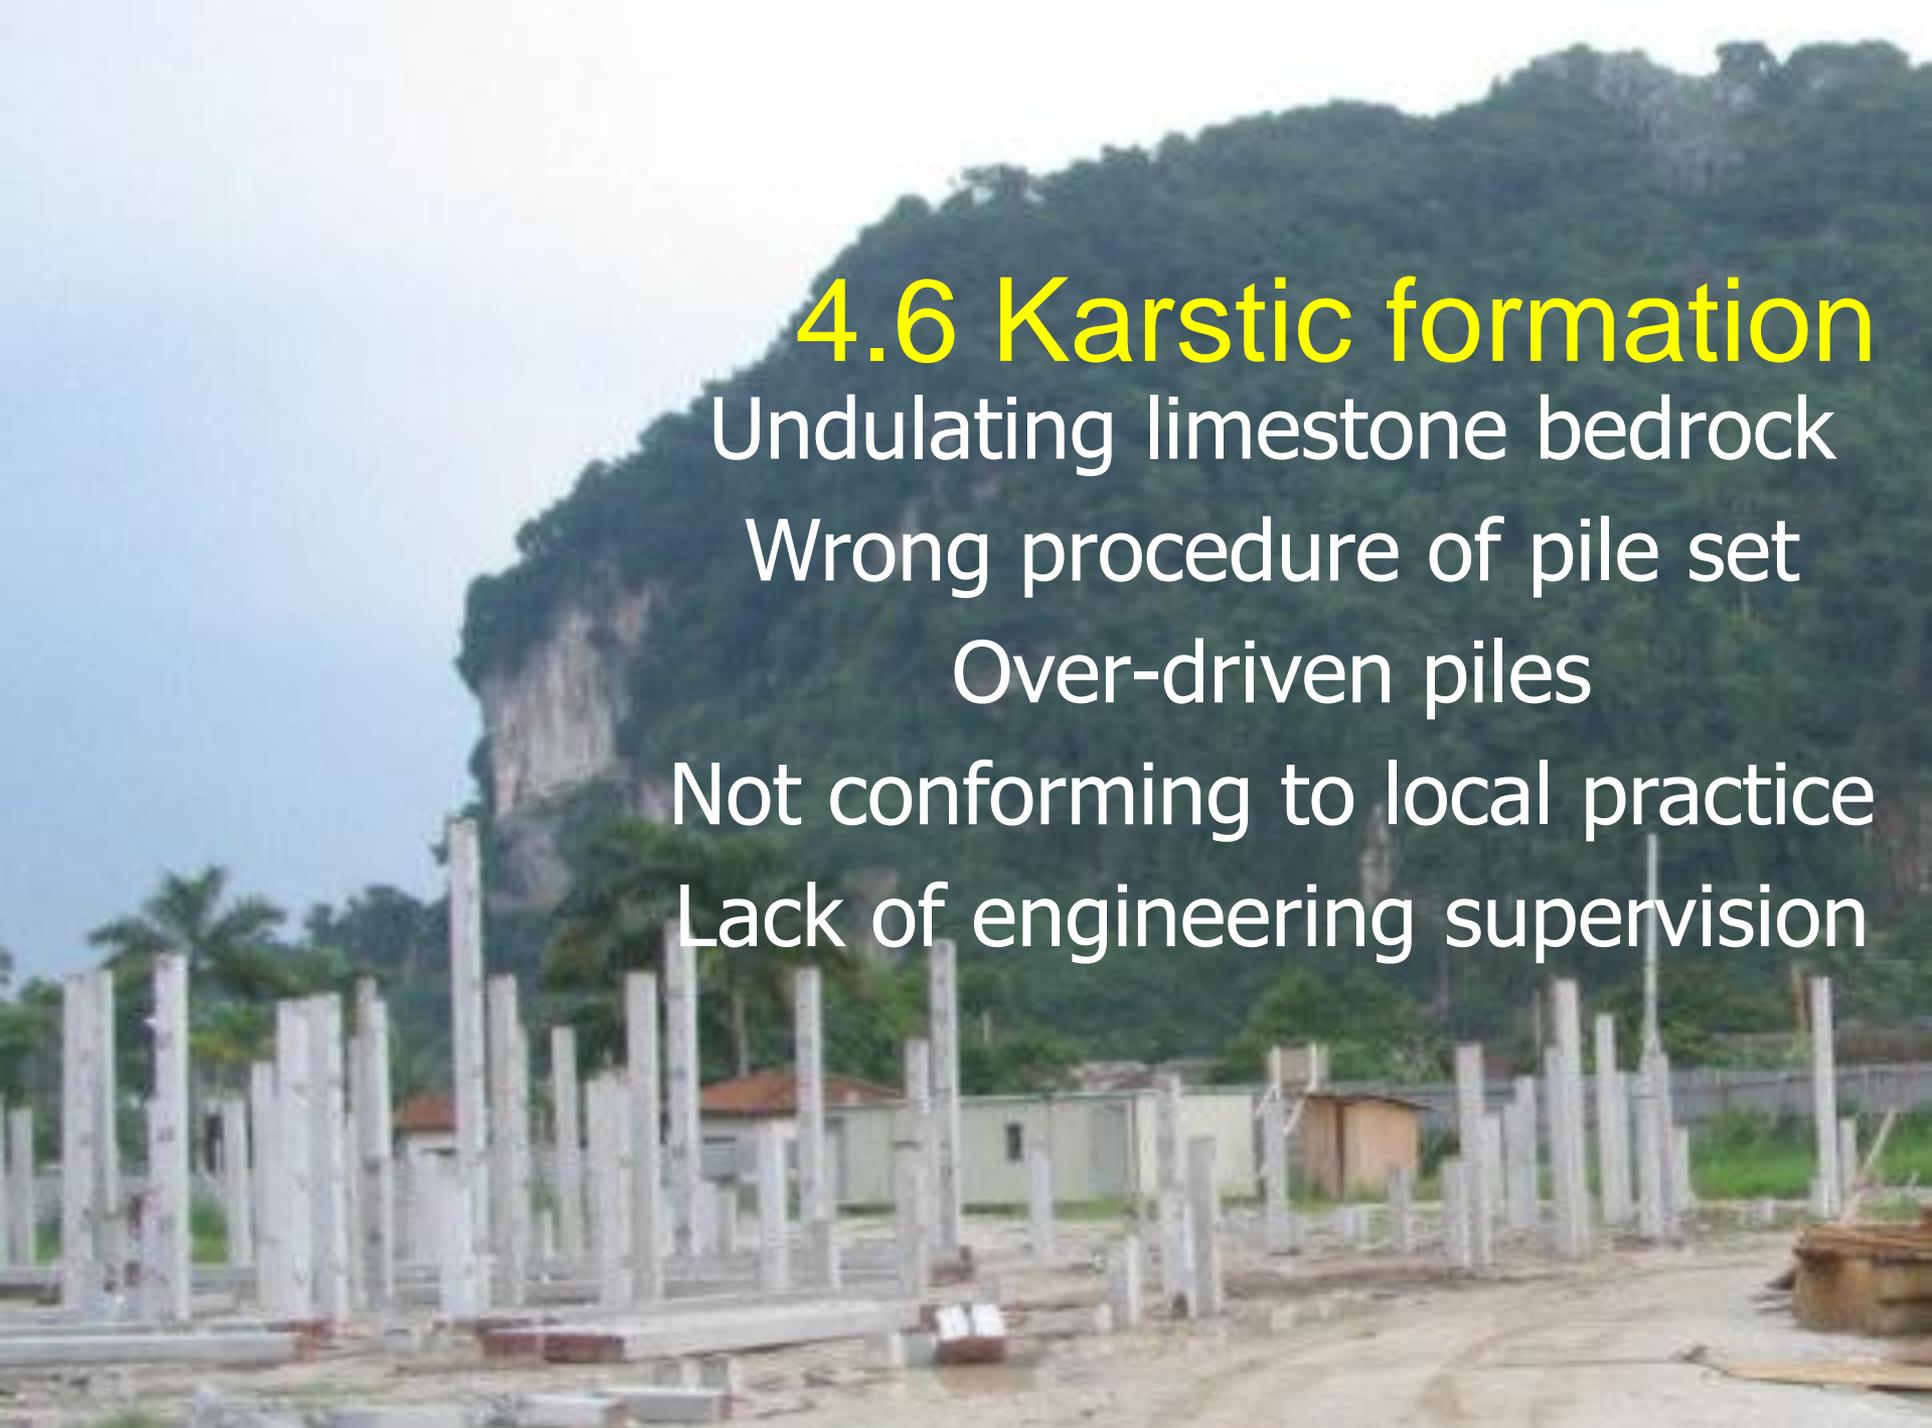
Undulating limestone bedrock

Wrong procedure of pile set

Over-driven piles

Not conforming to local practice

Lack of engineering supervision

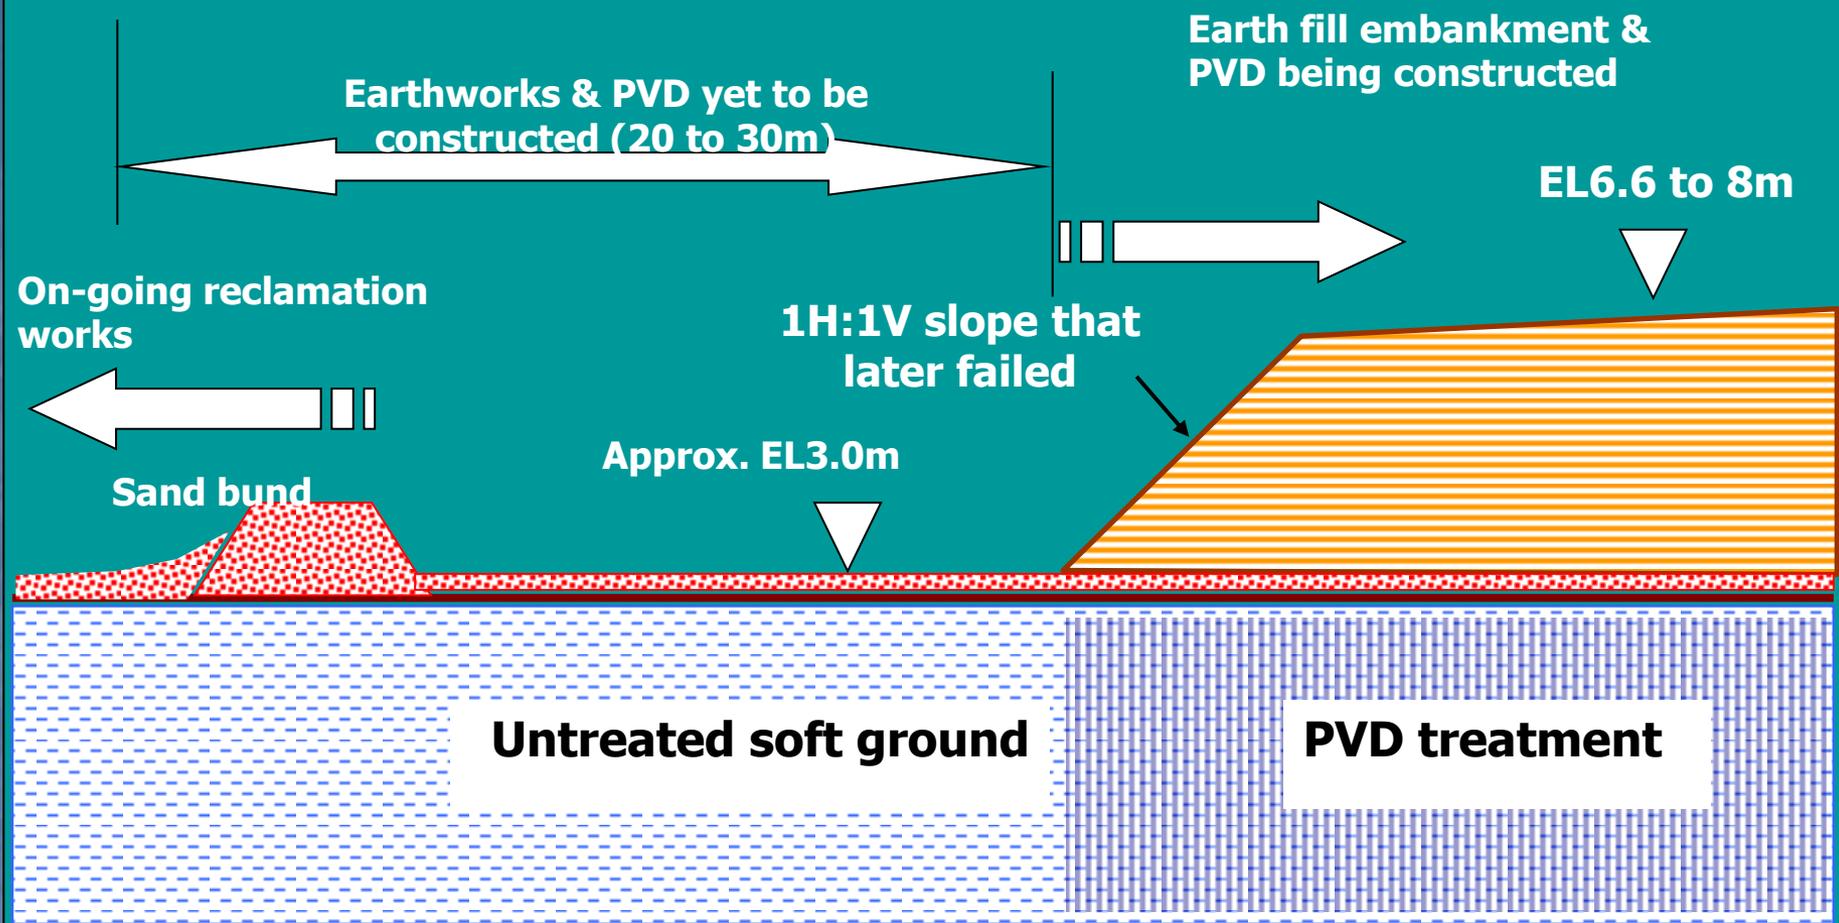
- Unconsolidated foundation
- Rapid build-up, excessive load
- Not responding to instrument results
- Lack of engineering supervision/control

SLOPE FAILURE

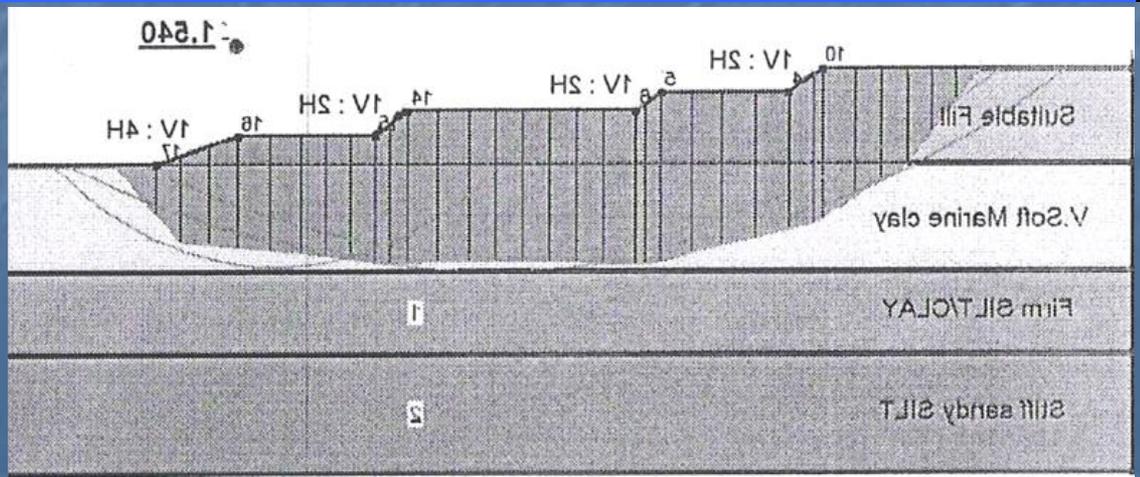
“Reconstruction” of the embankment details before failure

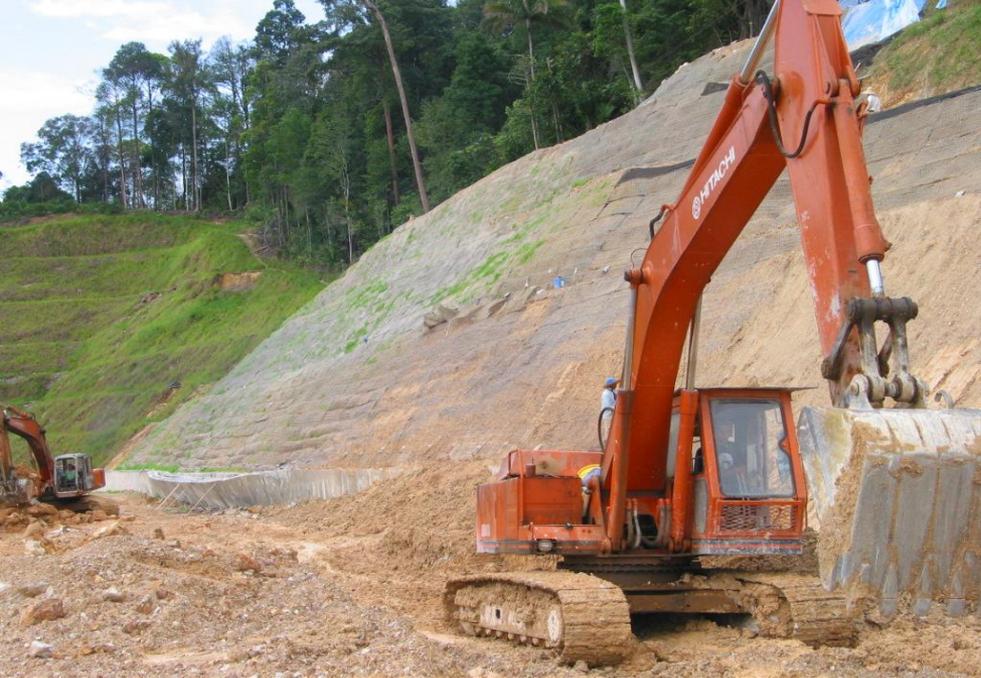
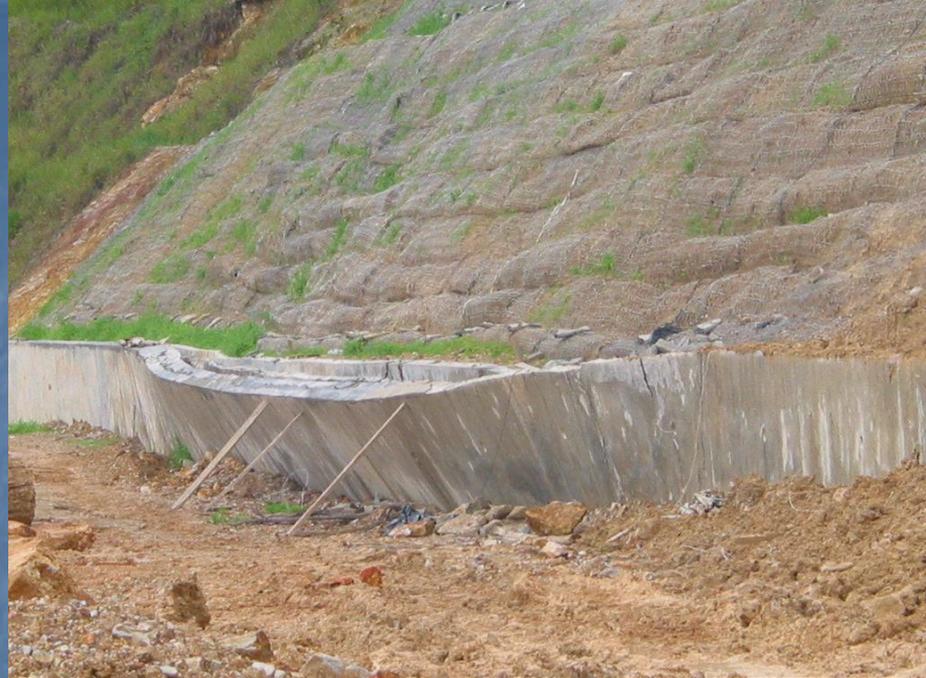
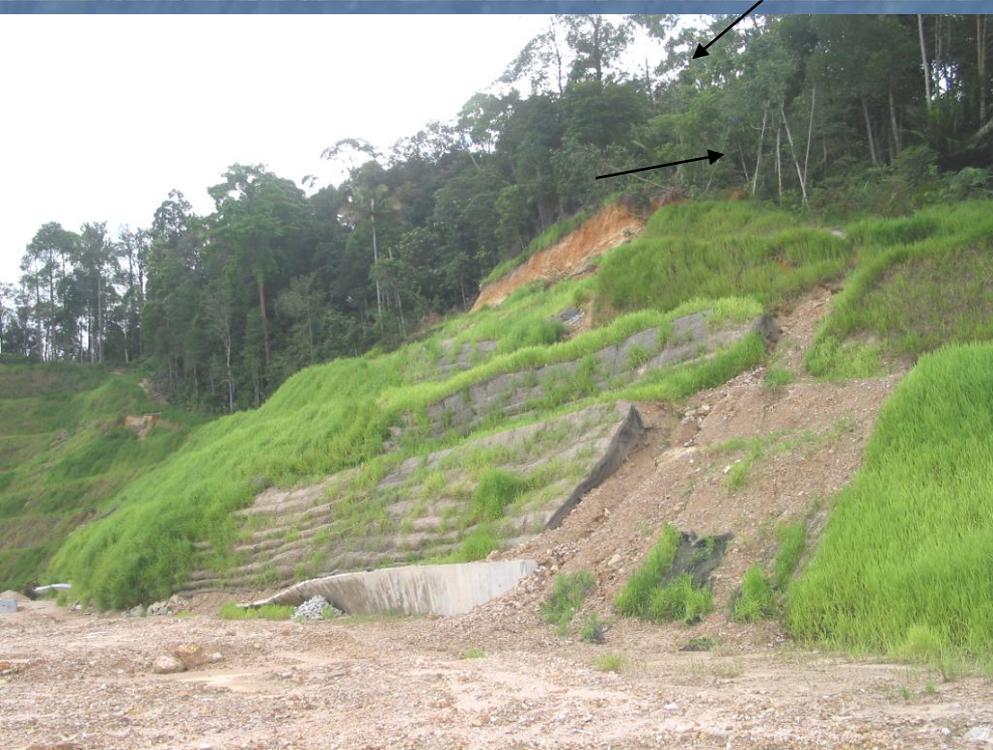
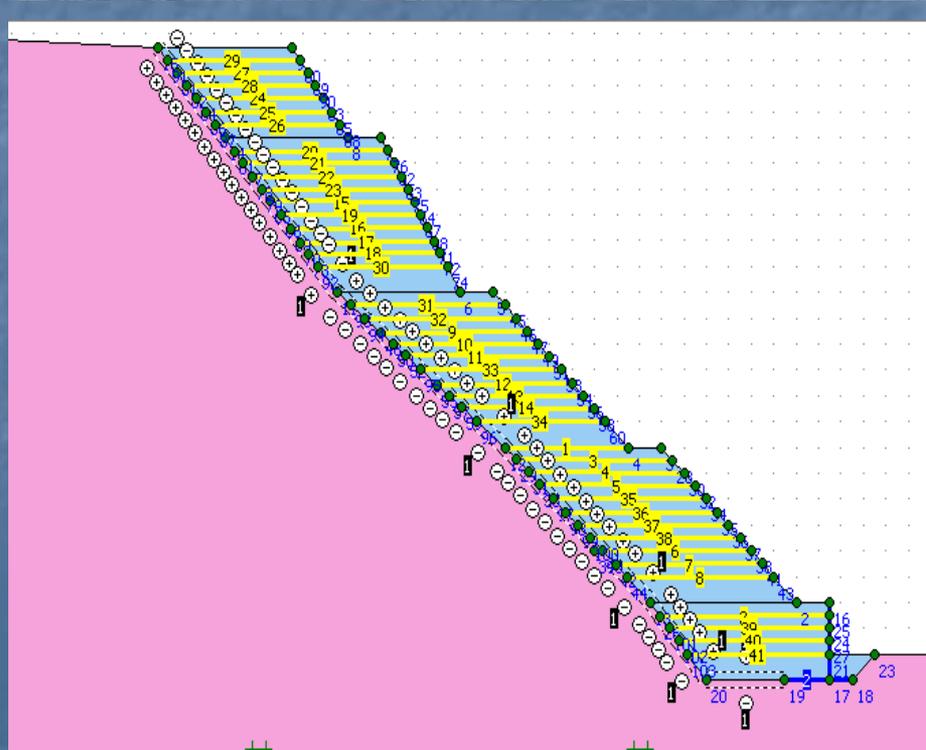
- Reconstruction of failure
- No increase in stability
- No internal reinforcement
- No counter weight

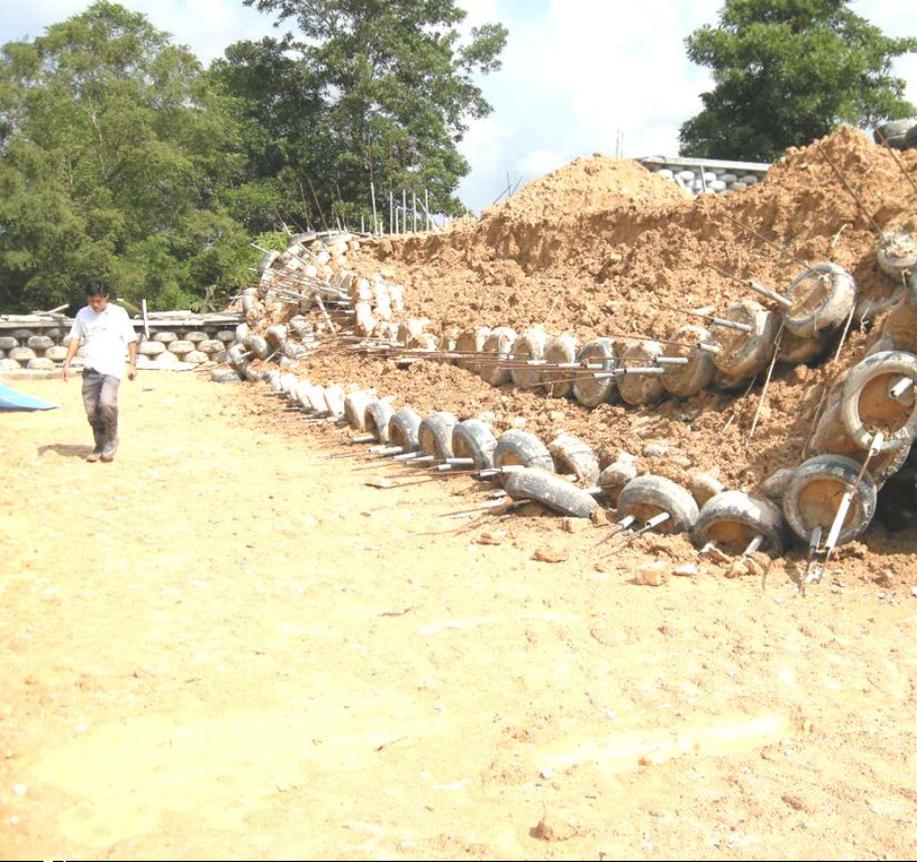
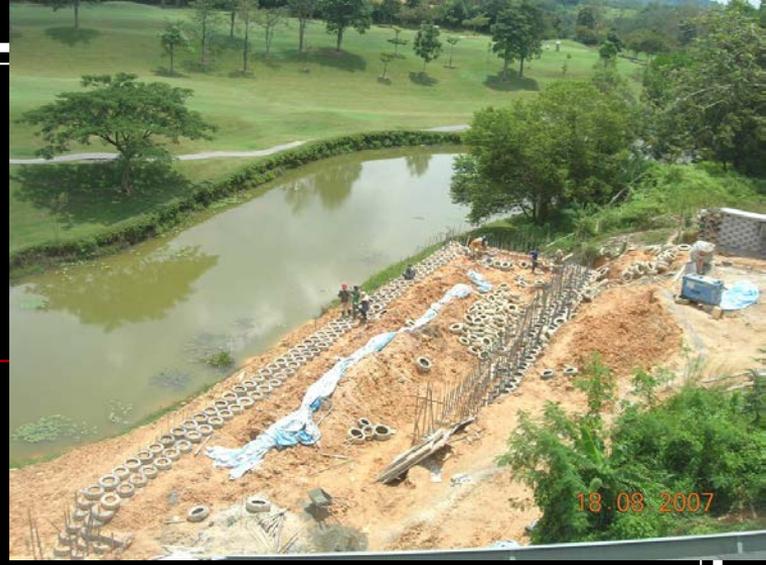
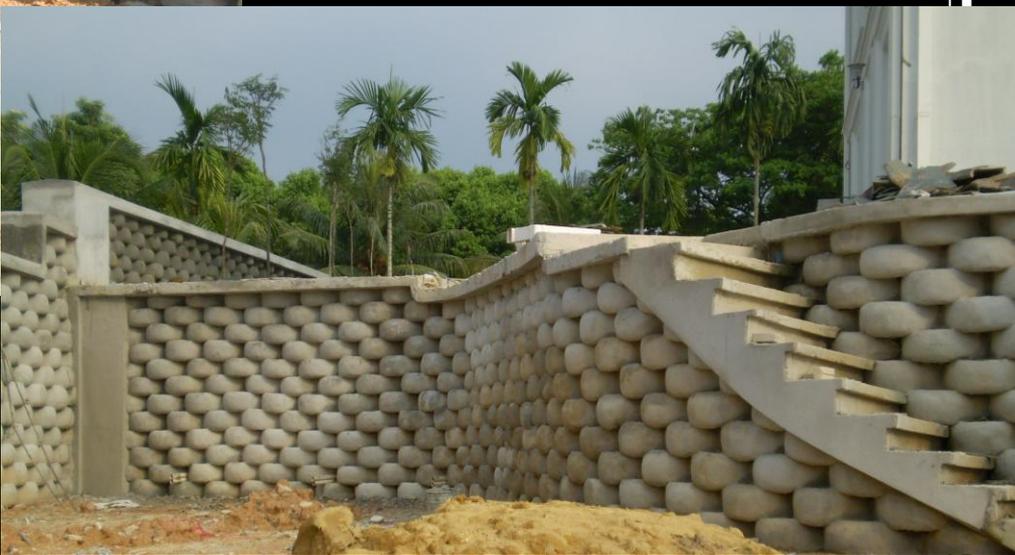
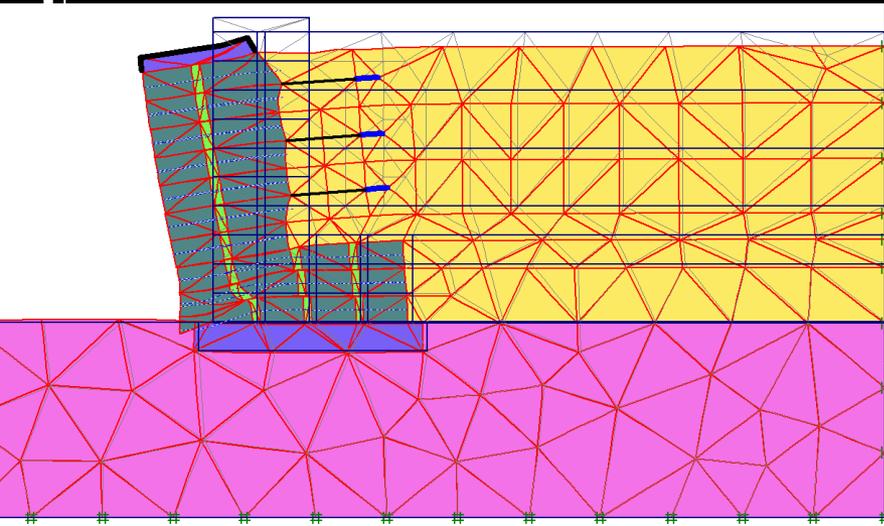
Innovative Rubber-tyre retaining wall

- Unproven design
- No relevant reference code of practice
- No engineering supervision
- Lack of grd water control

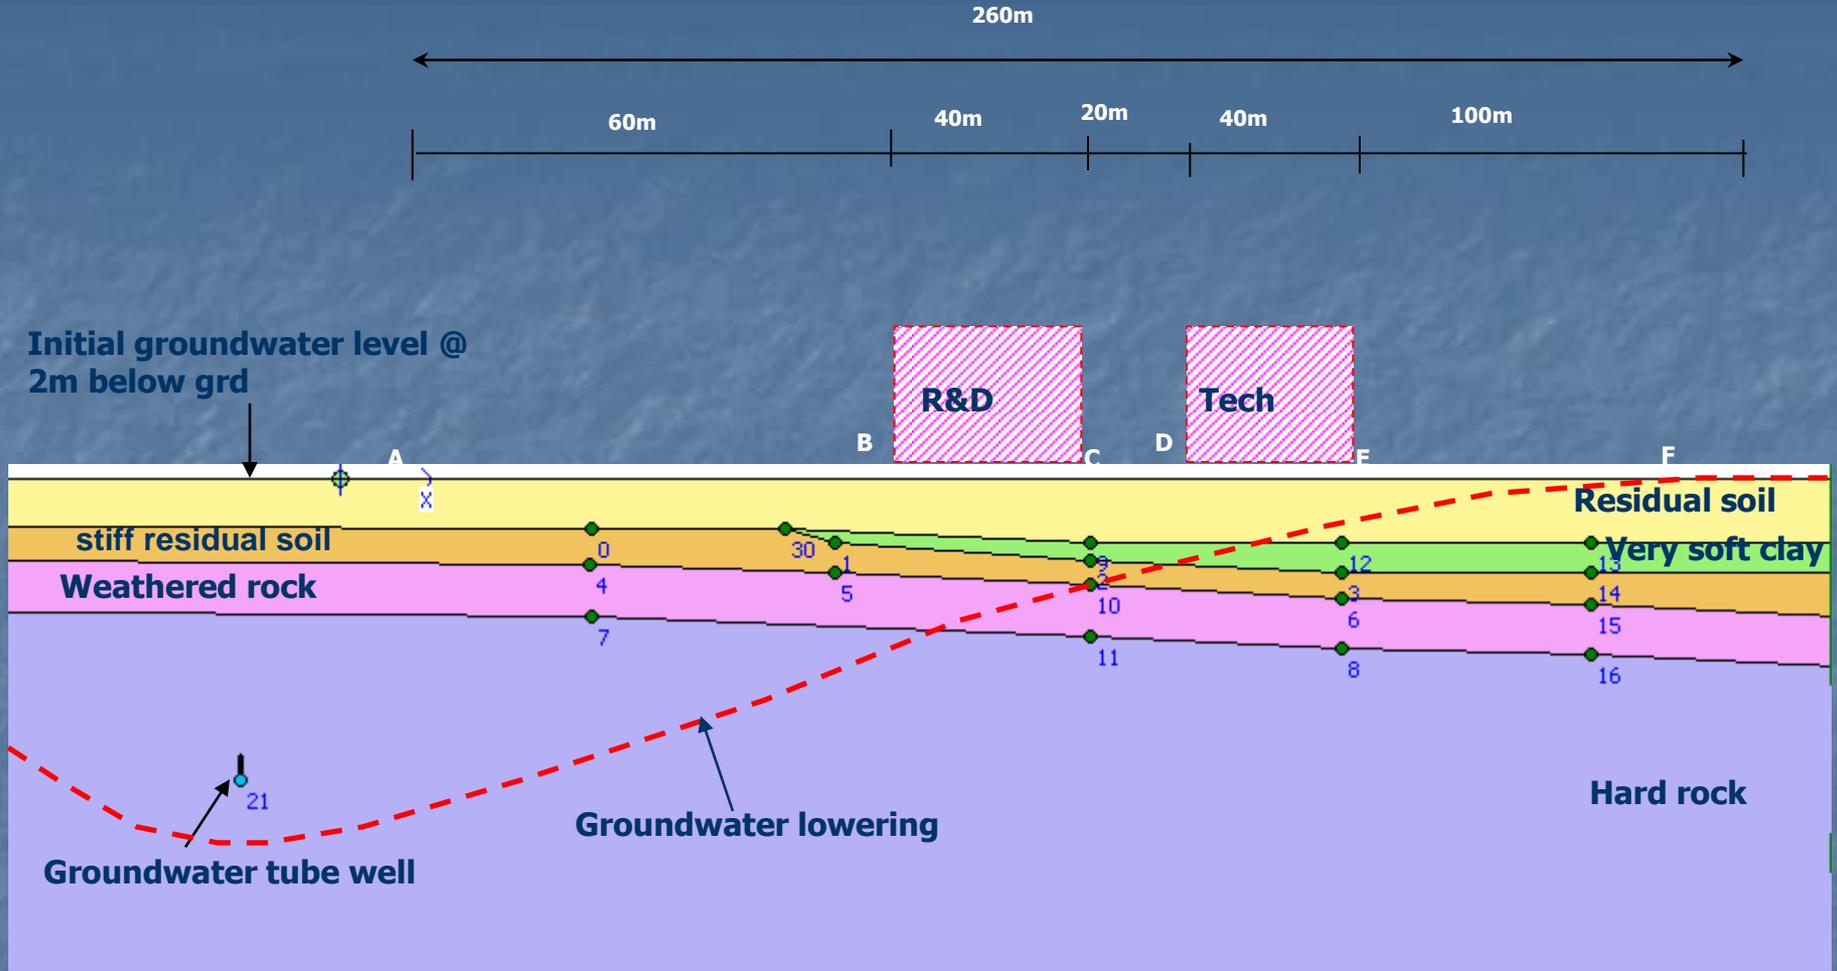
Figure 10.1: Geotechnical FE Model for the groundwater abstraction simulation

Surface point	Settlement (m)
B	0.120
C	0.227
D	0.308
E	0.342
F	0.296
