**FINAL INVESTIGATION REPORT**  
**BY**  
**SUBSTRUCTURE ANALYSIS AND SURROUNDINGS**  
**COMMITTEE**

**12 MARCH 2008**

**BADAN PENYIASATAN BEBAS (INDEPENDENT BOARD OF INQUIRY) KES  
KEJADIAN BANGUNAN RUNTUH (KOMPLEKS PELANCONGAN) DI PULAU  
BANDING, GERIK, PERAK DARUL RIDZUAN.**

# FINAL INVESTIGATION REPORT BY SUBSTRUCTURE ANALYSIS AND SURROUNDINGS COMMITTEE

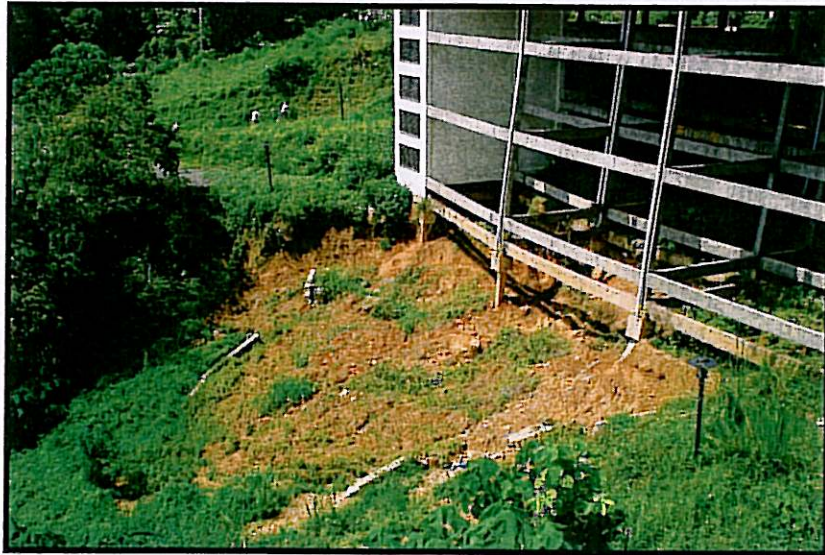
Based on the photograph captured on 24<sup>th</sup> October 2007 by JKR Perak (ref: Preliminary Report by Forensic & Structure Unit JKR Perak), slope failure at the edge and under the building was observed as shown in Plate 1A. Cracks were also observed at a few locations on the beams and walls of the building (Plate 1B).

**Plate 1A : Slip at the edge and below the building**

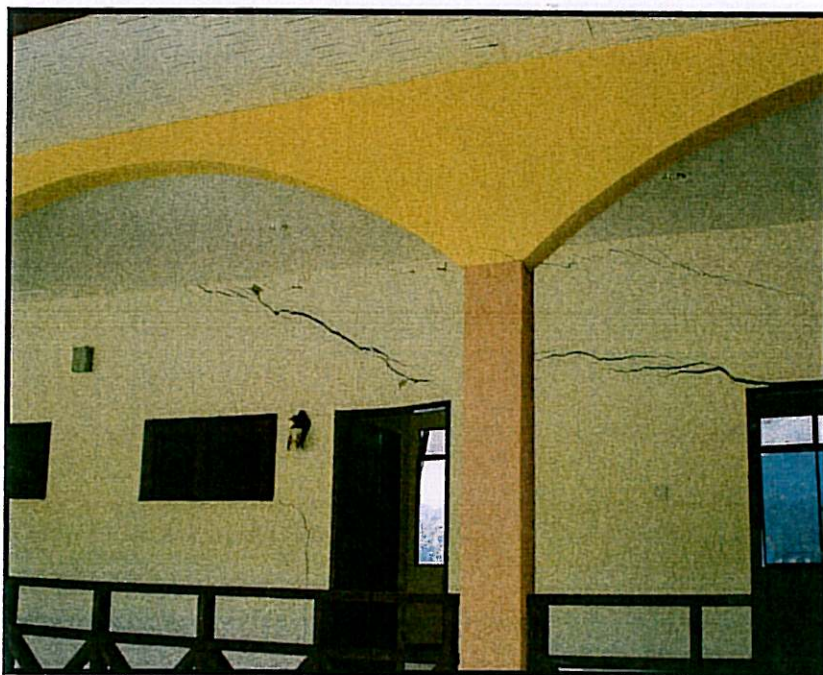
**Plate 1B : Hairline cracks in localized beams and walls**

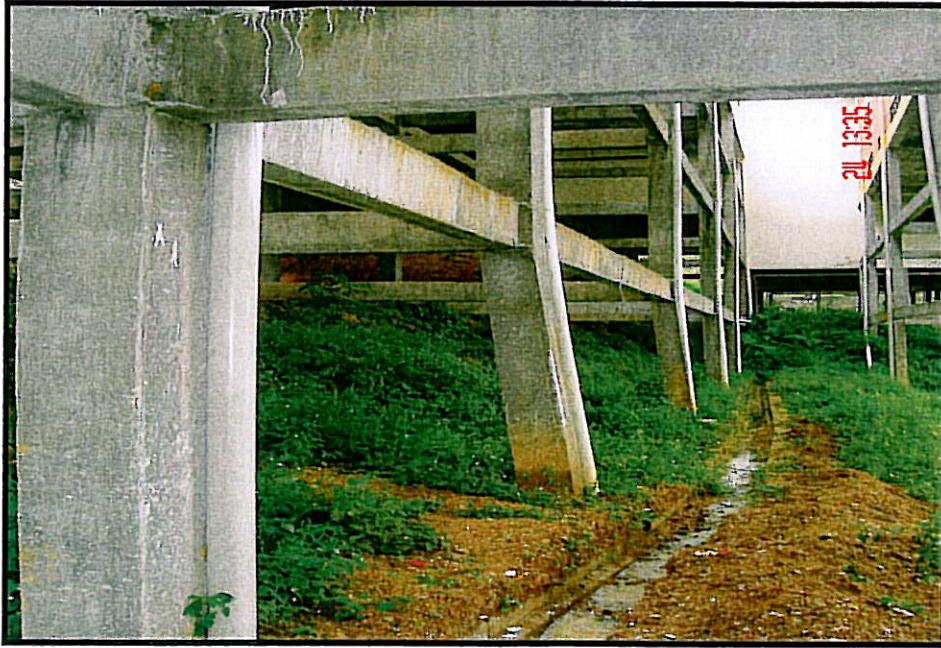
On the 23<sup>rd</sup> Sept 2007 during the second site visit it was observed a few piles beneath the columns of the building were also exposed and deflected. The columns at this zone had also deflected towards the lake side as shown (Plate 1C).

JKR Perak reported that the condition of some of drainage facilities before the building collapse occurred appeared to be heavily silted and have settled following the slope instability movements (Plate 1C). The discharge points of the rainwater down pipes had also been silted up or damaged locally and drainage facilities were completely damaged particularly at the failure location at the down slope (Plate 1E & 1F).

**Plate 1C : Columns deflected towards the lake side and drainage facilities heavily silted**

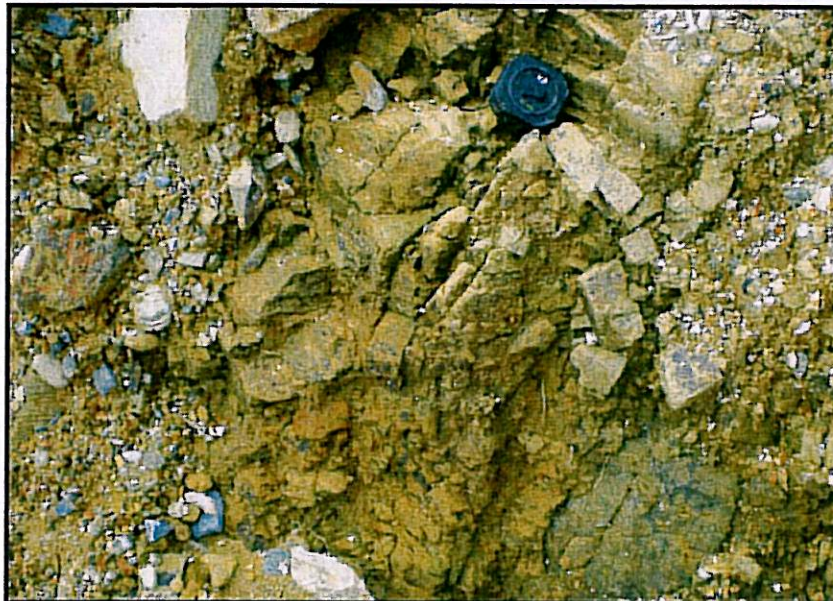
**Plate 1D: Residual soil of gravelly silt and sand at the**

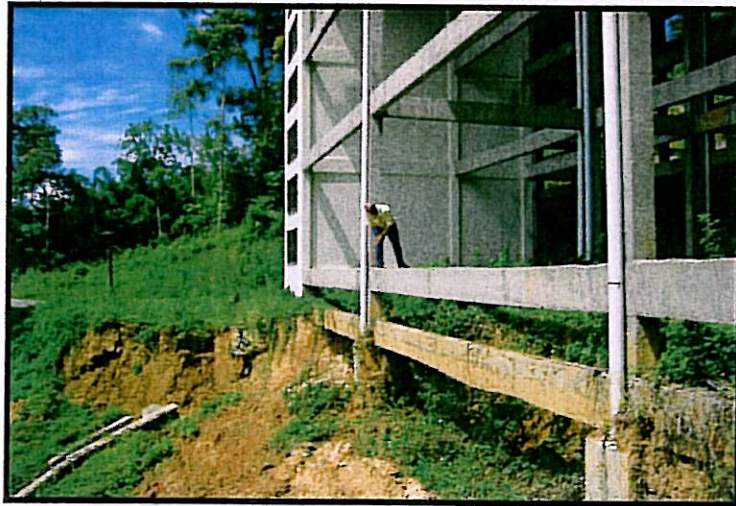
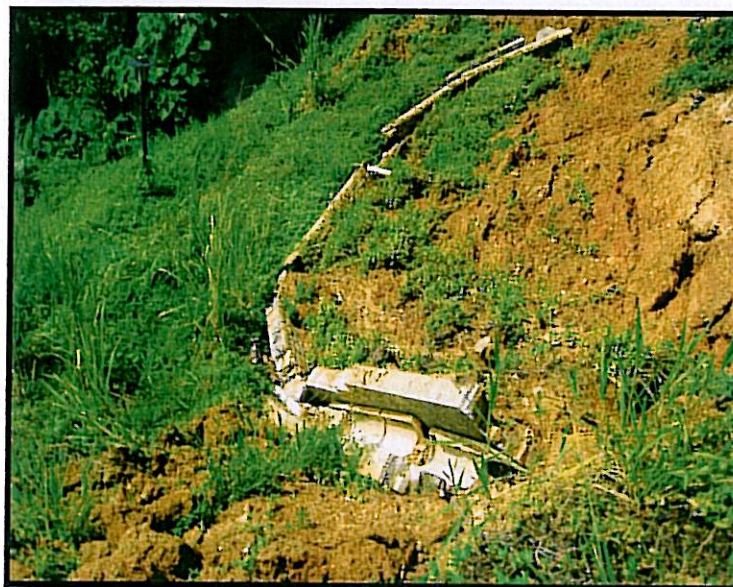
**Plate 1E & 1F :  
Discharge points of rainwater and  
drainage facilities completely damage at  
failure location**

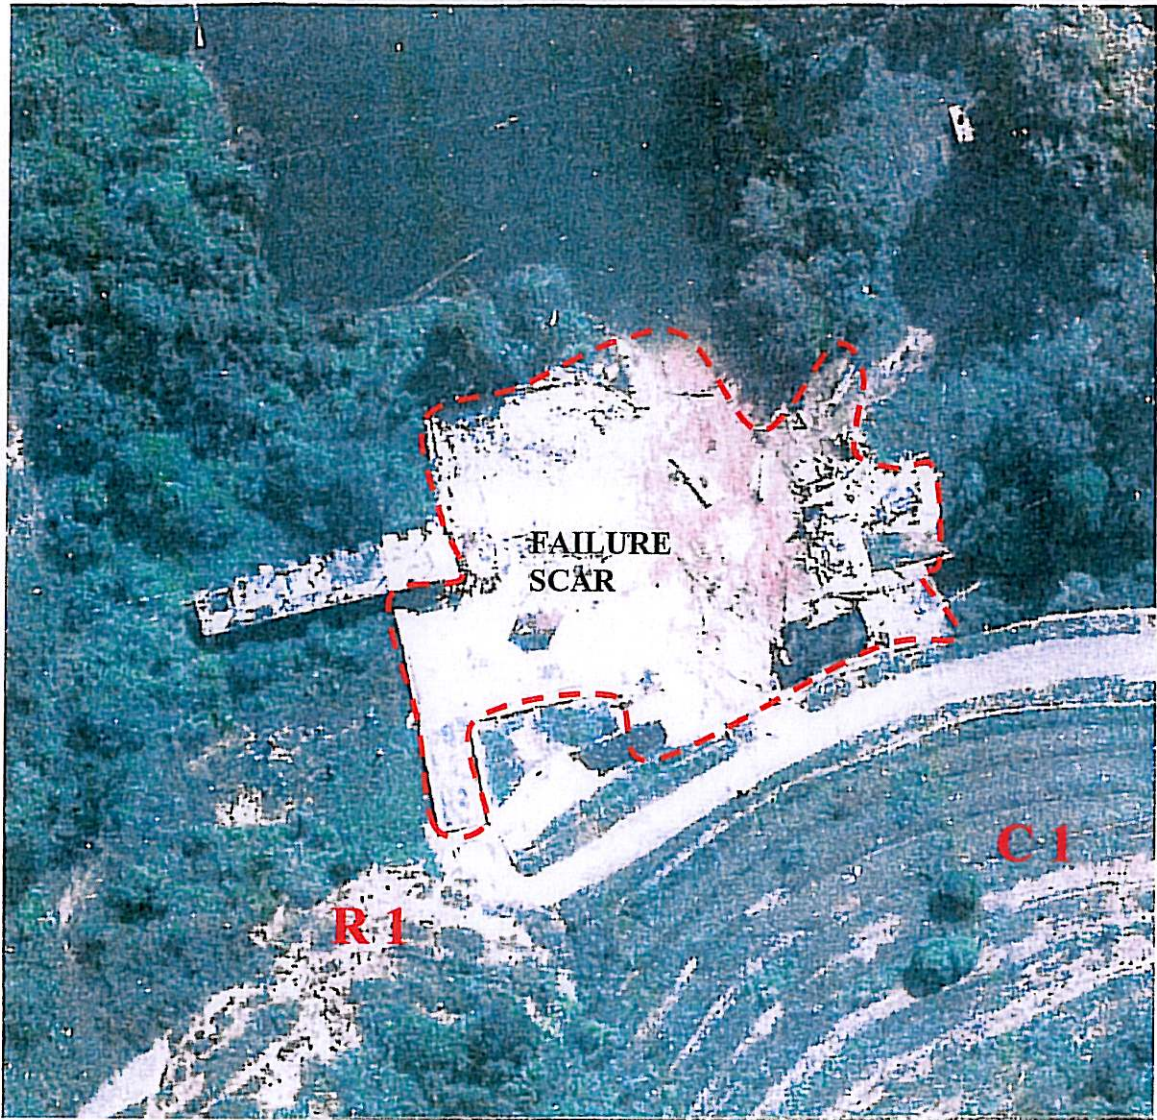
The scar of the failed slope is shown in Fig.1.1.

**Figure 1.1 : Close up view of Pulau Banding resort after the collapse (captured on 15<sup>th</sup> January 2008)**

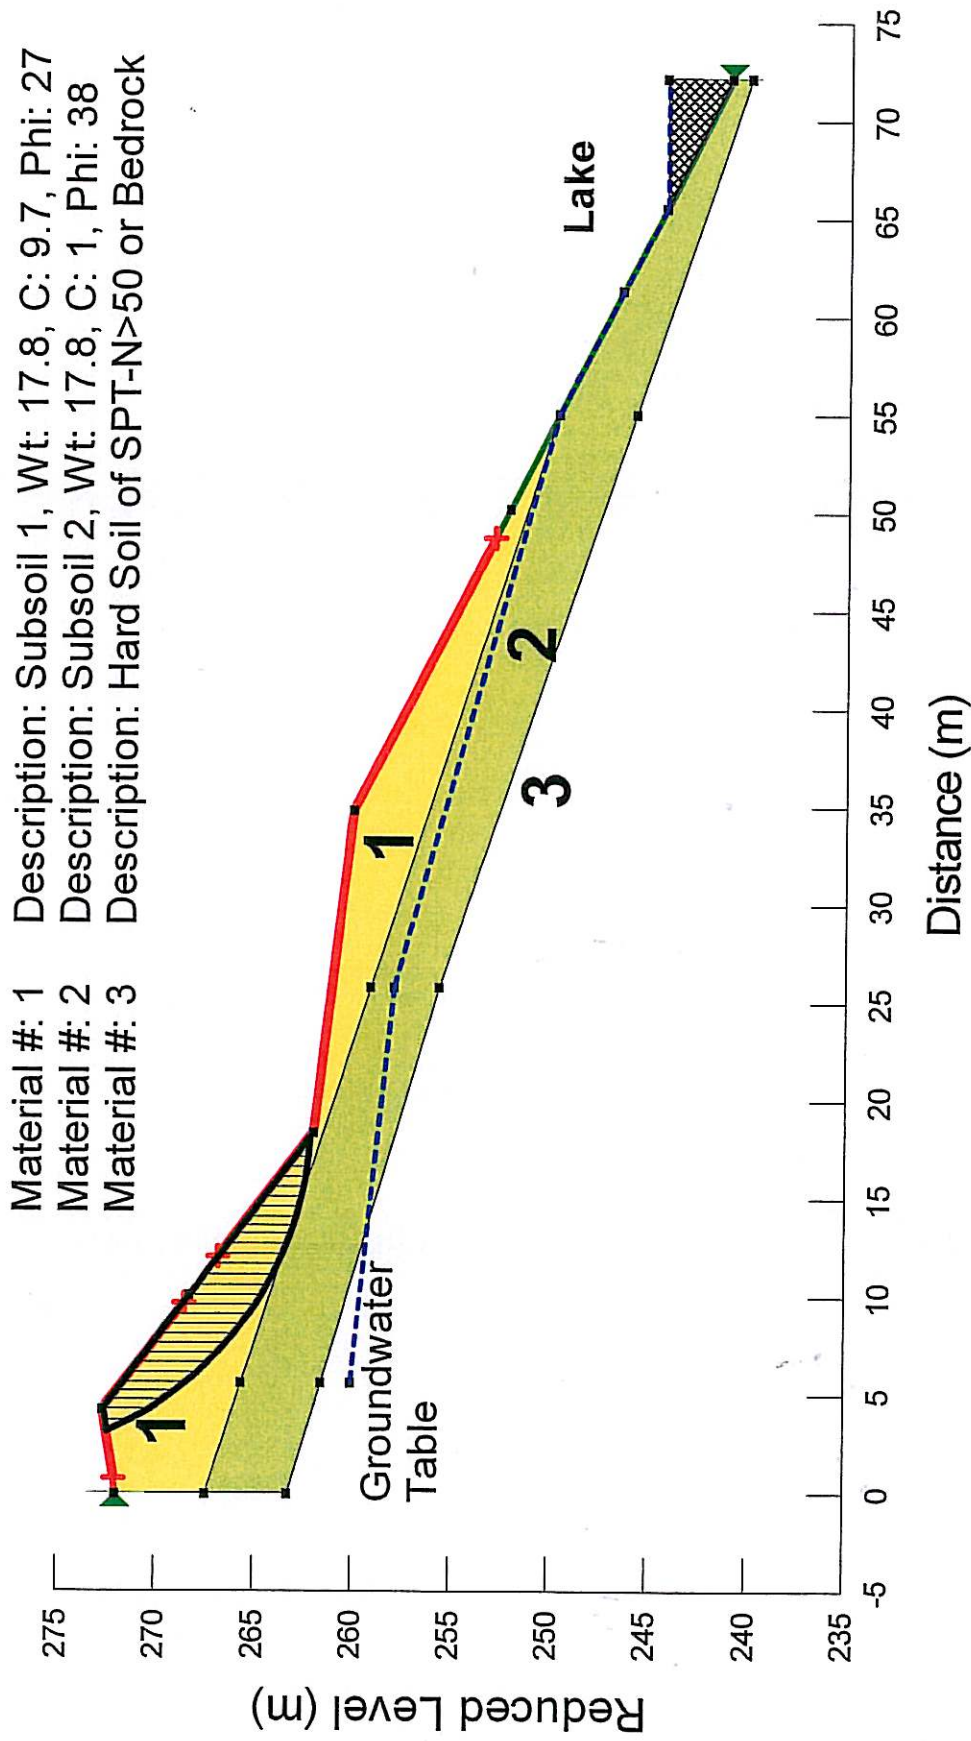
Figure No.	Description	Factor of Safety	Comments
1.13(a)	<ul style="list-style-type: none"> <li>▪ Cross-section CH. 120, Case 1</li> <li>▪ Subsoil 1: <math>C' = 9.7\text{kPa}</math>, <math>\phi' = 27.0^\circ</math></li> <li>▪ Subsoil 2: <math>C' = 3.0\text{kPa}</math>, <math>\phi' = 36.0^\circ</math></li> <li>▪ Stability check for upper slope</li> </ul>	1.34	<ul style="list-style-type: none"> <li>▪ Potential deep slip failure</li> <li>▪ Inadequate FOS (<math>&lt;1.4</math>)</li> <li>▪ <b>Unacceptable</b></li> </ul>

**Figure 1.13(a): Stability Analysis of Cross-section CH. 120**

Case 1 - Subsoil 1:  $C' = 9.7\text{kPa}$ ,  $\phi' = 32.4^\circ$ ; Subsoil 2:  $C' = 1.0\text{kPa}$ ,  $\phi' = 38.0^\circ$ ;  
 Stability Check for Upper Slope: Factor of Safety = 1.34 (<1.40, Unacceptable)

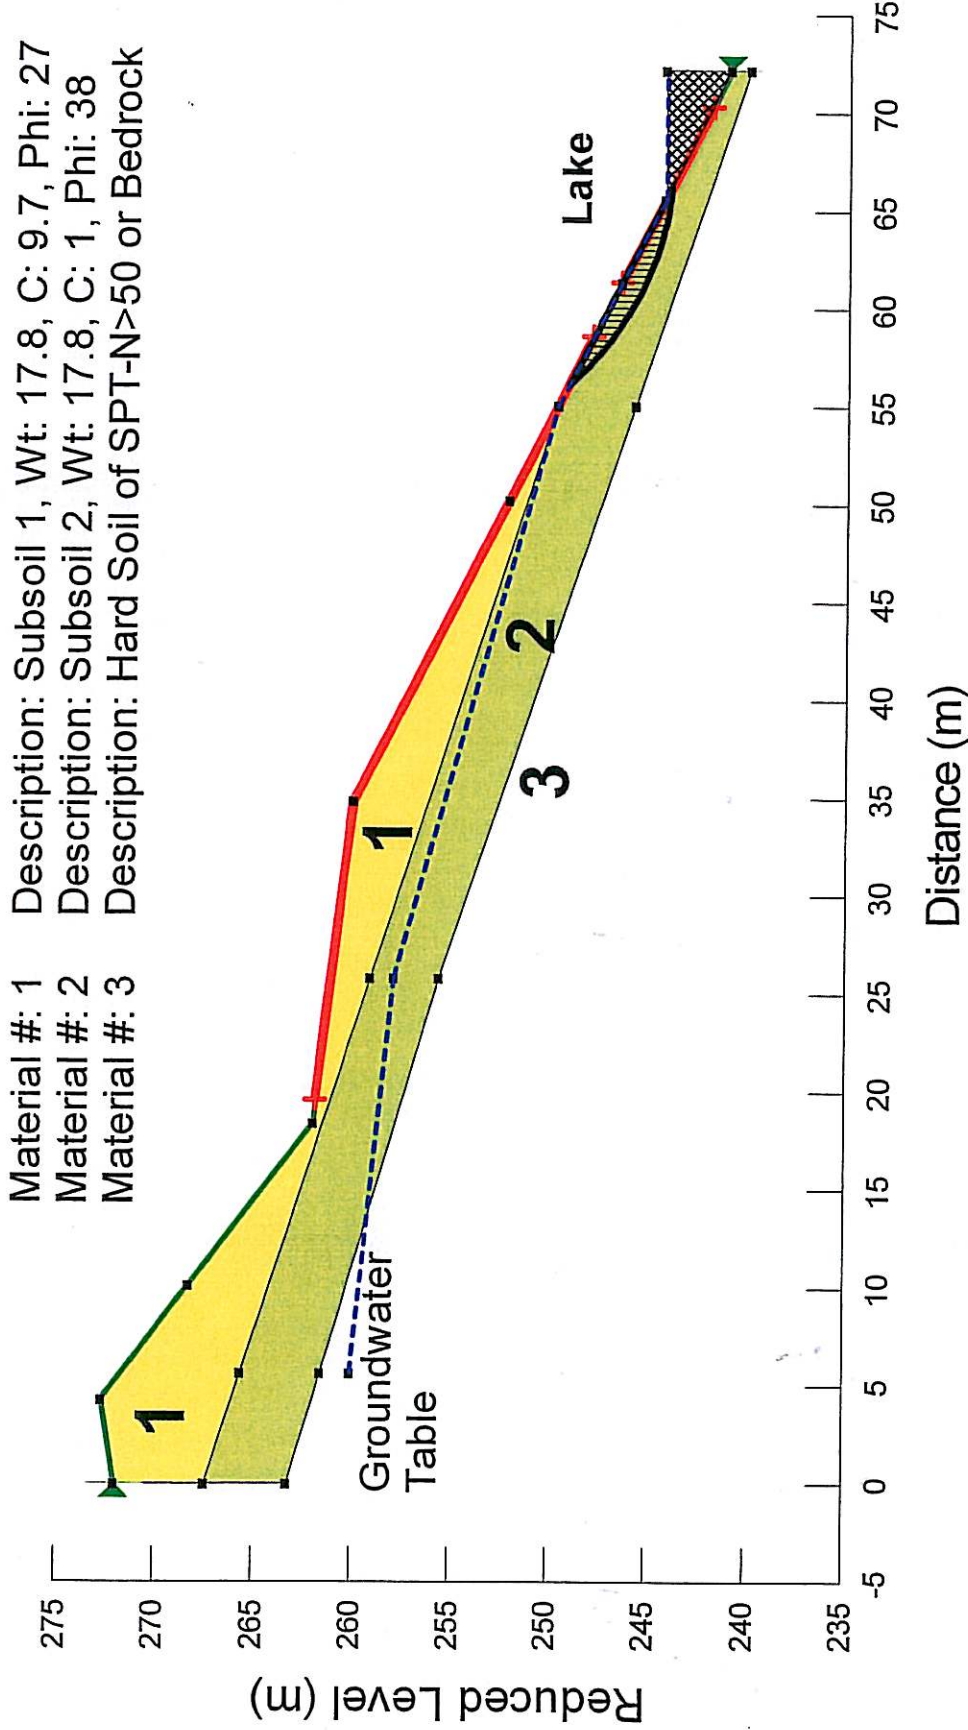
1.13(b)	<ul style="list-style-type: none"> <li>▪ Cross-section CH. 120, Case 1</li> <li>▪ Subsoil 1: <math>C' = 9.7\text{kPa}</math>, <math>\phi' = 27.0^\circ</math></li> <li>▪ Subsoil 2: <math>C' = 3.0\text{kPa}</math>, <math>\phi' = 36.0^\circ</math></li> <li>▪ Stability check 1 for lower slope</li> </ul>	0.74	<ul style="list-style-type: none"> <li>▪ Shallow slip failure</li> <li>▪ Inadequate FOS (<math>&lt;1.4</math>)</li> <li>▪ <b>Failure Expected (<math>&lt;1.0</math>)</b></li> </ul>

**Figure 1.13(b): Stability Analysis of Cross-section CH. 120**

Case 1 - Subsoil 1:  $C' = 9.7 \text{ kPa}$ ,  $\phi' = 32.4^\circ$ ; Subsoil 2:  $C' = 1.0 \text{ kPa}$ ,  $\phi' = 38.0^\circ$ ;  
Stability Check 1 for Lower Slope: Factor of Safety = 0.74 (<1.00, Failure expected)

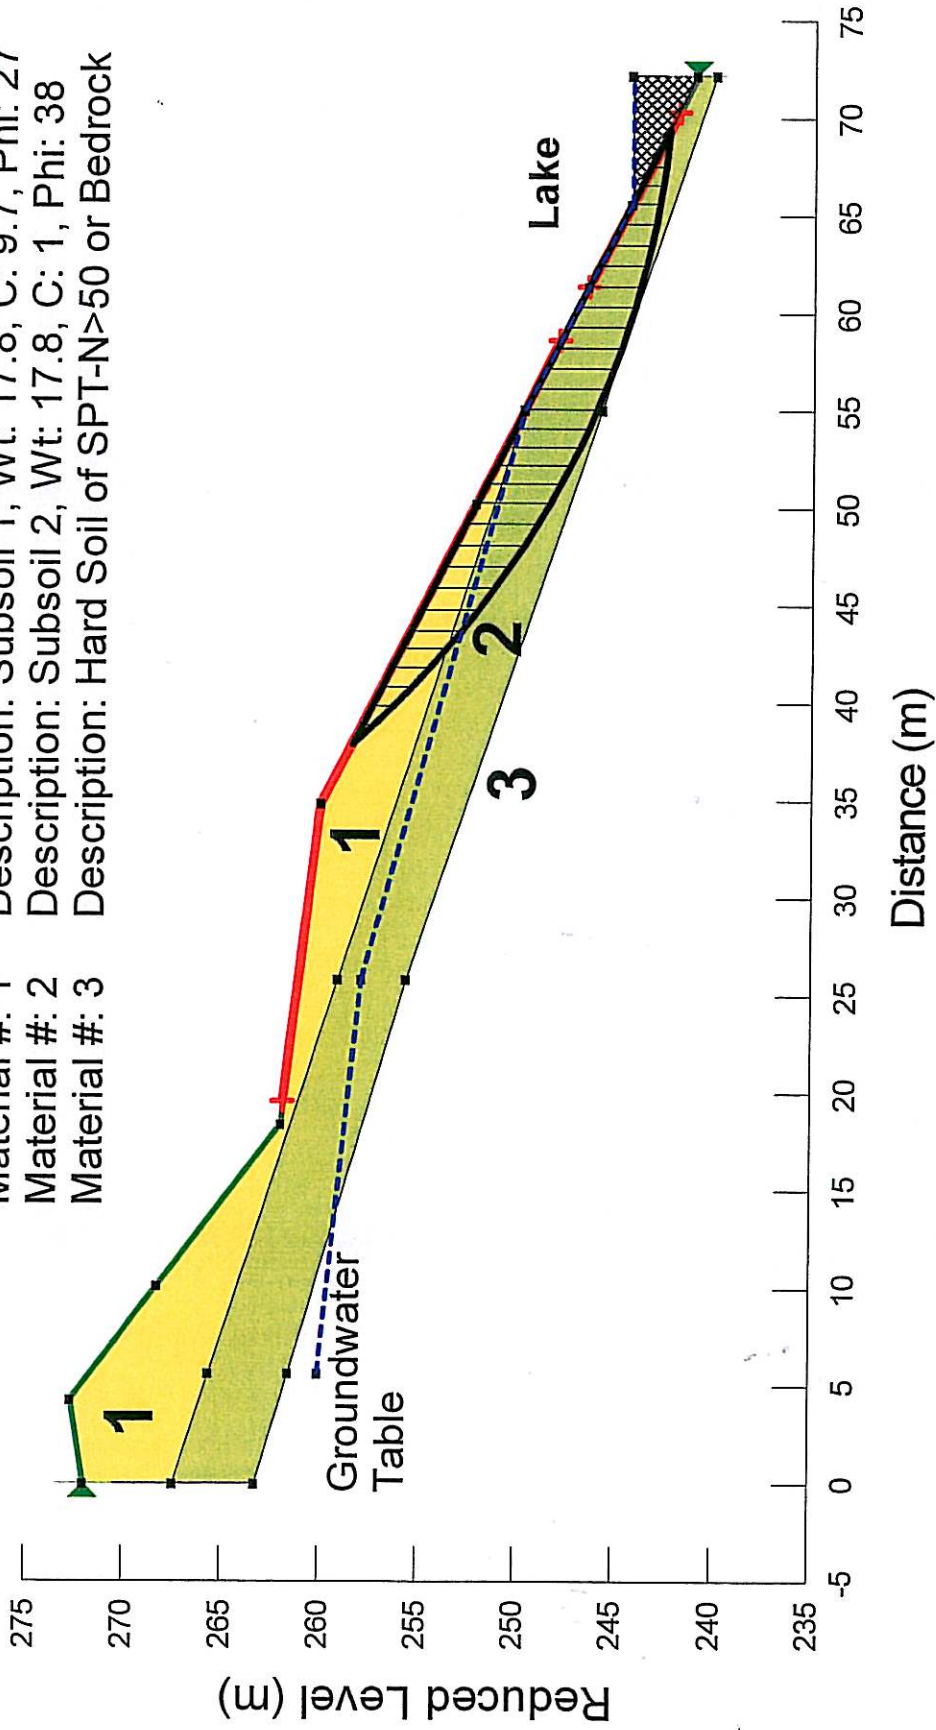
1.13 (c)	<ul style="list-style-type: none"> <li>▪ Cross-section CH. 120, Case 1</li> <li>▪ Subsoil 1: <math>C' = 9.7\text{kPa}</math>, <math>\phi' = 27.0^\circ</math></li> <li>▪ Subsoil 2: <math>C' = 3.0\text{kPa}</math>, <math>\phi' = 36.0^\circ</math></li> <li>▪ Stability check 2 for lower slope</li> </ul>	0.99	<ul style="list-style-type: none"> <li>▪ Relatively deep slip failure</li> <li>▪ Inadequate FOS (<math>&lt;1.4</math>)</li> <li>▪ <b>Failure Expected (<math>&lt;1.0</math>)</b></li> </ul>

Figure 1.13(c): Stability Analysis of Cross-section CH. 120

Case 1 - Subsoil 1:  $C' = 9.7\text{kPa}$ ,  $\phi' = 32.4^\circ$ ; Subsoil 2:  $C' = 1.0\text{kPa}$ ,  $\phi' = 38.0^\circ$ ;  
Stability Check 2 for Lower Slope: Factor of Safety = 0.99 (<1.00, Failure expected)

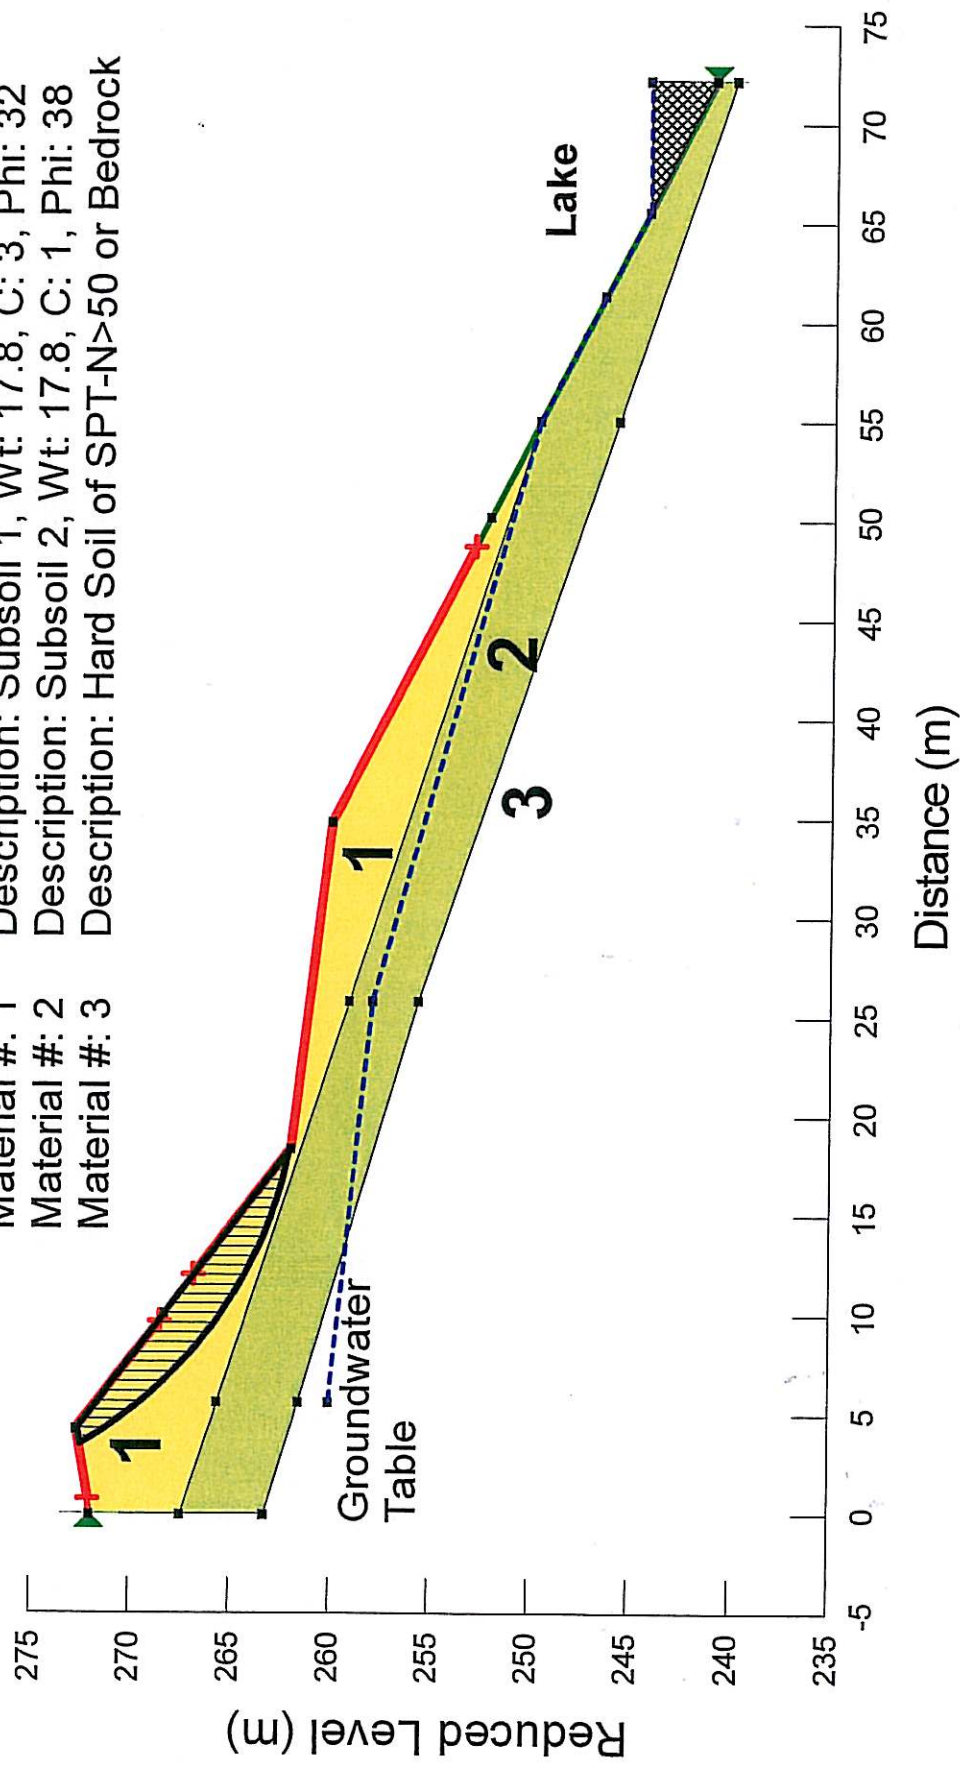
1.13(d)	<ul style="list-style-type: none"> <li>▪ Cross-section CH. 120, Case2</li> <li>▪ Subsoil 1: <math>C' = 3.0\text{kPa}</math>, <math>\phi' = 32.0^\circ</math></li> <li>▪ Subsoil 2: <math>C' = 3.0\text{kPa}</math>, <math>\phi' = 36.0^\circ</math></li> <li>▪ Stability check for upper slope</li> </ul>	1.15	<ul style="list-style-type: none"> <li>▪ Potential relatively deep slip failure</li> <li>▪ Inadequate FOS (<math>&lt;1.4</math>)</li> <li>▪ <b>Unacceptable</b></li> </ul>

**Figure 1.13(d). Stability Analysis of Cross-section CH. 120**  
 Case 2 - Subsoil 1:  $C' = 3.0\text{kPa}$ ,  $\phi' = 32.0^\circ$ ; Subsoil 2:  $C' = 1.0\text{kPa}$ ,  $\phi' = 38.0^\circ$   
 Stability Check for Upper Slope: Factor of Safety = 1.15 (<1.40, Unacceptable)

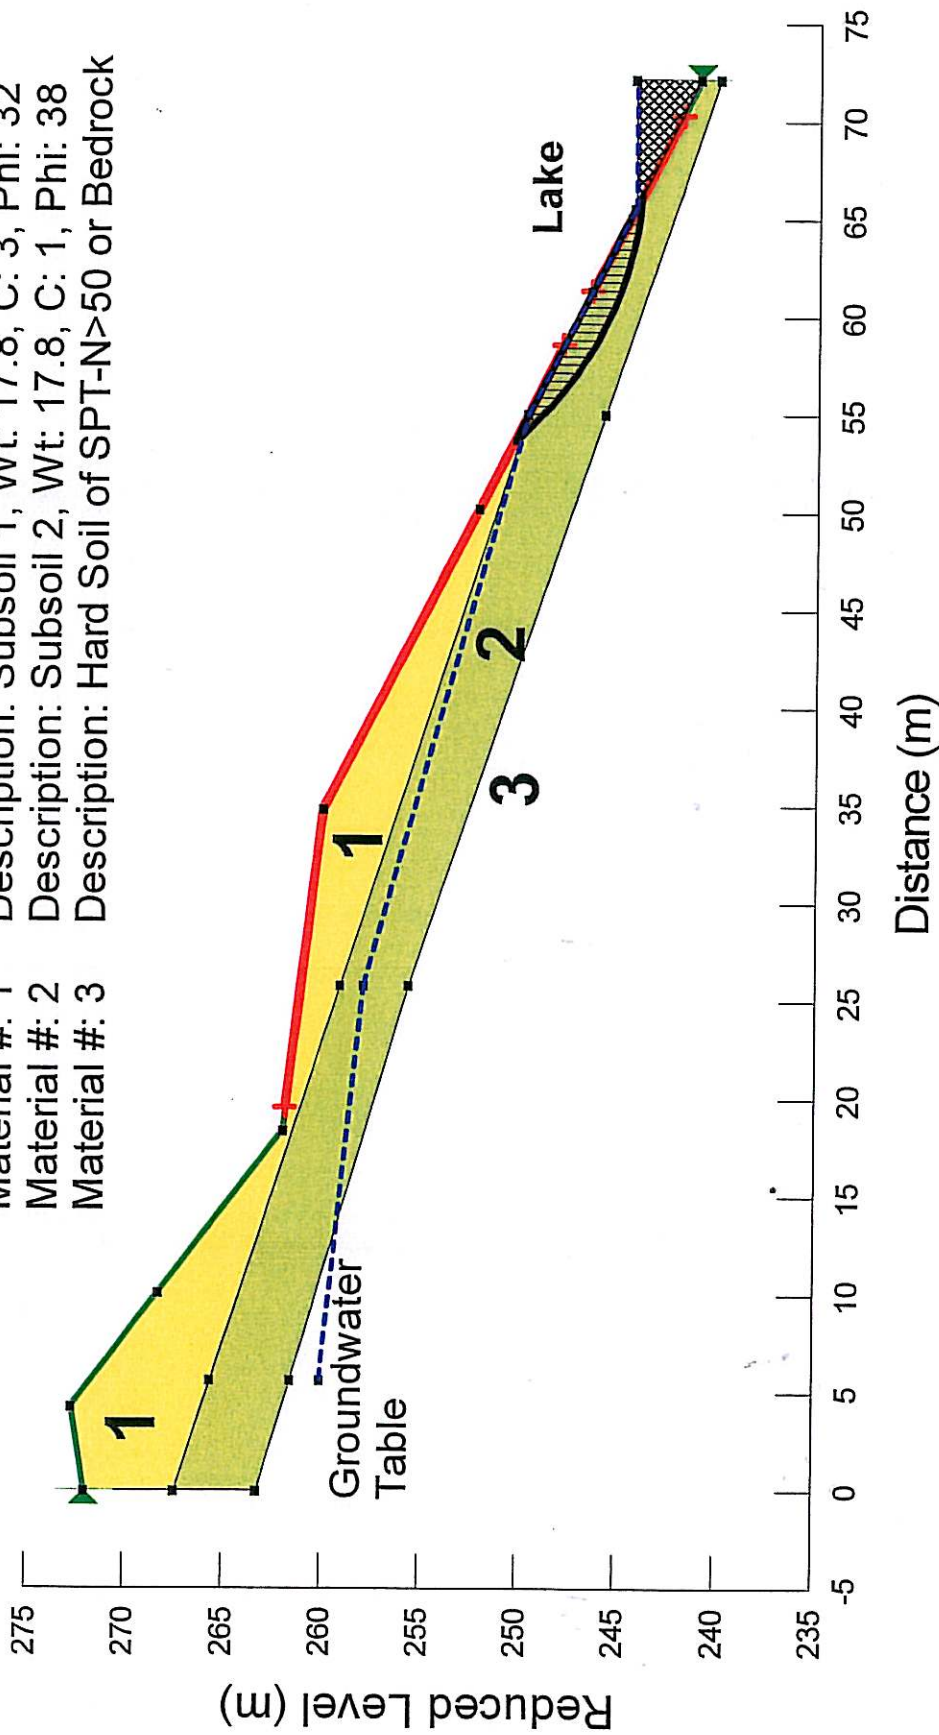
1.13(e)	<ul style="list-style-type: none"> <li>▪ Cross-section CH. 120, Case2</li> <li>▪ Subsoil 1: <math>C' = 3.0\text{kPa}</math>, <math>\phi' = 32.0^\circ</math></li> <li>▪ Subsoil 2: <math>C' = 3.0\text{kPa}</math>, <math>\phi' = 36.0^\circ</math></li> <li>▪ Stability check 1 for lower slope</li> </ul>	0.72	<ul style="list-style-type: none"> <li>▪ Shallow slip failure</li> <li>▪ Inadequate FOS (<math>&lt;1.4</math>)</li> <li>▪ <b>Failure Expected (<math>&lt;1.0</math>)</b></li> </ul>

**Figure 1.13(e). Stability Analysis of Cross-section CH. 120**

Case 2 - Subsoil 1:  $C' = 3.0\text{kPa}$ ,  $\phi' = 32.0^\circ$ ; Subsoil 2:  $C' = 1.0\text{kPa}$ ,  $\phi' = 38.0^\circ$   
Stability Check 1 for Lower Slope: Factor of Safety = 0.72 (<1.00, Failure expected)

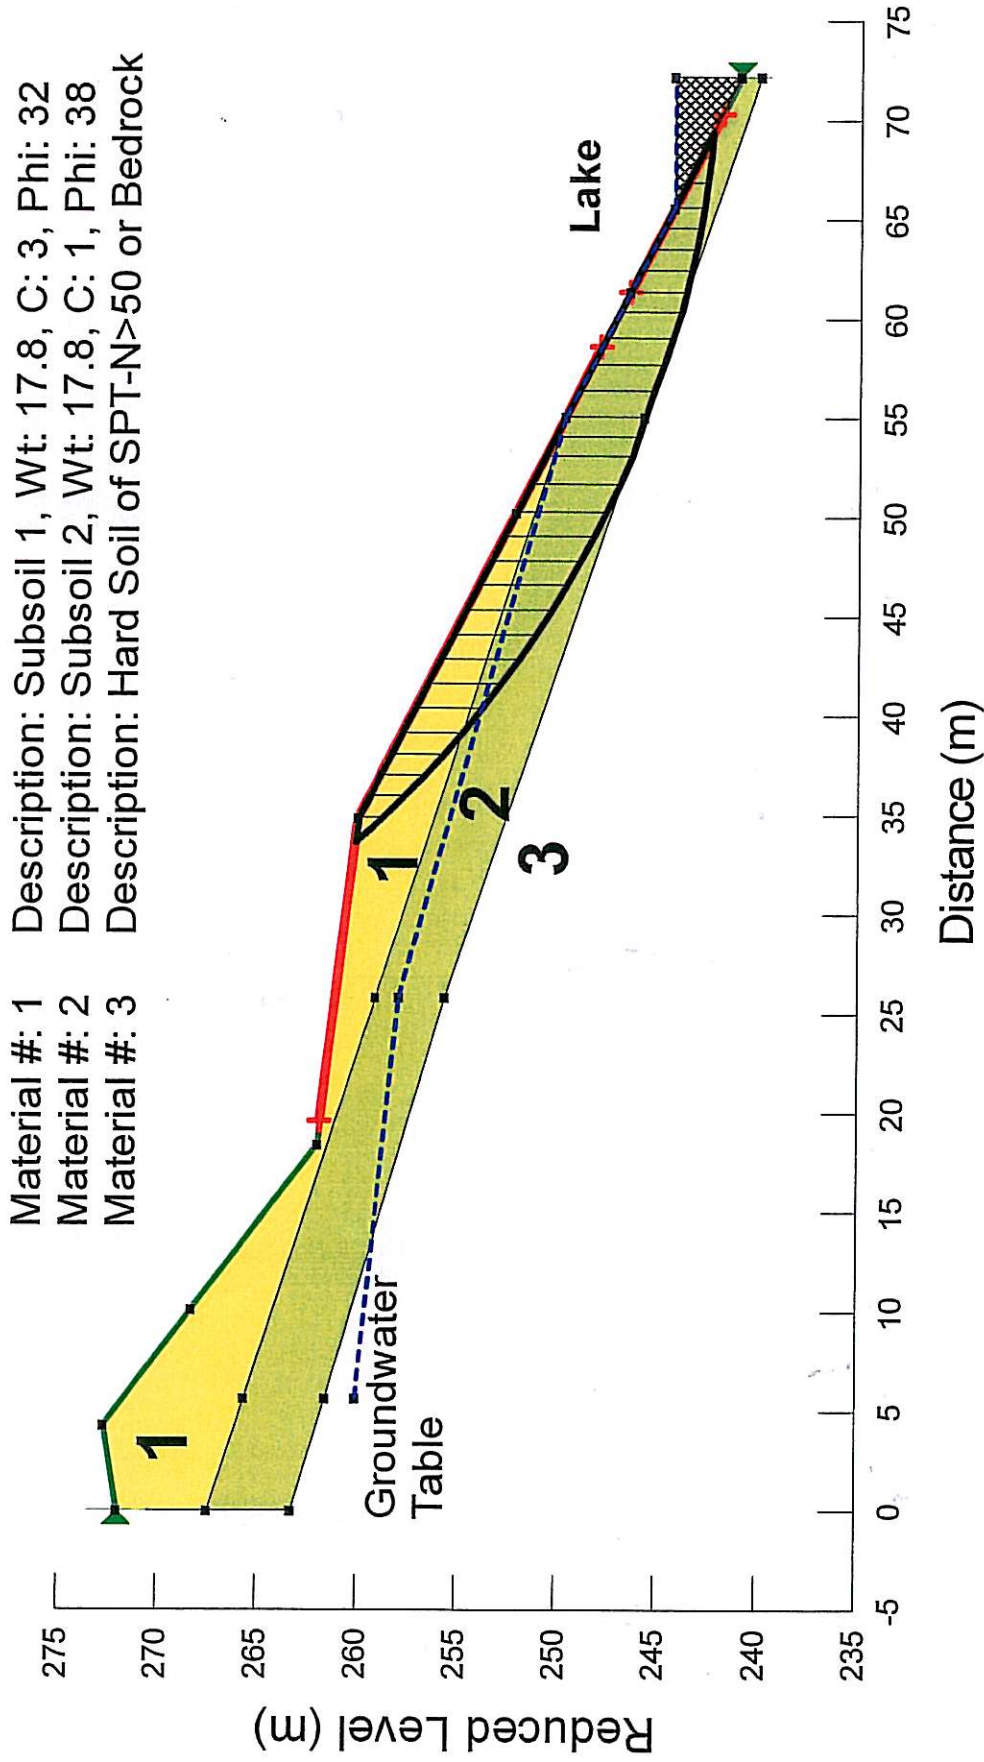
1.13(f)	<ul style="list-style-type: none"> <li>▪ Cross-section CH. 120, Case2</li> <li>▪ Subsoil 1: <math>C' = 3.0\text{kPa}</math>, <math>\phi' = 32.0^\circ</math></li> <li>▪ Subsoil 2: <math>C' = 3.0\text{kPa}</math>, <math>\phi' = 36.0^\circ</math></li> <li>▪ Stability check 2 for lower slope</li> </ul>	0.99	<ul style="list-style-type: none"> <li>▪ Deep slip failure</li> <li>▪ Inadequate FOS (<math>&lt;1.4</math>)</li> <li>▪ <b>Failure Expected (<math>&lt;1.0</math>)</b></li> </ul>

**Figure 1.13(f): Stability Analysis of Cross-section CH. 120**

Case 2 - Subsoil 1:  $C' = 3.0\text{kPa}$ ,  $\phi' = 32.0^\circ$ ; Subsoil 2:  $C' = 1.0\text{kPa}$ ,  $\phi' = 38.0^\circ$   
Stability Check 2 for Lower Slope: Factor of Safety = 0.99 (<1.00, Failure expected)

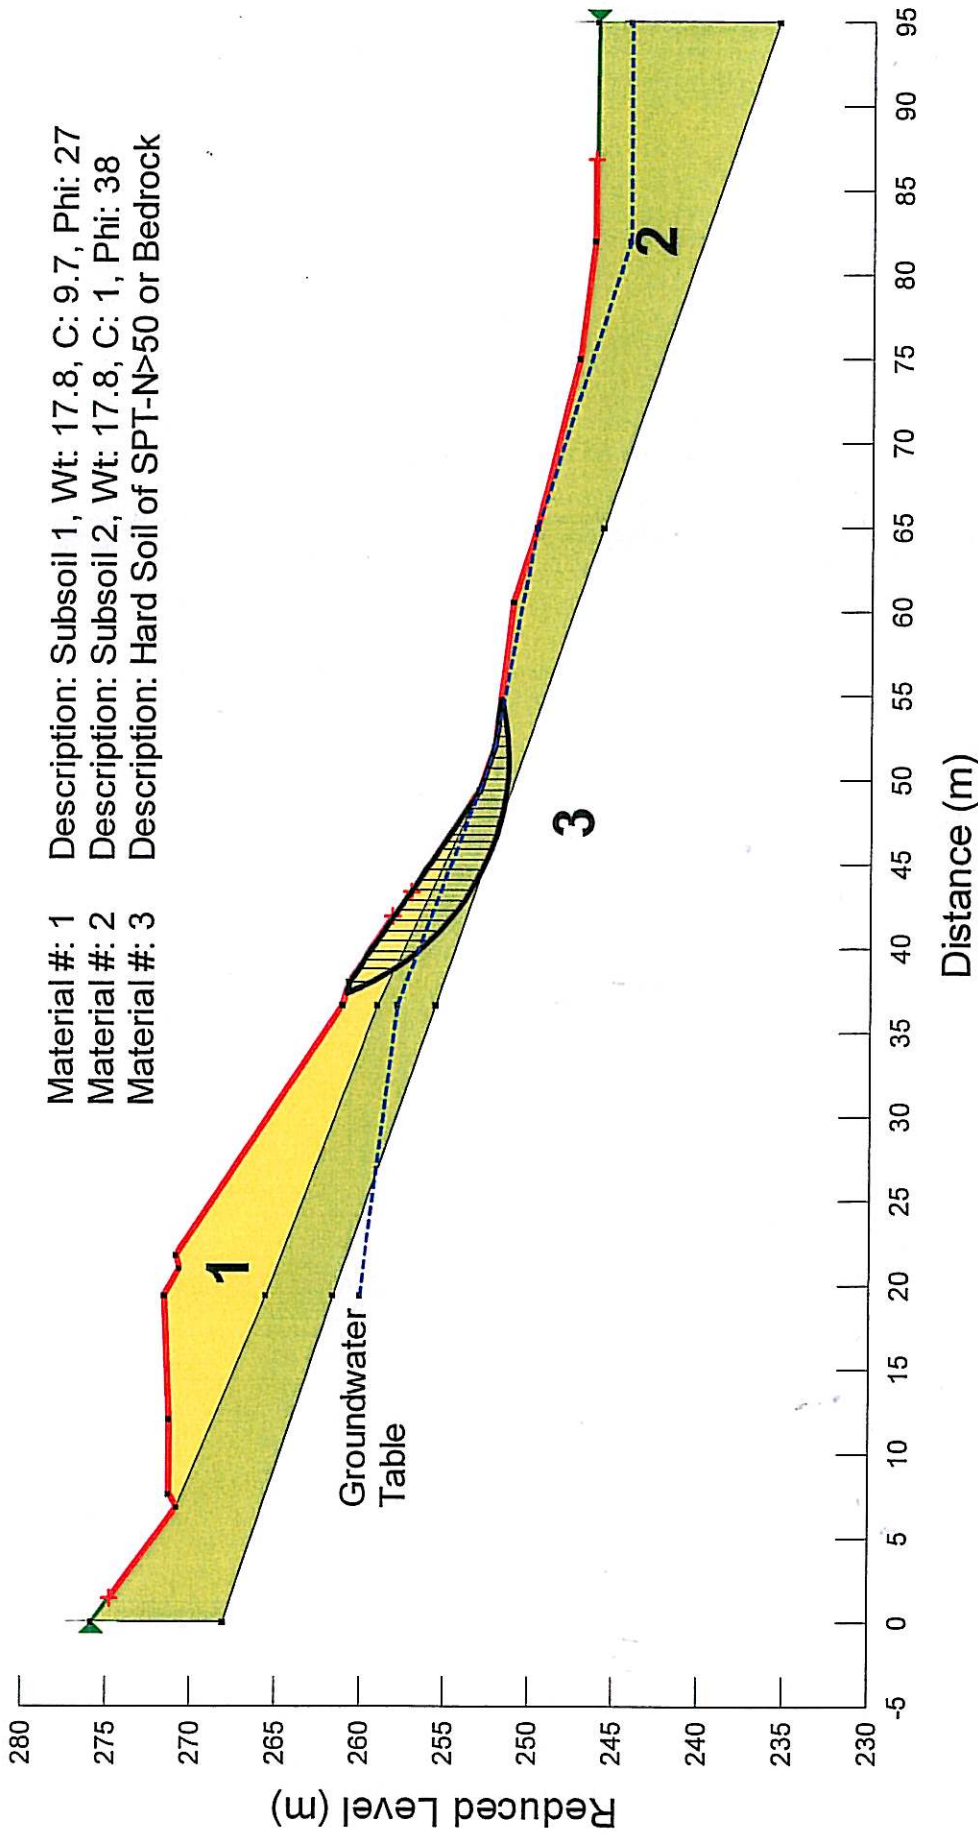
1.13(g)	<ul style="list-style-type: none"> <li>▪ Cross-section F-F, Case 1</li> <li>▪ Subsoil 1: <math>C' = 9.7\text{kPa}</math>, <math>\phi' = 27.0^\circ</math></li> <li>▪ Subsoil 2: <math>C' = 3.0\text{kPa}</math>, <math>\phi' = 36.0^\circ</math></li> </ul>	1.16	<ul style="list-style-type: none"> <li>▪ Potential deep slip failure</li> <li>▪ Inadequate FOS (<math>&lt;1.4</math>)</li> <li>▪ <b>Unacceptable</b></li> </ul>

In the case of Cross-section CH. 120, the computed factors of safety are less than unity, hence failures are expected. As for Section F-F, the computed factors of safety are about 1.1, which are unacceptable

**Figure 1.13(g): Stability Analysis of Cross-section F-F**  
Case 1 - Subsoil 1:  $C' = 9.7\text{kPa}$ ,  $\phi' = 32.4^\circ$ ; Subsoil 2:  $C' = 1.0\text{kPa}$ ,  $\phi' = 38.0^\circ$   
Factor of Safety = 1.16 (<1.40, Unacceptable)

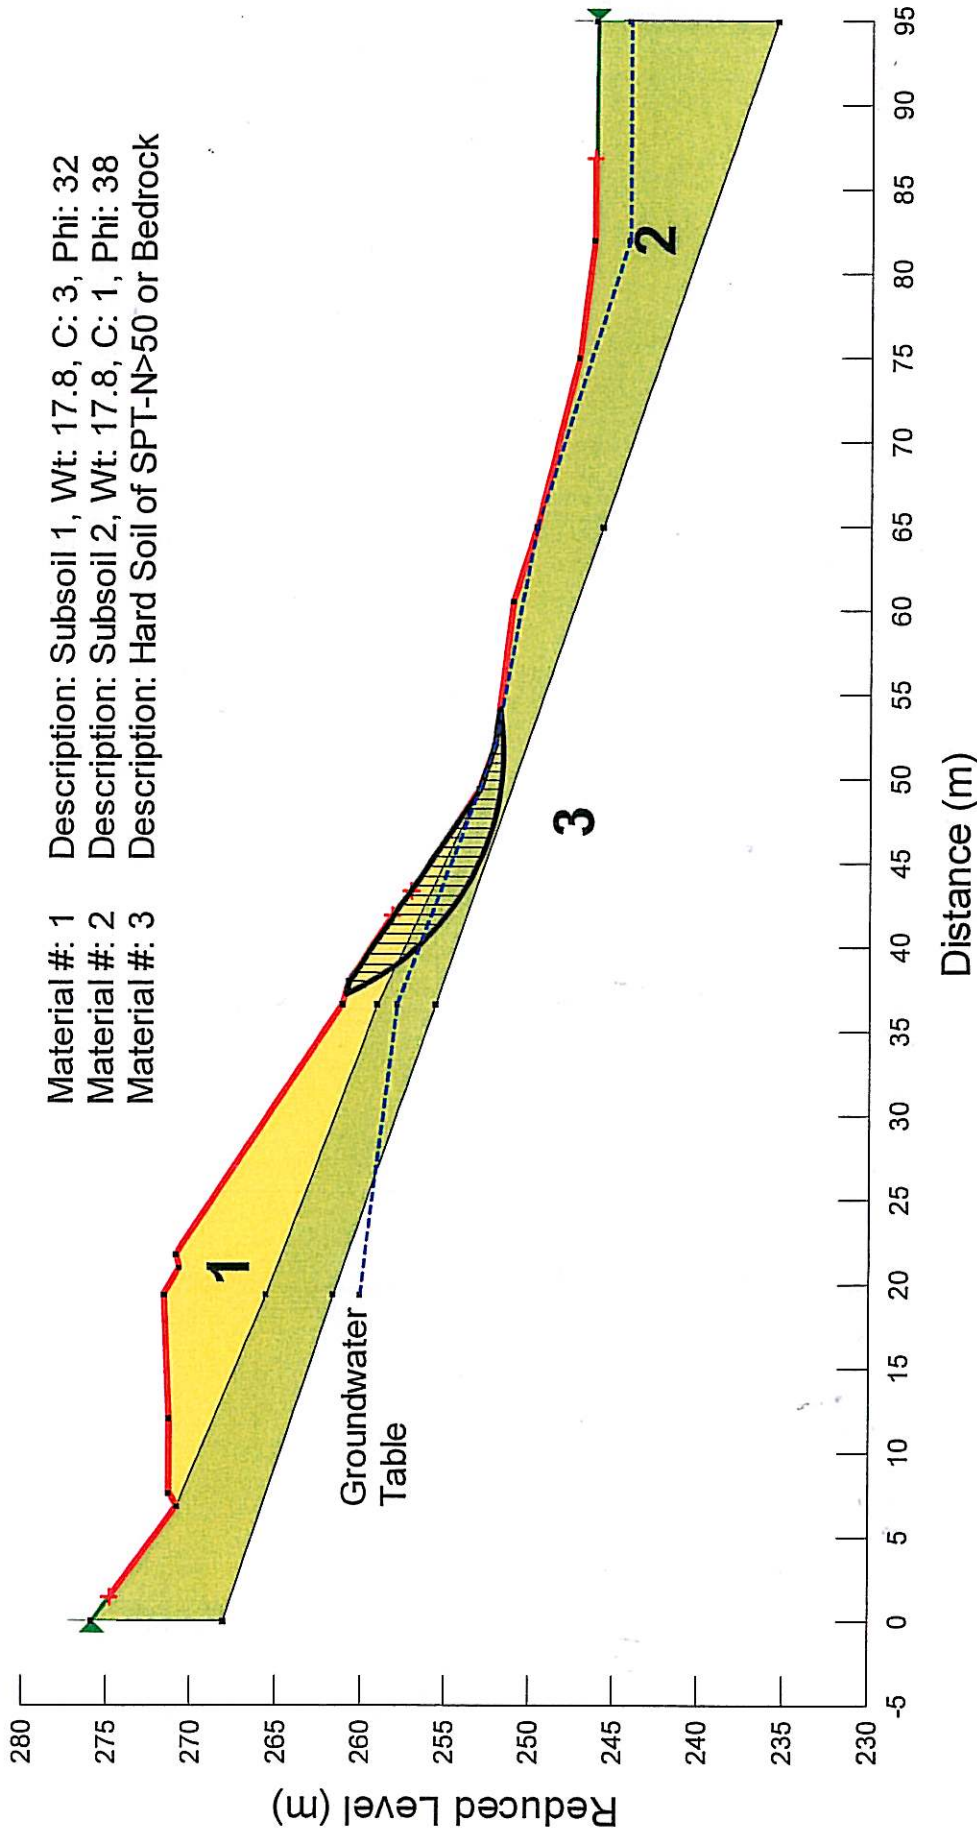
1.13(h)	<ul style="list-style-type: none"> <li>▪ Cross-section F-F, Case 2</li> <li>▪ Subsoil 1: <math>C' = 3.0\text{kPa}</math>, <math>\phi' = 32.0^\circ</math></li> <li>▪ Subsoil 2: <math>C' = 3.0\text{kPa}</math>, <math>\phi' = 36.0^\circ</math></li> </ul>	1.12	<ul style="list-style-type: none"> <li>▪ Potential deep slip failure</li> <li>▪ Inadequate FOS (<math>&lt;1.4</math>)</li> <li>▪ <b>Unacceptable</b></li> </ul>

**Figure 1.13(h): Stability Analysis of Cross-section F-F**  
 Case 2 - Subsoil 1:  $C' = 3.0\text{kPa}$ ,  $\phi' = 32.0^\circ$ ; Subsoil 2:  $C' = 1.0\text{kPa}$ ,  $\phi' = 38.0^\circ$   
 Factor of Safety = 1.12 (<1.40, Unacceptable)

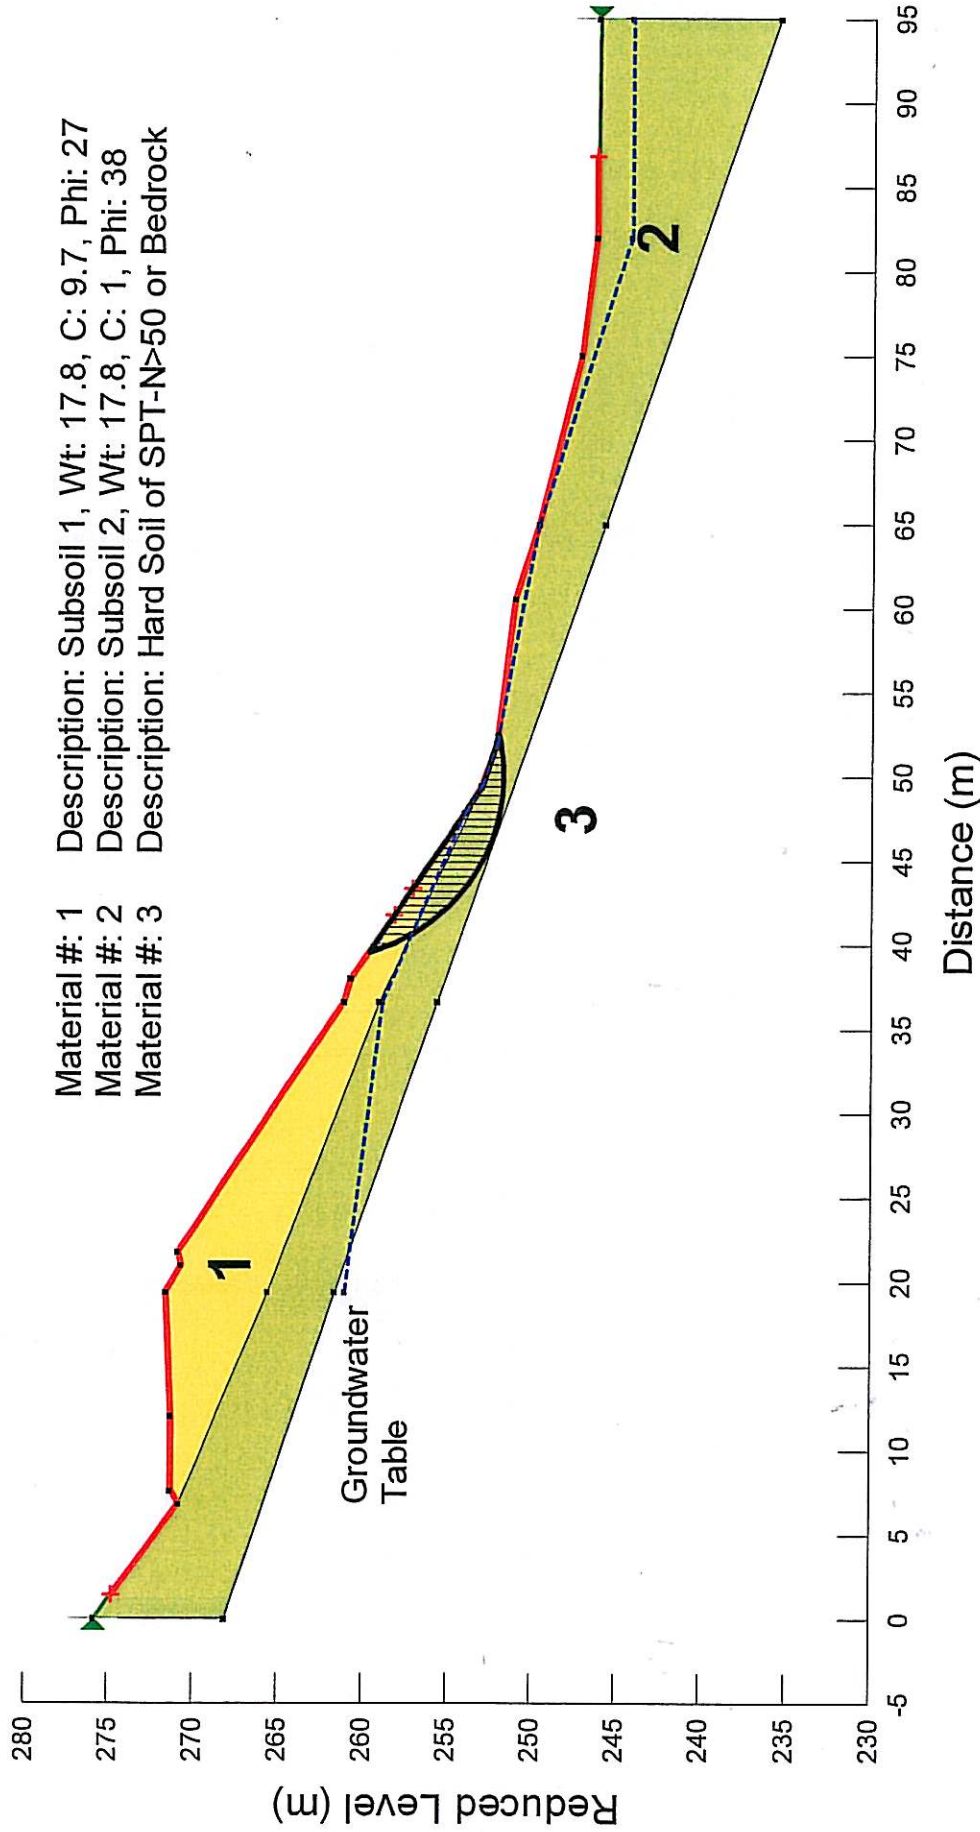
1.13(i)	<ul style="list-style-type: none"> <li>▪ <u>If groundwater level rises for 1.0m</u></li> <li>▪ Cross-section F-F, Case 1</li> <li>▪ Subsoil 1: <math>C' = 9.7\text{kPa}</math>, <math>\phi' = 27.0^\circ</math></li> <li>▪ Subsoil 2: <math>C' = 3.0\text{kPa}</math>, <math>\phi' = 36.0^\circ</math></li> </ul>	0.97	<ul style="list-style-type: none"> <li>▪ Deep slip failure</li> <li>▪ Inadequate FOS (<math>&lt;1.4</math>)</li> <li>▪ <b>Failure Expected (<math>&lt;1.0</math>)</b></li> </ul>

because the required is 1.4. If the groundwater table (as well as the lake water level) in Section F-F rises for 1.0m during the monsoon season, the factors of safety reduces from about 1.1 to about 0.9, and failure would be expected. The lake water level during the SI carried out by IKRAM on 29<sup>th</sup> December 2007 was 247.234 meters.

**Figure 1.13(i): Stability Analysis of Cross-section F-F if Groundwater Level Rises for 1m**

Factor of Safety = 0.97 (<1.00, Failure expected)
