**FINAL INVESTIGATION REPORT**  
**BY**  
**SUBSTRUCTURE ANALYSIS AND SURROUNDINGS**  
**COMMITTEE**

**12 MARCH 2008**

**BADAN PENYIASATAN BEBAS (INDEPENDENT BOARD OF INQUIRY) KES  
KEJADIAN BANGUNAN RUNTUH (KOMPLEKS PELANCONGAN) DI PULAU  
BANDING, GERIK, PERAK DARUL RIDZUAN.**

# FINAL INVESTIGATION REPORT BY SUBSTRUCTURE ANALYSIS AND SURROUNDINGS COMMITTEE

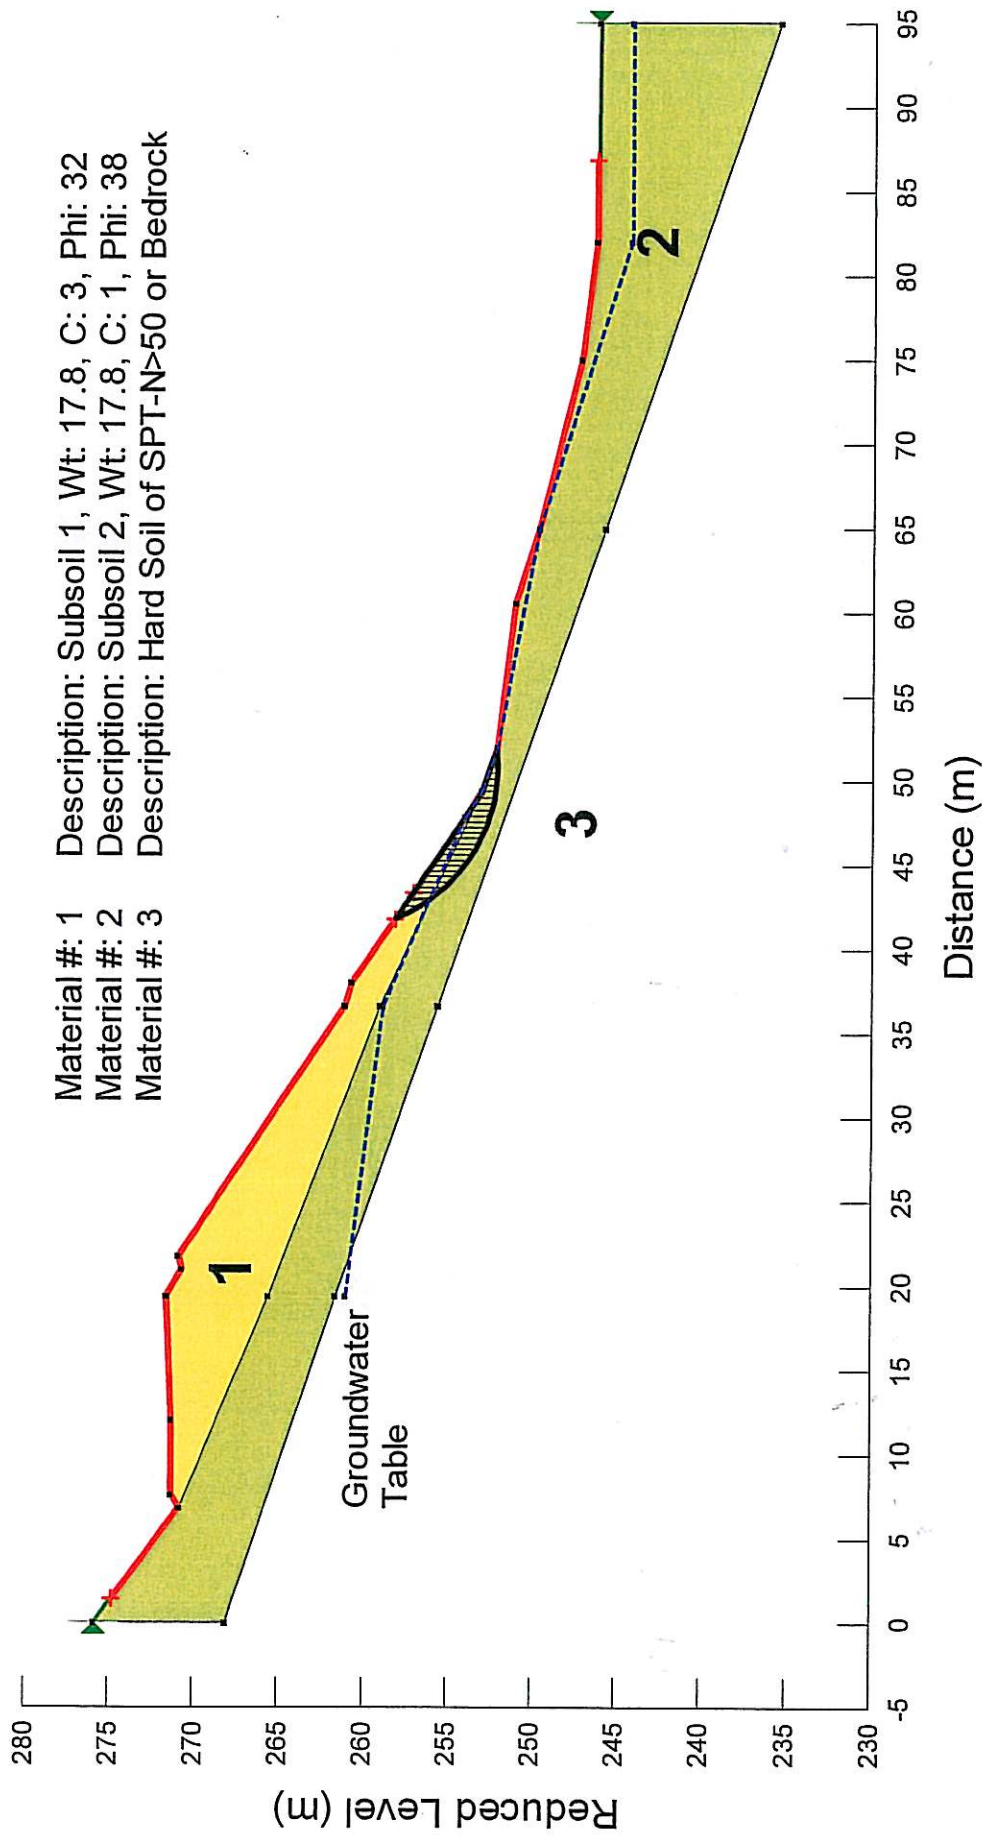
1.13(j)	<ul style="list-style-type: none"> <li>▪ <u>If groundwater level rises for 1.0m</u></li> <li>▪ Cross-section F-F, Case 2</li> <li>▪ Subsoil 1: <math>C' = 3.0\text{kPa}</math>, <math>\phi' = 32.0^\circ</math></li> <li>▪ Subsoil 2: <math>C' = 3.0\text{kPa}</math>, <math>\phi' = 36.0^\circ</math></li> </ul>	0.91	<ul style="list-style-type: none"> <li>▪ Relatively deep slip failure</li> <li>▪ Inadequate FOS (<math>&lt;1.4</math>)</li> <li>▪ <b>Failure Expected (<math>&lt;1.0</math>)</b></li> </ul>

because the required is 1.4. If the groundwater table (as well as the lake water level) in Section F-F rises for 1.0m during the monsoon season, the factors of safety reduces from about 1.1 to about 0.9, and failure would be expected. The lake water level during the SI carried out by IKRAM on 29<sup>th</sup> December 2007 was 247.234 meters.

**Figure 1.13(j): Stability Analysis of Cross-section F-F if Groundwater Level Rises for 1m**

Factor of Safety = 0.91 (<1.00, Failure expected)
