"BEST PRACTISE" BAGI KERJA-KERJA PENYELIAAN PEMBINAAN JAMBATAN DO & DONT'S IN BRIDGE CONSTRUCTION

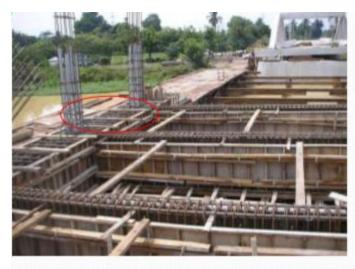
Arrangement of reinforcement for tranverse beam not following construction drawing.

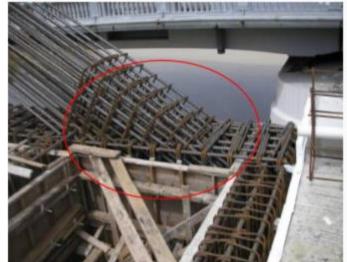
Insufficient reinforcement anchorage length provided at arch beam.

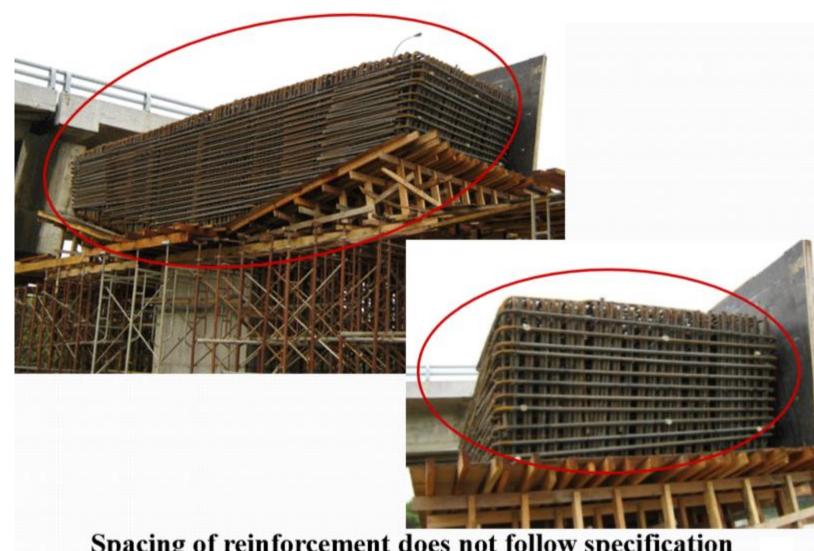
Spacing of reinforcement does not follow specification

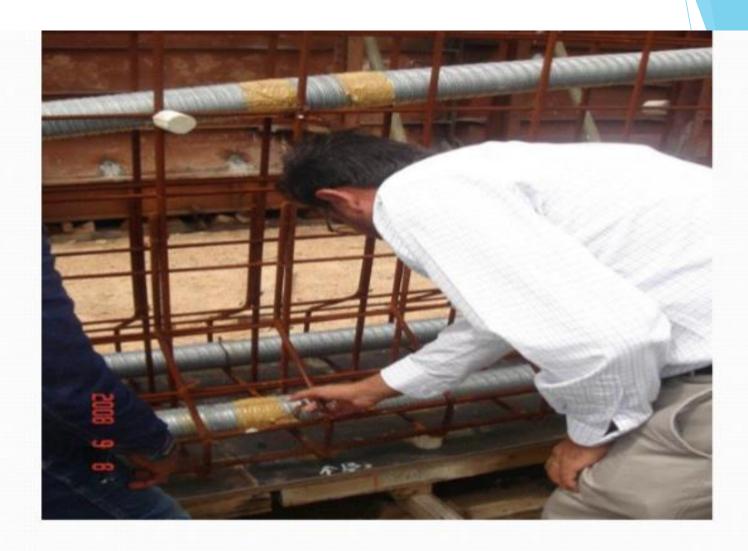
Joint in adjacent sheaths shall be staggered by at least 300mm

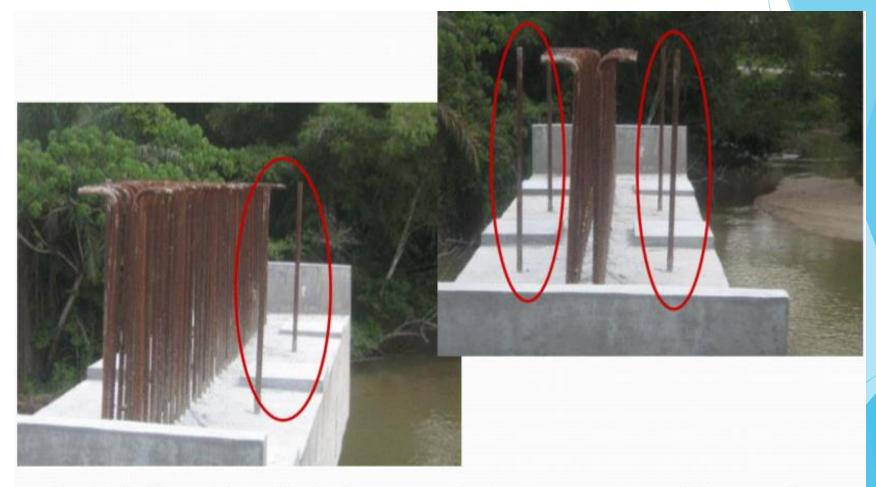
Installation of steel reinforcement at pier crosshead does not follow construction drawing

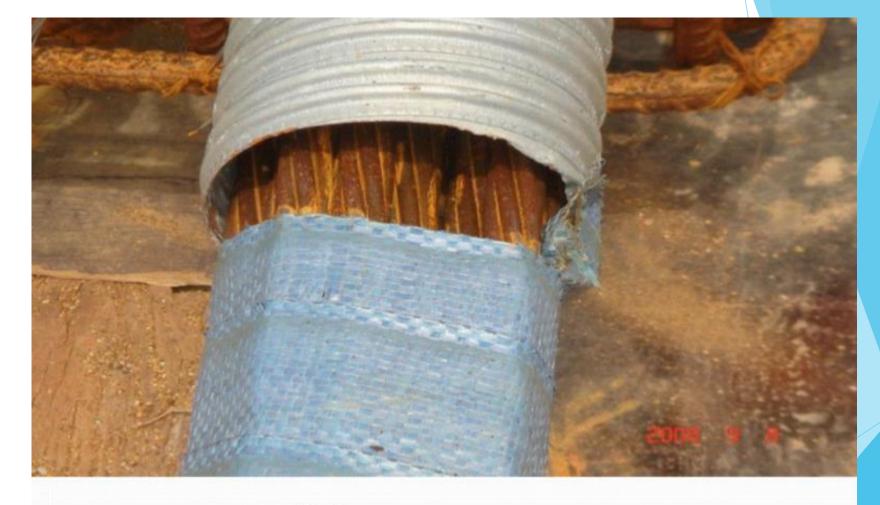
Do have common sense
Don't let prestressing tendon exposed to weather to avoid
corrosion.

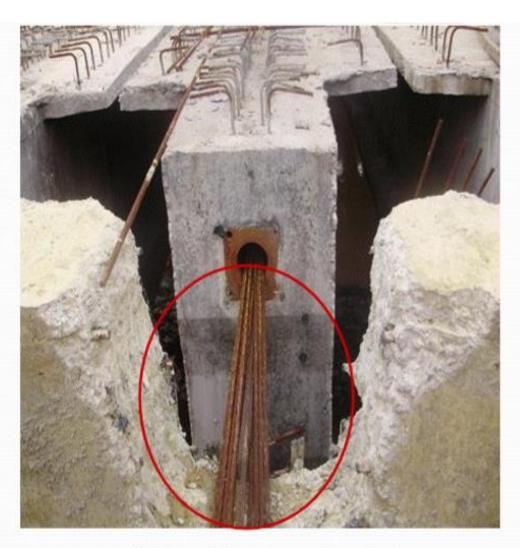
Tendon was corroded and not protected as per specification

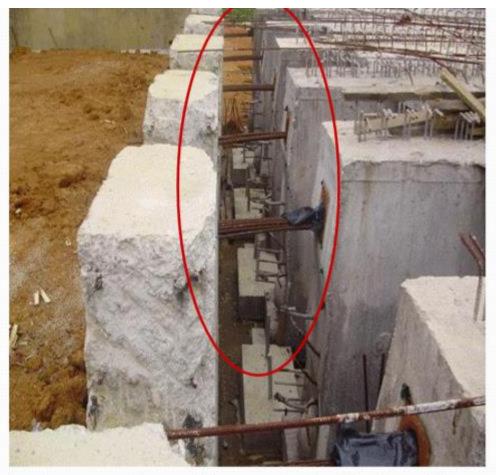
Distance between edge of beam to ballast wall exceeded the designated distance (50mm)

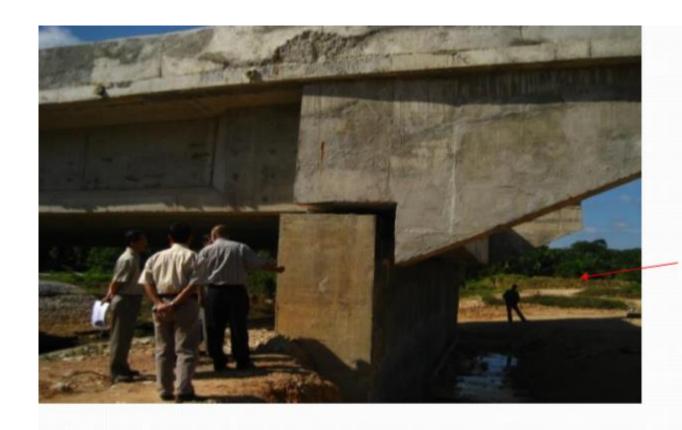
Embankment fill has been removed

Abutment 'B' was shifted 150mm towards river due slope failure of approach embankment.

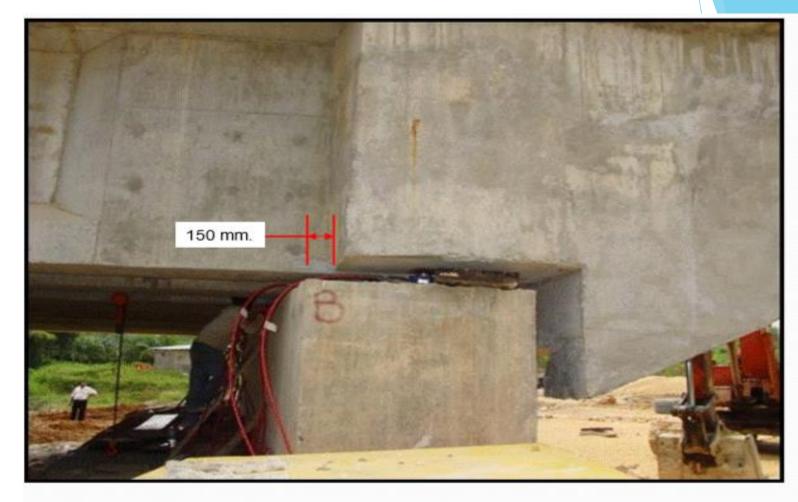
Abutment has been shifted approximately 150mm.

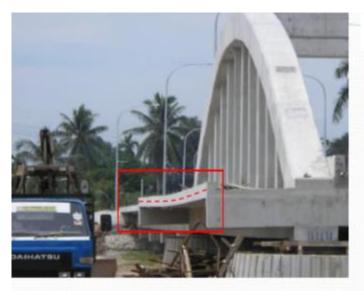
Sagging of walk way slab

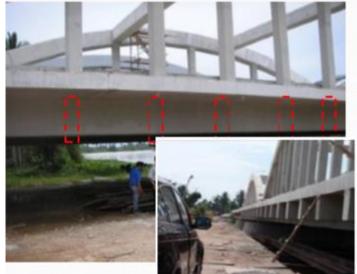
Tranverse beam not constructed below walk way slab (Not following construction drawing)

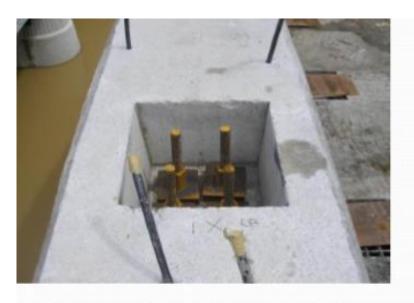
Pocket for end stress bar not immediately grouted.

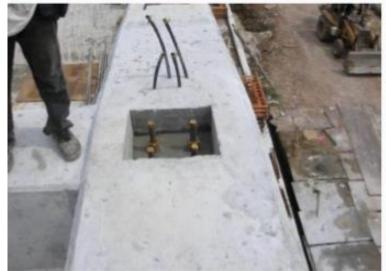
Pocket for end stress bar not immediately filled with shrinkage compensating concrete.

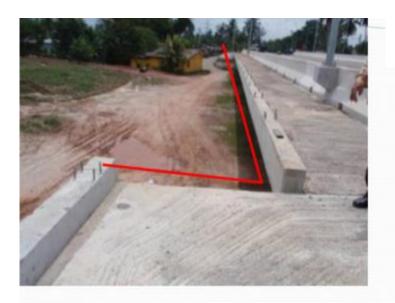
Walkway not constructed in line between main span with approach road.

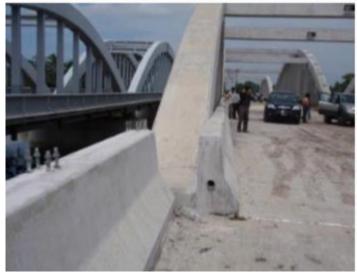
Kink at parapet could be hazards to drivers due direct impact of vehicles.

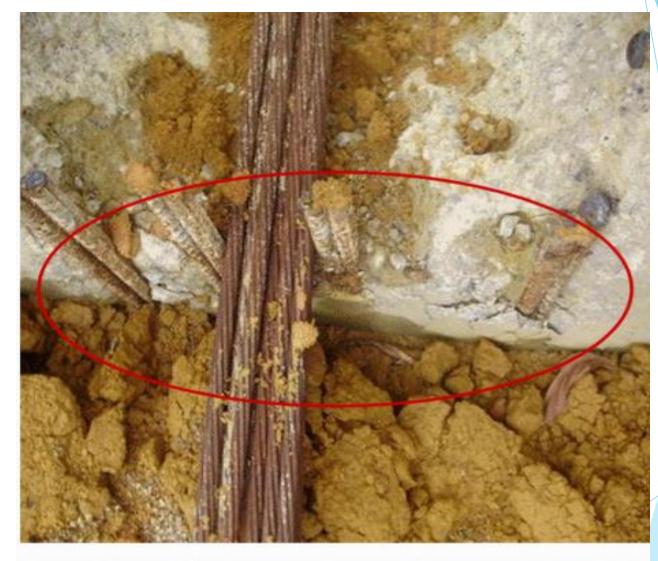
Insufficient concrete cover

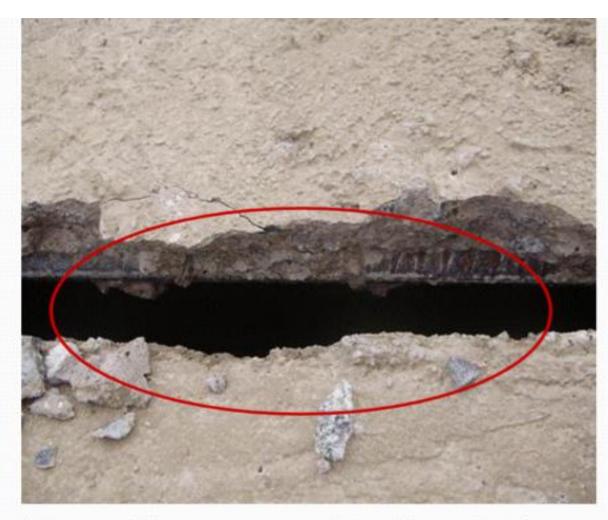
Cracking at beam exposing the reinforcement

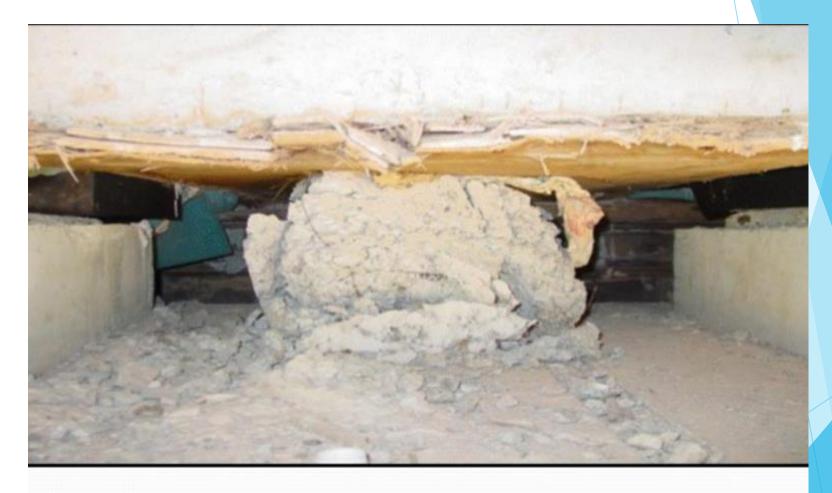
Damaged shear keys

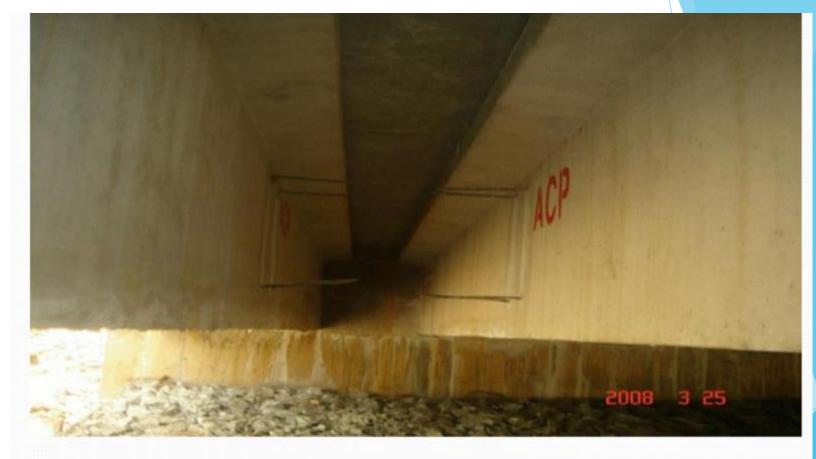
Don't certify a project completed Starter bars there, but intermediate diaphragm not constructed.

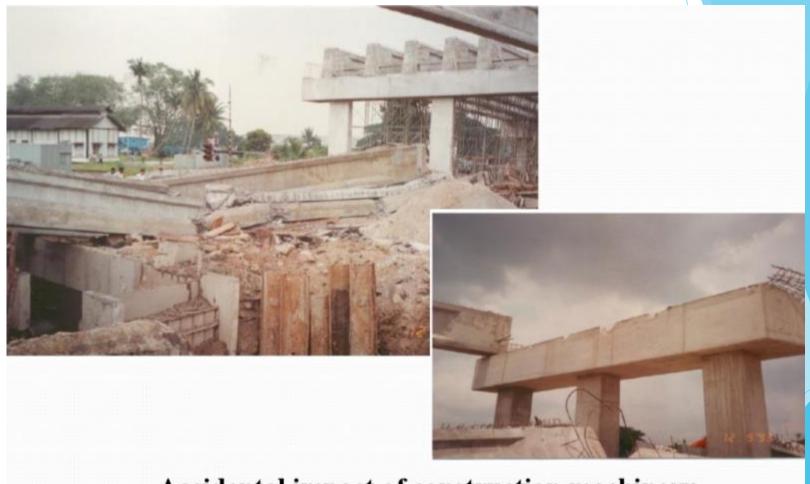
Accidental impact of construction machinery

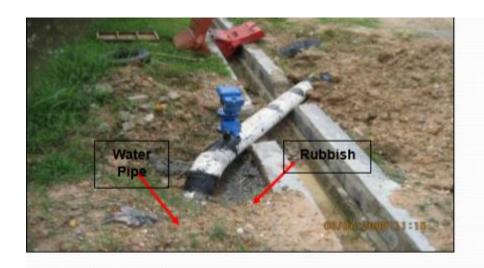
Water pipe was laid by punching through the wall of roads side drain.

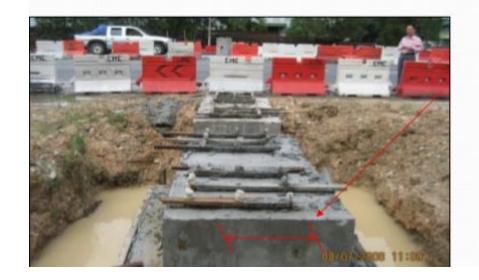
Deviation of anchor bolts deviated from the centreline of pile cap.

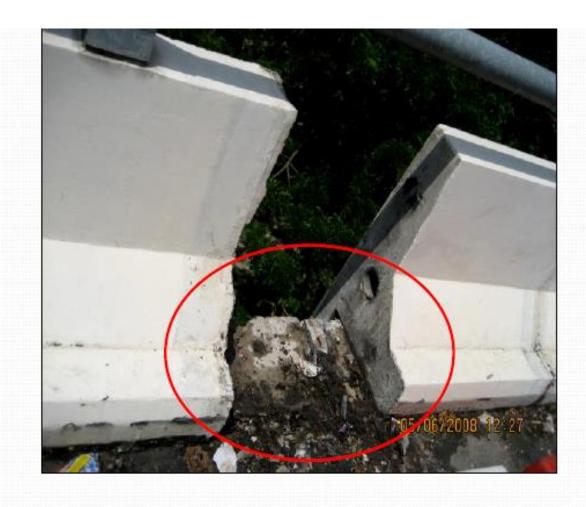
No leveling mortar before installation of precast parapets

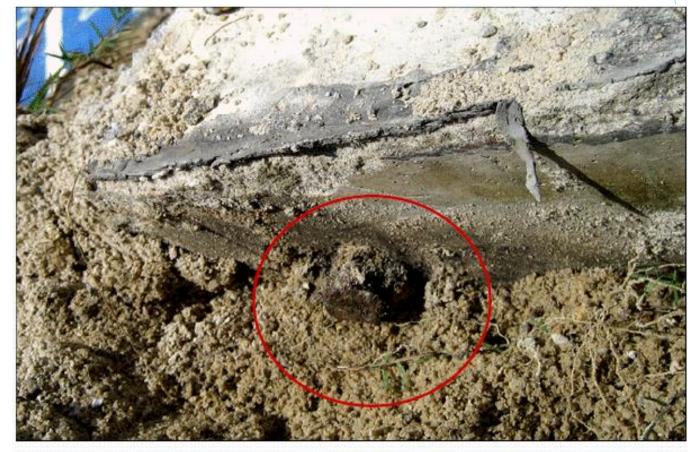
Broken and fractured anchoring bolt of precast parapet

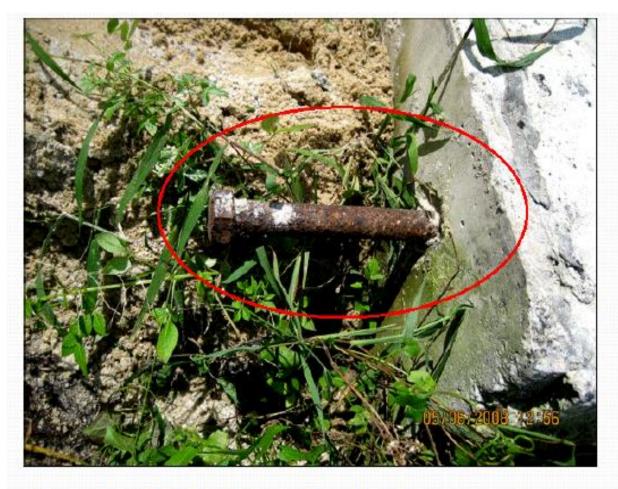
Corroded M24 h.d. used to tie the precast parapet shows that h.d. bolt was installed without approved resin or grouts

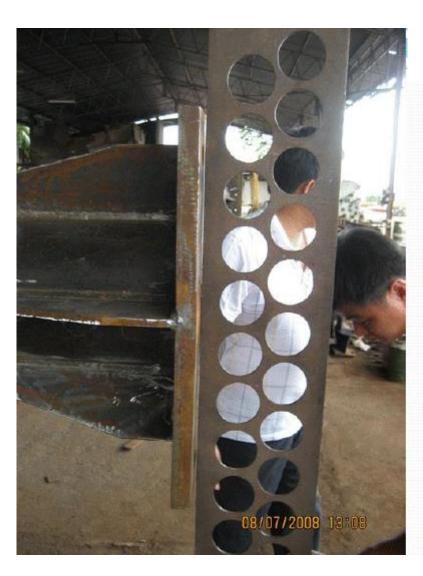
Buckling at steel baseplate occured.

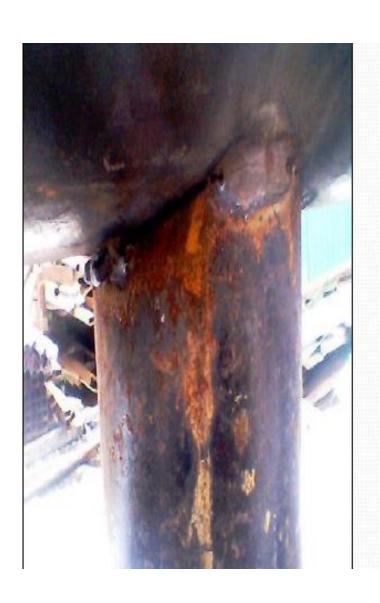
- Existing painting/coating was not removed before welding being carried out.
- The purpose is to avoid the mixing of chemical between painting and weld materials (contamination).
- Disburb/Affect the welding strength

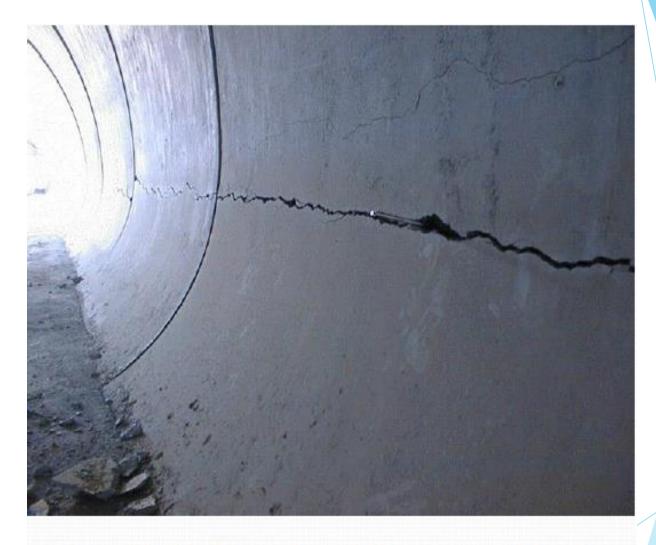
Don't backfill earthwork from one side only
