BLACKSPOT (BS)2015 EFFICACY REPORT

EFFECTIVE MONITORING OF TREATMENTS

SITE VISIT FOR LOCATIONS THAT DO NOT REACH > 70% OF THE EFFICACY OF TREATMENT

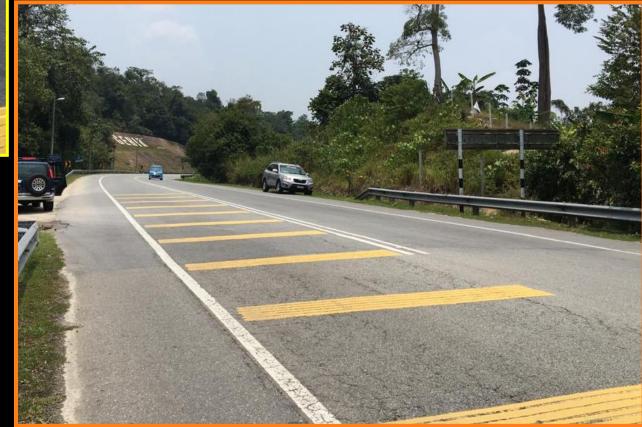
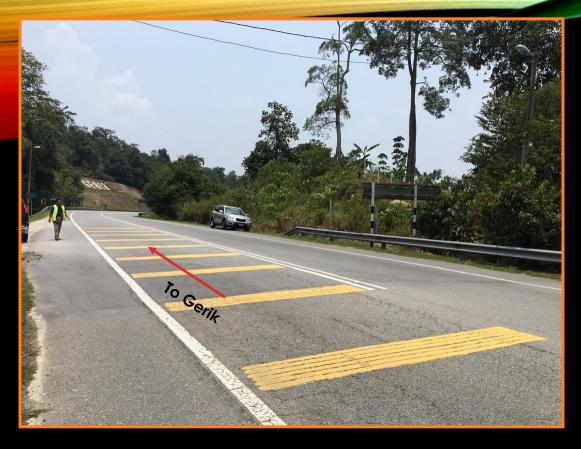
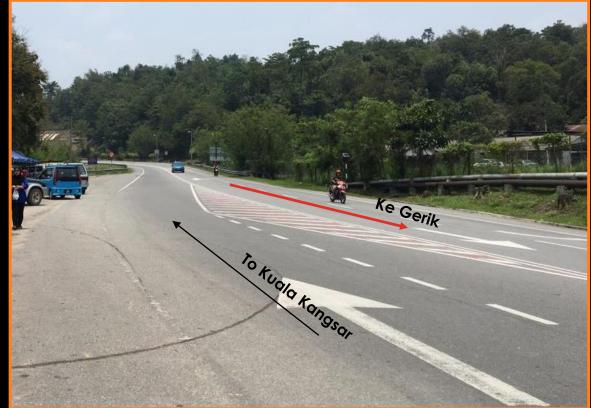
FT076, KM92, JALAN KUALA KANGSAR – GERIK – PENGKALAN HULU, HULU PERAK, PERAK

- The road marking has faded.
- Road <u>surface has cracked</u>.
- <u>The thickness of the Yellow Transverse Bar (YTB) has been lacking</u> (specification: 3 mm – 7 mm)
- YTB is far more than 100 meters to the intersection/accident area.

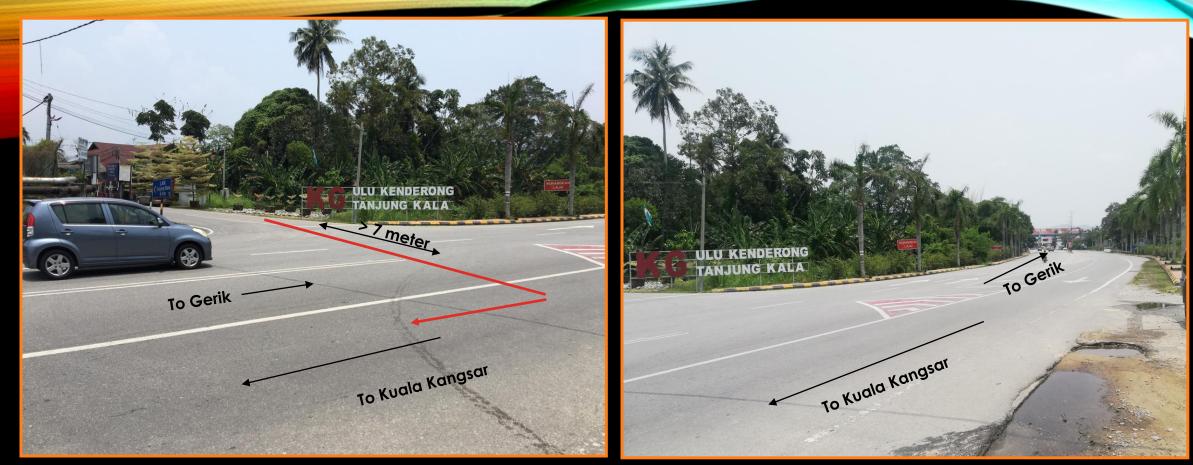
- The location of the accident is at a junction.
- Crossing exit from the junction to the main line FT076 is more than 7 metres.
- Continuous high traffic speed and volume.

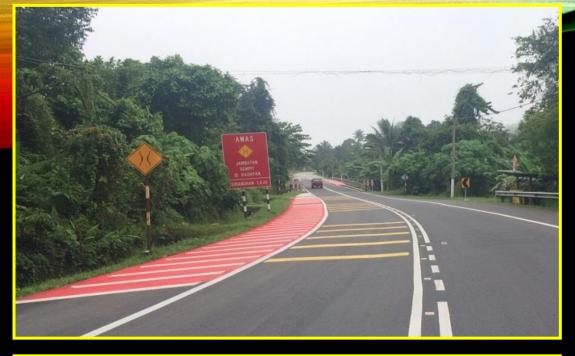
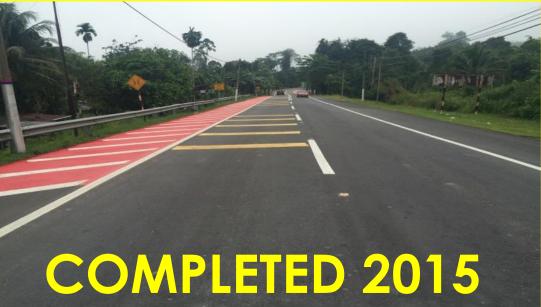
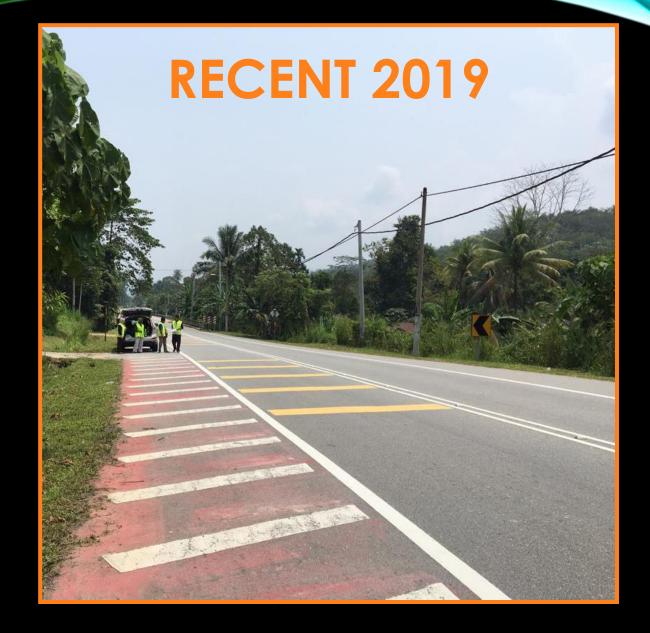
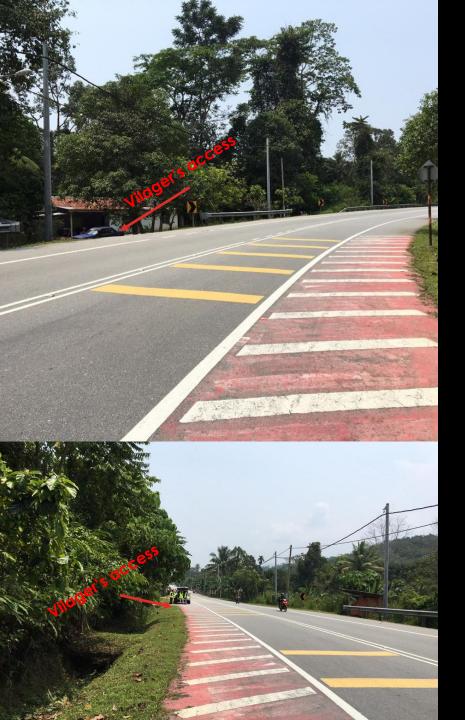
FT076, KM101, JALAN GERIK – PENGKALAN HULU, HULU PERAK, PERAK

Blackspot locations are in the bends area (selekoh) and interchange access into the village houses.

• The "AWAS KAWASAN KEMALANGAN" sign has been lost/stolen.

• High speed vehicle <u>after the</u> <u>bends</u> and enters the adjacent lane.

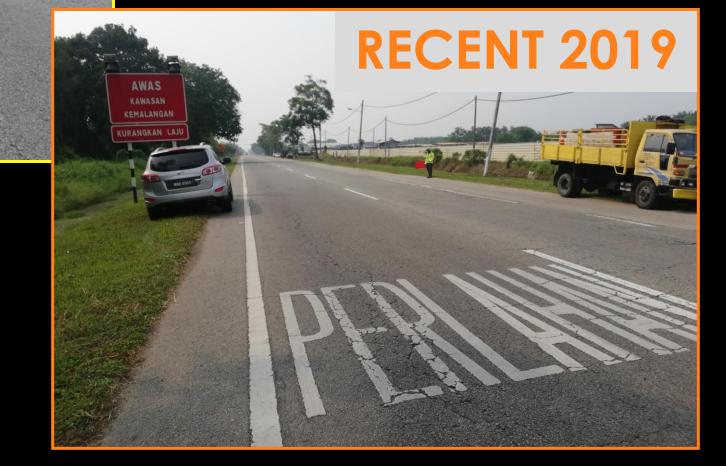
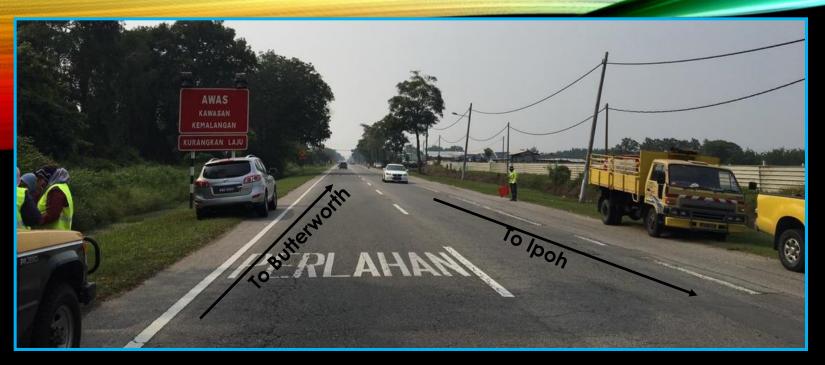
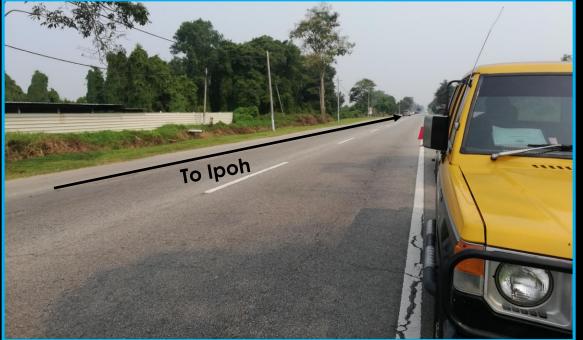
FT001, KM118, JALAN IPOH – BUTTERWORTH, KERIAN, PERAK

The location of accidents is on the <u>straight lane.</u>

The scope of treatment is painting the road line, Road Stud, delineator posts & Safety Signs/warning board.

- Volume traffic is high and straight path causes fast speeding vehicles.
- Accident type is head on collision when overtaking vehicles.

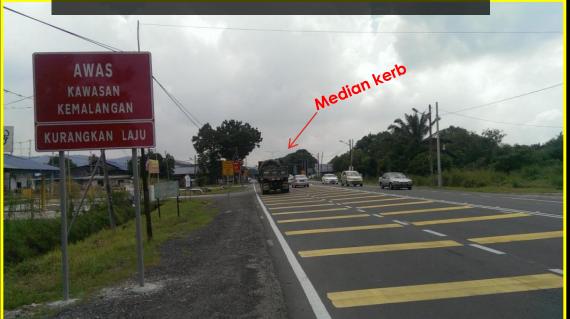
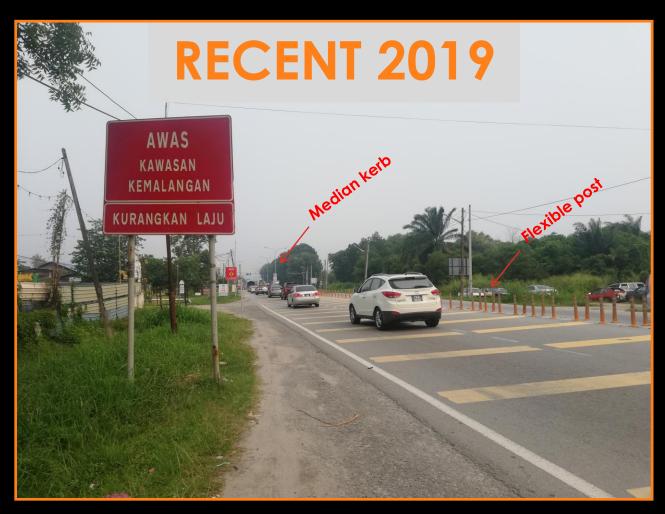
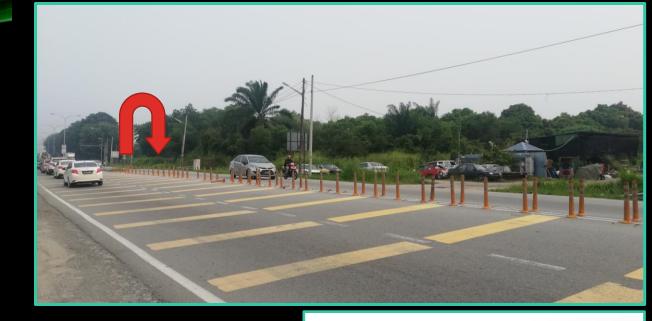
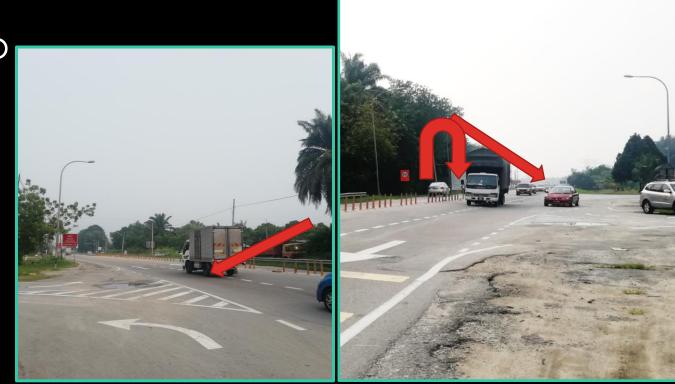
FT001, KM26, JALAN BESAR VALDOR – SG. BAKAP, SPS, P. PINANG

• The location of accidents is on the **straight lane.**

High traffic volume.

- A frequent accident occurred due to the vehicle making a U turn.
- In addition, accidents are also caused by vehicles crossing lanes to enter the opposite exit.

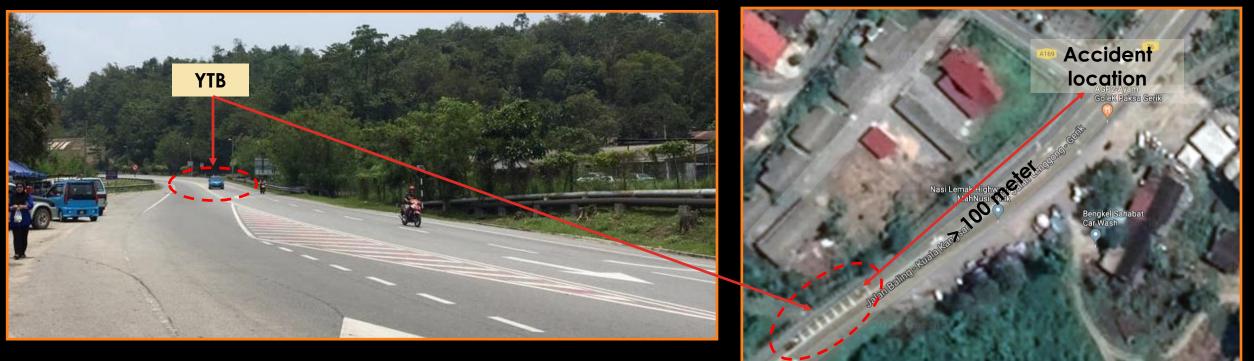
Yellow Tranverse Bar (YTB) is located at a distance that allow the vehicle to speed up again before arriving at the accident prone area.

1. Treatment must be carried out within the radius of the accident prone area.

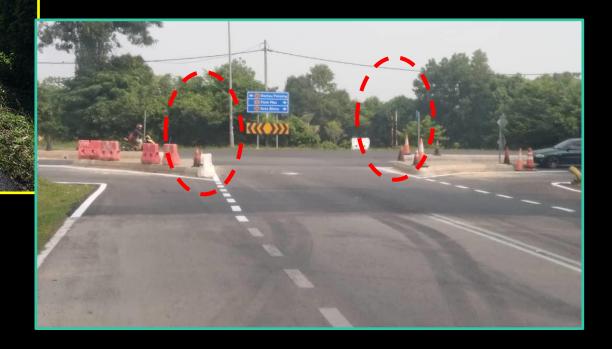
Missing scope: Street lights installation is highly needed to alert danger driving at bend when the area is filled in fog.

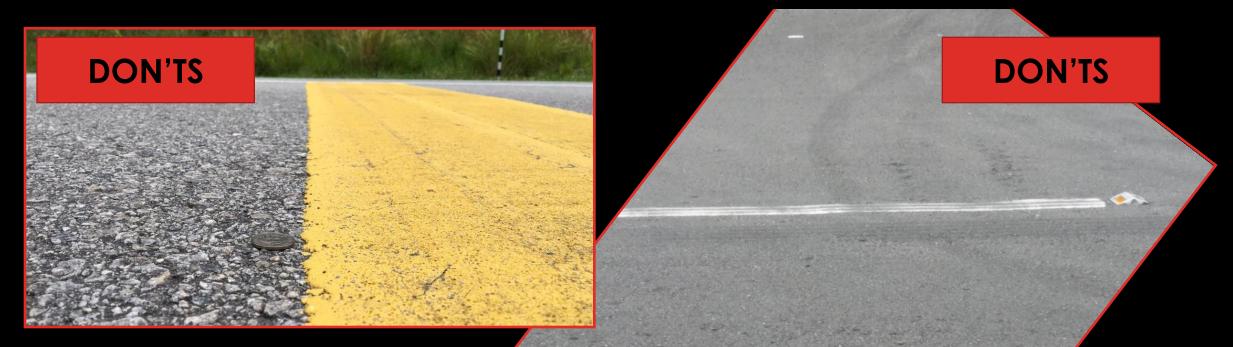
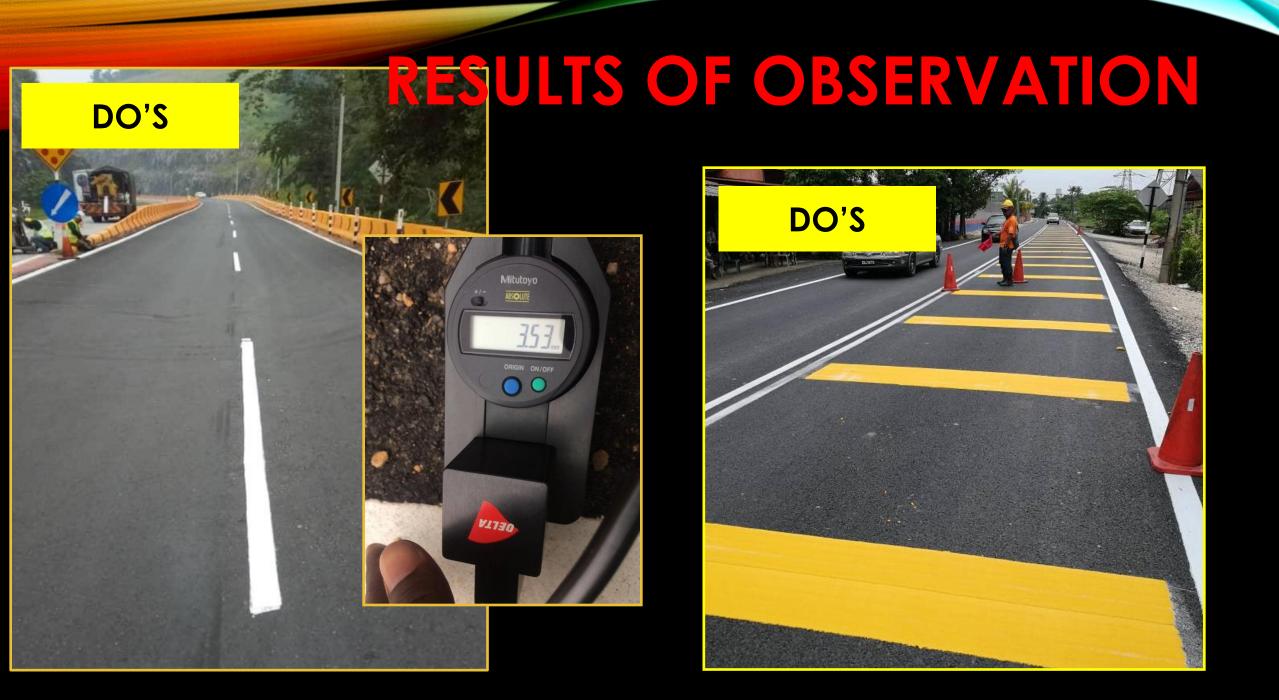
- 1. The road marked is constructed not in compliance with PWD's specification (for newly completed locations).
- 2. YTB thickness less than < 3 mm (Specification 5 7 mm)
- 3. Thin road lines. (Specification 3 5 mm)

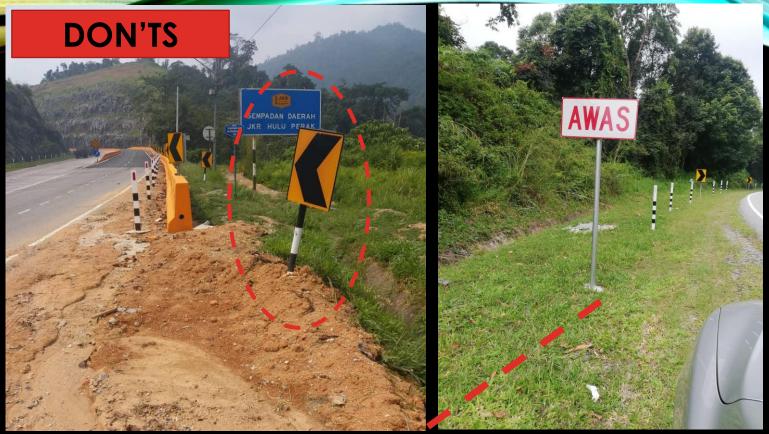
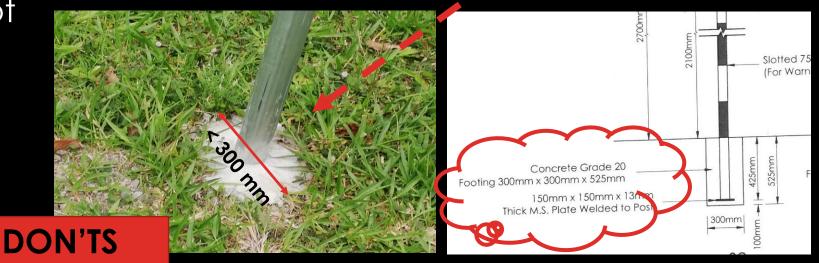
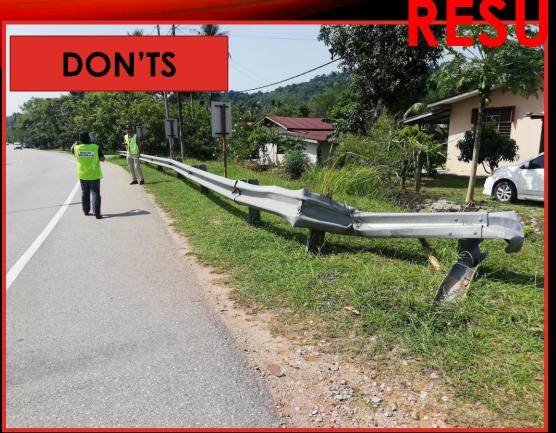
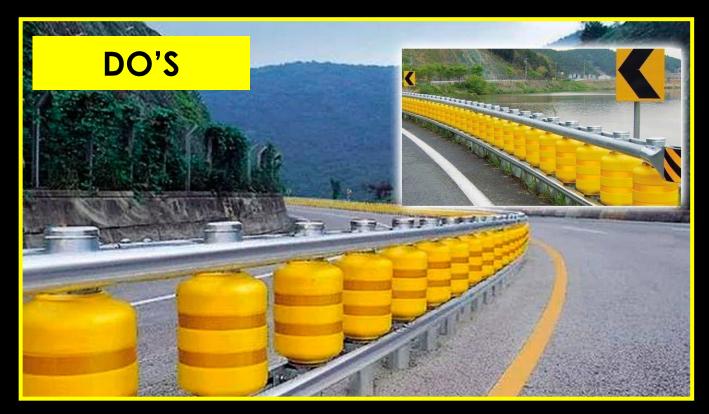
2. Loose sign boards/not planted properly.

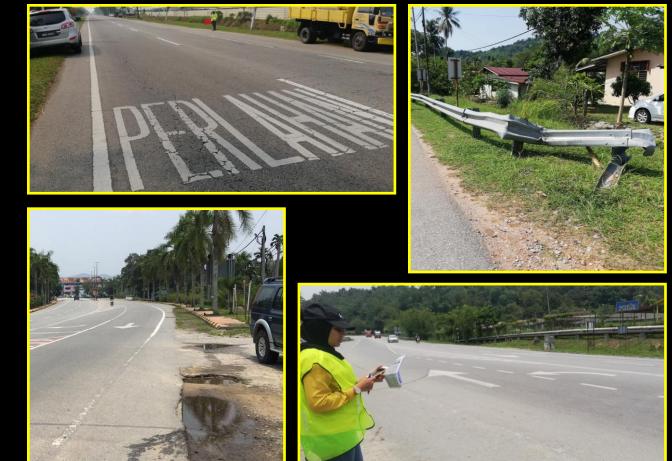
- 1. <u>Routine and periodic work is</u> not efficiently implemented.
- 2. Cracking on the road surface,
- 3. Unwashed signboards,
- 4. The road shoulder is not maintained.
- 5. Damaged guardrail left unrepaired.
- 6. Faded road panting.
- 7. Unmaintained drain.
- 8. <u>The Routine Inspector is not</u> <u>performing the duty diligently.</u>

2. PWD Daerah has to <u>prioritize</u> the application of allocations <u>to maintain road furniture</u> and to <u>improve the road surface</u> at <u>treated blackspot</u> <u>locations to ensure safety.</u> Surat Al-Baqarah Ayat 195
