Landslide Types & Processes

IR. DR. MOHD ASBI BIN OTHMAN

Mohd Asbi & Associates

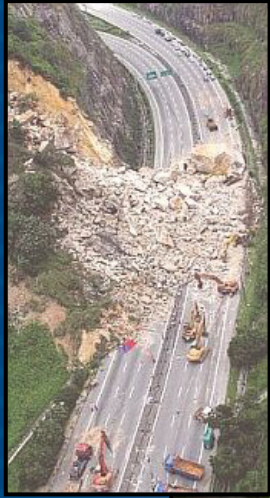
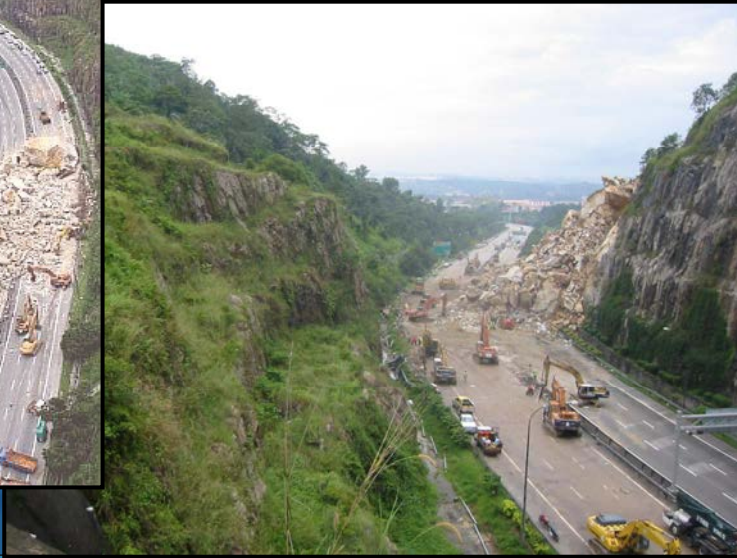
Case Study 1: Bukit Lanjan Rock Slope Failure

- On the 26 November 2003 at about 07:16 a very large rock slope failure occurred at kilometer 21.8 of the Bukit Lanjan Interchange on the New Klang Valley Expressway (NKVE).
- The rock slope failure involved an estimated 35,000 m³ of rock debris, mainly angular blocks of various sizes, which came to rest on the expressway. The failure materials blocked the entire expressway forcing the closure of the road to the public

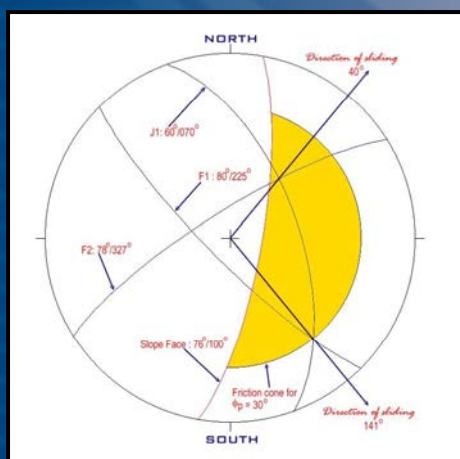
Case Study 1: Bukit Lanjan Rock Slope Failure

Discontinuity	Dip/Dip direction	Type
J1	60/070	Joint plane A
F1	80/225	Fault plane B
F2	78/327	Fault plane C (Release plane)

- The rock slope failure at Bukit Lanjan was due to a huge wedge block which was formed along the intersection between a steeply dipping fault plane F1 (dip/dip direction: $80^{\circ}/225^{\circ}$), and a more gently dipping major joint plane J1 (dip/dip direction: $60^{\circ}/70^{\circ}$), with a fault plane F2 (dip/dip direction: $78^{\circ}/327^{\circ}$) as a release plane.
- The line of intersection plunged at an angle of 33° with the direction of sliding toward 140° .
- The development of groundwater pressure within this release plane could have reduced the resisting force, subsequently promoting failure.

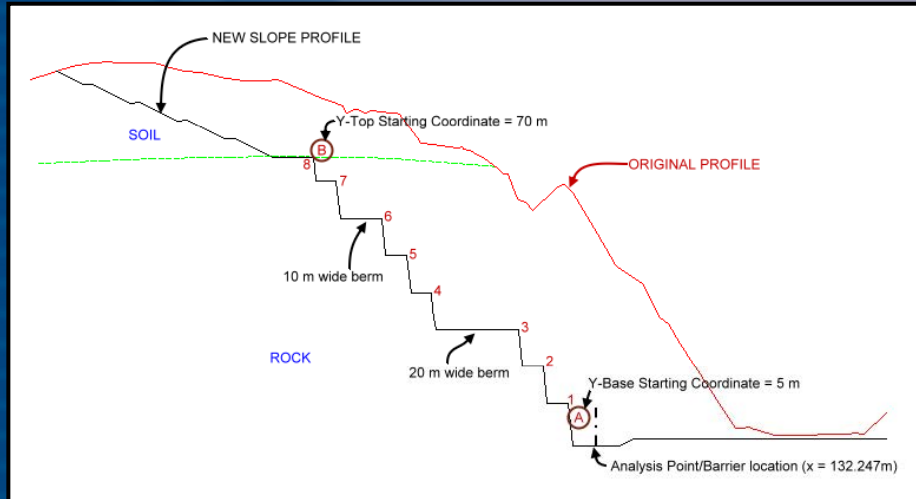
Trajectory analysis – Cross section

- The rehabilitation scheme chosen was rock slope re-profiling because the construction was quick, simple and most cost compared to other options.
- An overall rock slope profile of 48° was considered appropriate for the anticipated *in situ* instability condition

- Slope re-profiling usually reduces the possibility of large scale wedge and/or planar type failure.
- To contain localized minor rock and debris falls, the design would have to incorporate appropriately designed catch berms, rock bolts, rockfill buttress, protection screens, rock trap ditches and fencing.
- Localized stabilization measures such as rock bolts, rock anchors, dowels, shotcrete and concrete buttress were also anticipated to support kinematically unstable blocks that would become exposed during the construction works.
- Drainage works were also incorporated in the form of surface and horizontal drains; the latter were designed in excess of 20 metres to 30 meters in depth

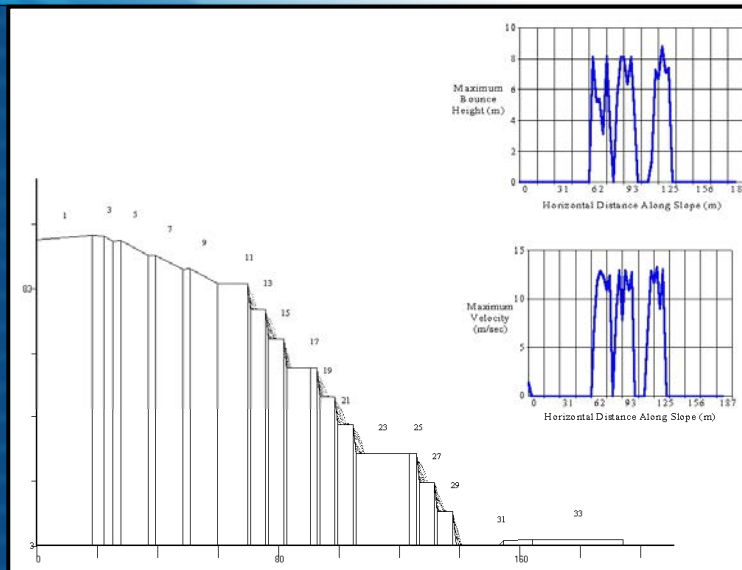
Trajectory analysis – Rock fall travel distance & bounce height

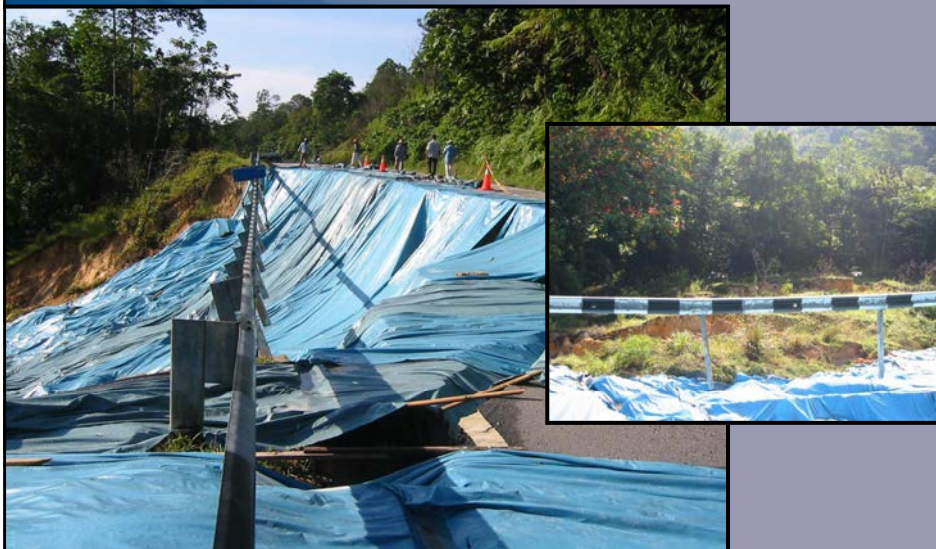
Case Study 2: Embankment Failure at Ulu Yam Road

- A major landslide occurred at KM 12, Jalan Ulu Gombak - Ulu Yam Baru (B23) located in Daerah Gombak on 22 Nov 2002.
- The landslide was triggered by intense and prolonged rainfall brought down tonnes of earth and damaged almost three-quarters of the width of the road. No fatalities were reported in the incident.
- The **rotational landslide** measured approximately 70m wide and 10m high. The crown and surface of rupture were circular.
- The toe of the slope was seen to have heaved indicating a very high pore water pressure build up prior to the failure.
- This is common for areas where large catchment is found upslope.

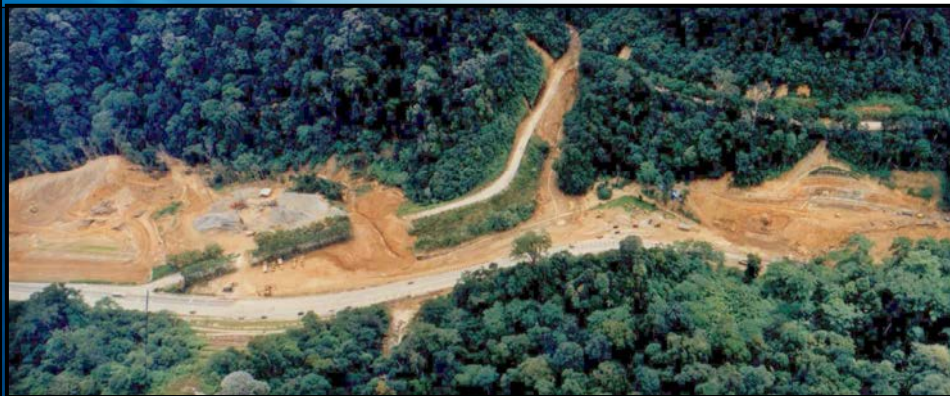
- The debris flow tragedy at the tunnel bypass road to the Genting Highlands occurred at about 5.20 p.m. on the 30th June 1995.
- The incident took 21 lives (one body missing) and injured another 22 persons.
- Most of the victims were buried under tonnes of mud, some 200 metres from the point where the debris flow crossed the bypass road

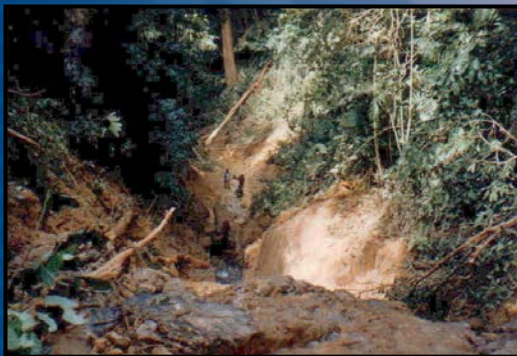
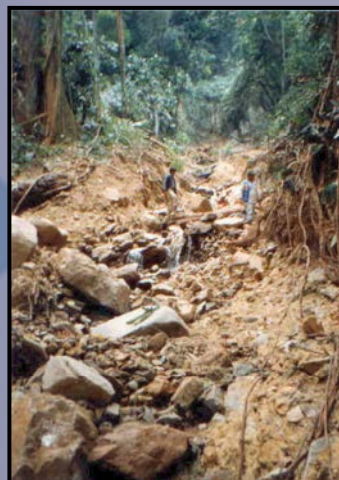
The aftermath at the main stream

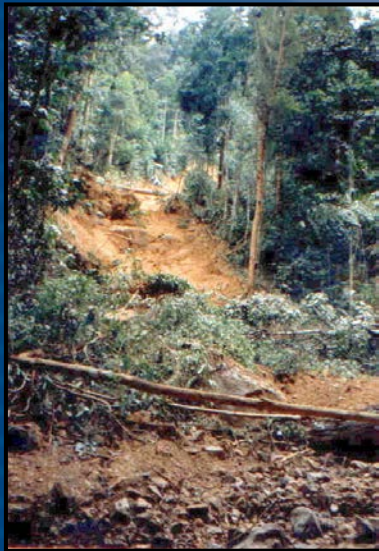
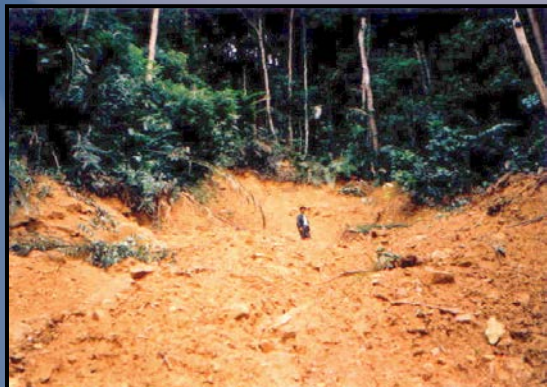
- The debris flow was initiated by the impounding of the main stream within a valley followed by subsequent breaching which resulted in massive flow sweeping across the tunnel bypass road with great force and velocity.
- The impounding was caused by a debris avalanche involving some 5100 cubic metres of earth, measuring 120 metres and 75 metres in length and height respectively from the main stream.

Debris avalanche responsible for the impounding

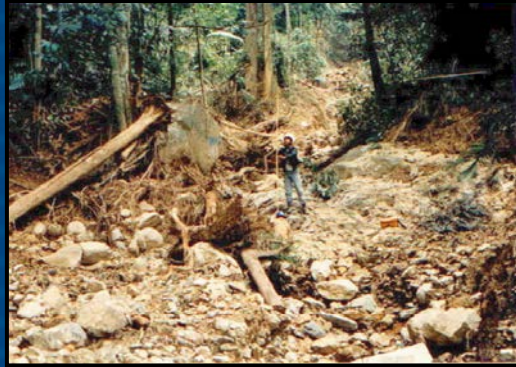
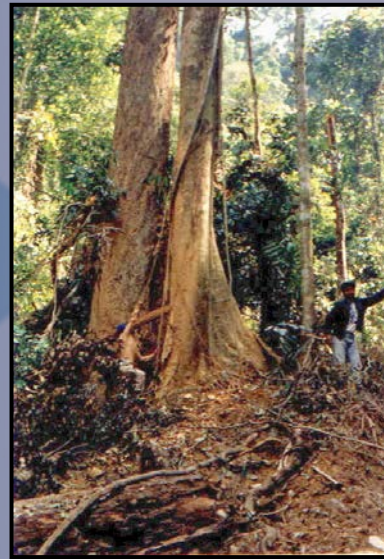
Evidence of impounding was clearly seen as mud stains on the bark of trees along the main stream.

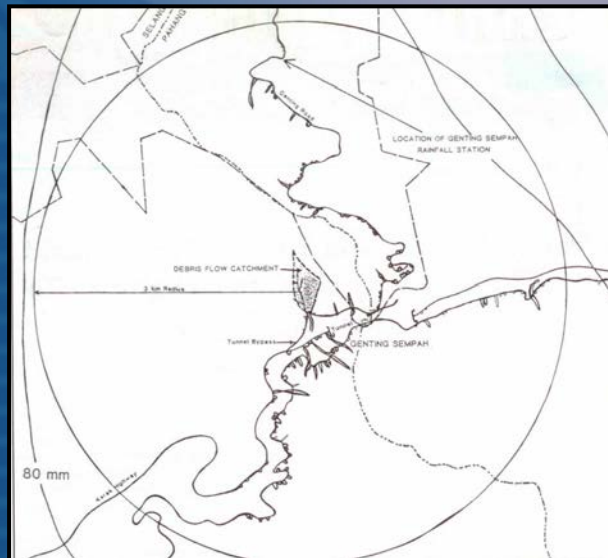
The 3-kilometer radius from the debris flow site where other debris flow and other forms of instability were recorded

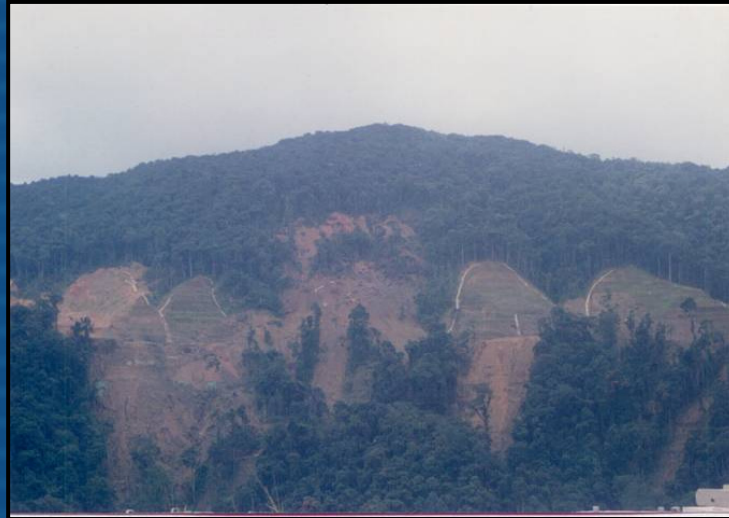
August 2000

After completion of a few berms, the slope started to fail. A series of failures on this slope was first reported in April 2000 after a long period of intense and heavy rainfall which triggered further retrogressive slips in the upper catchment .

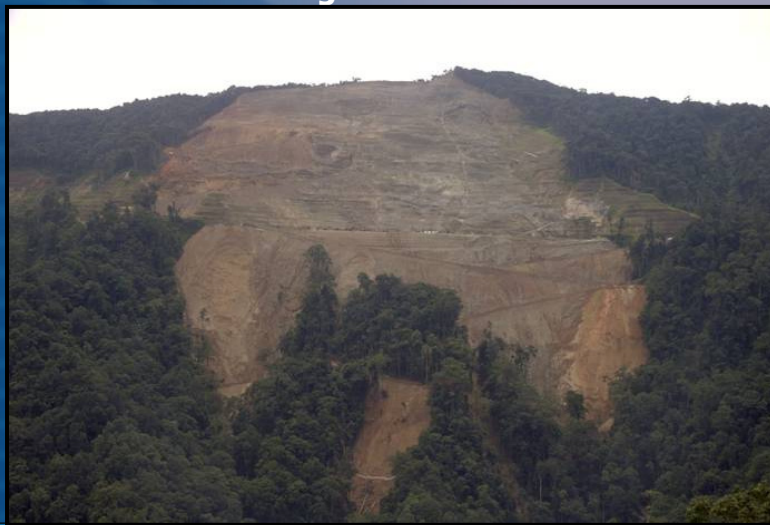
August 2003

Despite the efforts by the Main Contractor to stabilize the slope by re-profiling, the high cut slope at between CH23000-CH24560 is still experiencing deep-seated slope movement

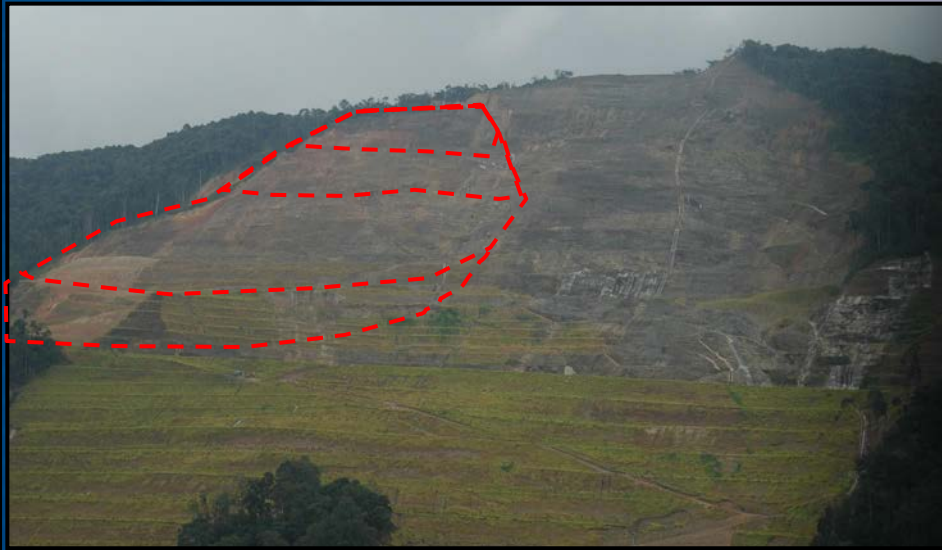
Field-sketch to show the approximate extend of the moving blocks within the major failure

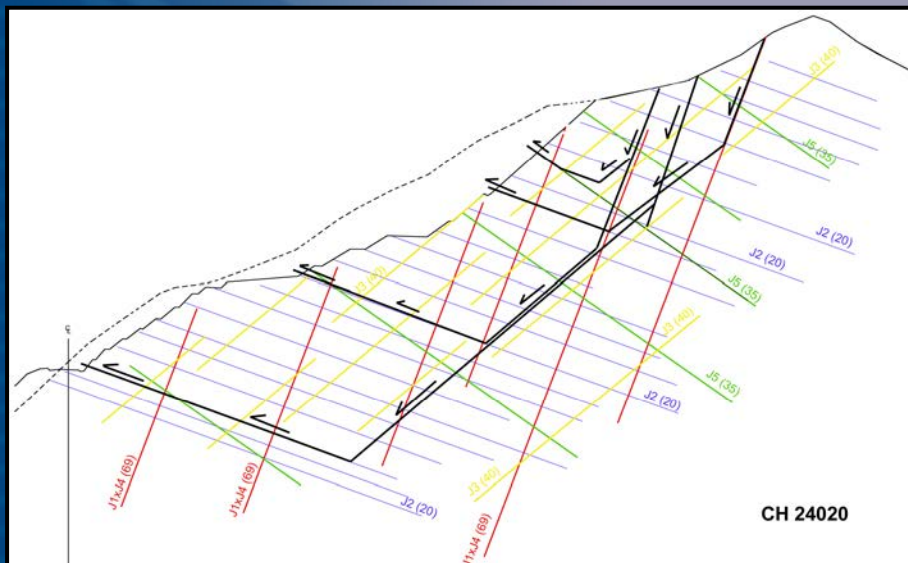
Interpretative cross section of the slope based on the kinematic stability analysis and field data, showing the likely structural orientation and mechanism of the slope failure in the form of a "passive wedge".

- The large-scale landslide is mainly attributed to unfavourable orientation of major discontinuities with respect to the cut slope orientation.
- The failure is a deep seated failure and still active, notably during heavy and prolonged rainfalls.
- Based on findings in the field and results of kinematic analysis, elements of instability still exists even though the slope is cut further inwards.

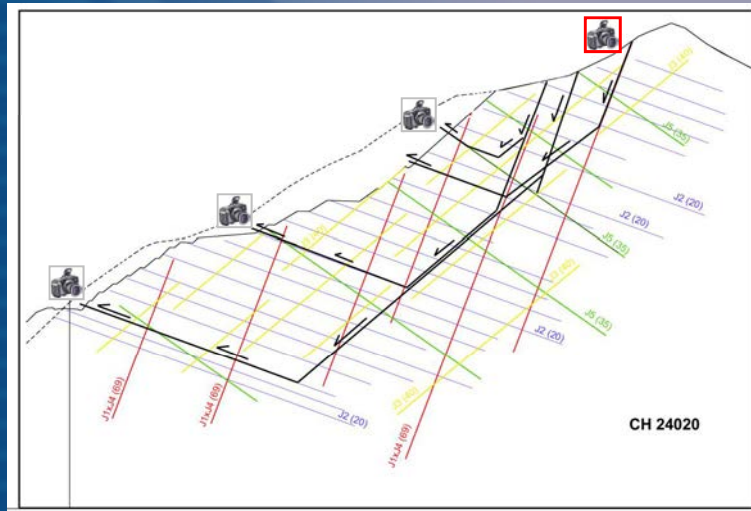
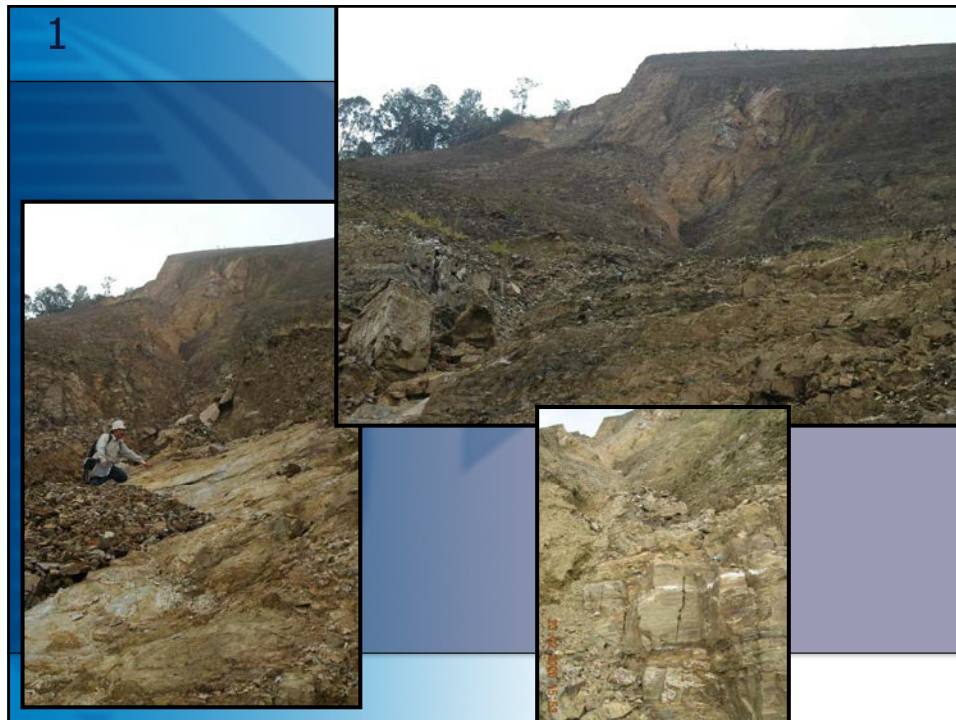
CH 23+900 – CH 24+400
(The major failure)

CROSS SECTION SHOWING THE LIKELY MECHANISME OF THE
MAJOR FAILURE BETWEEN CH 23900 – CH 24400

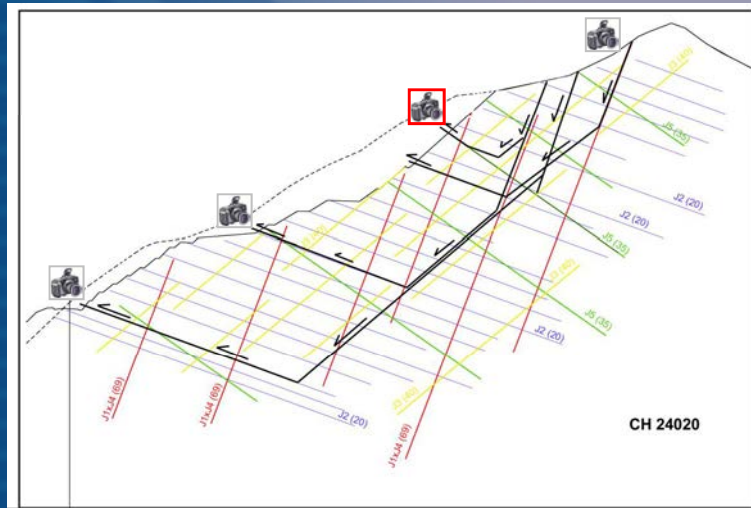
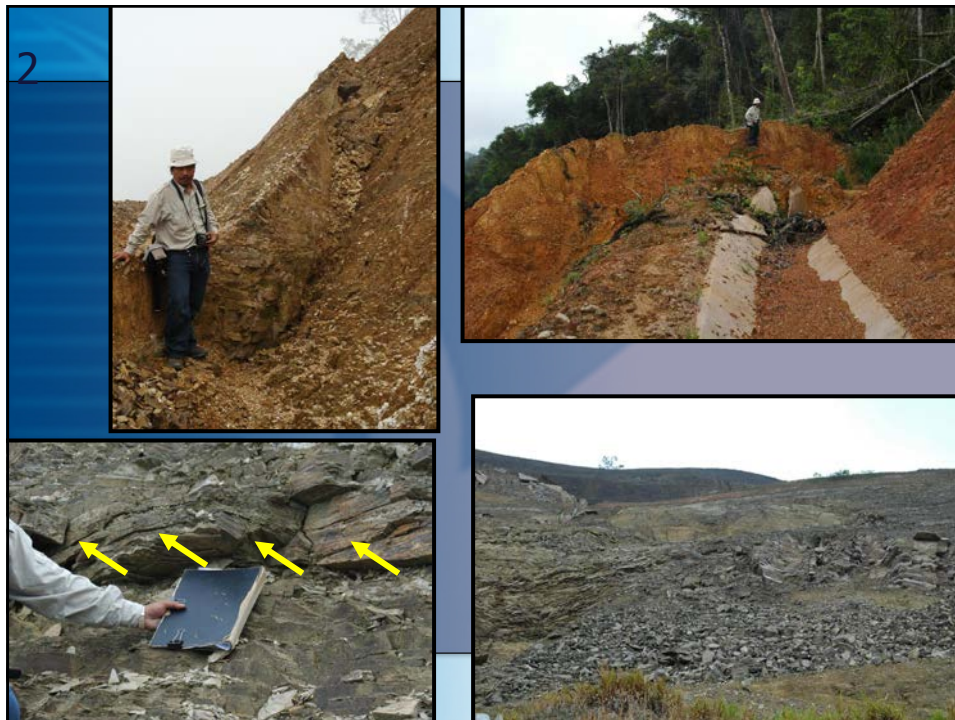
CH 23+900 – CH 24+400 (The major failure)

CROSS SECTION SHOWING THE LIKELY MECHANISME OF THE MAJOR FAILURE
BETWEEN CH 23900 – CH 24400

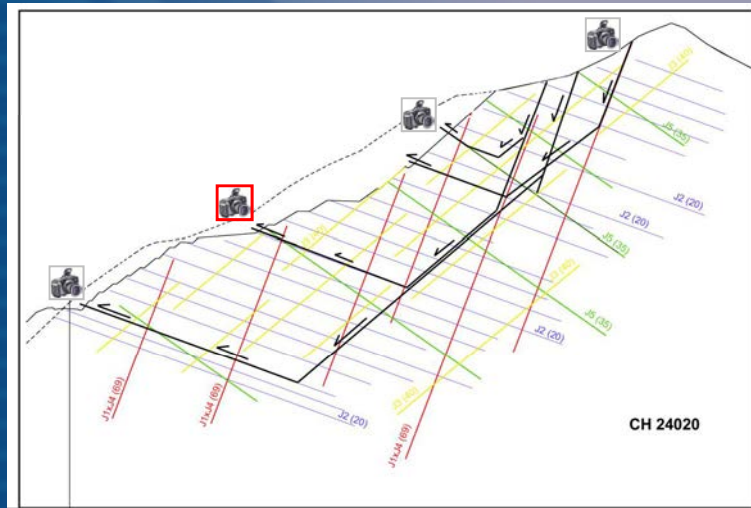
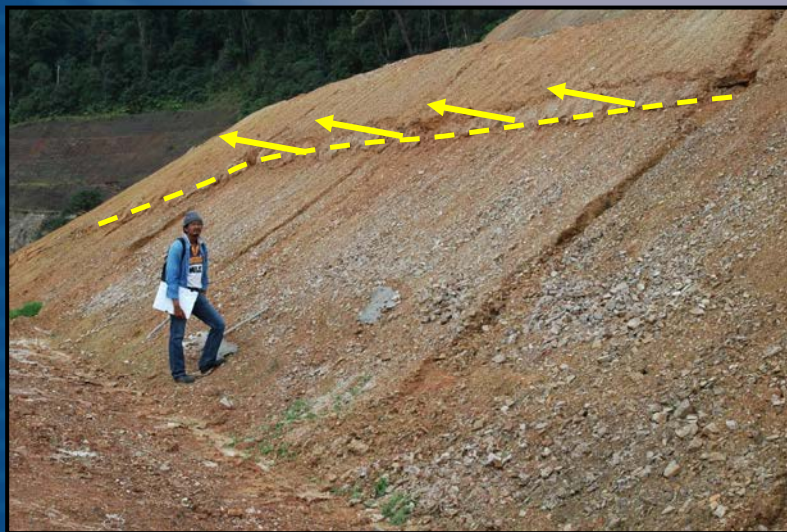
CH 23+900 – CH 24+400
(The major failure)

CROSS SECTION SHOWING THE LIKELY MECHANISME OF THE
MAJOR FAILURE BETWEEN CH 23900 – CH 24400

Basal Sliding Plane

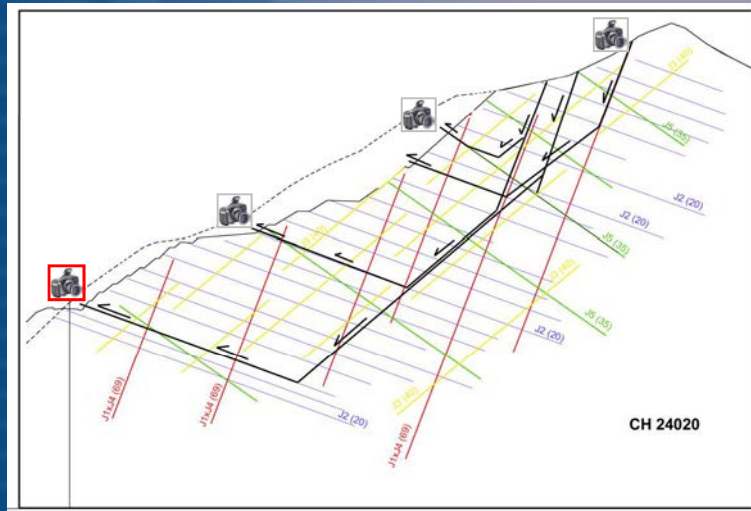
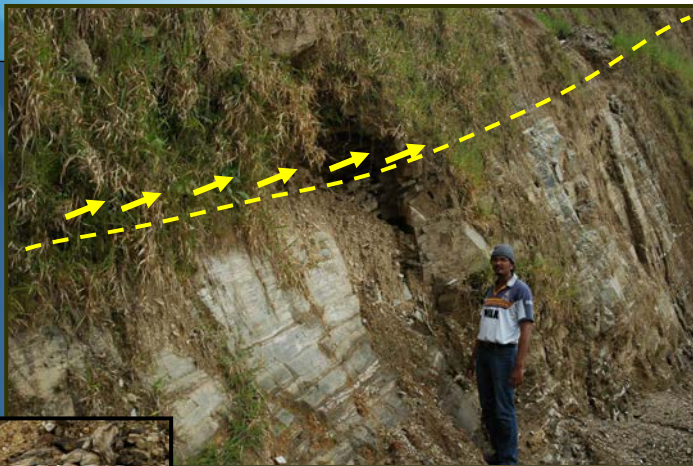
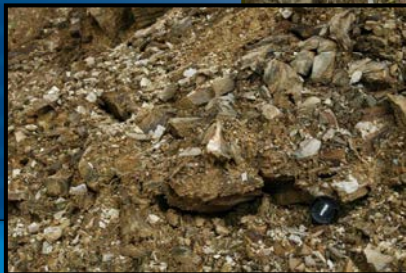
CH 23+900 – CH 24+400
(The major failure)

CROSS SECTION SHOWING THE LIKELY MECHANISME OF THE
MAJOR FAILURE BETWEEN CH 23900 – CH 24400

Basal Sliding Plane

- Ground water conditions and rainfall contributed significantly towards reducing the shearing resistance along discontinuities.
- The slope movement is reported to be still active, notably during and after prolonged rainfalls.
