Technical Issues Faced on Completed Government Hospital Project

Forensic Findings

Mesyuarat Tahunan Jurutera Mekanikal 2016
Cawangan Kejuruteraan Mekanikal, Ibu Pejabat JKR
5 September 2016

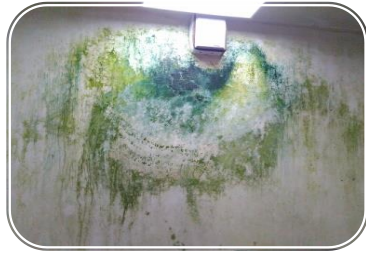
Mold

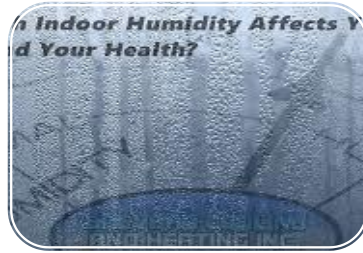
High Space
Humidity

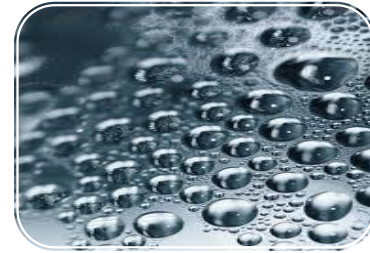
Condensation

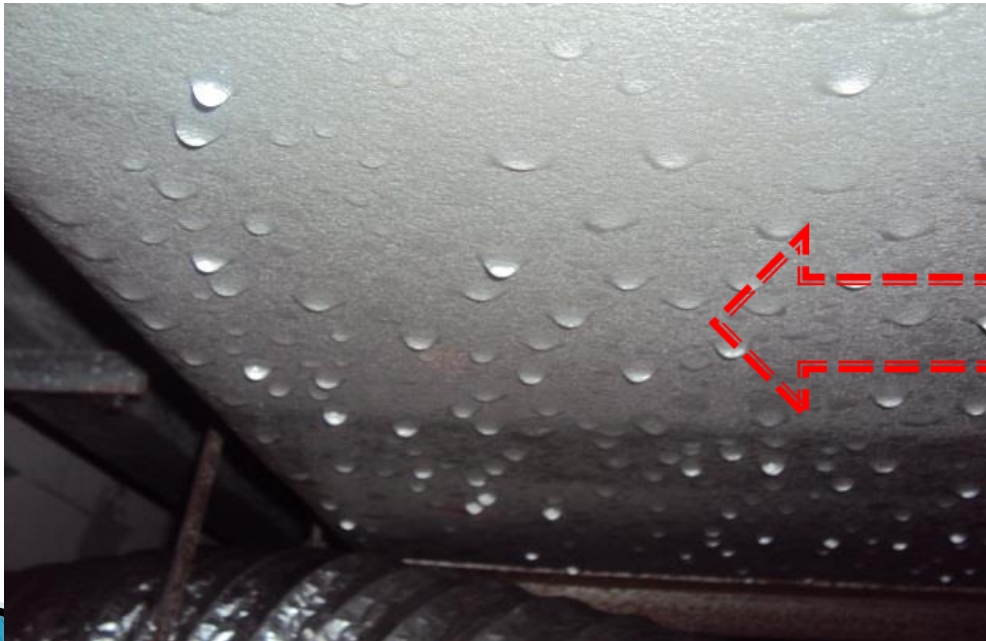
- ▶ This condition occurs due to reasons as below:
 - Surface Temp Lower Than Dew Point Temp

Dew Point Temp : 18°C

Surface Temp : 17.5°C

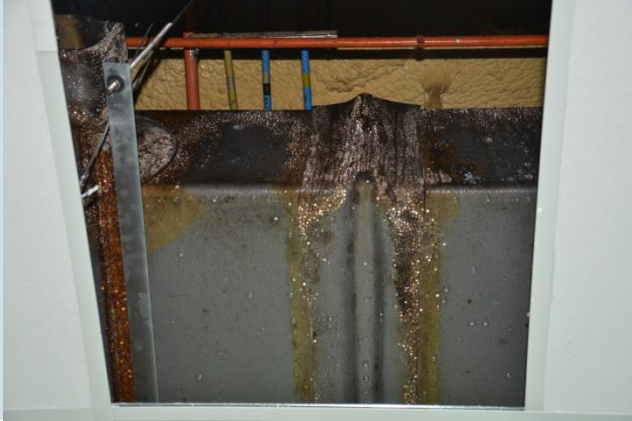
Before

Duct condensation on ducting.
Duct thickness 10 mm

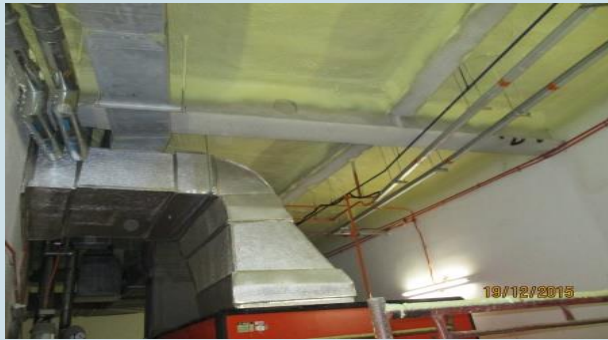
DUCT REROUTING Before

AHU duct outlet for General Medicine zone is at 90 deg relative to flow discharge direction from fan.

Design AirFlow $> 6250 \text{ l/s} \sim 13000 \text{ cfm}$

Measured AirFlow $> 3108 \text{ l/s} \sim 6500 \text{ cfm}$

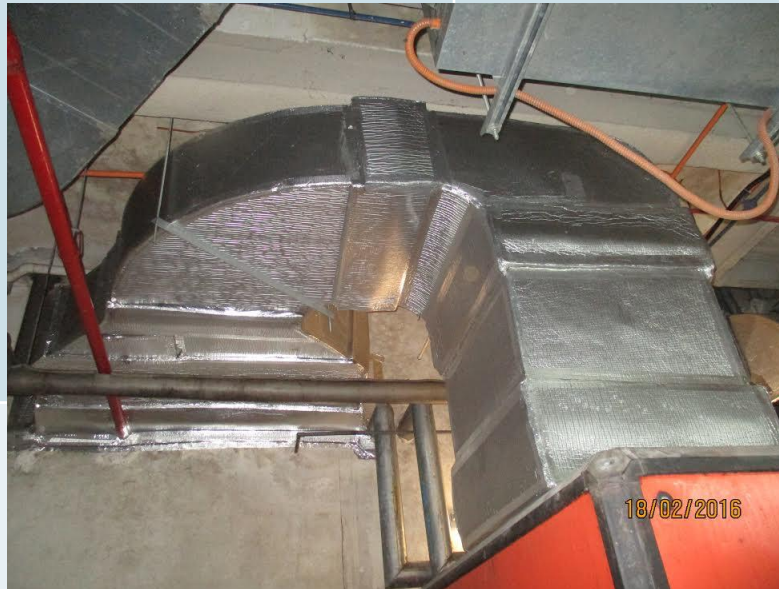
DUCT REROUTING After

Design AirFlow $> 6250 \text{ l/s} \sim 13000 \text{ cfm}$

Measured AirFlow $> 3108 \text{ l/s} \sim 6500 \text{ cfm}$ (Before Retrofit)

Measured AirFlow $> 4351 \text{ l/s} \sim 9100 \text{ cfm}$ (After Retrofit)

40% Air Flow Improvement

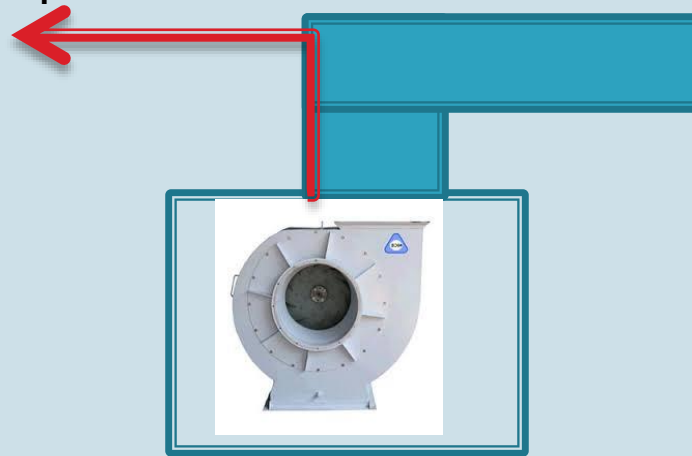
FAN REORIENTATION Before

As installed

Design AirFlow $> 5550 \text{ l/s} \sim 12000 \text{ cfm}$

Measured AirFlow $> 2500 \text{ l/s} \sim 5300 \text{ cfm}$ (Before Retrofit)

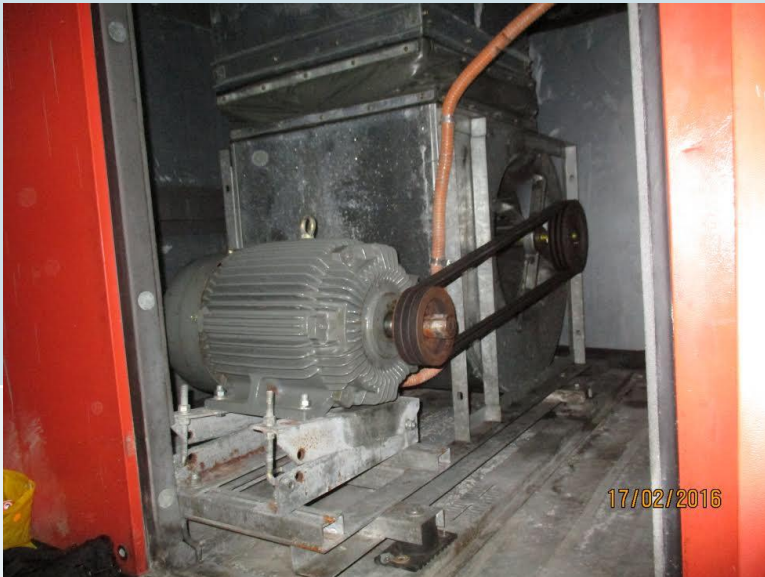
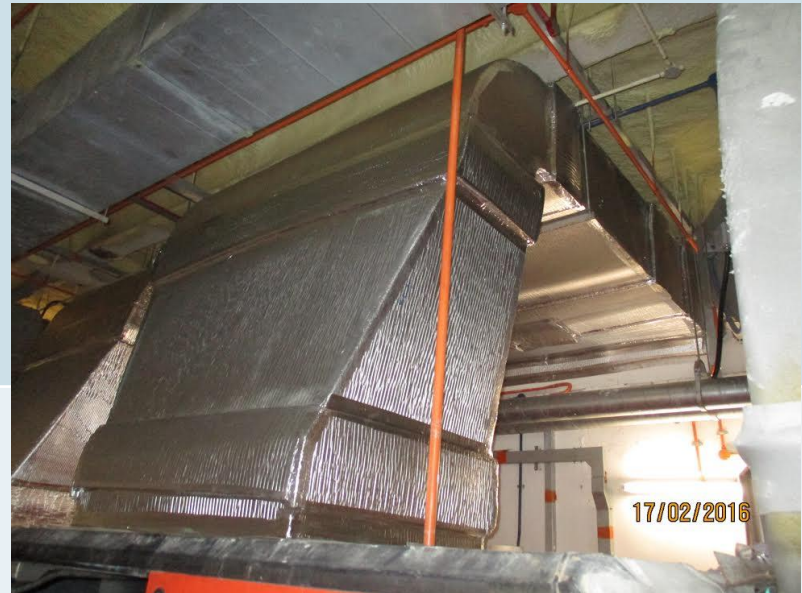
FAN REORIENTATION After

Design AirFlow $> 5550 \text{ l/s} \sim 12000 \text{ cfm}$

Measured AirFlow $> 2500 \text{ l/s} \sim 5300 \text{ cfm}$ (Before Retrofit)

Measured AirFlow $> 3000 \text{ l/s} \sim 6400 \text{ cfm}$ (After Retrofit)

Improved 20 % Air Flow

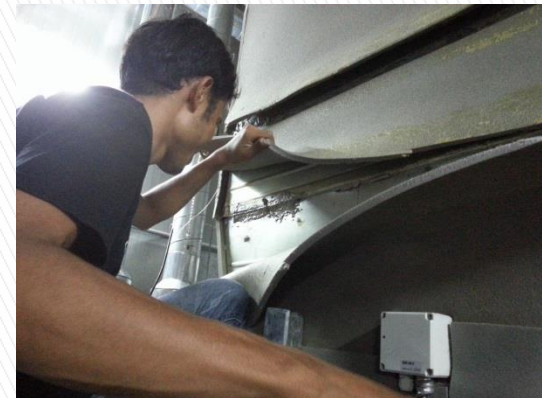
Existing duct seal was applied at duct corner only. New duct seal was applied along all transverse joint perimeter.

Ref case:
Retrofitting works
After duct reseal, supply air flow rate increases from 1900 cfm to 2500 cfm. An improvement of 32%.

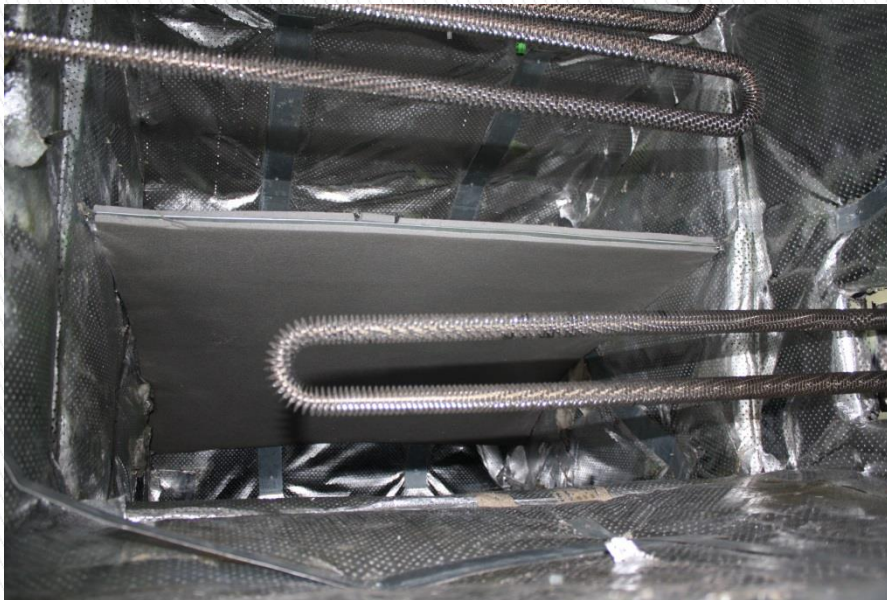
Duct elbow

Guide vane installation (wrong) resulting in less air flow and noise

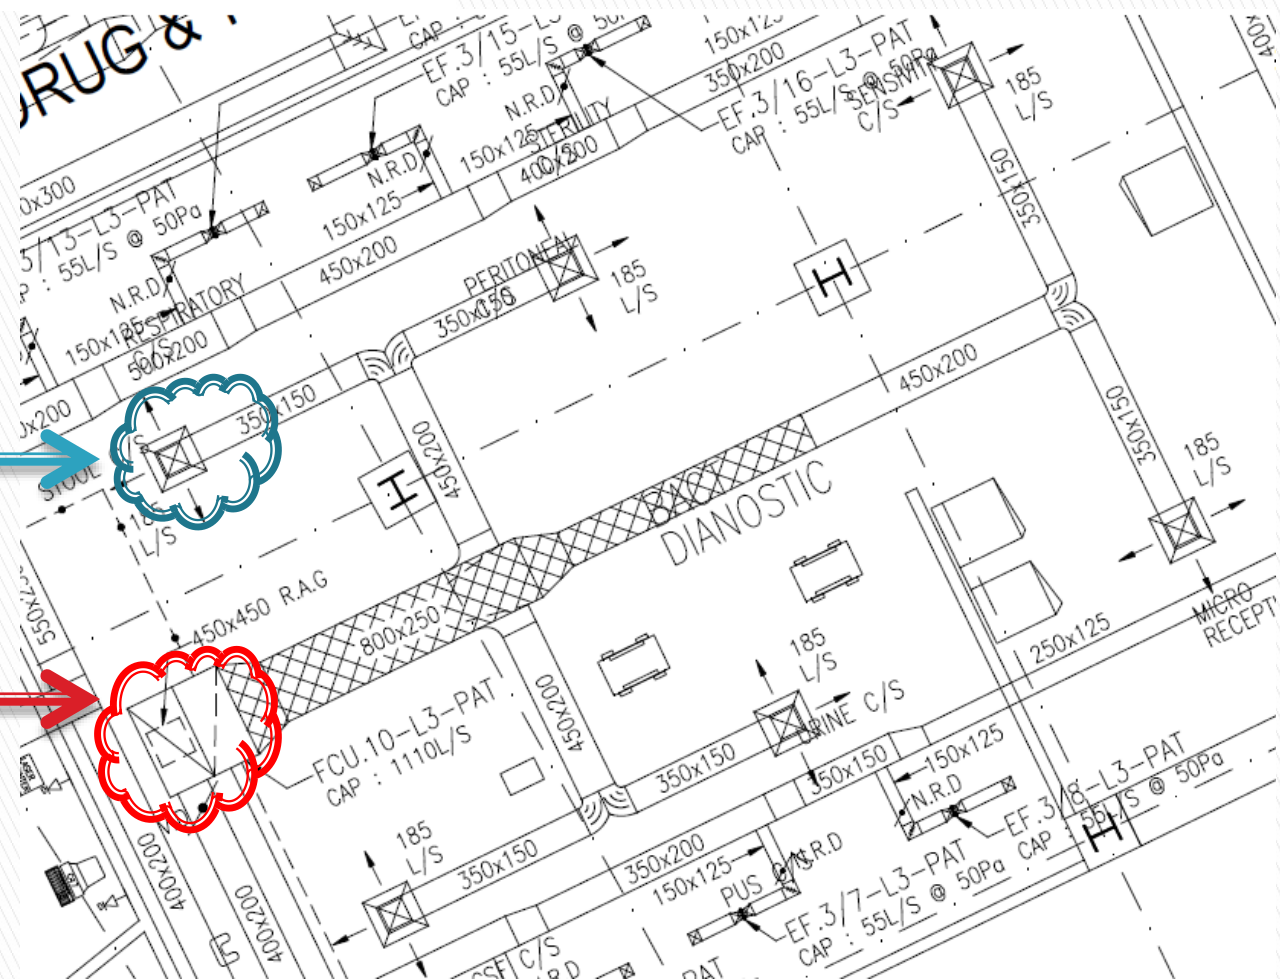
Insufficient number of return grilles. Added static loss and reduction of flow

1 return grille vs 6 supply diffusers

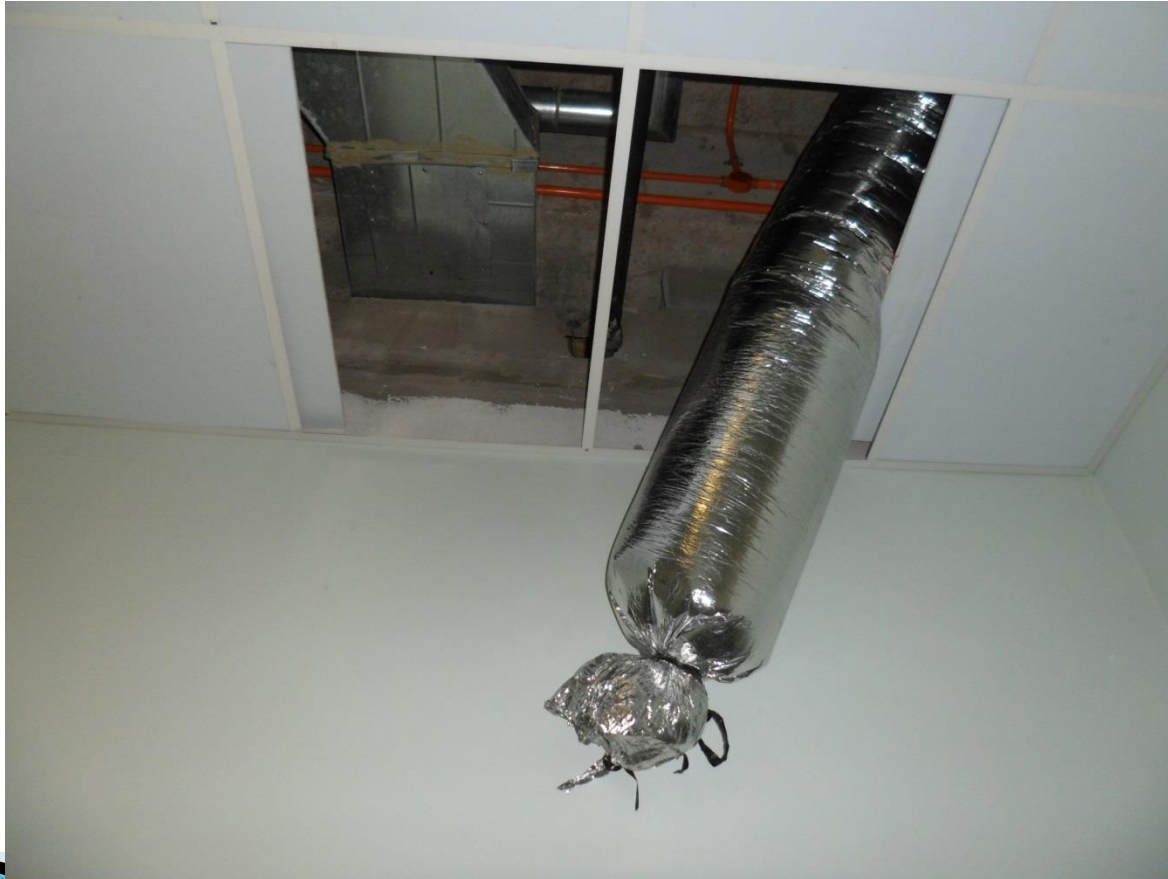
Wrong Capacity Selection

- ▶ FCU Capacity not meet/ the design parameter

- ▶ VSD installation
- ▶ New FCU with suitable room capacity

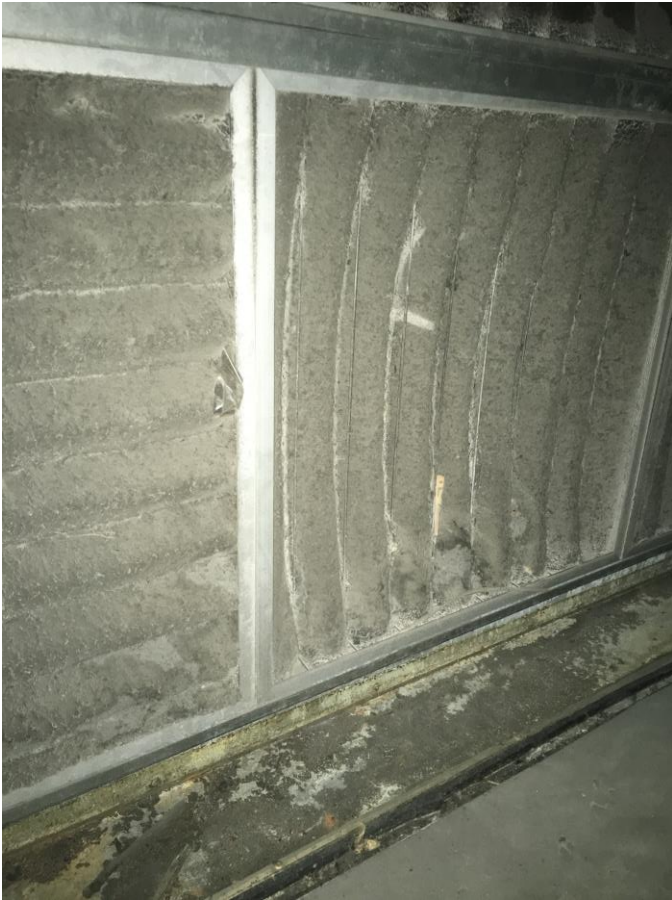
DIRTY AIR FILTER

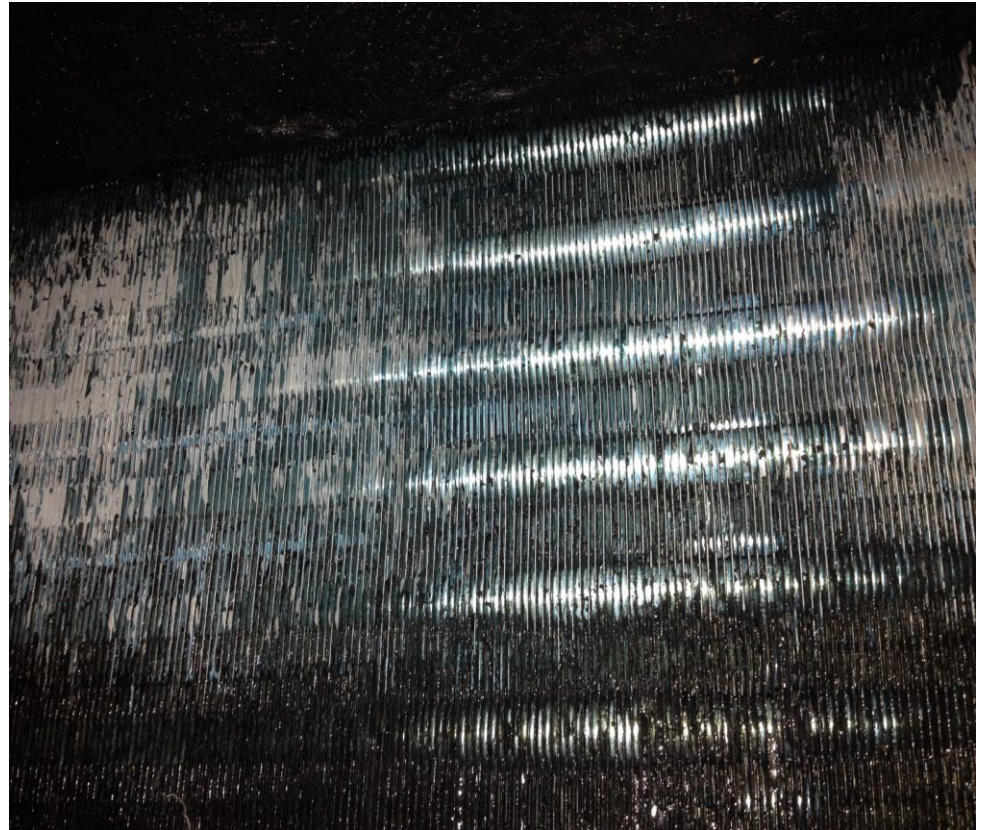
COOLING COIL CHOKE

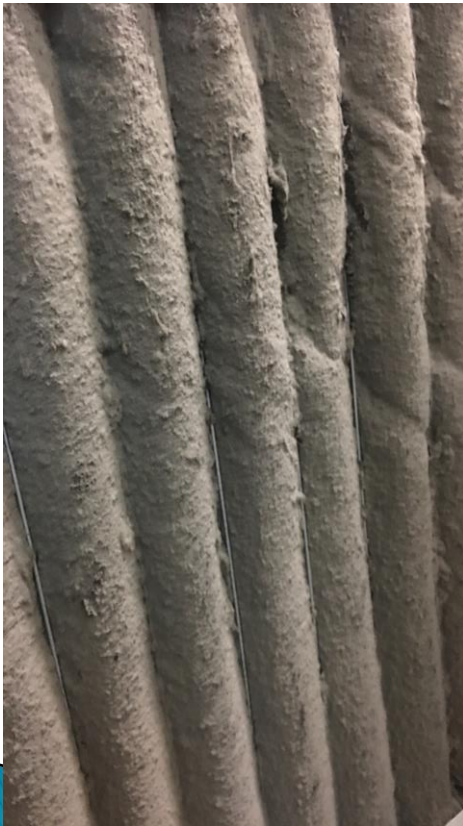
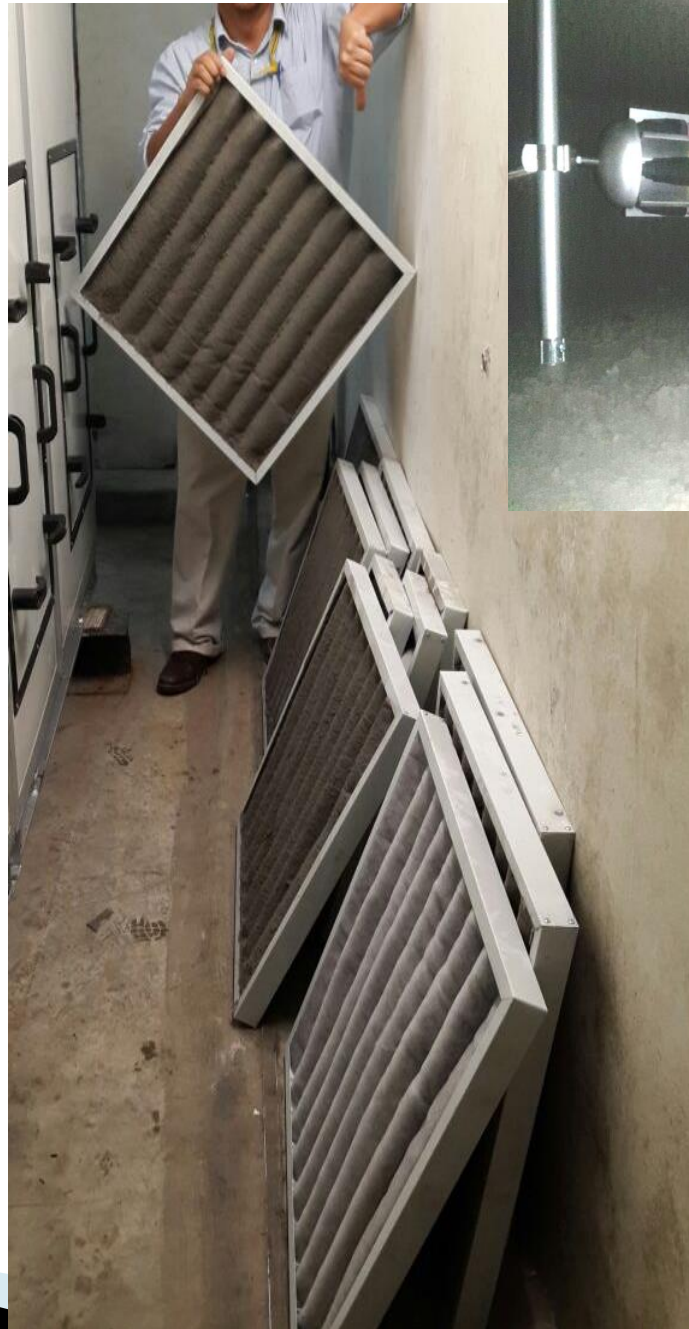
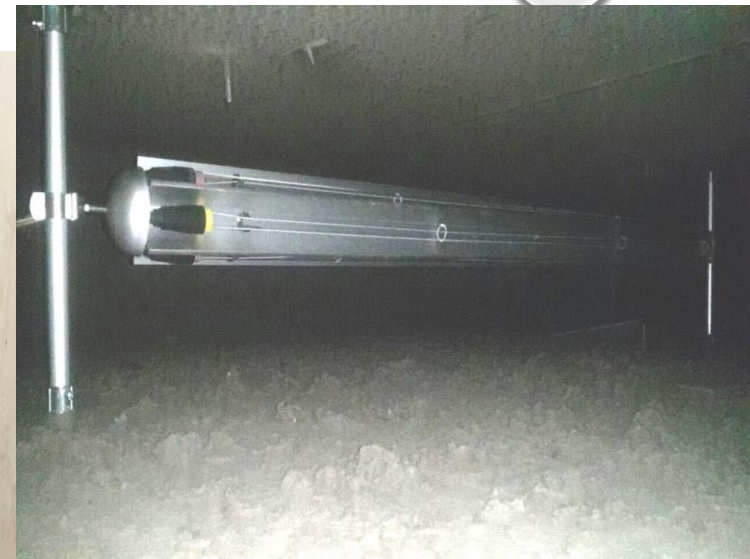
VIBRATION IN CEILING
SPACE 4 (WITH
ADDITIONAL TIE-ROD)

Air Filter clog
