ACCESS AUDIT IN THE BUILT ENVIRONMENT 2014

WORKSHOP REPORT

Audited Venue: Blok F, JKR

Group No. : 2

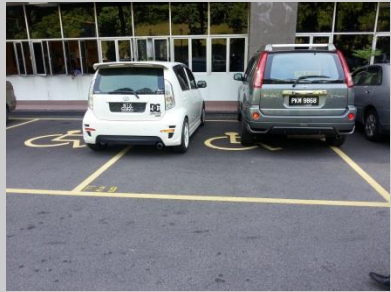
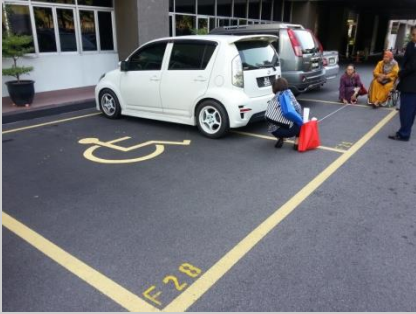
NO	ELEMENT	ANALYSIS	PROPOSAL
1	<p>PARKING</p>

<ol style="list-style-type: none"> Current parking size is 3500 x 5000mm No wheel stopper Imprinted symbol indicated but no vertical signboard OKU parking located more than 3300mm from entrance 	<ul style="list-style-type: none"> - Parking size should be in accordance with MS 1184: 2014 (3600 x 5400mm) - To add wheel stopper - To add vertical signboard

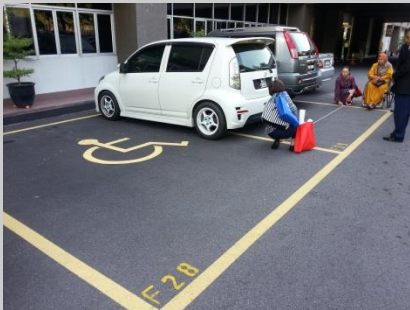
NO	ELEMENT	ANAYSIS	PROPOSAL
2	<p>PATHWAYS</p>

<ol style="list-style-type: none">1. Clear of steps and stairs2. No tactile guiding and warning blocks from parking to entrance	<p>- To provide tactile guiding and warning blocks</p>

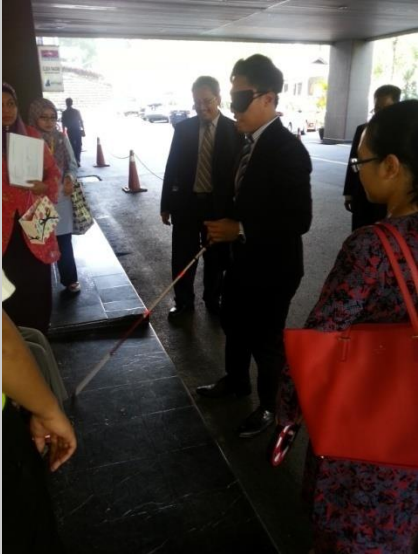
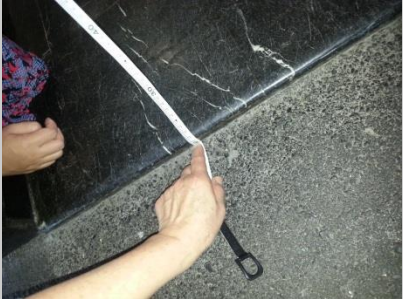
NO	ELEMENT	ANALYSIS	PROPOSAL
3	ENTRANCE

<ol style="list-style-type: none">1. The wide of the ramp is more than 1300mm2. Surface is slippery3. Gradient of the ramp is more than 1:124. The difference between road surface and ramp access is 13mm	<p>- Difference should be flushed</p>

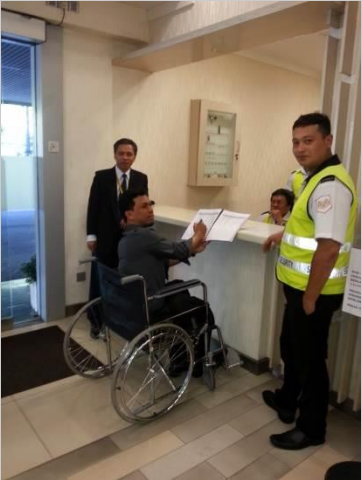
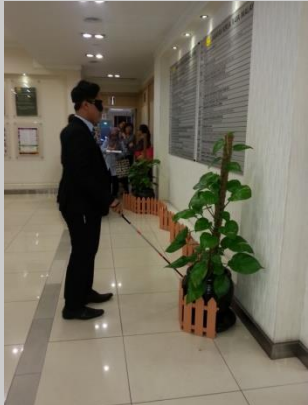
NO	ELEMENT	ANALYSIS	PROPOSAL
4	RECEPTION AND INFORMATION COUNTER

<ol style="list-style-type: none">1. Countertop not suitable for disabled. The height is 1050mm2. No waiting area3. Obstruction on walkway	<ul style="list-style-type: none">- Provide staff assistance- The height of counter should be between 740mm to 800mm See MS 1184 cl.19.4- Clear knee space underneath counter shall be minimum of 700mm- To provide- To remove the obstruction

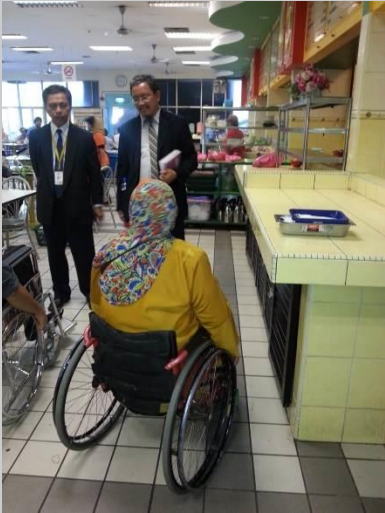
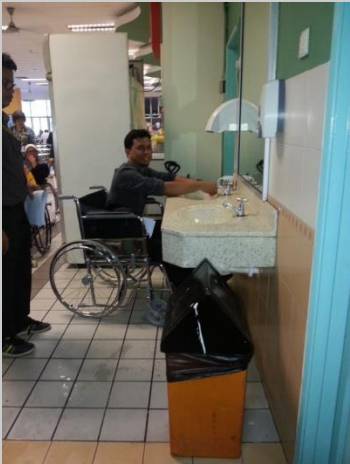
NO	ELEMENT	ANALYSIS	PROPOSAL
5	EATING AREA

<ol style="list-style-type: none">1. Eating area is accessible to People with Disabilities (PwDs)2. Cash and service counter not suitable for PwDs3. Tables with loose chairs – easily accessible4. Handwash basin accessible	<ul style="list-style-type: none">- Provide assistance from cafe helpers

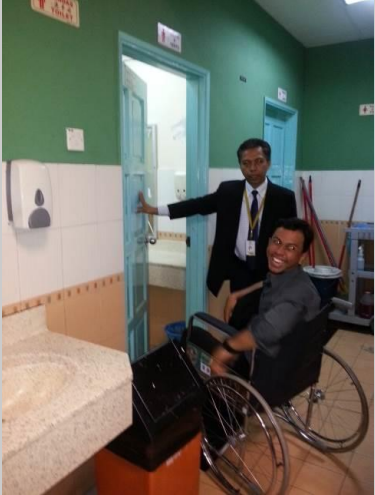
NO	ELEMENT	ANALYSIS	PROPOSAL
6	<p>TOILET</p>

<p>1. No People with Disabilities (PwDs) toilet</p>	<p>- To provide accessible toilet for PwDs with grab bars</p>

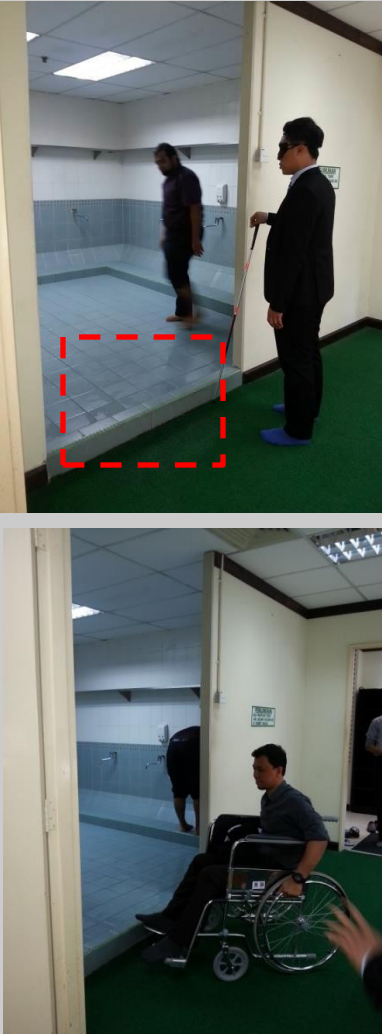
NO	ELEMENT	ANALYSIS	PROPOSAL
7	<p>SURAU</p>

<ol style="list-style-type: none">1. Kerb at the entrance to ablution area2. No railing hook and concrete stool3. Slippery surface at ablution area	<ul style="list-style-type: none">- To remove threshold/ kerb-To provide railing hook and concrete stool

<ul style="list-style-type: none">- To provide rubber matt

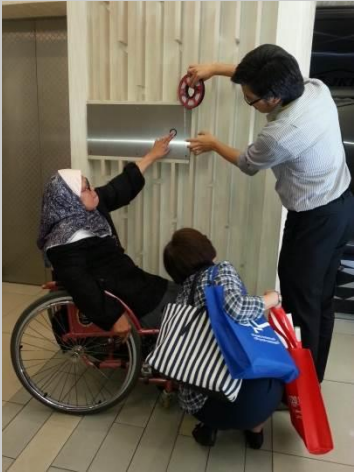
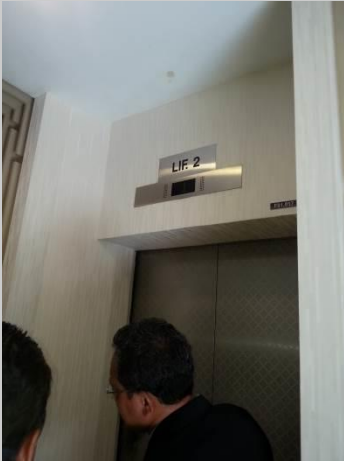
NO	ELEMENT	ANALYSIS	PROPOSAL
8	<p>LIFT</p>

<ol style="list-style-type: none">1. Opening width is 1100mm2. No accessible path leading to the lift3. Emergency button not reachable4. Call button more than 1400mm height	<ul style="list-style-type: none">-Tactile to be installed leading to the main entrance.-To provide Audio and Visual installed for safety reasons and guidance.-To provide visual indicator light-To provide mirror wall in the lift car-Provide side button panel

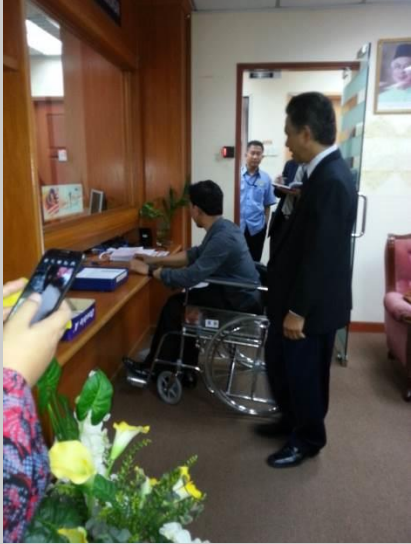
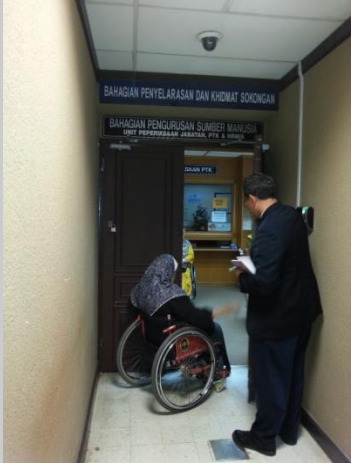
NO	ELEMENT	ANALYSIS	PROPOSAL
9	<p data-bbox="208 301 469 339">OFFICE AREA</p>

<ol style="list-style-type: none"><li data-bbox="660 358 996 568">1. Width of corridor to office entrance is 1550mm<li data-bbox="660 644 1012 972">2. Solid timber door at the entrance with the width 1500mm – hard for PwDs to open	<ul style="list-style-type: none"><li data-bbox="1079 644 1837 801">- To replace the timber door with glass door with colour sticker for visual propose<li data-bbox="1079 872 1499 915">- To provide door bell
