**FINAL REPORT**

**KAJIAN BAGI MENGGANTIKAN JAMBATAN SULTAN ISKANDAR  
DI FT001/639/90, KUALA KANGSAR, PERAK  
- THE STRUCTURAL ASSESSMENT AND REHABILITATION  
OF JAMBATAN SULTAN ISKANDAR**

**VOLUME 1 OF 4 : MAIN REPORT**

RPT/TC/275/14/40-FinalReport - Vol 1 of 4

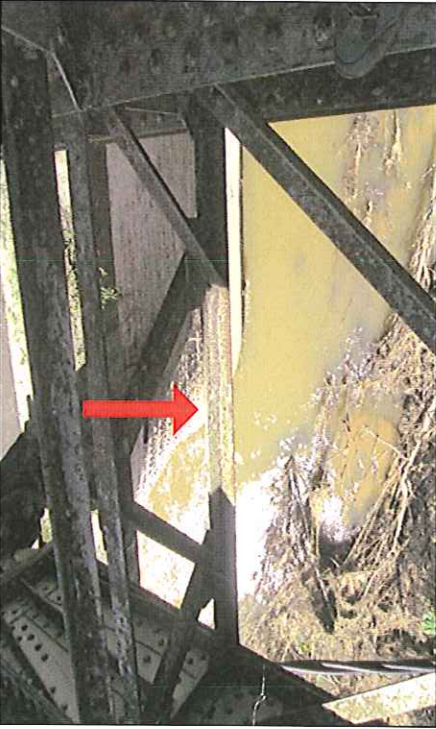
Picture M—S1—P5

Minor corrosion on inclined cross bracing.

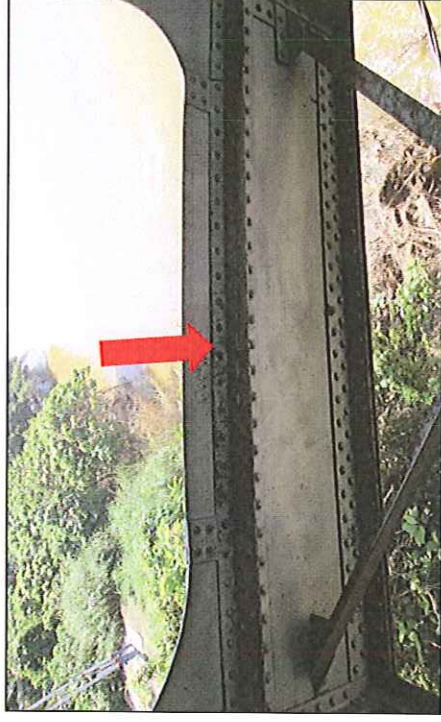
Picture M—S1—P8

Minor corrosion on top flange of arch beam.

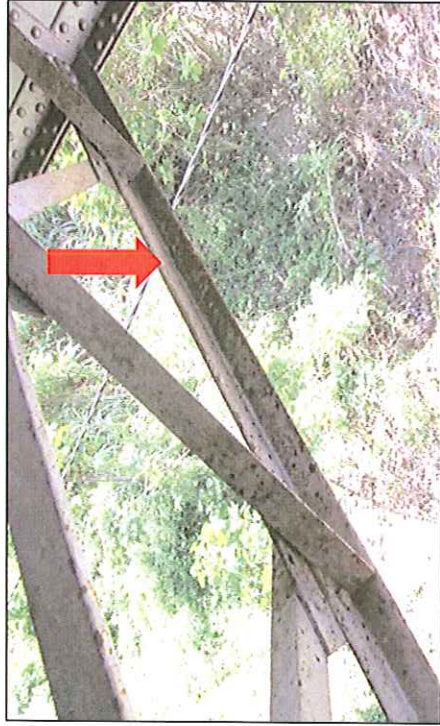
Picture M – S4 – P10

Minor corrosion on inclined cross bracing.

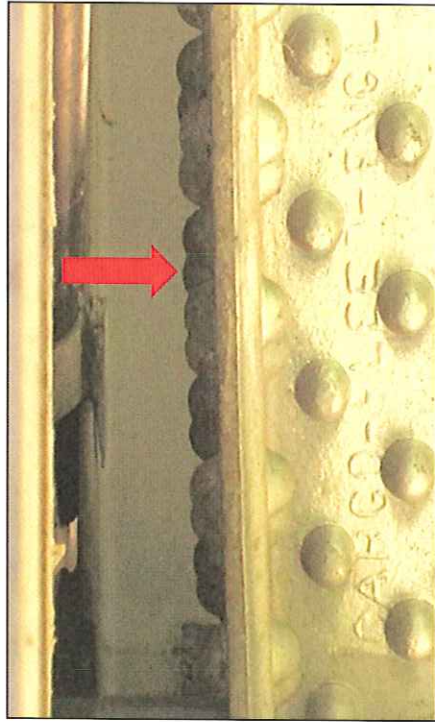
Picture M-S1-P18

Minor corrosion on top flange of arch beam.

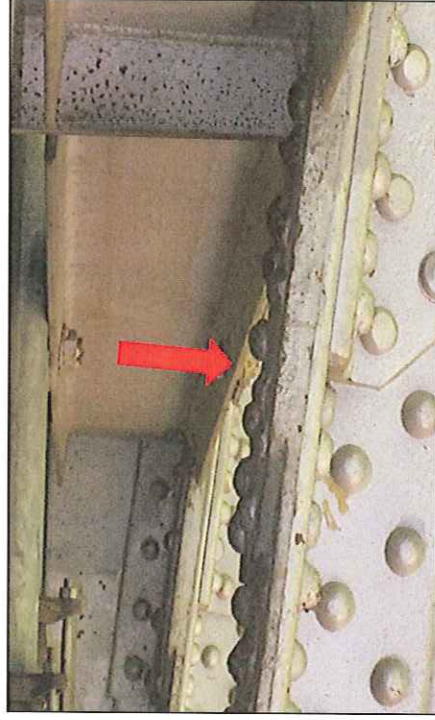
Picture M-S1-P20

Minor corrosion on top flange of arch beam.

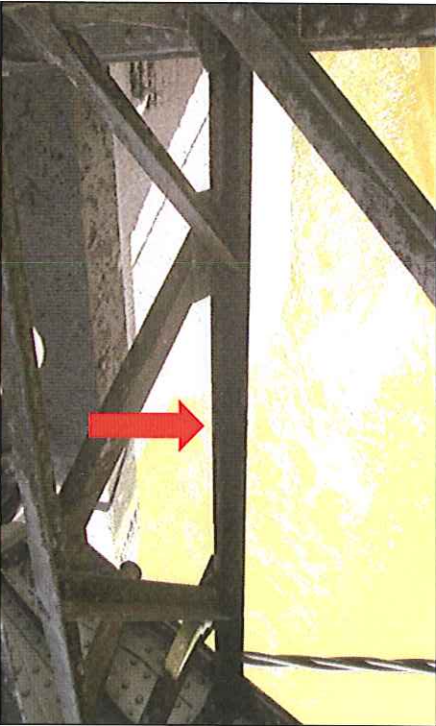
Picture M – S2 – P1

Minor corrosion on inclined cross bracing.

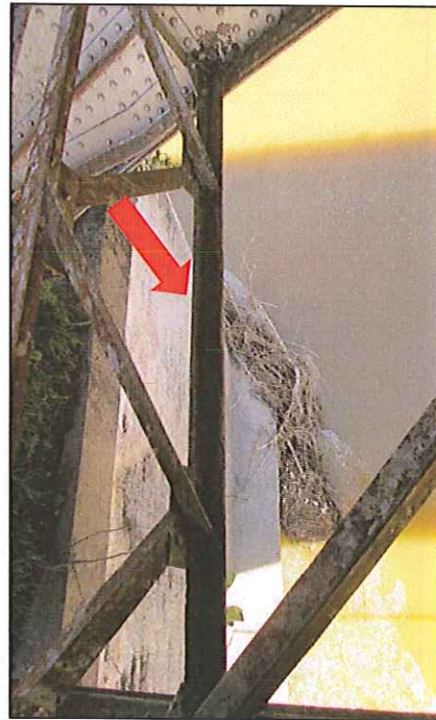
Picture M – S2 – P2

Minor corrosion on inclined cross bracing.

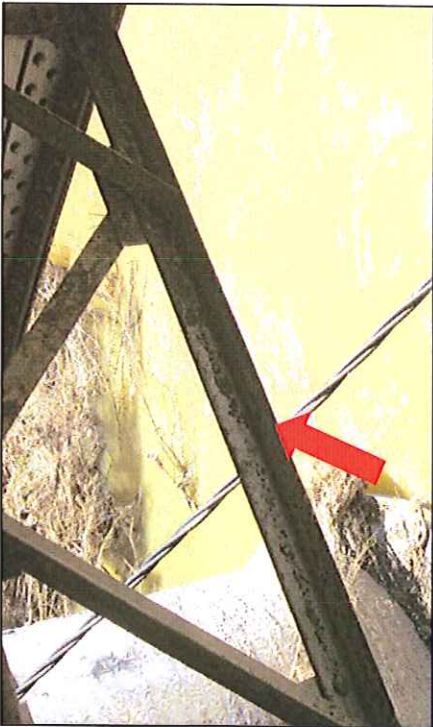
Picture M – S2 – P25

Minor corrosion on inclined cross bracing.

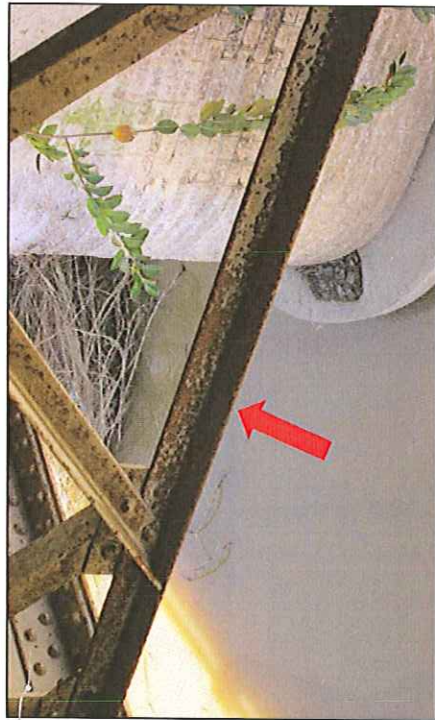
Picture M – S4 – P26

Minor corrosion on inclined cross bracing.

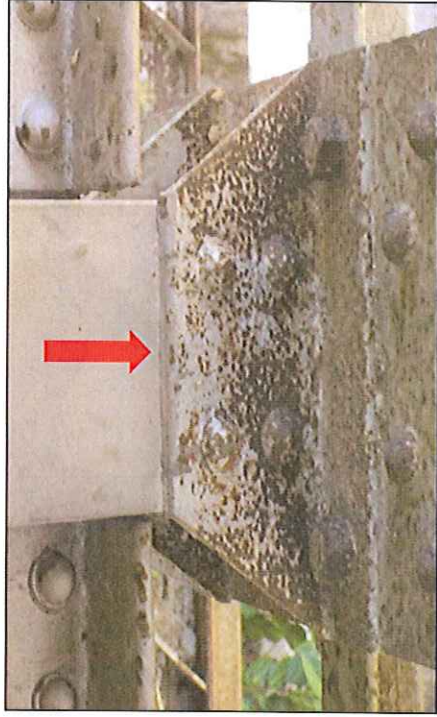
Picture M – S2 – P27

Minor corrosion on vertical bracing joint of arch beam.

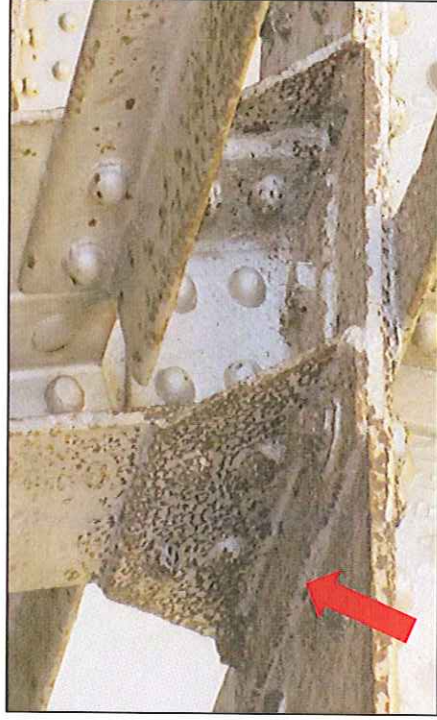
Picture M – S4 – P28

Minor corrosion on vertical bracing joint of arch beam.

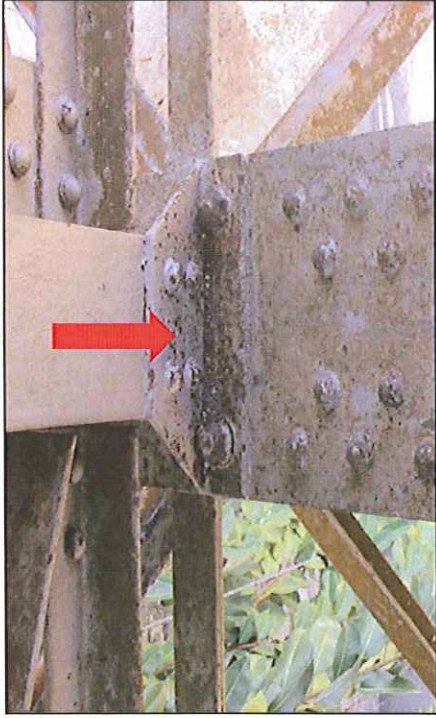
Picture M-S2-P33

Minor corrosion on vertical cross bracing joint of arch beam.

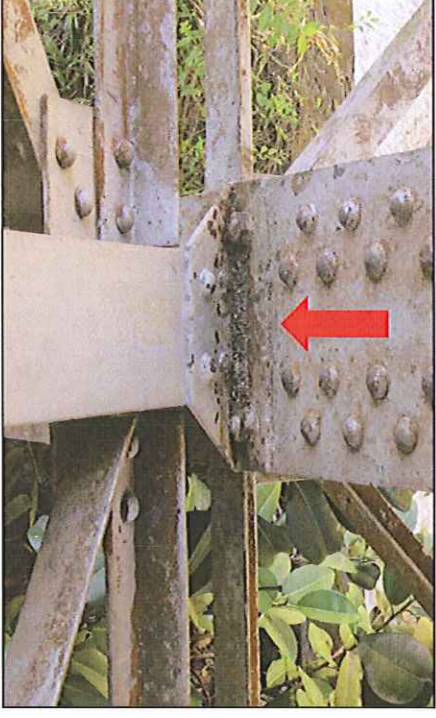
Picture M-S2-P35

Minor corrosion on vertical bracing joint of arch beam.

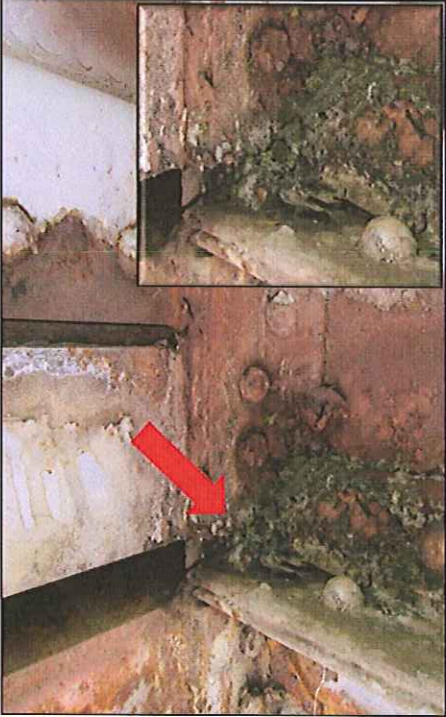
Picture M-S2-P41

Moderate corrosion and crack line on steel plate.

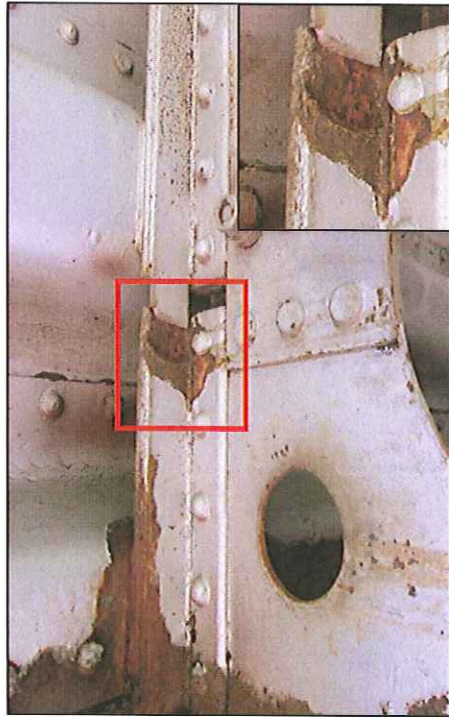
Picture M-S2-P42

Moderate corrosion and crack line on steel plate.

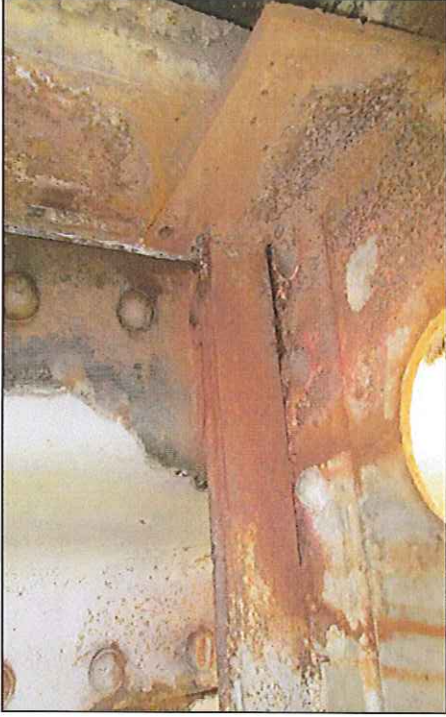
Picture M-S2-P43

Moderate corrosion and crack line steel plate.

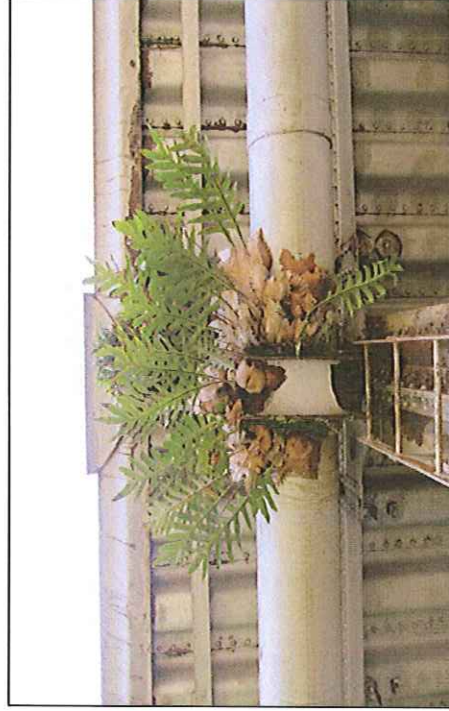
Picture M-S2-P44

Moderate corrosion, vegetation and crack line on steel plate.

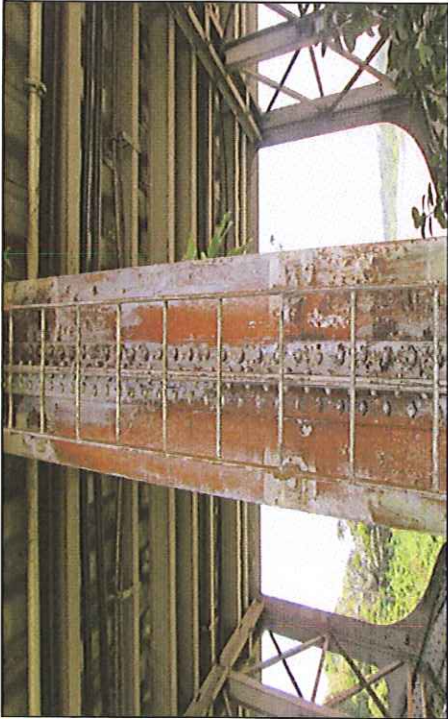
Picture M – S2 – P49

Minor corrosion on overall middle frame.

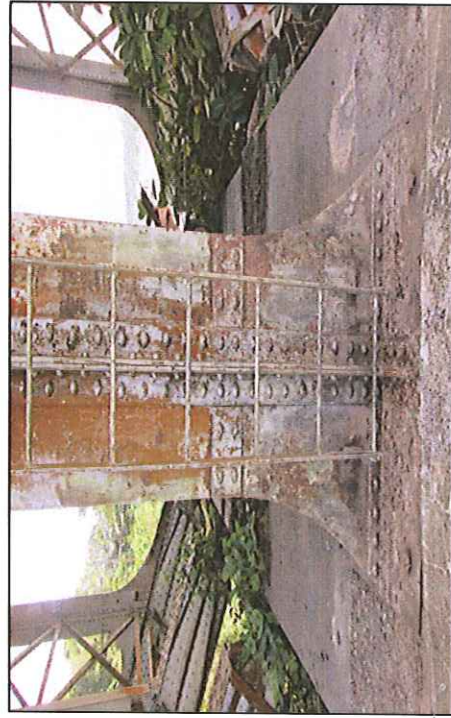
Picture M – S2 – P50

Minor corrosion on overall middle frame.

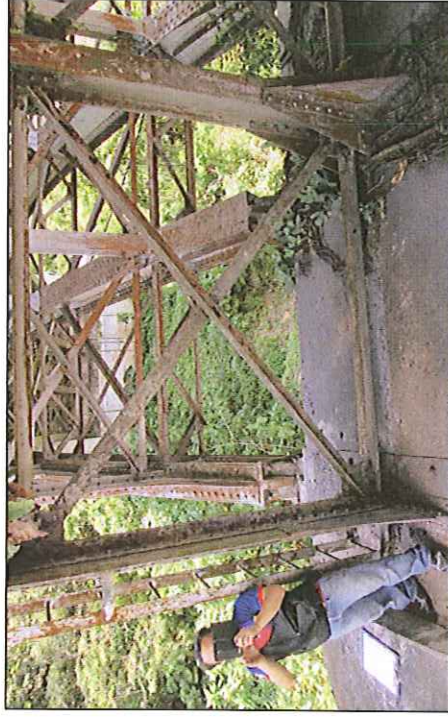
Picture M – S2 – P51

Minor corrosion on overall middle frame.

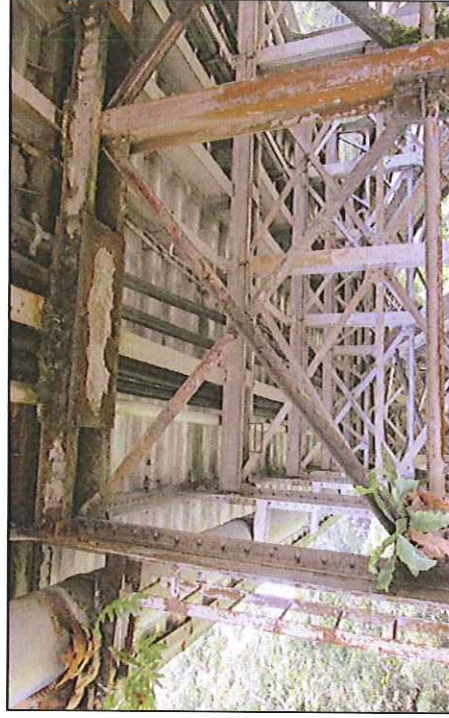
Picture M – S2 – P52

Moderate corrosion on overall middle frame.

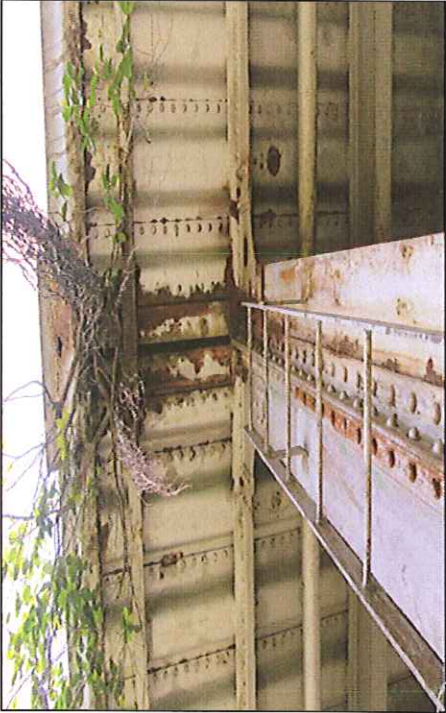
Picture M-S2-P57

Moderate corrosion on overall middle frame.

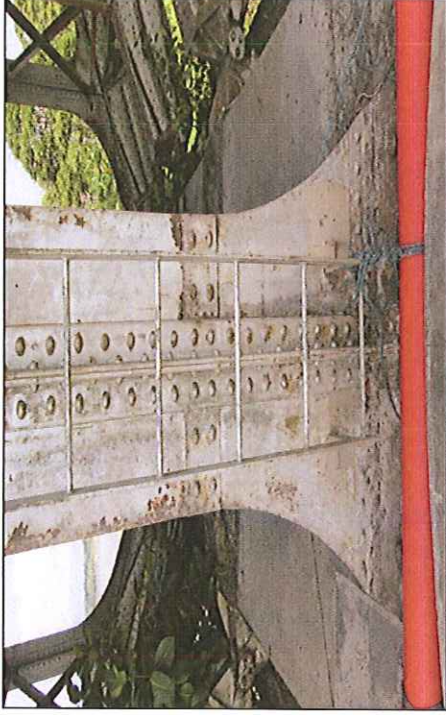
Picture M-S2-P59

Minor corrosion on overall middle frame.

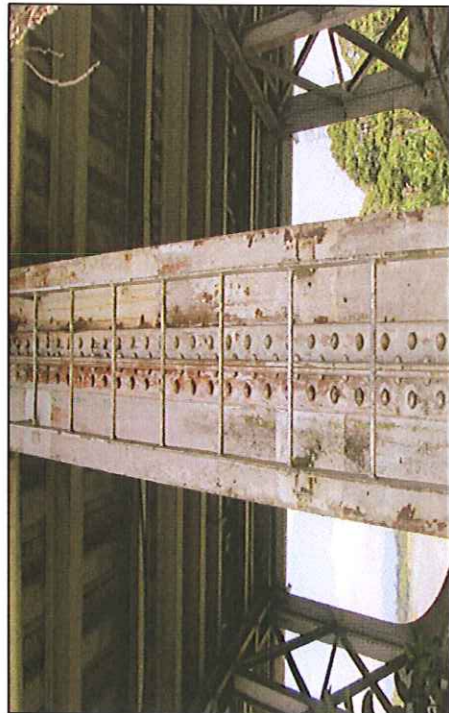
Picture M-S2-P58

Minor corrosion on overall middle frame.

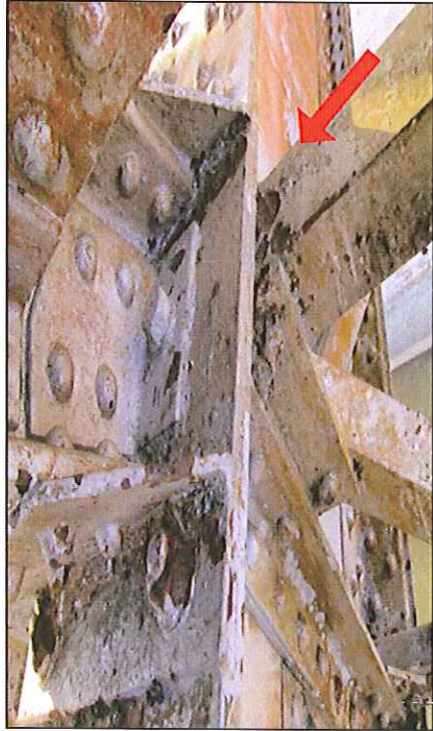
Picture M – S3 – P6

Minor corrosion on vertical bracing of arch beam.

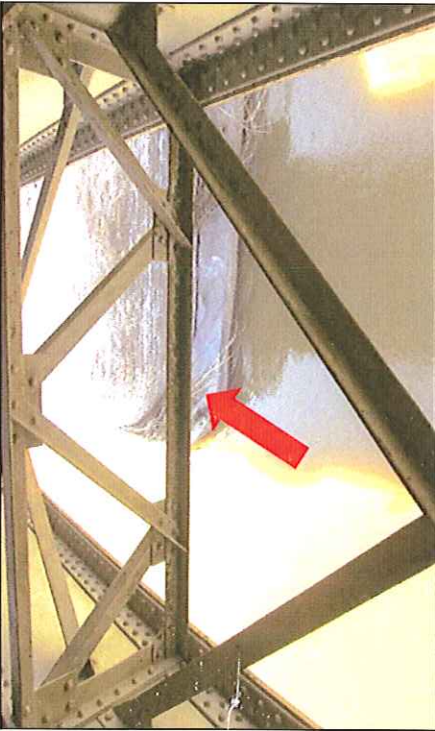
Picture M – S3 – P17

Minor corrosion on inclined cross bracing.

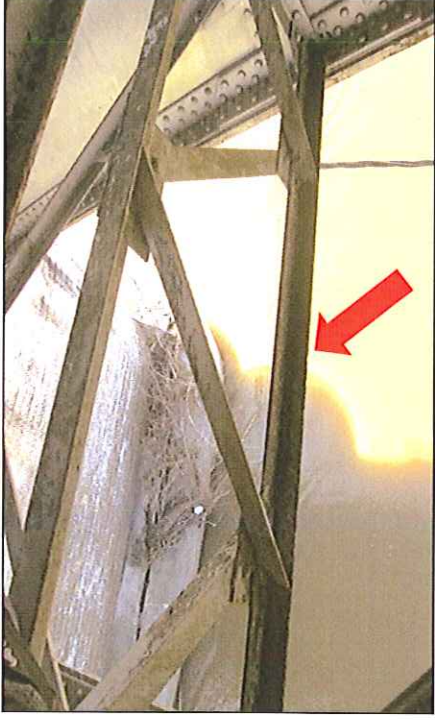
Picture M – S3 – P19

Minor corrosion on inclined cross bracing.

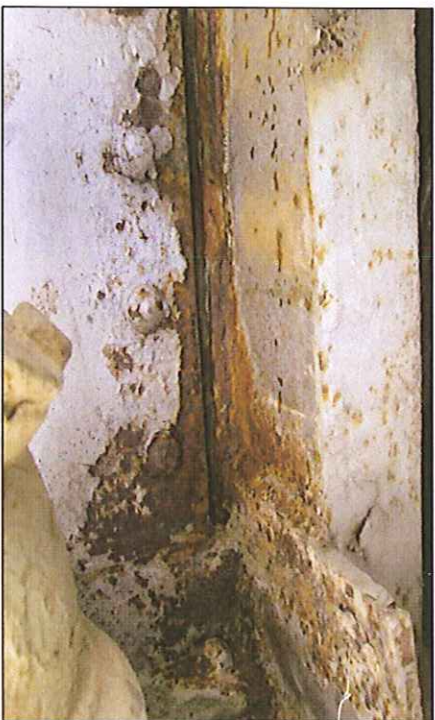
Picture M – S3 – P33 and M – S3 – P34  
Moderate corrosion on steel frame.

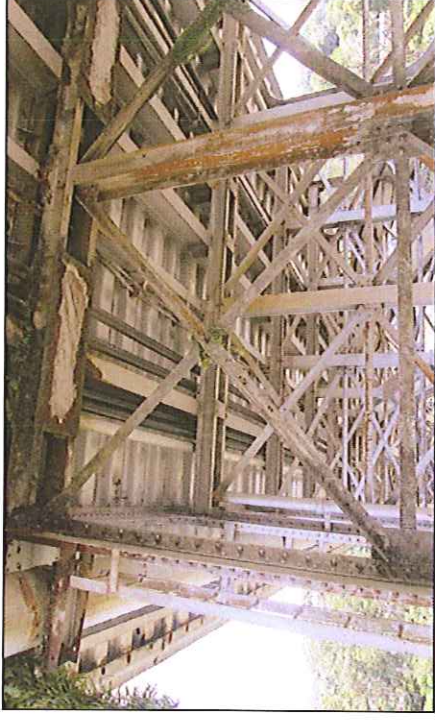
Picture M – S3 – P43

Moderate corrosion on overall middle frame.

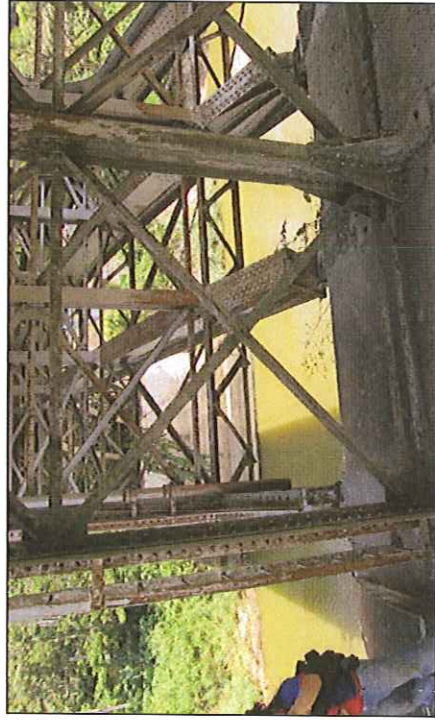
Picture M – S3 – P42

Minor corrosion on overall middle frame.

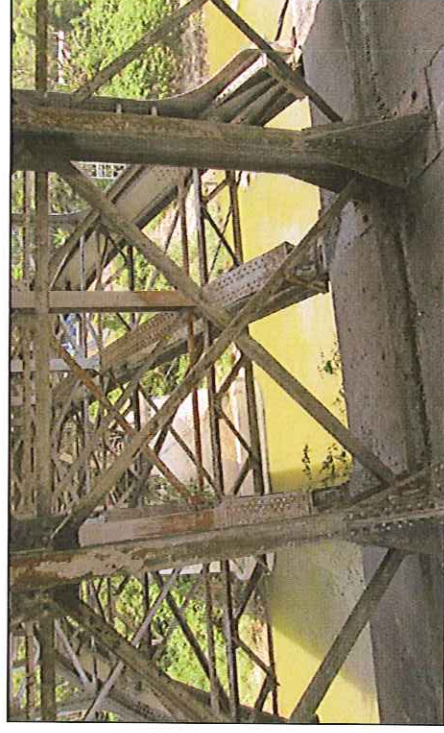
Picture M – S3 – P44

Minor corrosion on overall middle frame.

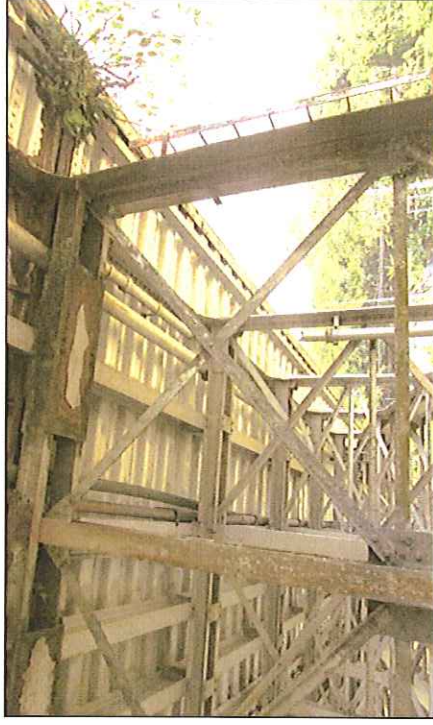
Picture M – S3 – P47

Moderate corrosion on overall middle frame.

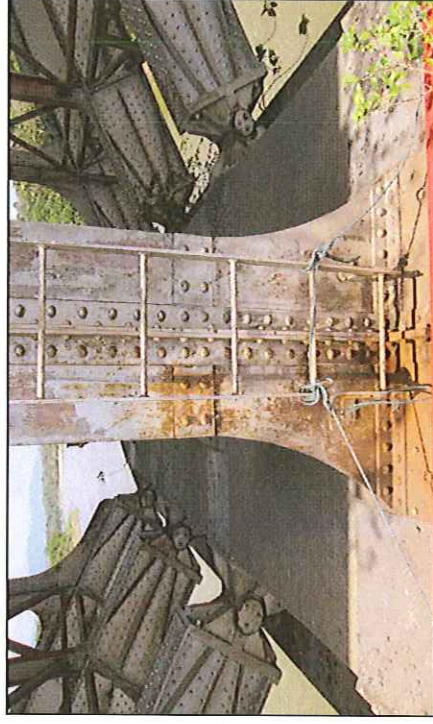
Picture M – S3 – P48

Minor corrosion on overall middle frame.

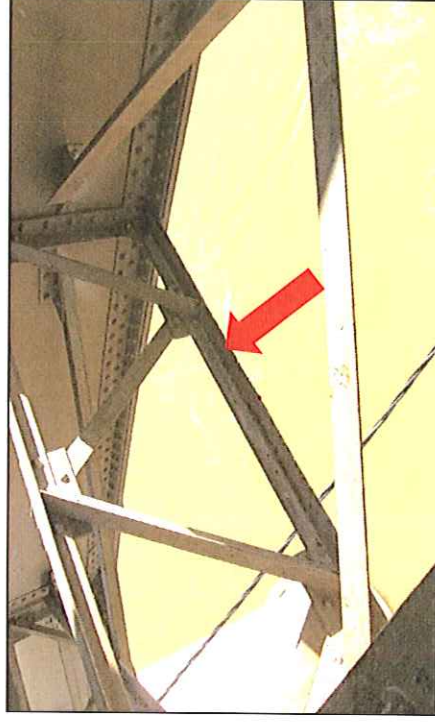
Picture M – S4 – P20

Minor corrosion on inclined cross bracing.

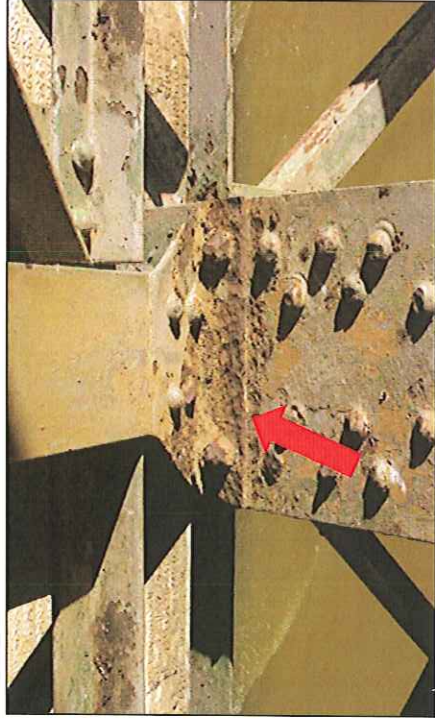
Picture M – S4 – P26

Moderate corrosion on vertical bracing joint of arch beam.

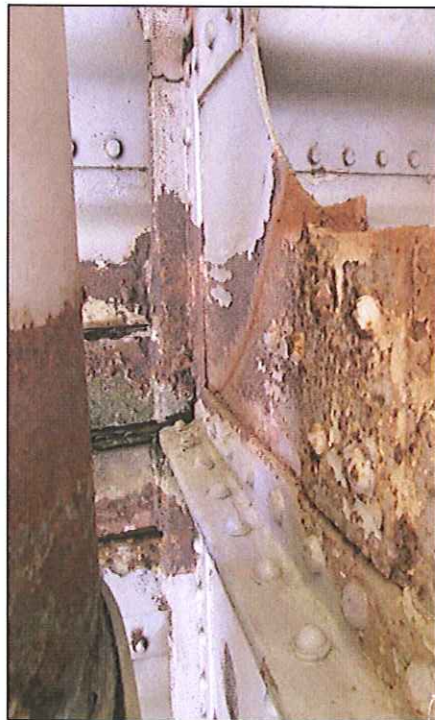
Picture M – S4 – P43 and M – S4 – P44

Moderate corrosion and crack line on steel plate.

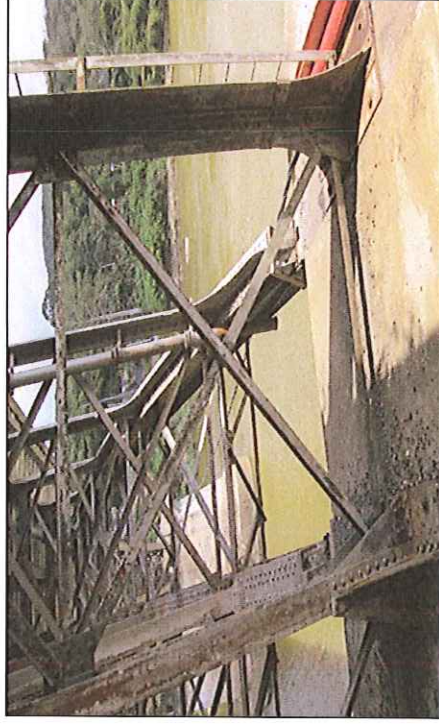
Picture M – S4 – P52

Minor corrosion on overall middle frame.

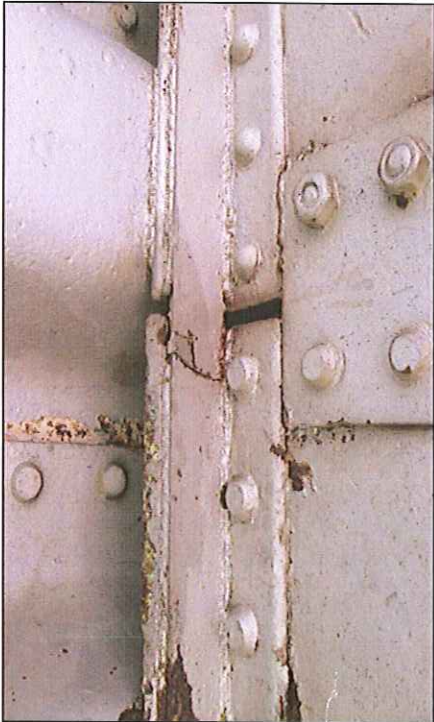
Picture M – S5 – P21 and M – S5 – P22

Moderate corrosion and crack line on steel plate.

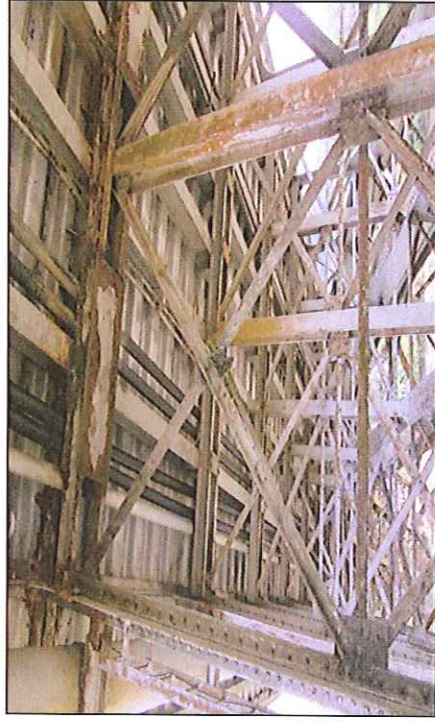
Picture M – S5 – P28

Moderate corrosion on overall middle frame.

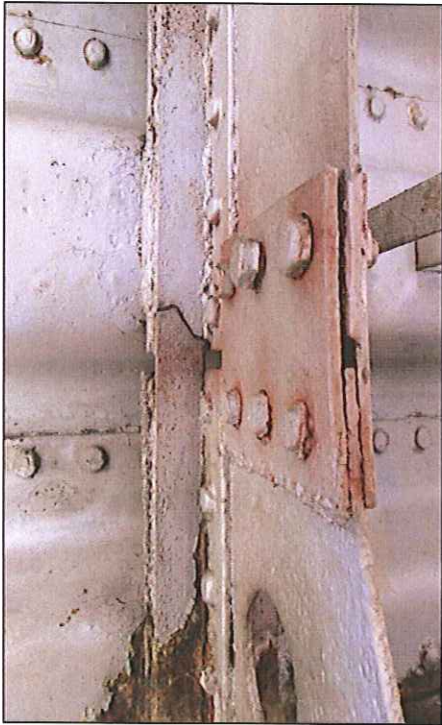
Picture M – S5 – P25 and M – S5 – P26

Moderate corrosion and crack line on steel plate.

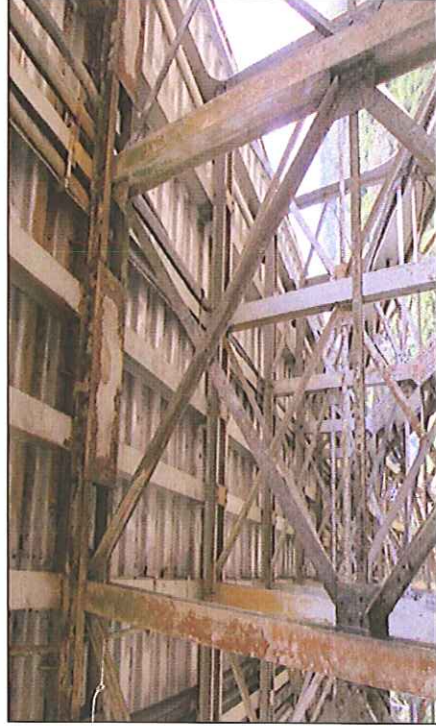
Picture M – S5 – P30

Moderate corrosion on overall middle frame.

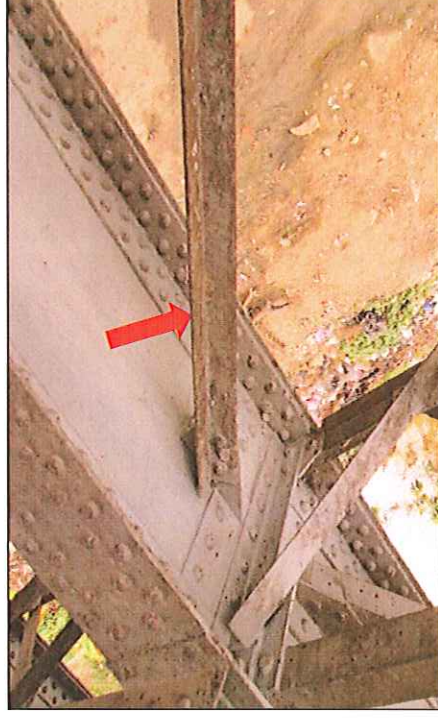
Picture M-S6-P12

Minor corrosion on horizontal cross bracing.

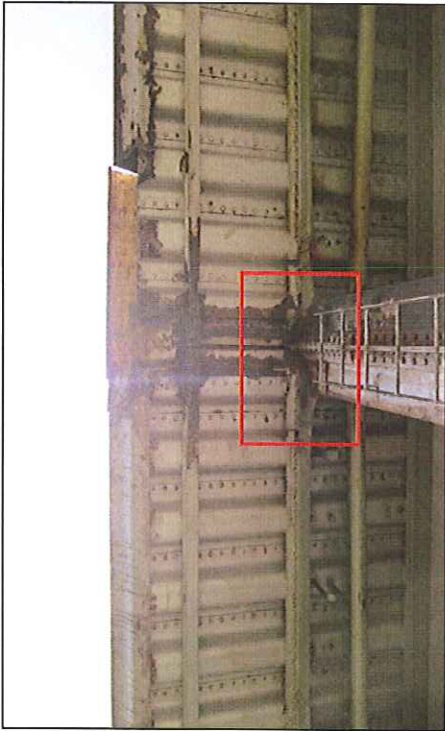
Picture M – S6 – P13 and M- S6 –P14

Moderate corrosion and crack line on steel plate near expansion joint.

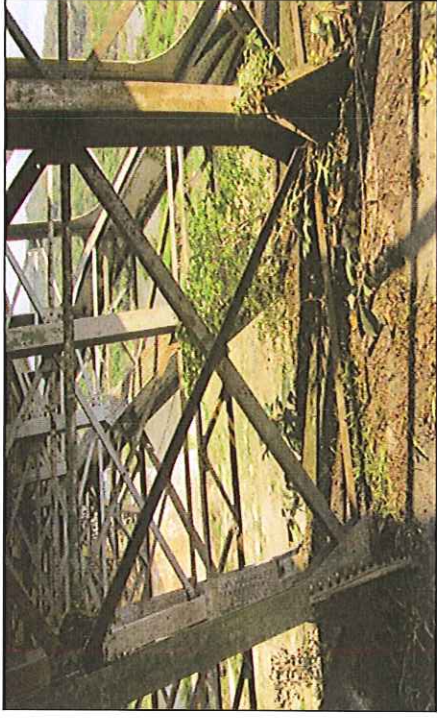
Picture M – S6 – P23

Minor corrosion on overall middle frame.

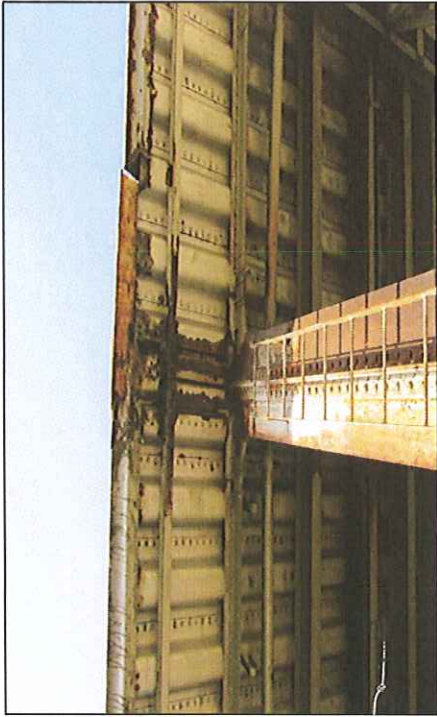
Picture M – S6 – P29

Moderate corrosion on overall middle frame.

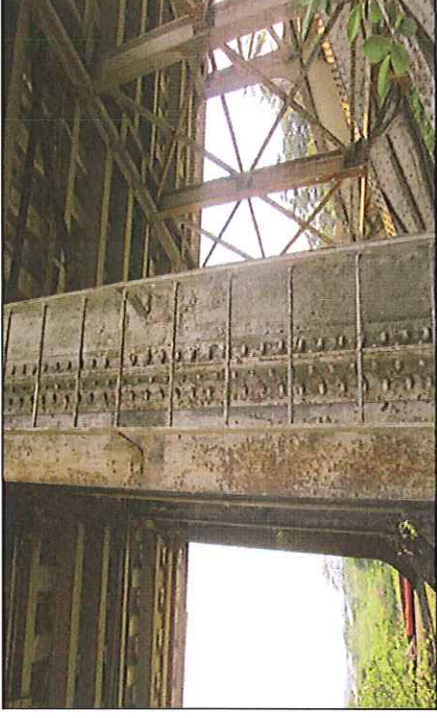
Picture M – S6 – P31

Minor corrosion on overall middle frame.

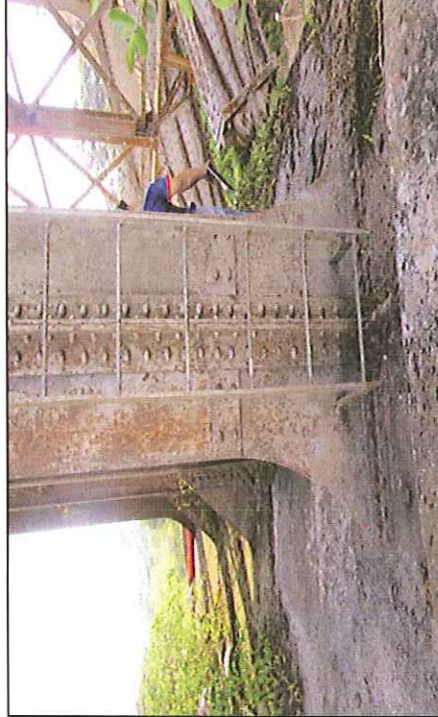
Picture M – S6 – P30

Minor corrosion on overall middle frame.

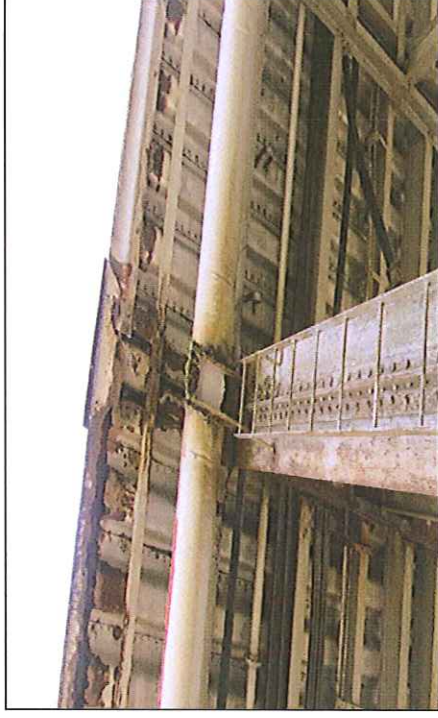
Picture M – S6 – P32

Minor corrosion on overall middle frame.

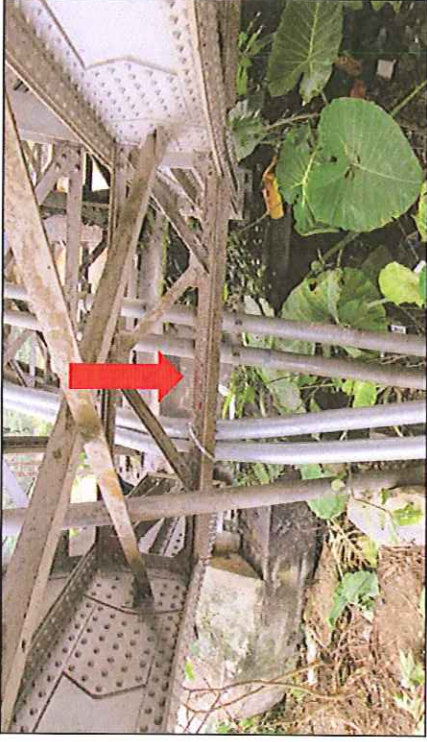
Picture M-S7-P19

Minor corrosion on inclined cross bracing.

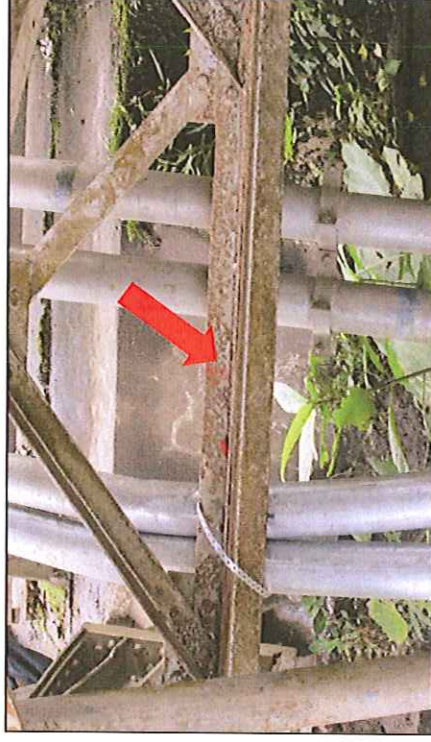
Picture M-S7-P20

Minor corrosion on inclined cross bracing.

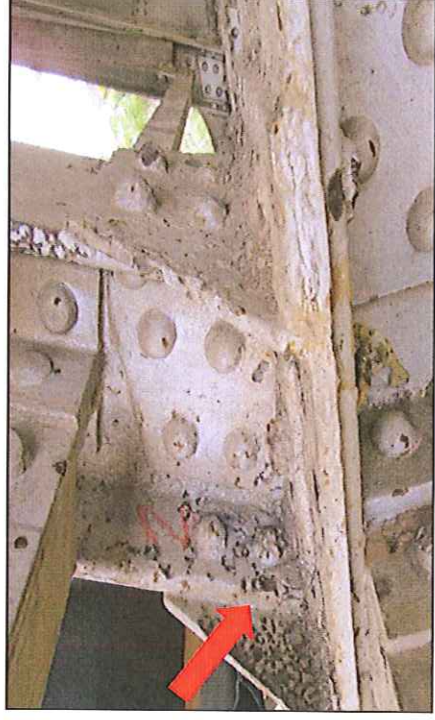
Picture M – S7 – P32

Minor corrosion on vertical bracing joint of arch beam.

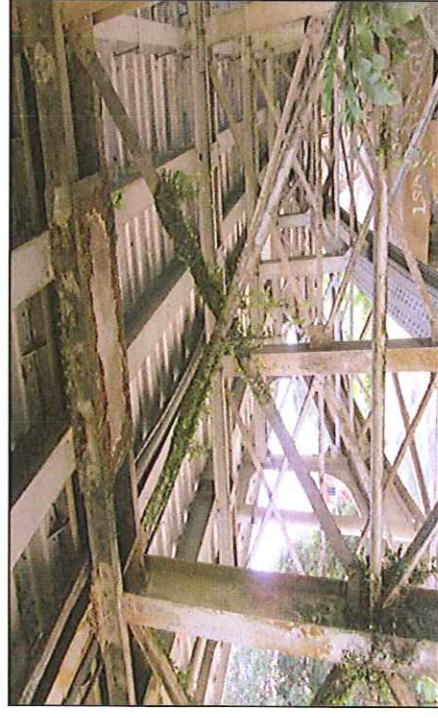
Picture M – S7 – P40

Moderate corrosion on overall middle frame.

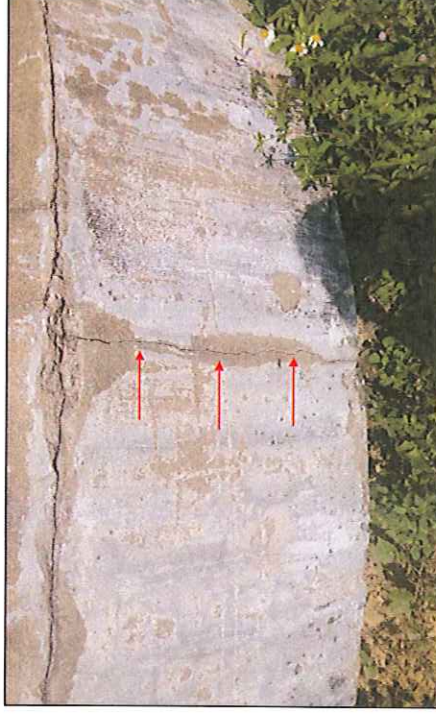
Picture 15 – Pier 6 (toward Sungai Siput)

Vertical crack line on the surface of the pier's pile cap.

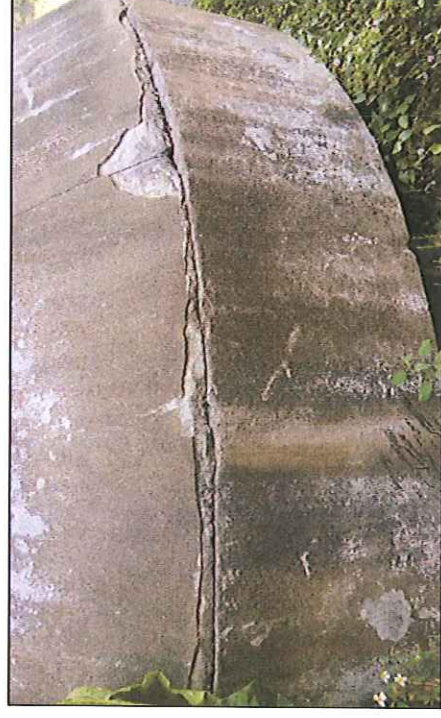
Picture 16 – Pier 6 (toward Kuala Kangsar)

Separation crack line on the surface of the pier's pile cap.

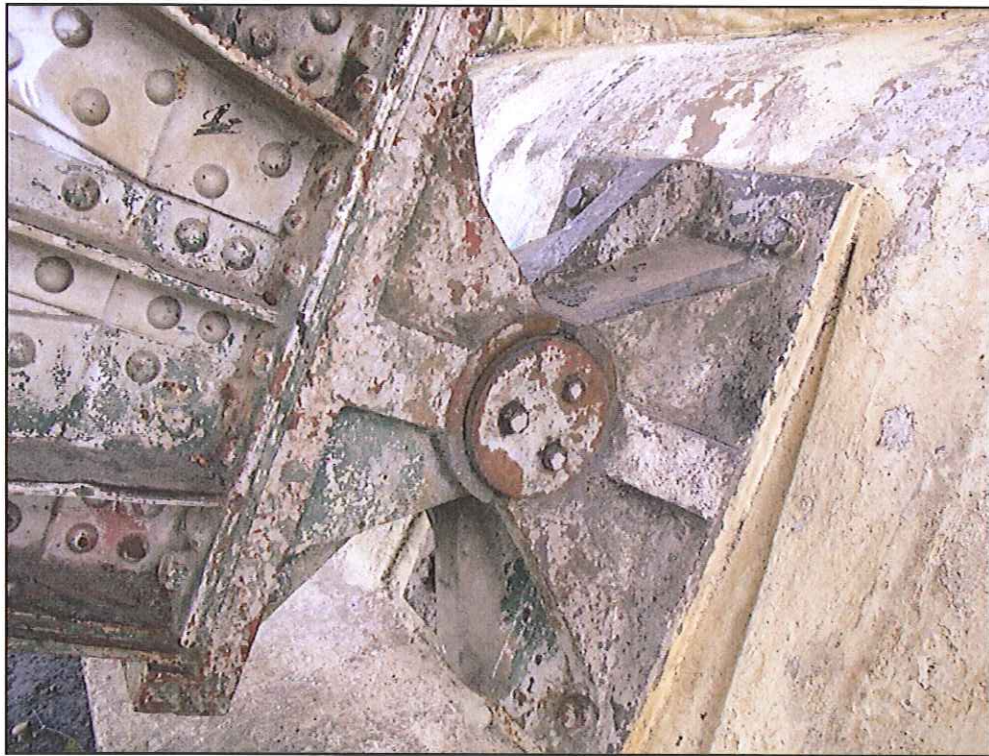
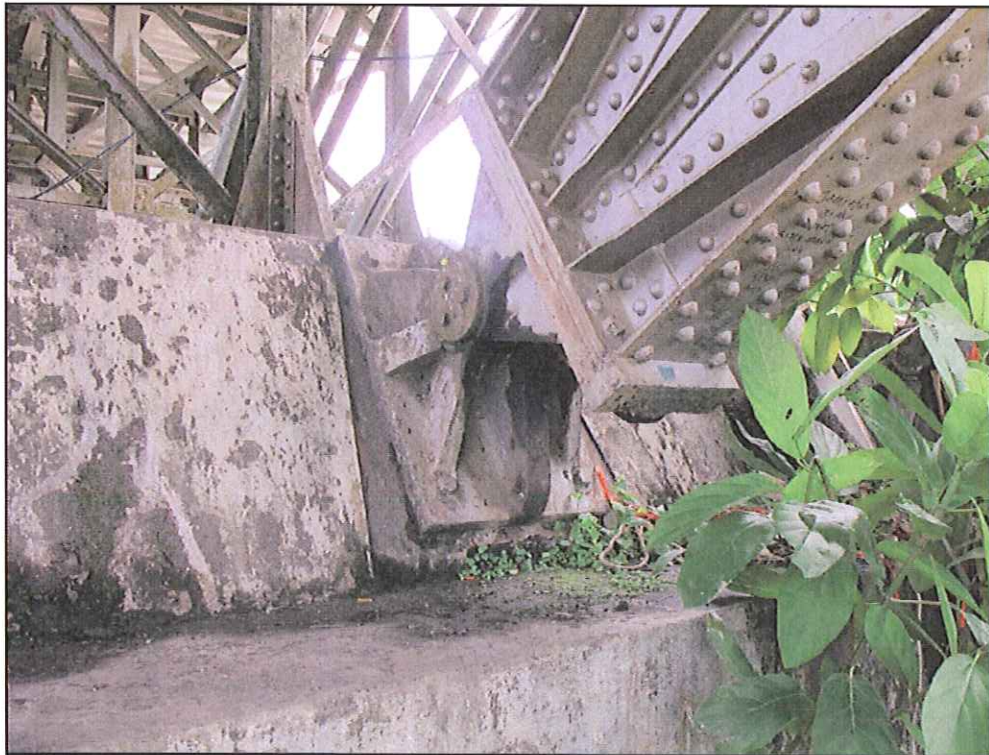
Picture B1 & B2 :- The bridge's steel bearings were found to be generally in good operating condition. General maintenance works for cleaning and re-greasing have been recommended.

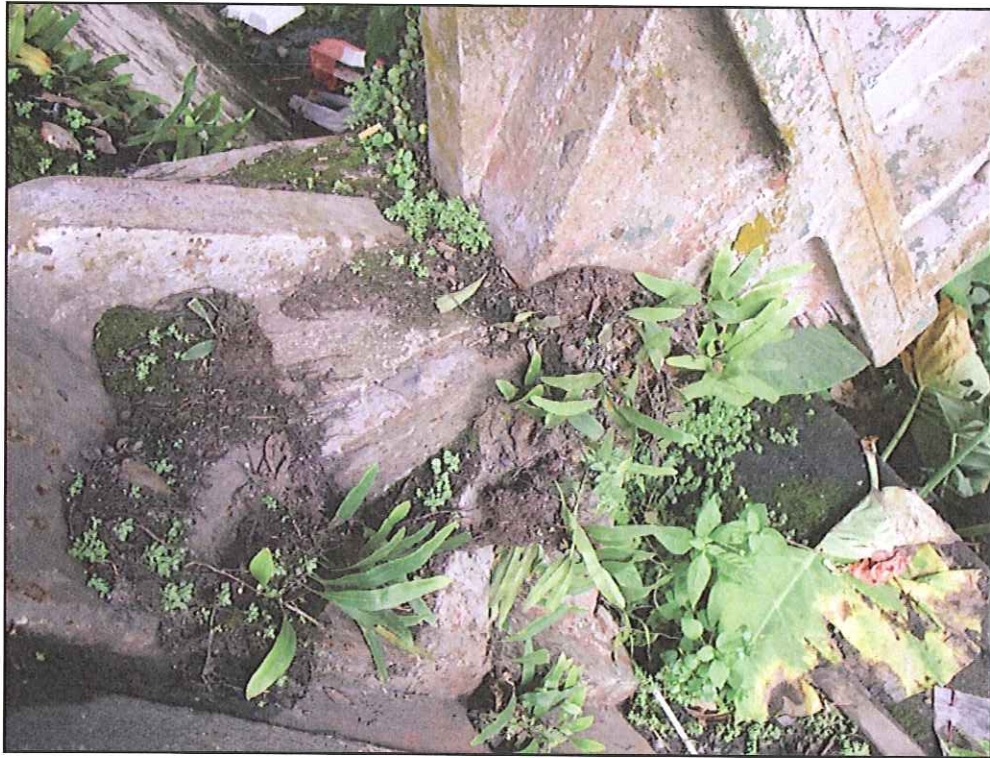
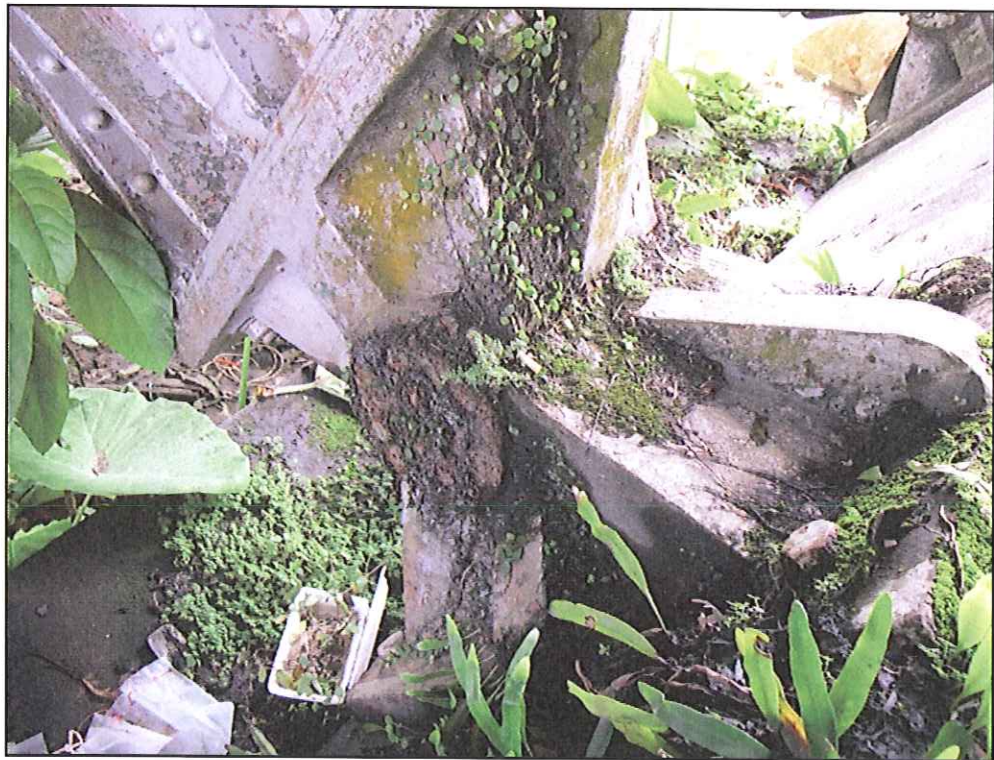
Picture B3 & B4 :- Some of the bridge's steel bearings with debris/vegetation accumulation and minor rusting. General maintenance works to remove all such vegetation growth with cleaning of the minor rust and re-greasing have been recommended.
