# A Unique challenge on fire protection in heritage building

A study on Fire Risk Index Method for Historic Timber Museums:  
Islamic Museum, Melaka & Stamp Museum, Melaka

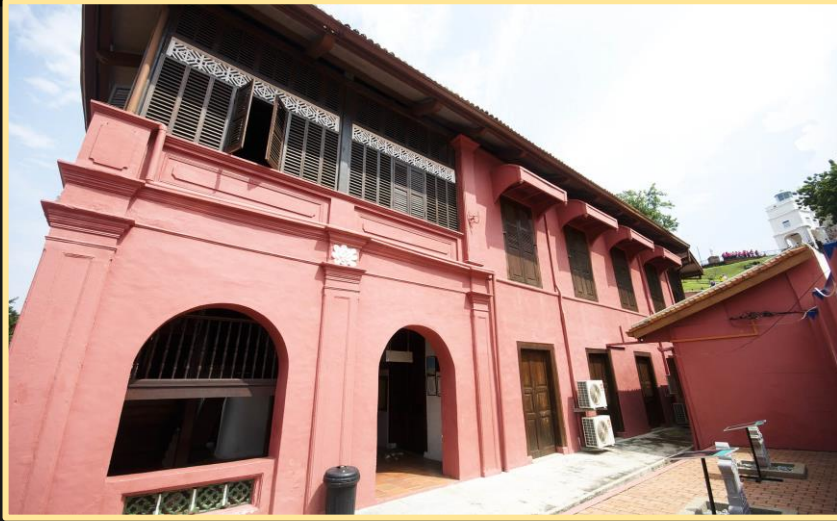
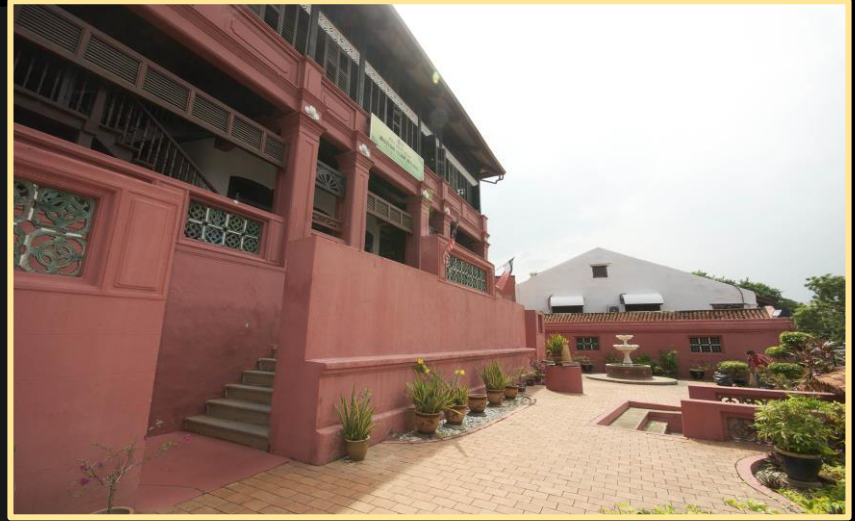
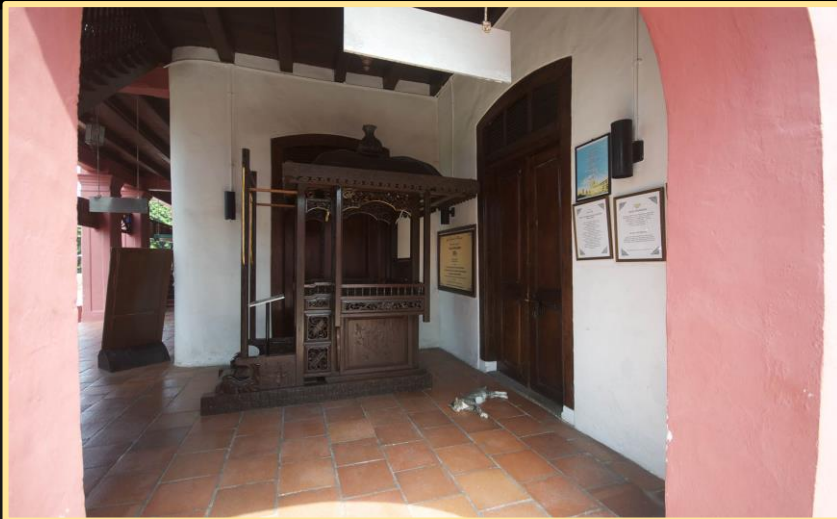
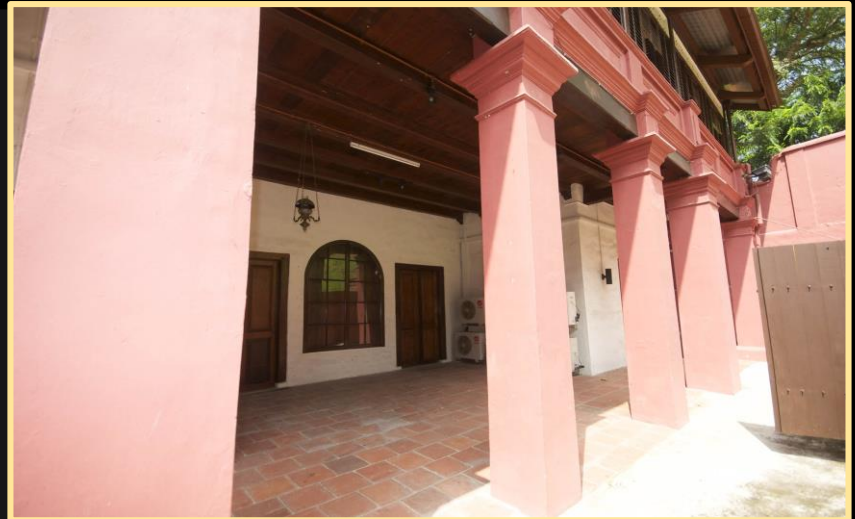
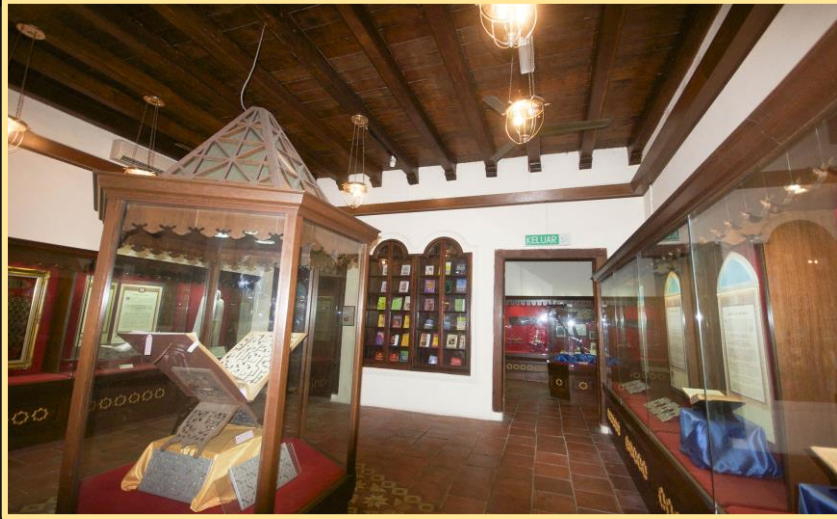
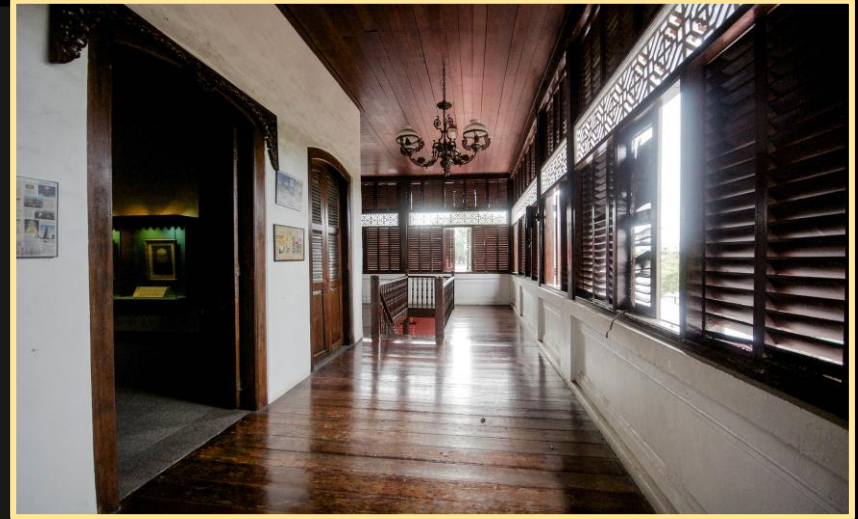
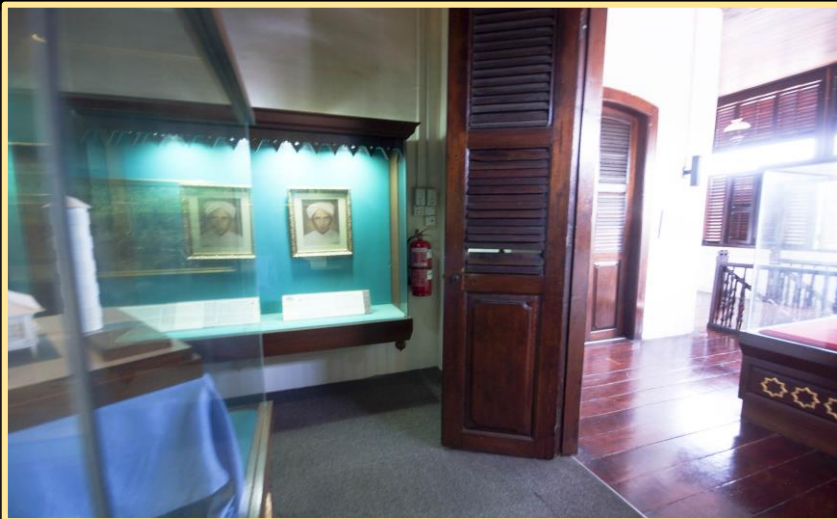
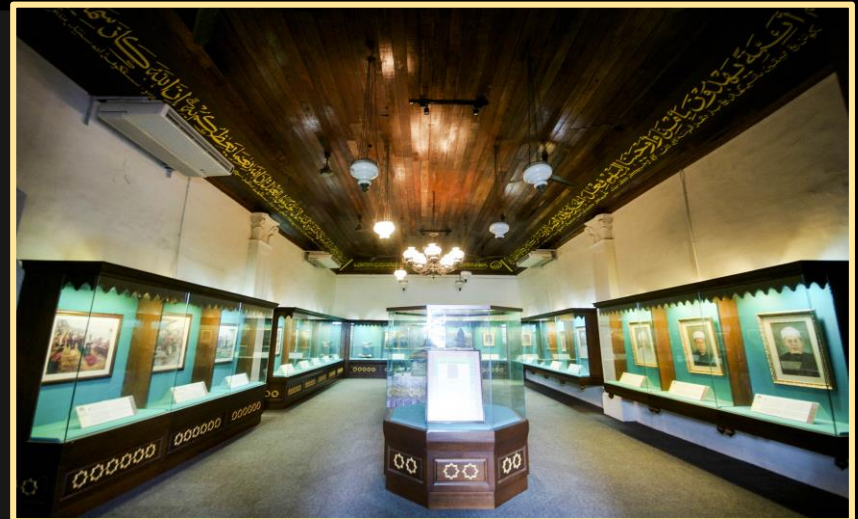
# Islamic Museum - Exterior

No	Parameter	weight	Islamic Museum	Stamp Museum	Findings
1	Lining in rooms	0.0576	0.288	0.288	Both have similar lining material
2	Suppression system	0.0668	0.000	0.000	Both do not have sprinkler system
3	Fire service	0.0681	0.215	0.215	Both building located near to the fire station
4	Compartmentation	0.0666	0.133	0.000	The interior of Islamic Museum is compartmentalized into 8 rooms
5	Structure-separating	0.0675	0.189	0.000	Stamp Museum has an open internal layout allowing fire to spread
6	Doors	0.0698	0.210	0.302	Stamp Museum has a self closing fire rated door as compared to Islamic Museum
7	Windows	0.0473	0.142	0.142	Both buildings have a similar huge wooden frame windows
8	Facade	0.0492	0.000	0.112	Islamic Museum has more combustibile material as a façade of the building as compared to Stamp Museum

No	Parameter	weight	Islamic Museum	Stamp Museum	Findings
9	Roof space	0.0515	0.000	0.000	Both buildings do not provide any fire suppression system in roof space area
10	Adjacent building	0.0396	0.000	0.000	Both buildings do not have any buffer zone @ setback
11	Smoke control system	0.0609	0.000	0.000	Both buildings use natural ventilation
12	Detection system	0.0630	0.000	0.315	Stamp Museum is equipped with smoke detector as compared to Islamic Museum
13	Signal System	0.0512	0.000	0.205	Stamp Museum is equipped with automated signal system as compared to Islamic Museum
14	Escape routes	0.0620	0.283	0.283	Both buildings provide adequate escape routes
15	Structure – load bearing	0.0630	0.233	0.233	Both buildings have similar structural system

No	Parameter	weight	Islamic Museum	Stamp Museum	Findings
16	Maintenance and information	0.0601	0.016	0.016	Both museum have a poor fire information system in the building
17	Ventilation system	0.0558	0.000	0.000	Both building using natural ventilation
	SCORE	1.0000	1.709	2.111	
	<b>Risk Index (=5-score)</b>		<b>3.291</b>	<b>2.889</b>

**Stamp Museum has a lower fire risk as compared to Islamic Museum**

- Based on the findings from the case study, there are substantial fire risks in historic timber building museums in Malaysia.
- Fire risk assessment helps to identify potential risks and underline parameters for Fire Safety Management Plan for the use of caretakers, in this case PERZIM.
- Fire risk assessment should be introduced in dilapidation reports or building planning approval for conservation projects.
- FRIM assessment method is suitable for historic timber building museum.
- FRIM can be used by the Authority for fire safety guidelines and checklist.
- FRIM is suitable for conservators and professionals to evaluate their design proposals for conservation projects.
- FRIM is suitable for academicians for their researches in historic buildings.
