Condition Assessment of The Deteriorated Reinforced Concrete Bridge: Jambatan Sungai Senduk Ulu, Jambatan Sungai Cheh, Jambatan Bukit Gantang

PROF. MADYA IR. DR. RAIZAL SAIFULNAZ MUHAMMAD RASHID

- This is a case of deterioration Reinforce Concrete (RC) Beam acting as bridge component. Focusing on diagnosing deterioration of three bridges in same road alignment.
- The site studied are at State Road, Taiping Perak under custodian of Public Work Department (PWD). This bridges approximately build 60 years ago.
- This bridges consist of multiple span of bridge, use of RC beam as superstructure and probably simply supported system. There is no defect or distress observed from the top of bridge but from below the bridge, deterioration of RC beam deterioration are noticeably observed (e.g cracking, delamination, spalling and discoloration).

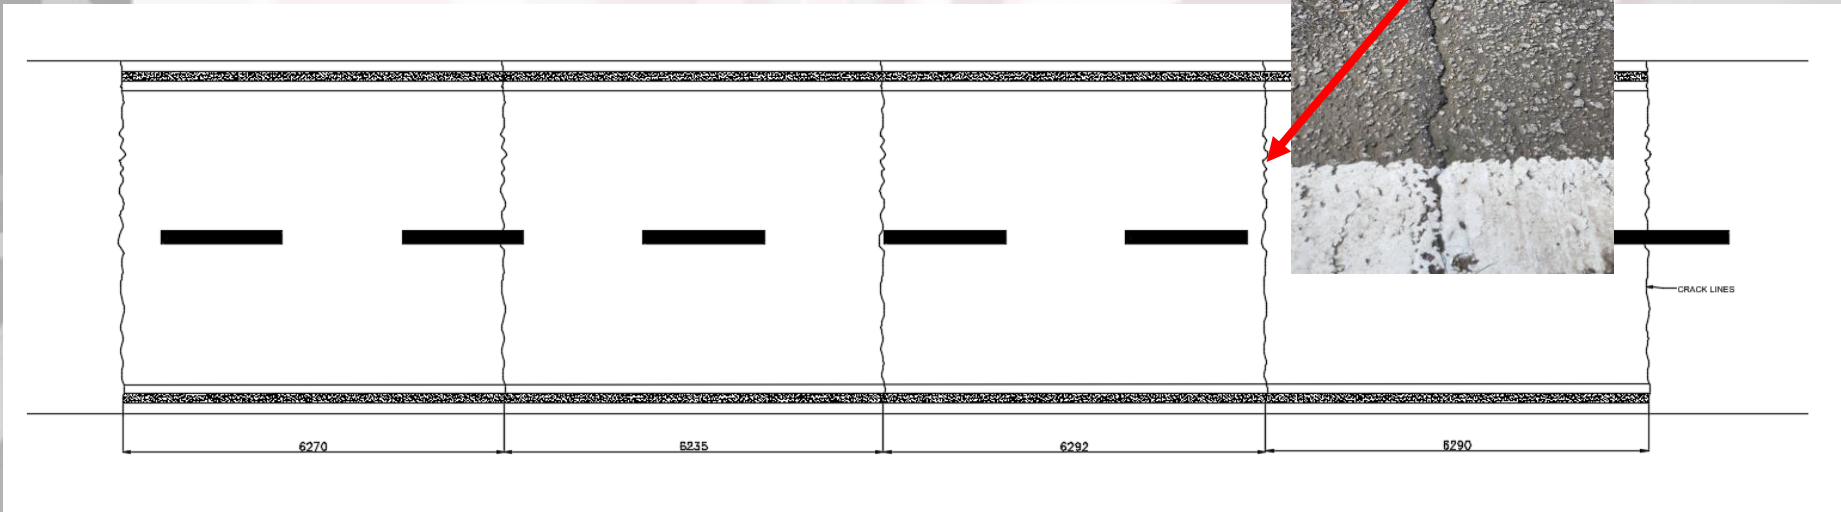
Jambatan Sungai Senduk Hulu

Transverse crack observed on the pavement indicates simply supported beam girder. Possible penetration of water to the structure.

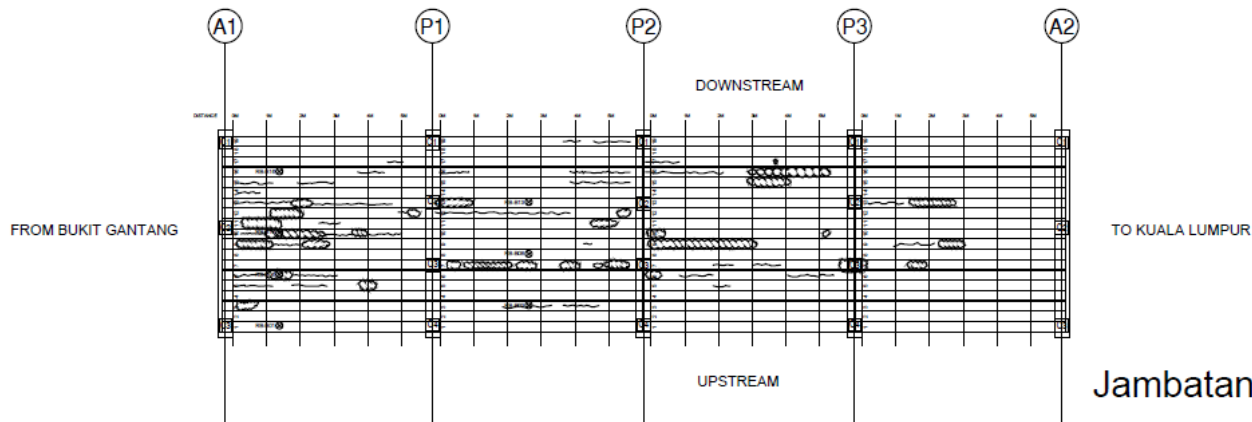
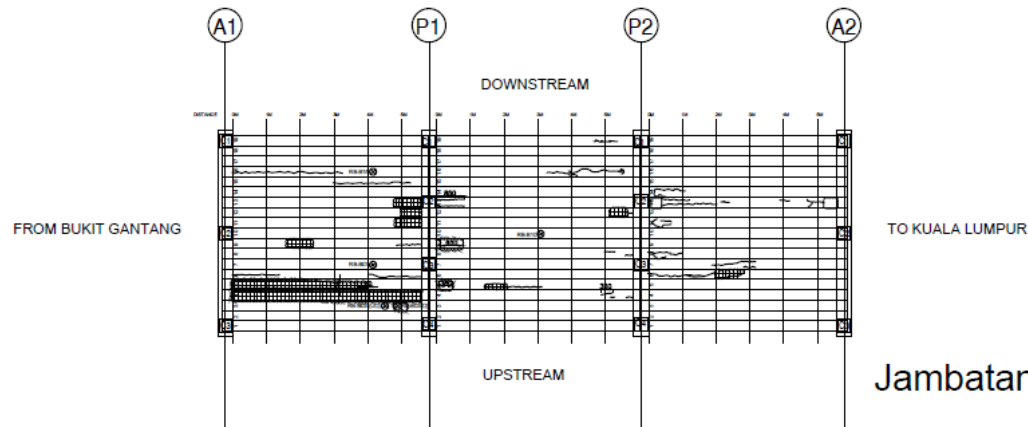
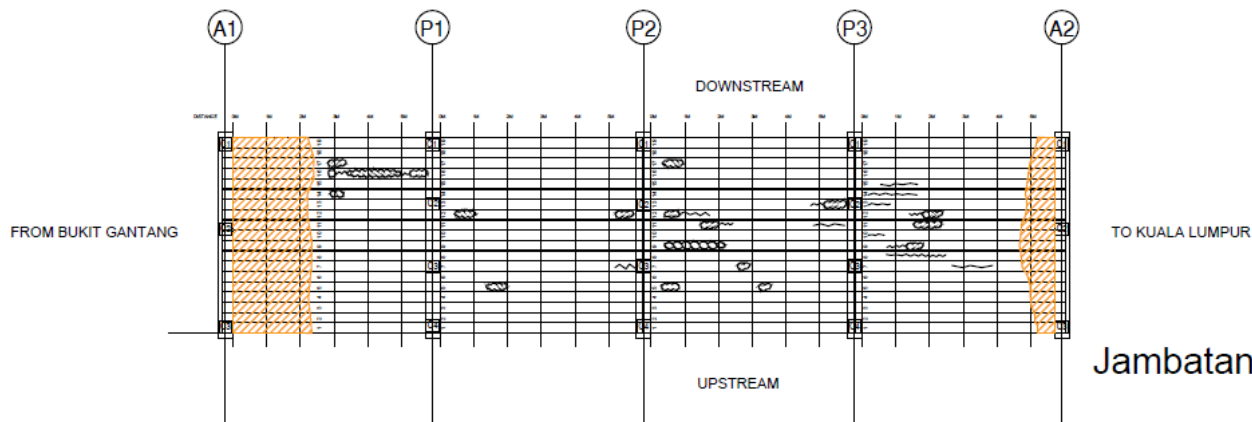
Defect Mapping of all three bridges

Bil	Defect Component	Cracking	Delamination	Spalling
1.	Deck	Transverse cracks were observed on the pavement deck about 6.2m spans c/c	No sign	No sign
2.	Girders	Most cracks were found along the reinforcement bar. These may be associated with stresses created during the embedded metal corrosion process	Delamination areas were observed from 0.15m ² to as large as 1.2m ² which is equivalent to three quarter spans of the girder.	Concrete spalling exposing severely corroded rebars were found in many locations on the girder, showing serious concerns in its structural integrity. The depth of detached concrete cover measured are varies, from 25mm to 65mm.
3.	Piers	No sign	No sign	No sign
4.	Abutments	No sign	No sign	No sign

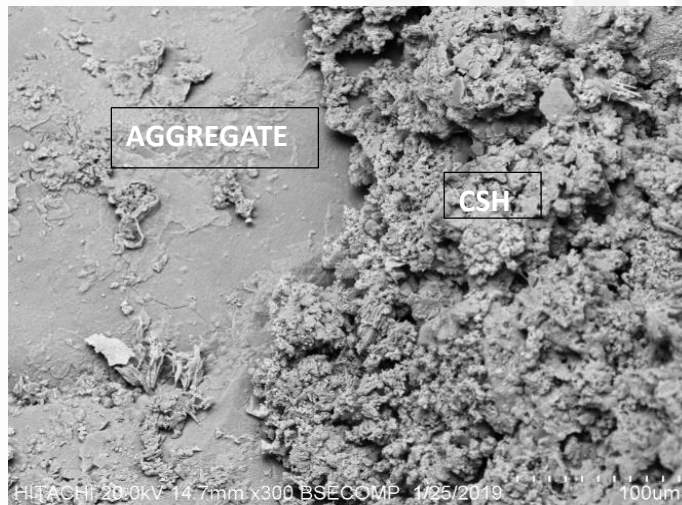
- CSH gel, calcite and ettringite crystals are present in the sample as shown in Fig. 7 and 8. The presence of calcite (Calcium Carbonate) indicates signs of carbonation.

Figure 7: The bind between CSH and aggregate is sufficient

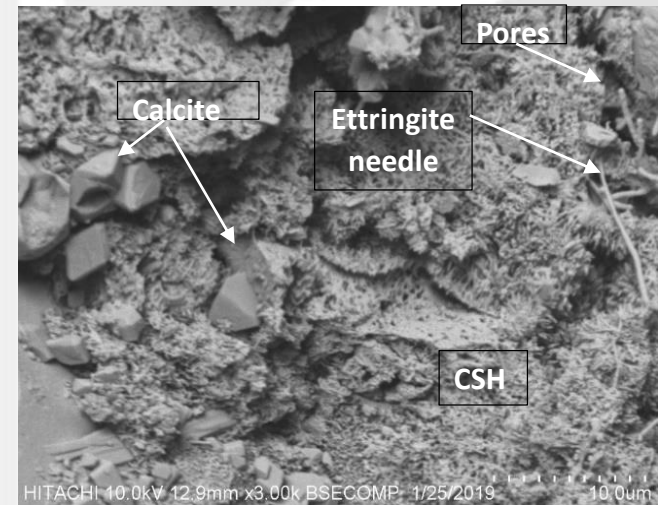
Figure 8: Calcite and ettringite crystal are present. Minimal ettringite crystals demonstrate minimal porous volume.

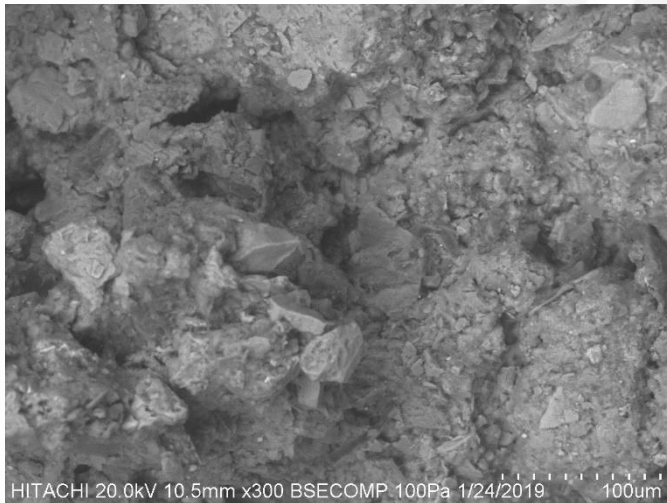
- No trace of sulphate and chloride substances in the soil which subsequently the probability of sulphate attack and chloride attack from the external environment is low.

Figure 9: SEM Image for Soil Sample at Sg. Senduk Ulu

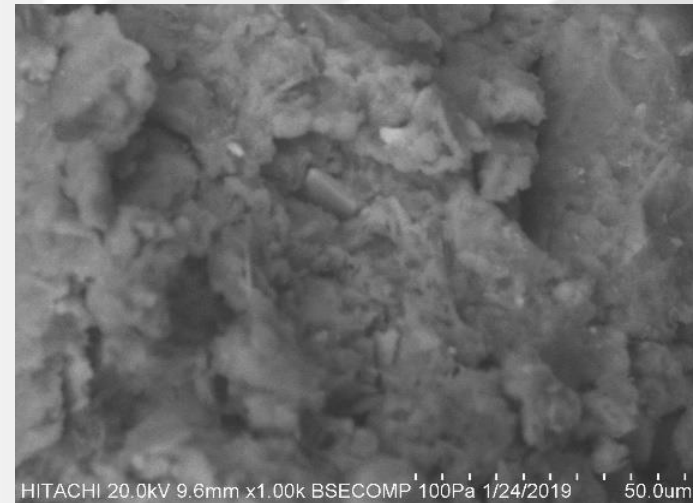
Figure 10: SEM Image for Soil Sample at Sg. Senduk Cheh

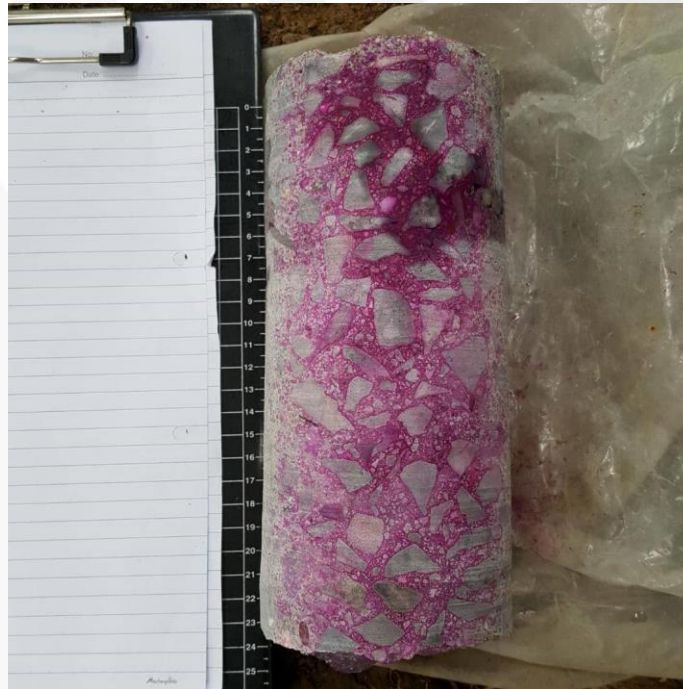
No trace of carbonation attack as specimen turn to purple color.
