6.0 Conclusion

7.0 Recommendations for Rehabilitation and Strengthening

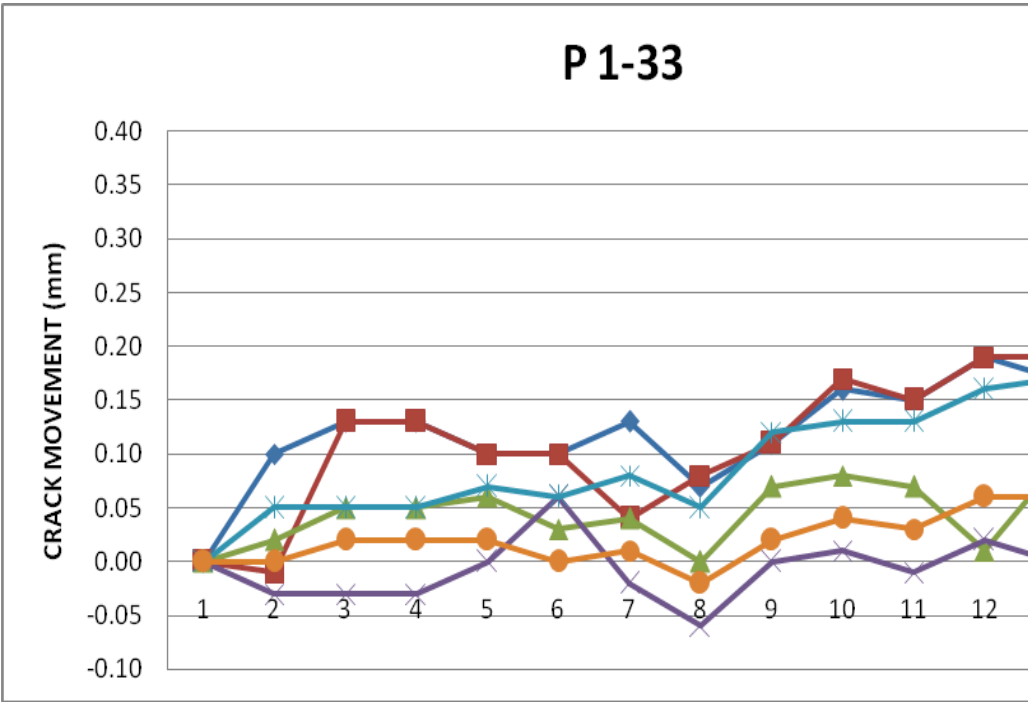
Figure 1: Crack Movement Reading at Pier 1-33

-
- 5.4 Figure 1 and Figure 2 show the graphical plots of crack movement at 'T'-shape pier during the monitoring period. It can be seen that the movement of crack for 5A is consistently much higher with maximum reading up 0.32 mm compared to other readings at less than 0.20mm.
- 5.5 Figure 3 until Figure 8 show the graphical plots of crack movement at 'L'-shape pier. From the graph, it can be seen that the maximum reading at Pier 1-10A and P1-11A approach 0.30mm. The other points have movement at less than 0.25 mm.

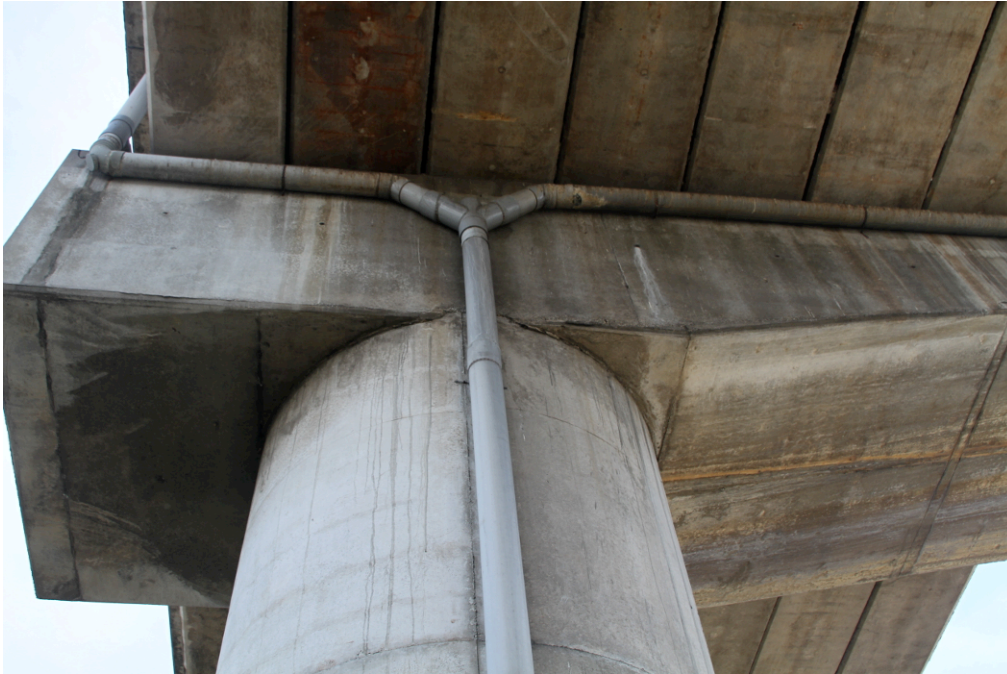
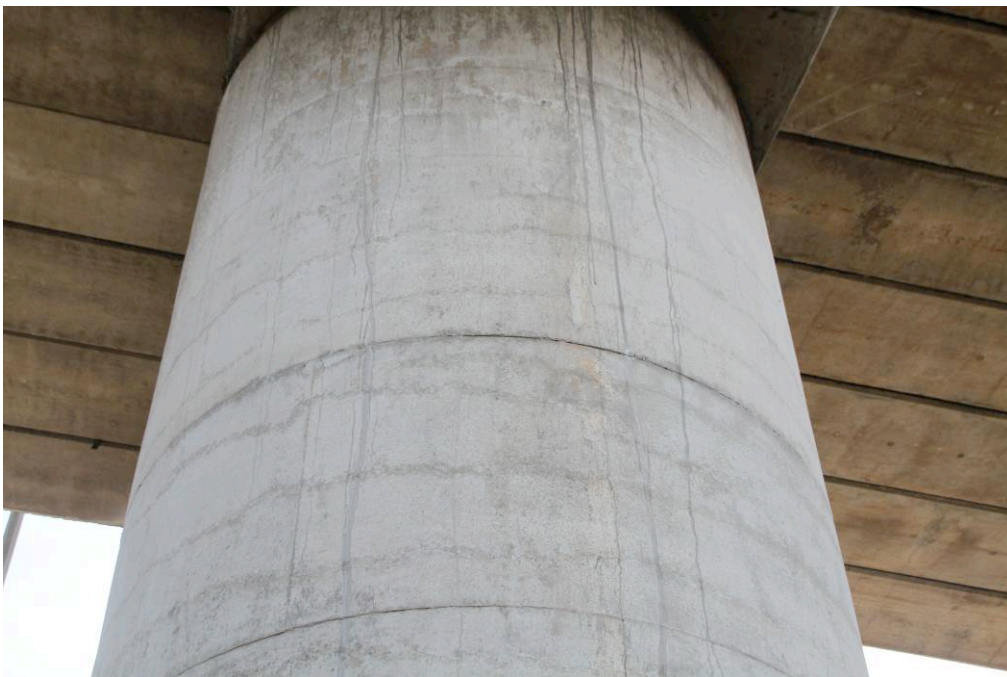
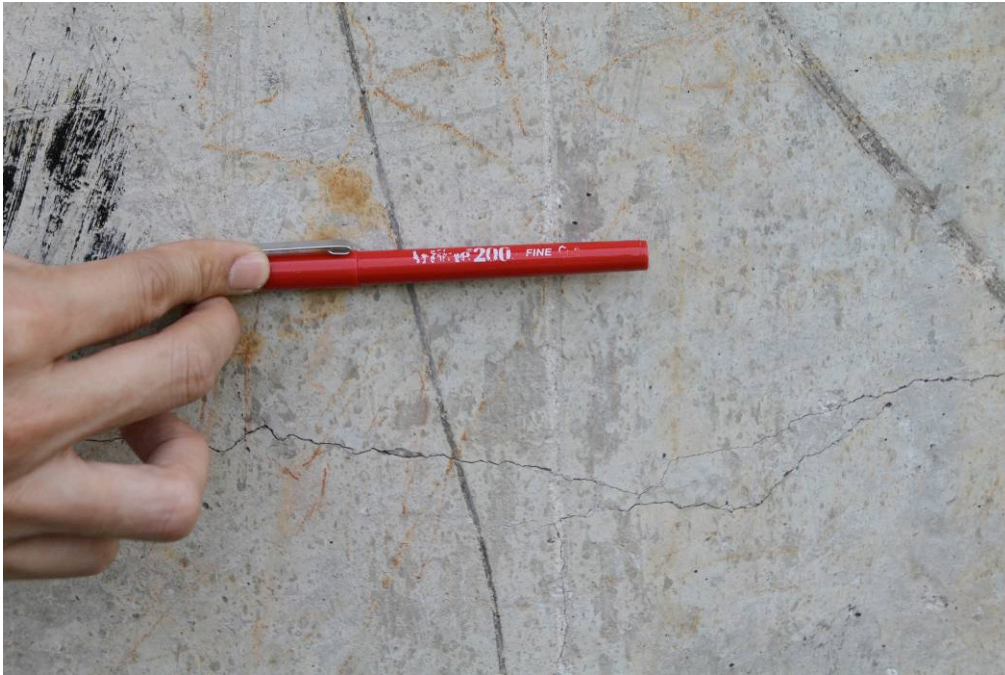
6.1.2 For SLS check, the crack width of the pier column is checked against the maximum allowable serviceability crack width of 0.25mm. It is found that P-25 and P-33 columns meet the allowable limit. However, the crack widths for P-11A (inverted “L” pier) under three (3) different traffic load conditions are found to be more than 0.25mm with a maximum value of 0.416mm. Hence, the existing column design for P-11A does not fulfil the SLS requirement.

Figure 13: Pier P-11A

Figure 14: Pier Column P-11A (Rear view)

Figure 15: Pier Column P-11A (Close up)

All cracks to be sealed and applied with two coats of polymer-modified cementitious waterproofing coating (SIKA Top Seal 109 MY) which has crack bridging capacity up to 1.0mm.

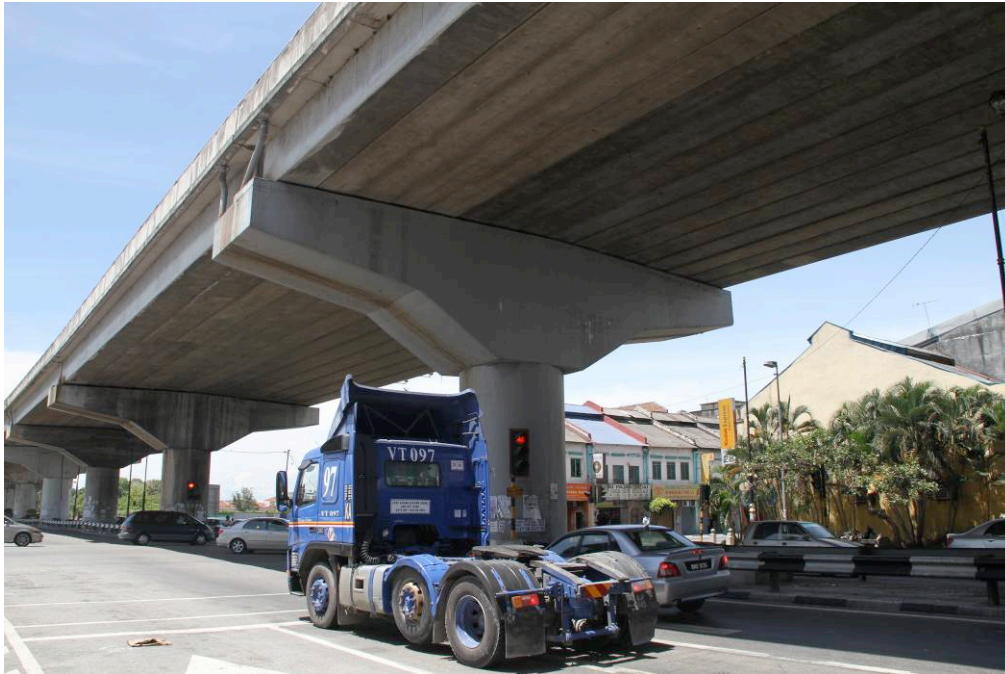
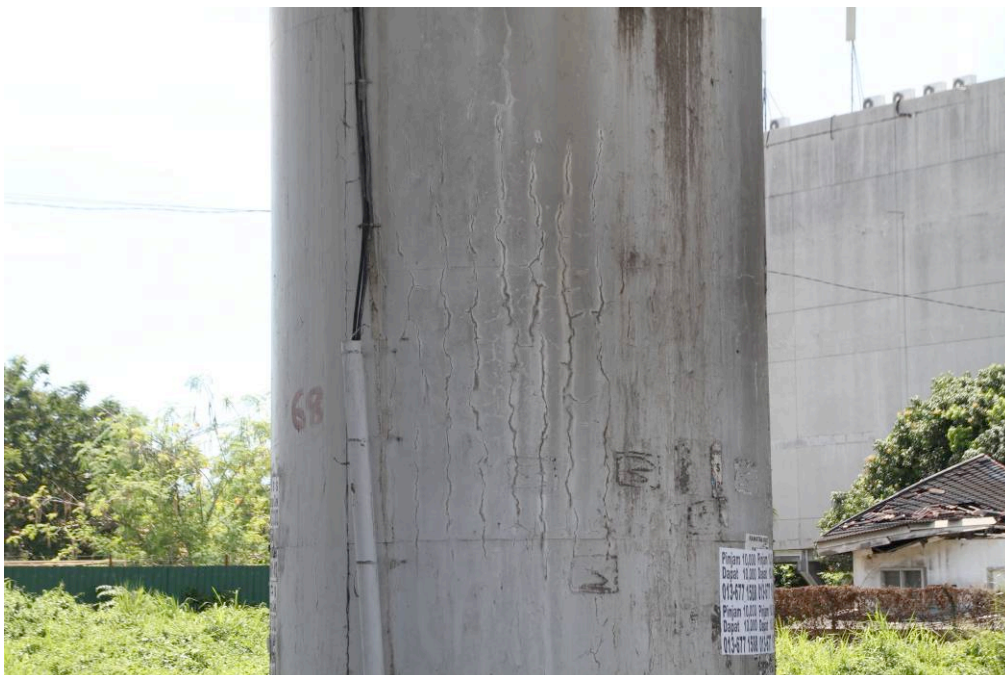
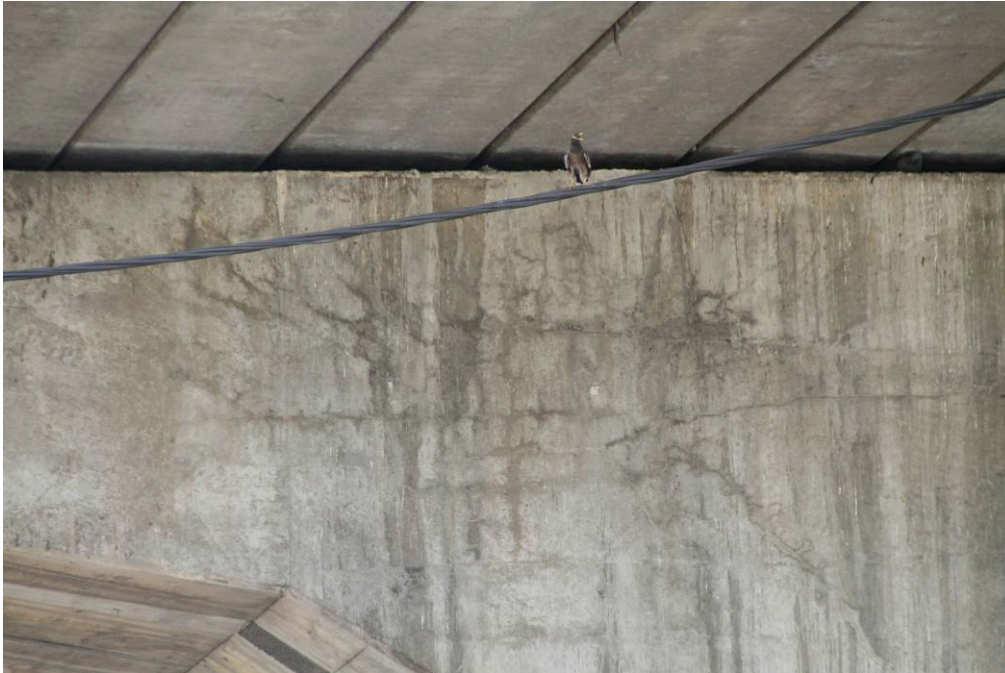
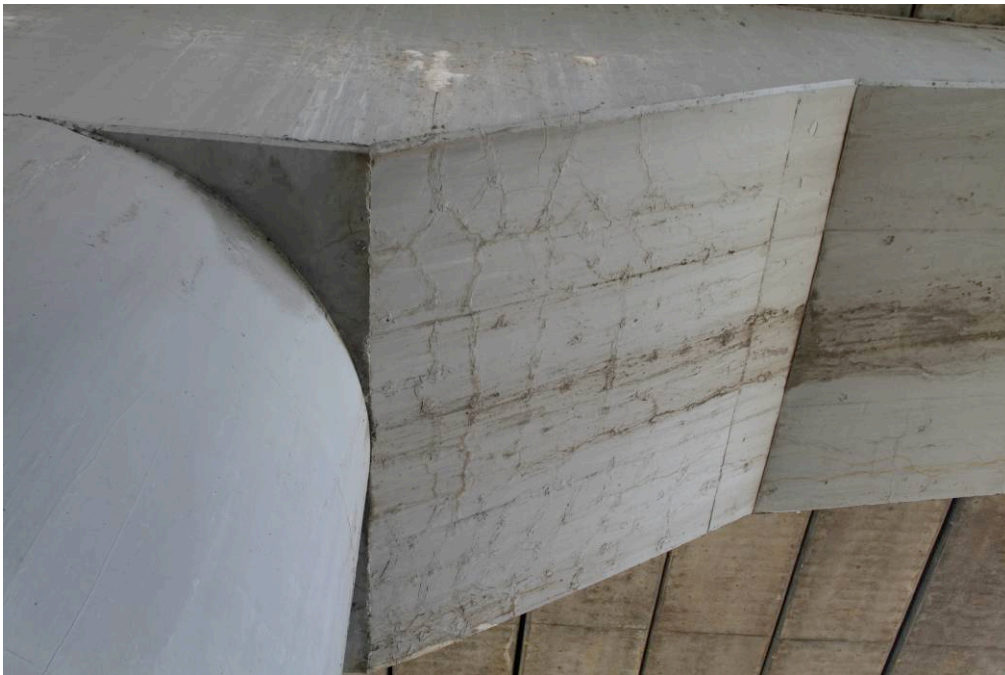
- 6.2.3 The existing shear design for P-11A and P-33 crosshead is found adequate.
- 6.2.4 It is found that the existing shear capacity for P25 is marginally insufficient to resist the maximum induced shear force at the existing section with depth of 2.0m. .

Figure 21: Pier P-25

Figure 22: Pier Column P-25 (Close up)

Figure 23: Pier Crosshead P-25 (Close up)

Figure 24: Pier Crosshead P-25 (Underside)

Use Epoxy-bonded CFRP at both sides of crosshead to enhance the anchorage capacity of the existing main column rebars. Upper portion of the existing column shall be enlarged to provide sufficient anchorage for

the bonded CFRP. All cracks shall be sealed before applying the protective coatings. All surfaces with CFRP shall be applied with 25mm thick wet sprayed fire protection mortar (SIKACRETE 213F), the remaining surface to be applied with two coats of polymer-modified cementitious waterproofing coating (SIKA Top Seal 109 MY) which has crack bridging capacity up to 1.0mm.

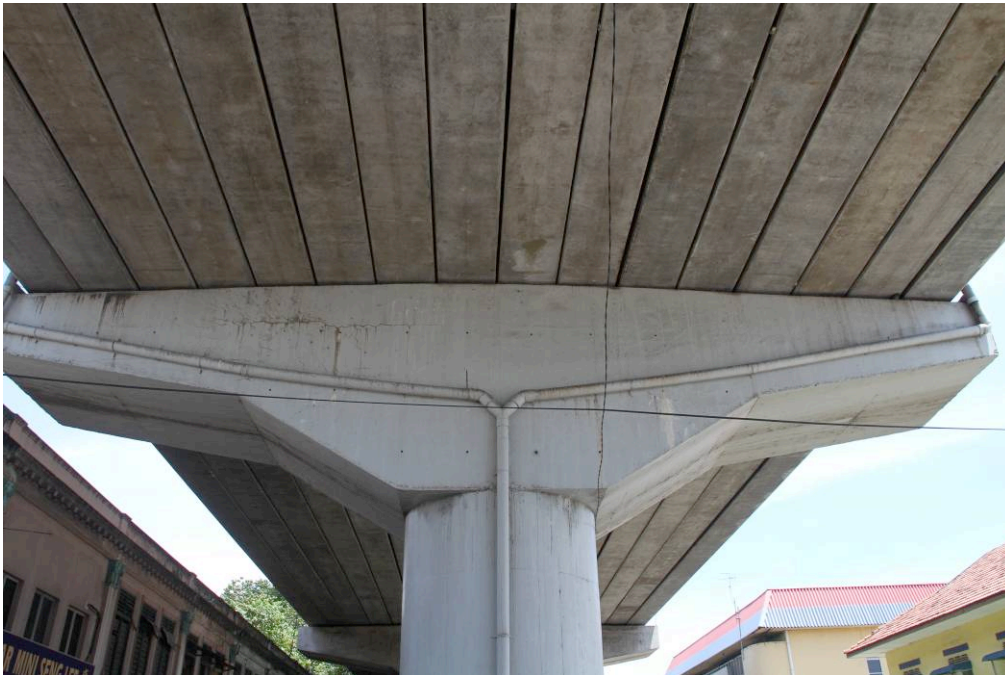
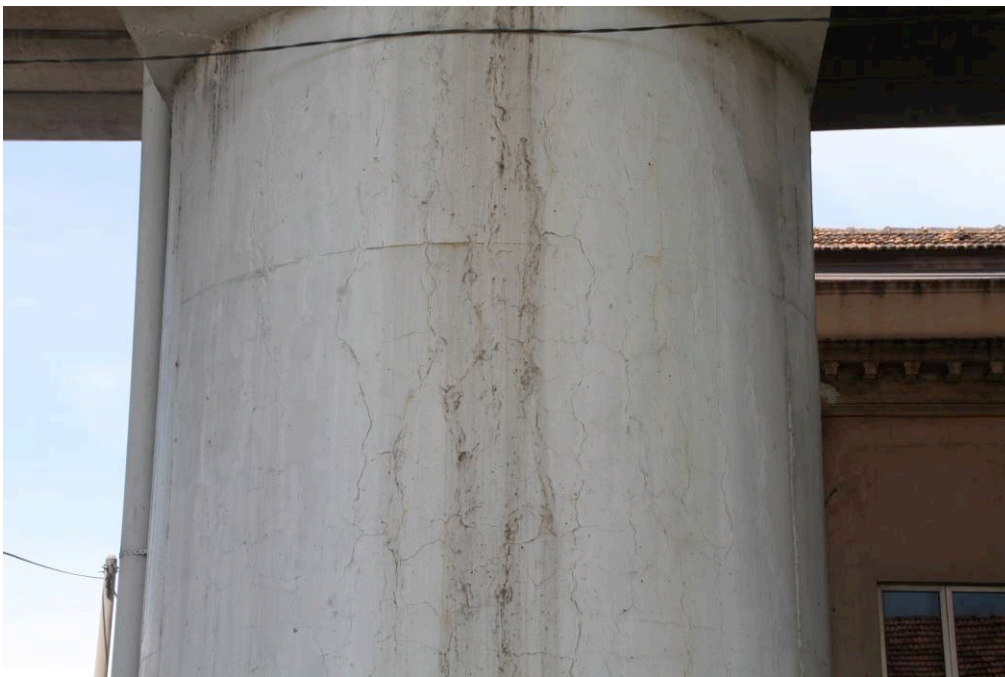
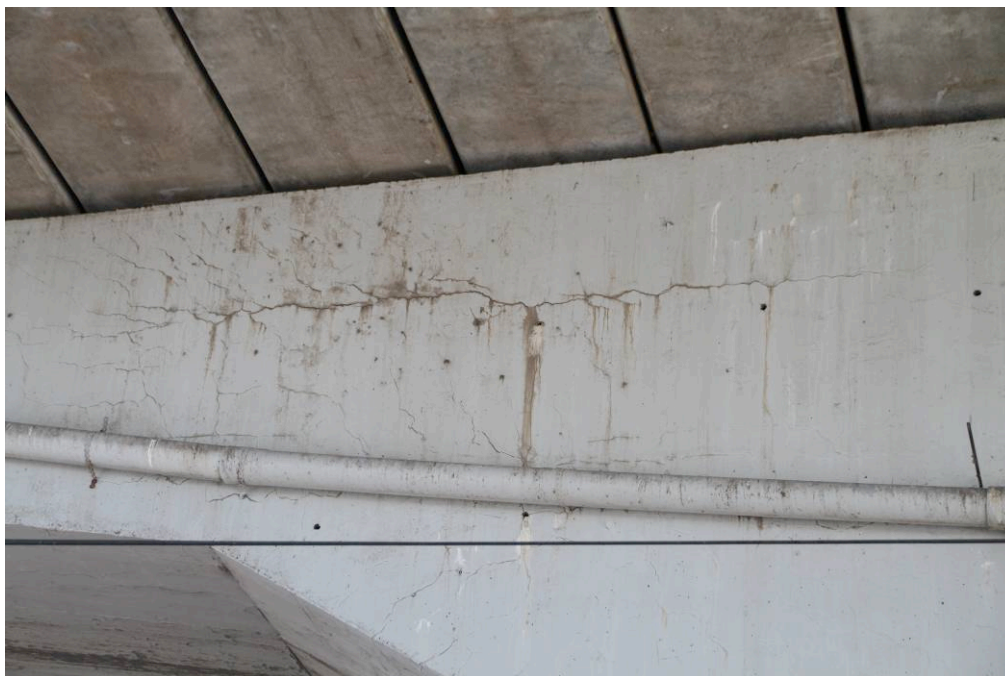
- 6.3.1 Based on crack mapping, L-shape pier and crosshead were found with crack within 0.1mm to 0.4mm width. T-shape pier also were found with crack within 0.1mm to 0.4mm width. However, crack at crosshead of the T-shape pier has maximum width of 4.0mm at Pier No.33.

Figure 25: Pier P-33

Figure 26: Pier Column P-33 (Close up)

Figure 27: Pier Crosshead P-33 (Close up)
