Geotechnical Forensic Engineering – Case Histories Ir. Dr. Gue See Sew G&P Geotechnics Sdn Bhd

Contents

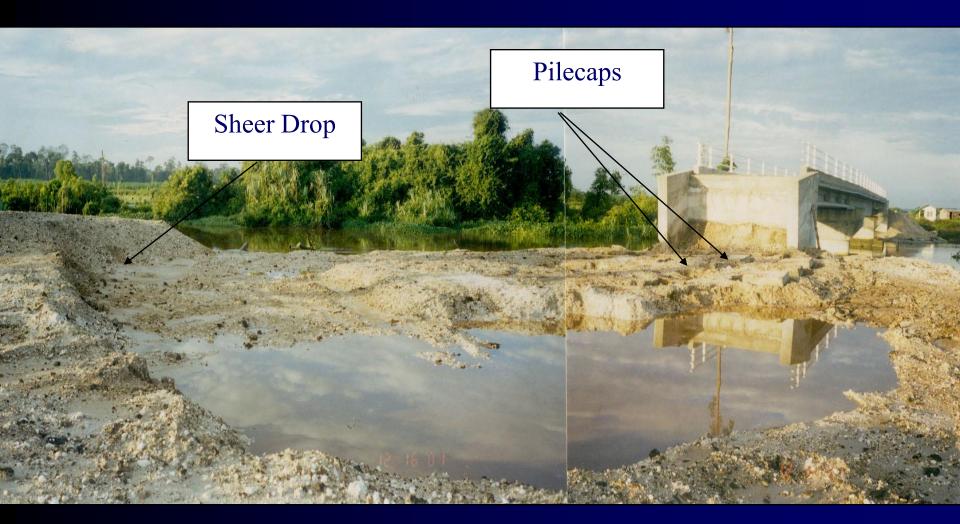
<u>Slip Failure of Embankment</u>

- At Approach Embankment
 25m from Abutment II
- $\mathbf{Fill} = \mathbf{3m}$.
- Abutment II :
 - Tilted 550mm on top.
 - Angular distortion of 1/6
- 300mm gap between bridge decks.

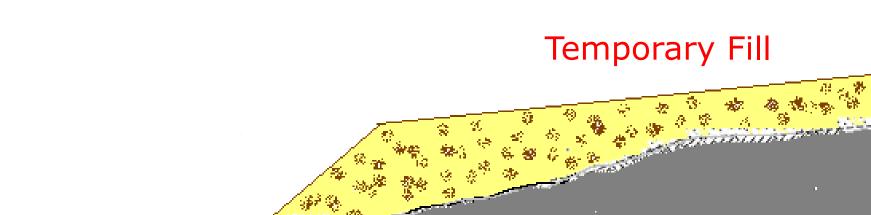
Failure due to Temporary Fill

Soft Clay

Temporary Fill

- Proper design and review.
- Stability check of embankment & abutment (both circular & wedge failures)
- Most critical :-

During construction. (must check temporary works)

Proper full-time supervision

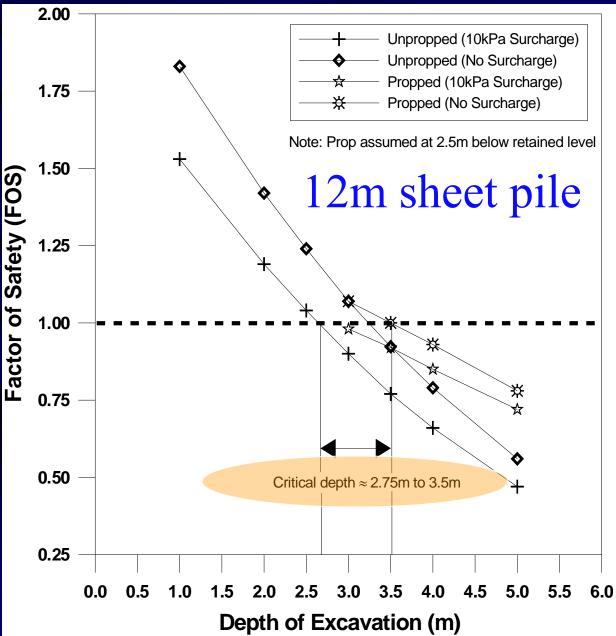
Stability of Sheet Pile Penetration Depth

- Inadequate geotechnical design
- Over-excavation caused failure. (lack of site control)
- Need to check for :-

Overall stability Basal Failure Hydraulic Failure

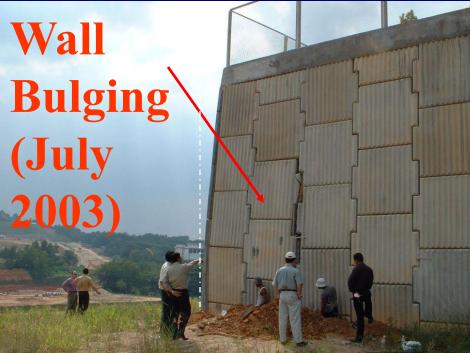
Gap Opening (December 2002)

> Gap Opening (July 2003)

Gap Opening & Bulging

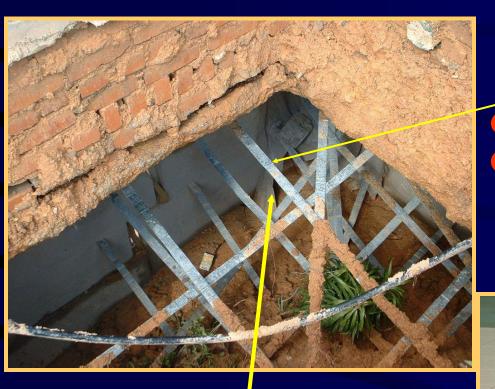
Ground Settlement at Top of RS Wall

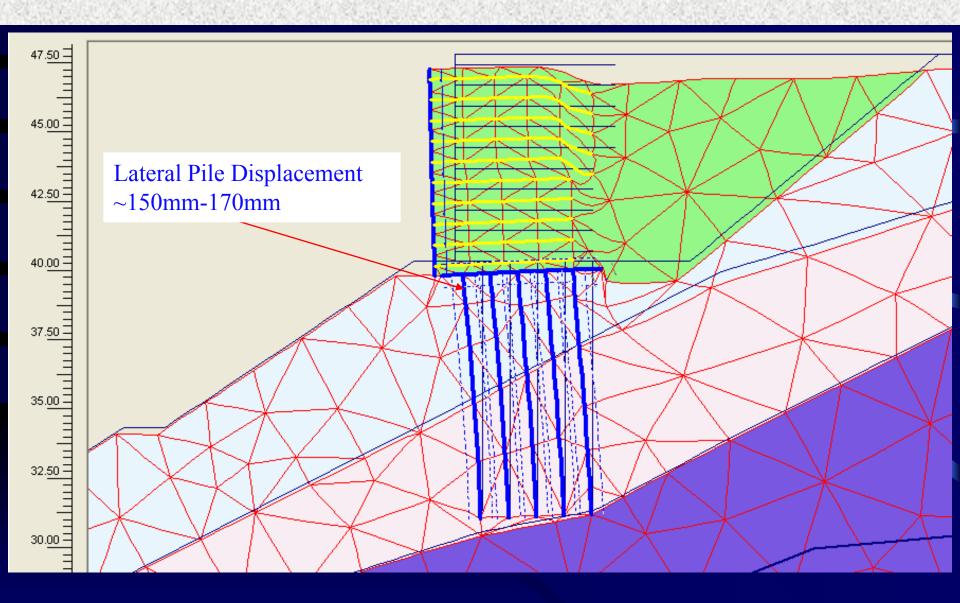
FEM Analysis – Displaced RC Piles

Analysis Type	Aspect	Remarks / Findings
Structural & Geotechnical Capacity of	Pile Axial Capacity Check	Adequate
Piled Foundation	Pile Lateral Resistance Check	Inadequate (Fail)
	RC Base Slab Check	Inadequate (Fail)

- Inadequate pile lateral resistance
- Inadequate shear and moment resistances of RC piles and slab
- = Slab Cracked + Displaced Forward

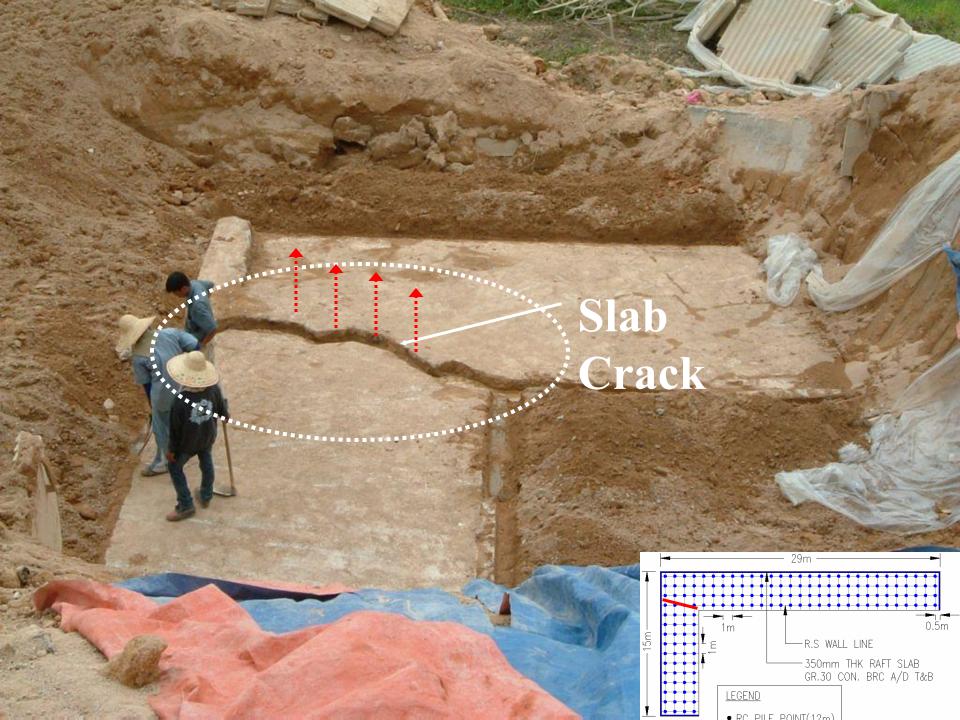
CAUSES OF FAILURE

MAIN CAUSES

→Lateral Movement →Foundation Instability
