FIRE RISK INDEX METHOD

FOR HISTORIC TIMBER MUSEUMS :

ISLAMIC MUSEUM, MELAKA

STAMP MUSEUM, MELAKA

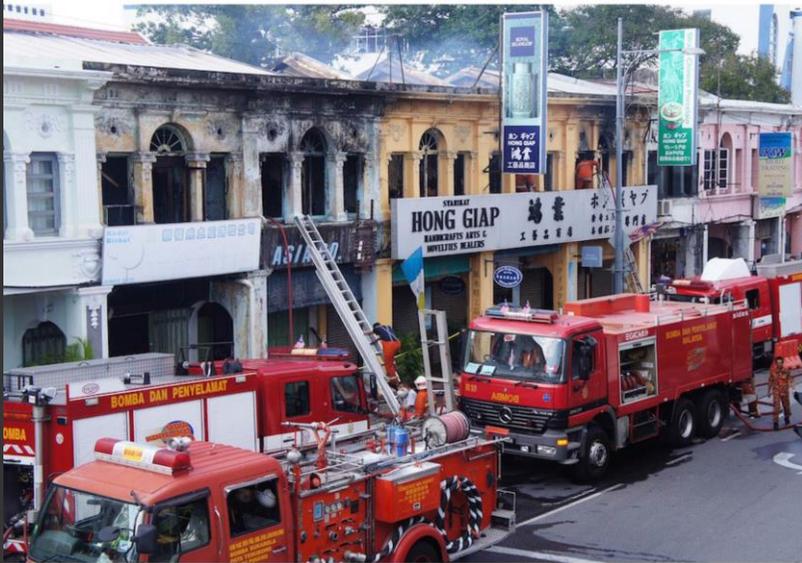
Fire destroys three heritage shophouse on Lebuhr Penang in George Town yesterday morning. – The Malaysian Insight pic, September 13, 2017.

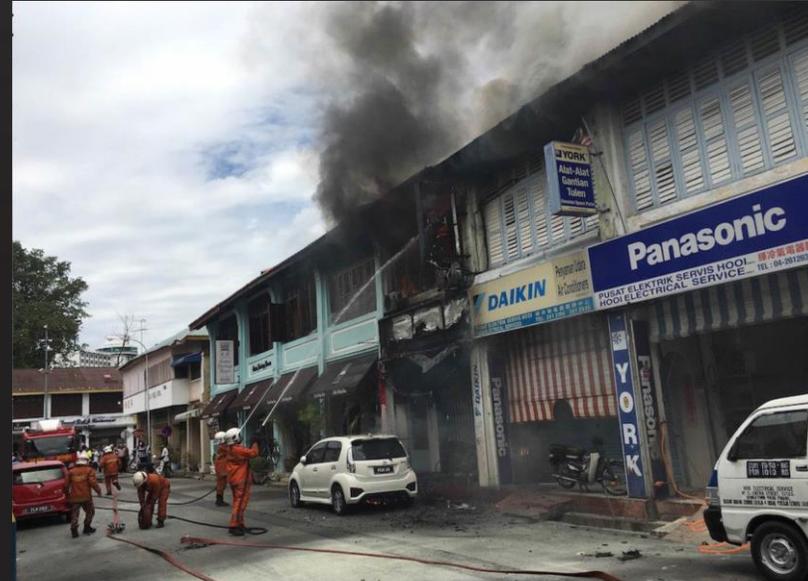
A pre-war shophouse on Lebuhr Cintra in the Unesco heritage city of George Town is lost to fire today. – The Malaysian Insight pic, September 13, 2017.
