KR'S PROJECTS CASE STUDY OF HEALTH FACILTY PROJECTS

Ar. MOHD. FIRDAUS MOHD. ZAINOL ROHAIMI MANSOR

MOULD GROWTH IN HEALTH FACILITY BUILDINGS

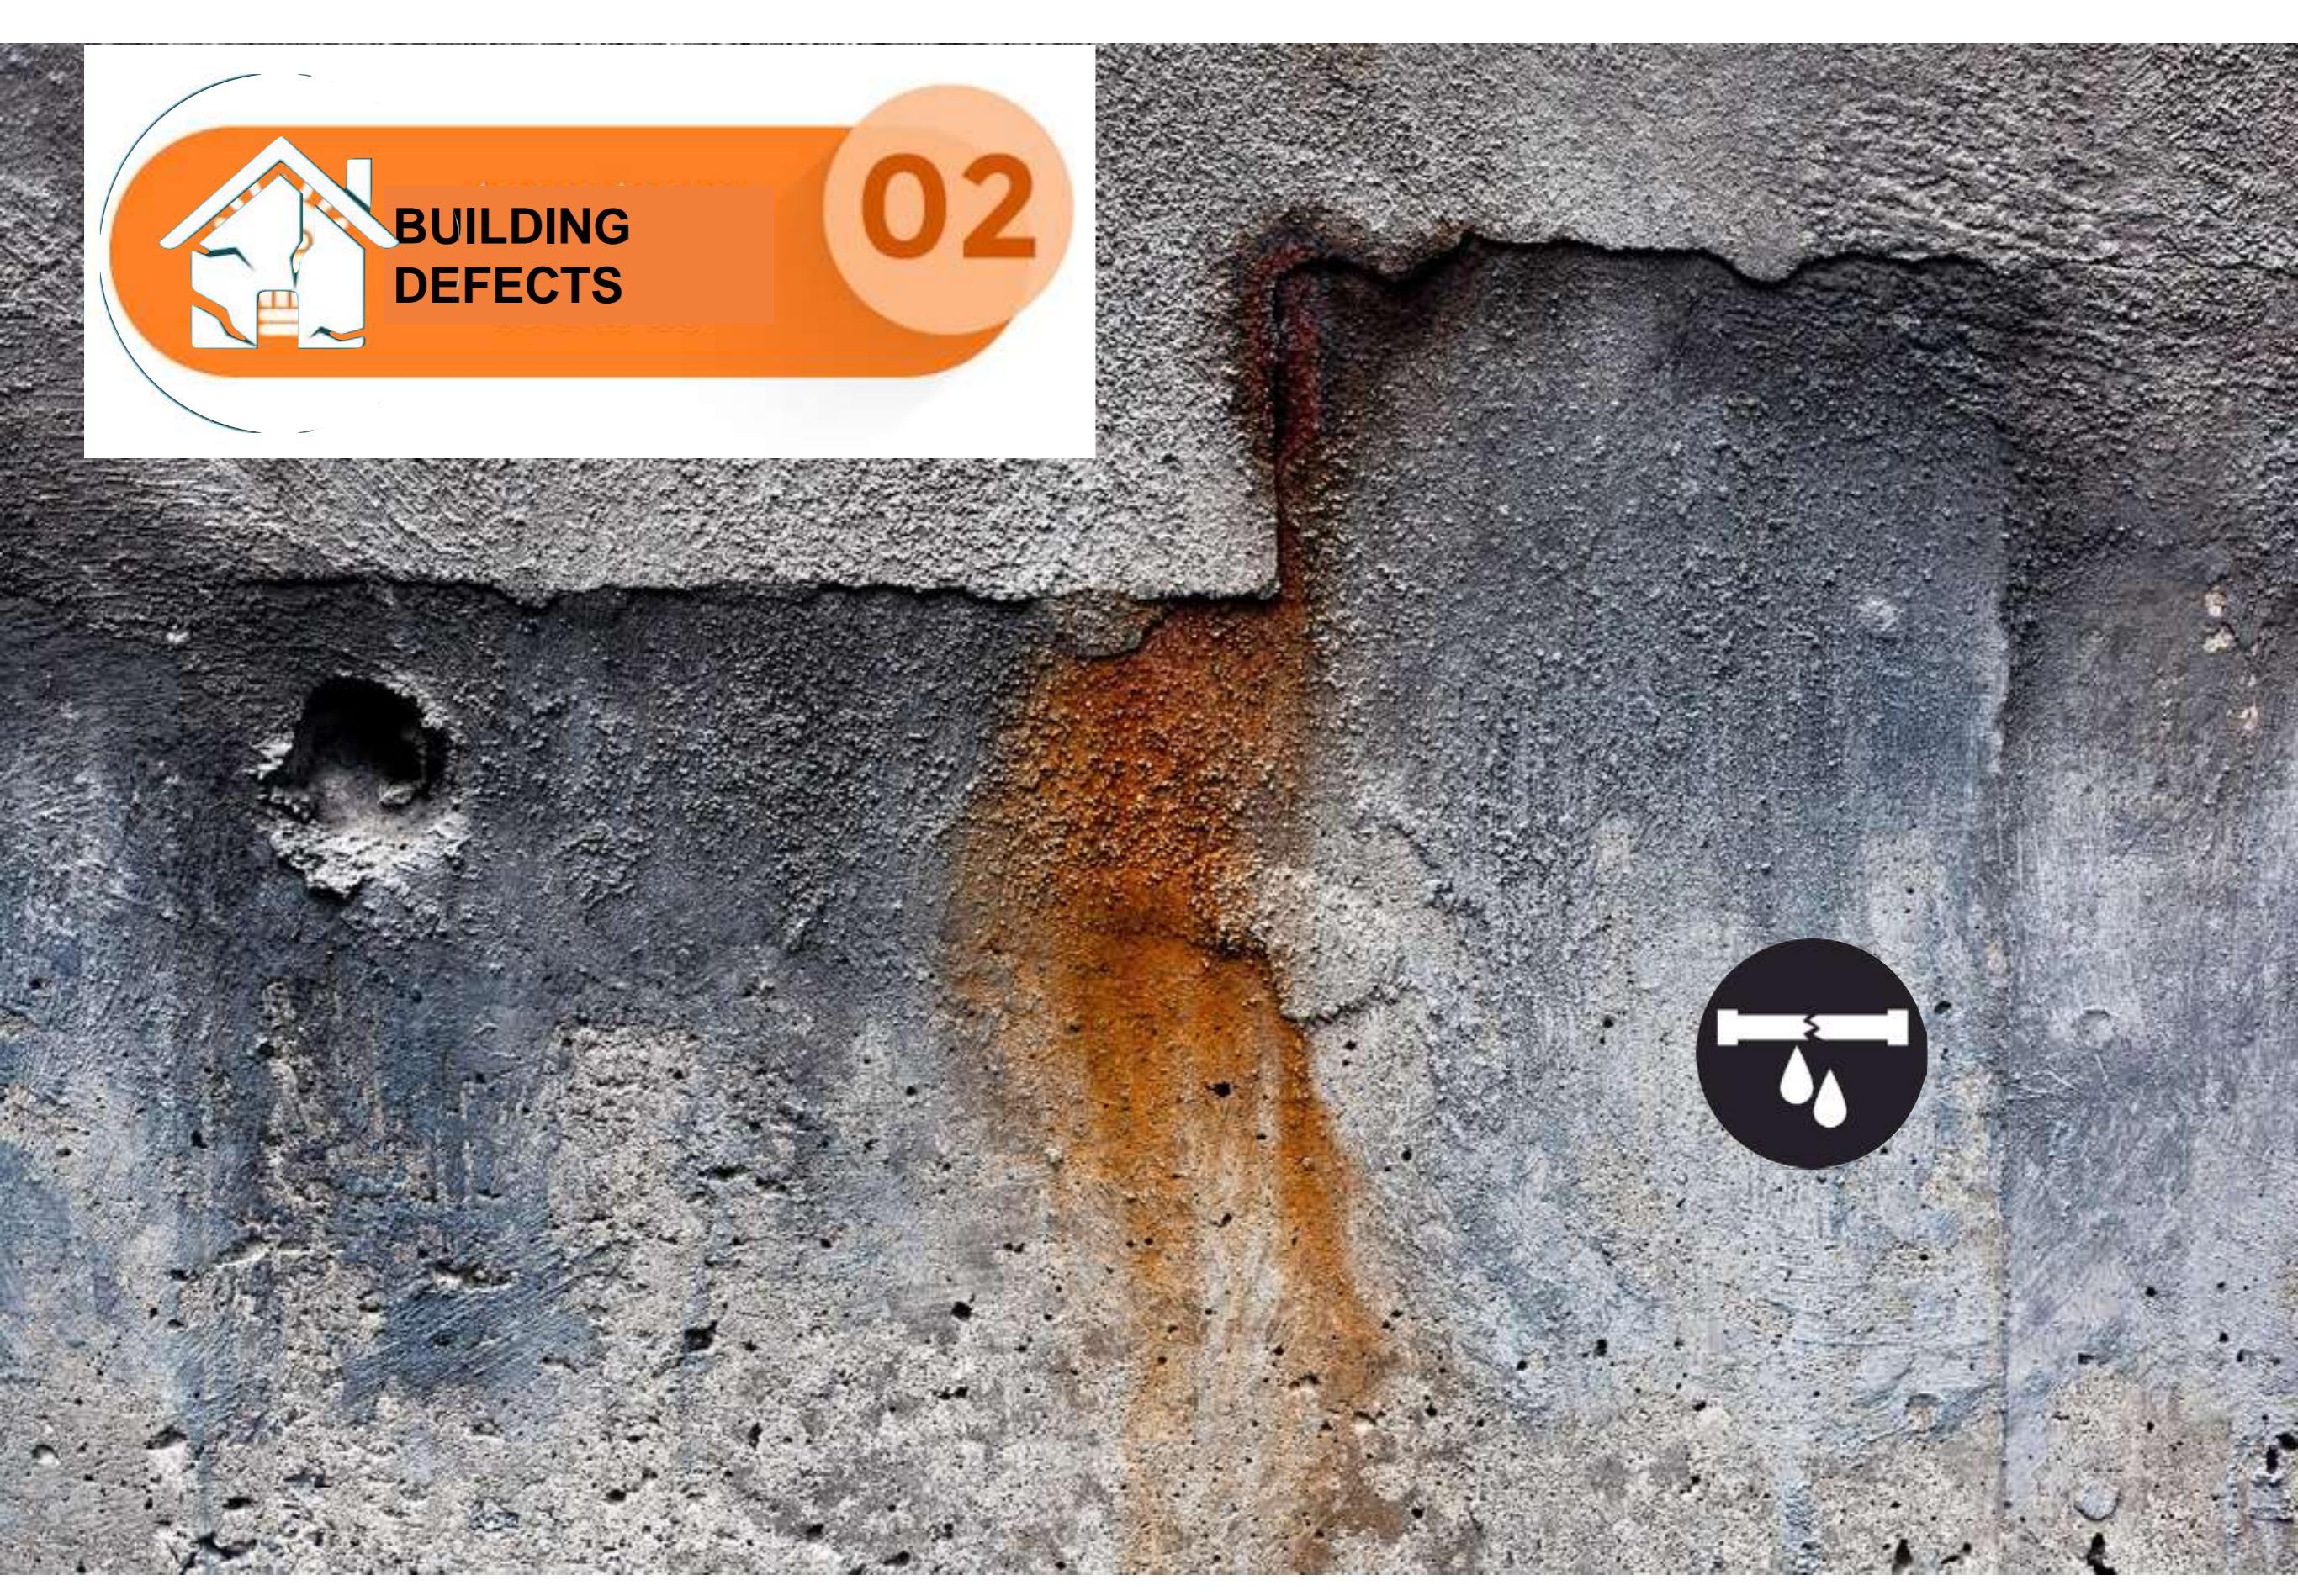
Excess moisture can cause some building materials to corrode and rust.

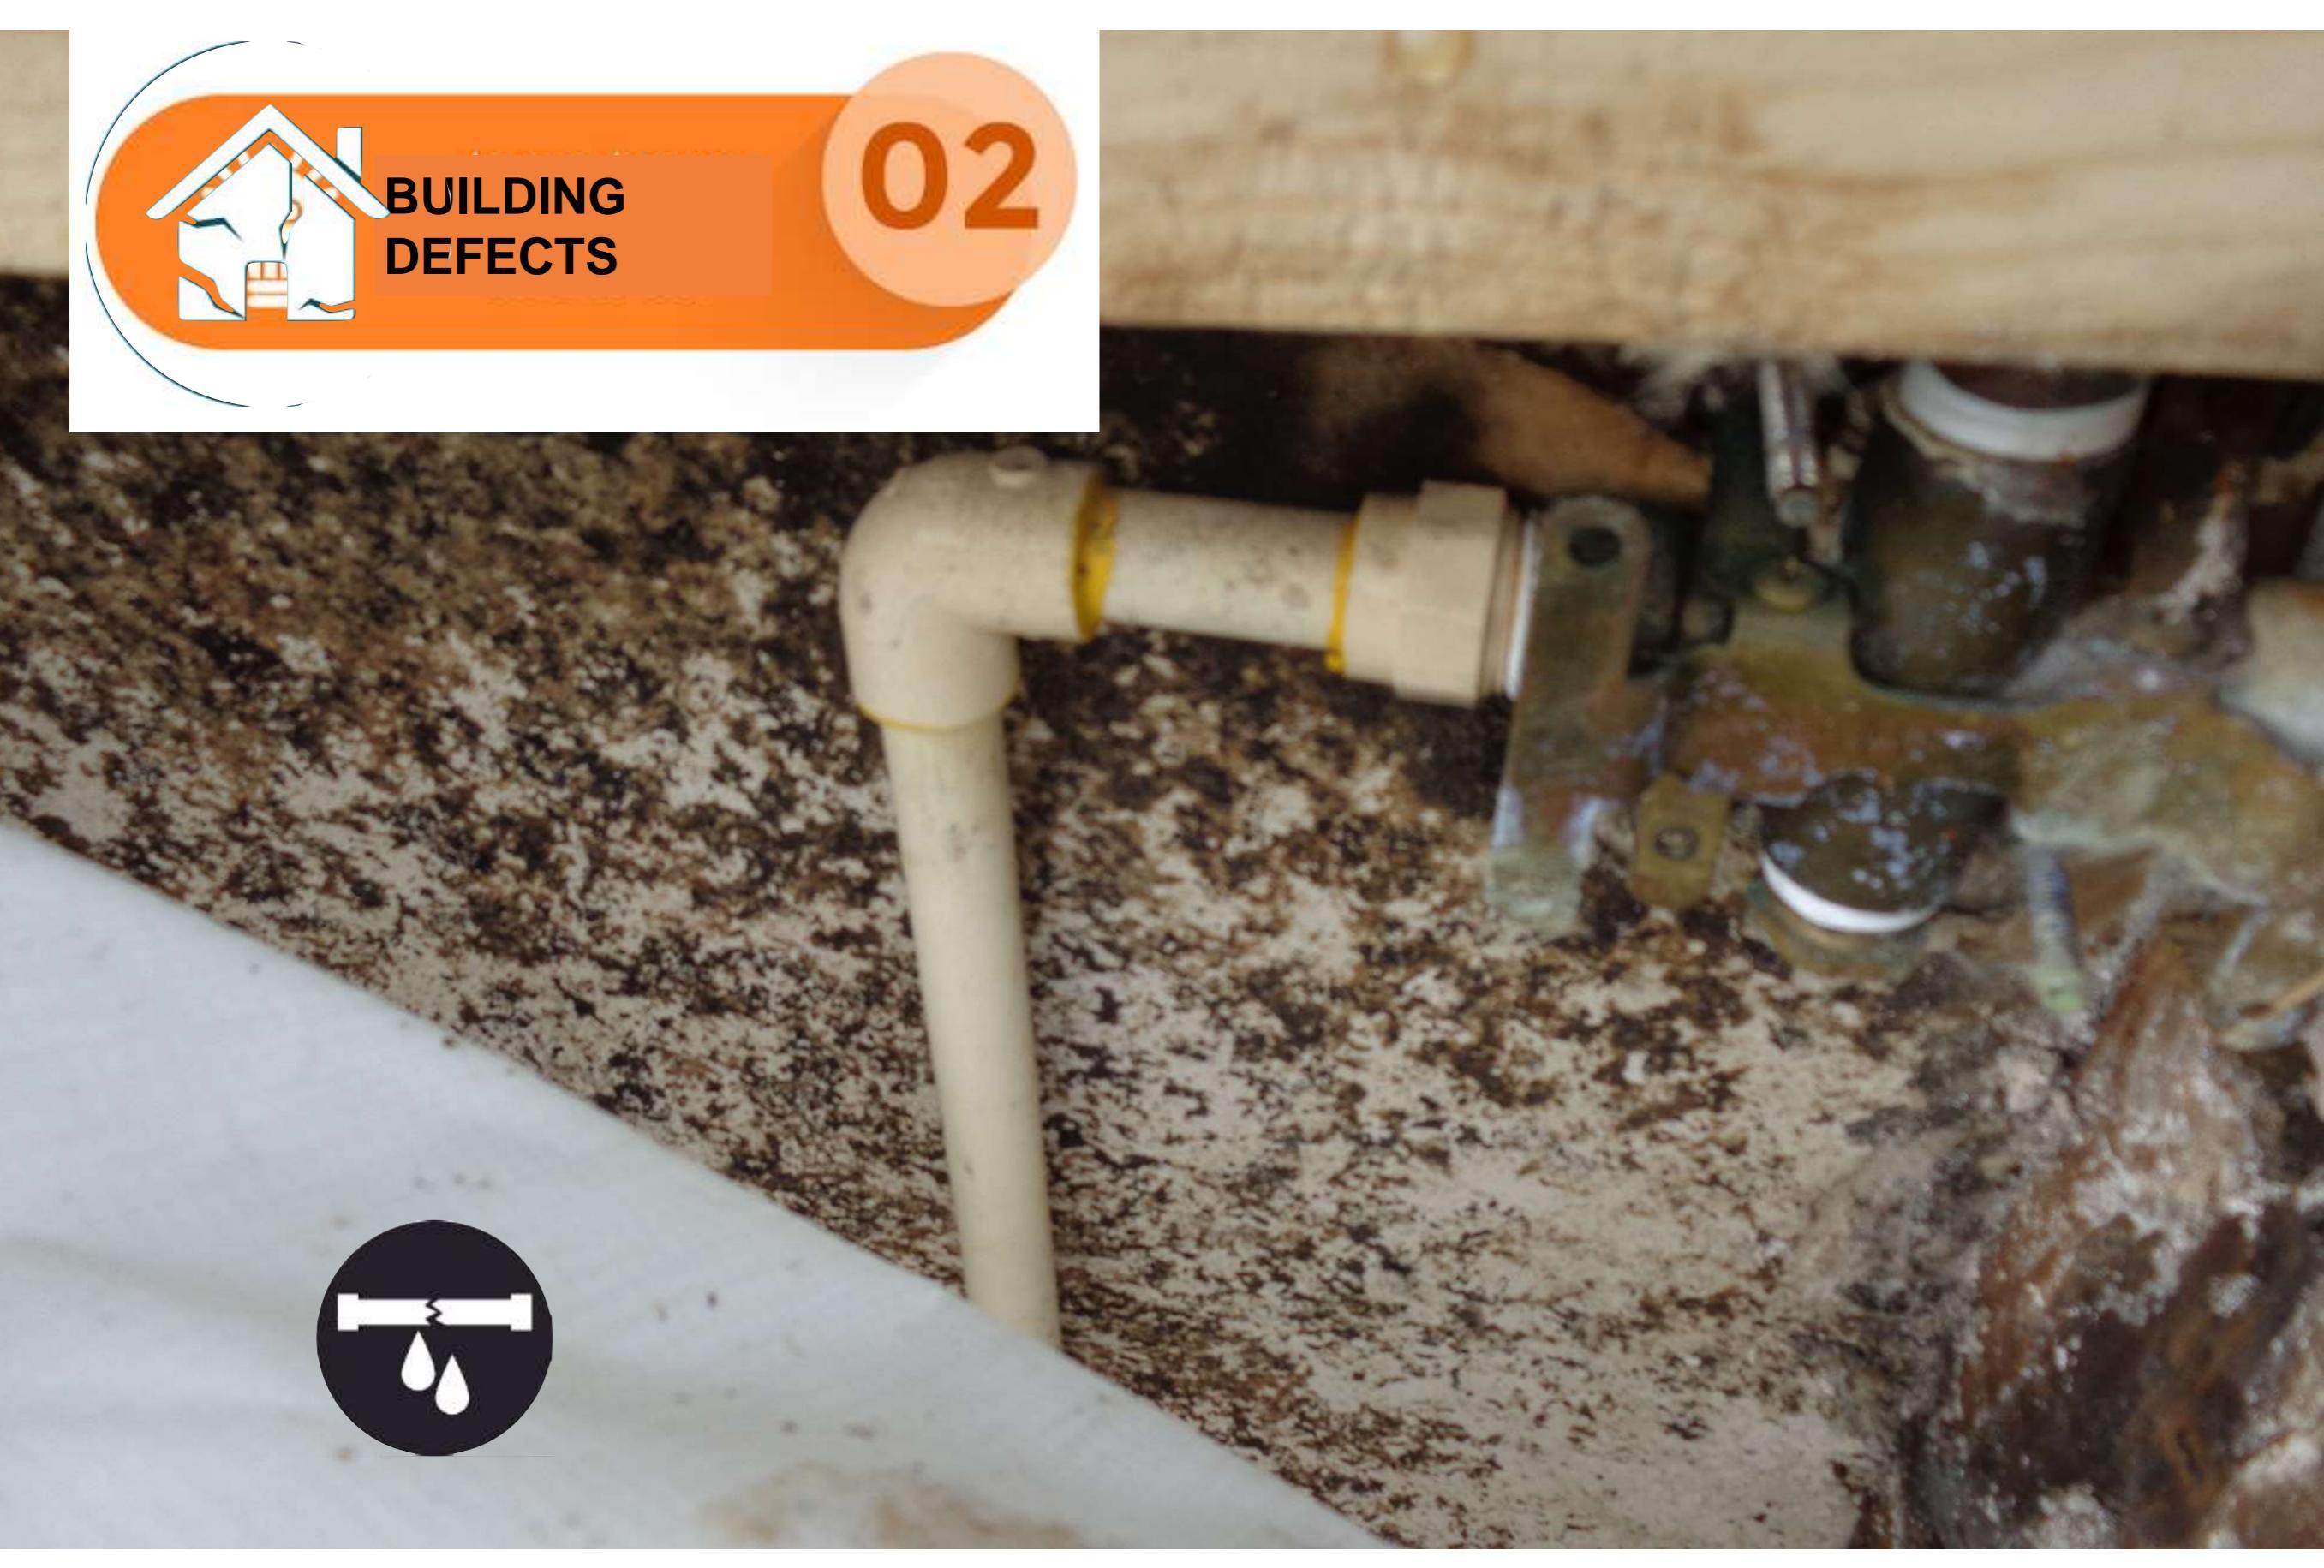
Prolonged water leakage either from mechanical piping system or infiltration of rainwater

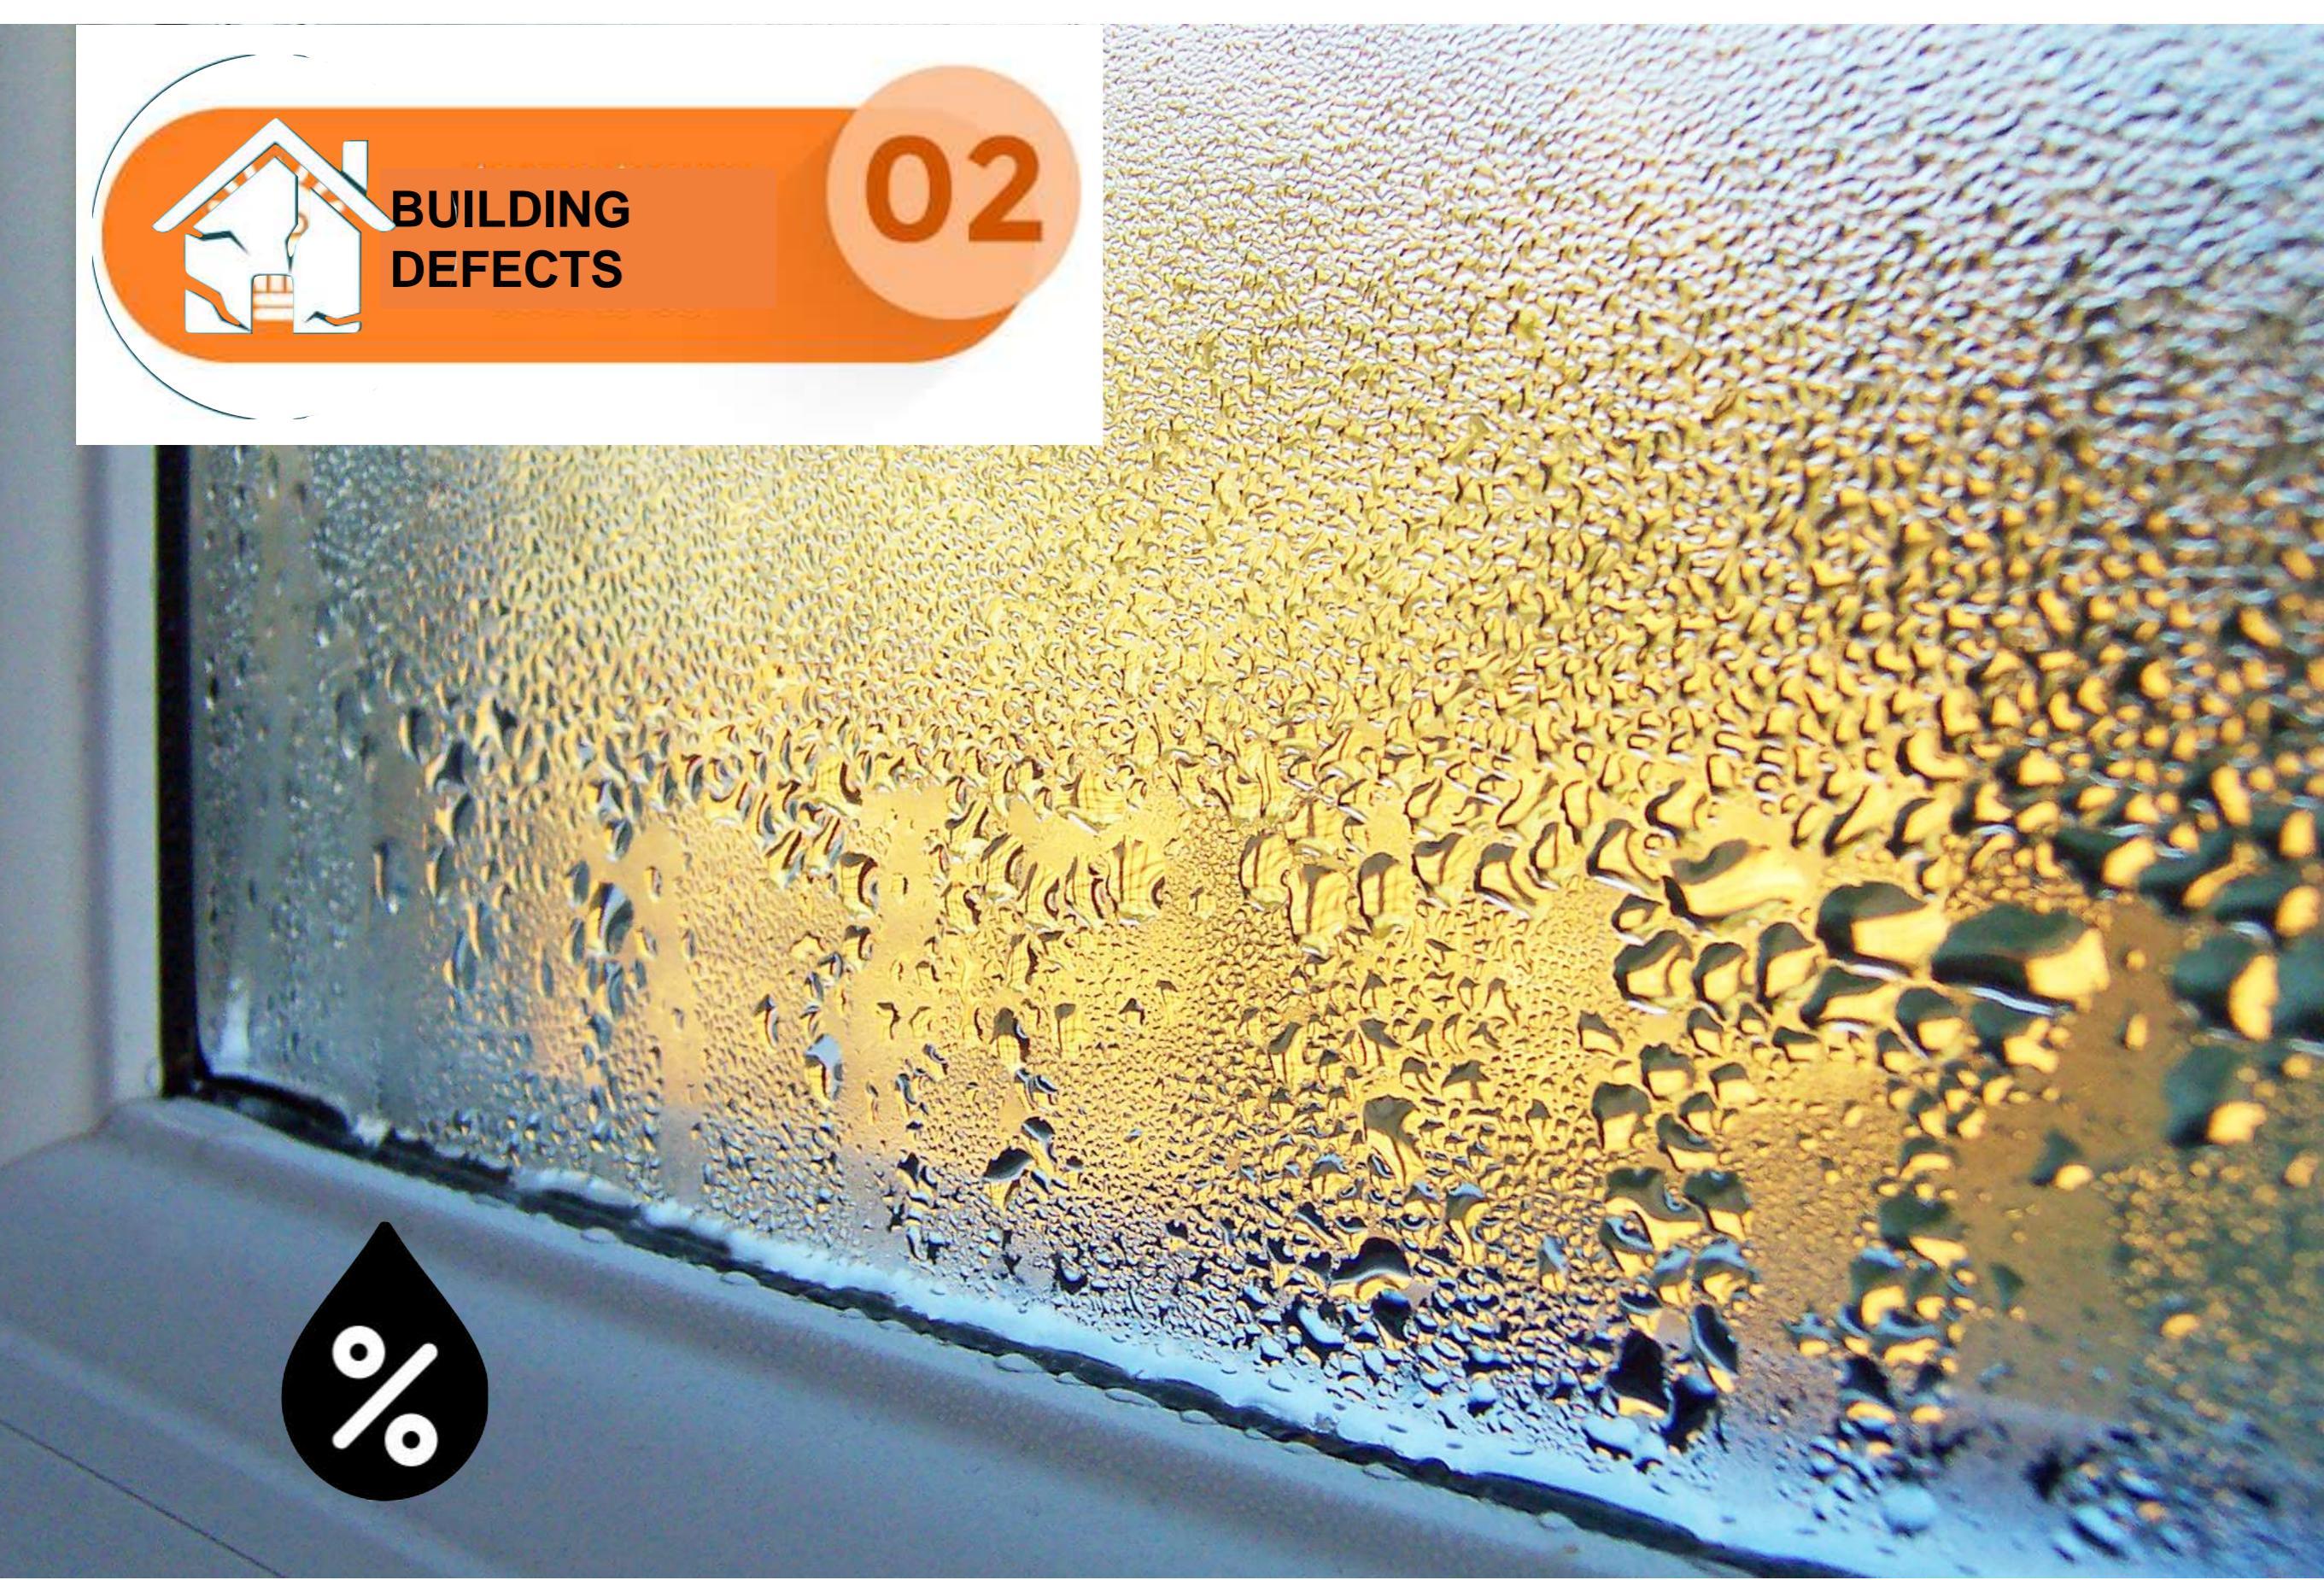
Condensation on windows, walls and surfaces is a sign that humidity levels are too high.

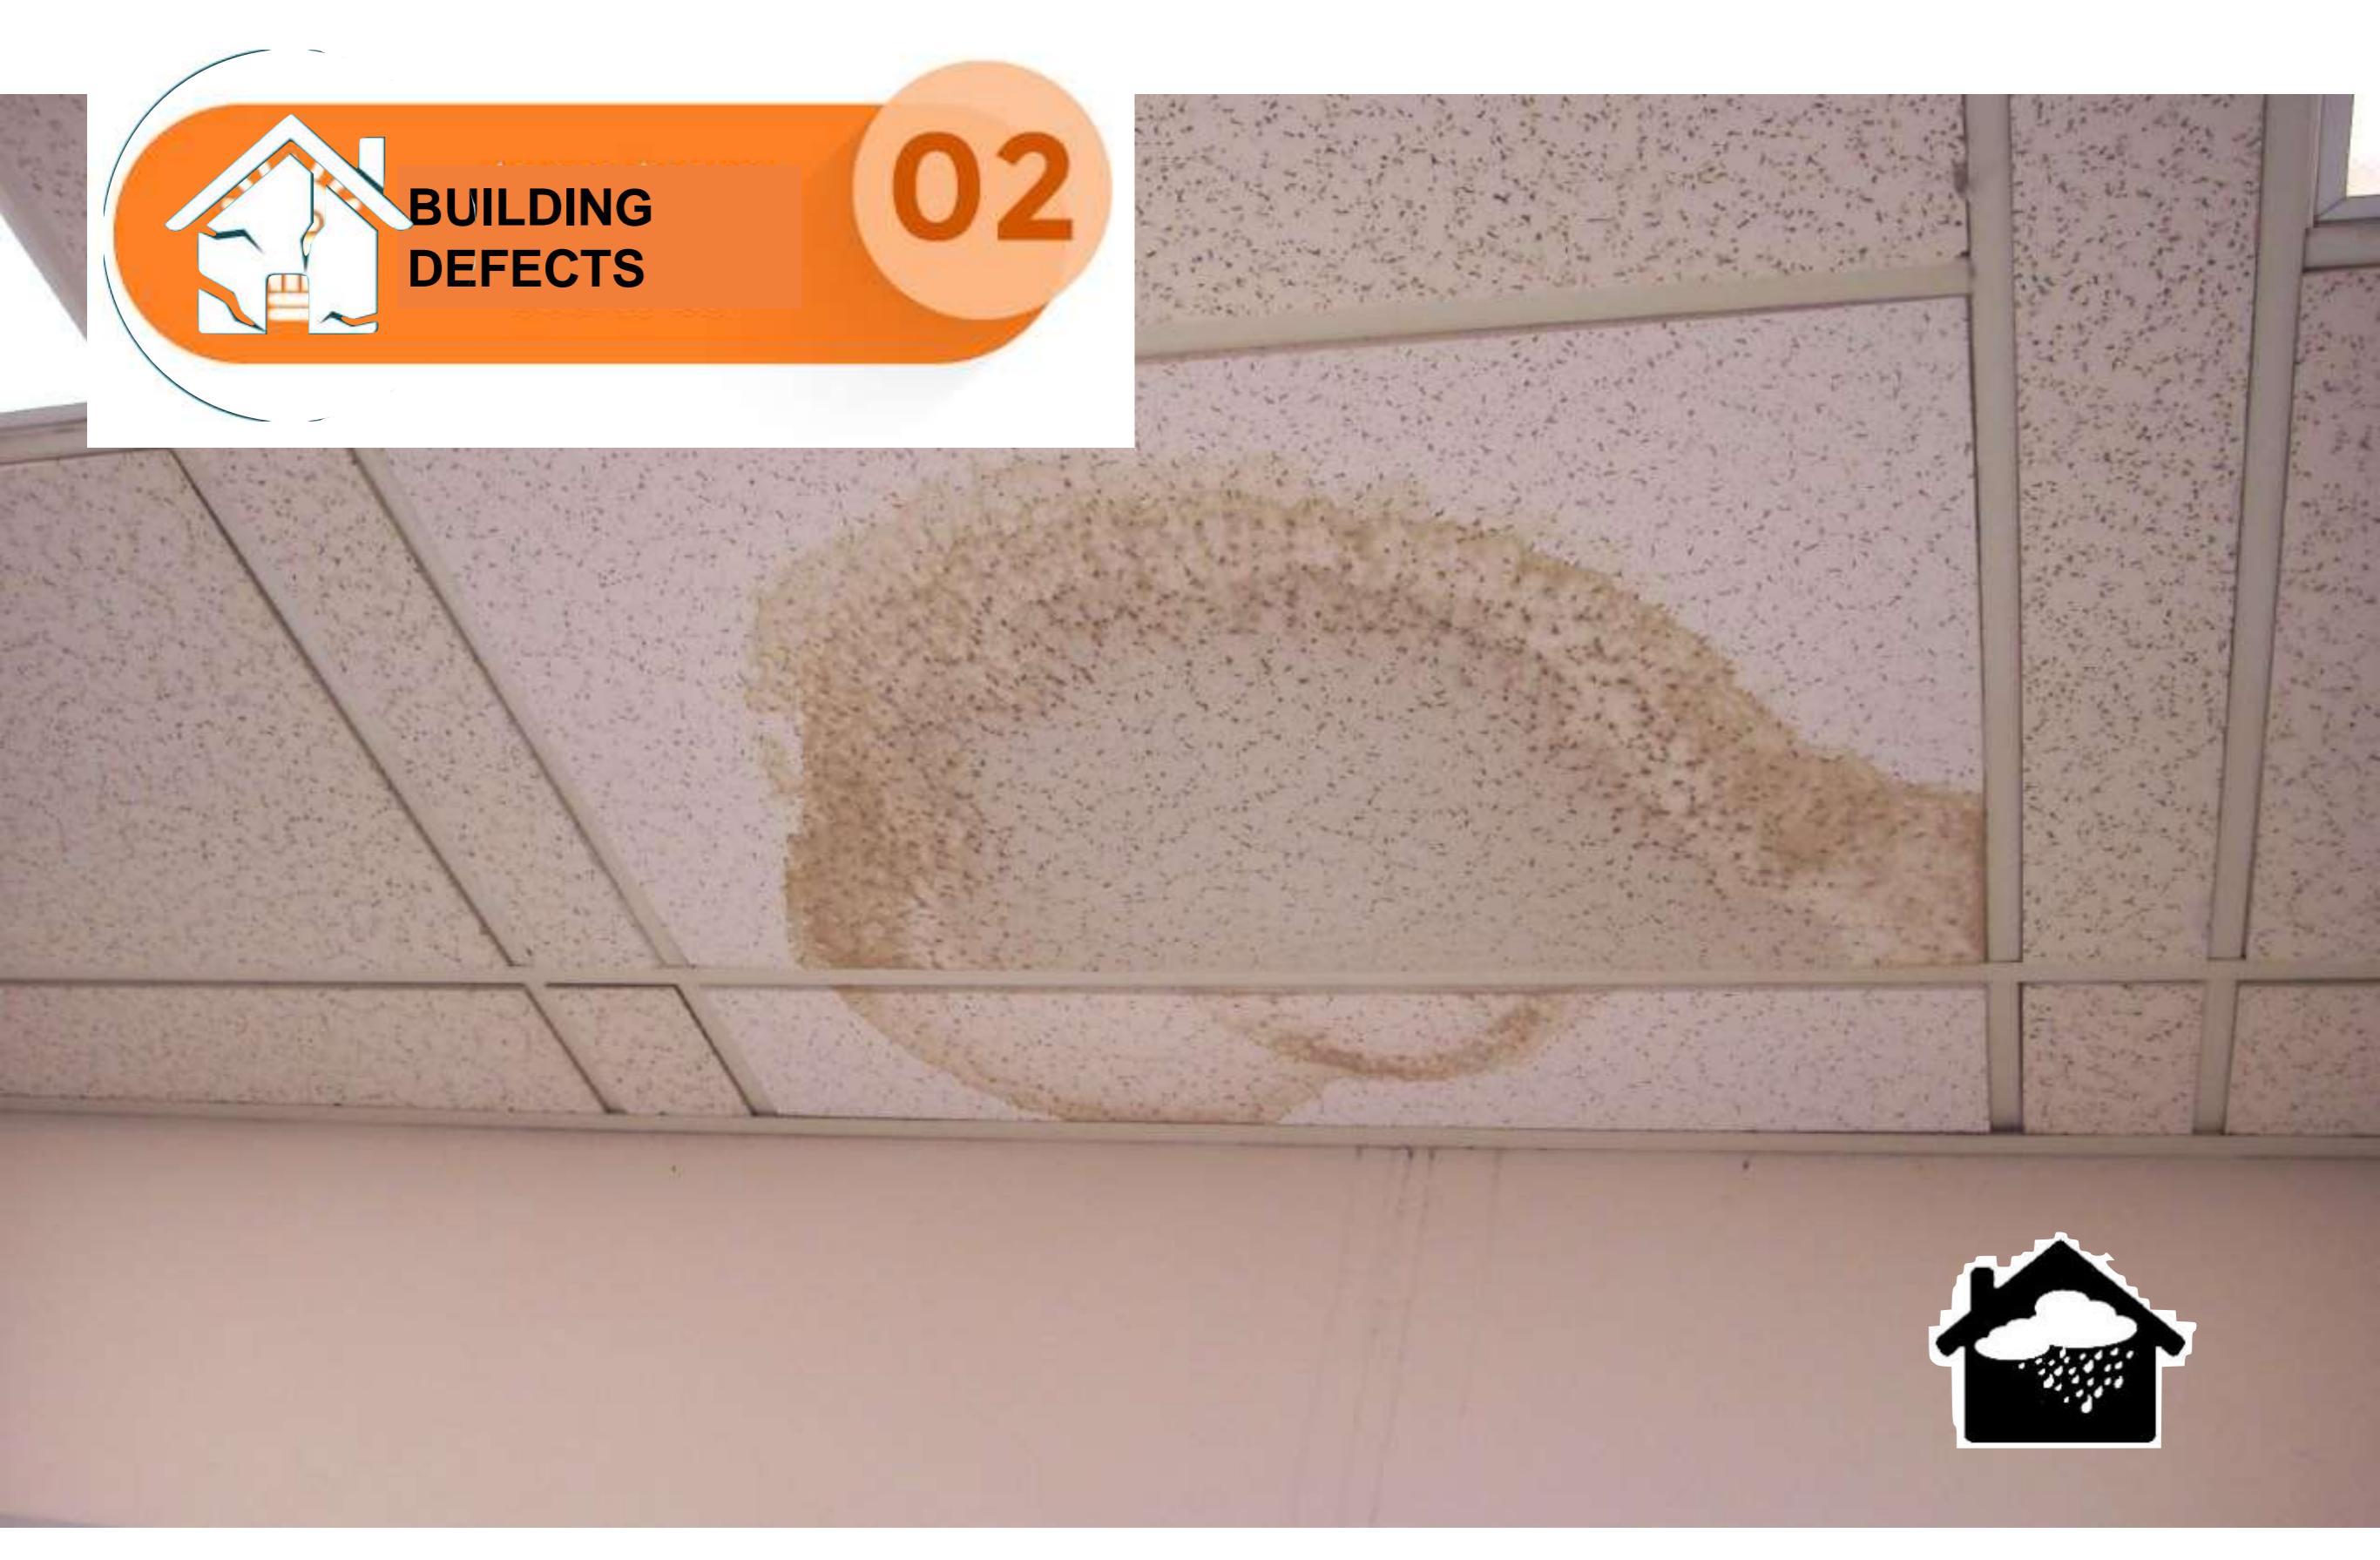
Water stains on ceilings and walls are an obvious sign of moisture problems.

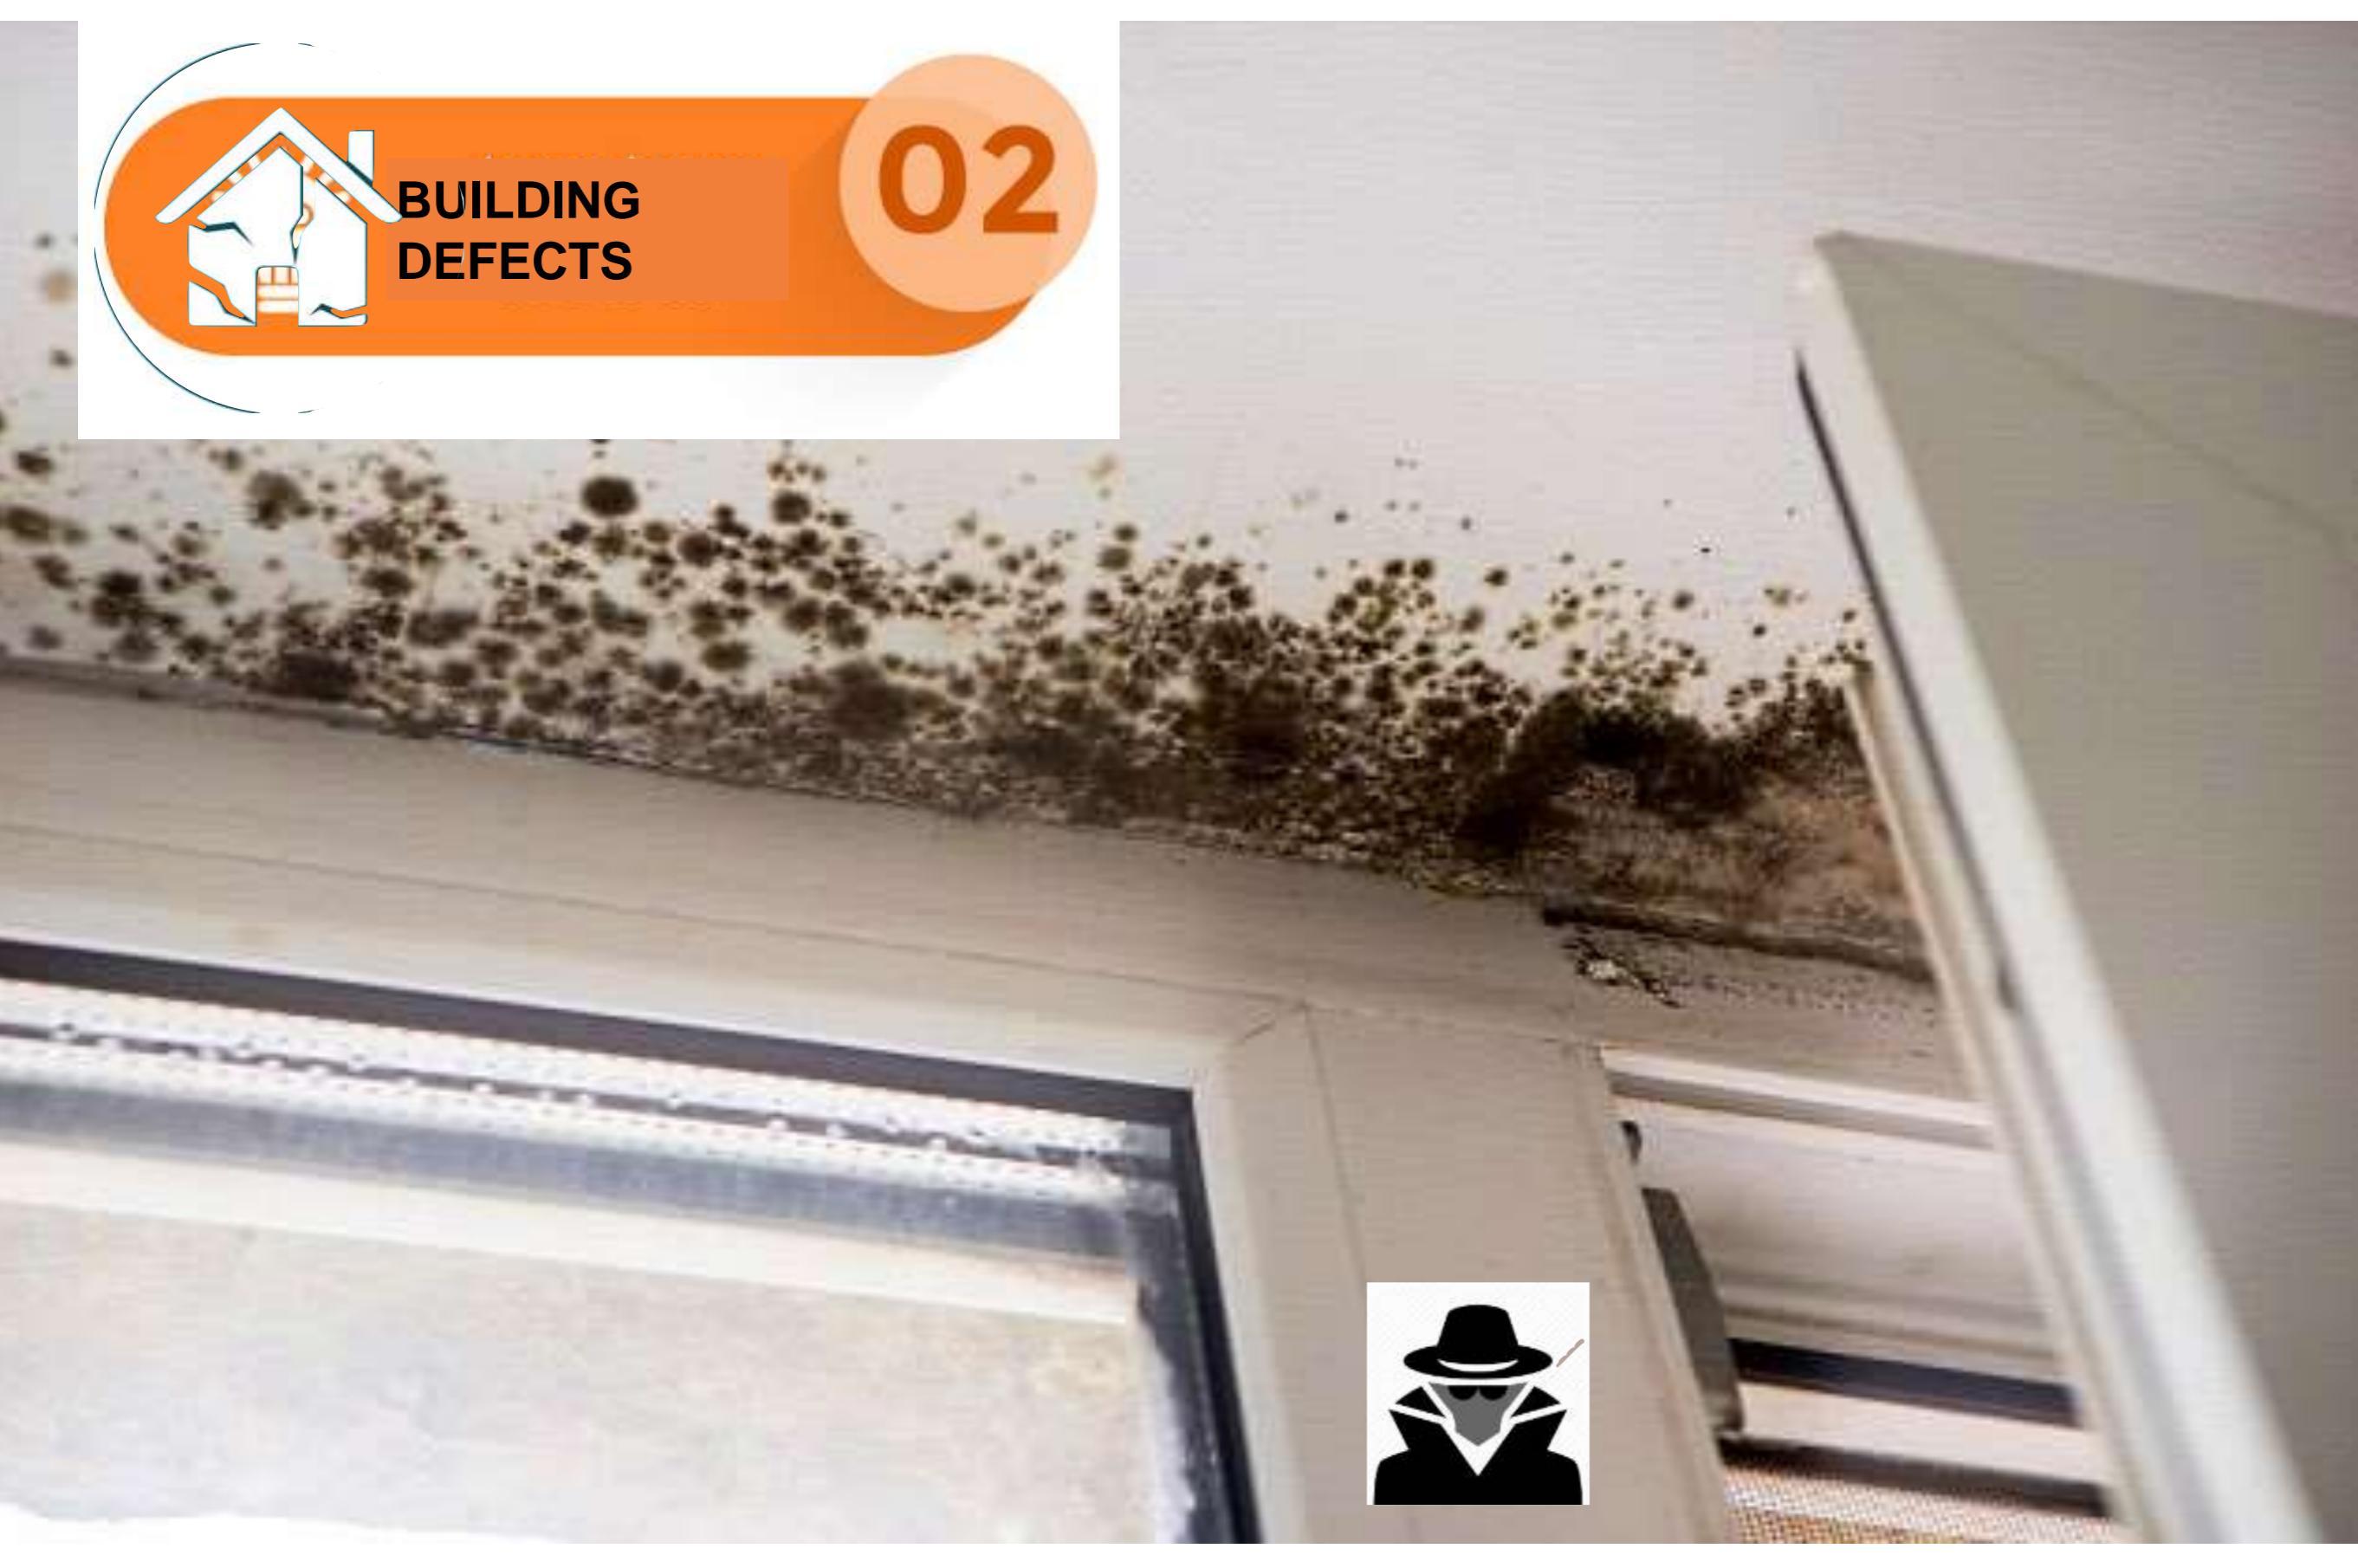
Condensation occurs when warm moist air meets a cold surface, which means it often occurs around windows

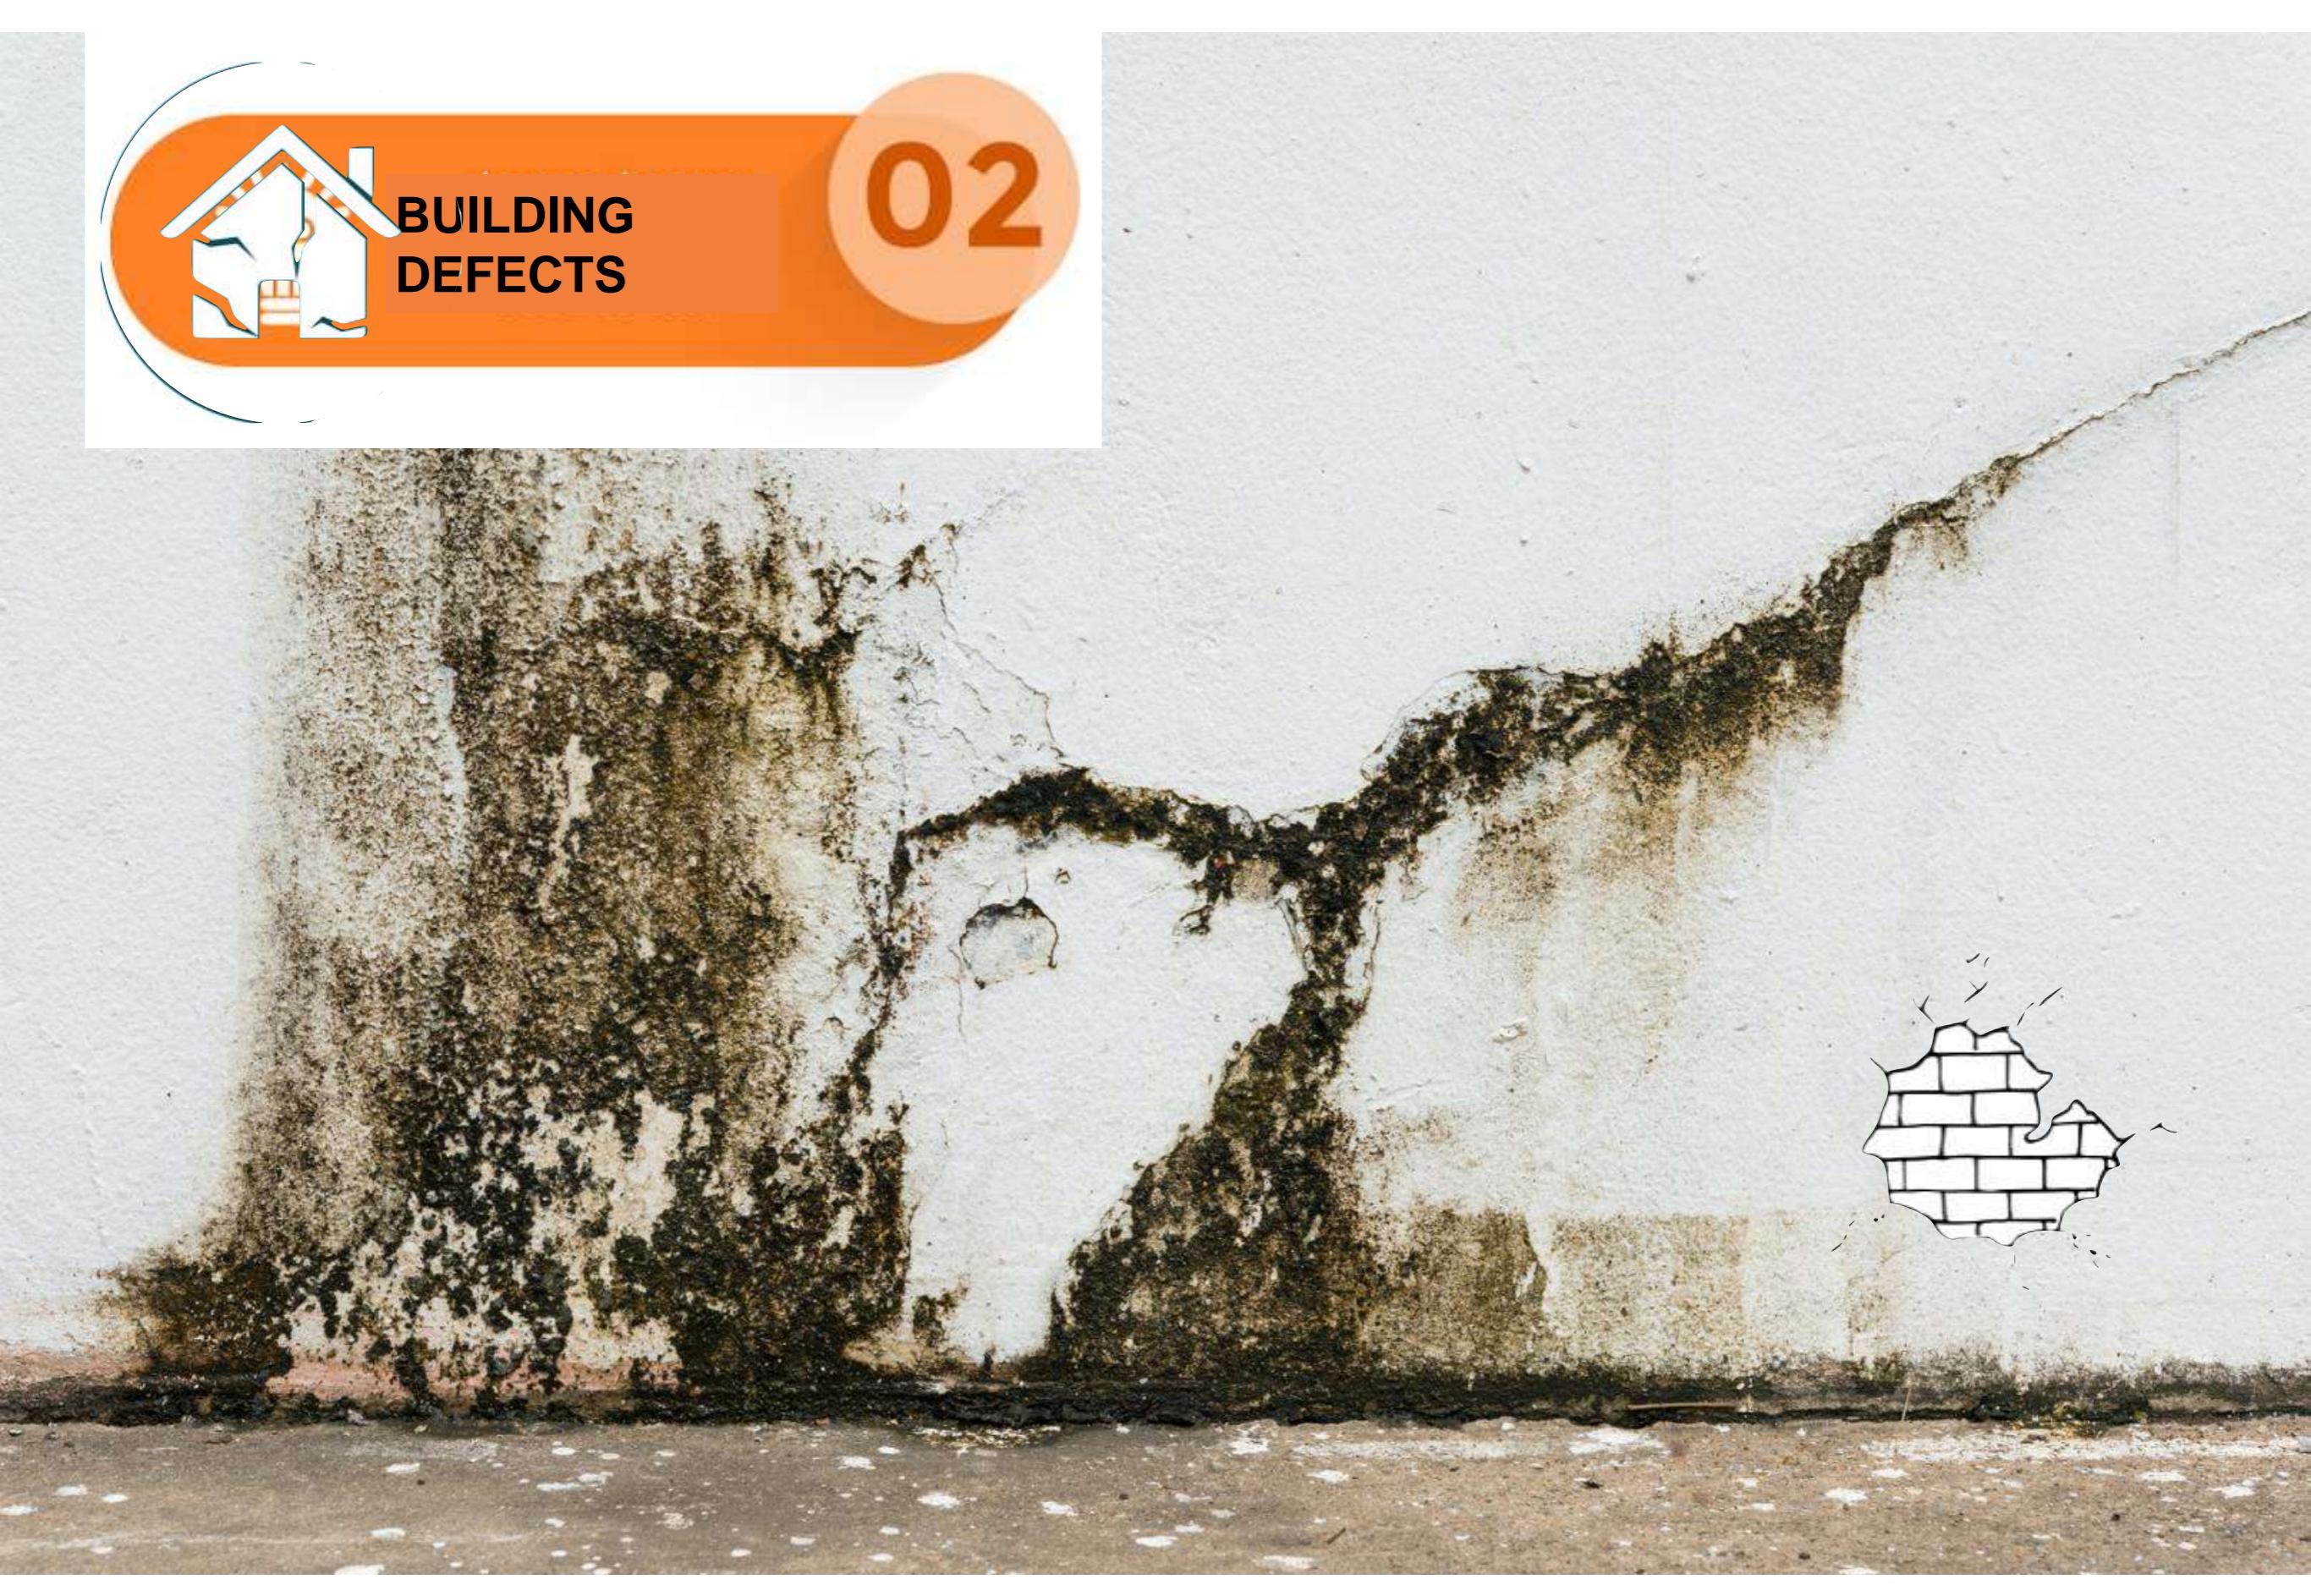
Wall cracks that may cause water seepage and penetration.
