KR'S PROJECTS CASE STUDY OF HEALTH FACILTY PROJECTS

Ar. MOHD. FIRDAUS MOHD. ZAINOL ROHAIMI MANSOR

MOULD GROWTH IN HEALTH FACILITY BUILDINGS

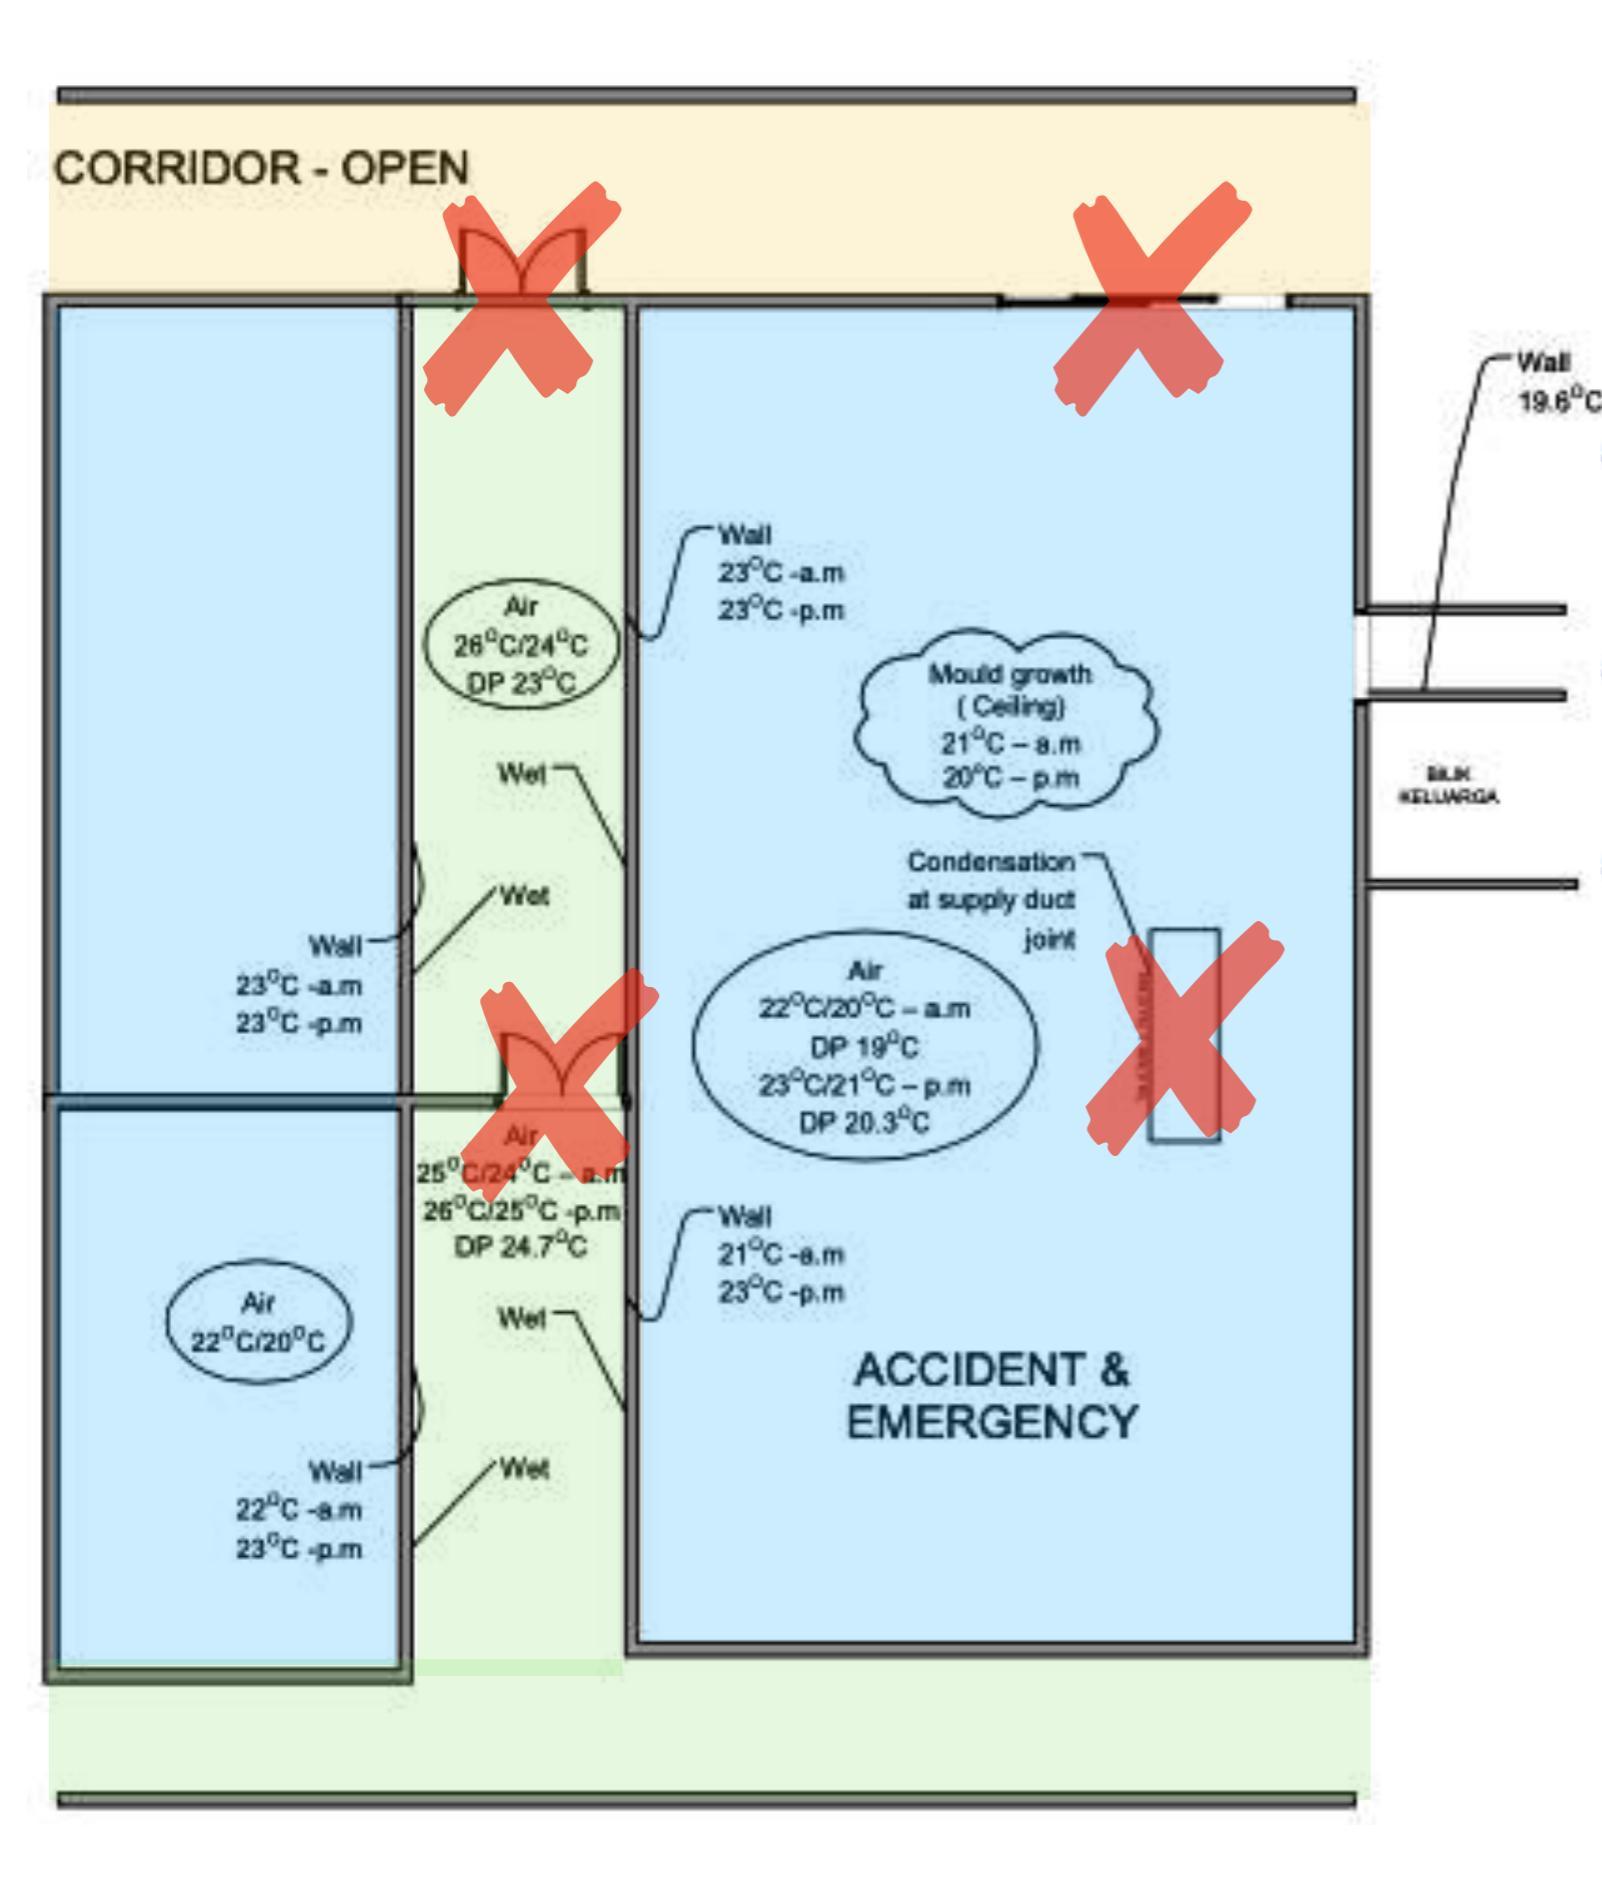
Kondensasi di Accident & Emergency (A&E)

automatic sliding door terbuka terlalu lama sebelum ditutup kembali. Masa untuk menutup kembali melebihi 20 saat setiap kali dibuka

Suhu pada dinding luar didapati berada dibawah dew point udara sekeliling menyebabkan kondensasi pada permukaannya.

kondensasi pada supply air duct connection akibat sambungan yang tidak kemas

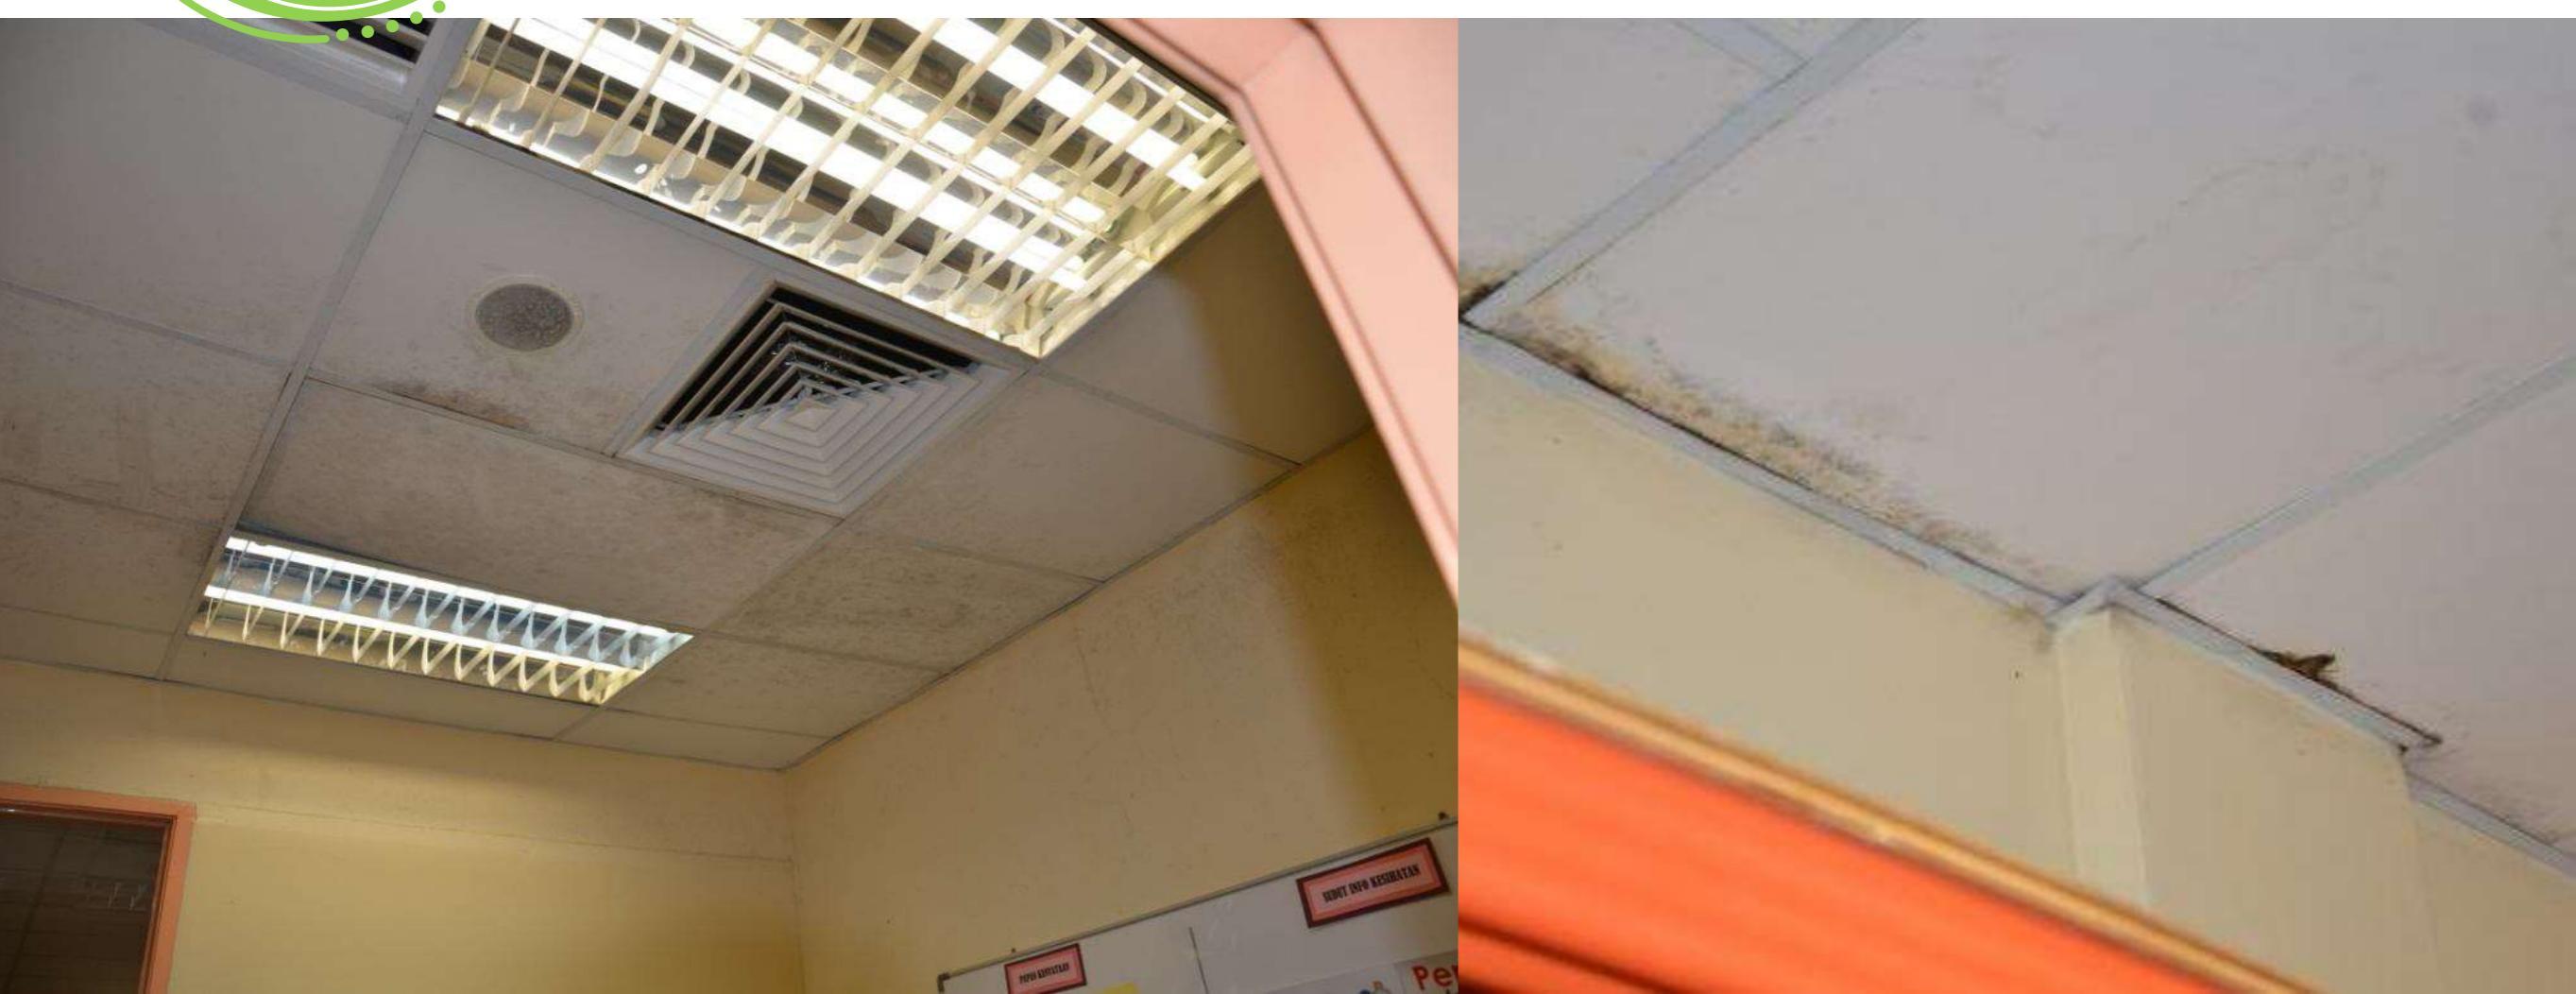
KLINIK KESIHATAN JENIS 3 MERLIMAU, MELAKA

Mould growth on ceiling Due to temperature differences in the room and above the ceiling

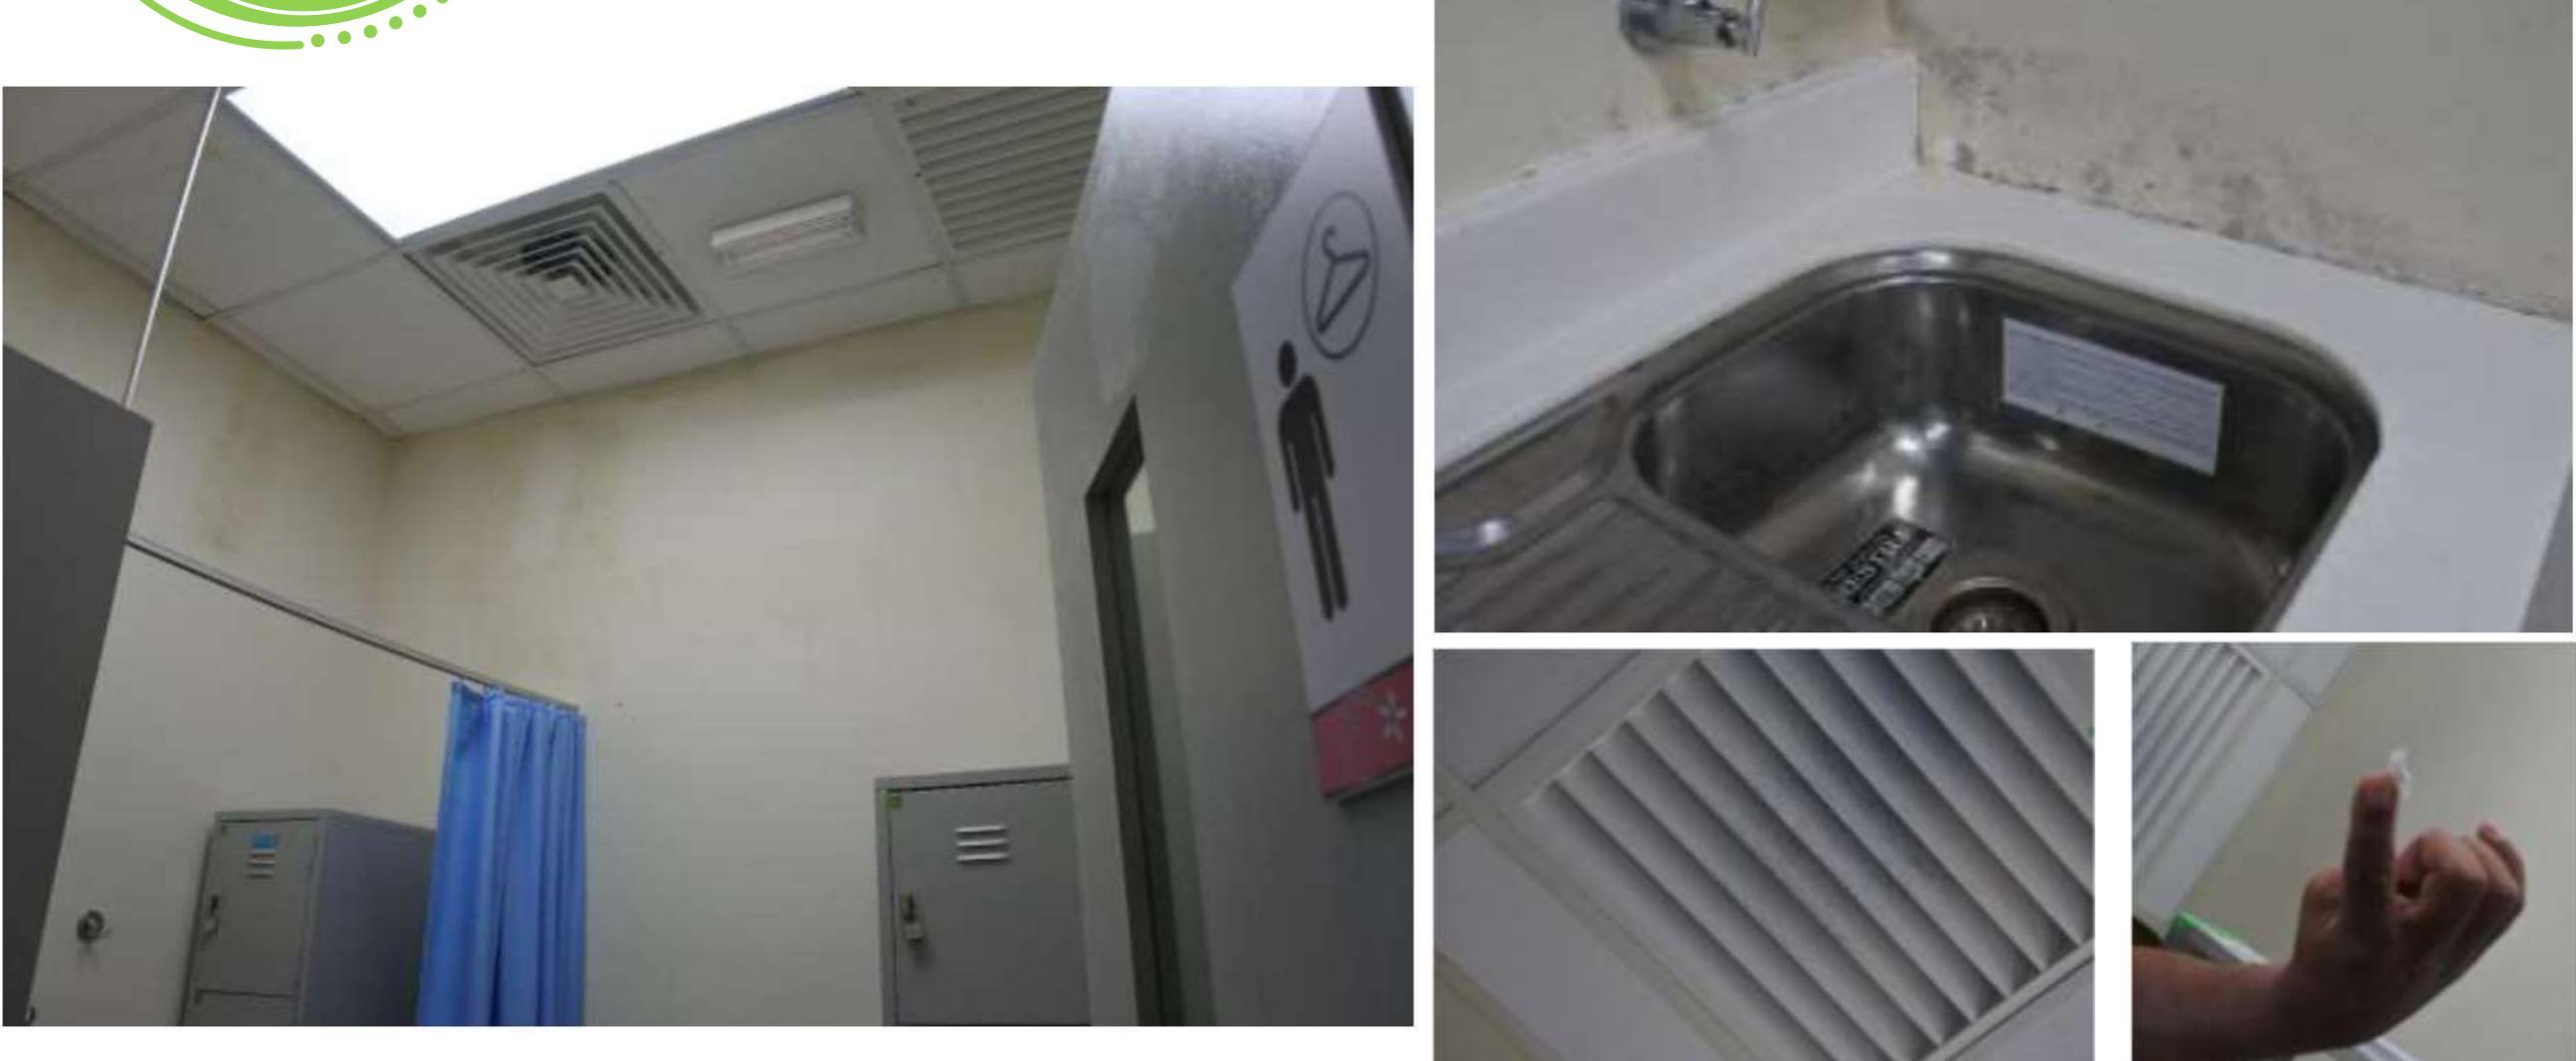
KOMPLEKS OBSTETRIK HOSPITAL TENGKU AMPUAN RAHIMAH, KLANG, SELANGOR DARUL EHSAN – FASA 2

Mould growth on wall

Due to stagnant air, temperature not consistent (condensation), water splash and nutrients for fungus to grow (dust).

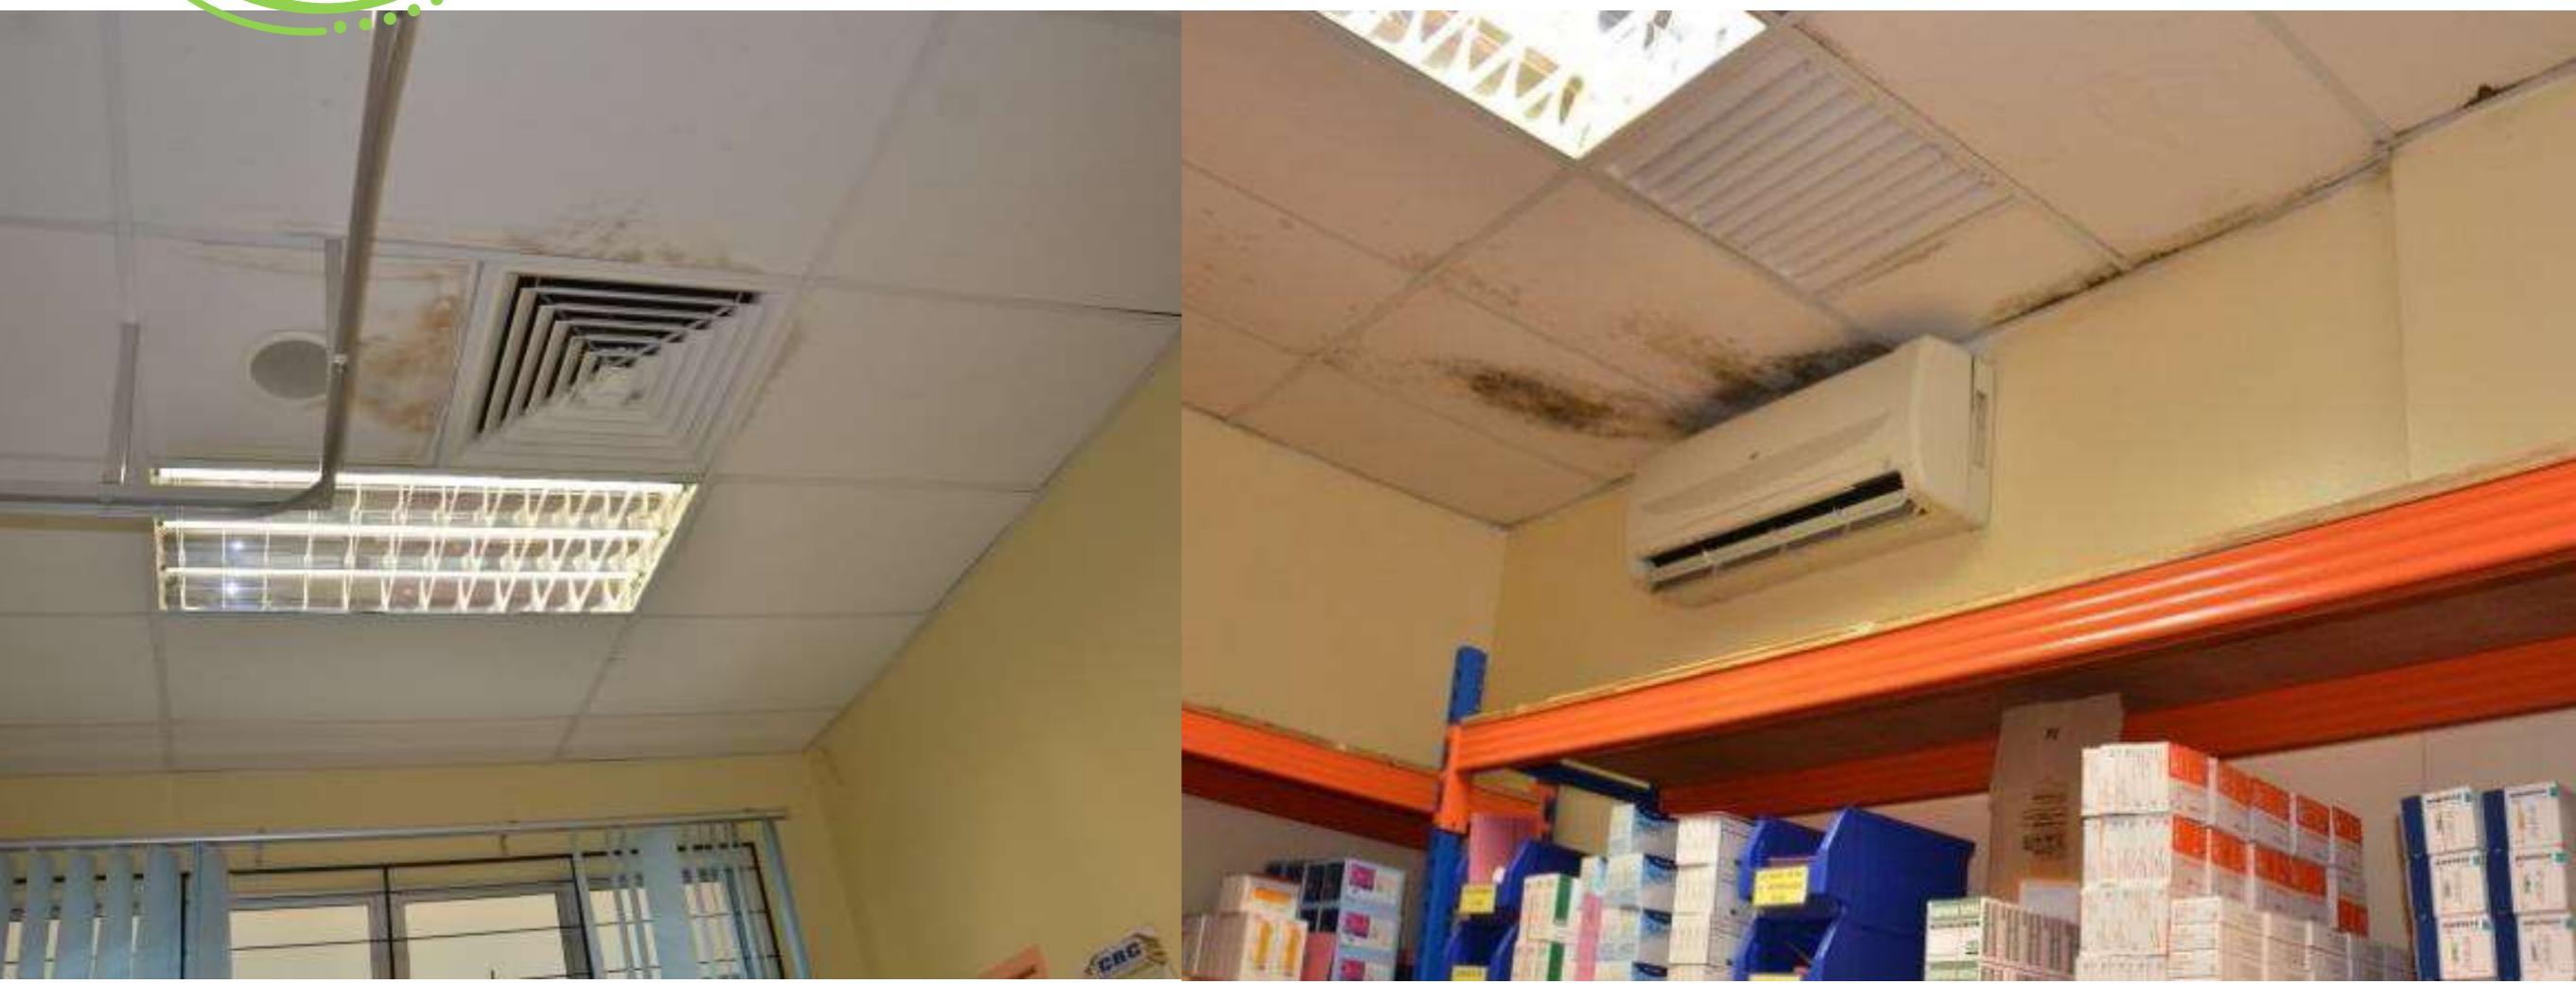
KLINIK KESIHATAN JENIS 3 MERLIMAU, MELAKA

Mould growth on ceiling Due to temperature differences in the room and above the ceiling

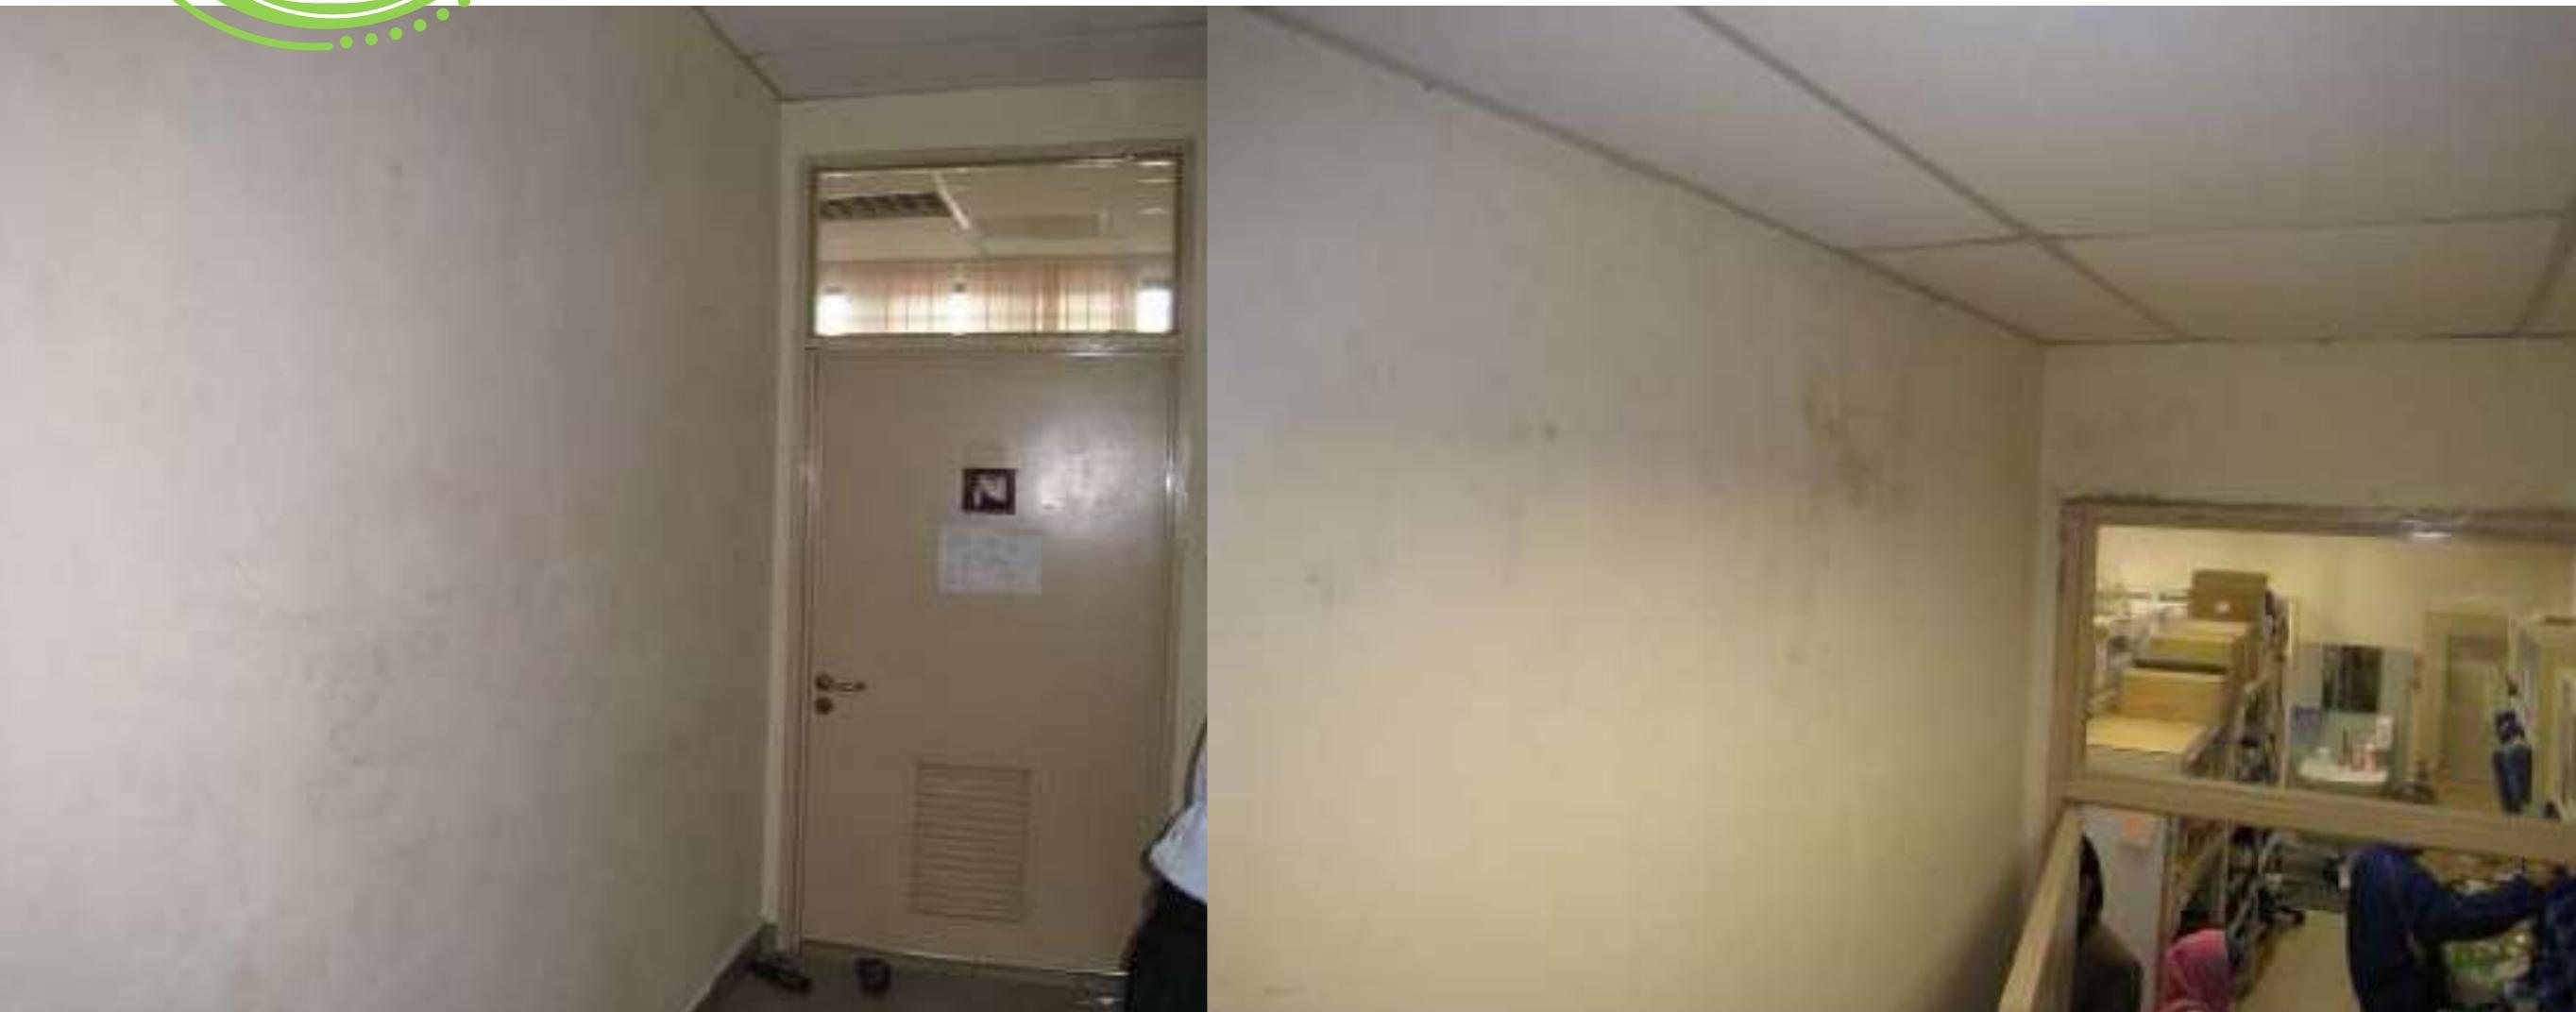
KLINIK KESIHATAN JENIS 3 LUKUT, NEGERI SEMBILAN

Mould growth on wall Due to temperature differences (AC24 hrs. Vs 8 hrs.) in the rooms by using single wall design

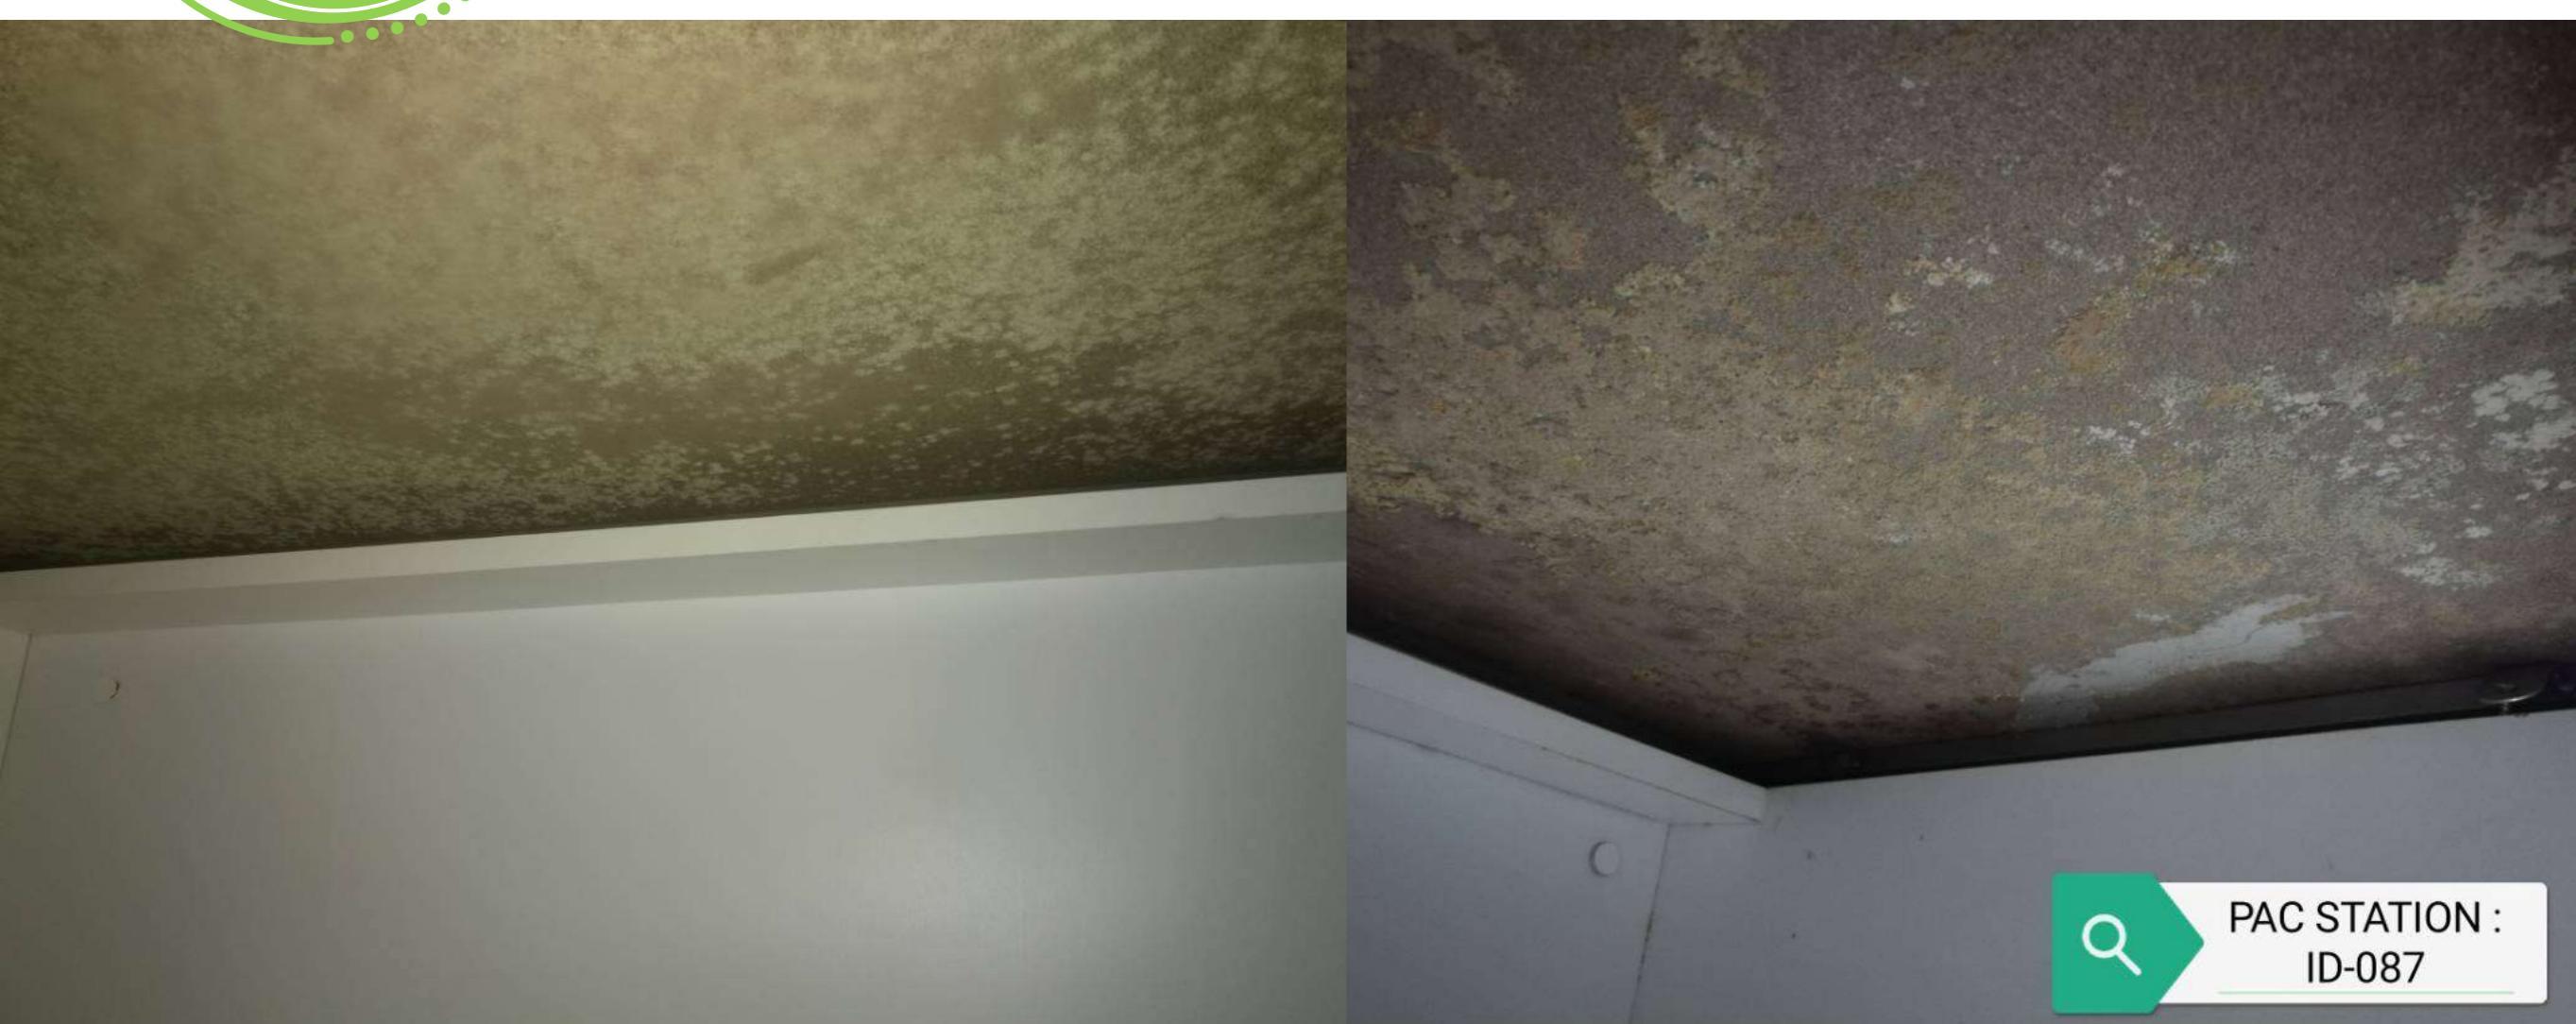
WOMEN & CHILDREN HOSPITAL KUALA LUMPUR

Mould underneath built-in furniture Due to humidity

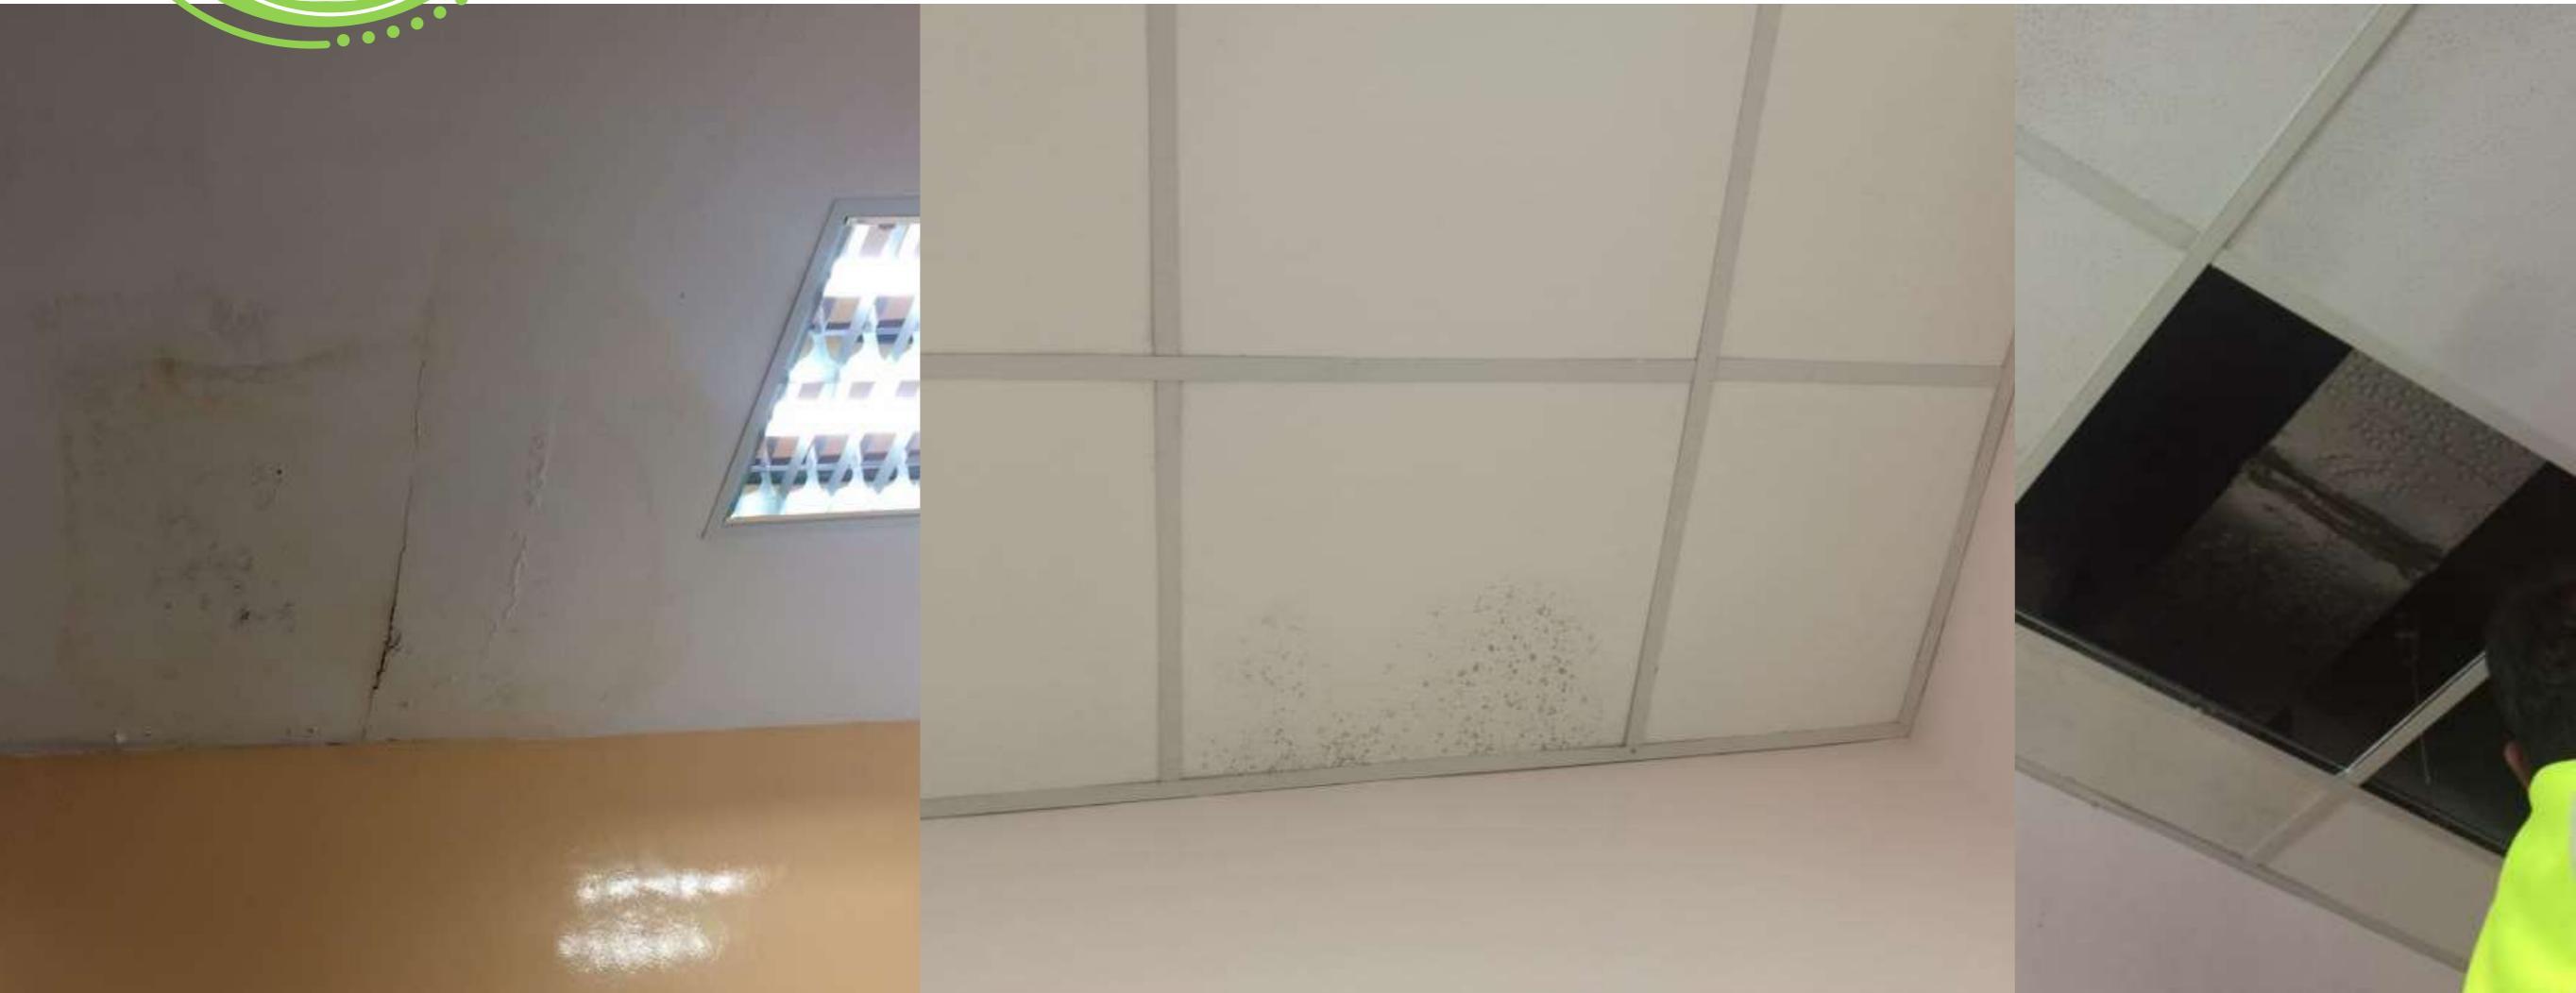
WOMEN & CHILDREN HOSPITAL KUALA LUMPUR

Mould growth on ceiling Due to condensation on the above mechanical ducting
