ACCESS AUDIT IN THE BUILT ENVIRONMENT 2014

WORKSHOP REPORT

Audited Venue: BANGUNAN KKR2

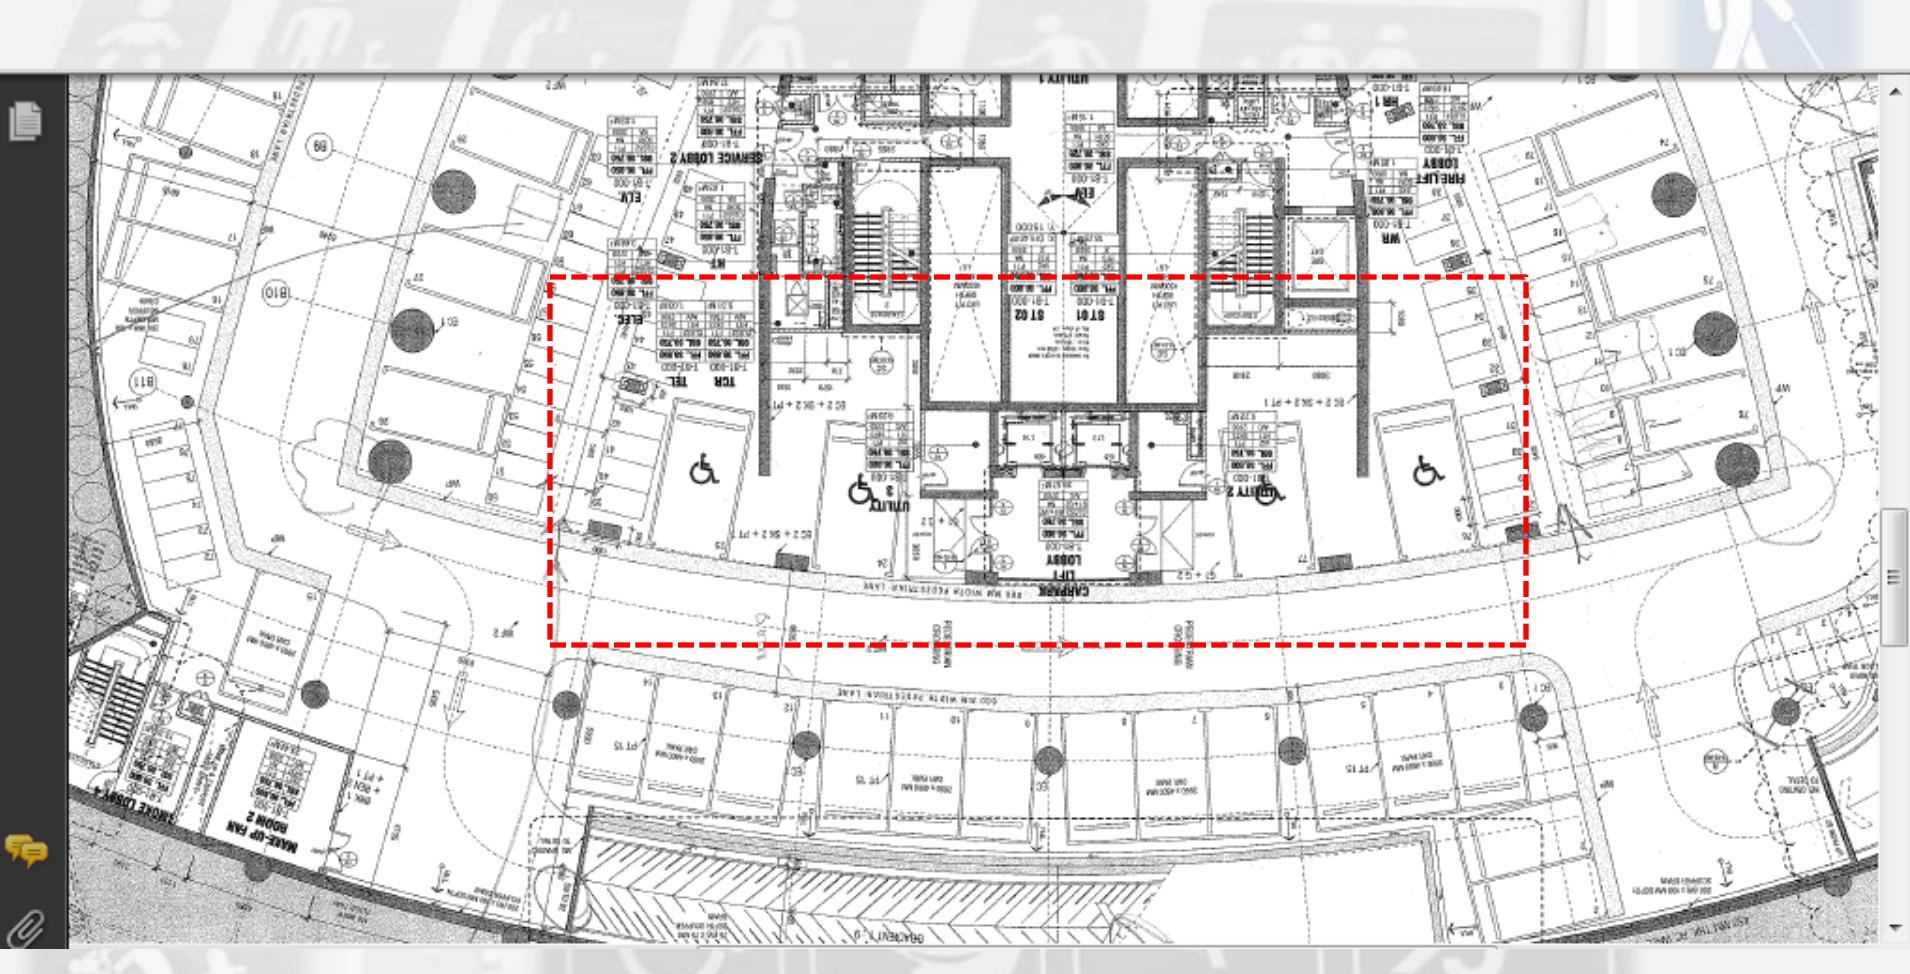
NO	ELEMENT	ANALYSIS	PROPOSAL
1	<image/> <image/> <image/>	1. Gradient more than 1:12, +- 1:14	1. Should provide railing along the ramp at both sides
		2. No railing at both sides	2. To provide landing min. 1200mm in length at interval not more than 6000mm, follow MS1184:2014
		3. No landing, distance too far.	3. At landing should provide warning tactile
		4. No guiding block/warning tactile at both side of ram area	 As part of information/ transition on changes of path usage esp for blind sight user
		5. No curb	5. Should provide signage for guidance.
		6. No signage	braille text. Font size should be bigger for blind sight people.
		7. Grating gap too large

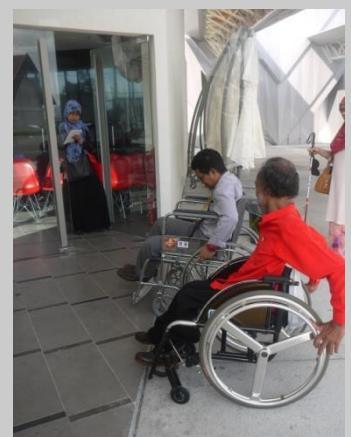
5 CAFETERIA

1. No ramp provided at entrance café.

2. No wash hand basin provided for wheelchair users.

3. The design for dining table is practical for wheelchair users.

- 1. Should provide ramp.
- 2. Should provide wash hand basin for wheelchair user.

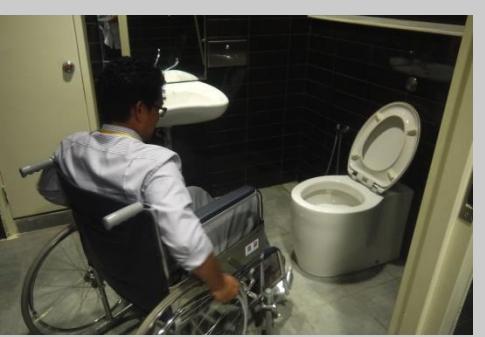
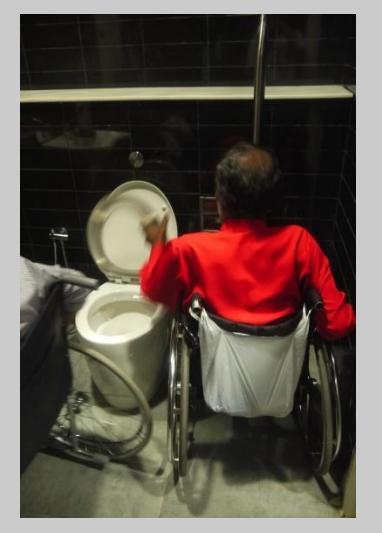
NO ELEMENT 1 ACCESSIBLE TOILETS -(PwDs)

1. Accessible toilets are provided.

- 2. No directional signage to the **accessible toilets**. Hard to find it from the main lobby. Position of signage is not at appropriate location.
- 3. Sufficient space to maneuver a wheelchair.
- 4. The dimension of the toilet is sufficient.
- 5. WC and bidet mounted too high at 600m.
- 5. Wash basin mounted at appropriate height.
- 6. Lower edge of the mirror positioned correctly.

- 1. Should provide more directional signage, big fonts, contras color, appropriate location. Pictogram with emboss signage type and braille text. Font size should be bigger for blind sight people.
- 2. Clear maneuvering space in front of the toilet should be minimum 900mm x 900mm.
- 3. The min dimensions for an accessible toilet are 1700mm width x 2200 mm depth.
- 4. Should be mounted at 450-500 mm height.
- 5. Should be mounted at 800-850 mm.

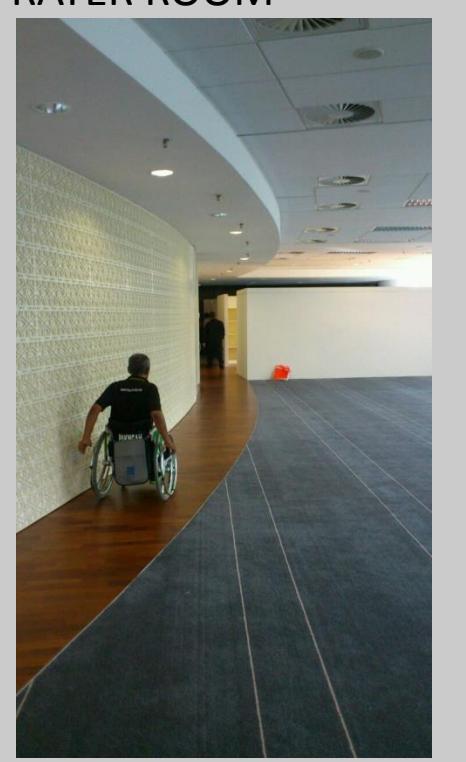
1 PRAYER ROOM

- 1. Entrance to the prayer room is accessible.
- 2. Door sizes is acceptable but too heavy.
- 3. Seating is provided at the entrance.
- 4. No space allocated for the wheelchair bound.
- 5. No railing, hook and no seating provided at the ablution area.
- 6. Ablution space is well drained.
- 7. Slippery finishes at ablution area.

- 1. Should provide lighter doors, easier to handle by OKU.
- Curb or step at the ablution is dangerous .
- Should provide railing at walls, hook and seating.
- Should use unslippery floor material and skid proof
