Private & Confidential Prepared by Kumpulan **IKRAM** Sdn Bhd

Final Report – Volume I Executive Summary Report

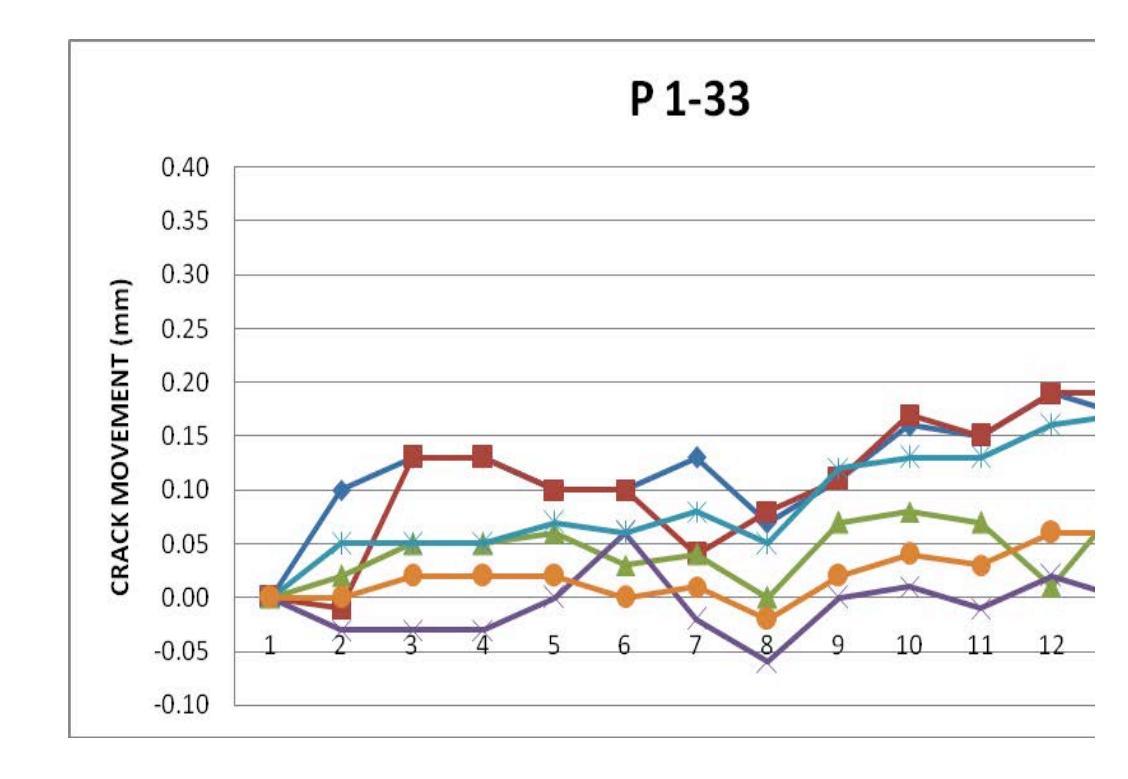
Figure 1: Crack Movement Reading at Pier 1-33

- 5.4 Figure 1 and Figure 2 show the graphical plots of crack movement at 'T'-shape pier during the monitoring period. It can be seen that the movement of crack for 5A is consistently much higher with maximum reading up 0.32 mm compared to other readings at less than 0.20mm.
- 5.5 Figure 3 until Figure 8 show the graphical plots of crack movement at 'L'-shape pier. From the graph, it can be seen that the maximum reading at Pier 1-10A and P1-11A approach 0.30mm. The other points have movement at less than 0.25 mm.

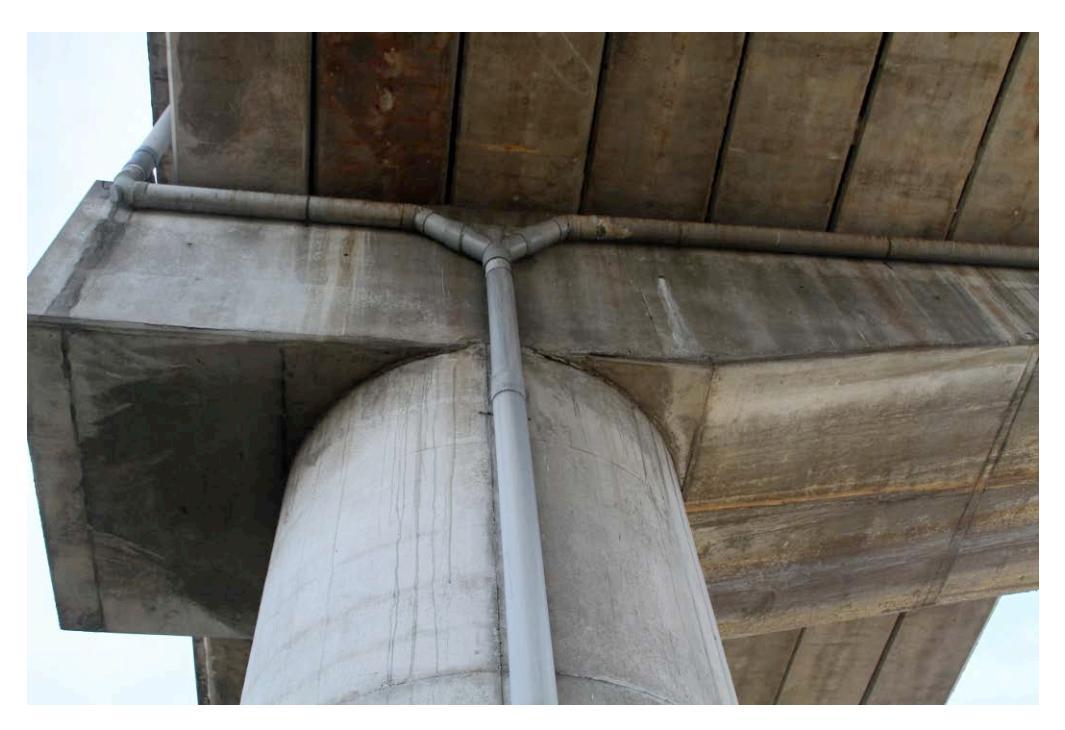
Figure 13: Pier P-11A

- 6.1.2 For SLS check, the crack width of the pier column is checked against the maximum allowable serviceability crack width of 0.25mm. It is found that P-25 and P-33 columns meet the allowable limit. However, the crack widths for P-11A (inverted "L" pier) under three (3) different traffic load conditions are found to be more than 0.25mm with a maximum value of 0.416mm. Hence, the existing column design for P-11A does not fulfil the SLS requirement.

- 6.2.2 The design of crosshead for P-25 and P-33 ("T" shape Pier") is found to be adequate for their bending moment capacities at ULS. However, ultimate moment capacity of P-11A crosshead is found to be marginally less than the induced moments; about 6% less.

- 6.2.5 Crack widths calculated for P-25 and P-33 crosshead are within the allowable limit of 0.25mm, which satisfies the SLS criteria. Whereas, the crack width for P-11A is found to marginally exceed the allowable limit of 0.25mm.

Use Epoxy-bonded CFRP at both sides of crosshead to enhance anchorage capacity of the existing main column rebars. Upper portion of the existing column shall be enlarged to provide sufficient anchorage for the bonded CFRP. All cracks shall be sealed beforehand and applied later with the protective coatings. All surfaces with CFRP shall be applied with a 25mm thick wet sprayed fire protection mortar (SIKACRETE 213F). The remaining surfaces to be applied with two coats of polymer-modified cementitious waterproofing coating (SIKA Top Seal 109 MY) which has crack bridging capacity up to 1.0mm.

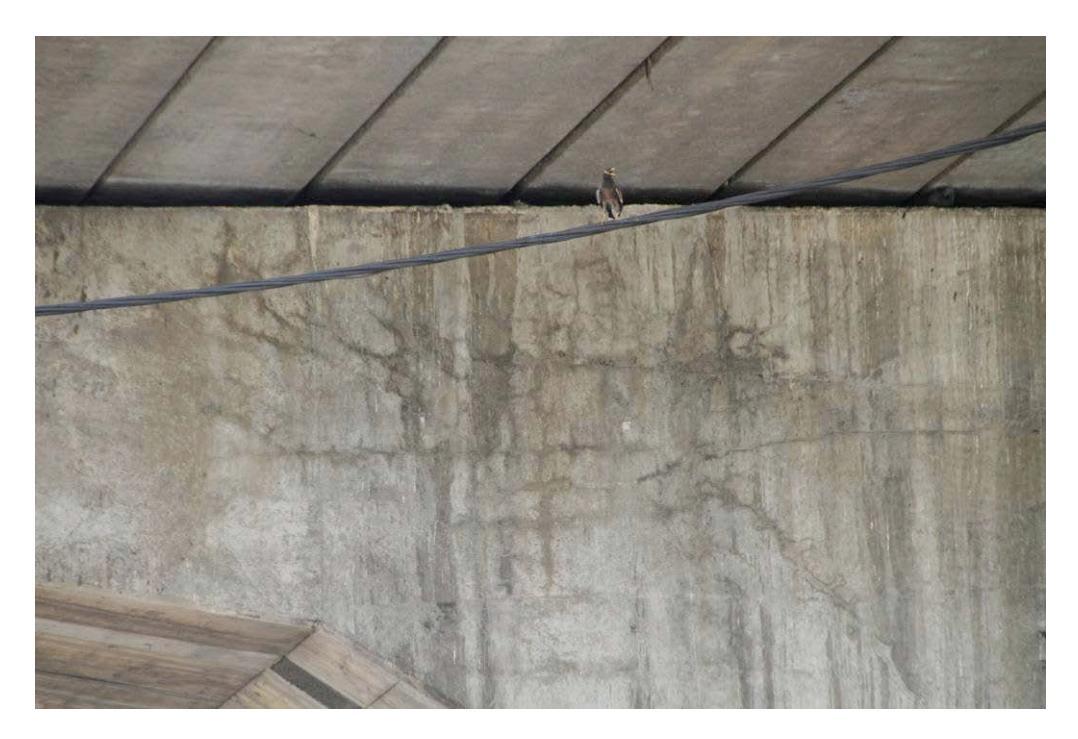
Figure 23: Pier Crosshead P-25 (Close up)

- 6.2.3 The existing shear design for P-11A and P-33 crosshead is found adequate.
- 6.2.4 It is found that the existing shear capacity for P25 is marginally insufficient to resist the maximum induced shear force at the existing section with depth of 2.0m. .

Use Epoxy-bonded CFRP at both sides of crosshead to enhance the anchorage capacity of the existing main column rebars. Upper portion of the existing column shall be enlarged to provide sufficient anchorage for

the bonded CFRP. All cracks shall be sealed before applying the protective coatings. All surfaces with CFRP shall be applied with 25mm thick wet sprayed fire protection mortar (SIKACRETE 213F), the remaining surface to be applied with two coats of polymer-modified cementitious waterproofing coating (SIKA Top Seal 109 MY) which has crack bridging capacity up to 1.0mm.

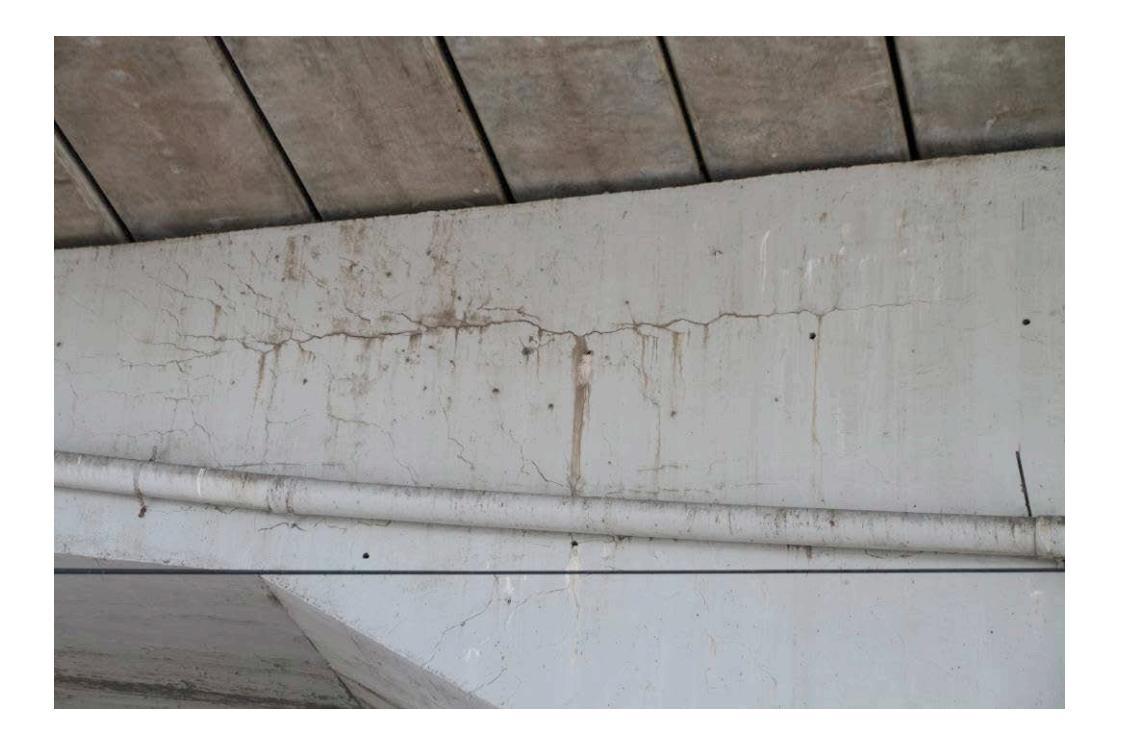
Figure 27: Pier Crosshead P-33 (Close up)

- 6.3 Crack Mapping & Material Testing
  - 6.3.1 Based on crack mapping, L-shape pier and crosshead were found with crack within 0.1mm to 0.4mm width. T-shape pier also were found with crack within 0.1mm to 0.4mm width. However, crack at crosshead of the T-shape pier has maximum width of 4.0mm at Pier No.33.
