Power Quality Study Capacitor Bank Failures Politeknik Seberang Perai

Cawangan Kejuruteraan Elektrik – UiTM Pulau Pinang

Power Quality Team

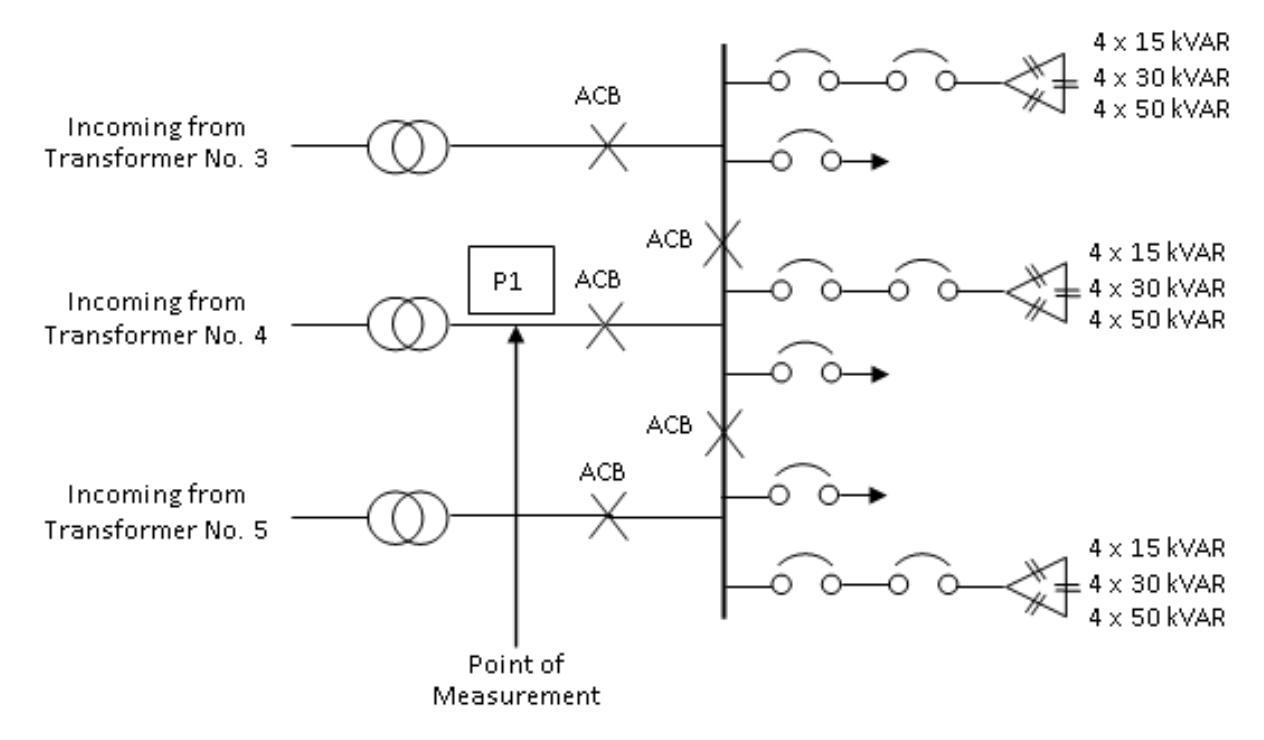
Simplified single line diagram of MSB No.2

The measurements of voltage and current were taken at point P1

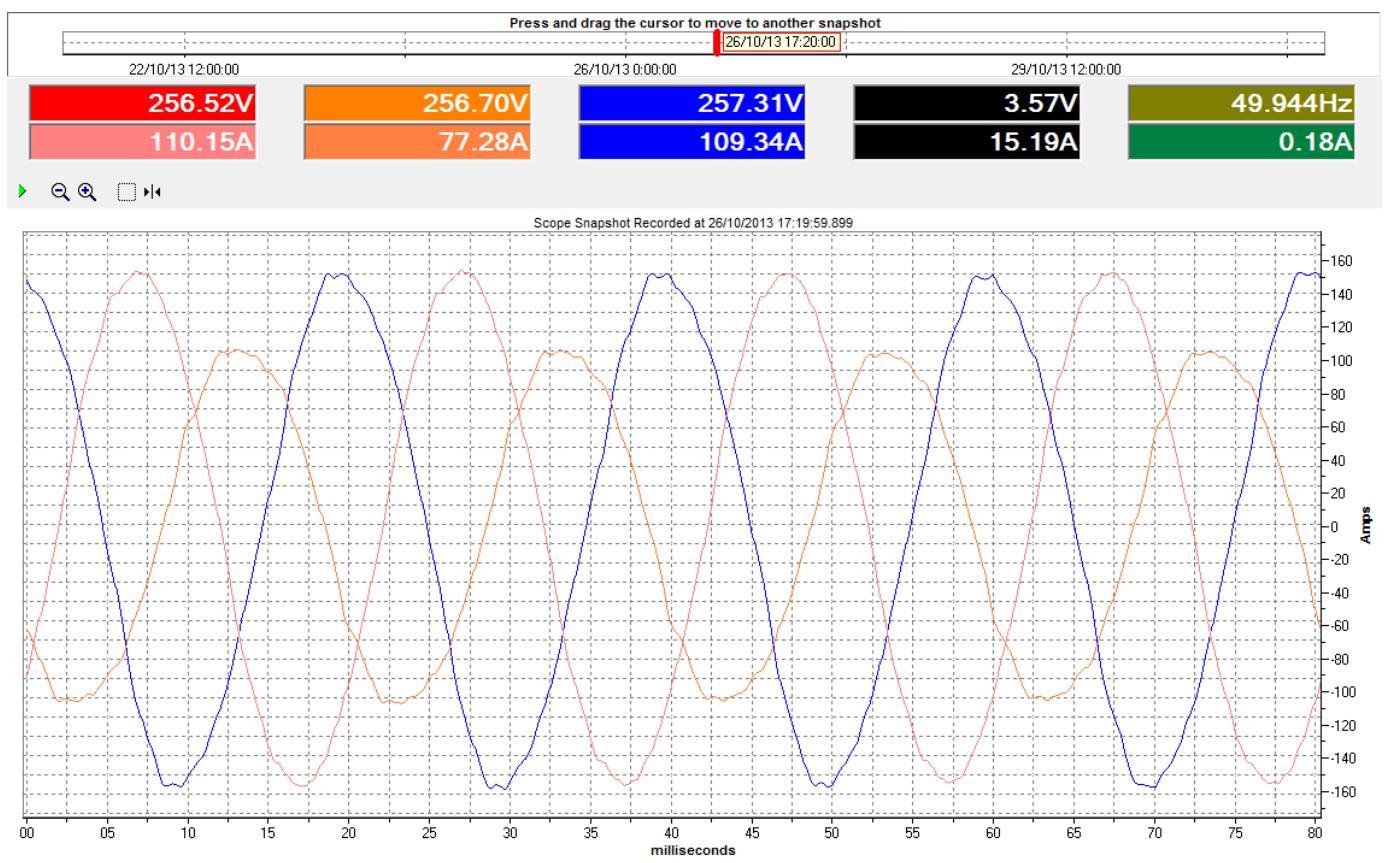
The current waveforms are slightly distorted

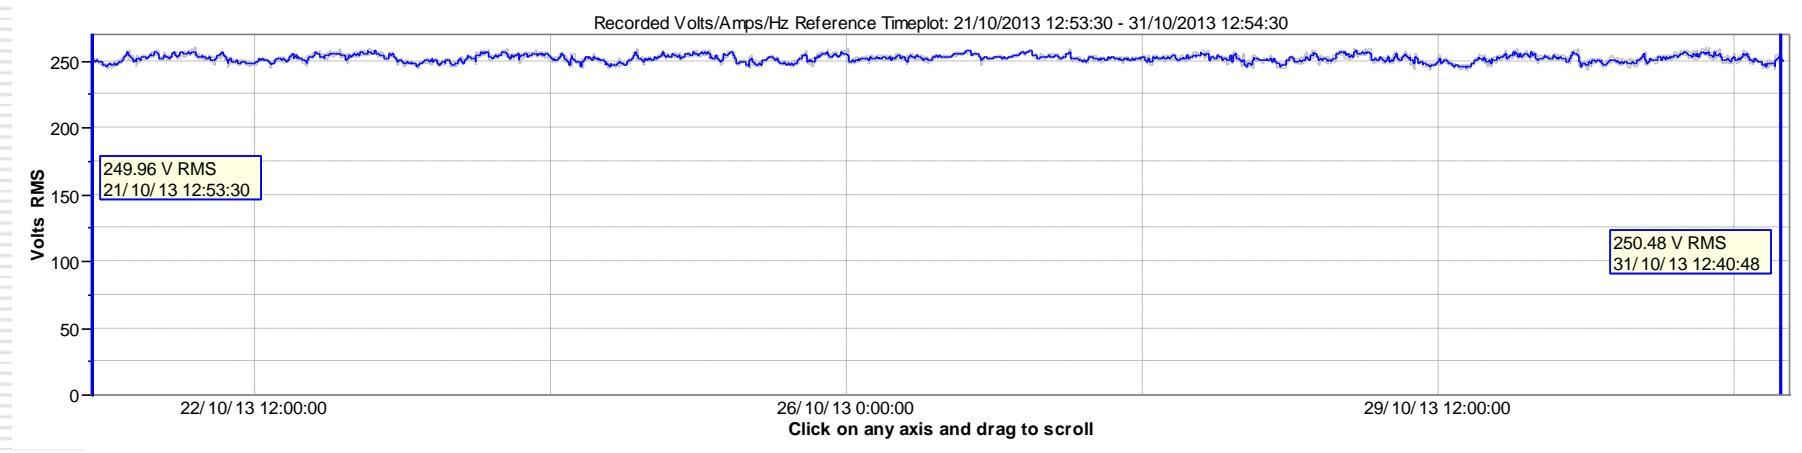
The recorded <u>10 minutes trend data average</u> RMS phase voltage V_{L1N} , V_{L2N} and V_{L3N} at P1 are 256.88V (11.69%), 257.18V (11.82%) and 257.71V (12.05%) respectively. These voltages exceed +10% limit of the nominal voltage

- Reduce the supply voltage to the nominal value by changing the position of the tap-changer of the transformer.
- At a supply of 400 V (3-phase), use power capacitors with a rated voltage of 525 V.

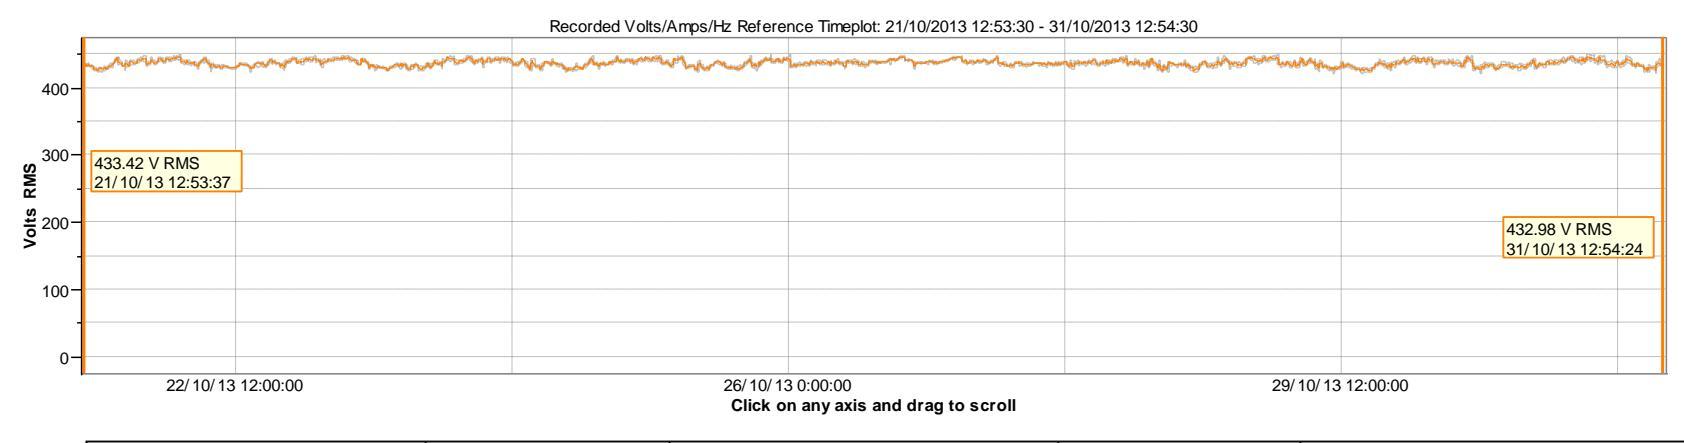
For recorded 10 minutes trend data of 3-phase voltage, average RMS 3-phase voltage V_{L1L2}, V_{L2L3} and V_{L3L1} at P1 are 444.81 V (11.20 %), 446.33 V (11.58 %) and 445.61 V (11.40 %) respectively. These voltages exceed the rated voltage of the capacitor (440 V)

- The supply voltage exceeds the rated voltage of the capacitor (440 V) and this overvoltage has caused the damage to the capacitors. It also shortens the life expectancy of the capacitors
- When the capacitor case expands upward, it indicates that the capacitor has reached end of service life (damage due to ageing).

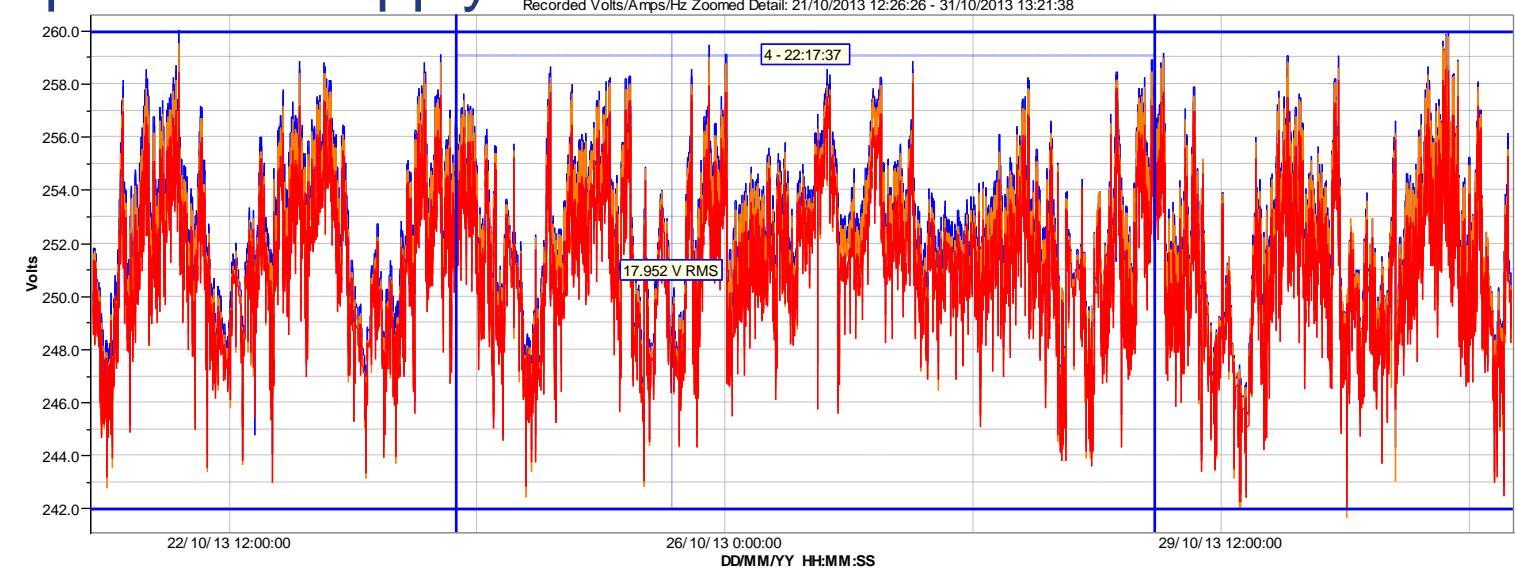
The voltage profiles experience voltage fluctuations. The voltage fluctuation is 18 V (7.8 %). This voltage fluctuation is considered high (above 6 % of nominal voltage, i.e. >13.8 V).

This indicate the voltage is a weak supply or high system impedance supply
Recorded Volts/Amps/Hz Zoorred Detail: 21/10/2013 13:21:38

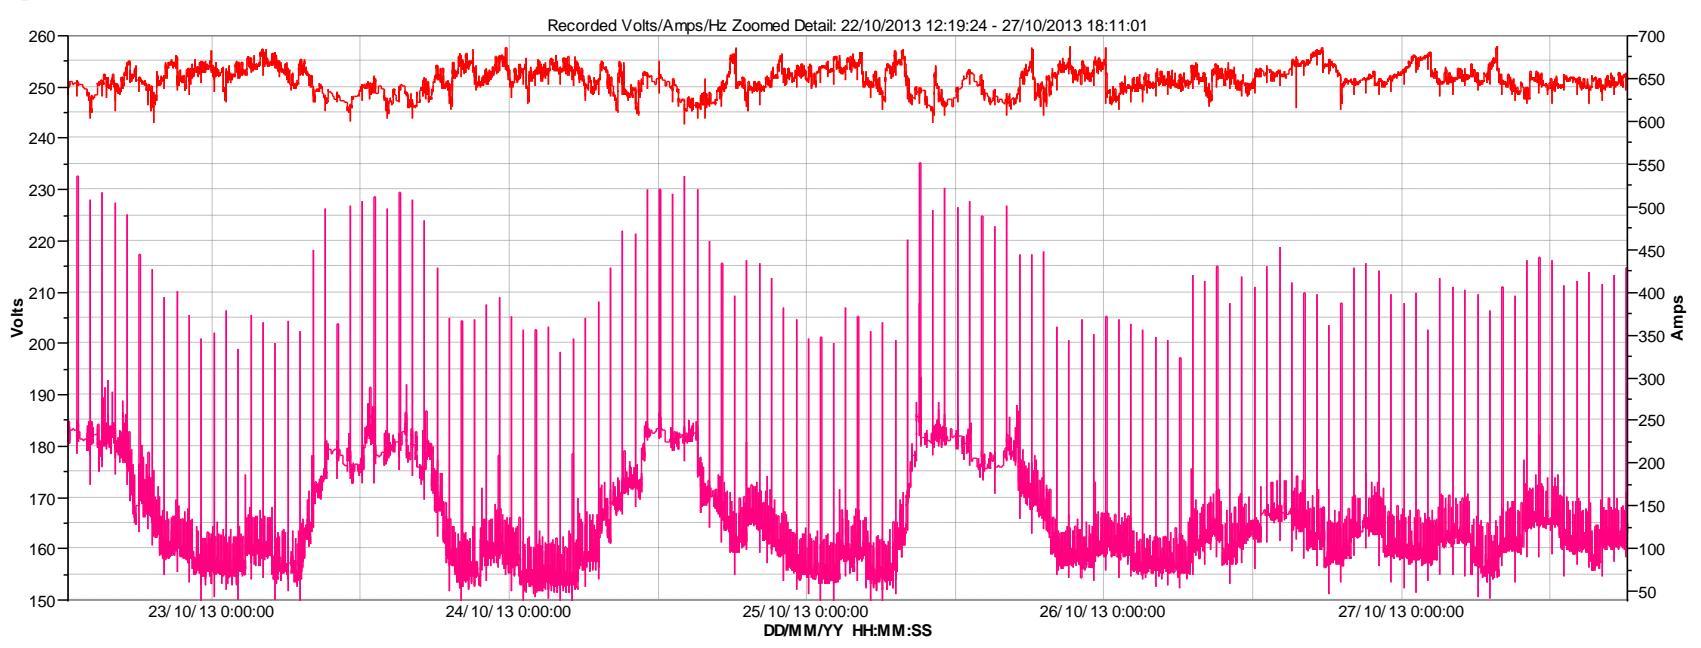
The voltage fluctuations can be related to undersize cable, loose or defective wiring, such as insufficiently tightened screws connection on power conductors.

- a) Check the wiring installation of the electrical system and correct all the wiring errors such as improper neutral-to-earth bond, intermittent single line-to-earth fault and improper cable joint.
 -) Check for loose neutral connections.
 - Inspect the wiring for other equipment, light fittings etc. for loose joints and terminations.
- d) Use exothermic welding connection between earthing conductor to the earth electrode.

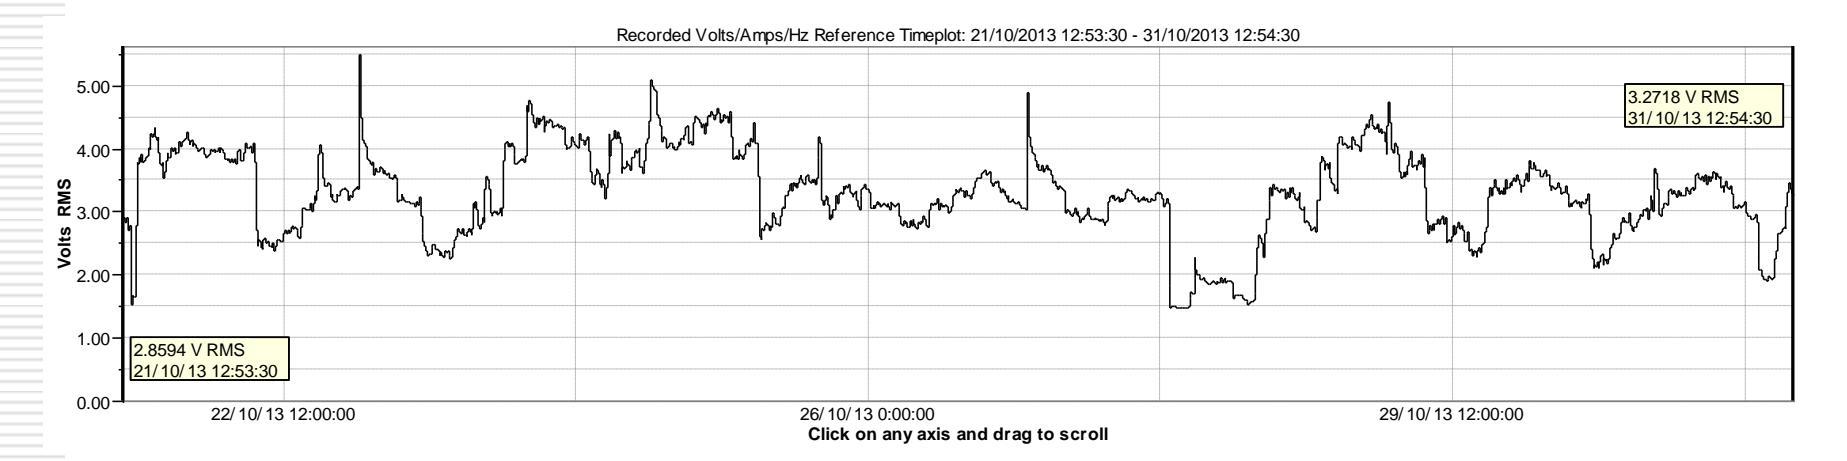
- The 10 minutes trend data average RMS neutral-to-earth voltage V_{NE} at P1 is 5.50 V.
- The high levels of V_{NE} indicates a loose connection at the earth electrode.

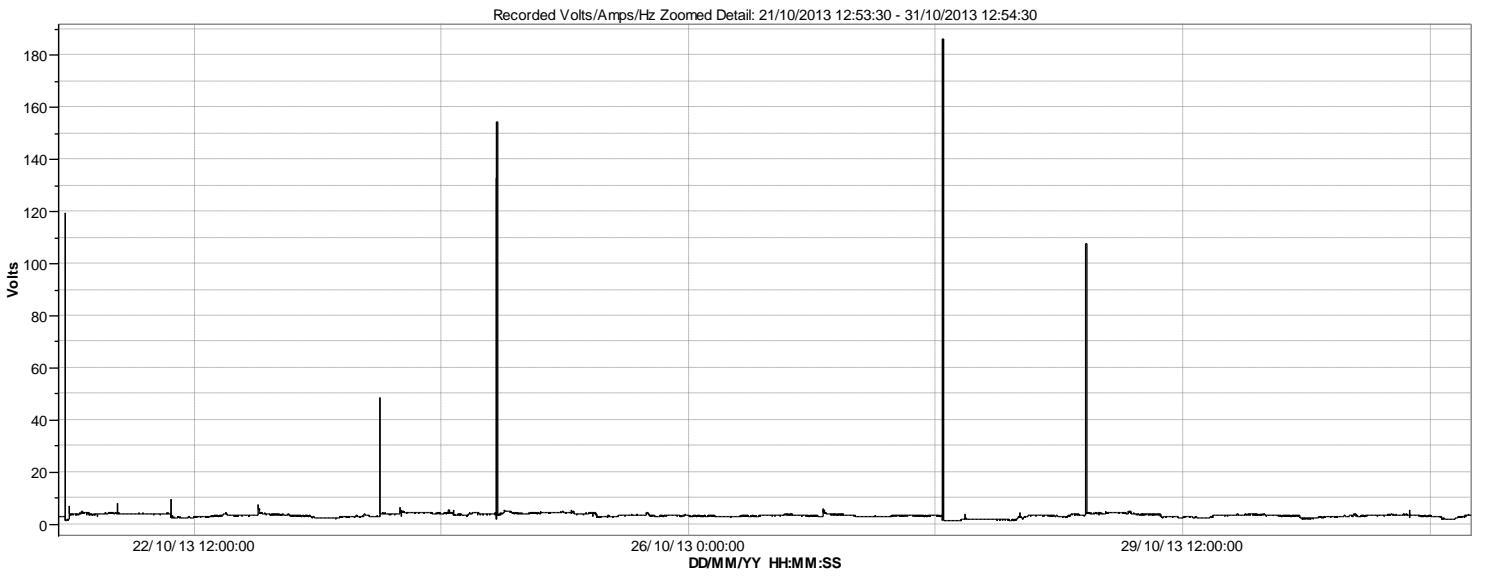
The detail view data average RMS neutral-toearth voltage V_{NE} is 186.47 V. The magnitude of the V_{NE} is high therefore it contributes to the power quality problem.

The neutral-to-earth impulses indicate that there are wiring errors in the electrical wiring installation (intermittent single line-to-earth fault)
 These neutral-to-earth impulses can result in equipment damage over time and also can cause nuisance tripping of RCCB

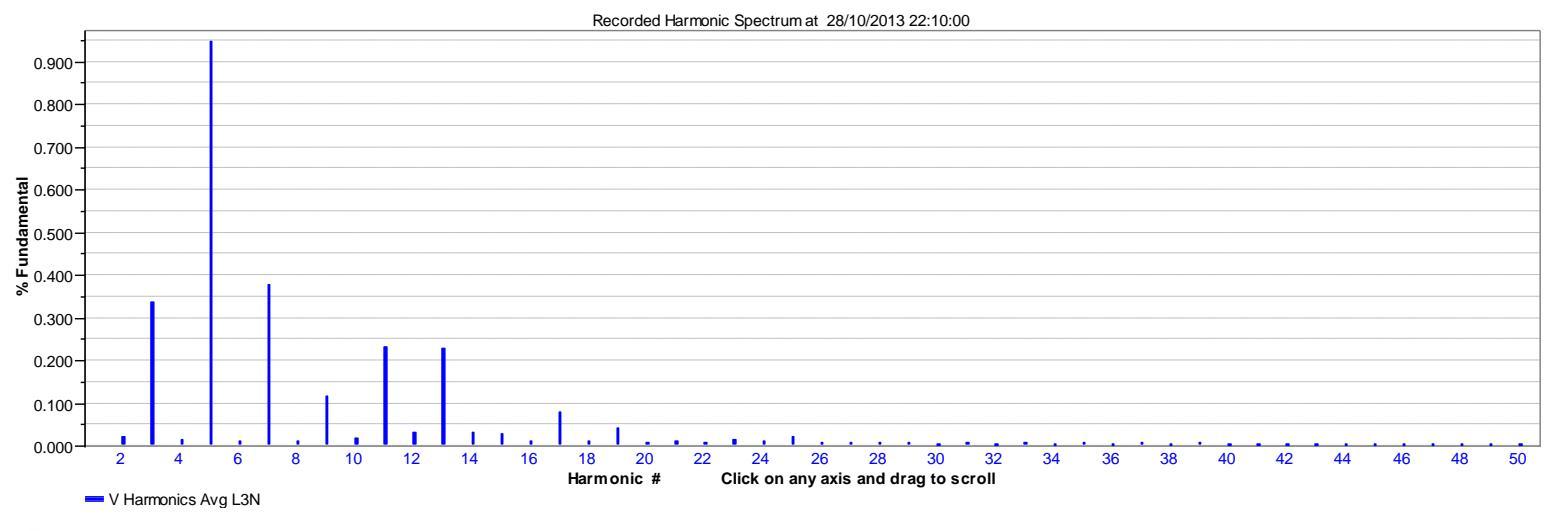
The average VTHD of phase L1N, phase L2N and phase L3N at P1 are 1.03 %, 1.09 % and 1.14 % respectively.

The values of VTHD are acceptable and within the limit (8 % based on IEC 61000-2-2).

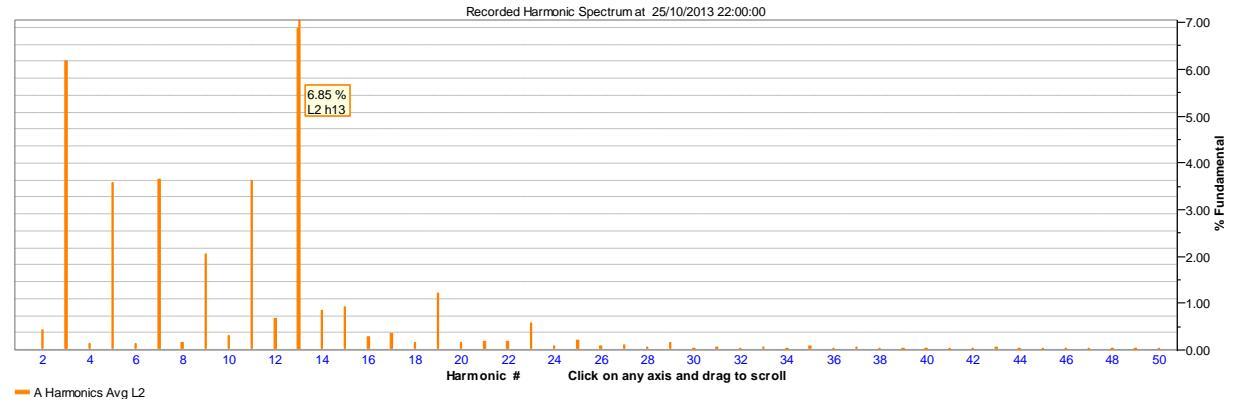
The average ITHD of phase L1, phase L2 and phase L3 at P1 are 2.88 %, 3.43 % and 2.75 % respectively. The values of ITHD are low therefore they do not contribute to the distortion of the supply voltage

Evaluation of the results clearly shows that the capacitor failures at MSB No. 2 are not caused by harmonics.

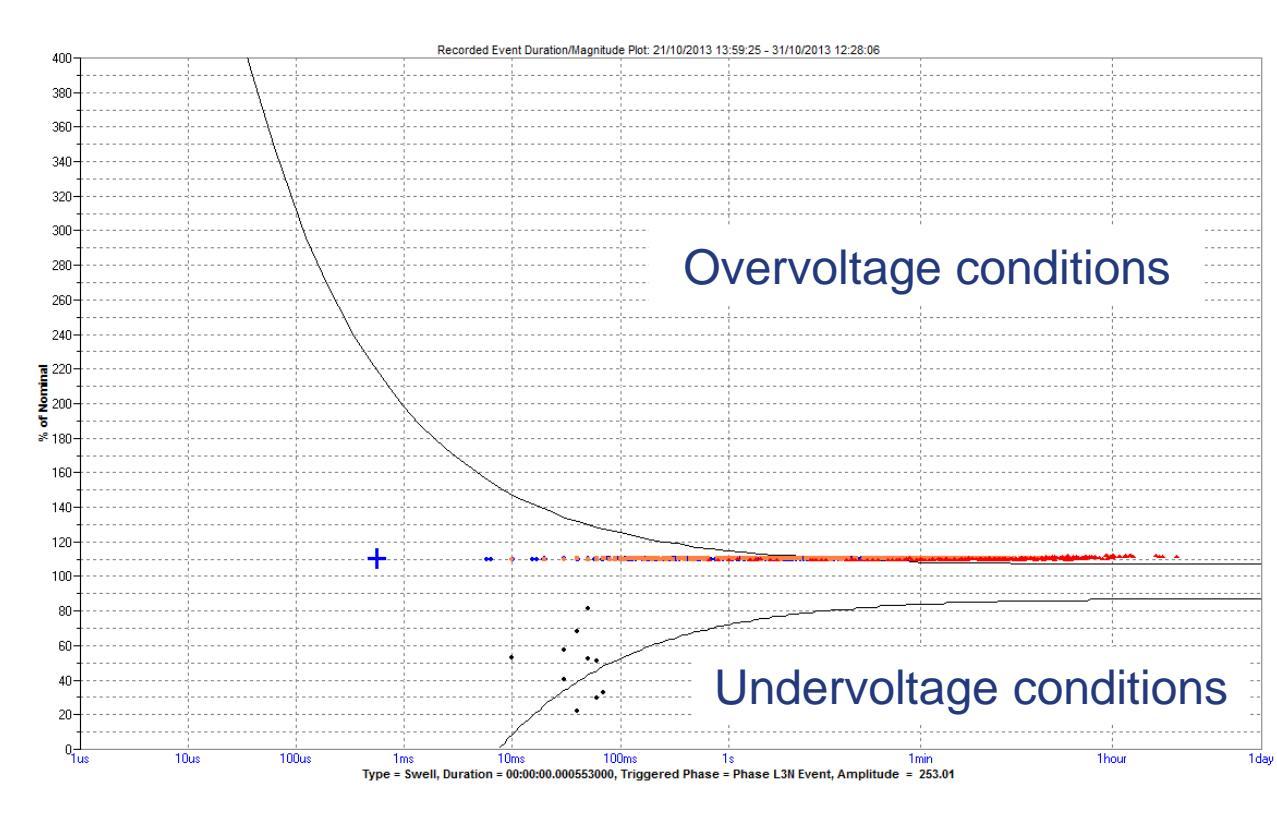
Computer and Business Electronic Manufacturers Association (CBEMA) tolerance curve

- There are a total of 2670 recorded events, all of which are overvoltages.
 - These overvoltages will stress the insulation of the equipment and can significantly shorten the lifespan of the equipment.
