CURRENT INVENTORY OF DAMS

OBJECTIVE OF DAM SAFETY MONITORING & SURVEILLANCE

DAM SAFETY MANAGEMENT

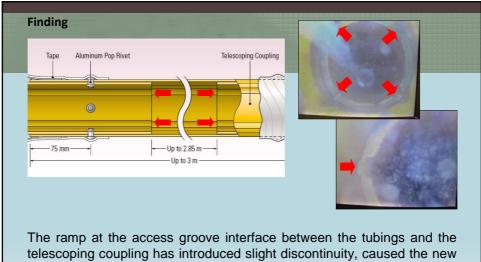
The ramp at the access groove interface between the tubings and the telescoping coupling has introduced slight discontinuity, caused the new inclinometer probe (Bluetooth inclinometer), which is much lighter compared to the old inclinometer probe, to experience difficulty to advance into the tubing.
