# CIVILCORE

# **DEVELOPMENT OF LANDSLIDE HAZARD ASSESSMENT MODEL FOR CUT-SLOPES ALONG TAMPARULI – SANDAKAN ROAD IN SABAH, MALAYSIA**

**Suhaimi Jamaludin**

**Cawangan Kejuruteraan Cerun  
JKR Malaysia**

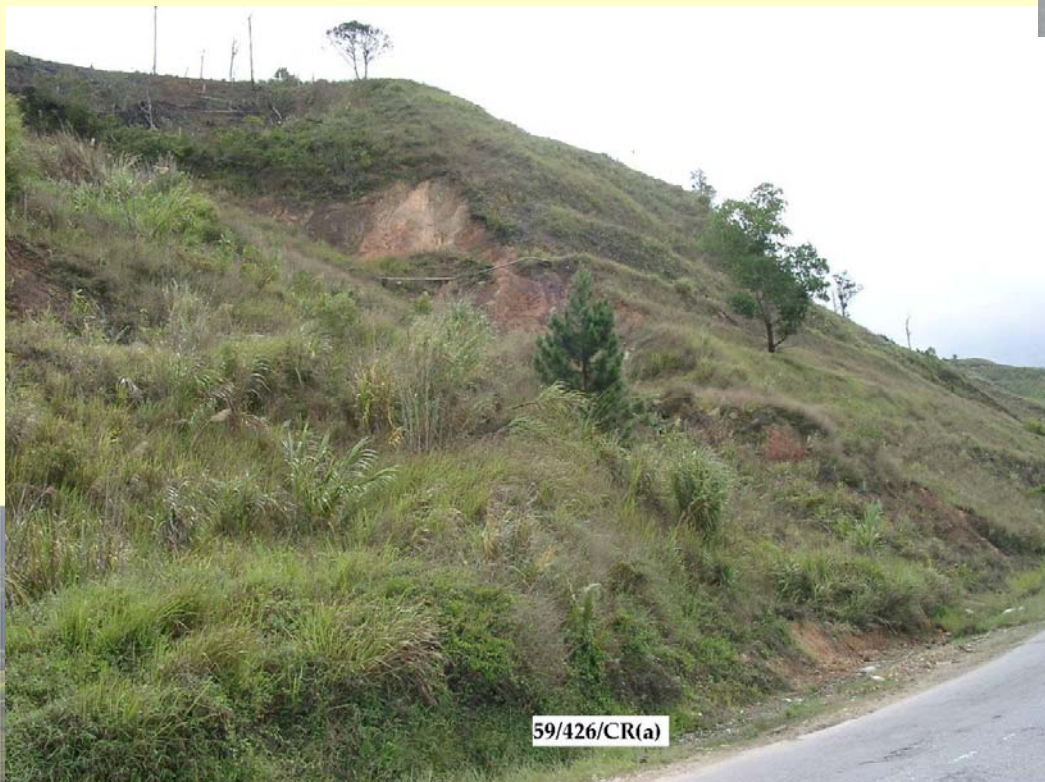
78/708/CR(a)

# **Landslides or Slope Failure**

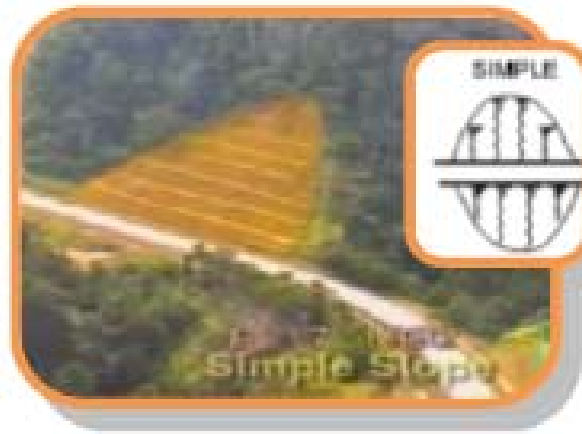
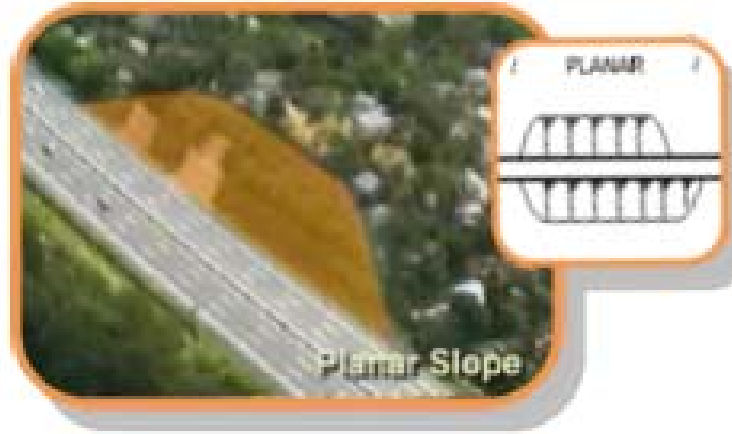
**Slope Shape**

**Simple**

**Planar**

**Asymmetrical**

**Compound**

| Slope Parameter | Discriminant Function Coefficients |
|---|---|
| Slope shape | 0.163 |
