INTERPRETATION OF INSTRUMENTATION AND MONITORING WORKS

Kursus Instrumentasi dan Pengawasan Cerun serta Sistem Amaran Awal

IMPLEMENTATION OF SLOPE MONITORING PROGRAM AND INSTALLATION OF REAL TIME VIBRATION MONITORING SYSTEM AT GUNUNG PULAI WATER TREATMENT PLANT

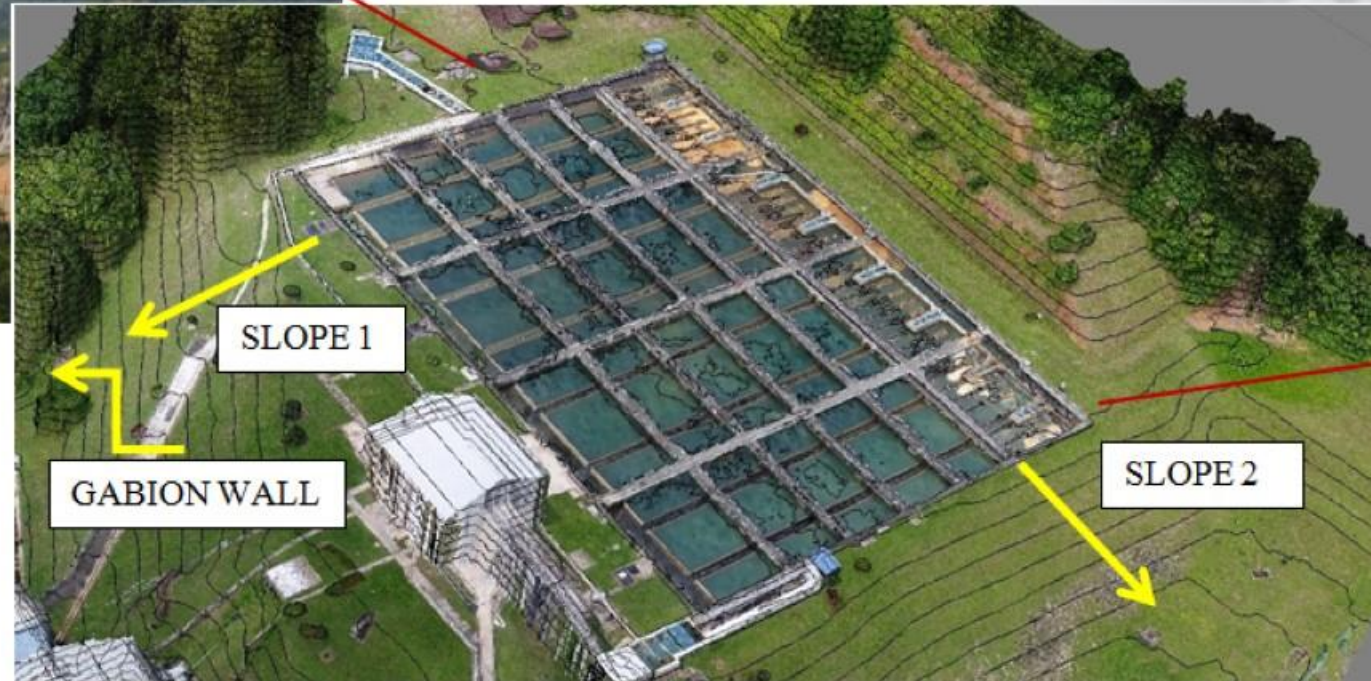
- There are six (6) nearby active quarries have been identified in the area, the two nearest quarries are **Malaysian Rock Products Sdn. Bhd. (MRP)**, is about 500m to the South-west and **Sibelco Quarry** is located about 1300m North-east from the GPWTP

SLOPE 1

GABION WALL

SLOPE 2

Sibelco Quarry (1300m)

- ❑ There are six (6) nearby active quarries have been identified in the area, the two nearest quarries are Malaysian Rock Products Sdn. Bhd. (MRP), which is about 500m to the South-west and Sibelco Quarry which is located about 1300m North-east from the GPWTP
- ❑ Based on the safe buffer zone of 500m (as imposed by Department of Environment (DOE)) being the closest quarry, operation at MRP Quarry has been selected for the monitoring purpose

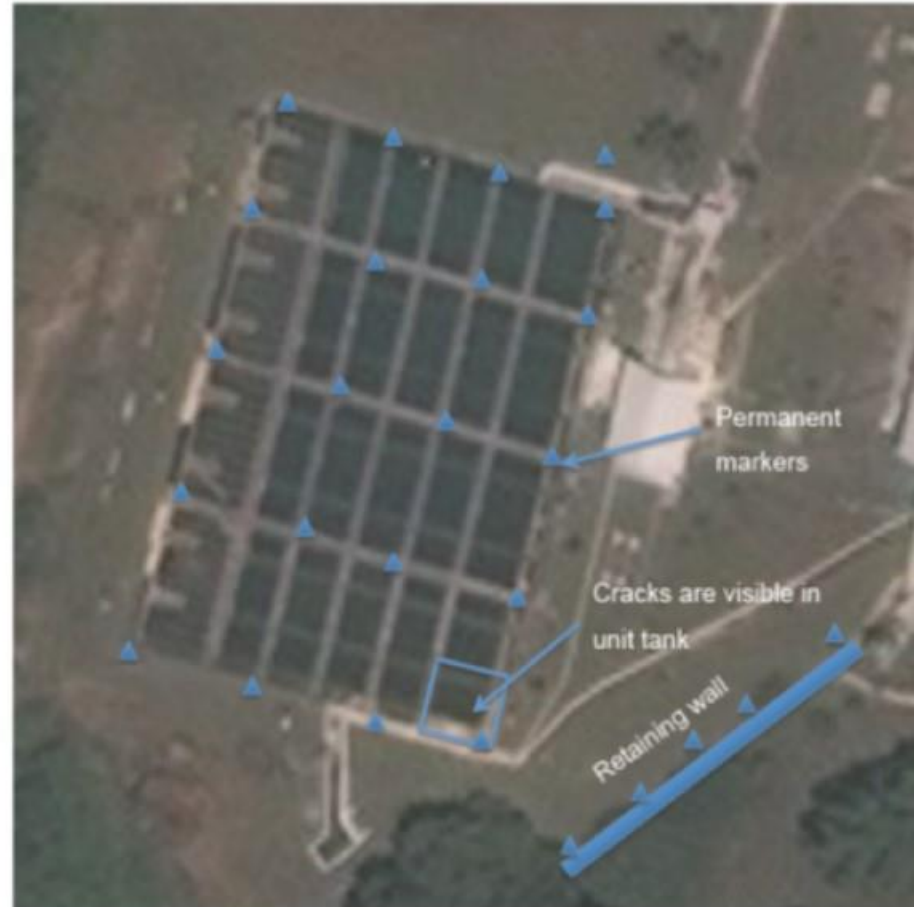
Settlement Monitoring at the Water Treatment Plant

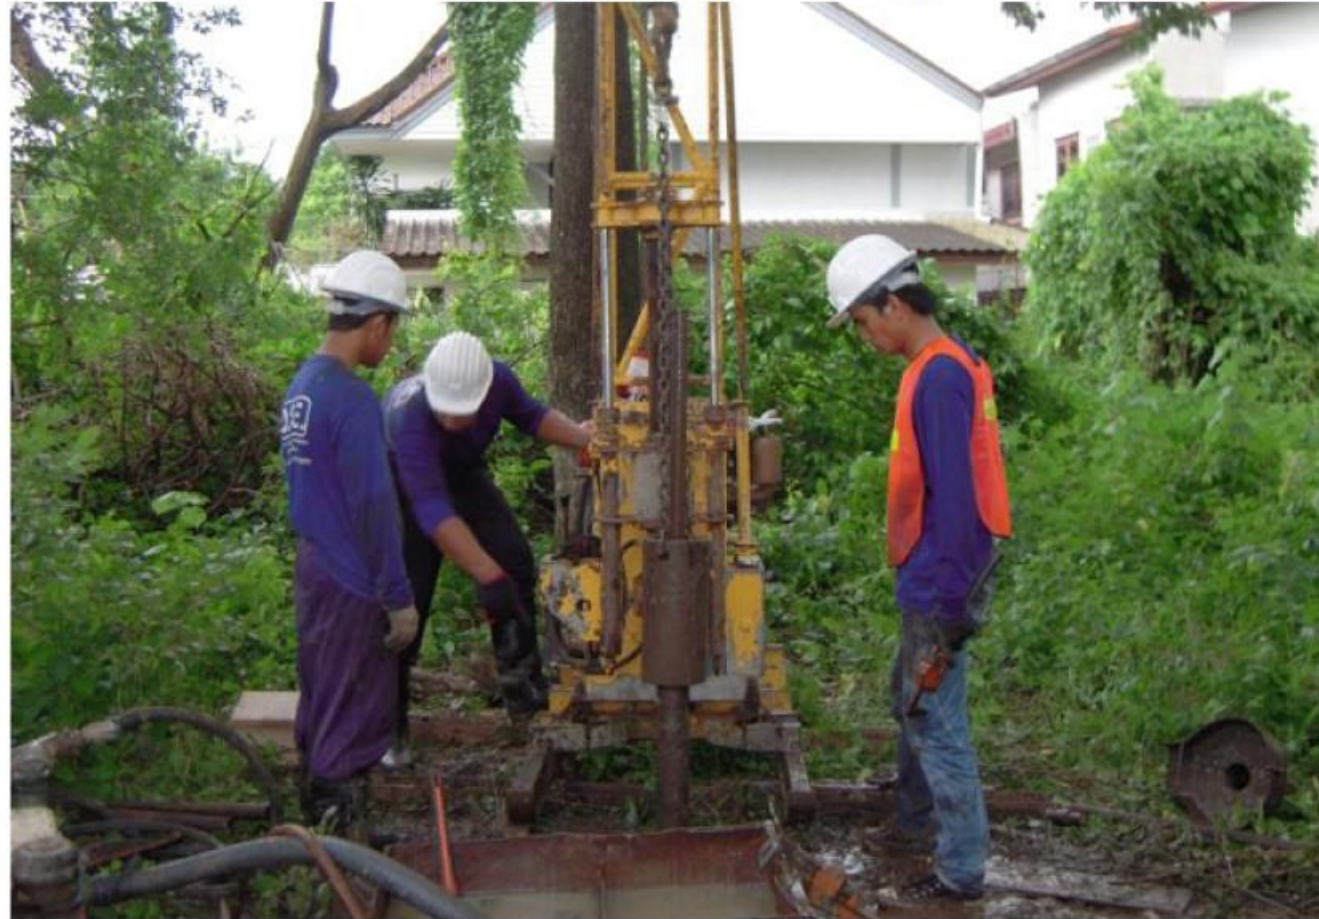
Slope Stability Monitoring and Analysis

Subsurface profile investigation

- ☐ Explored the subsoil condition at the proposed site by four (4) exploratory borehole
- ☐ Carried out Standard Penetration Test.
- ☐ Installed and monitored two (2) numbers of Pneumatic Piezometer
- ☐ Installed and monitored one (1) number of Inclinator
- ☐ Obtained undisturbed and disturbed samples
- ☐ Performed laboratory test on selected samples

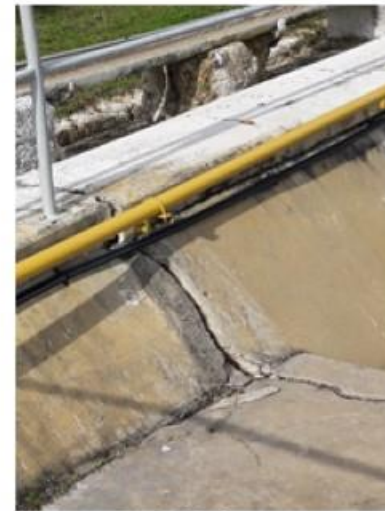
CRITICAL CRACK INCREMENT

- Crack propagation monitoring critical value of crack increment is 1.27mm which pointed at the slope area (P1B)

- (1) The crack monitoring results indicate the size of cracks are within allowable limit **and**, the increments of crack are not significant for the most of locations, except on three locations at near slope area (at point P1A1, P1A2 and P1B). **The settlement monitoring works also concluded that all monitoring point are not exceed $\pm 0.6\text{mm}$ and can be considered stable, except for points E1 and G3 at near slope area. To conclude, both settlement and crack monitoring results give clear indication that the soil under the corner area is not stable**

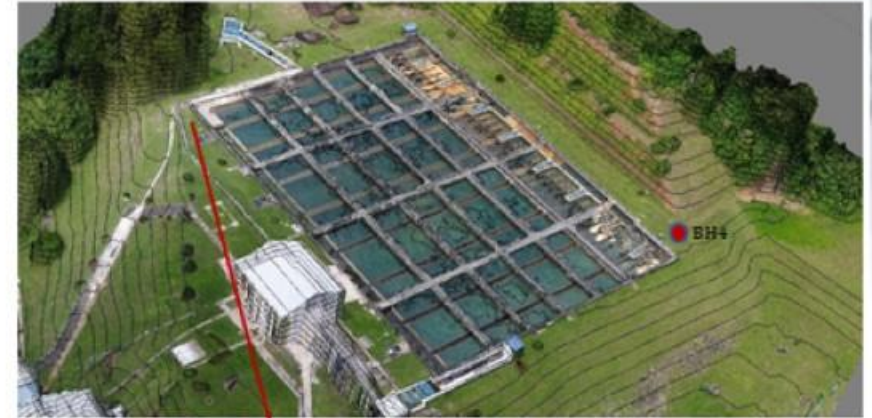
Rotary Drilling:

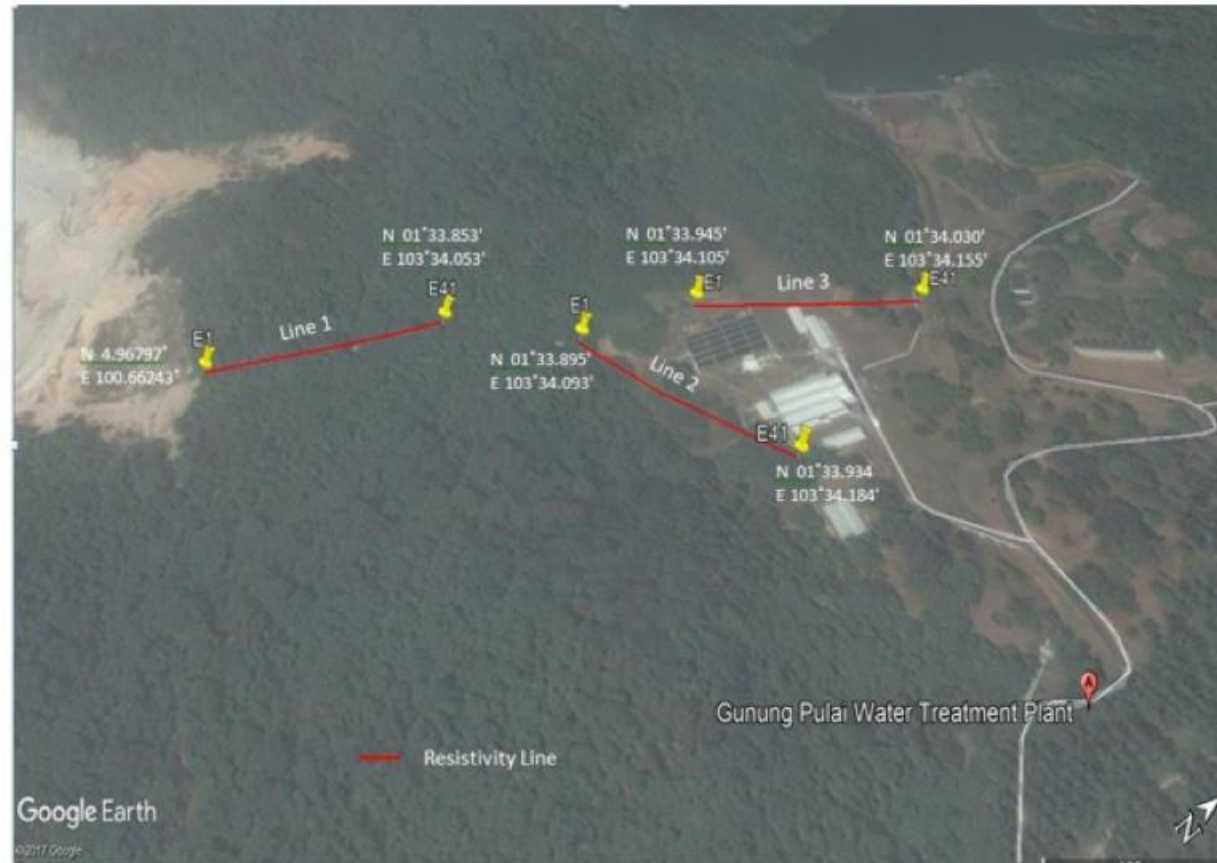
Resistivity Imaging

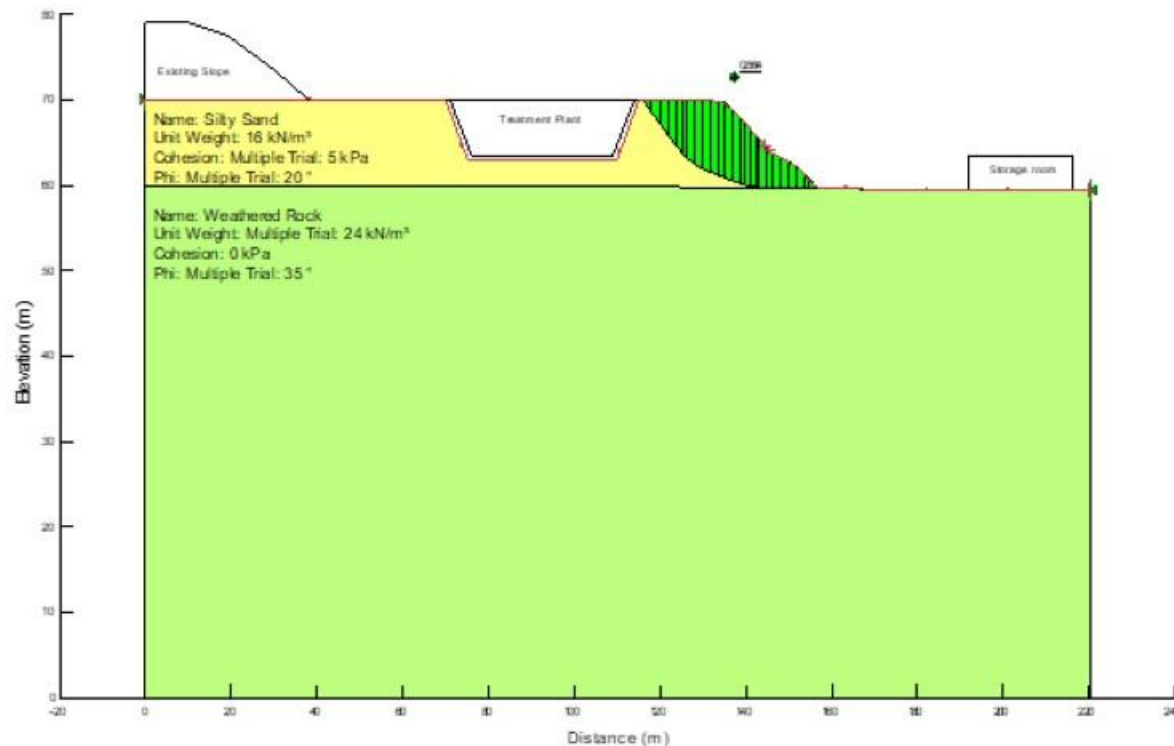
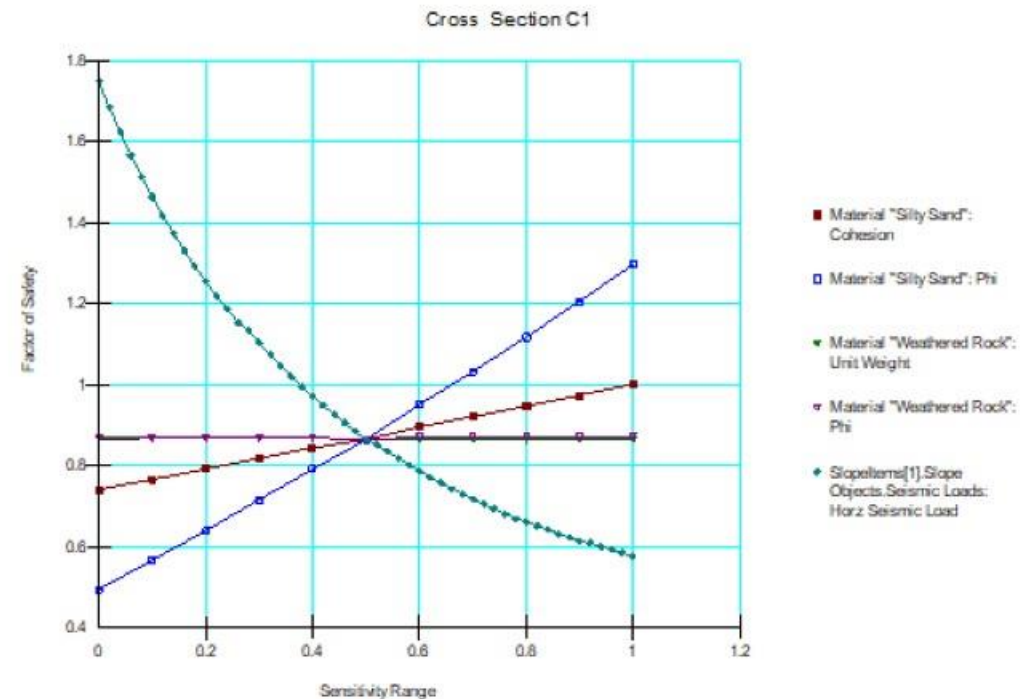
STABILITY OF CROSS SECTION C1

- ❑ The failure feature is likely global and deep seated with the FOS = 0.864 via sensitivity analysis.
- ❑ The FOS = 1 (stable condition) with sensitivity of k_h , ϕ' and c' at 0.21g, 24° and 10kN/m³ (in-situ $\phi' = 20^\circ$ and $c' = 5\text{kN/m}^3$) respectively on top soil (Silty SAND) but FOS is not sensitive to bottom soil (Weathered Rock)
- ❑ The results indicate any decrease in ϕ' and c' (wetting/saturated condition) or increase in k_h cause instability on slope

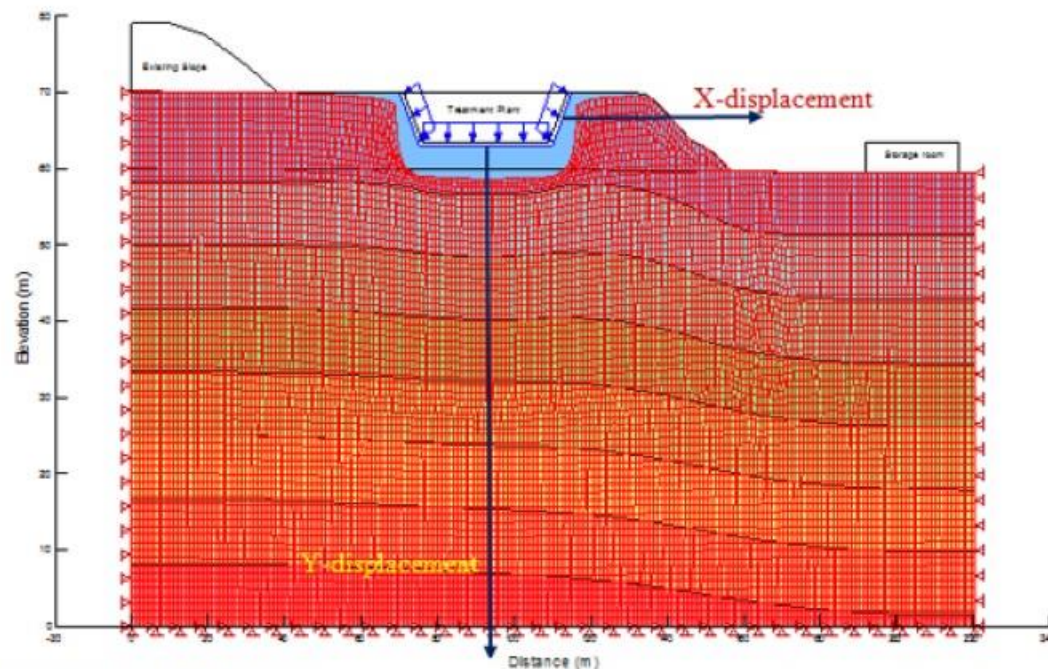
LOAD AND DEFORMATION ANALYSIS OF C1

- ❑ The vertical displacement is maximum on the bottom of treatment plant (Y-displacement = 110mm)
- ❑ The horizontal displacement, X-displacement = 10mm to 60mm
- ❑ The results indicate applied load significantly affect deformation at both vertical and horizontal directions which could have contributed to $FOS < 1$ in slope stability analysis

- (2) **The results of Load-Deformation analysis on cross sections of original slope also show maximum vertical displacement on the bottom of treatment plant, and horizontal displacement is also decreasing from 150mm to 10mm toward the slope. The results indicate applied structural and water loads significantly affect deformation at both vertical and horizontal directions which could have contributed to $\text{FOS} < 1$ in slope stability analysis.**

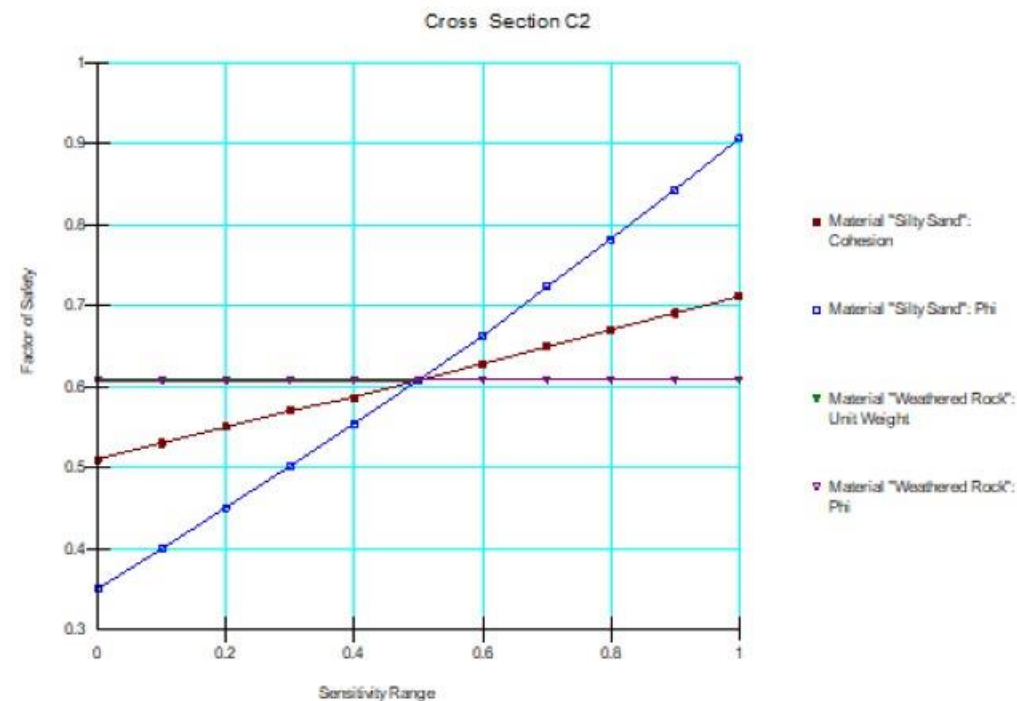
STABILITY OF CROSS SECTION C2

- ❑ The failure feature is likely global and deep seated with the FOS = 0.608 via sensitivity analysis.
- ❑ The FOS < 1 for all k_h , ϕ' and c' values to show original slope at cross section C2 is unstable. However, the sensitivity trends are similar to cross section C1 where it is sensitive to top soil but FOS is not sensitive to bottom soil
- ❑ The results indicate the slope at C2 is likely to fail (to compare to FOS for C1 = 0.864)

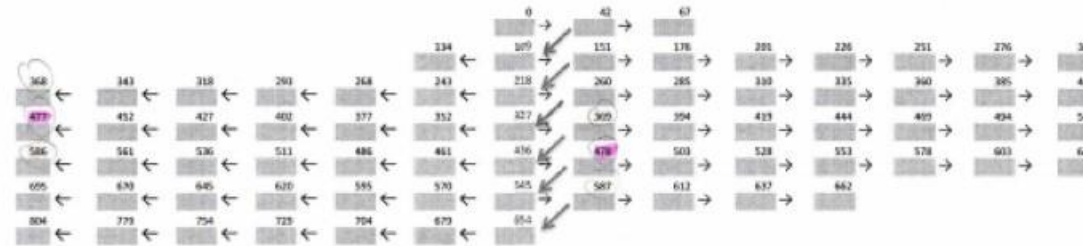
Typical Blast Design Parameters for Production Blasting in Quarry

Free Face

HOLES DESCRIPTION				EXPLOSIVES USAGE		REMARK
Total Holes:	72			EZ-Det 25ms,24m:	72	
Burden:	11	3.35m		EZ-Det 25ms,12m:	0 nos	
Spacing:	11	3.35m		Emulex 25 mm:	0.00 kgs	
Depth:	50	15.85m		Emulex 50 mm:	0.00 kgs	
Subdrill:	0	0.92 m		Booster 250gm:	0.00 kgs	
Stemming:	7	2.13 m		Booster 400gm:	35.3	
Drilling Pattern:		Square		IED (Initiation):	2 nos	
No. of Rows:	8			TLD 17ms:	0 nos	
Holes Diameter:	89	mm		TLD 42ms:	6	
Stemming Material:		Chipping		TLD 67ms:	6	
Cubic Meter:		12,344.30	m3	ANFO:	0 Kgs	
Total Tonnage:		32,095.17	mT	Bulk Emulsion:	6432	
				Powder Factor:	0.52	kg/m3

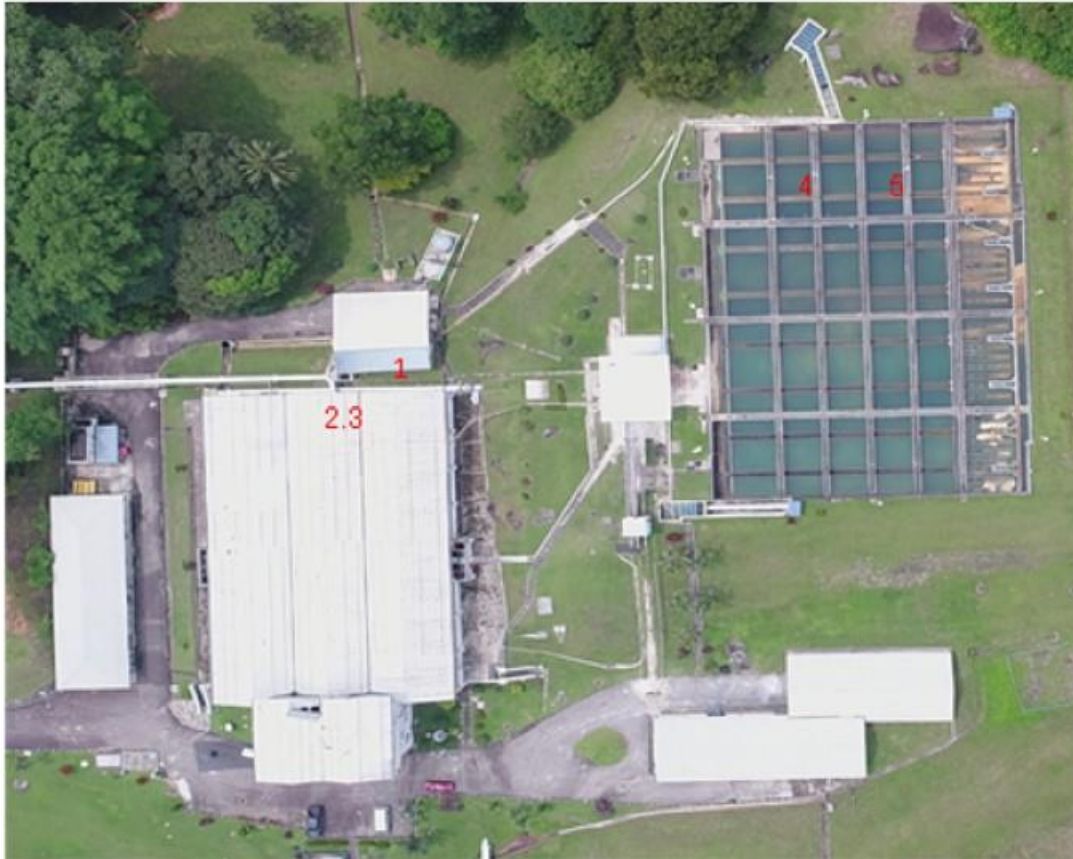
INSTALLATION OF VIBRATION MONITORING DEVICES

- ❑ Ground vibration at GPWTP has been continuously monitored using five (5) vibration sensors installed at strategic locations since 22nd February 2018
- ❑ The triggering value for the sensor is set at 0.5mm/s so as to allow the sensors to monitor a much lower vibration level

- 1. DA-B5 (Ground Level)
- 2. 39-E2 (2nd Floor Level)
- 3. 37-1A (Roof Level)
- 4. 3D-13 (Dosing)
- 5. 3C-24 (Plant)

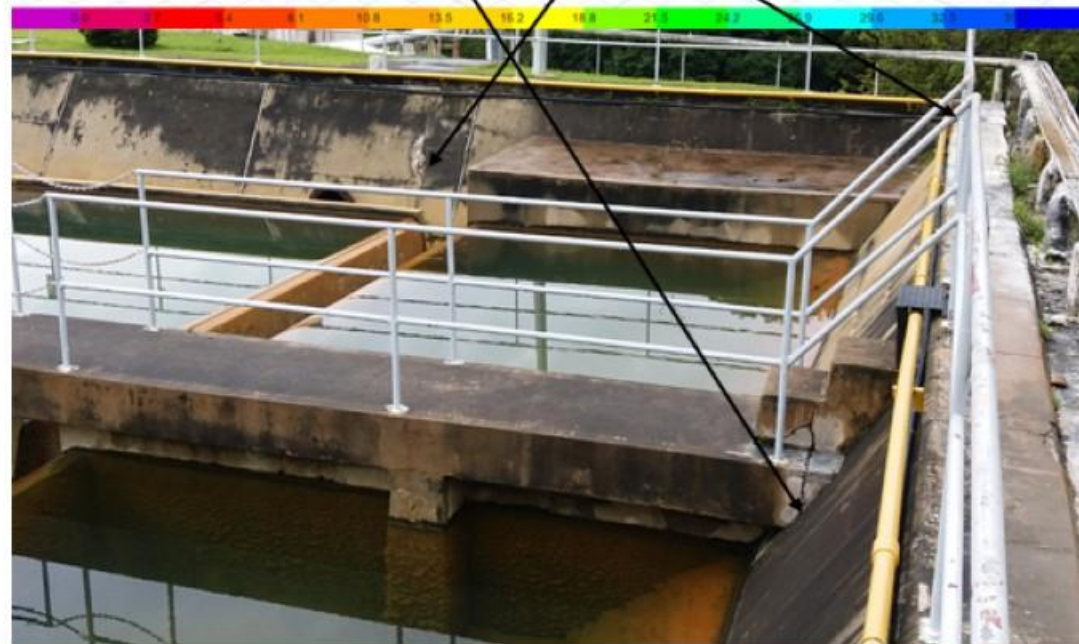
Principal stress distribution on the wall due to 150mm settlement

- (6) A small amount settlement at the corner of surrounding walls of the sedimentation tank causes the principal stress to exceed the considered ultimate capacity of concrete (i.e. 20MPa). This implies settlement can result in a significant damage to the surrounding concrete walls as the settlement reaches 150mm the damage zones become similar to the observed cracks on the wall of sedimentation tank. It can be concluded that it is likely that the observed damage to the sedimentation tank is due to excessive settlement of the structure rather than the blast induced forces.
