# **KEJADIAN TANAH RUNTUH DI LALUAN PERSEKUTUAN**

**148**

**SHARING KNOWLEDGE**

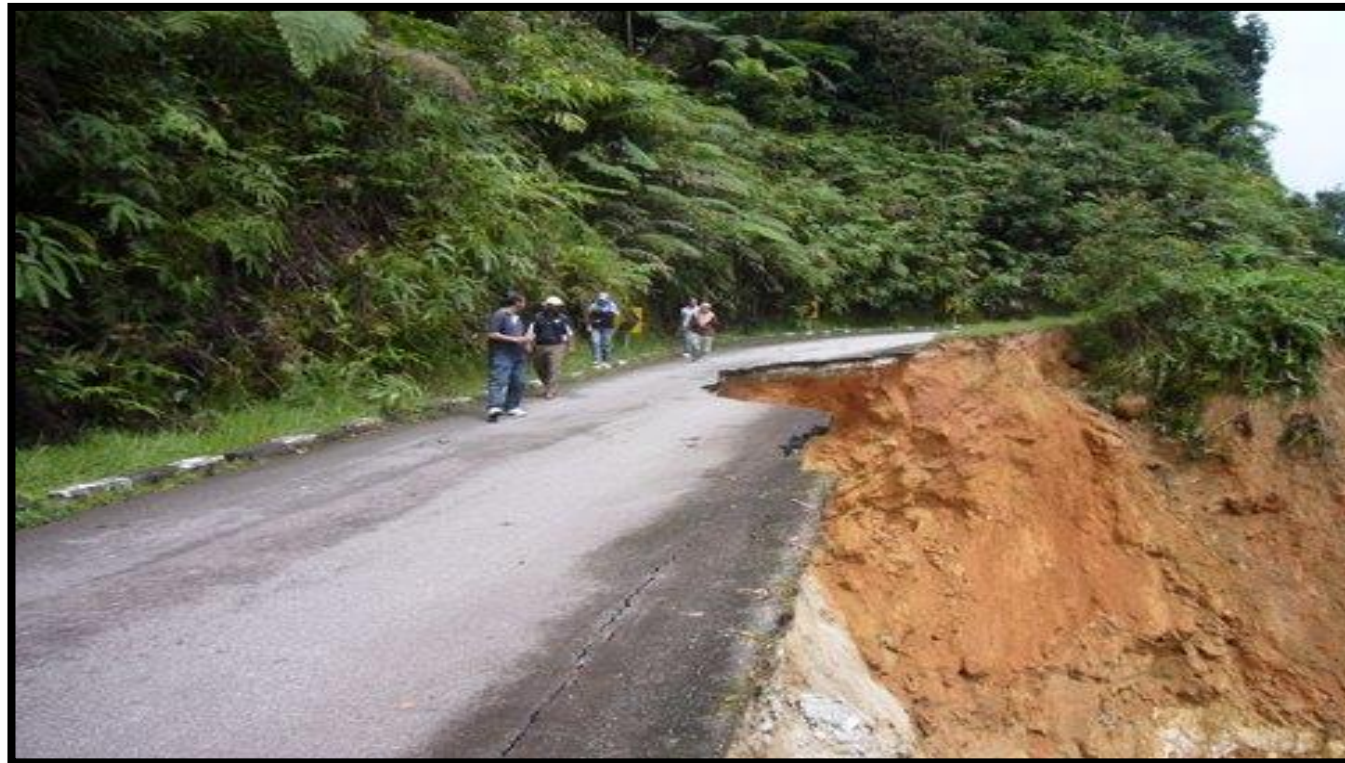
## **19 Jan 2008 – Hakisan dan Runtuhan**

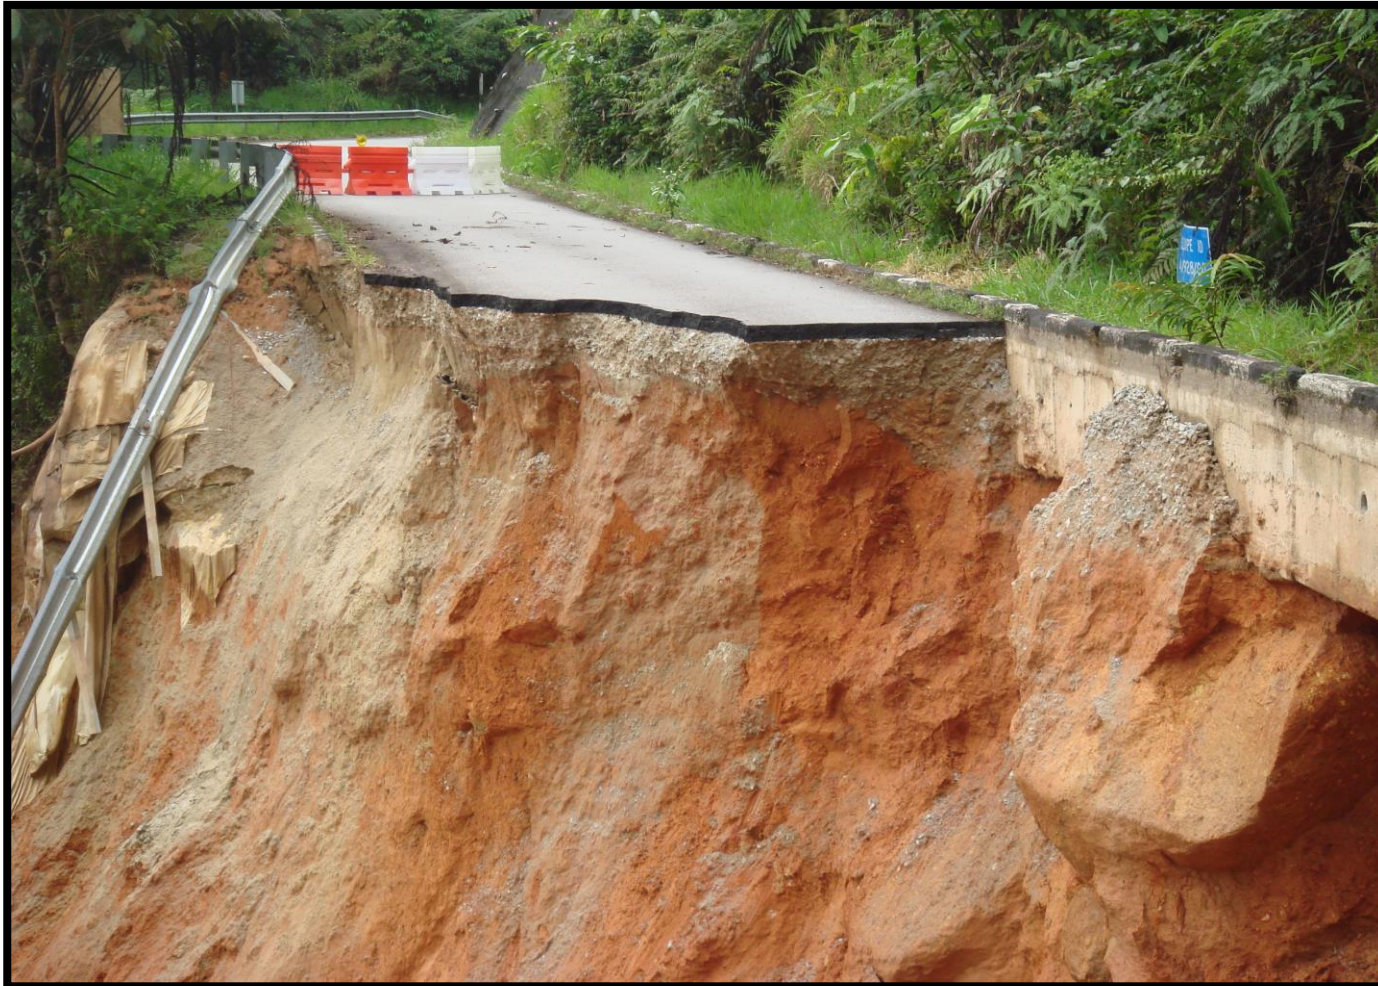
**1 Feb 2008- Hakisan cerun tambakan semakin membesar sehingga ke sisi jalan**

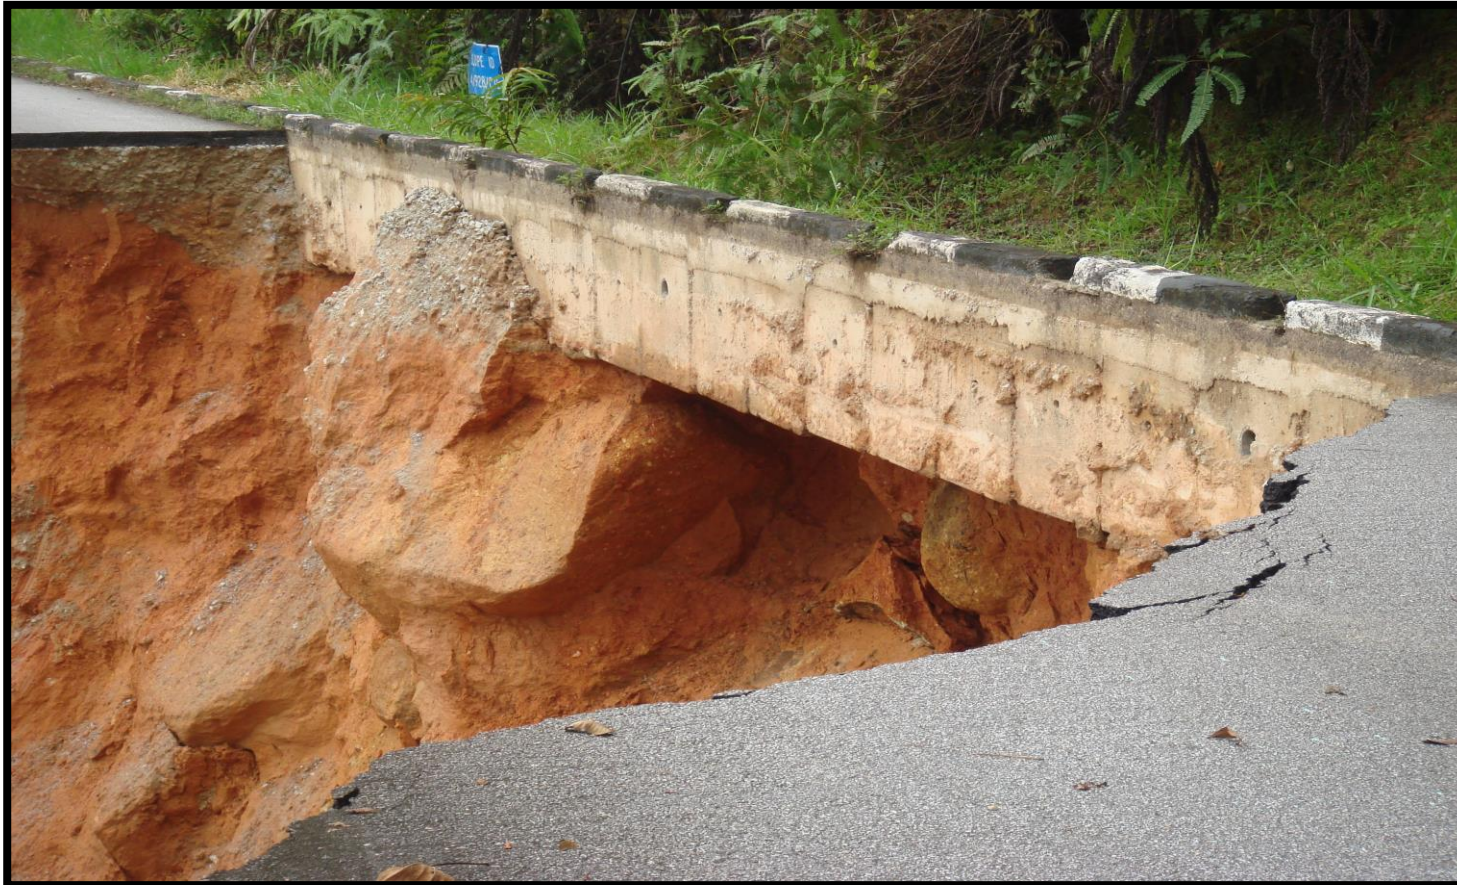
**1 Feb 2008 – Longkang sedia ada ditemui  
tergantung pada Boulder**

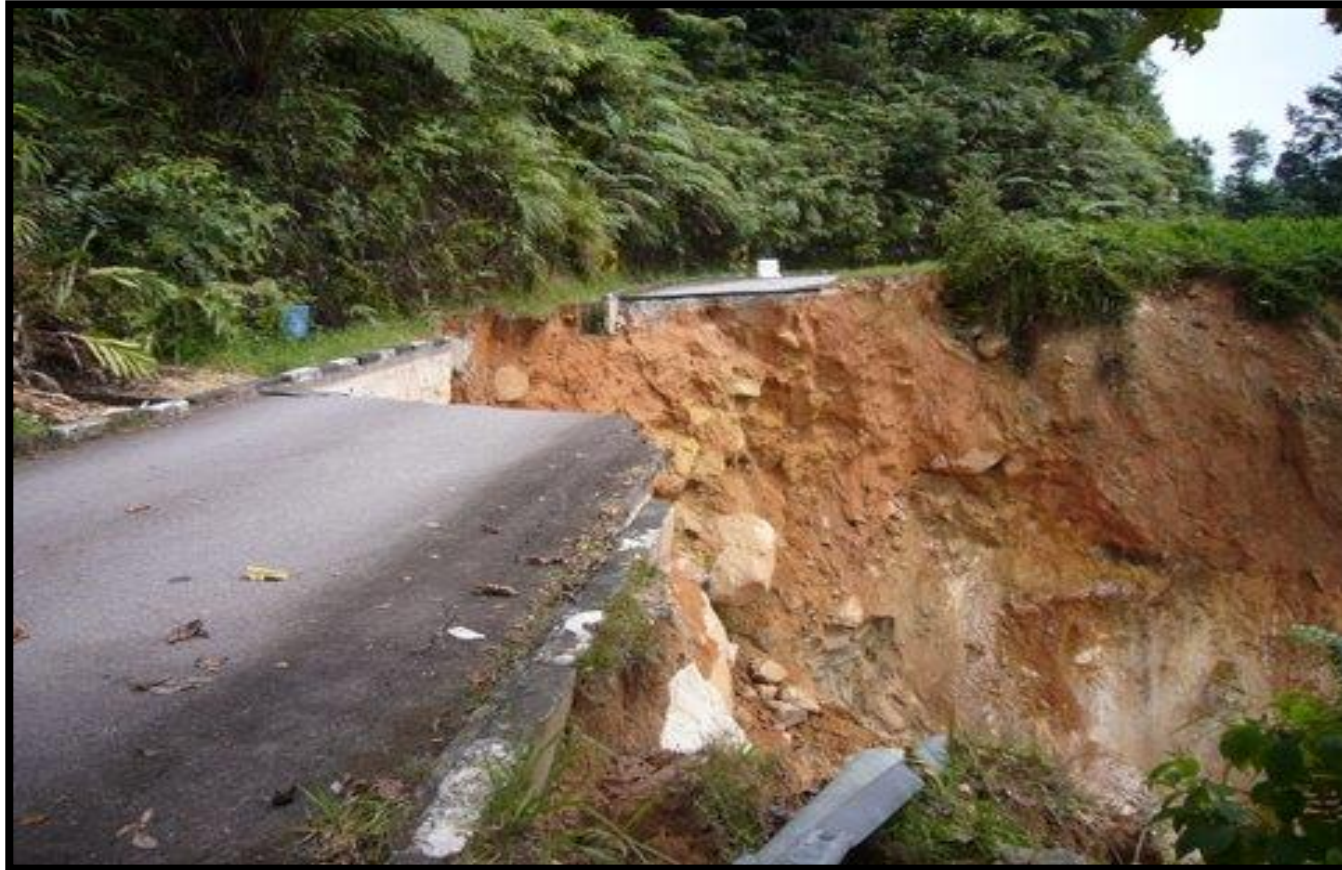
**14 Feb 2008 – Cerun mulai gagal**

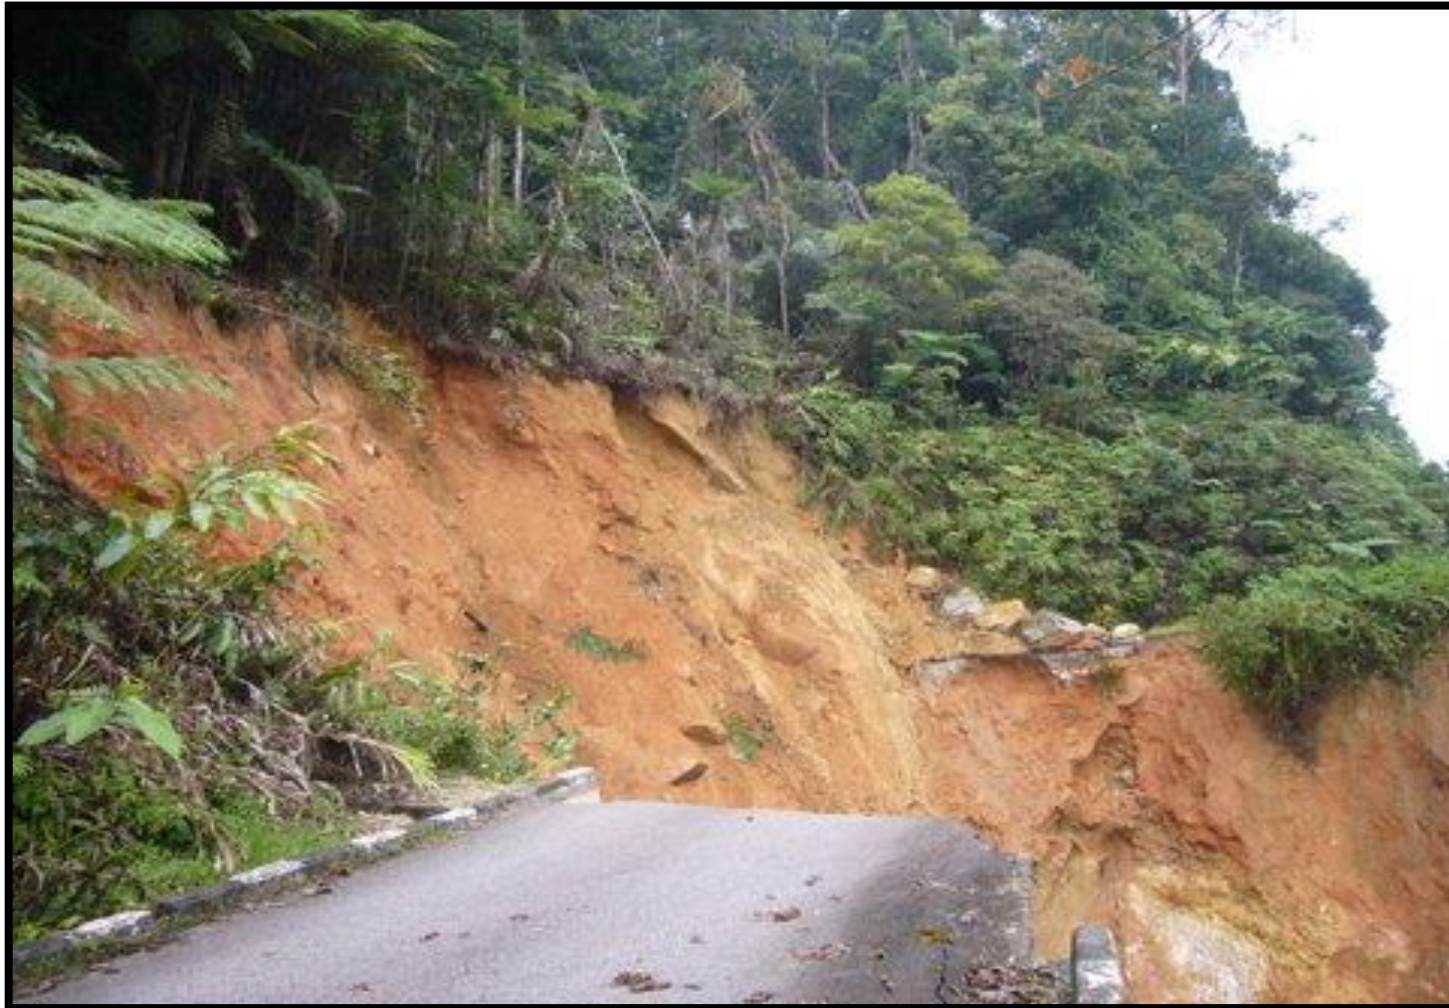
**3 Mac 2008- Sekitar 10m tinggi cerun potongan  
mula runtuh selepas berlaku hujan lebat**

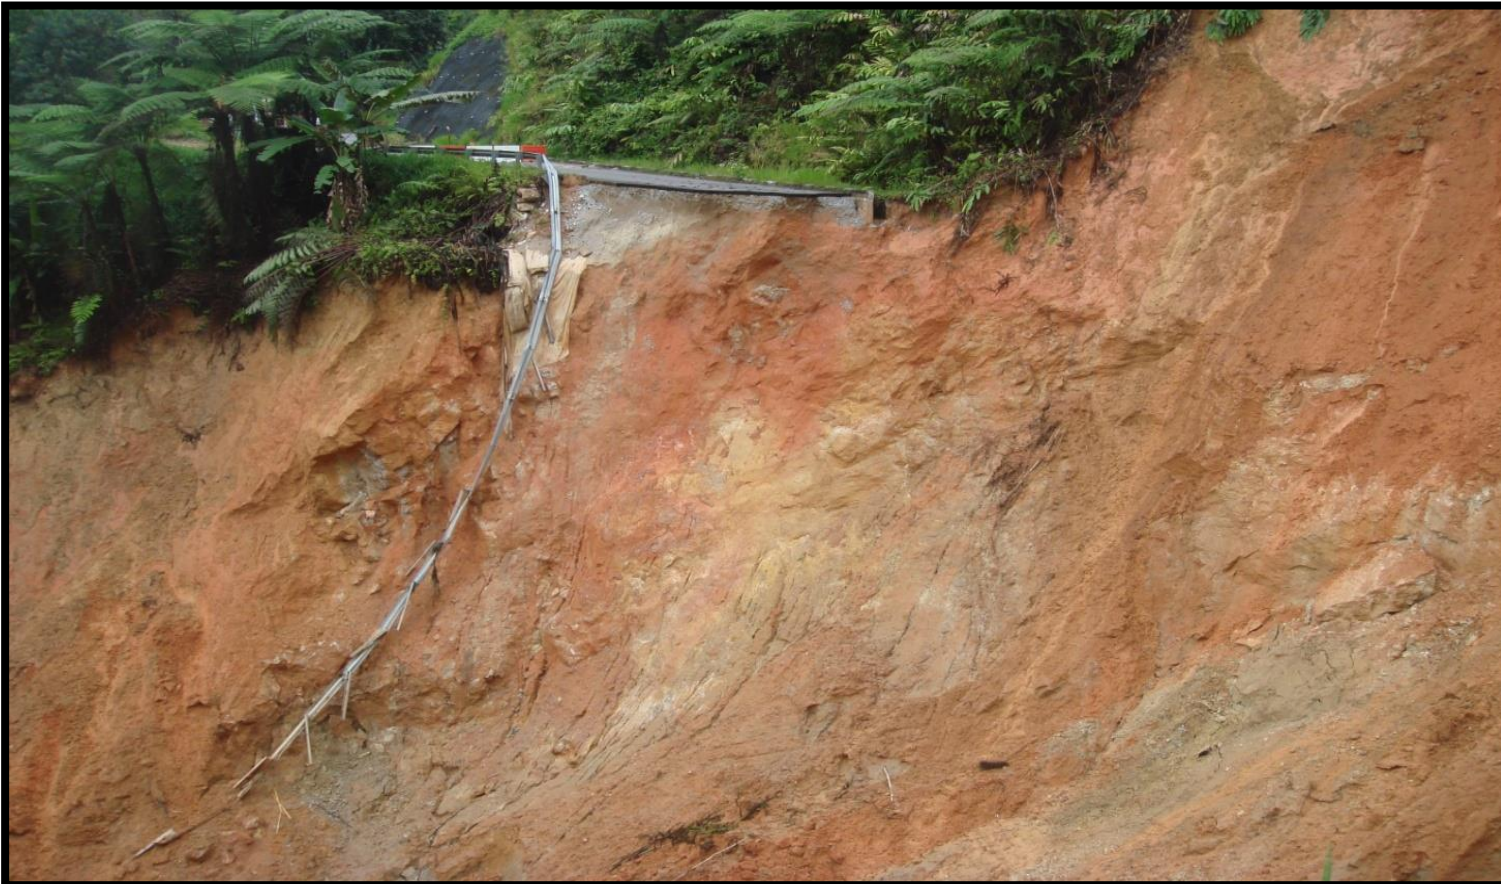
**2 April 2008- Keadaan runtuhan yang semakin membesar.**

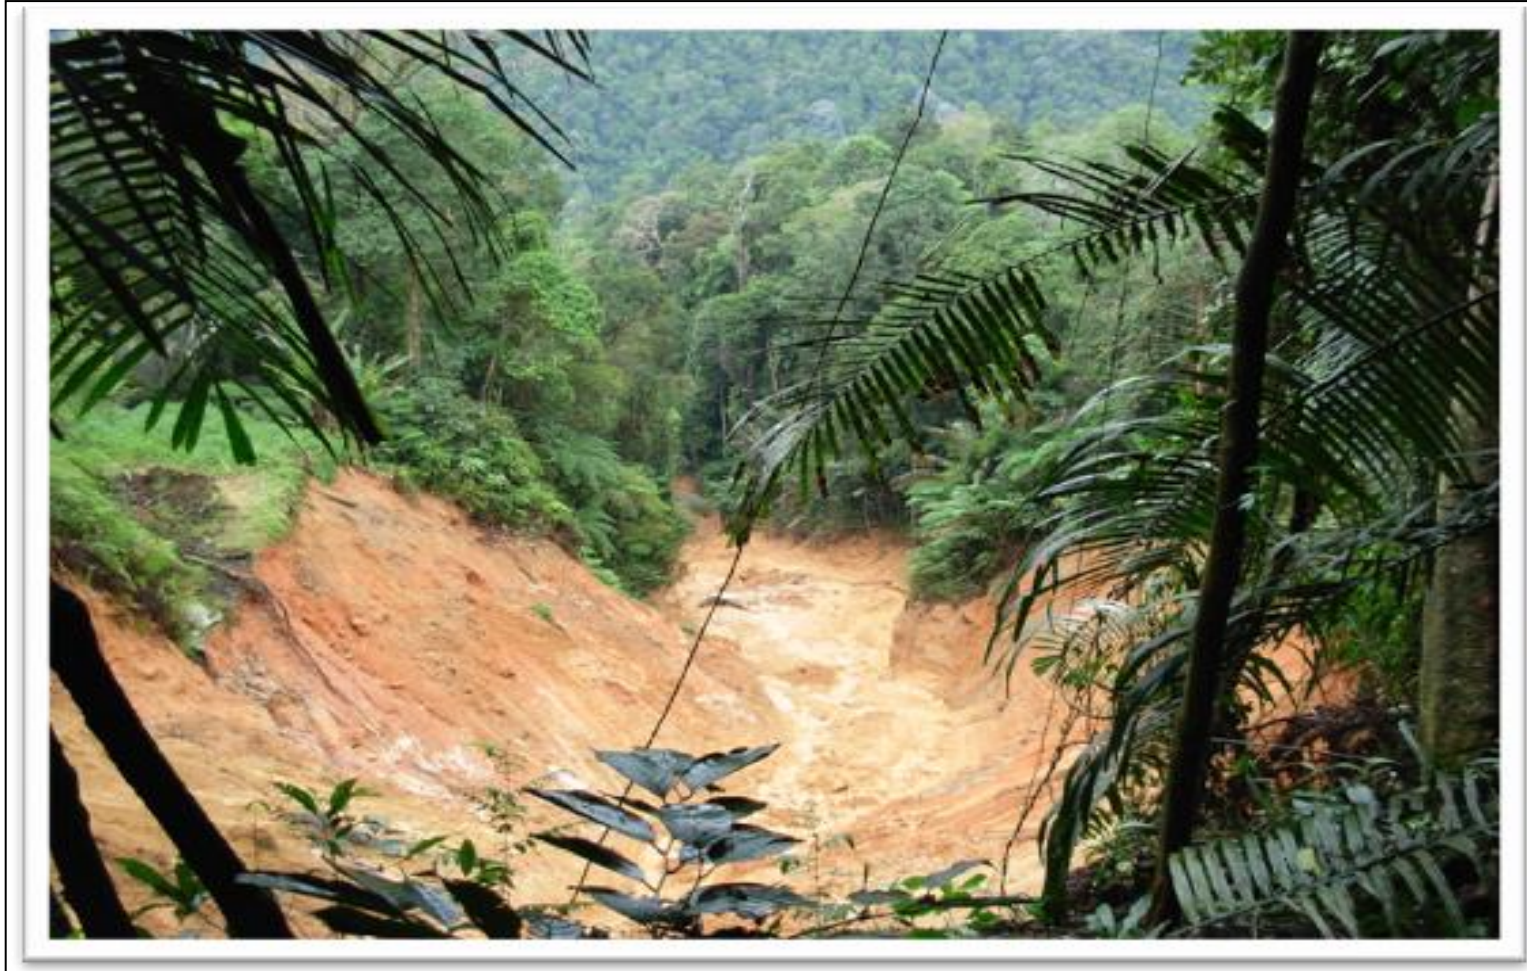
## 2 April 2008- Pandangan Down slope

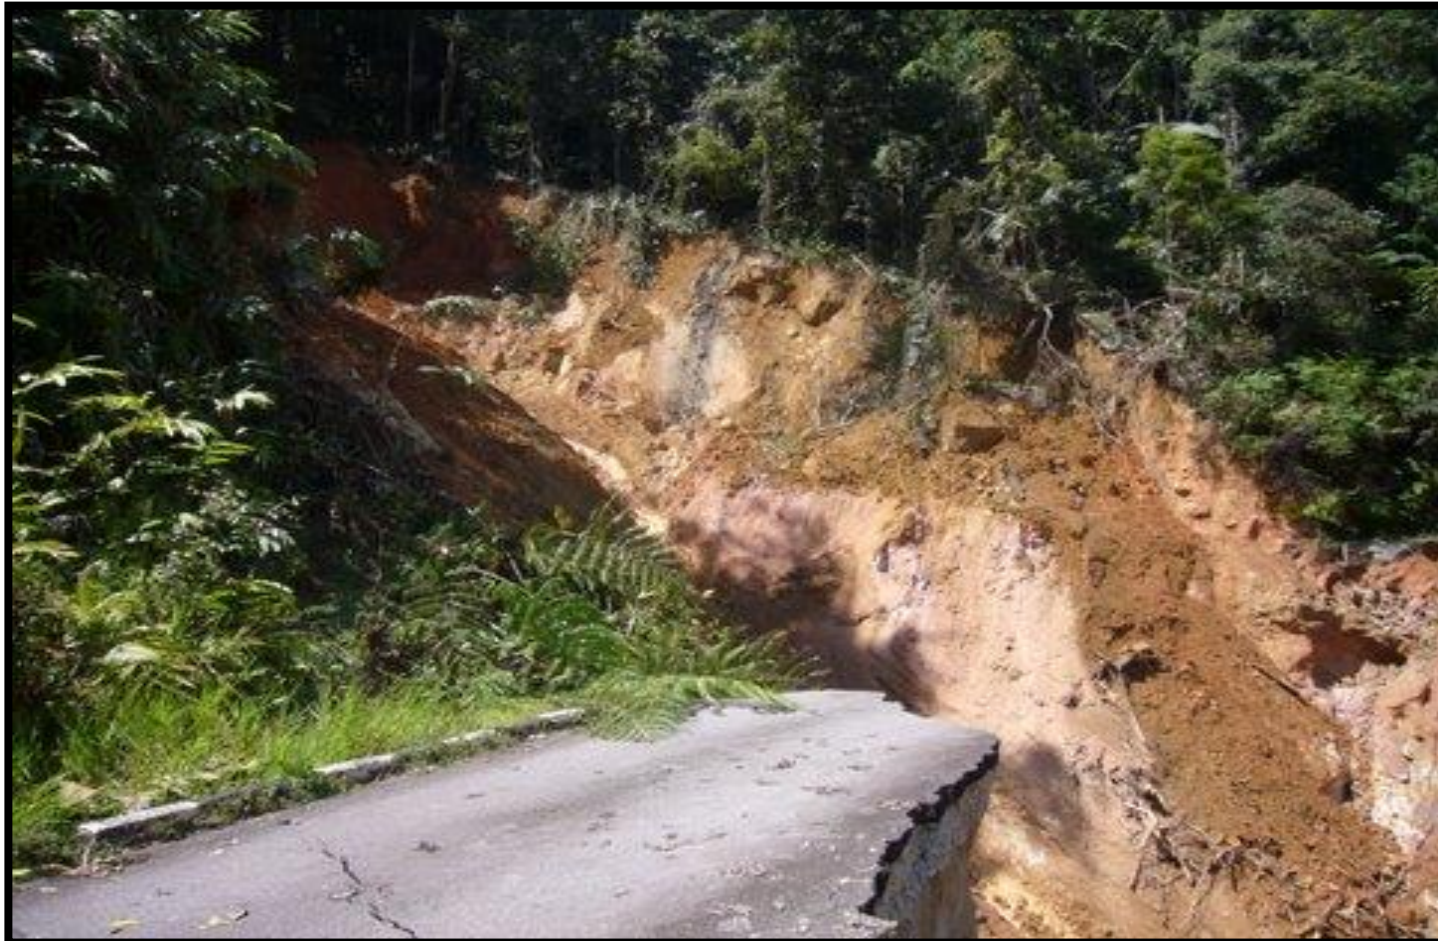
**14 April 2008- Ketinggian cerun potong yang gagal adalah sekitar 50m kepada puncak cerun.**

- 14 April 2008 - Disebakan oleh keadaan semasa, JKR Pahang memutuskan untuk menggunakan Option 2 iaitu menggunakan Steel Bridge dan rawatan geoteknik di sekitar cerun.
- 23 April 2008 – Mesyuarat Penyelarasan di CKC.

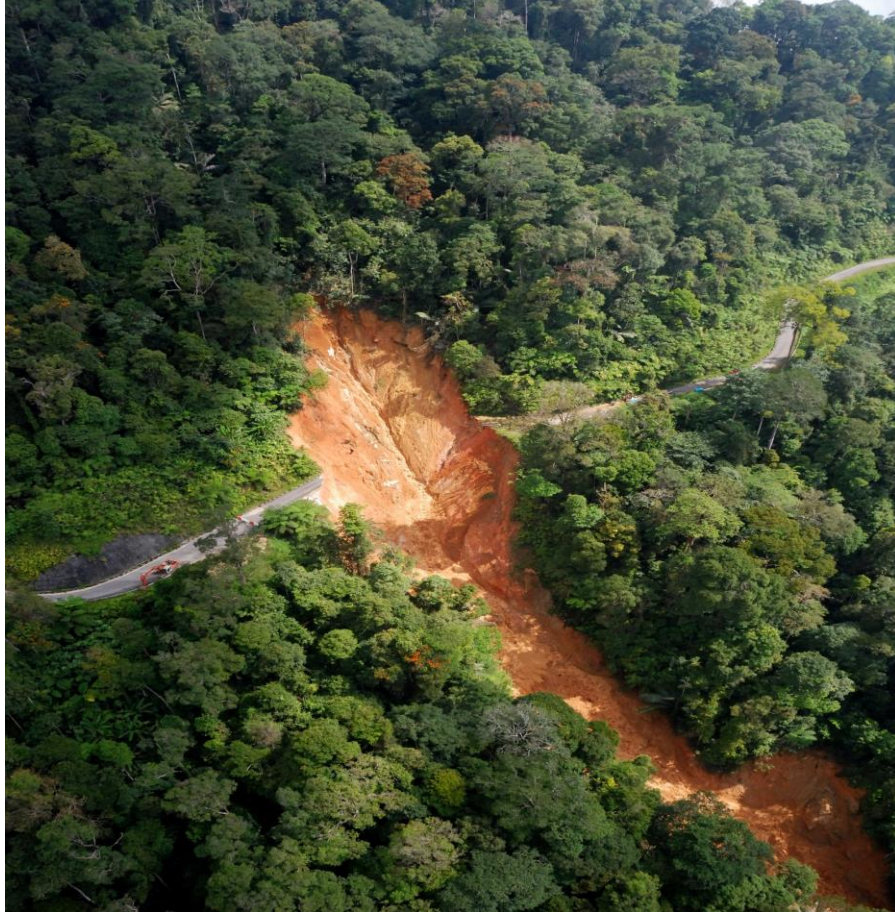
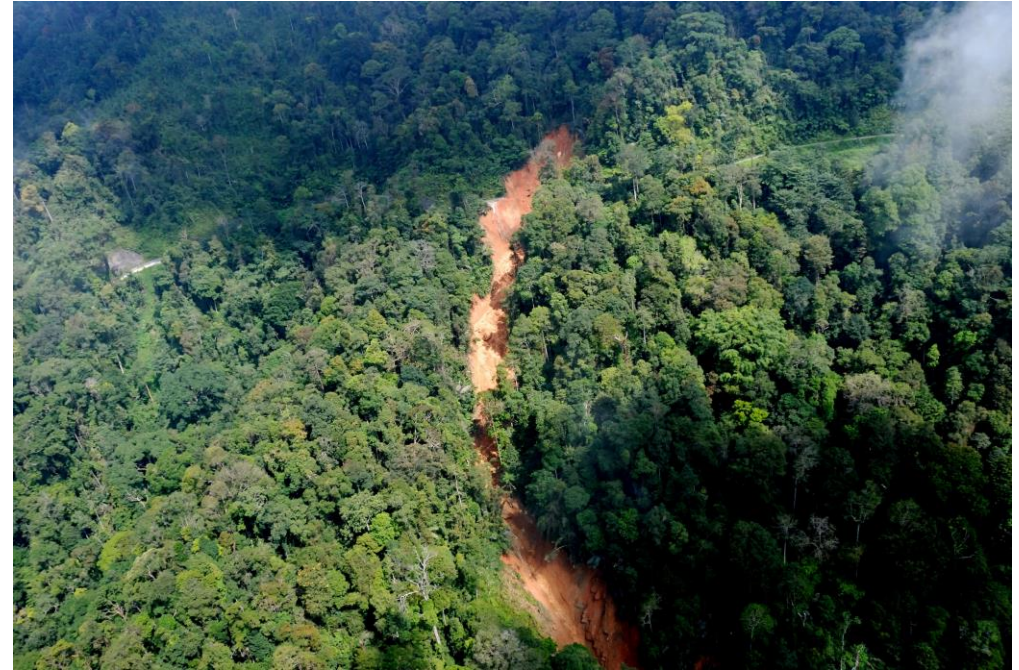
Upslope - FT 148

# RETROGRESSIVE CIRCULAR FAILURE & DEBRIS FLOW — JULAI 2008

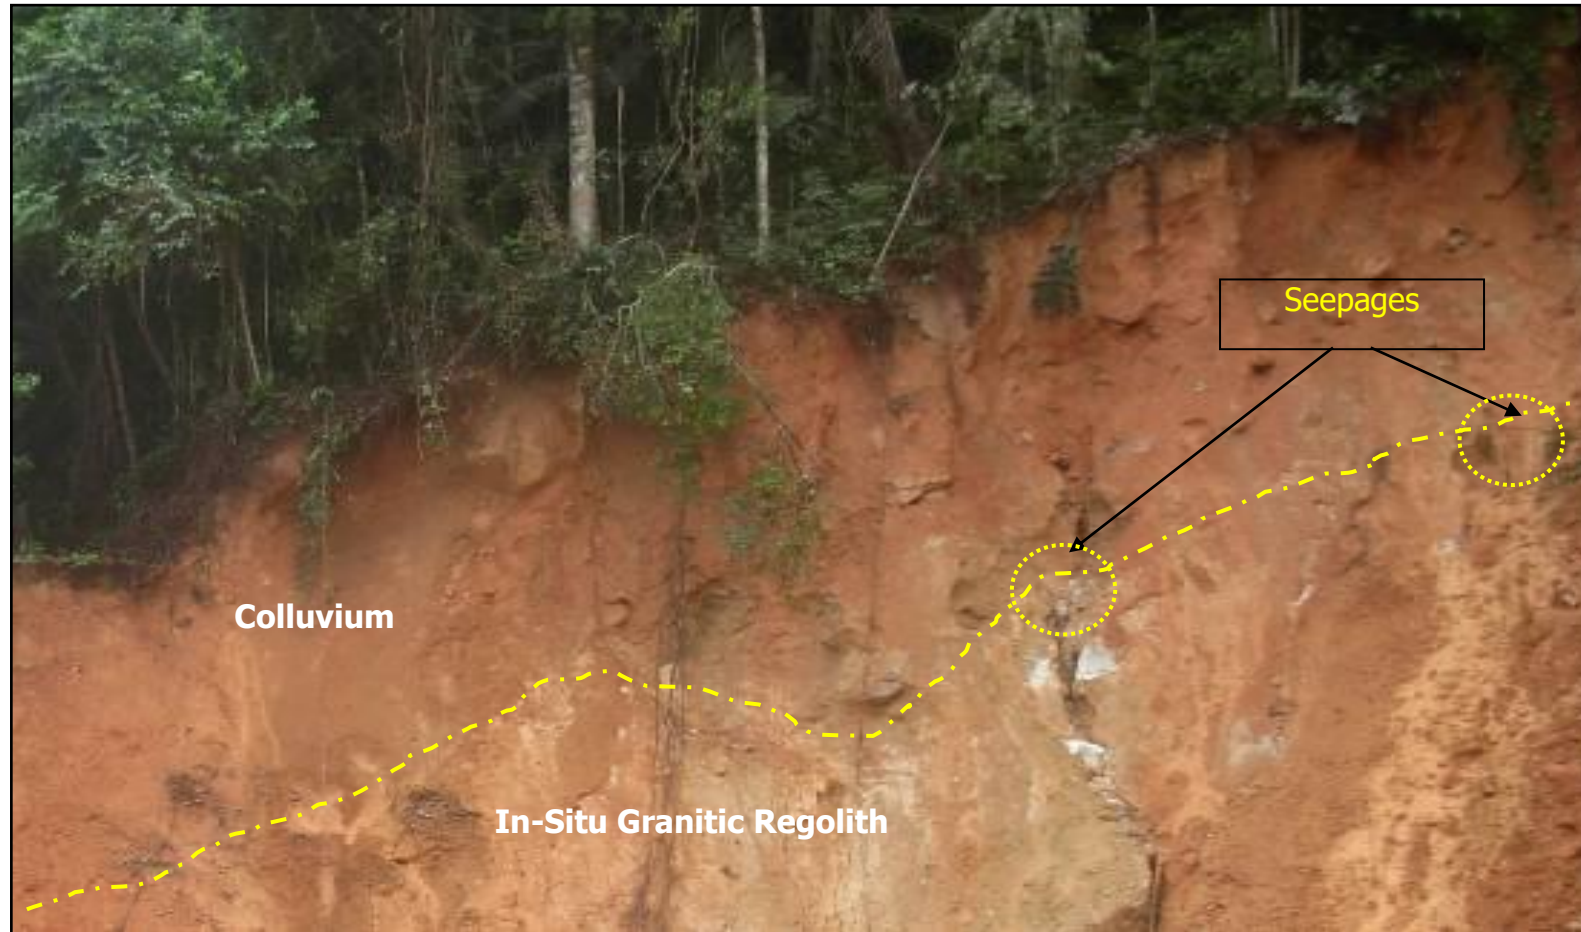
Closer view of the main failure scarp, exposing the unconformable contact between the overlying colluvium deposit and the underlying granitic regolith/in-situ soils. Note the seepages that developed along the boundary between the two different geologic materials.

- ☐ Present of intersection of two relict discontinuities which form a wedge and the line of intersection is day lighting toward the valley axis. The relict structure are kaolinite-infilled.
- ☐ Geomorphic setting of the slope which located in uphill or hanging valley which is highly favourable for slope failure.

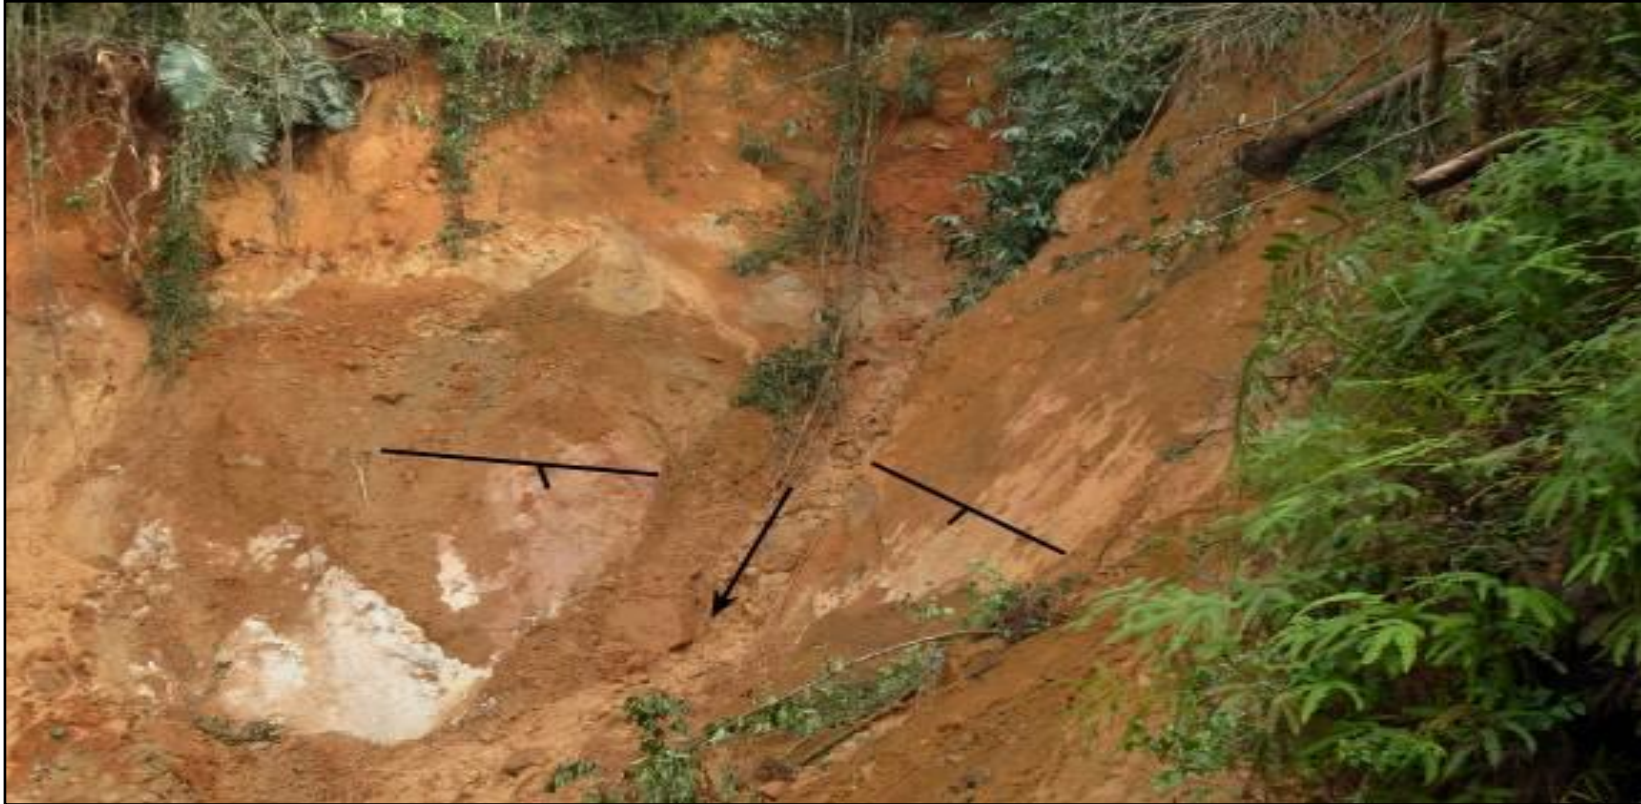
View of the failure scar exposing the two intersecting major relict discontinuities which defining a wedge-shaped geometry. Arrow indicates the line of intersection between the two planes (marked by lines with tick marks), and the exposed whitish materials are the kaolinite dyke.
