## **DEVELOPMENT OF ALERT WARNING SYSTEM**

**ALERT WARNING SYSTEM  
AT HUTAN LIPUR GUNUNG PULAI 1  
JOHOR DARUL TAKZIM**

INSTALLATION OF AN EARLY WARNING  
SYSTEM AT SUNGAI AYER HITAM BESAR  
CATCHMENT AREA HUTAN LIPUR GUNUNG  
PULAI 1 (HLGP1), KULAI, JOHOR BAHRU

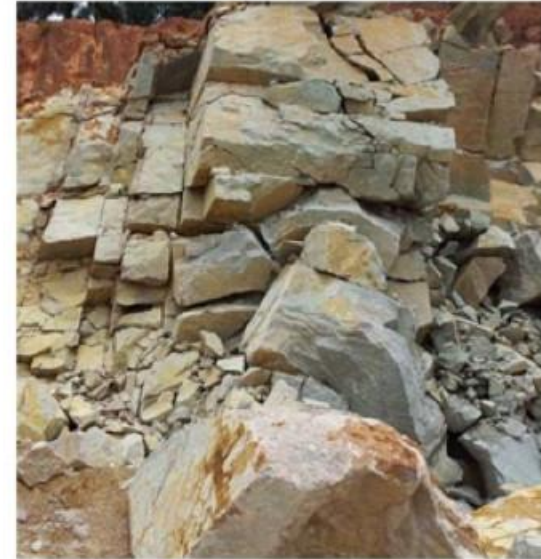
**Pelotan **stereo-net** & **polar**, arah potensi kegagalan (*the direction of any potential failures*) dalam batuan boleh ditentukan**

**Potensi gagal sendeng ke arah Timur :**  
**TIDAK KRITIKAL**

**(Aras 1 dan Aras 2 terletak di arah Barat)**
