A COMPREHENSIVE STUDY ON THE VIBRATION OF HIGHWAY BRIDGES

Final Report

Volume I

**A COMPREHENSIVE STUDY ON THE VIBRATION
FOR HIGHWAY BRIDGES**

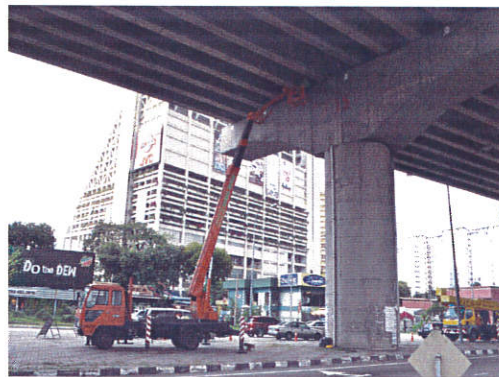
- a. By foot for inspection of the approach spans, namely Spans 1 to 4 and Span 24. Some of the higher piers and bearings were accessed by the use of a ladder and some of the higher deck was inspected by using binoculars.
- b. Using a skylift for inspection of Spans 5 to 23. For the inspection of these spans, the skylift was positioned on the central median near the two piers of that span in order to have the closest access to the pier crossbeams, bearings, beams and end diaphragms (See Figure 11).

Figure 11: Inspection using skylift

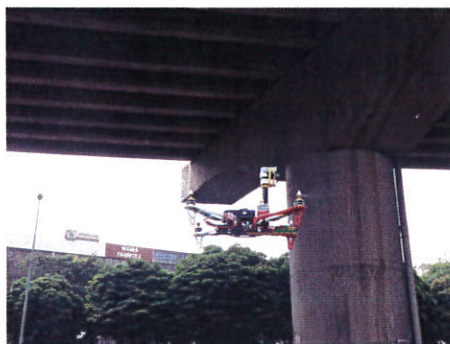
During the early stage of the study, the Consultant had used an unmanned aerial vehicle (UAV) with attached camera for inspection of the bridge deck and bearings (see Figure 12). The pictures collected at this early stage were useful as a reconnaissance survey and presented in the preliminary inspection reports.

Figure 12: Remote controlled UAV used for inspection

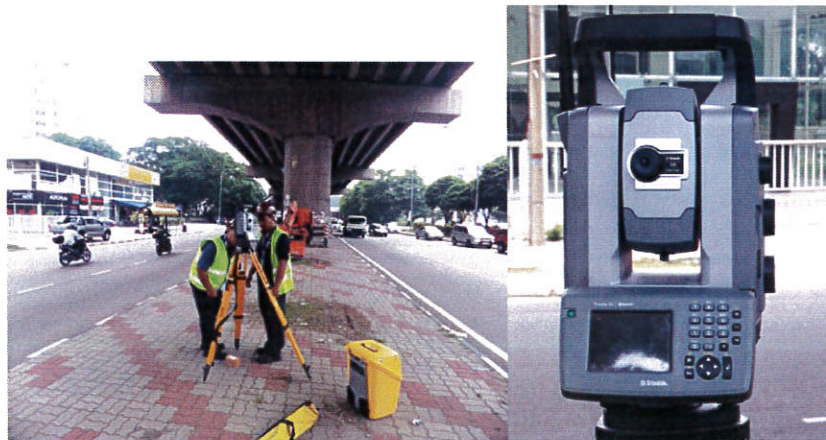
Figure 14: Trimble S8 1" robotic total station

The Surveyor used the Trimble Real-time Monitoring to monitor the deflection of the beams and pier. This system consists of a Trimble S8 1" Robotic HP with Finelock Total Station (Figure 14) for target measurement; Trimble Access Software for field data collection, data computation, analysis of target displacement and review; Trimble Monitoring Prisms (Figure 15) for target (monitoring point) and as references (control points); an internal barometer in total station for automatic PPM correction of EDM distances measurement.

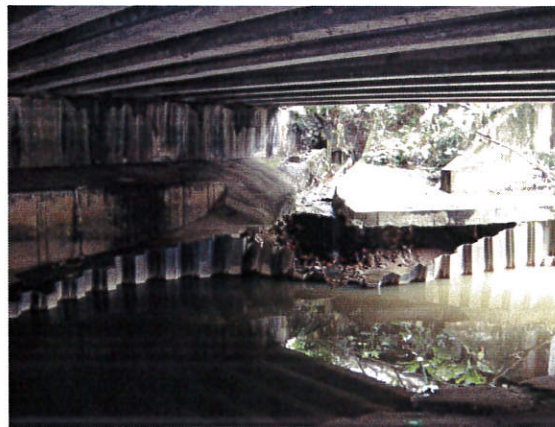
Figure 37: Damaged sheet piles

The sheet piles bank protection at downstream of the Abutment A of the slip road bridge had tilted and deformed resulting in exposure of the soil behind them and below the RC slab. See Figure 37. The failures could have been caused by the water from the roadside drain being channelled directly at the sheet piles (bottom picture). During the time of inspection, some of the exposed soil had been washed away and some of the sheet piles in front of Abutment A had tilted slightly. It is recommended that immediate remedial action be taken to rectify the damage. Even though the damage is slightly downstream from Abutment A, early intervention is important as the exposed soil is susceptible to further erosion/scouring and failure may propagate further and affect the integrity of Abutment A.

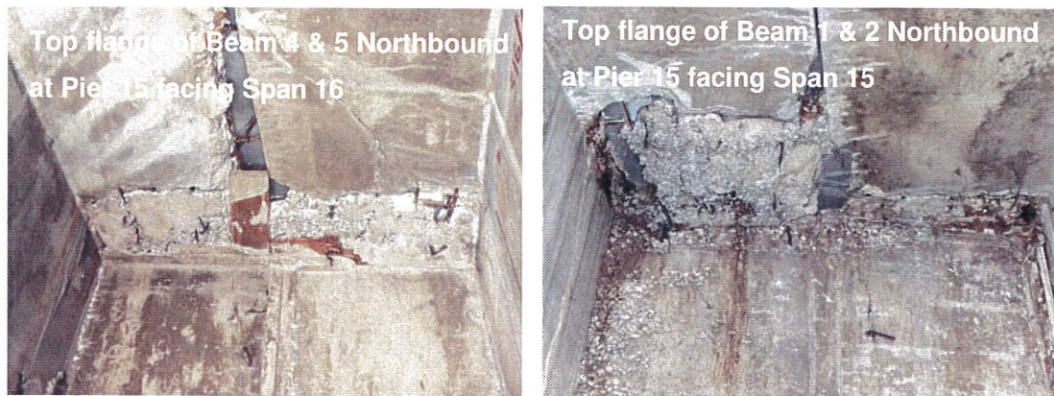
Figure 39: Some top flanges at beam ends that suffered from poor concreting

resulting in poor concrete finish with some having exposed reinforcement. Even with these defects, no structural damage was detected. Notwithstanding, it is recommended that the poor concrete be repaired to ensure that there is no future durability problem such as corrosion and spalling of reinforced concrete members.

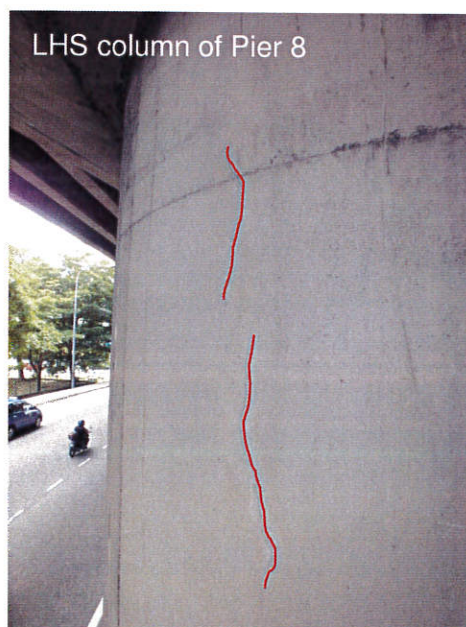
Fine vertical cracks were observed at the columns of Pier P2, P8, P9, P12, P13, P16 and P 19. See Figure 41. These cracks were fine with width of not more than 0.2mm and were located randomly on the surfaces of the pier columns. These cracks were likely to be caused by shrinkage based on their width, location and pattern of the cracks, i.e., triggered by tensile stresses induced in the surfaces of the columns due to volumetric reduction of concrete during the hydration process. Nonetheless, they should be monitored to check whether they are dormant or active.

a) *Fine vertical cracks at left hand side of Pier 8 column with maximum width of 0.2mm (red line drawn adjacent to crack)*

- b) Vertical cracks at left hand side of Pier 19 column with maximum width of 0.2mm (red line drawn adjacent to crack).

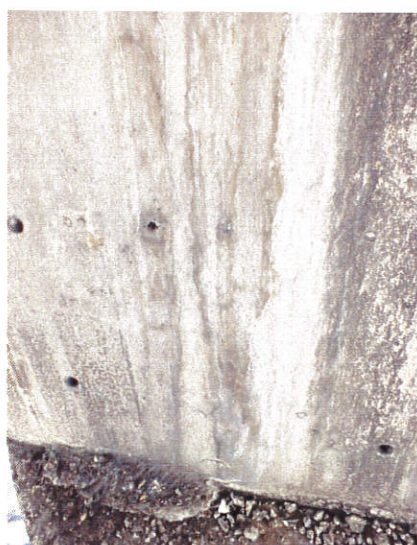
Fine vertical cracks were observed at the base of pier crossbeam of Pier P7 and P14. See Figure 42. These cracks with surface width lesser than 0.1mm occurred at the base of the crossbeams directly above the pier column and propagated vertically up. The crack at Pier 7 occurred only on the back face. The crack at Pier 14 occurred at both the front face and back face of the pier crossbeam but it is unlikely that they are through cracks as their locations and patterns did not match one another. These cracks did not appear to be structural and could have occurred during construction when the crossbeams were rotated into positions or when the crossbeams were stressed into place. Nonetheless, JKR should monitor them periodically to verify that they are dormant.

a) *Fine vertical crack with width smaller than 0.1mm at the back face of the Pier 7 crossbeam (red line drawn adjacent to crack)*

b) *Fine vertical crack with width smaller than 0.1mm at the front face of the Pier 14 crossbeam*

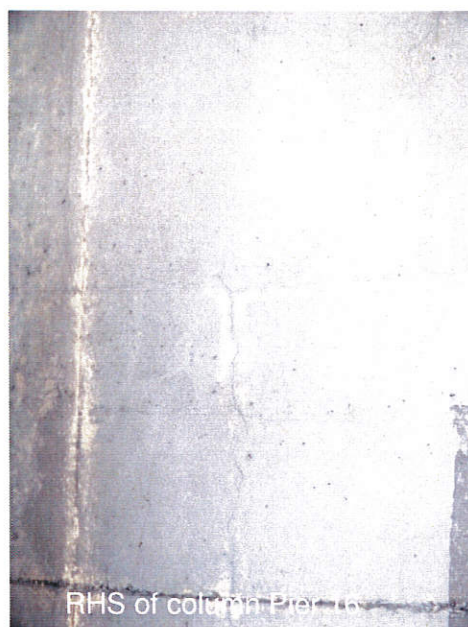
Fine vertical and transverse cracks were observed in the columns of Pier P16. See Figure 43. These cracks especially on the right hand side of the column were quite apparent even though the measured maximum width was only 0.2mm. From the observation of the crack it is difficult to determine the cause of the cracks but based on the crack widths, their locations and patterns they were unlikely to be caused by structural deficiency. JKR could confirm this by monitoring them periodically to check whether they are active or dormant.

Figure 43: Fine vertical and transverse cracks with maximum width of 0.2mm at right hand side of column Pier 16

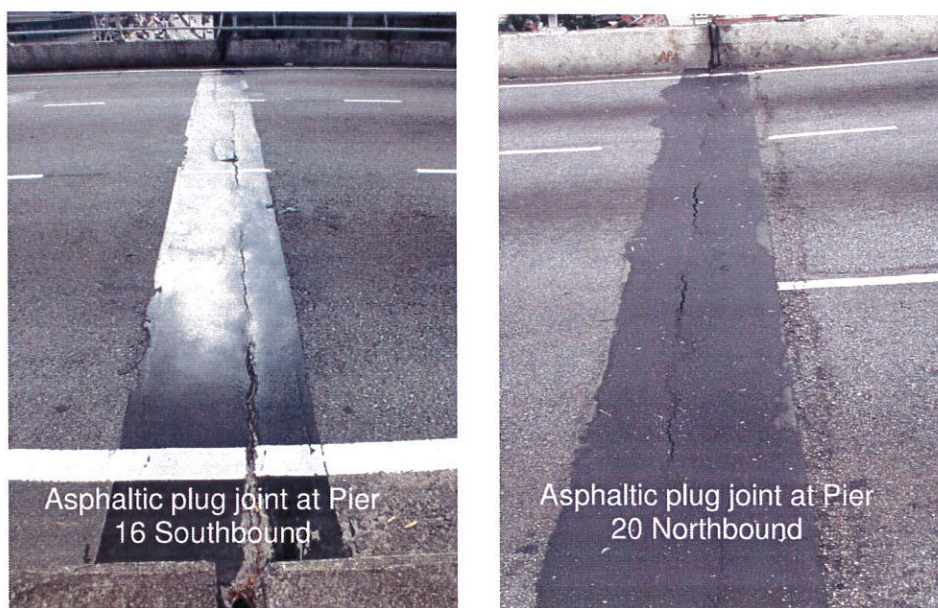
Figure 46: Cracks in asphaltic plug expansion joints

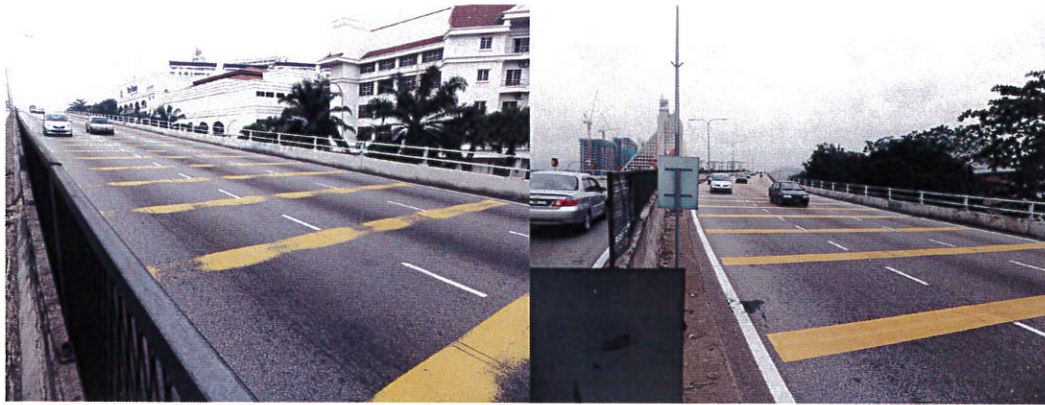
There is an anomaly observed in Span 4 (Northbound B4, B6) which has caused the vibration readings to exceed 80mg for approximately 2% of all span records. The spans over Frame #1 are on a negative gradient and have transverse bars on the pavement (see Figure 51). The combined effect of acceleration/deceleration from low/high speeds coupled with impulse induced when travelling over the transverse bars are suspected to be the source of this anomaly. The effect of surface roughness

a) Northern approach

b) Southern approach

Figure 51: Transverse bars at approach spans

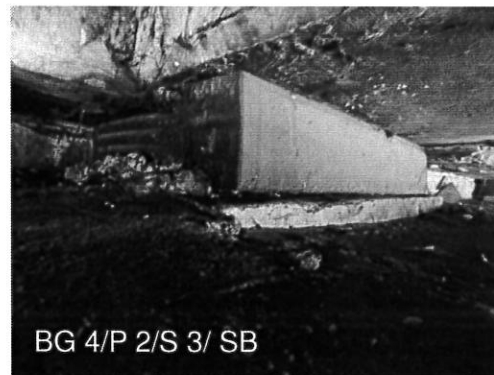
A few of the rubber bearings at Pier 2 were observed to have less than full contact with the beams and bottom plinths (see Figure 57). From the site inspection, area of contact was estimated to be about 75% of the existing bearing size. The bearings were nonetheless found to be in good condition with no visible sign of deformation or displacement. Apparently, the defect in seating was too minor to have caused the bridge to vibrate.

Figure 57: Some bearing that was not in proper contact with the beams

To further satisfy itself the Consultant had proceeded with a study using the calibrated FE model. In the model, elastomeric bearings are modelled as a special “link” element which takes into consideration the compressive and lateral shear stiffness of elastomeric bearings. By assigning values of stiffness to cater for two extreme cases of the bearing seating conditions, namely, “Fully Contact” and “Partially Contact”. The results are plotted in Figure 58.
