# **LESSONS LEARNED: Best Practice for Quality Architecture**

**A Chapter on Ceiling System:  
What Went Wrong,  
What Can Be Learned and What Can Be Done**

**Prepared by : Bahagian Reka Bentuk Fasiliti Pendidikan Tinggi | Cawangan Arkitek, IPJKR**

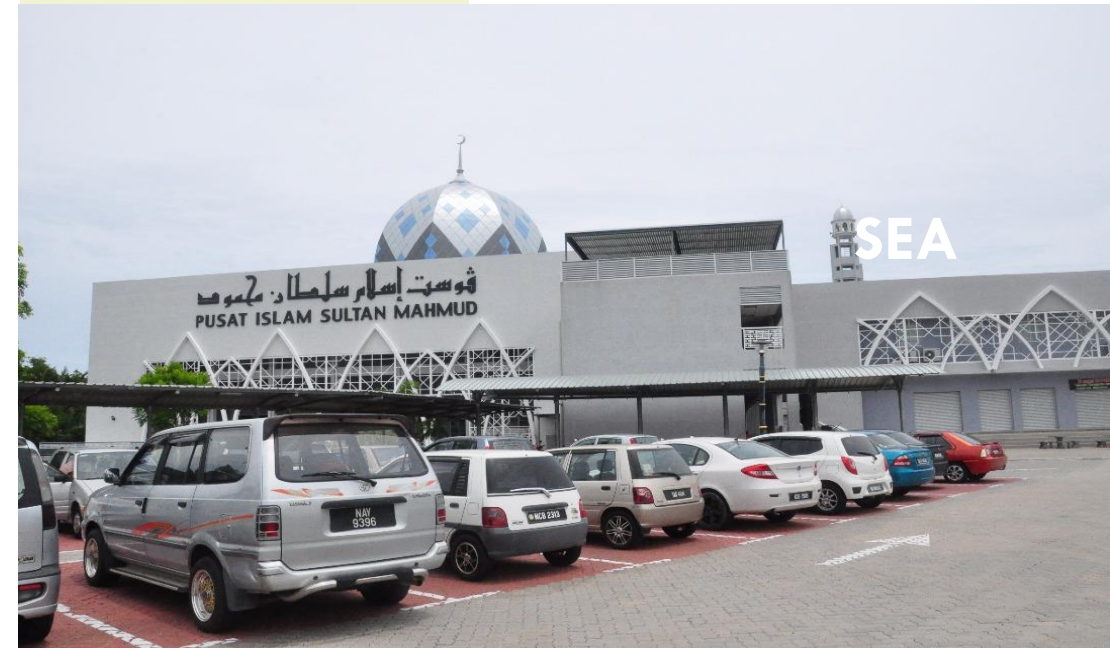
## **Type of Ceiling: Aluminium Strip Ceiling**

- **Failure/Defects:**  
Aluminium Strip Ceiling  
Collapsed
- **Location:**  
Mosque's Verandah

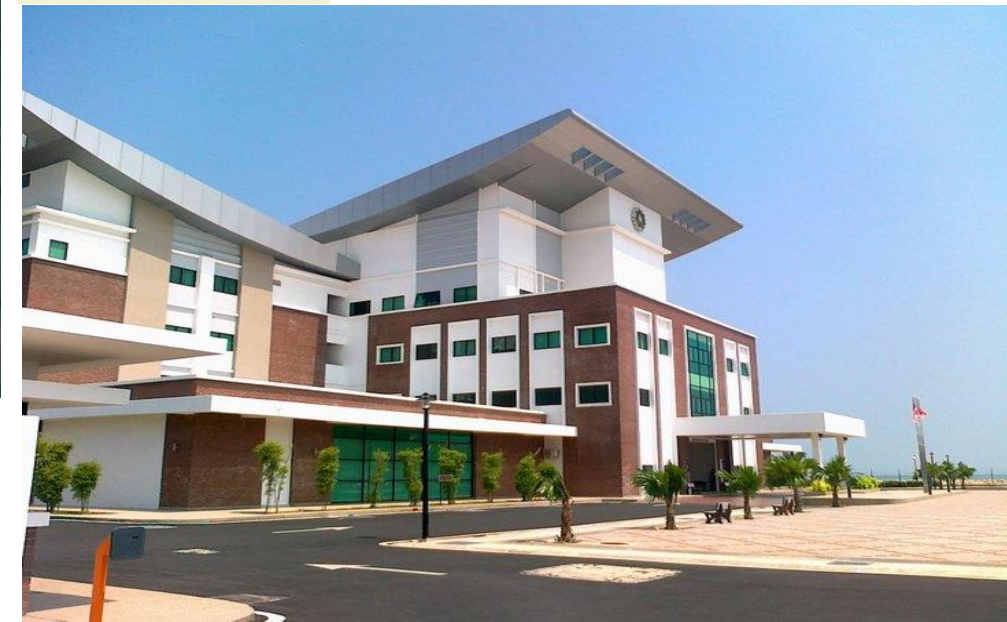
### TELOK MAS, MELAKA

- Coastal area
- Expose to direct wind and weather
- Regional Headquarter Office

- **Failure/Defects:**  
External aluminium strip ceiling plunge into the balcony area
- **Location:**  
Roof Top Floor  
(Main office building)  
Third Floor  
(Balcony Area)

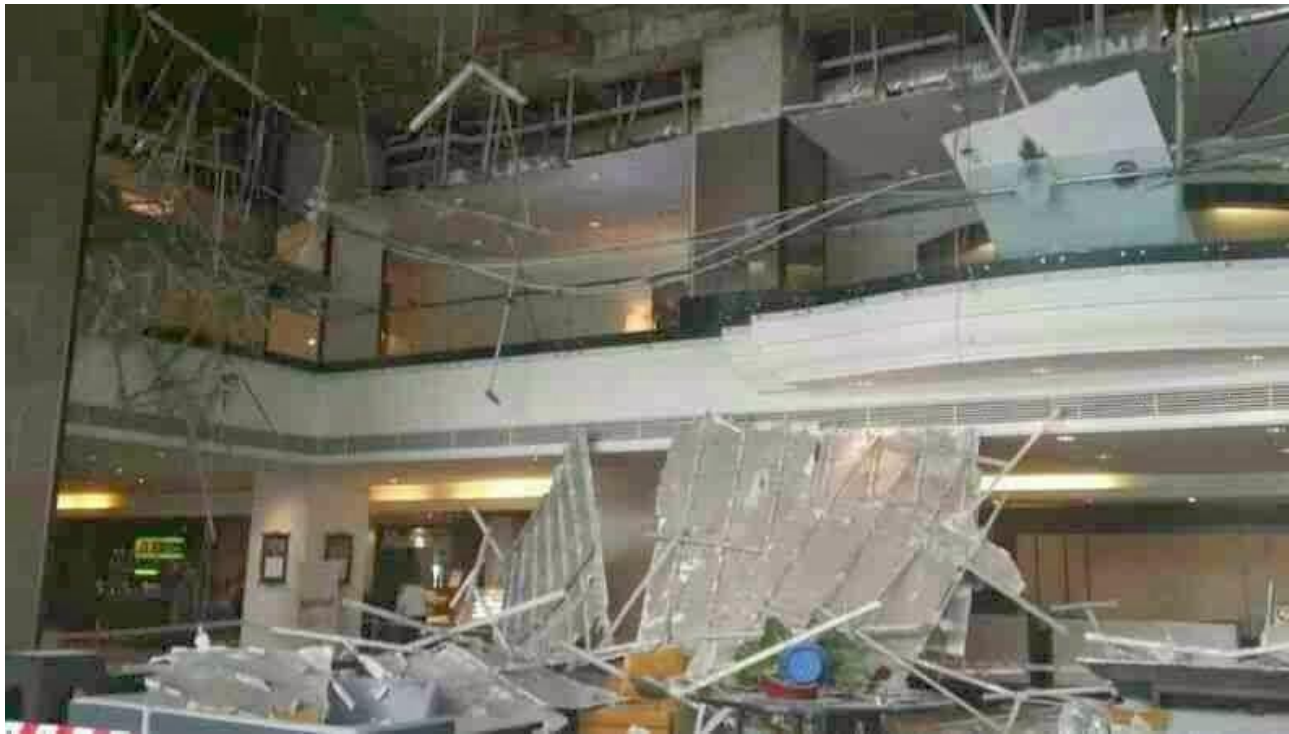
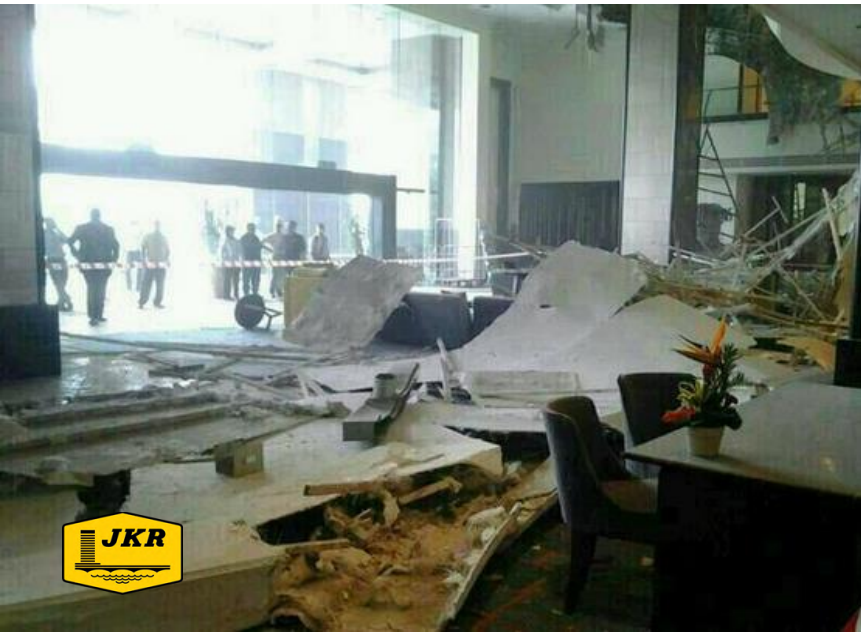
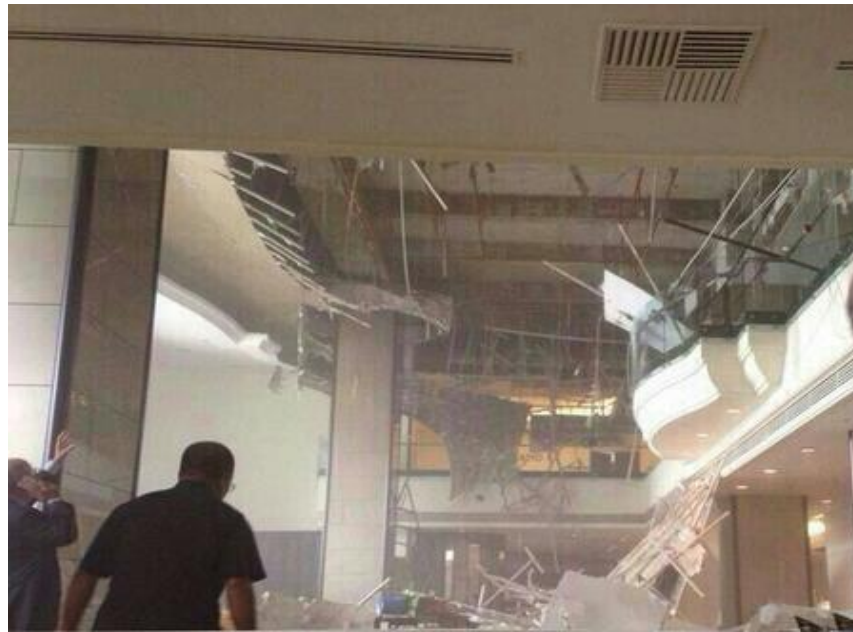
# Concorde Hotel Shah Alam

A portion of the ceiling of the Concorde Hotel here collapsed but no casualties or injuries were reported.

It is learnt that the hotel was undergoing upgrading works but it is not known if the ceiling collapsed due to construction work.

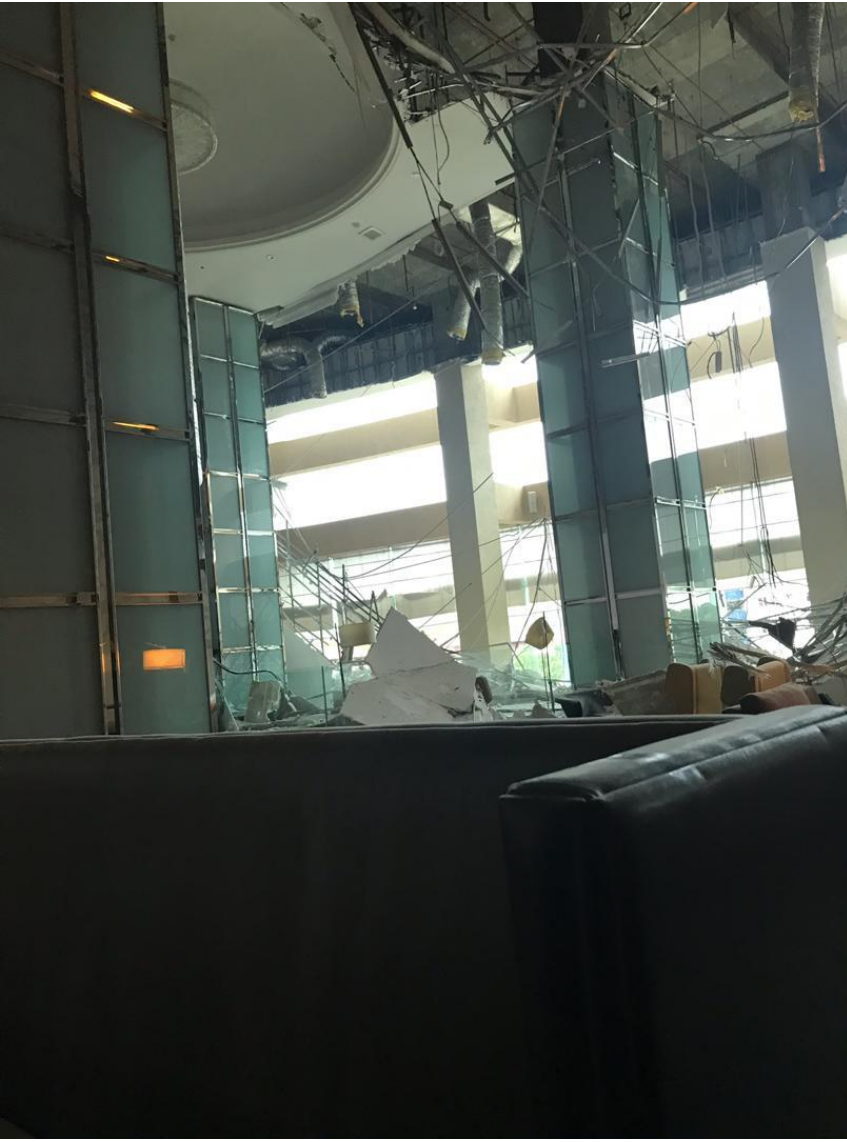
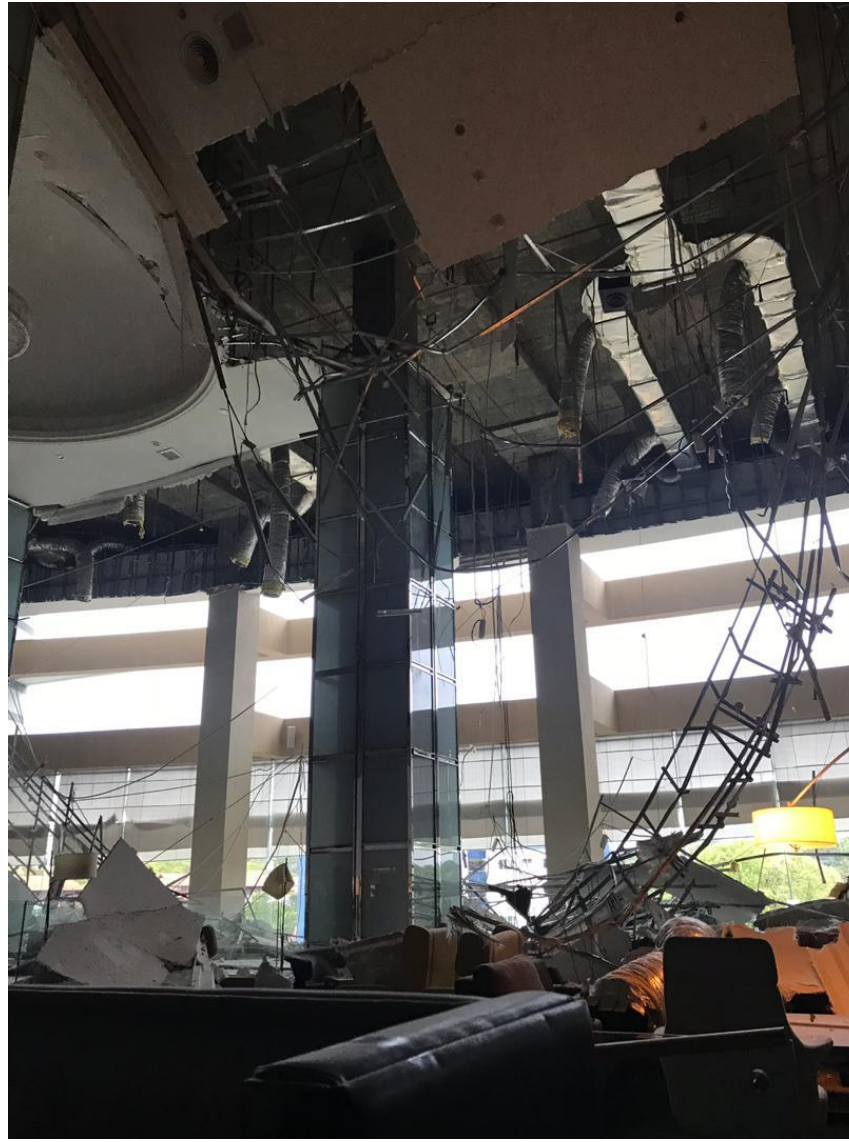
# KL Hilton

14<sup>th</sup> October 2018

According to a report from the KL Fire and Rescue Department, the ceiling collapsed just before 3.40am. At the time, repairs were being carried out on the electrical wiring.

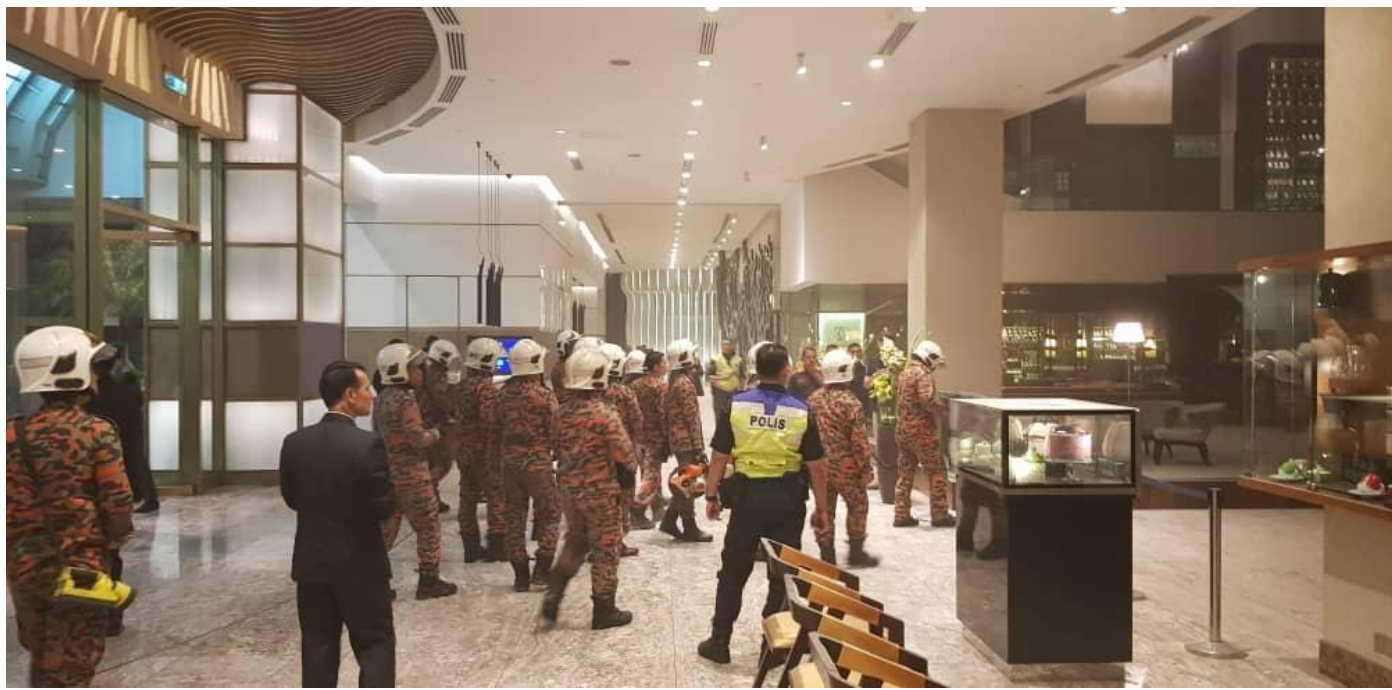
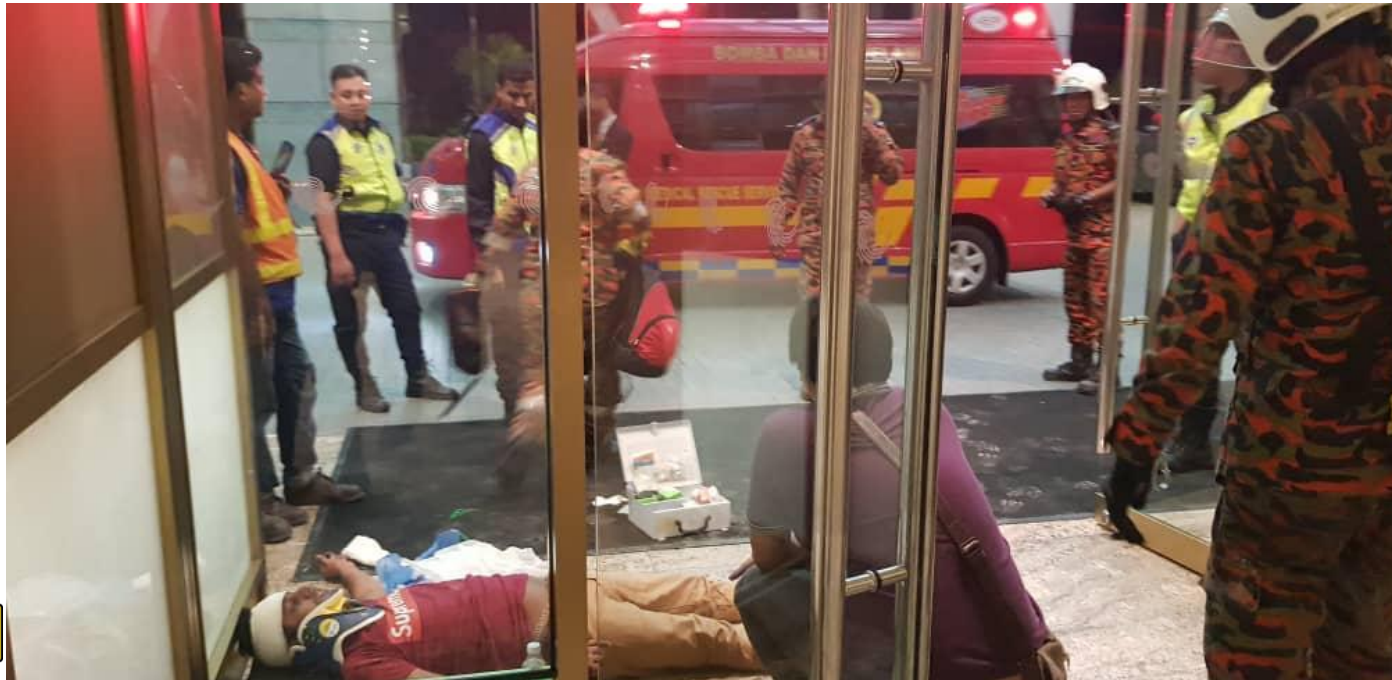
KUALA LUMPUR: A foreign worker suffered head injuries after falling some 40 feet, when the plaster ceiling of the lobby at the Hilton Kuala Lumpur in KL Sentral came crashing down early this morning.

Some 1,500 square feet of the ceiling collapsed, causing the foreign worker from Bangladesh to fall.

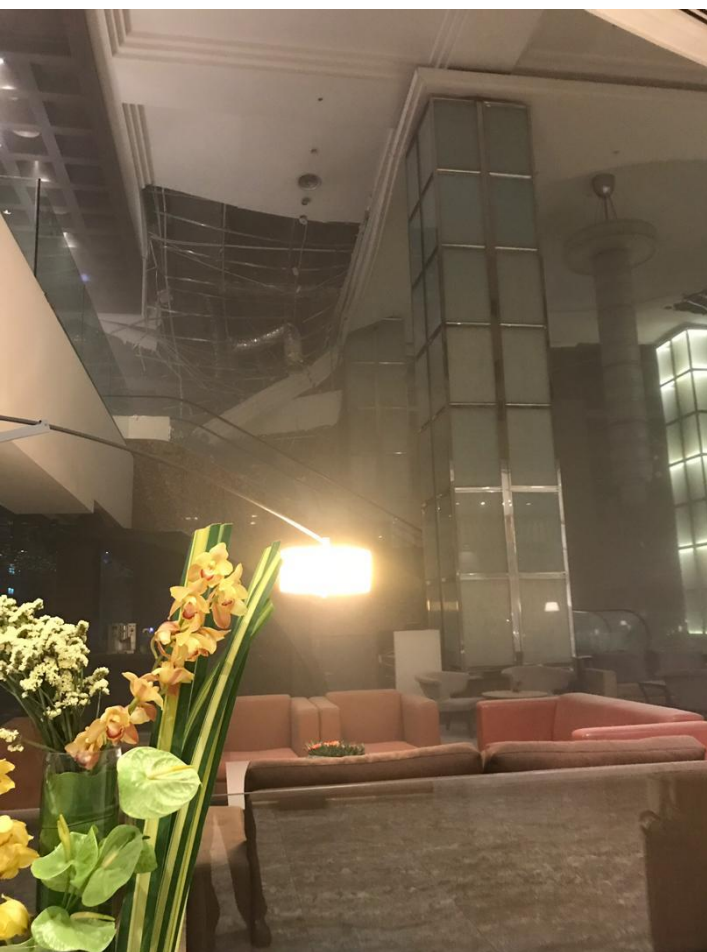
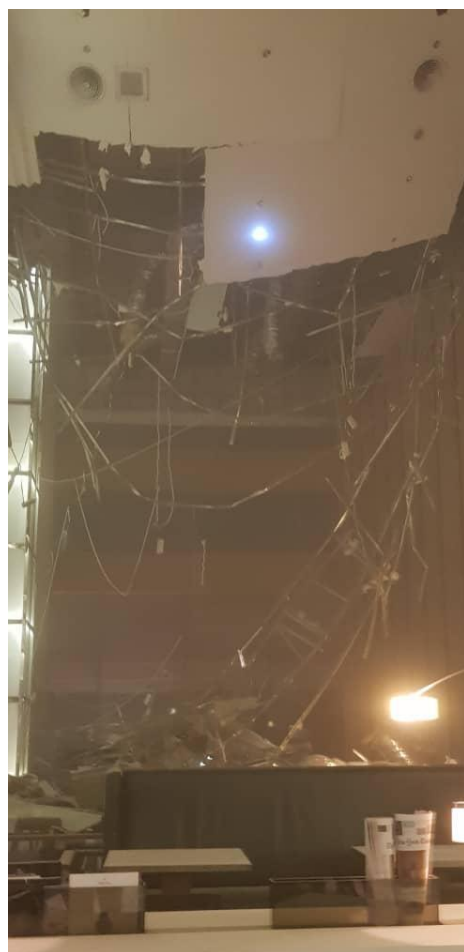
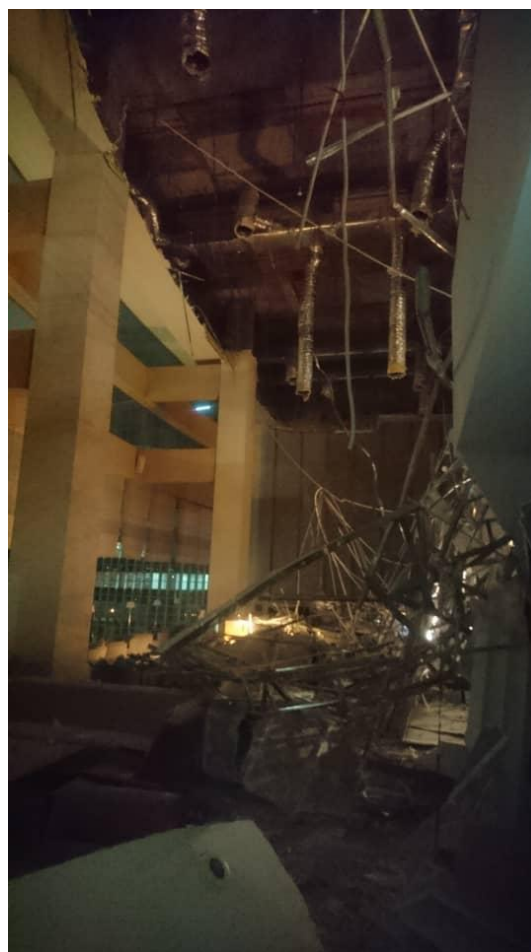
A Hilton Kuala Lumpur spokesman said during an overnight routine maintenance work on the ceiling lobby by an approved maintenance contractor, an incident occurred causing a part of the ceiling to give way. The area will be temporarily closed to the public
