# Power Quality Study

**Voltage Sags (Dips) in Distribution System and  
Residual Current Circuit Breaker (RCCB)  
Nuisance Tripping at Distribution Board  
ISTANA BUDAYA**

**JKR – UiTM**

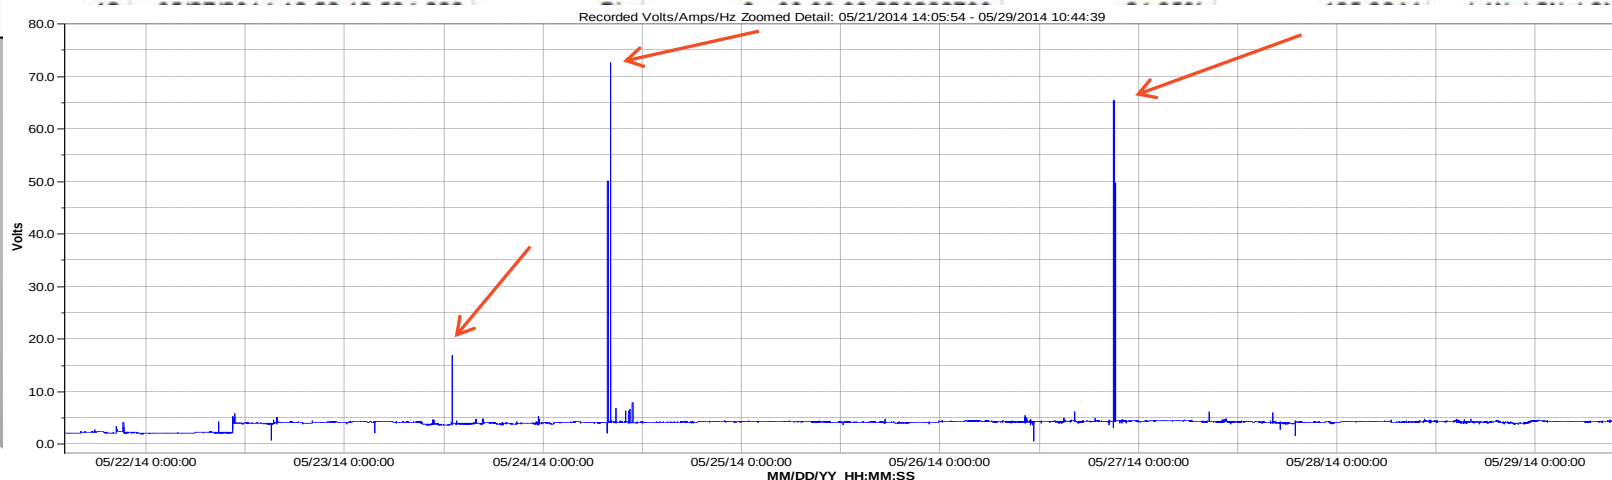
# Neutral to Ground Voltage Events – MSB D

Indicates 'Intermittent Single Line-to-Ground Fault (SLG)' within electrical supply distribution system

- Indicates 'Intermittent Single Line-to-Ground Fault (SLG)' within electrical supply distribution system.
- Can cause damage to electronic equipment and nuisance tripping of RCCB.

- i. Check the wiring installation of the electrical system and correct all the wiring errors such as intermittent single line-to-ground fault and improper cable joint.
- ii. Check for loose neutral connections.
- iii. Inspect the wiring for other equipment, light fittings etc. for loose joints and terminations.
