SLOPE FAILURES IN TROPICAL RESIDUAL SOILS

Presented by:
Ir. Liew Shaw Shong

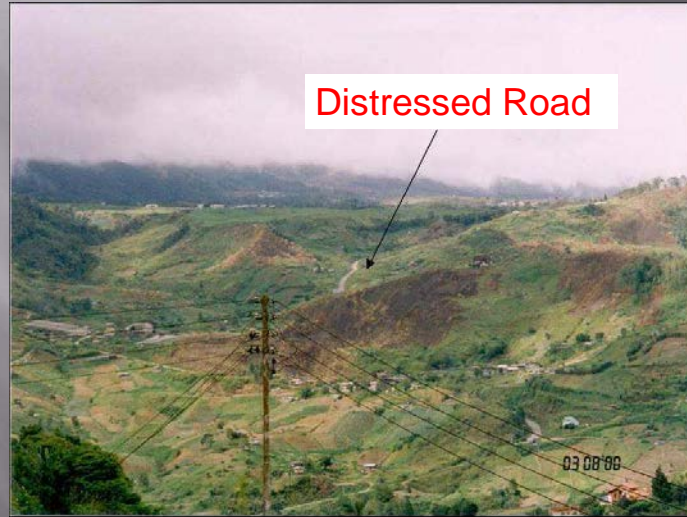
A. Creep Movement of Slope, Sabah

- Damage of road pavement and drains.
- Tension cracks, settlement and lateral movement.
- Investigation of root causes.

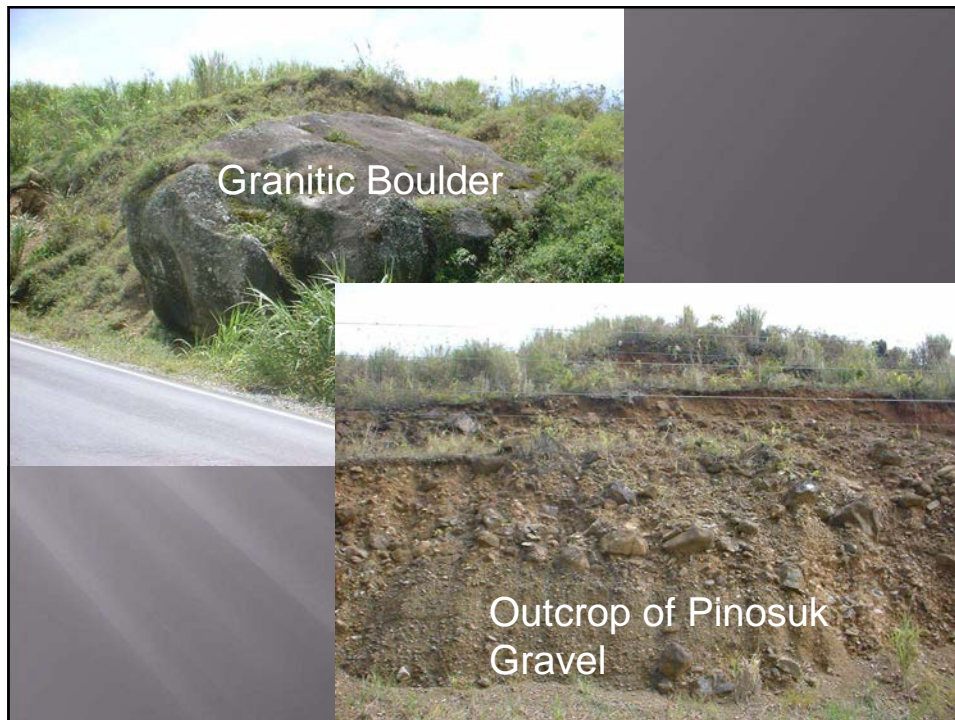
- ▣ RL1335m to RL1500m.
- ▣ Terrain : Undulating/Sloping.
- ▣ Outcrops: Granitic boulder/ Grey Shale/ Sandstones.
- ▣ Deposits of Pinosuk Gravel from Mt. Kinabalu.
- ▣ Glaciation & Ancient Mudflow.

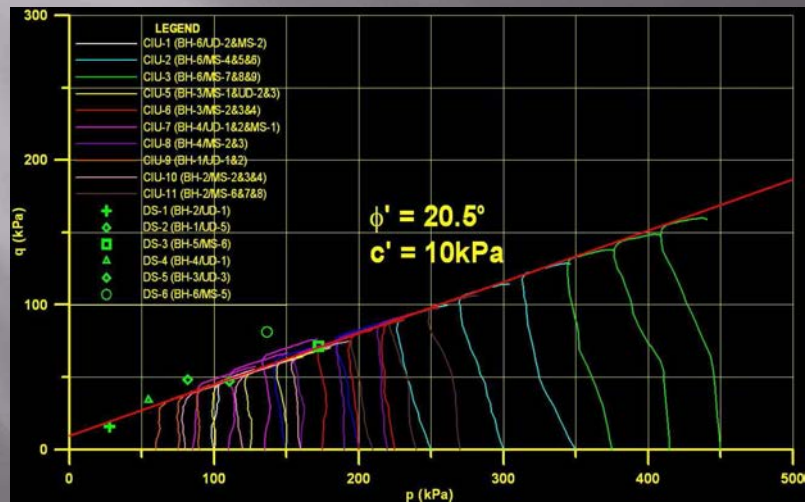
Shear Strength Test Results

- ▣ Six Boreholes & Inclinometers
- ▣ Six Piezometers (GWT : 1.5~2.5m)
- ▣ C.I.U. Tests & Direct Shear Box Tests ($\phi' = 21^\circ$, $c' = 10\text{kPa}$).
- ▣ Others Properties : $w_n = 7\%$ to 13% ,
 $\gamma_{\text{bulk}} = 21 \sim 23.7\text{kN/m}^3$
- ▣ Normally Consolidated

- Interpreted laboratory shear strength parameters are too high to cause instability.
- Back-analysis shear strength parameters:
 $\phi' = 13^\circ \sim 16^\circ$, $c' = 0 \sim 5 \text{ kPa}$

- ▣ Carry out **continuous sampling** at identified shear surface for observing **slicken-sided surface** and direct shear testing.
- ▣ Carry out **ring shear test** and/or **multiple reversal direct shear box test** to determine **residual strength**.

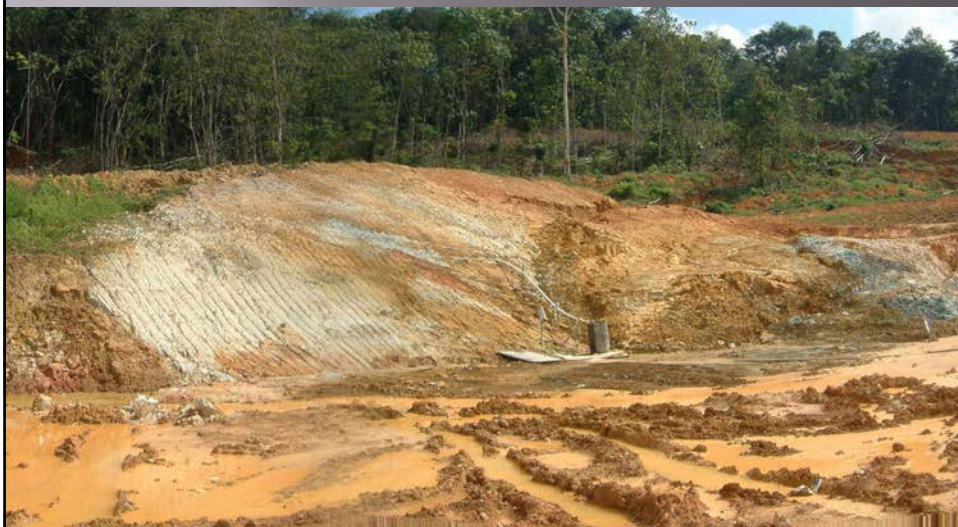
B. Cut Slope Failure in Johor

- RL54m to RL106m.
- Terrain : Sloping.
- Geology: Mainly basic intrusive gabbro and intermediate intrusive.
- Two berms cut slope 1V:1.5H.
- Slope collapsed after heavy downpour.

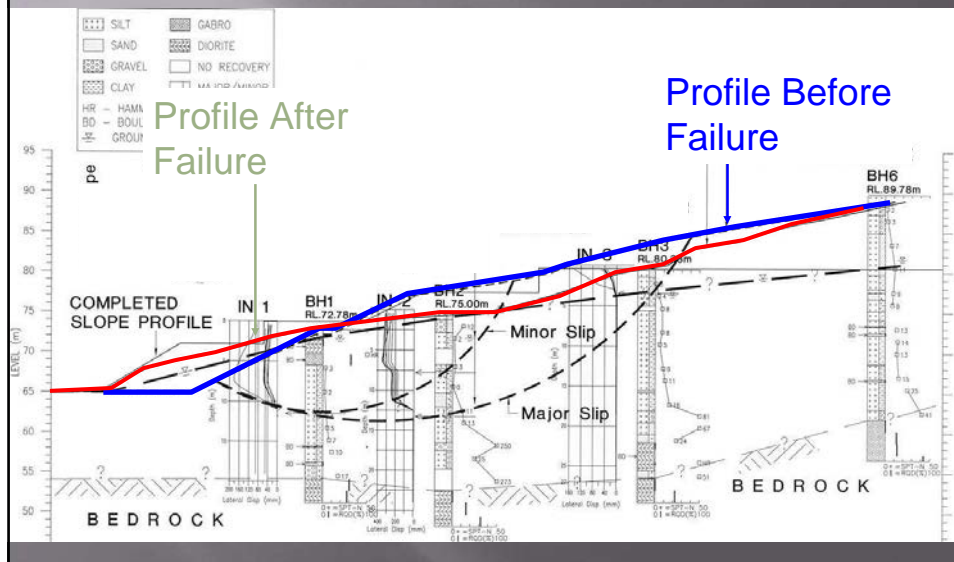
Slope Profile for Back Analysis

- ▣ Back-analyses were performed for 2 conditions:
 - a. Slope profile after cutting, before failure
(critical state strength)
 - b. Slope profile after failure.
(residual strength)
- ▣ The interpreted slip surface & monitored groundwater level is used for back-analysis.

- Back-analyses using PC-Stabl6 and Plaxis.
- Back-analyses results :
 - a. Mobilised shear strength : $c' = 0$ kPa, $\phi' = 24^\circ - 25.9^\circ$
 - b. Residual strength : $c' = 0 - 0.5$ kPa, $\phi' = 14.4^\circ - 15^\circ$

- The investigation deduced that there is likely an unidentified thin weak layer at the slip surface with low shear strength.
- Boreholes are not able to capture the thin layer and could only be detected by inclinometers.
- **Residual shear strength** should be used for remedial design works.

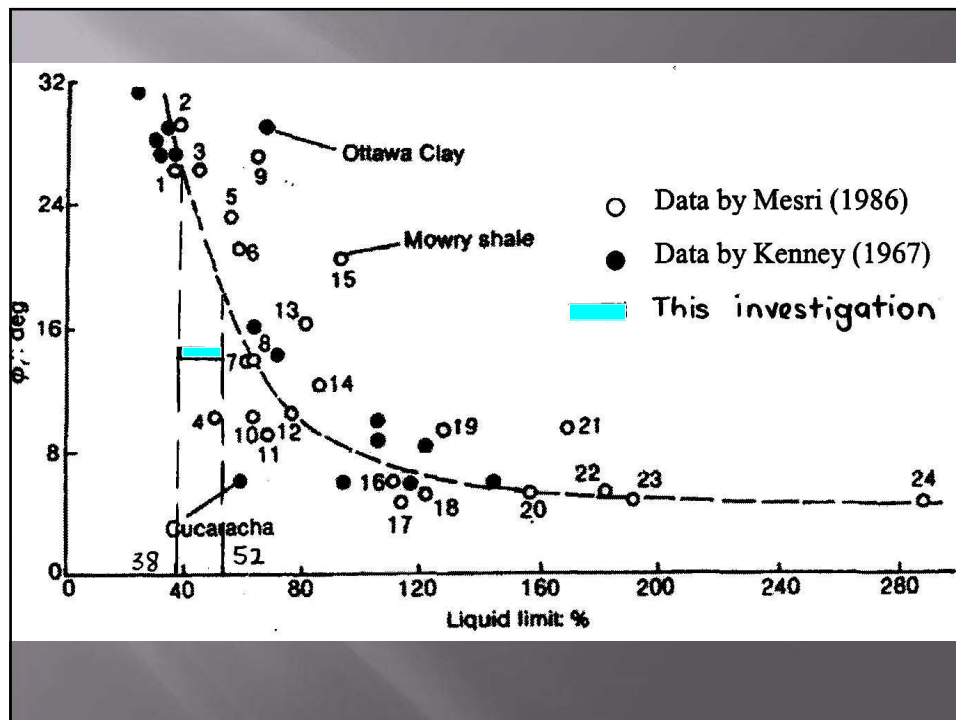
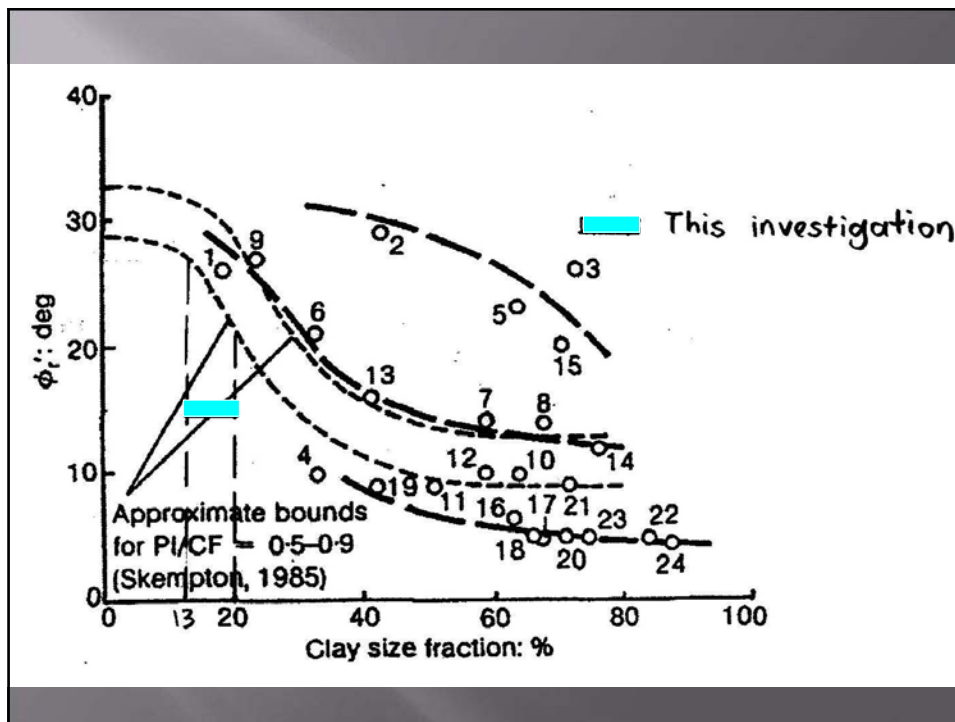
Residual Strength

- ▣ Comparisons with literature:
 - a. Residual friction angle – **Liquid Limit.**
 - b. Residual friction angle – **Clay size fraction**
- ▣ Back analysed residual friction angle are **lower** as compared to literatures.

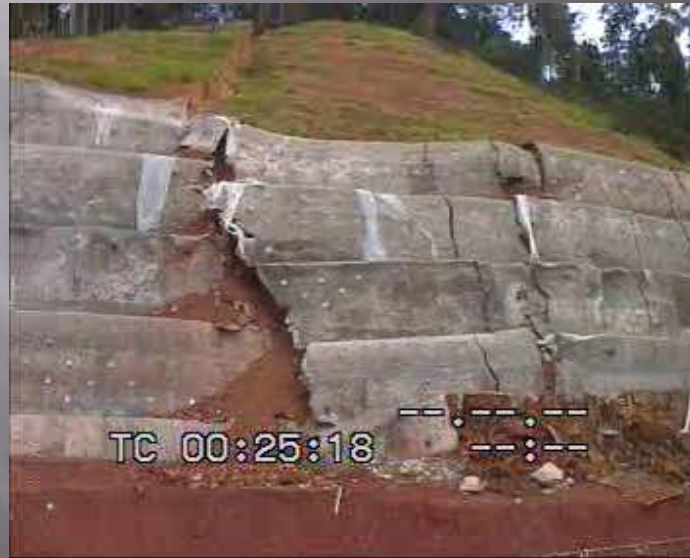
C. Cut Slope Failure at Gua Musang, Kelantan

- RL210m to RL330m.
- 7 Upper berms of 1V:1H Cut Slope & 5 Lower berms of 4V:1H Soil Nailed Slope
- Soil Nail : 12m with spacing of 1m(V):1m (H)
- Geology : Shale Facies in Gua Musang Formation (mainly consists of Mudstone & Sandstone)
- A massive slope failure occurred before soil nails were installed at the lowest berm.

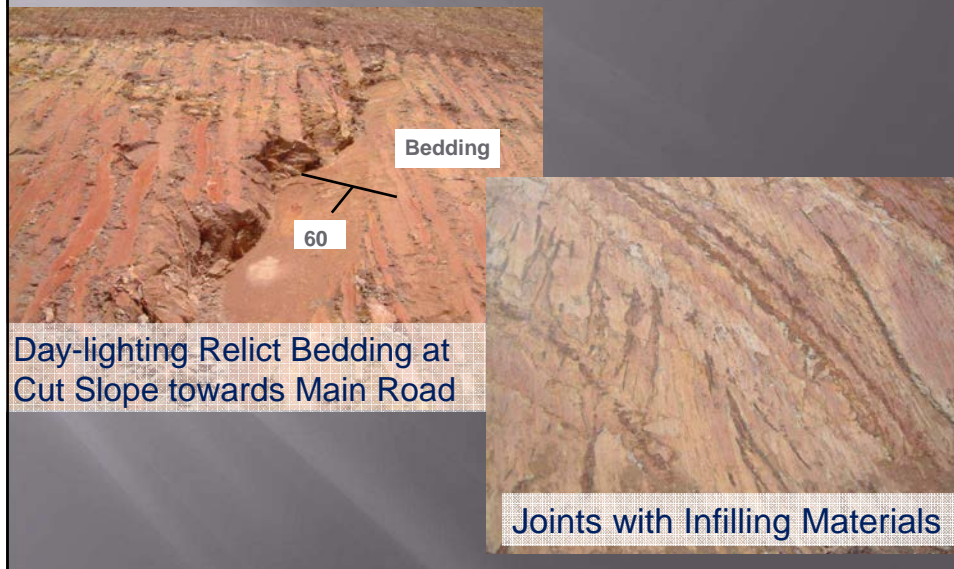
Site Observations

- ❑ Steep upper cut slope of 1V:1H.
- ❑ Inadequate soil nail length (12m).
- ❑ Day-lighting relict geological structures of Grade III to V materials at the upper cut slope.
- ❑ Progressive failure have leaded to develop of a continuous shear surface.

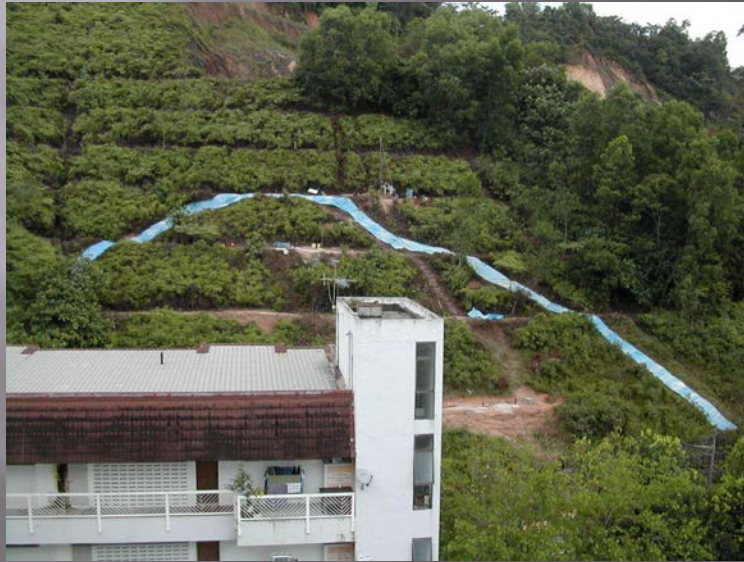
D. Cut Slope Failure at Kuala Lumpur

- The cut slope with 6 berms was formed in 90s
- Slope gradient varies from 1V:1.72H (lowest berm) to 1V:1H (highest berm)
- RL75m to RL110m.
- Geology: Granite formation.
- Slope movement was detected in Nov 2002 and obvious tension cracks were found at the lowest three berms.

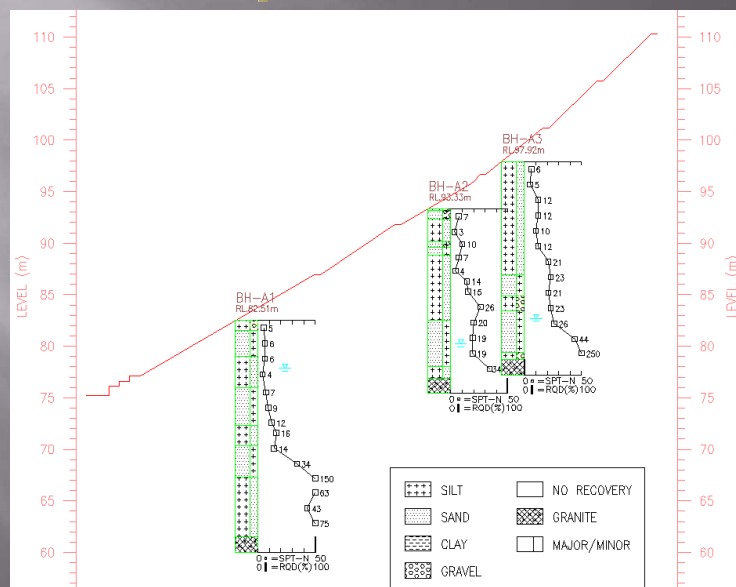
Slope Profile

- ▣ Max lateral movement (IN. 1)
~ 8mm with the depth of shear surface of about 7m tallies with stability analyses.

- ▣ The gradient of the cut slope is steep and is not stable in long term
- ▣ Slope strengthening works with installation of soil nails and subsoil drainage system have proven an effective solution to stabilise the distressed slope.

- ❑ Installation of Soil Nails (12m, 18m and 27m).
- ❑ Installation of horizontal drains.
- ❑ Repairing and re-construction of berm drains.

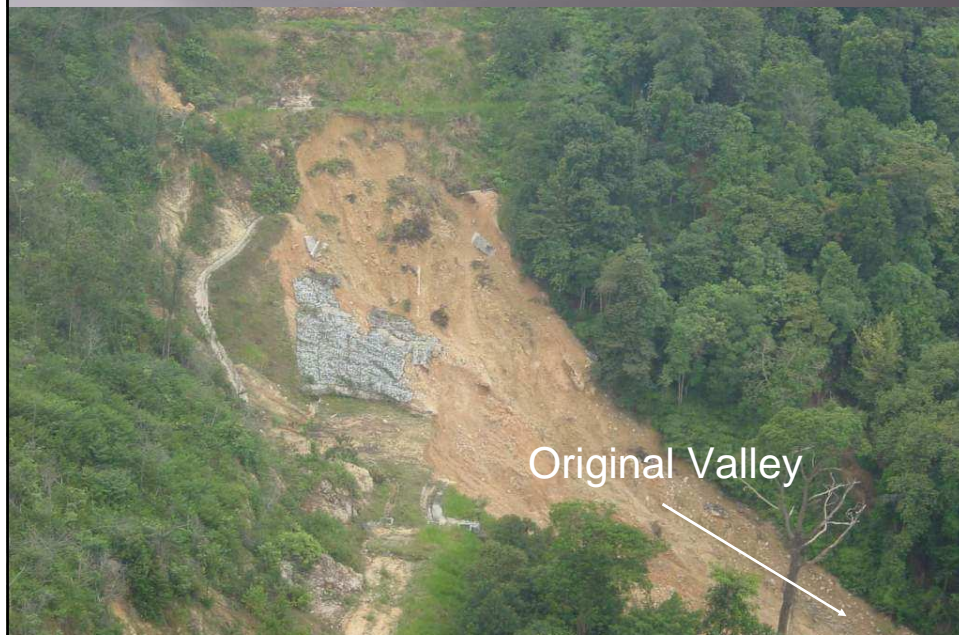
E. Fill Slope Failure at Salak Tinggi

- ▣ Fill slope over a natural valley to form pipeline platform.
- ▣ Three berms slope : 20m height.
- ▣ Another three slopes on top of platform.
- ▣ Geology: Kenny Hill formation with interbedded sandstone and siltstone.
- ▣ Slope collapsed after heavy downpour.

- Valley terrain (Channelised runoff).
- Steep fill slope gradient – steepest gradient of 1V:1H.
- Marginal FOS when groundwater level rises near to ground surface.
- Poor drainage system lead to saturation and erosion.

- Fill embankment over valley.
- Fill embankment comprises of :
rock toe and seven berm slope (1V:2H).
- Provision of extensive subsoil drainage :
French drain and drainage blanket.
- Upgrading and construction of new drainage system.

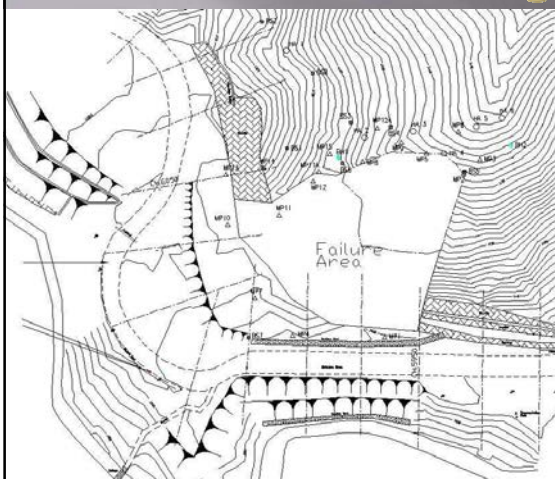
Site Plan showing Failure Area

- Geology: Granite and metamorphic rocks
- Slope with varying degrees of weathering: rock to soil.
- 7.5 berms of 4V:1H Soil Nailed Slope
- Maximum height = 45m
- 12m soil nail length at 1.5m c/c

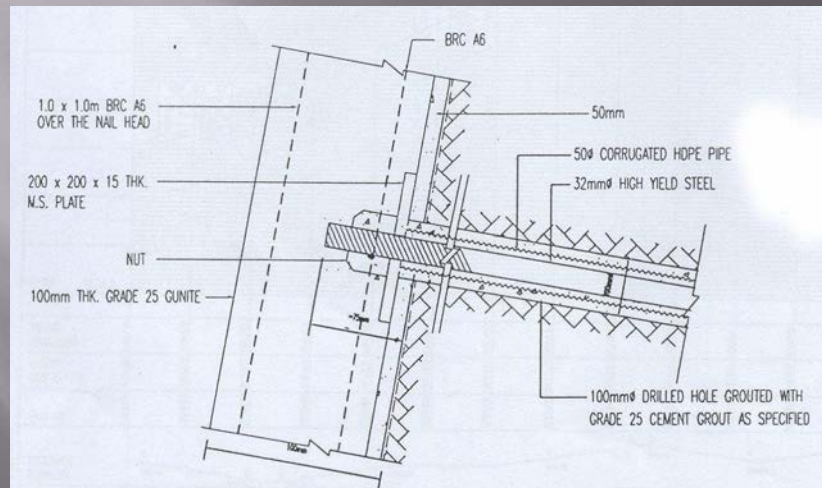
Shotcrete Facing as per Construction Drawing

- ▣ Inadequate design of shotcrete facing of soil nailed slope.
- ▣ FOS against overall failure is inadequate and marginally stable.
- ▣ Rainfall/ groundwater is not a triggering cause to failure.

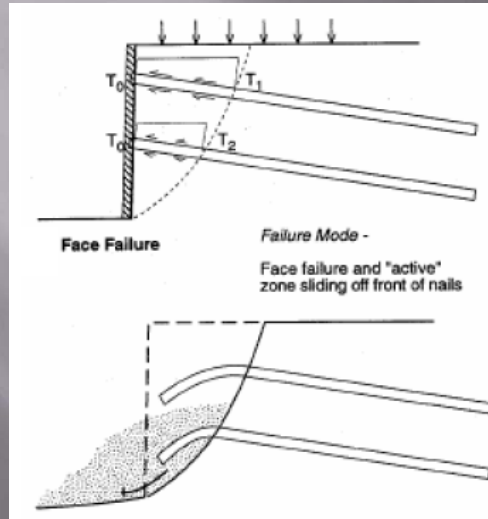
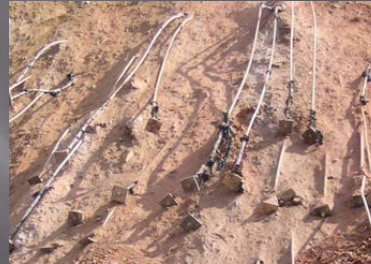
Facing Failure Mode for Soil Nailed Wall

- ▣ 4 Failure modes (nail tendon failure, nail pull-out failure, facing failure) & overall failure shall be checked. **Facing failure check** is usually neglected.
- ▣ Facing design is critical especially when soil nailed slope is **steep and high**.
- ▣ **Hoek-Brown failure criterion** is appropriate for establishing engineering parameters of weathered rock mass of different formation in Malaysia.

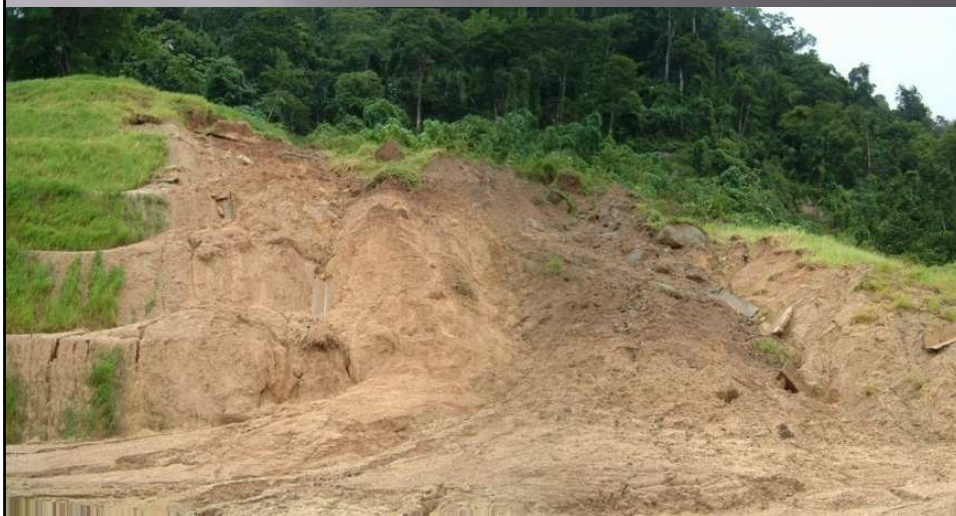
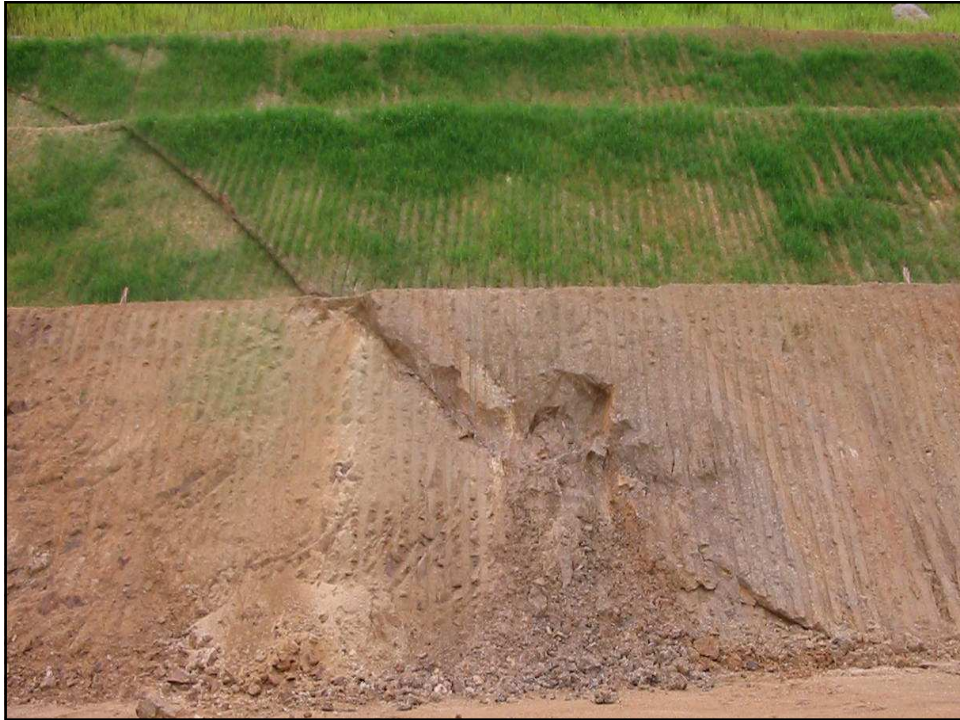
G. Cut Slope Failure at Kedah

- ▣ High ground RL300m – RL350m.
- ▣ Bedrock : Intact granite bedrock with prismatic feldspar phenocrysts.
- ▣ 5 to 6 berms : 27m height.
- ▣ Slope gradient 1V:1H.
- ▣ Two failure incidents:
 - a. Localised stretch (50m).
 - b. Major slope failure (250m) after 1 month following heavy rainfall.

- ▣ FOS against overall failure indicates the slope is at the verge of failure for the water level measured during investigation.
- ▣ Rainfall leading to rise of groundwater is the triggering cause to failure.

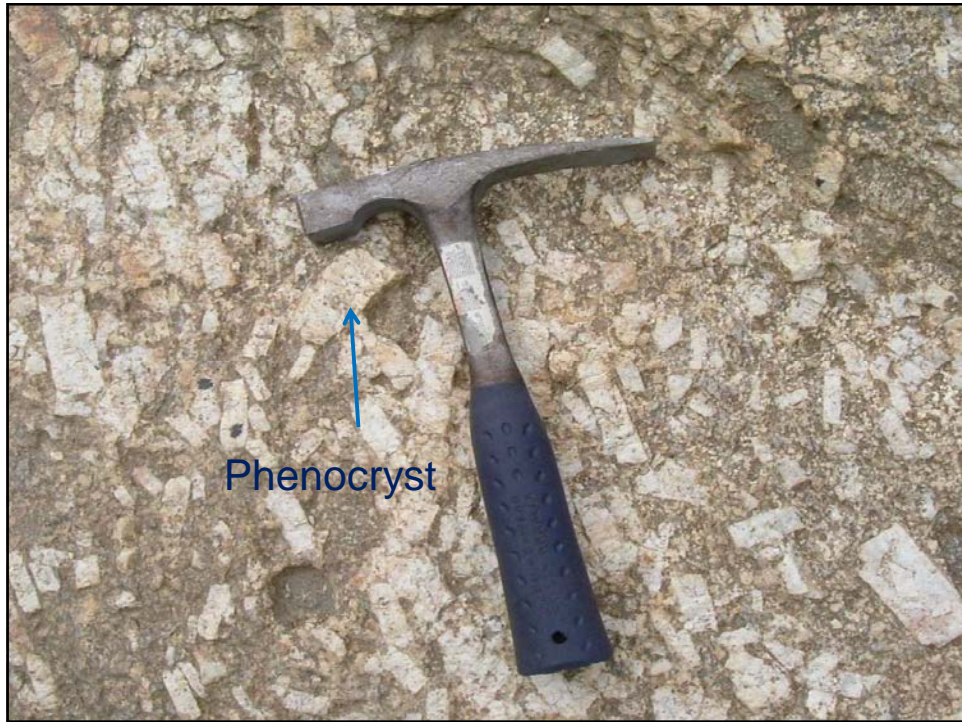
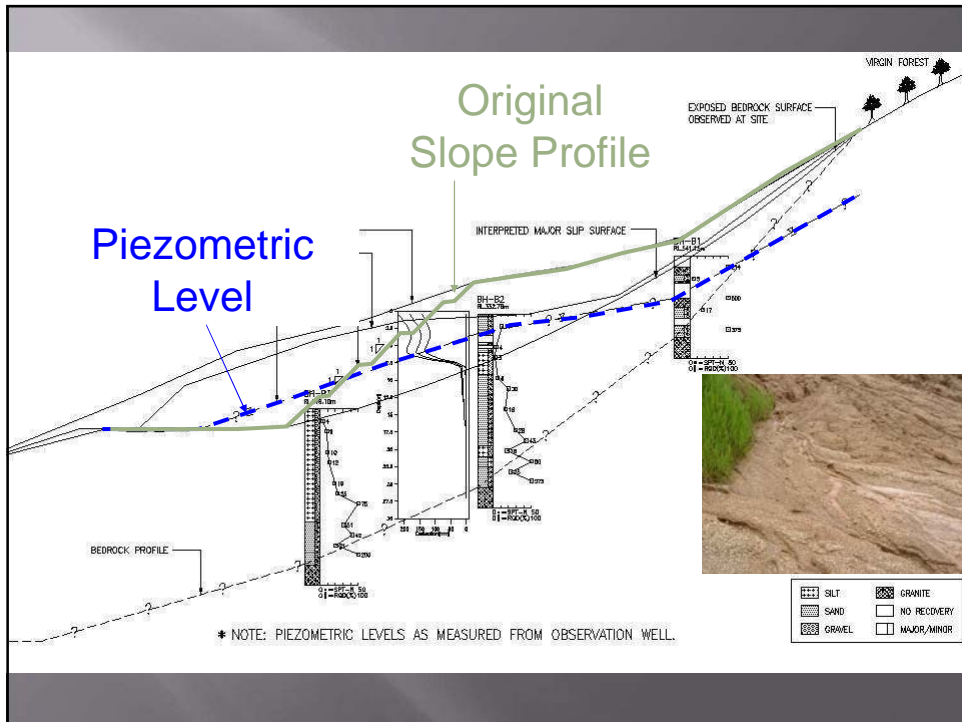
- ▣ Sandy material within failed mass.
- ▣ CIU test :
 - a. $c_p' = 2\text{kPa}$, $\phi_p' = 30^\circ$
 - b. $c_{cr}' = 0\text{kPa}$, $\phi_{cr}' = 28^\circ$
- ▣ Back Analysis :
 - a. $c_m' = 0\text{kPa}$, $\phi_m' = 30^\circ$
