KR'S PROJECTS CASE STUDY OF HEALTH FACILTY PROJECTS

Ar. MOHD. FIRDAUS MOHD. ZAINOL ROHAIMI MANSOR

MOULD GROWTH IN HEALTH FACILITY BUILDINGS

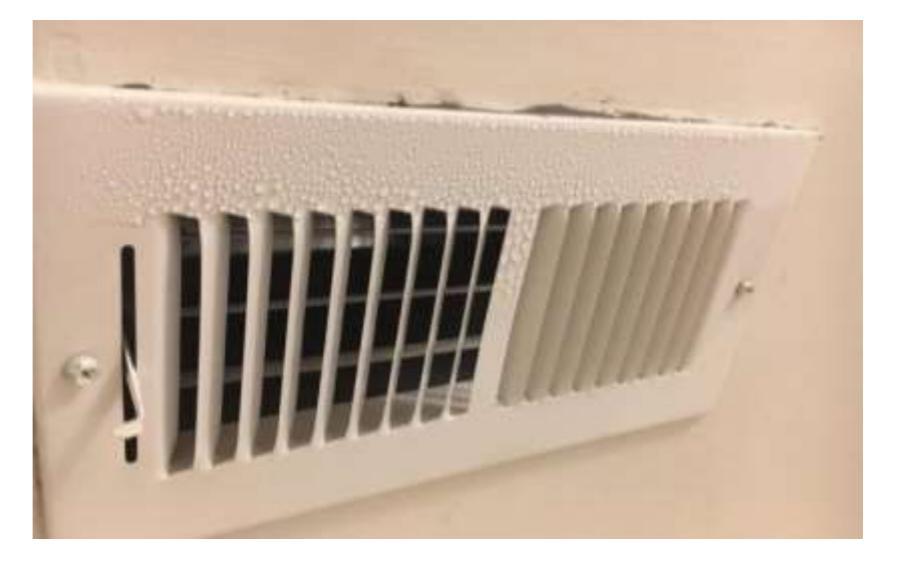
Kondensasi di Accident & Emergency (A&E)

automatic sliding door terbuka terlalu lama sebelum ditutup kembali. Masa untuk menutup kembali melebihi 20 saat setiap kali dibuka

Suhu pada dinding luar didapati berada dibawah dew point udara sekeliling menyebabkan kondensasi pada permukaannya.

kondensasi pada supply air duct connection akibat sambungan yang tidak kemas

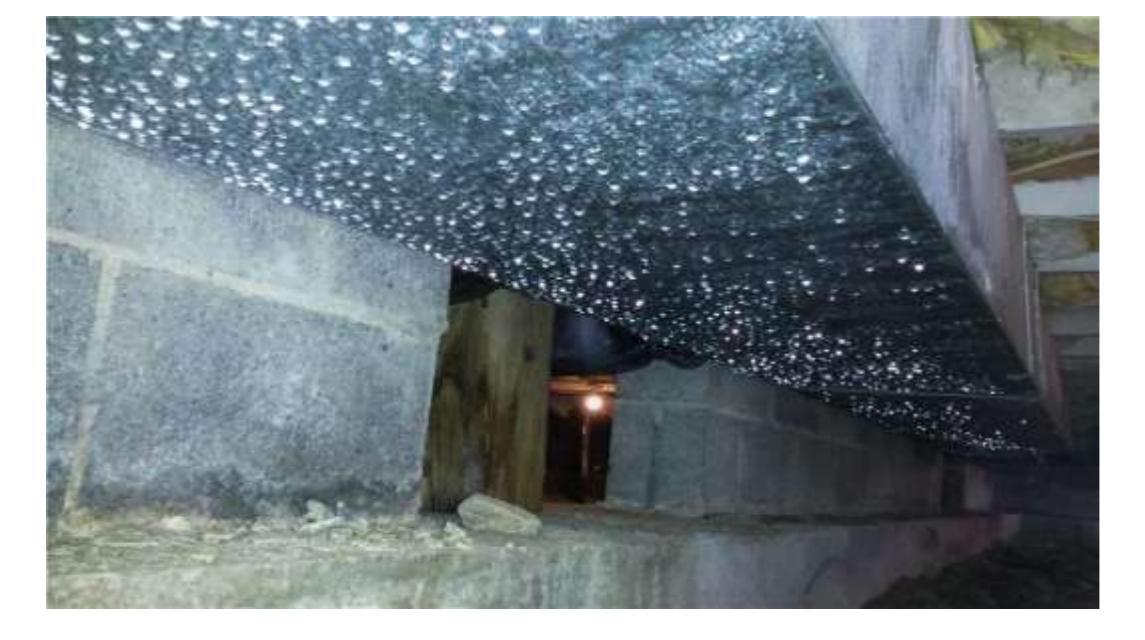
Kondensasi di Inpatient & Pharmacy

Suhu udara didalam ruang di keduadua belah bahagian lorong tersebut adalah rendah iaitu pada 20oC Dan suhu di dinding tersebut juga adalah dibawah dew point udara sekeliling.

kelembapan relatif yang tinggi kerana ianya terbuka kepada udara luar

kondendasi pada sesalur udara yang membawa exhaust air yang tidak ditebat. Condensate water daripada kondensasi ini menitik keatas siling.

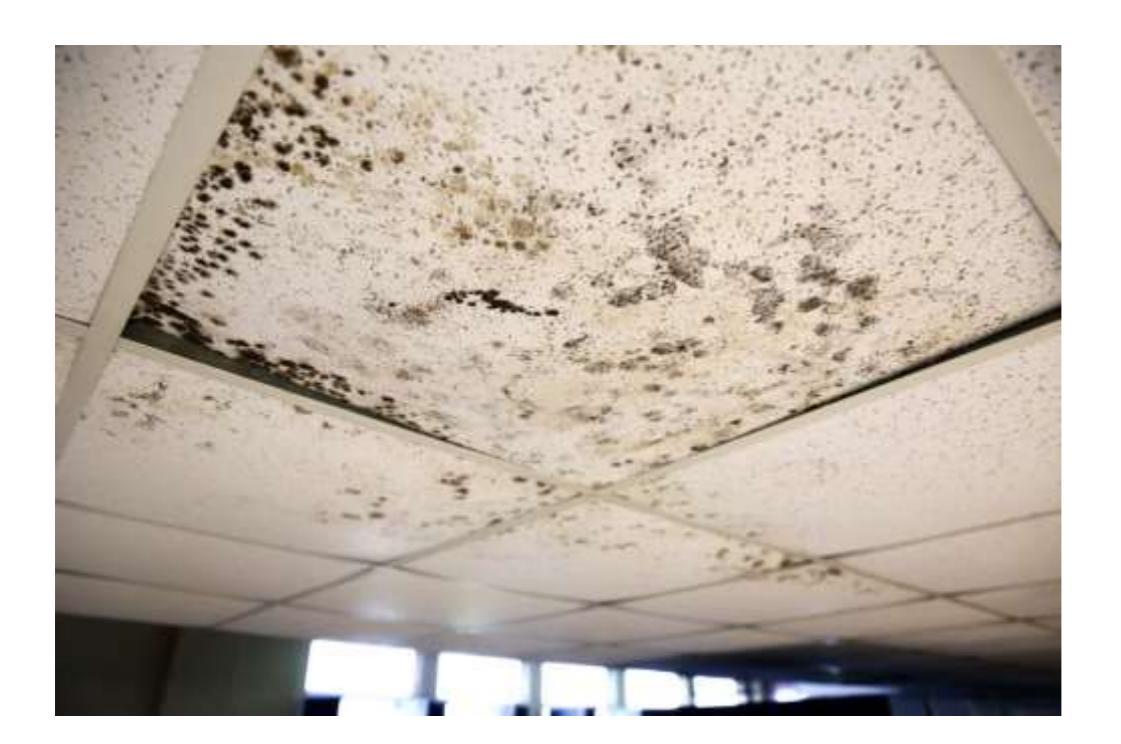
PENILAIAN TERHADAP OPERASI SISTEM HAWA DINGIN DI HOSPITAL SULTAN ISMAIL JOHOR BHARU TARIKH LAPORAN 12HB JUN 2007 Kondensasi di Cafetaria Level 2

Suhu udara didalam cafeteria adalah 21.9oC DB dan 22oC WB pada relative humidity 92%

Suhu permukaan siling didapati rendah dibandingkan dengan suhu dewpoint pada sianghari dan menyebabkan berlakunya kondensasi dan tompokan kulat.

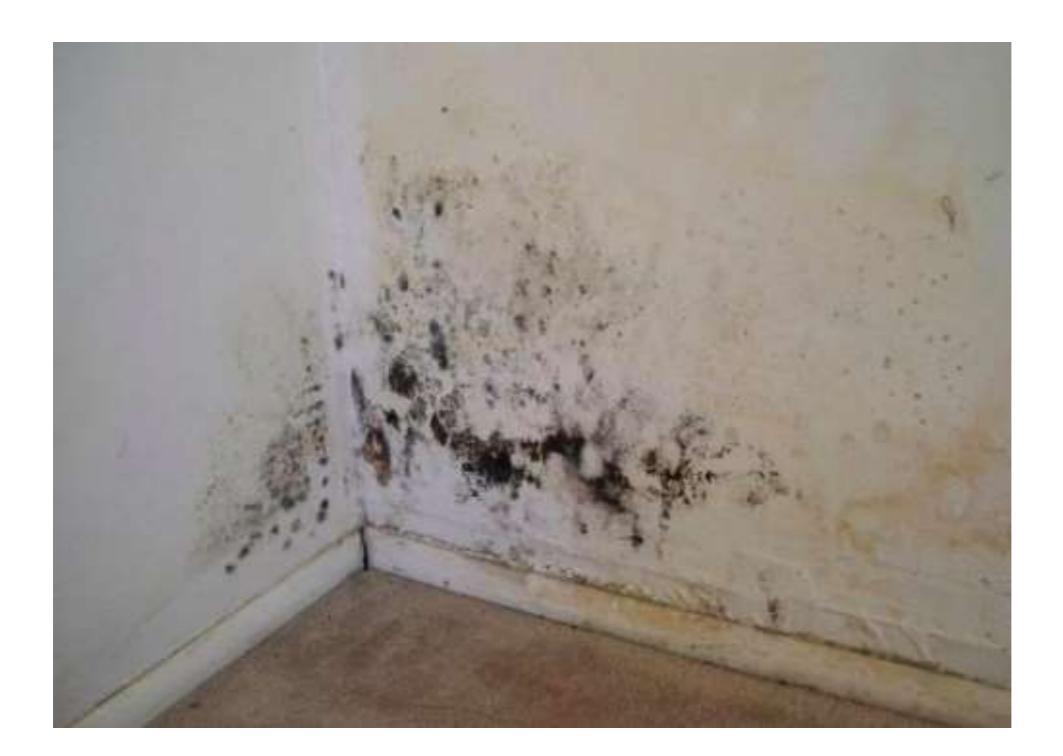
Kondensasi di Jabatan Pathology

kondensasi di dinding dan luar pintu masuk ke jabatan Patologi

Kondensasi pada waktu siang dan malam iaitu apabila suhu dinding lebih rendah dari suhu dewpoint udara sekeliling. Bilik sebelahnya adalah beroperasi 24 jam walaupun tiada penghuni atau aktiviti.
