FORENSIC ENGINEERING FOR GEOTECHNICAL ENGINEERS

4.0 Circumstances Leading to Geotechnical Failure - 1

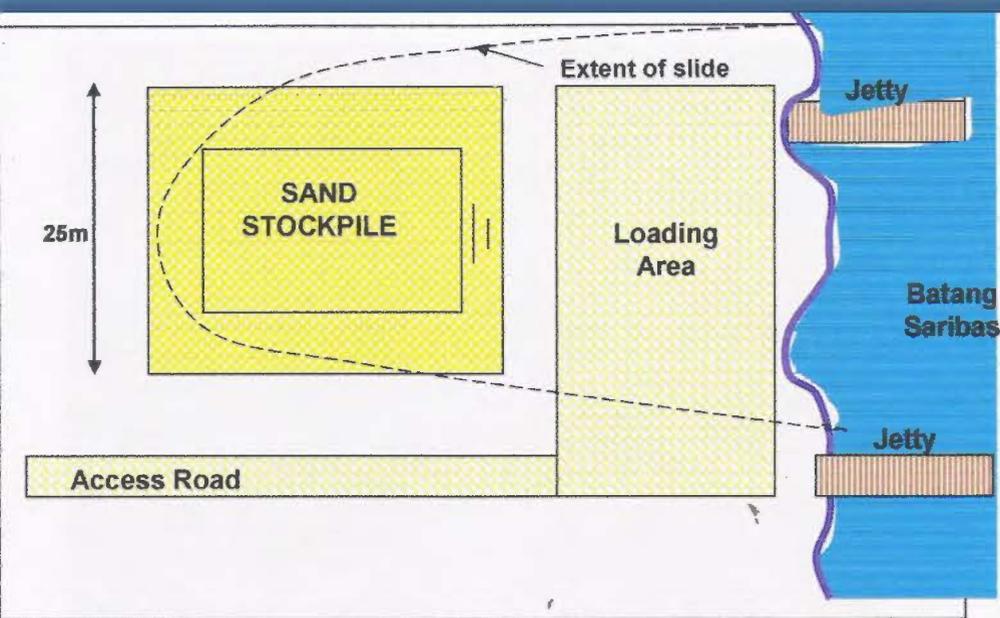
Plan of Stockpile & Jetty Area

4.1 Surcharge load

- Excessive surcharge load
- Large stockpile on soft grd

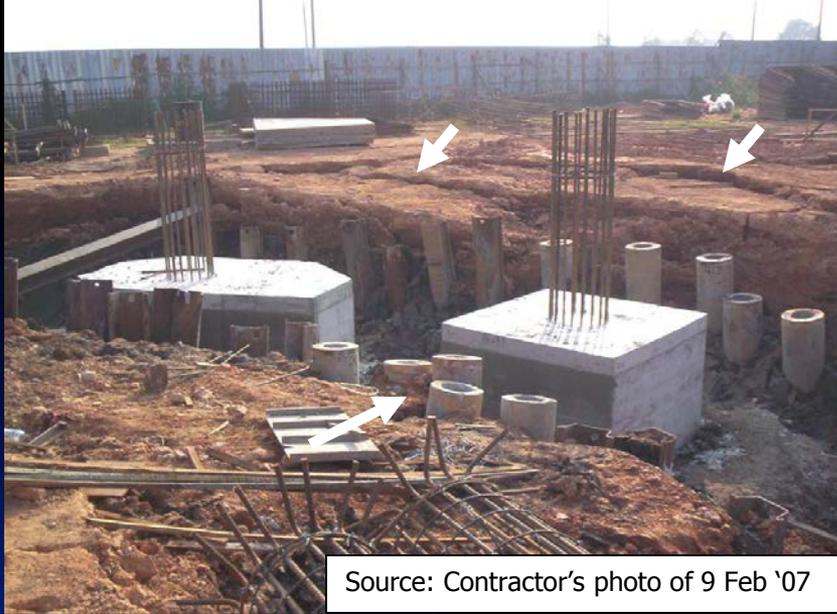
Source: Contractor's photo 5th Mar'07

- Under-estimation of soft ground strength
- Ignorance of adverse effects
- Lack of engineering supervision/control
- No warning in document
- Un-detailed method statement
- No provision of temporary support

Induced surrounding ground movement towards the central un-braced excavation

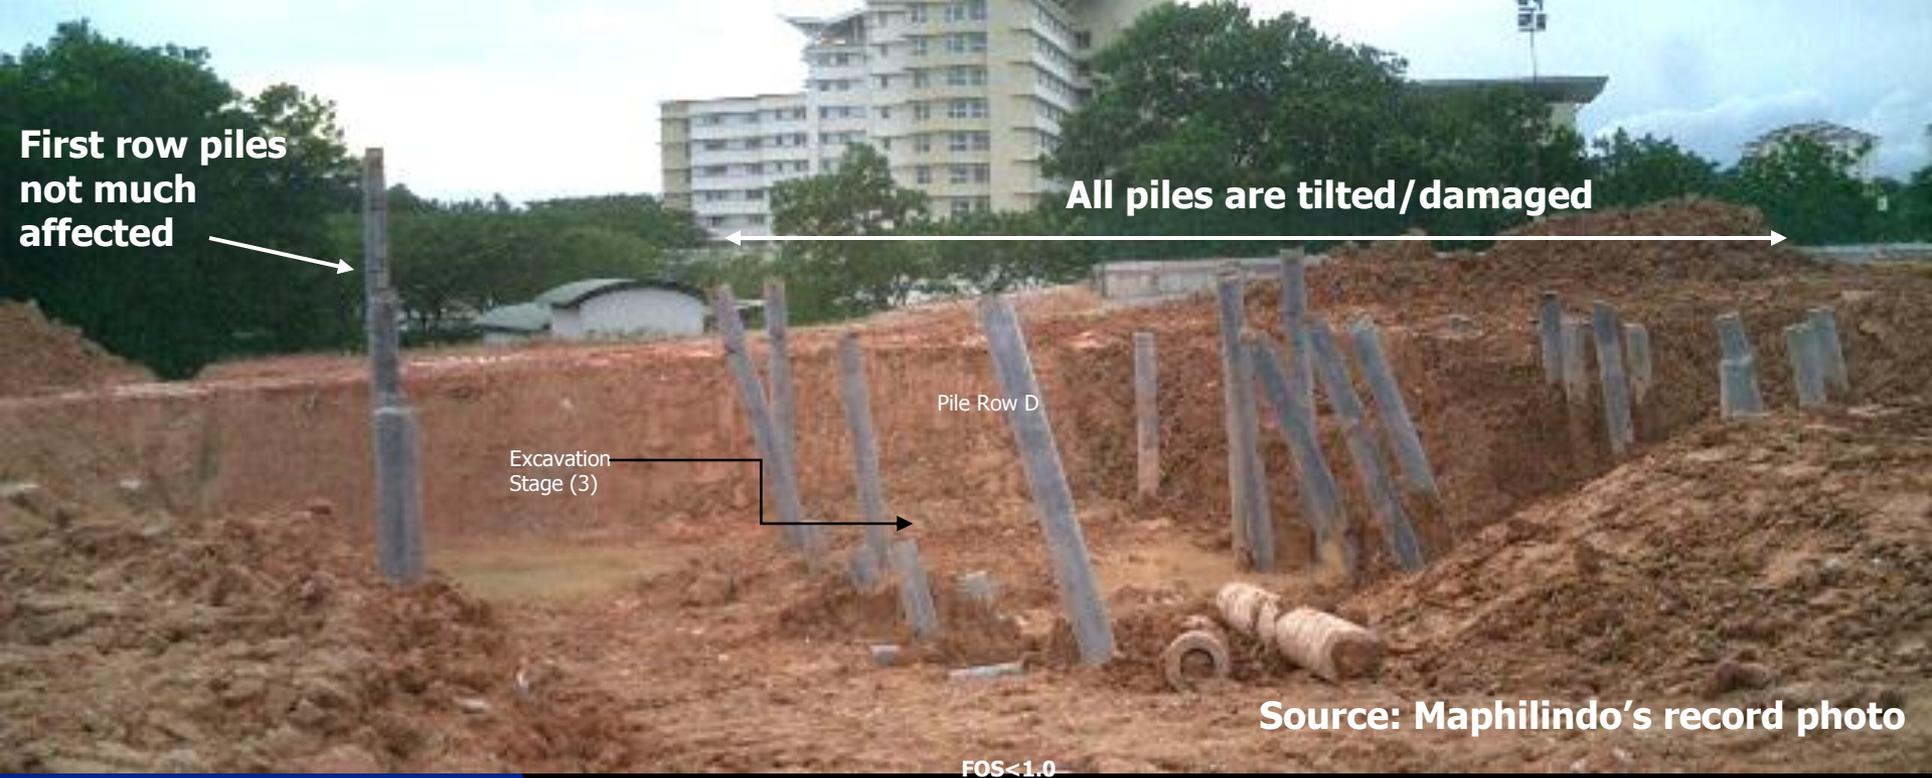
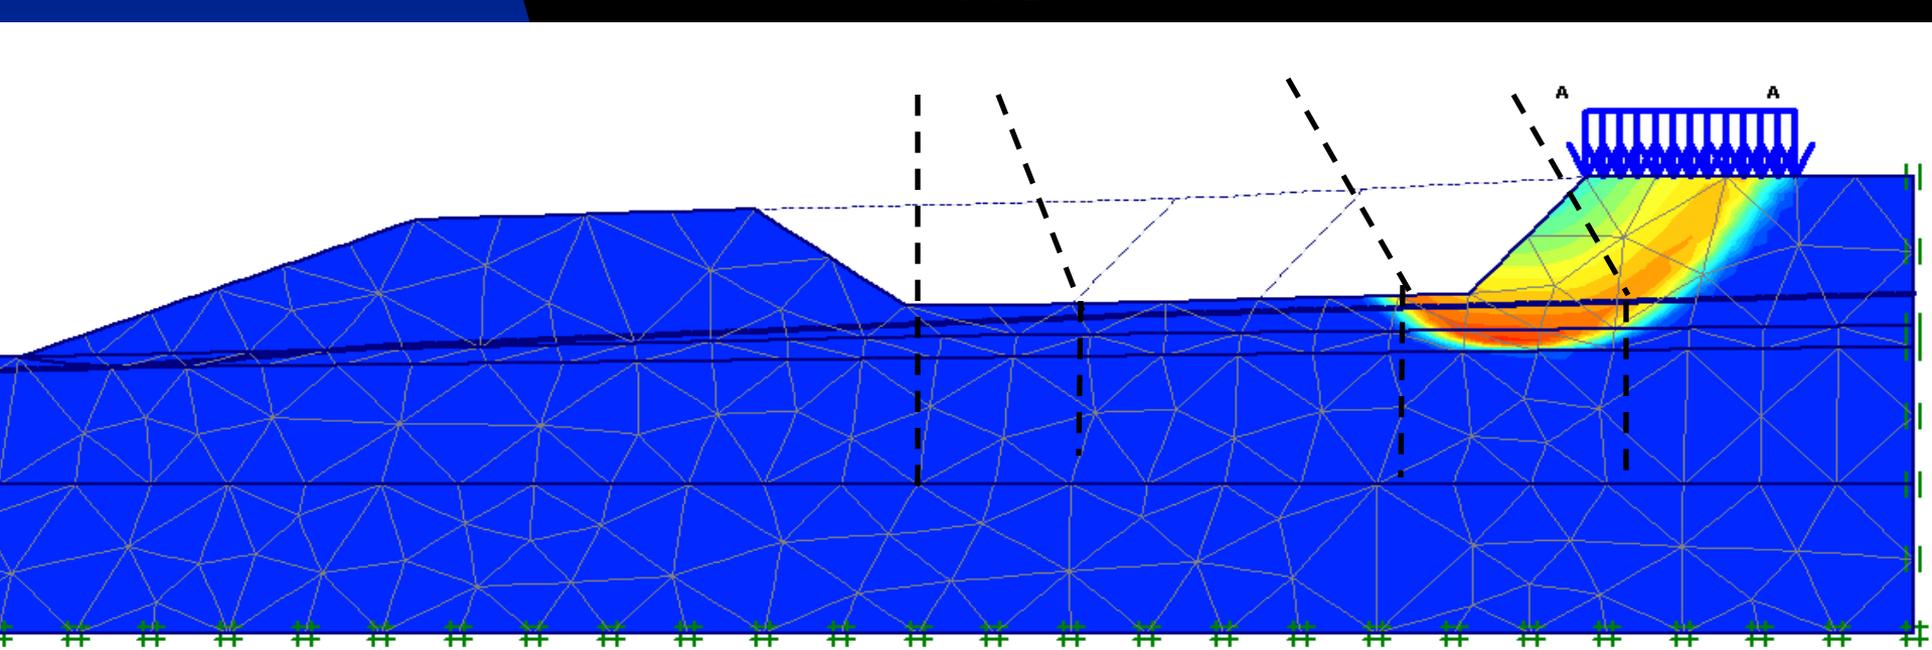
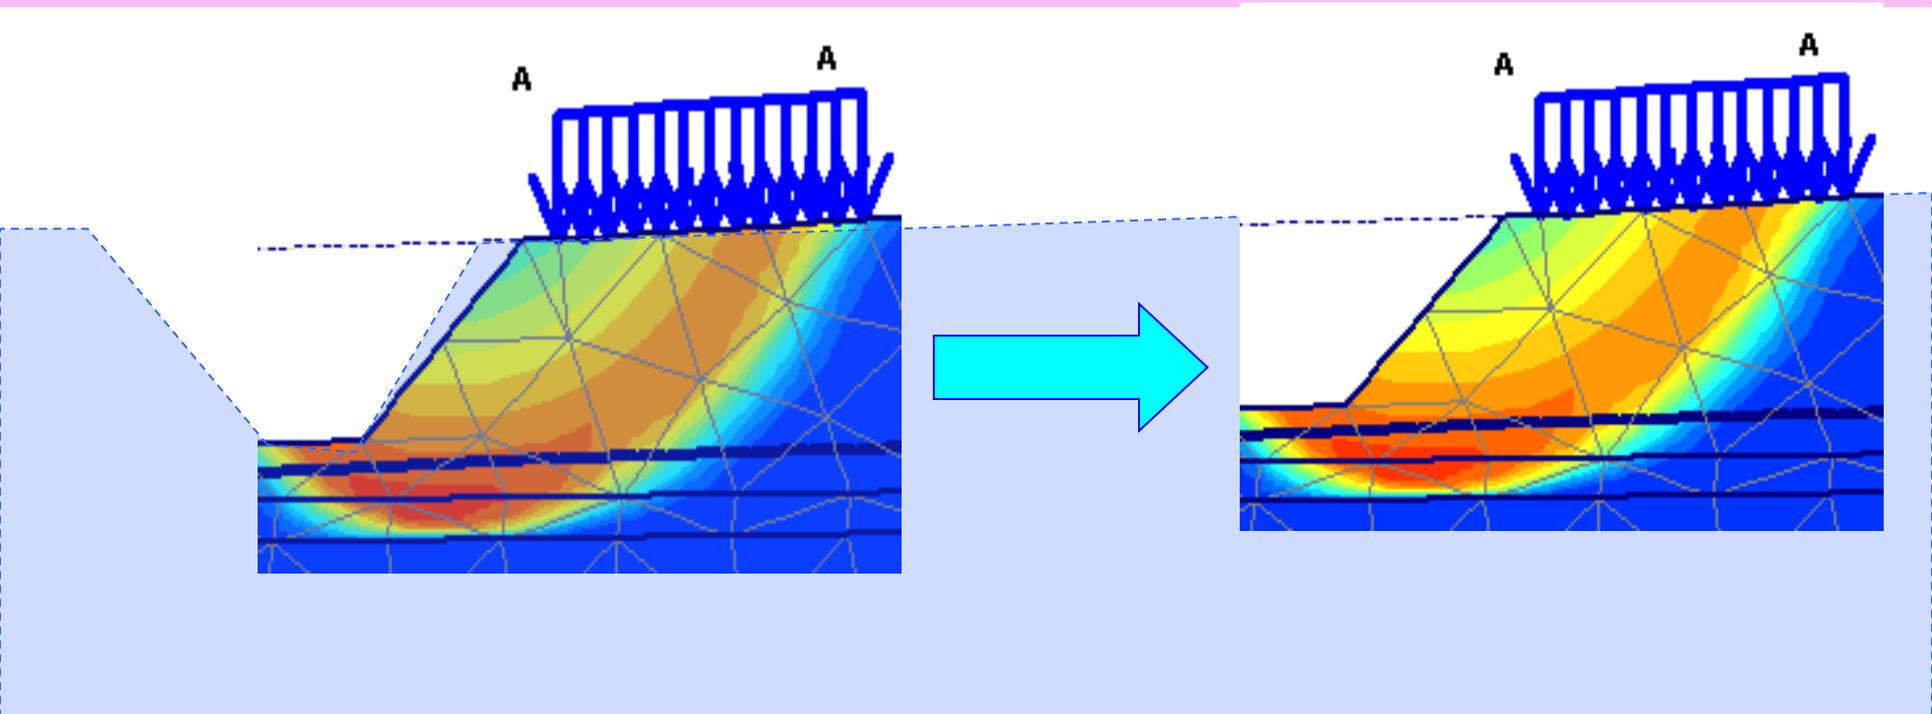
- Construction mtd inducing failure
- Underlying thin soft layer
- Machine load
- Steep excavated slope

Illustration on the hidden hazard below excavation level

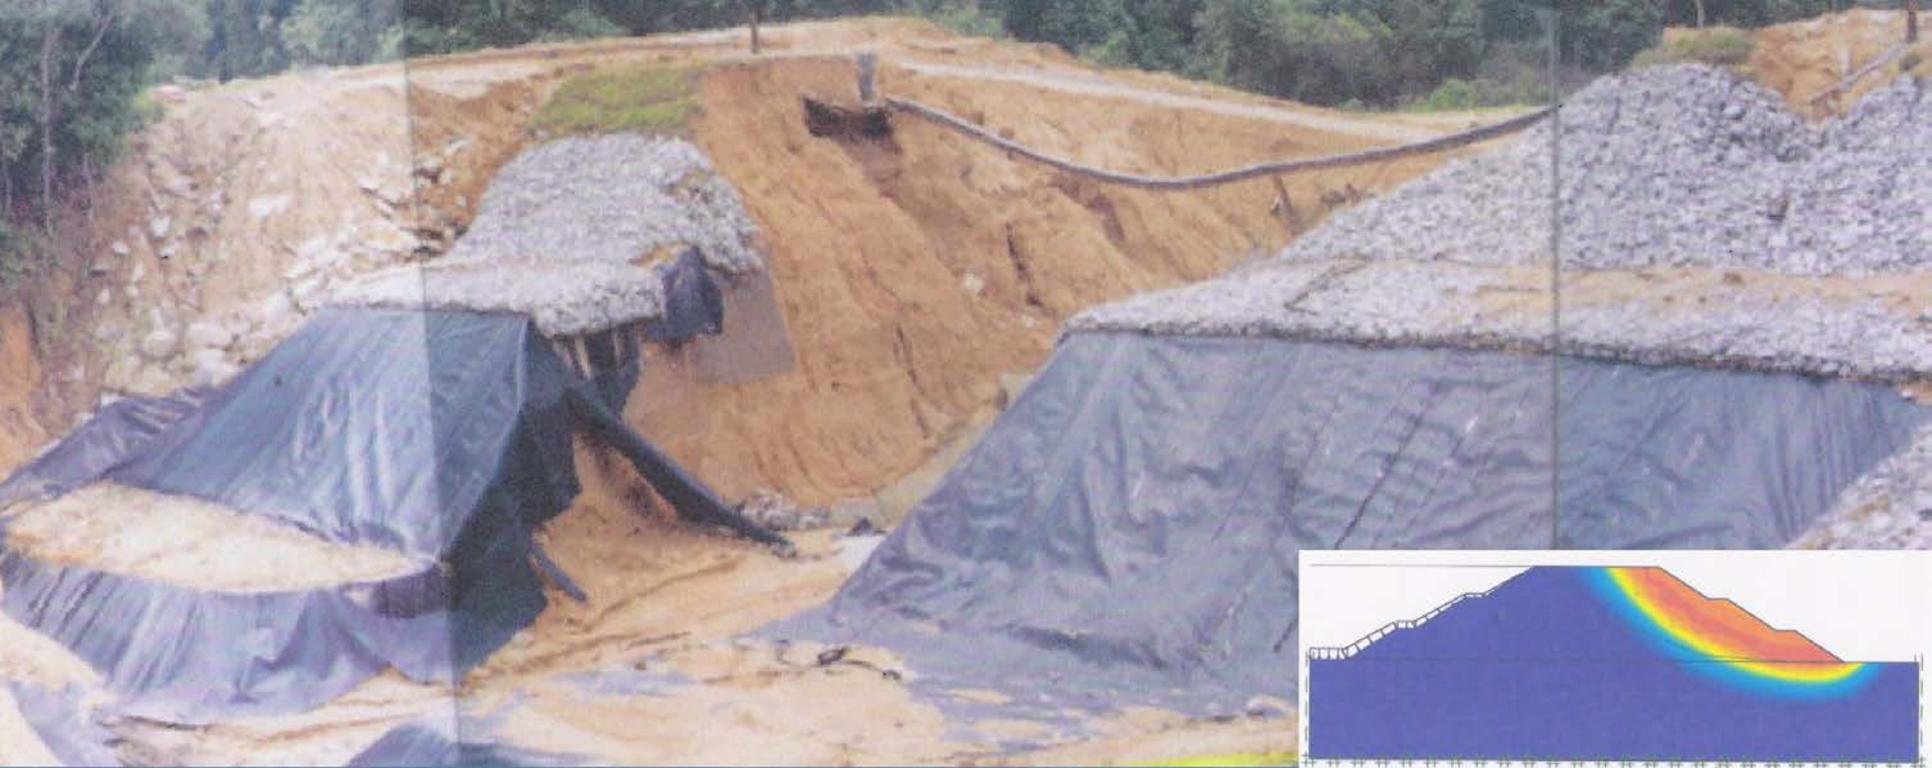
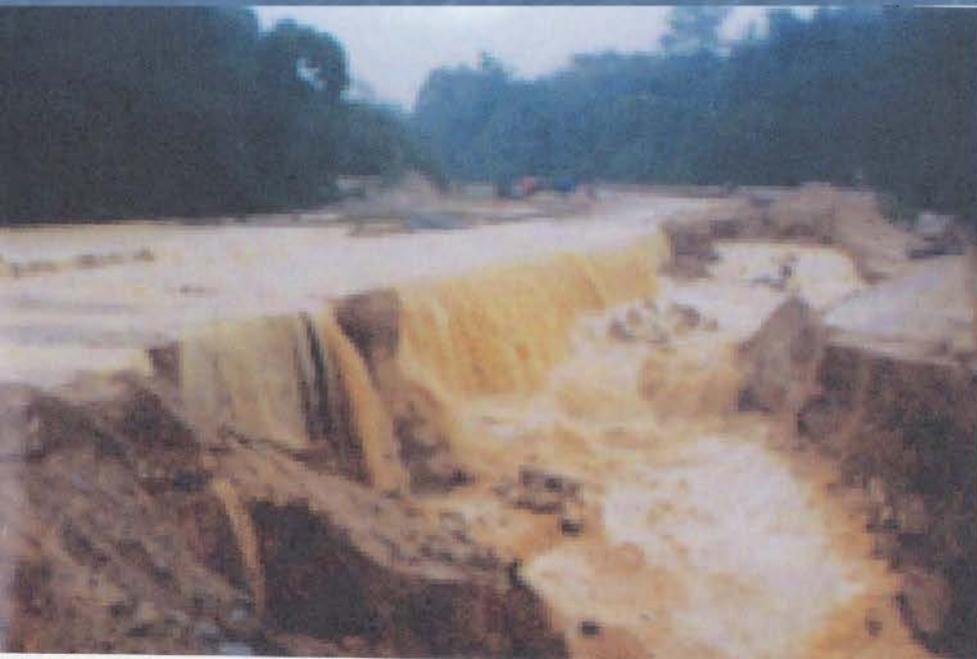
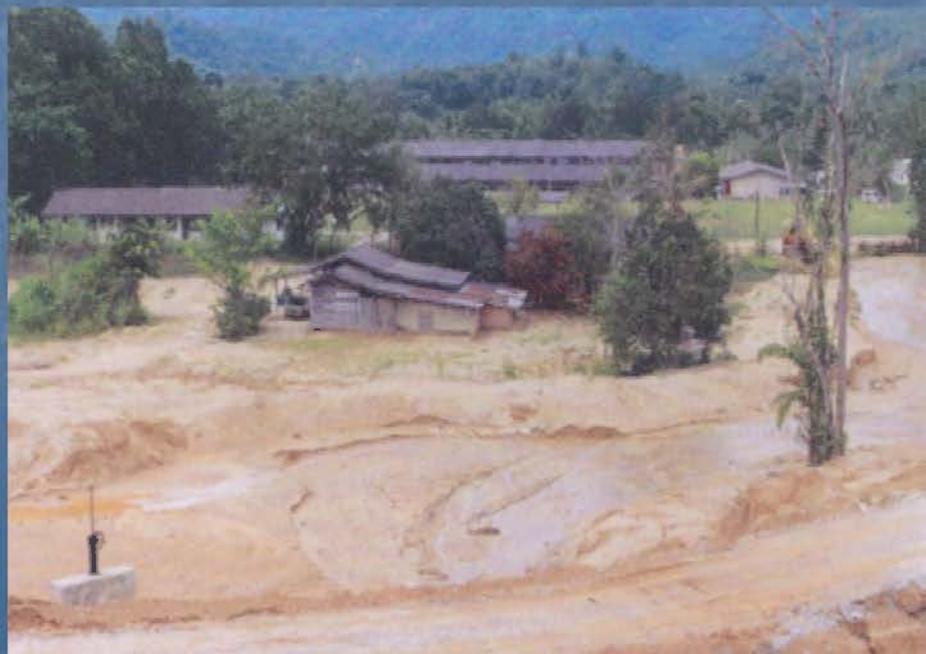
- Simple design but multiple functions
- Perhaps no design
- Extreme changes in boundary condition
- Under-capacity for flood, overtopping
- Unstable slope

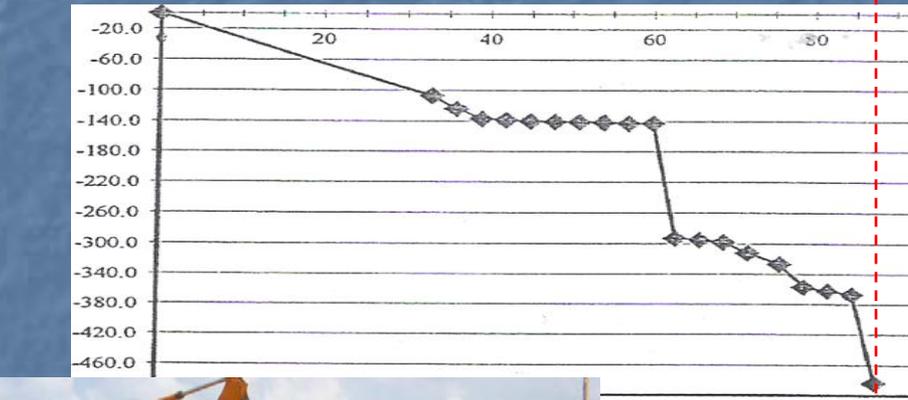
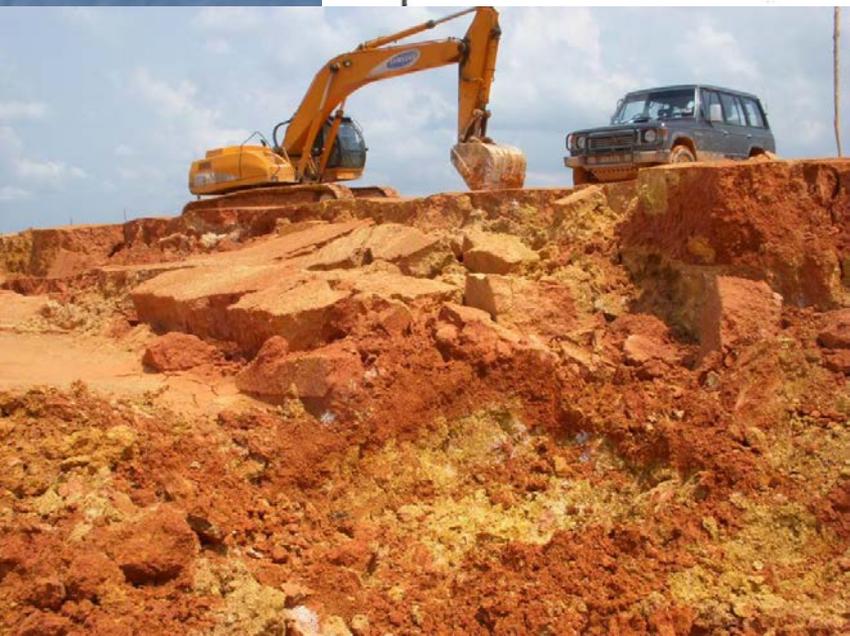
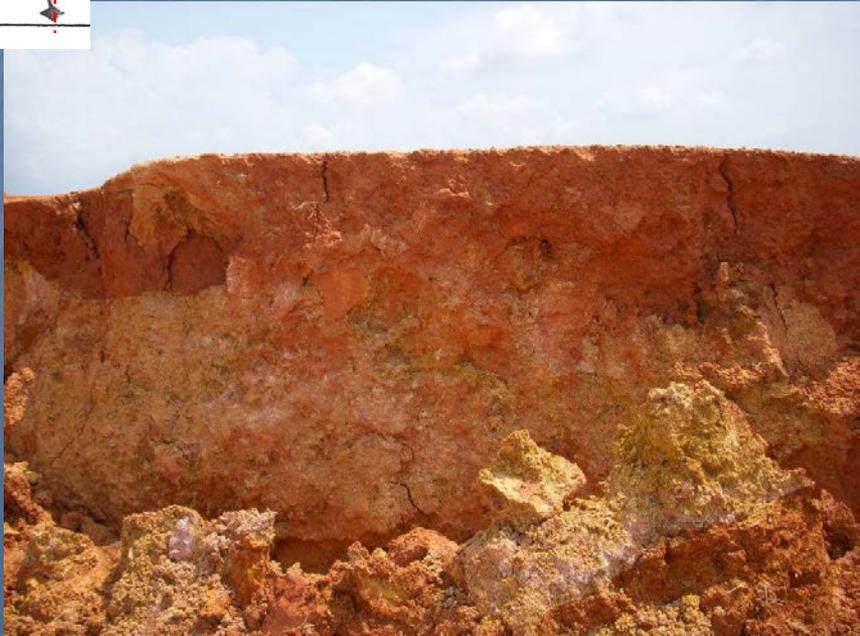
SLOPE FAILURE

- Unconsolidated foundation
- Rapid build-up, excessive load
- Not responding to instrument results
- Lack of engineering supervision/control

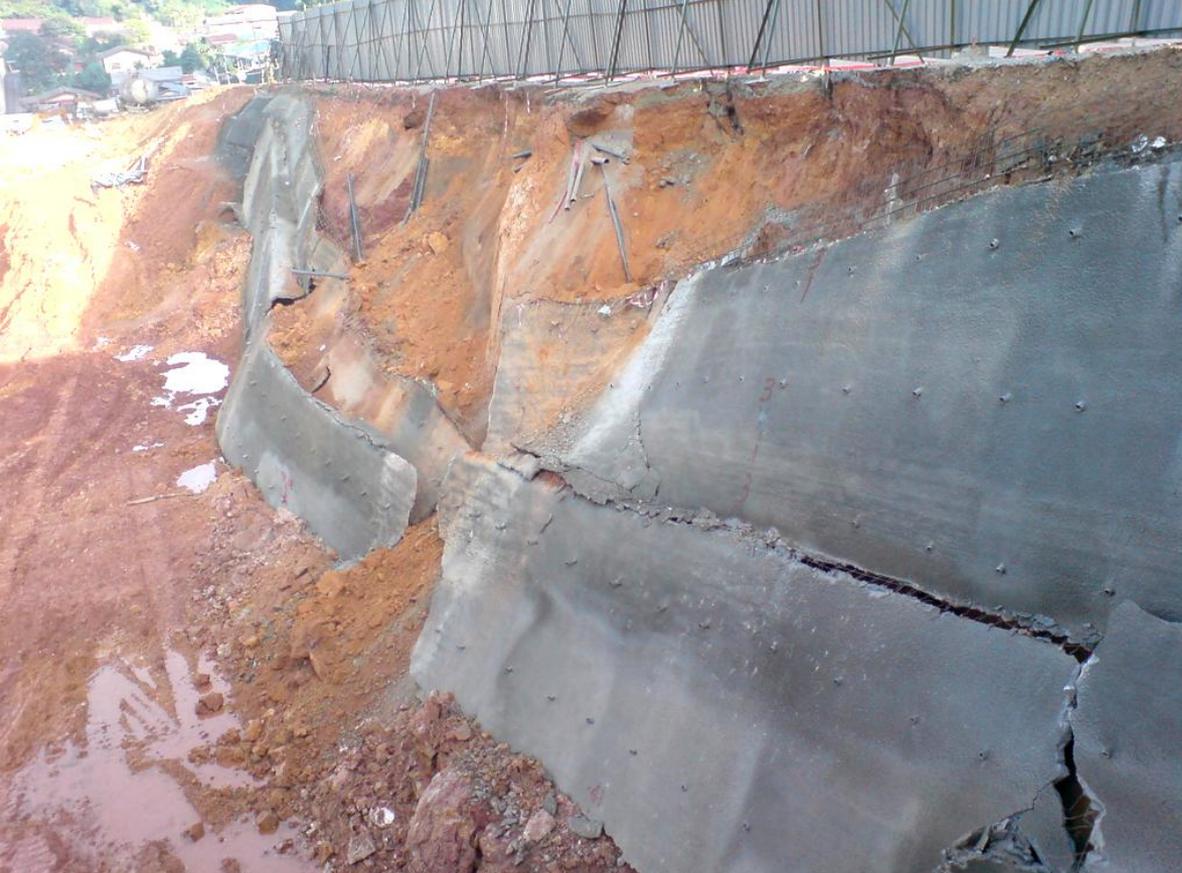
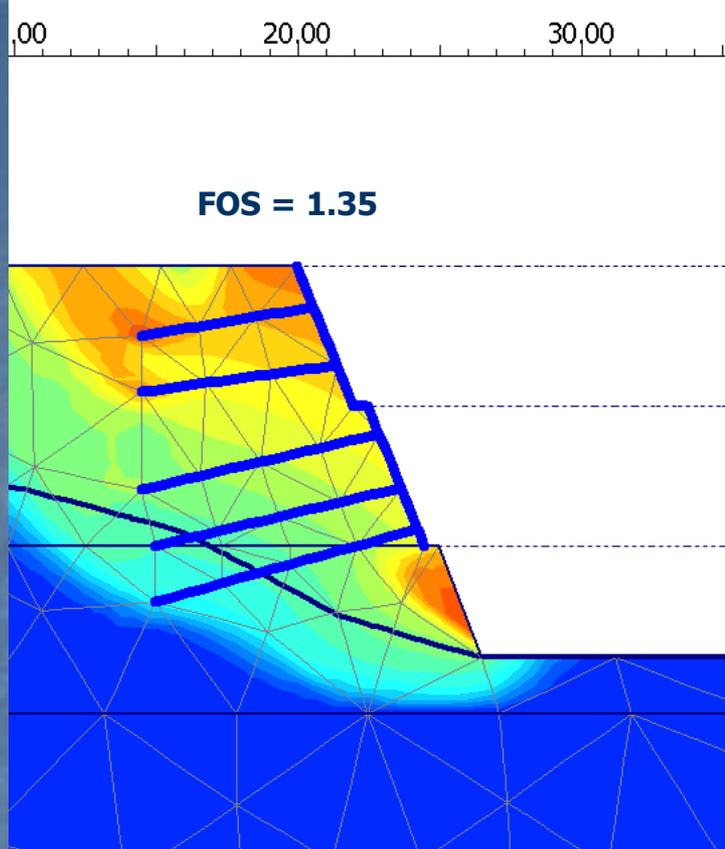
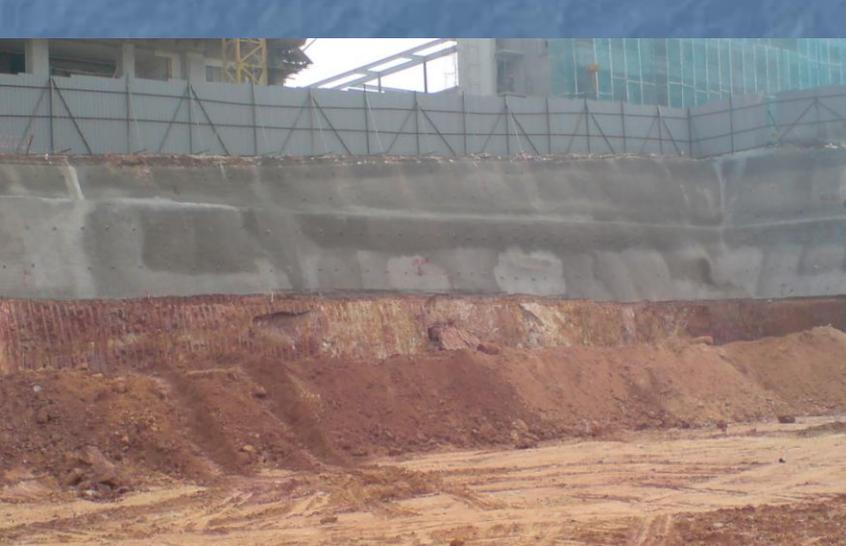
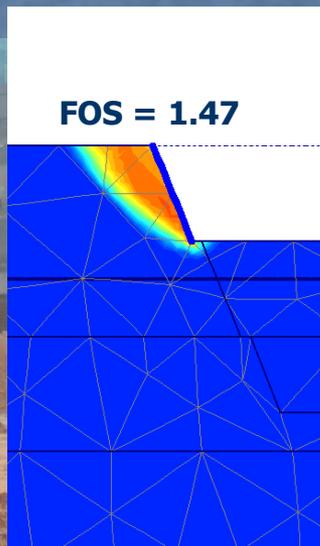
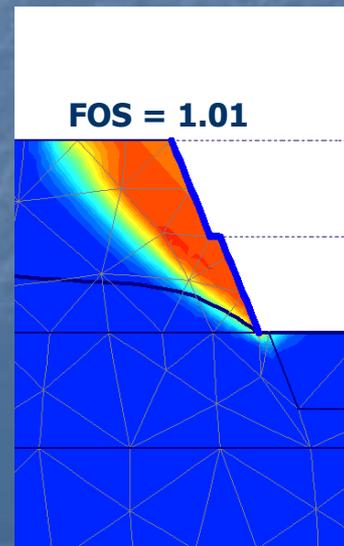
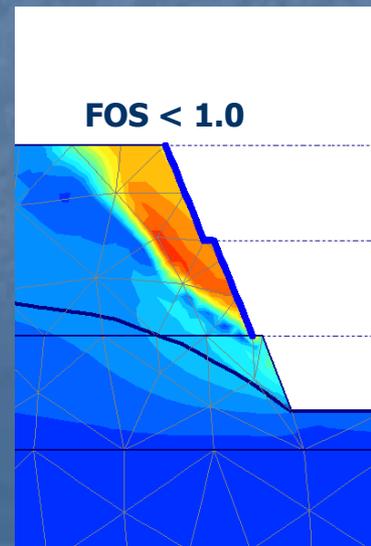
- No indication in drawing
- No enforcement in construction
- Lack of engineering supervision/control
- Client assuming engineer's role

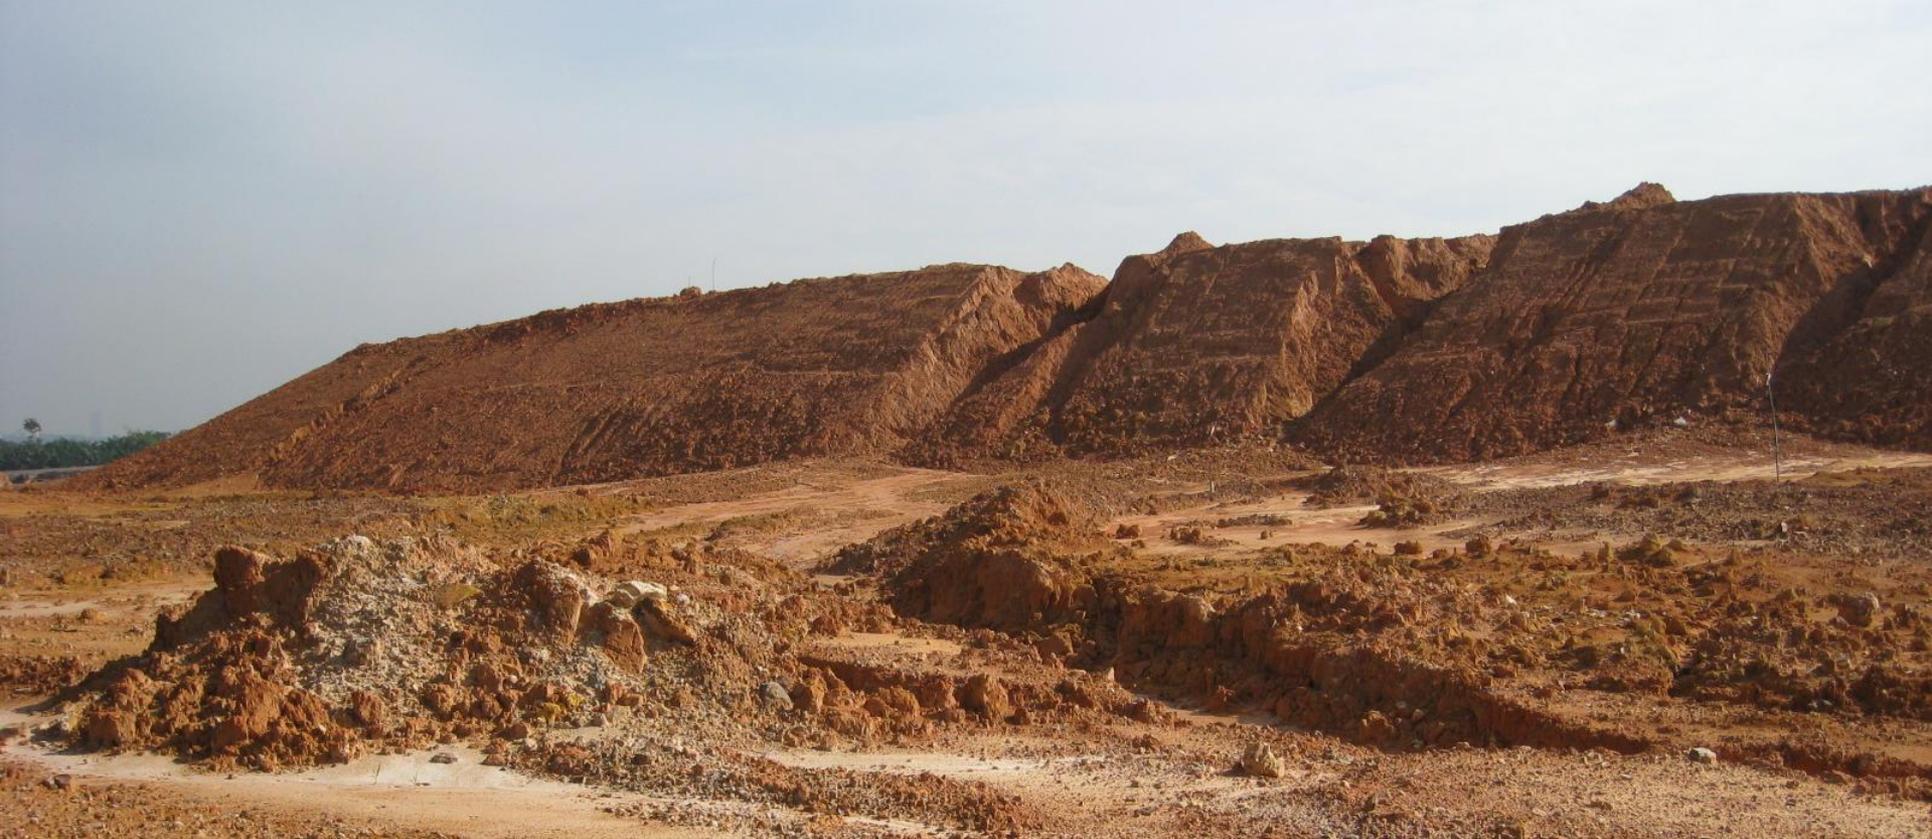
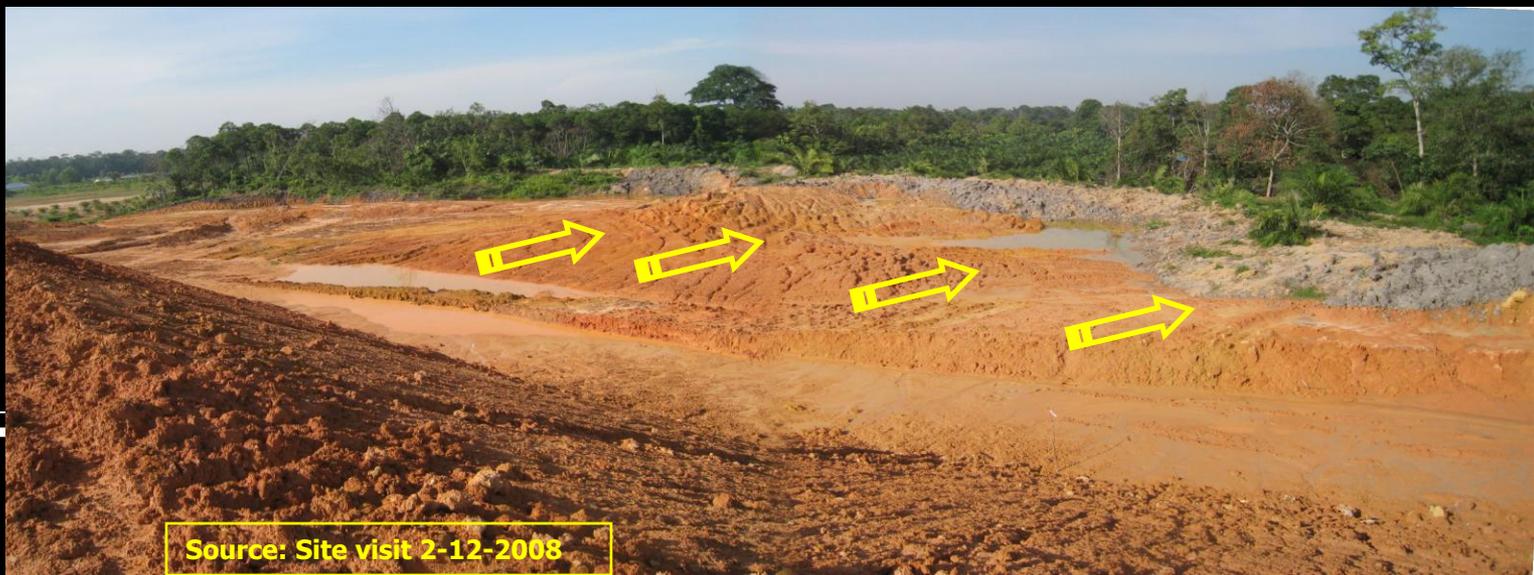
Source: Site visit 2-12-2008

- Purposely built to fail as cheap means of excavation
- Uncontrolled boundary condition
- Lack of engineering supervision/control

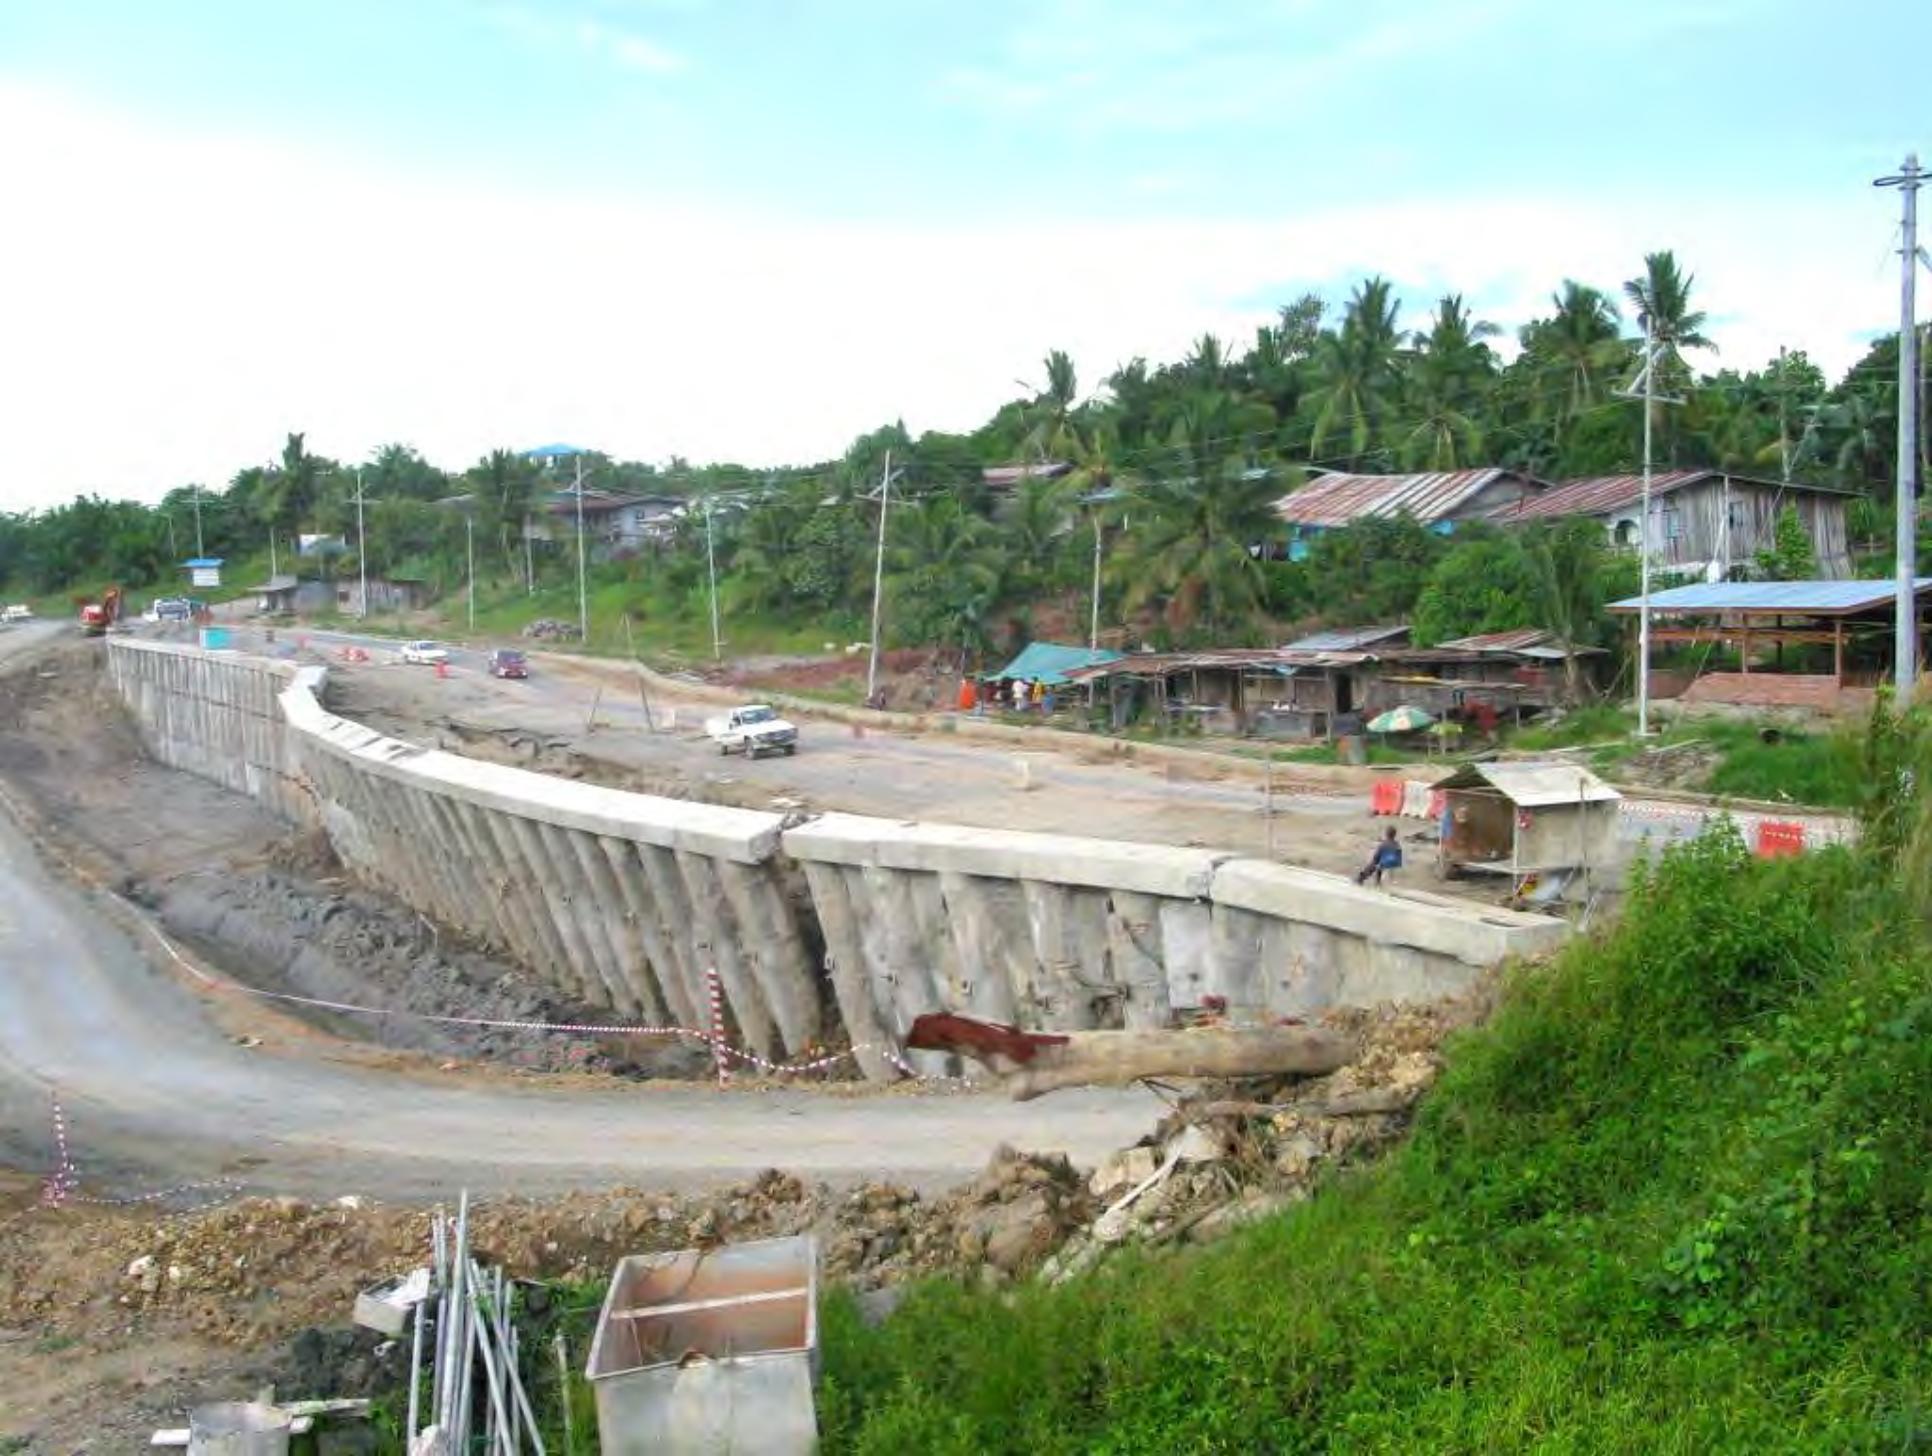
- Unfavourable geological feature
- Geological evolution
- Peculiar material properties
- Pre-existing sheared surfaces
- Fighting against nature

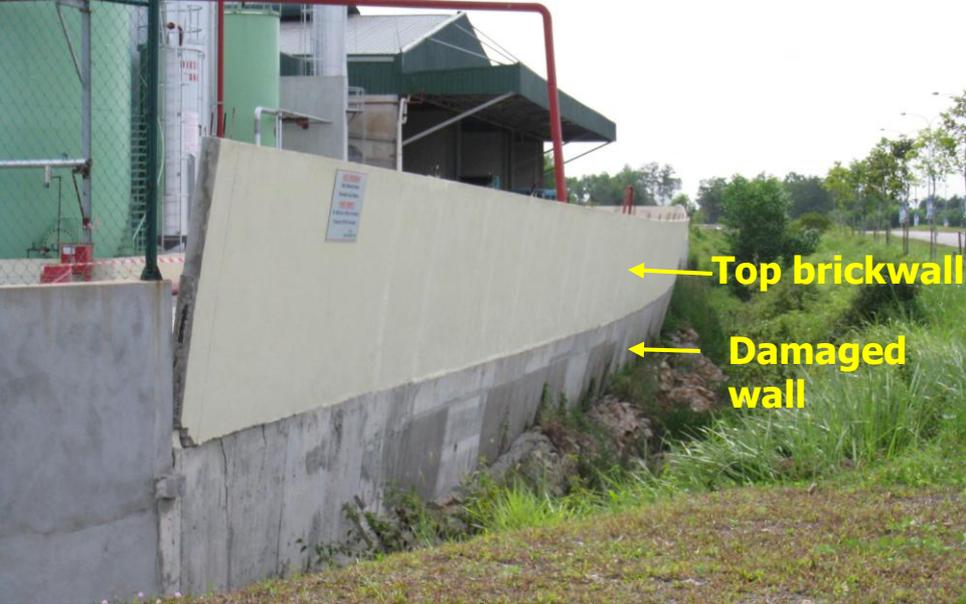
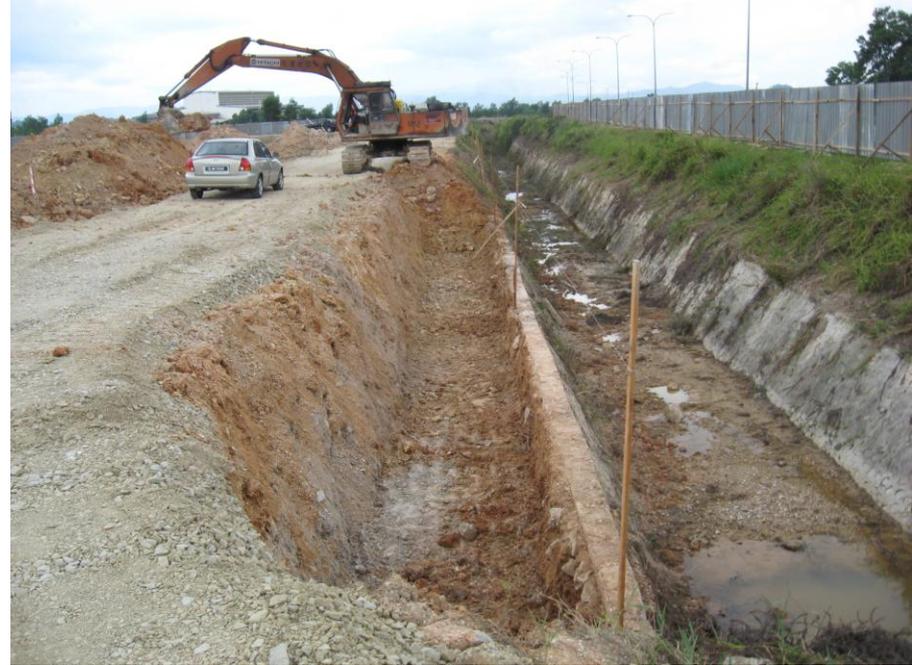
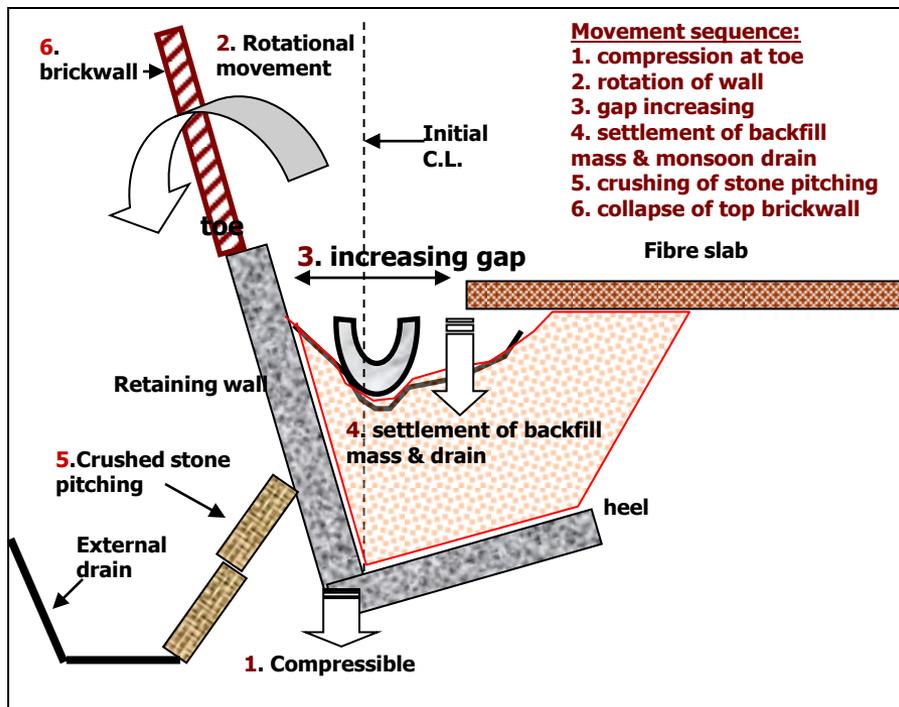
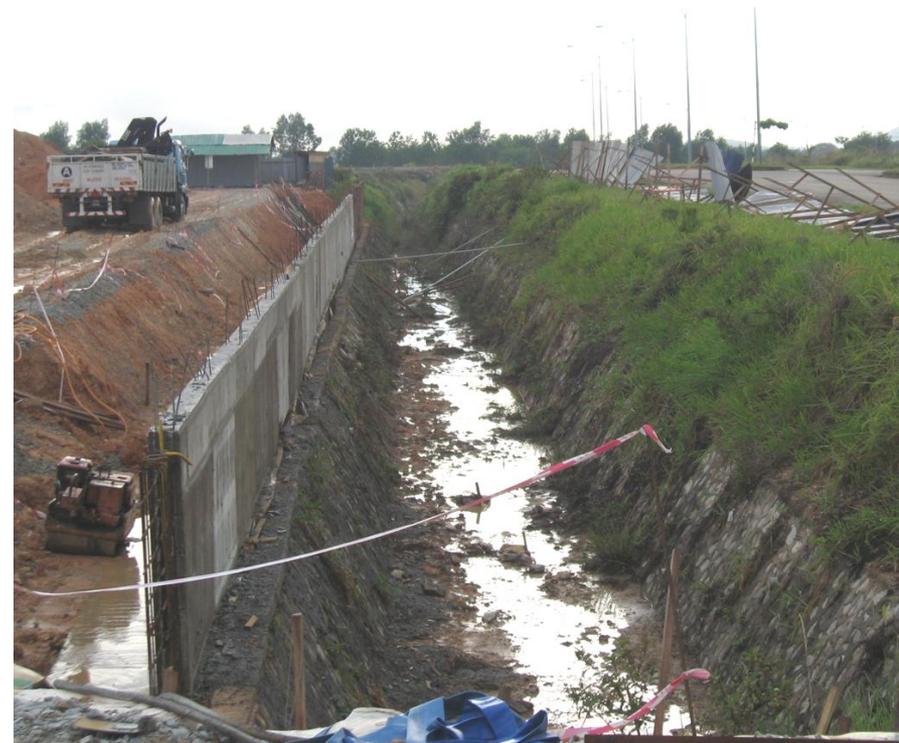
- Foundation material not the same as anticipated
- Site information not relayed to designer
- Client assuming role of engineer
- Negative effect of value engineering
