**FINAL INVESTIGATION REPORT**  
**BY**  
**SUBSTRUCTURE ANALYSIS AND SURROUNDINGS**  
**COMMITTEE**

**12 MARCH 2008**

**BADAN PENYIASATAN BEBAS (INDEPENDENT BOARD OF INQUIRY) KES  
KEJADIAN BANGUNAN RUNTUH (KOMPLEKS PELANCONGAN) DI PULAU  
BANDING, GERIK, PERAK DARUL RIDZUAN.**

# FINAL INVESTIGATION REPORT BY SUBSTRUCTURE ANALYSIS AND SURROUNDINGS COMMITTEE

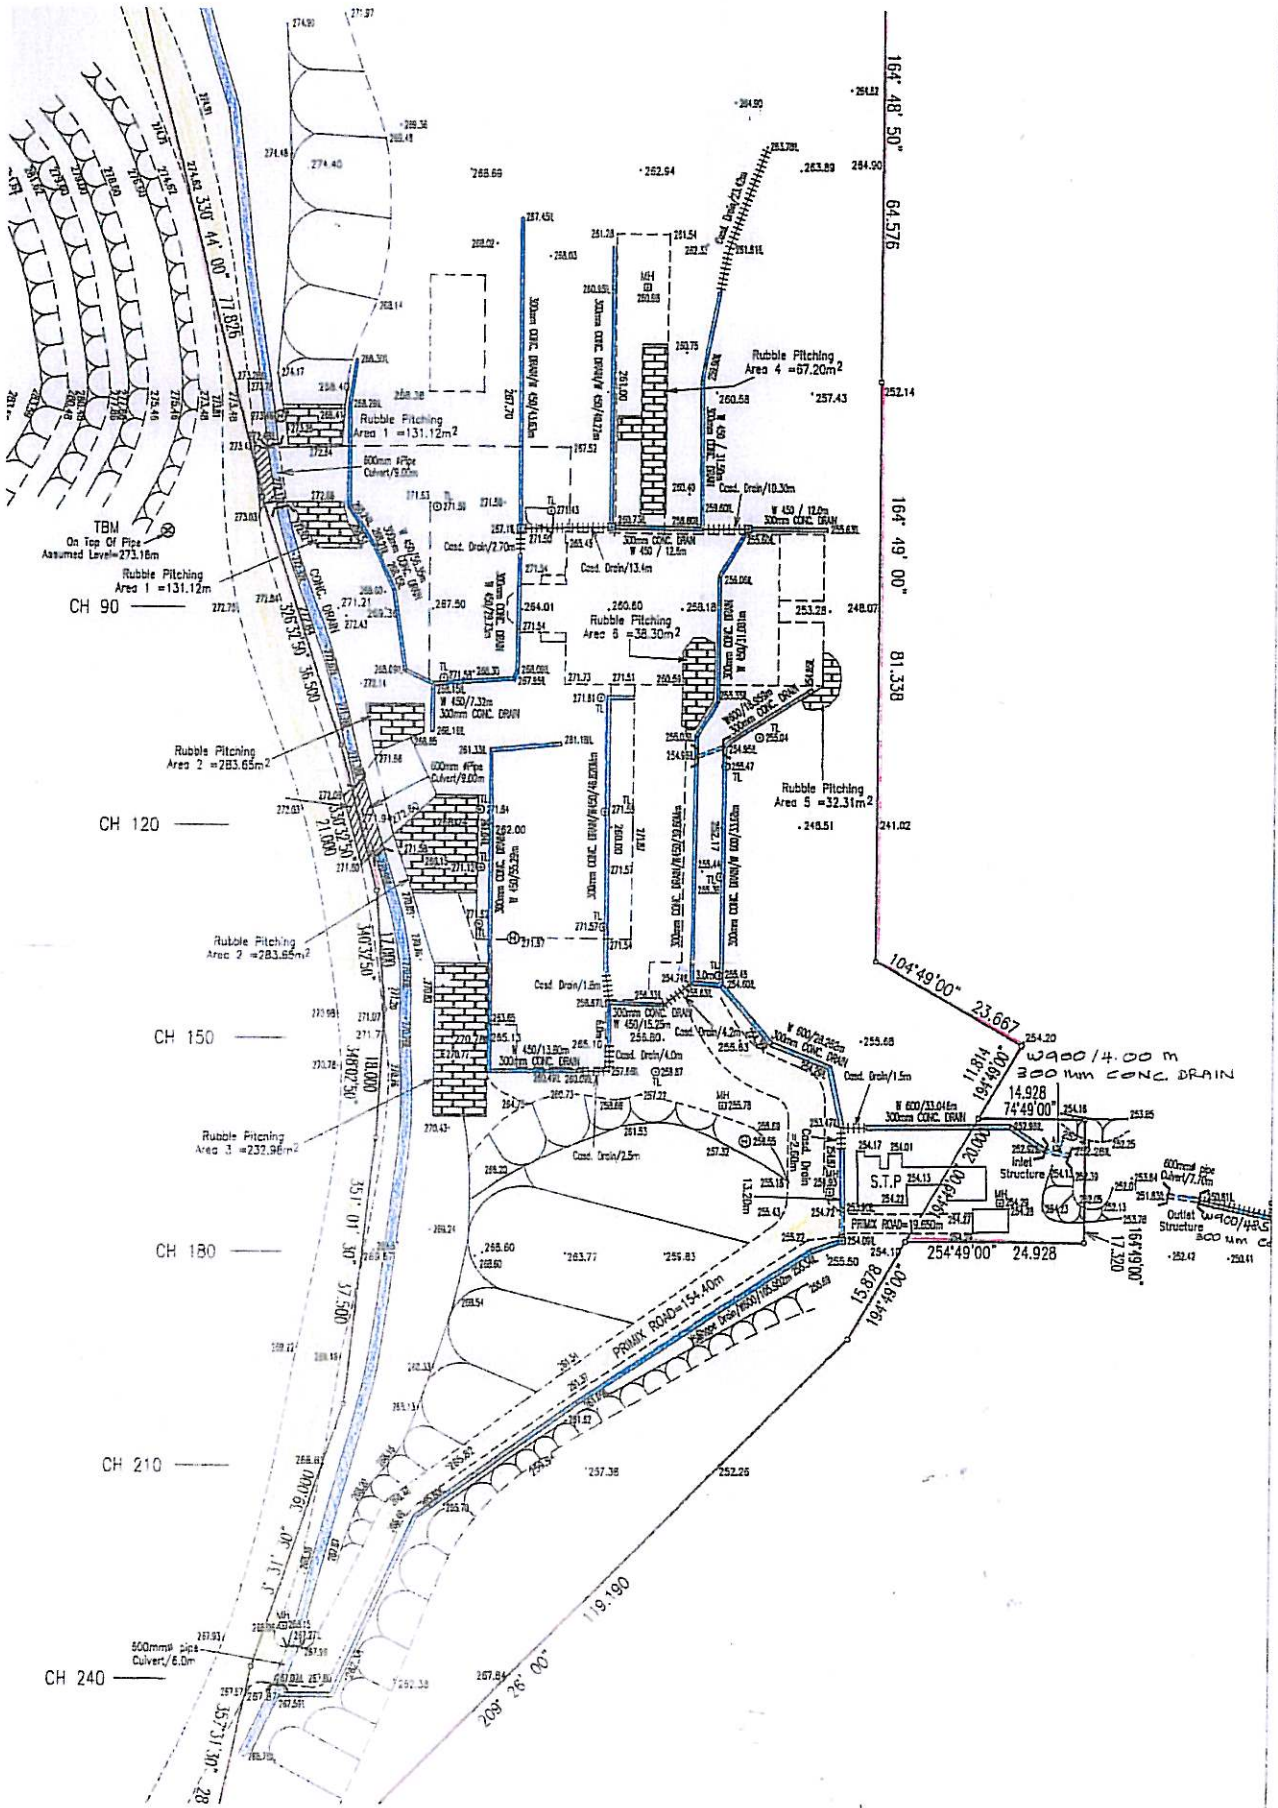
Figure 1.5: As-built Survey Plan

The working platform (formation level) was designed to a profile by cutting the earth at the high area and filling the original ground at the lower level. Generally both the cut and fill slopes are designed to a gradient of 1v:1.5h to 1v:1h, as shown in Figures 1.3 and 1.4. The As-built Drawings also indicate gradients up to 1v:1h in both the cut and fill slopes, as shown in Figures 1.5 and 1.6.

The as-built drainage system as shown in Figure 1.5 was such that, the surface runoff from the upslope would be intercepted by concrete drain

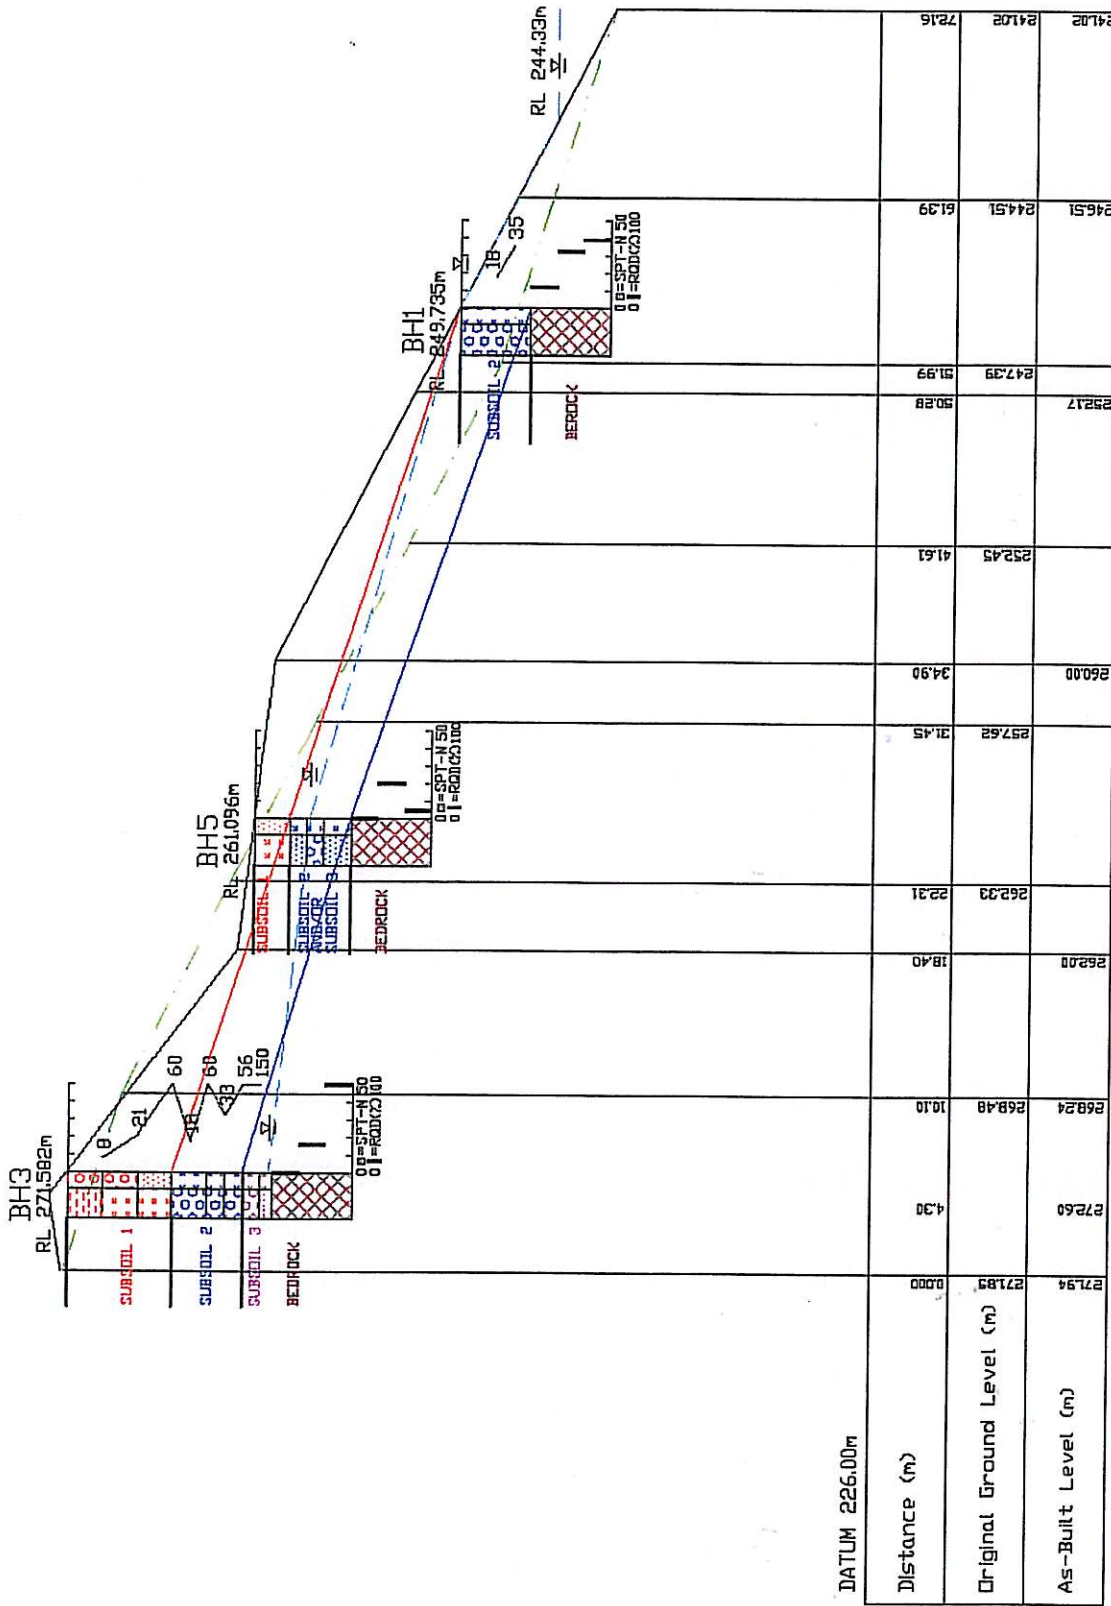
Figure 1.6: Cross-section CH. 120

- (a) Cross-section CH. 120 from the As-built Survey Drawing dated 27 April 2006 prepared by Jurukur Rakyat. The As-built Survey Drawing was reproduced as Figure 1.5 and the cross-section was reproduced as Figure 1.6.
- (b) Cross-section F-F from the latest Survey Plan (after the collapse of the building) dated 15 January 2008 prepared by Abdullah Taha & Rakan-Rakan. The Survey Plan was reproduced as Figure 1.8 in Section 8.0 of this report, and the cross-section was reproduced as Figure 1.12.

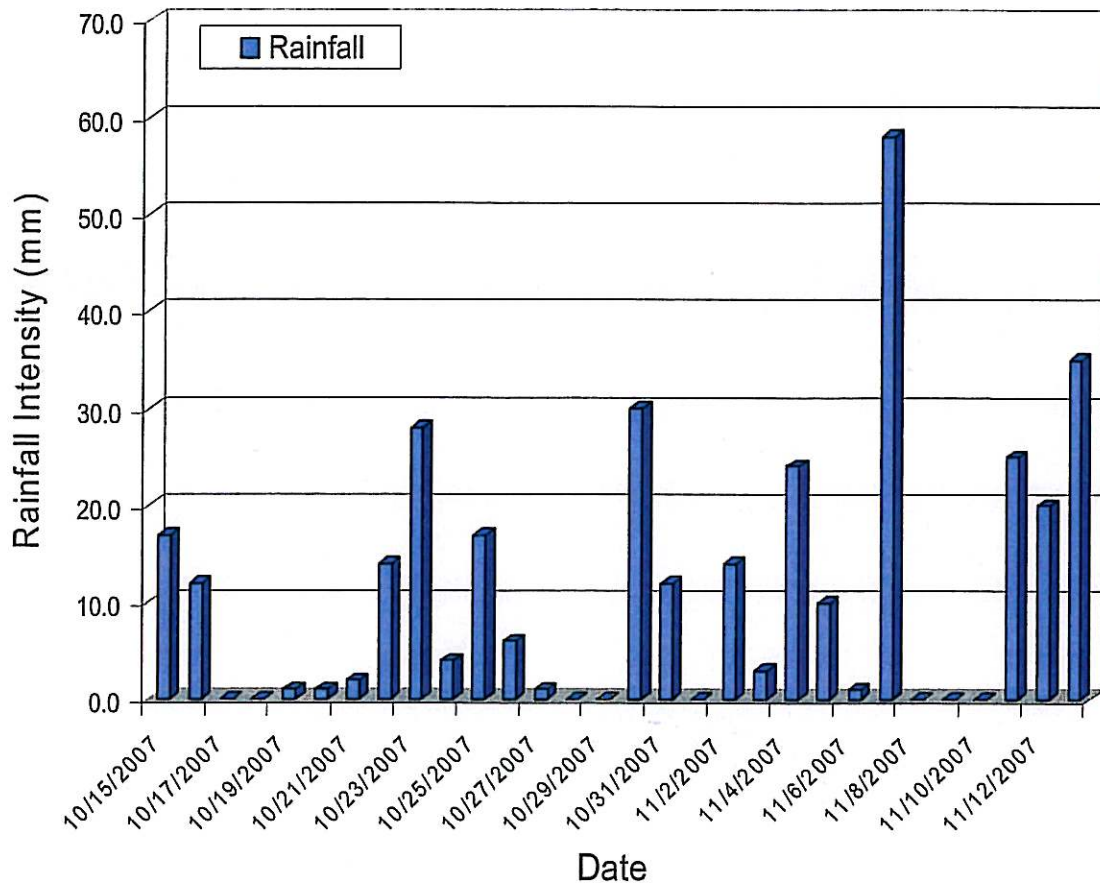
**Figure 1.7 : Daily rainfall record at Banding Station 30 days prior to the building failure**

Analysis of the rainfall pattern was carried out for the 30 and 7-day period prior to 13<sup>th</sup> November 2007. The rainfall of 355mm corresponding with 22 rainy days was recorded within the 30-day period prior to the total collapse of the building. Figure 1.7 shows the 30-day rainfall pattern. A total of 138mm rainfall was recorded during the 7-day period prior to the event. The total rainfall of 355mm at Pulau Banding Station 30 days prior to the collapse is normal and the return period is less than 1 in 5 years.

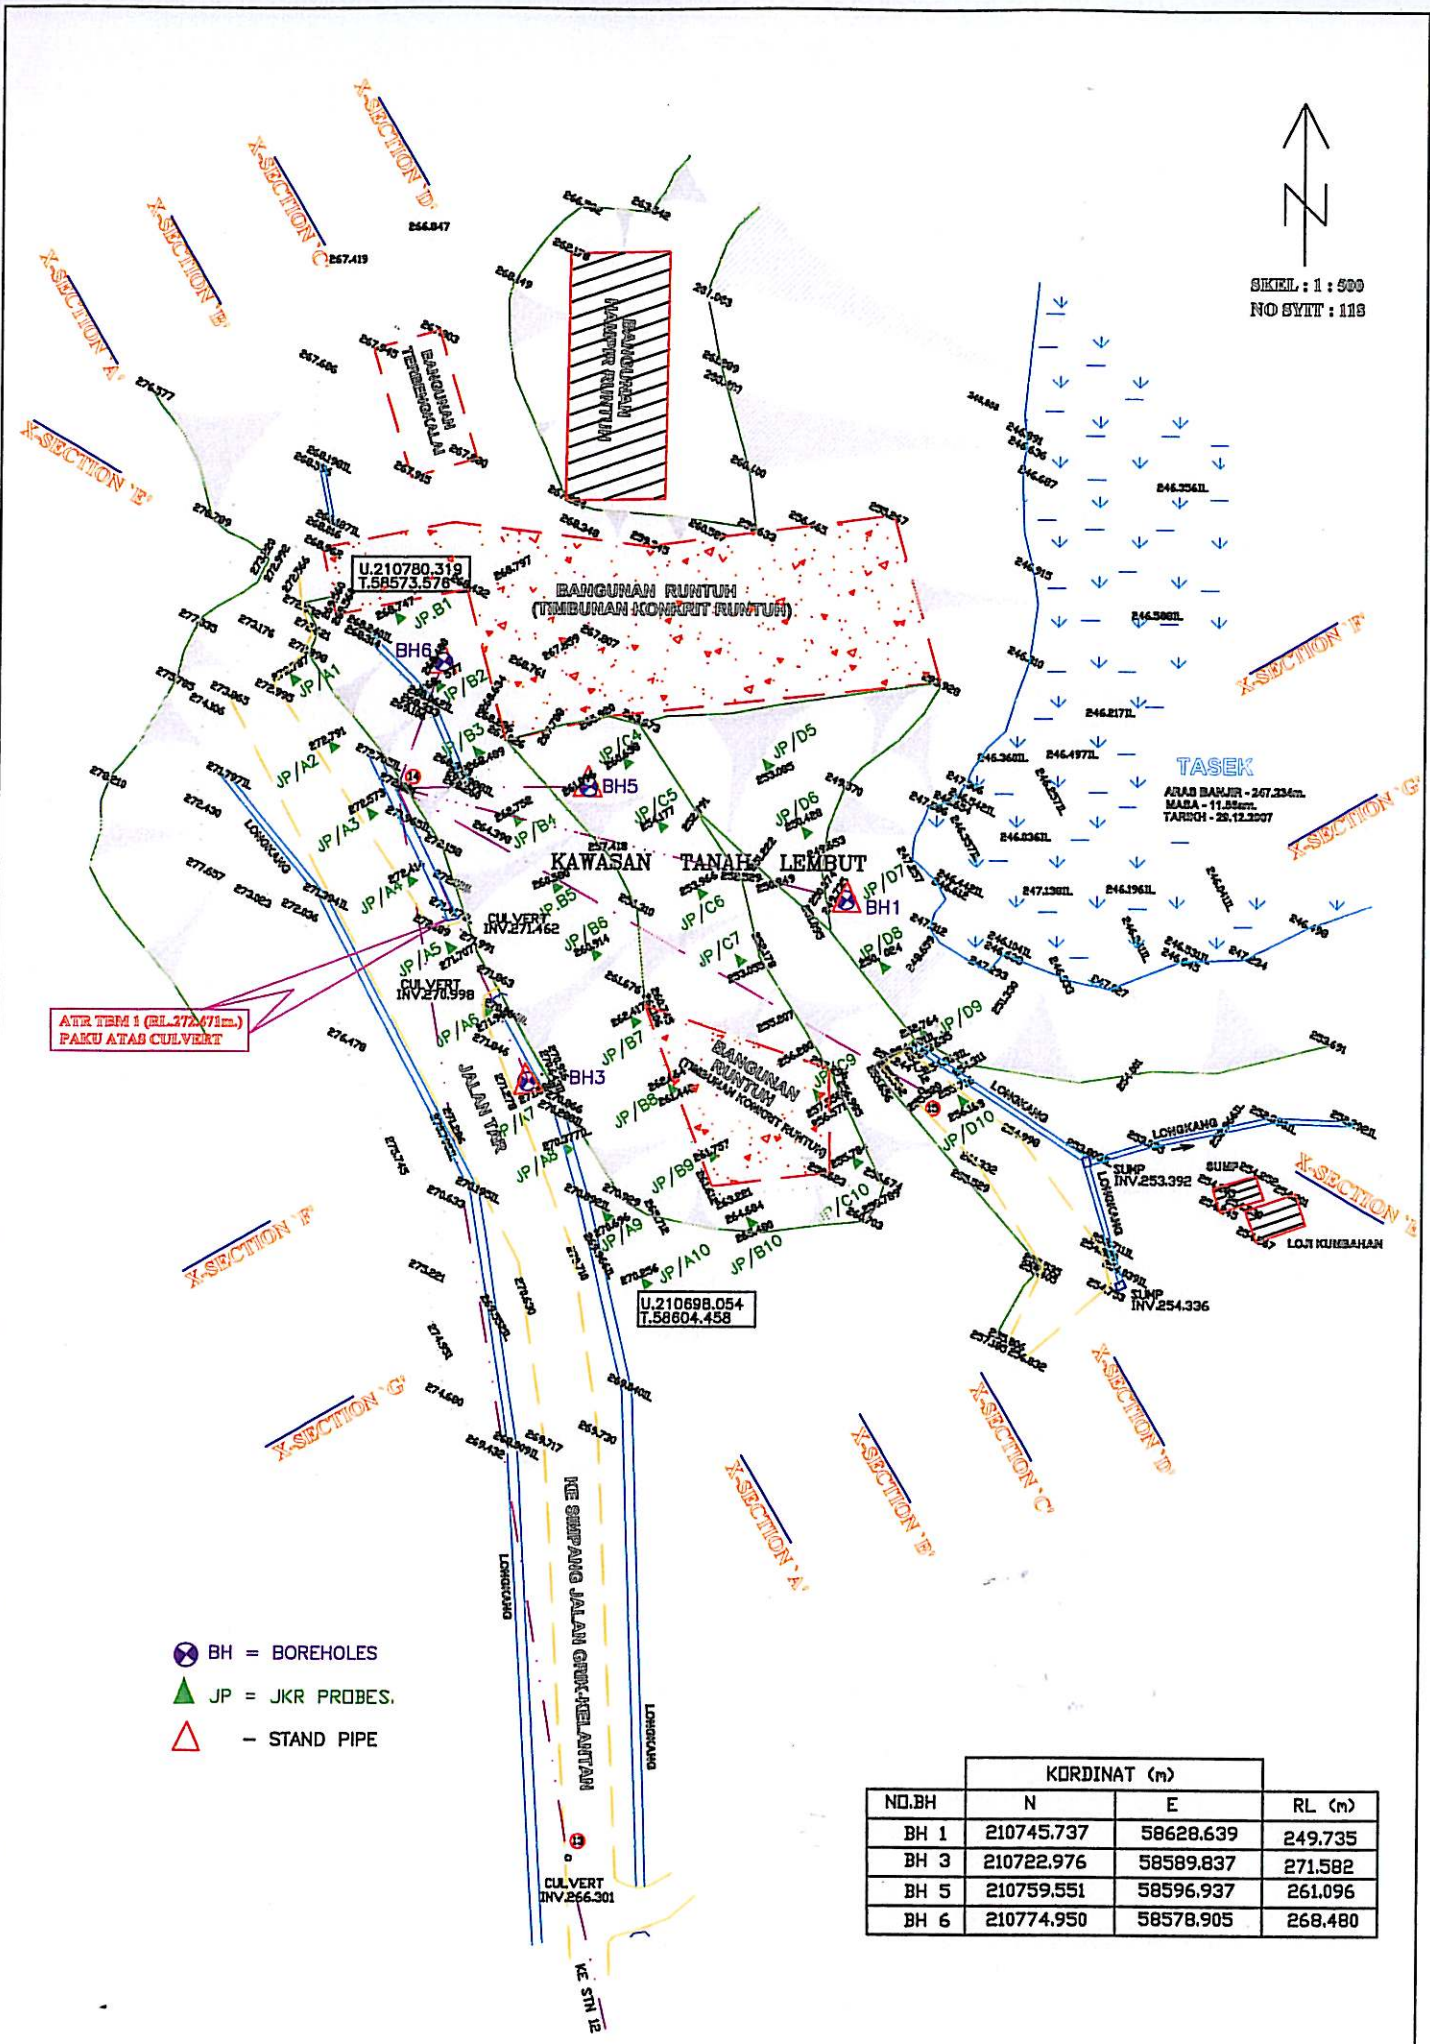
Figure 1.8 : Location of Soil Investigation

The locations of boreholes, standpipes and JKR probe tests are shown in Figure 1.8

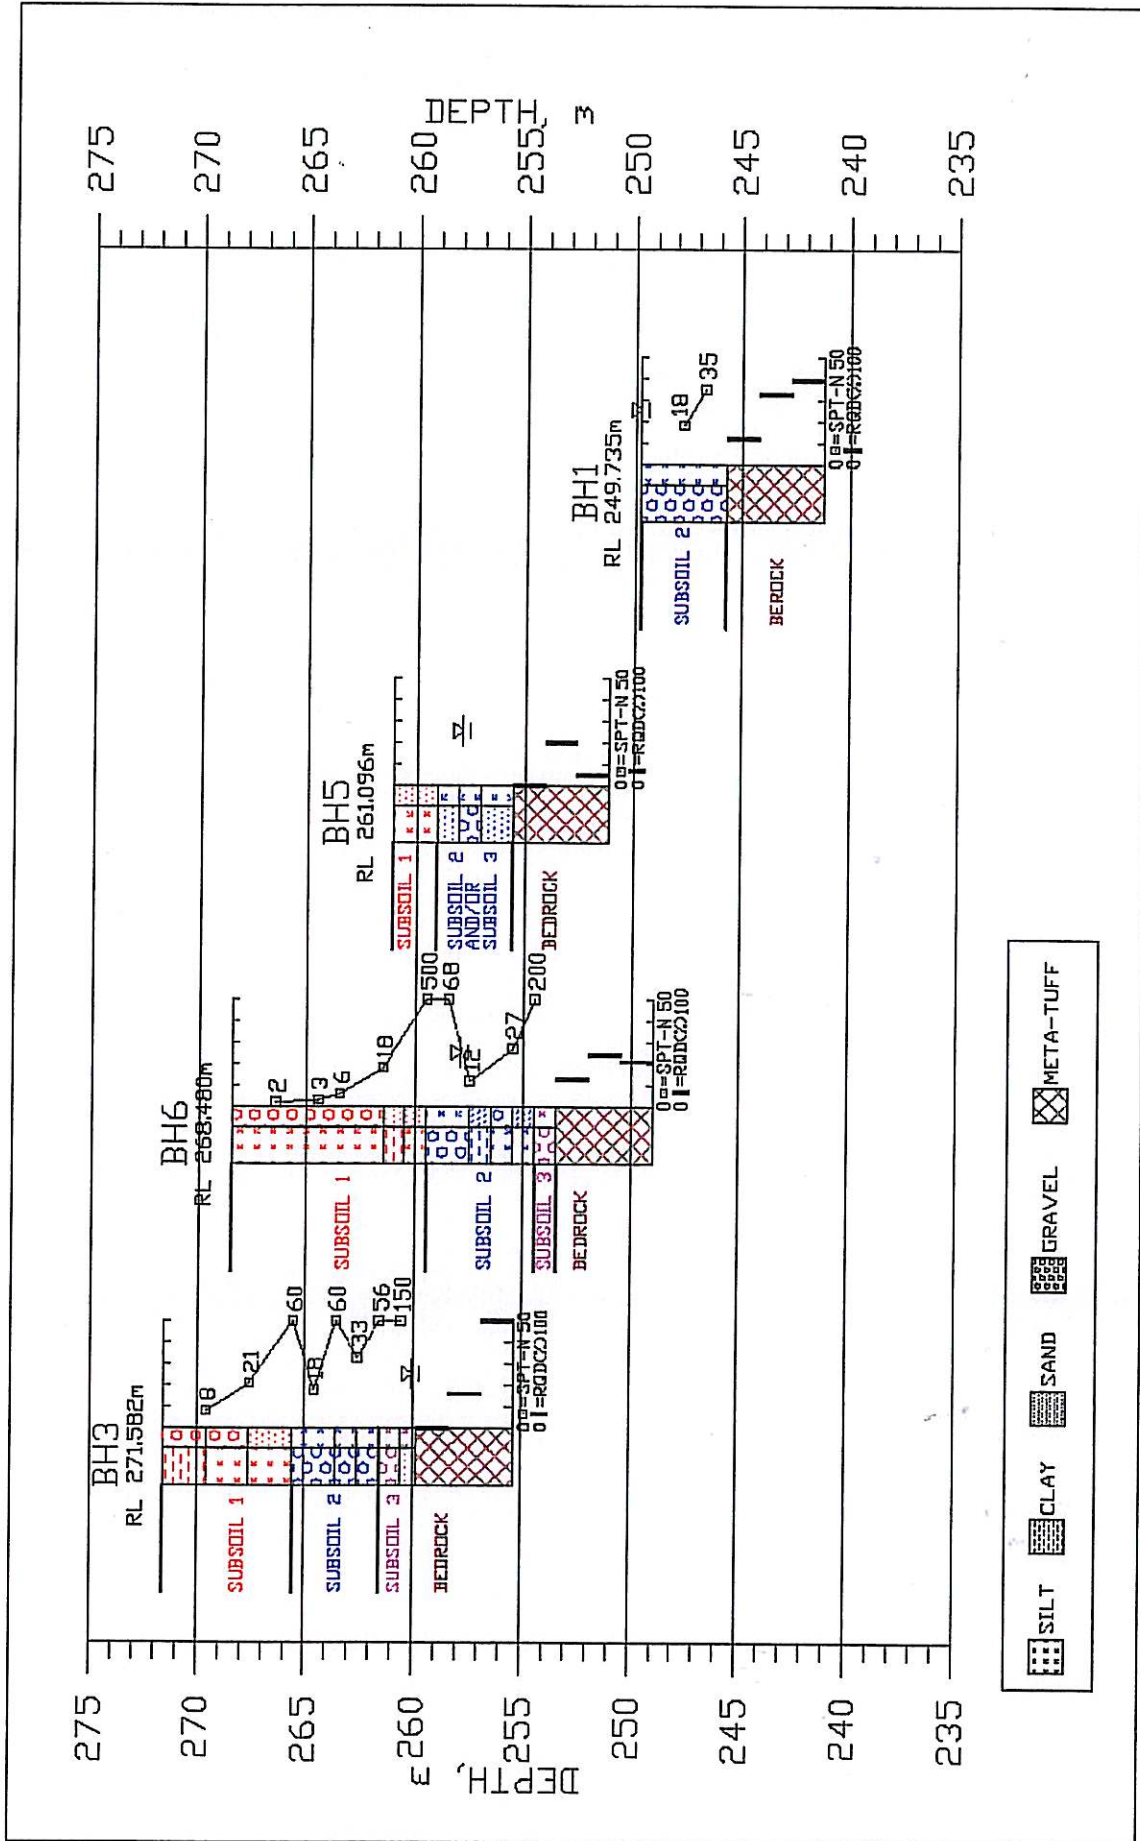
Figure 1.9: Simplified Engineering Borehole Log

Four number exploratory boreholes, referred to as BH1, BH3, BH5 and BH6 were drilled. Figure 1.9 shows the simplified engineering borehole logs derived from the soil classifications based on the grain size distribution (sieve analysis) tests and Atterberg limits tests on the disturbed and undisturbed samples obtained from the boreholes. The soil classifications were performed according to the British Soil Classification System in BS 5930:1999 (Code of Practice for Soil Investigations).

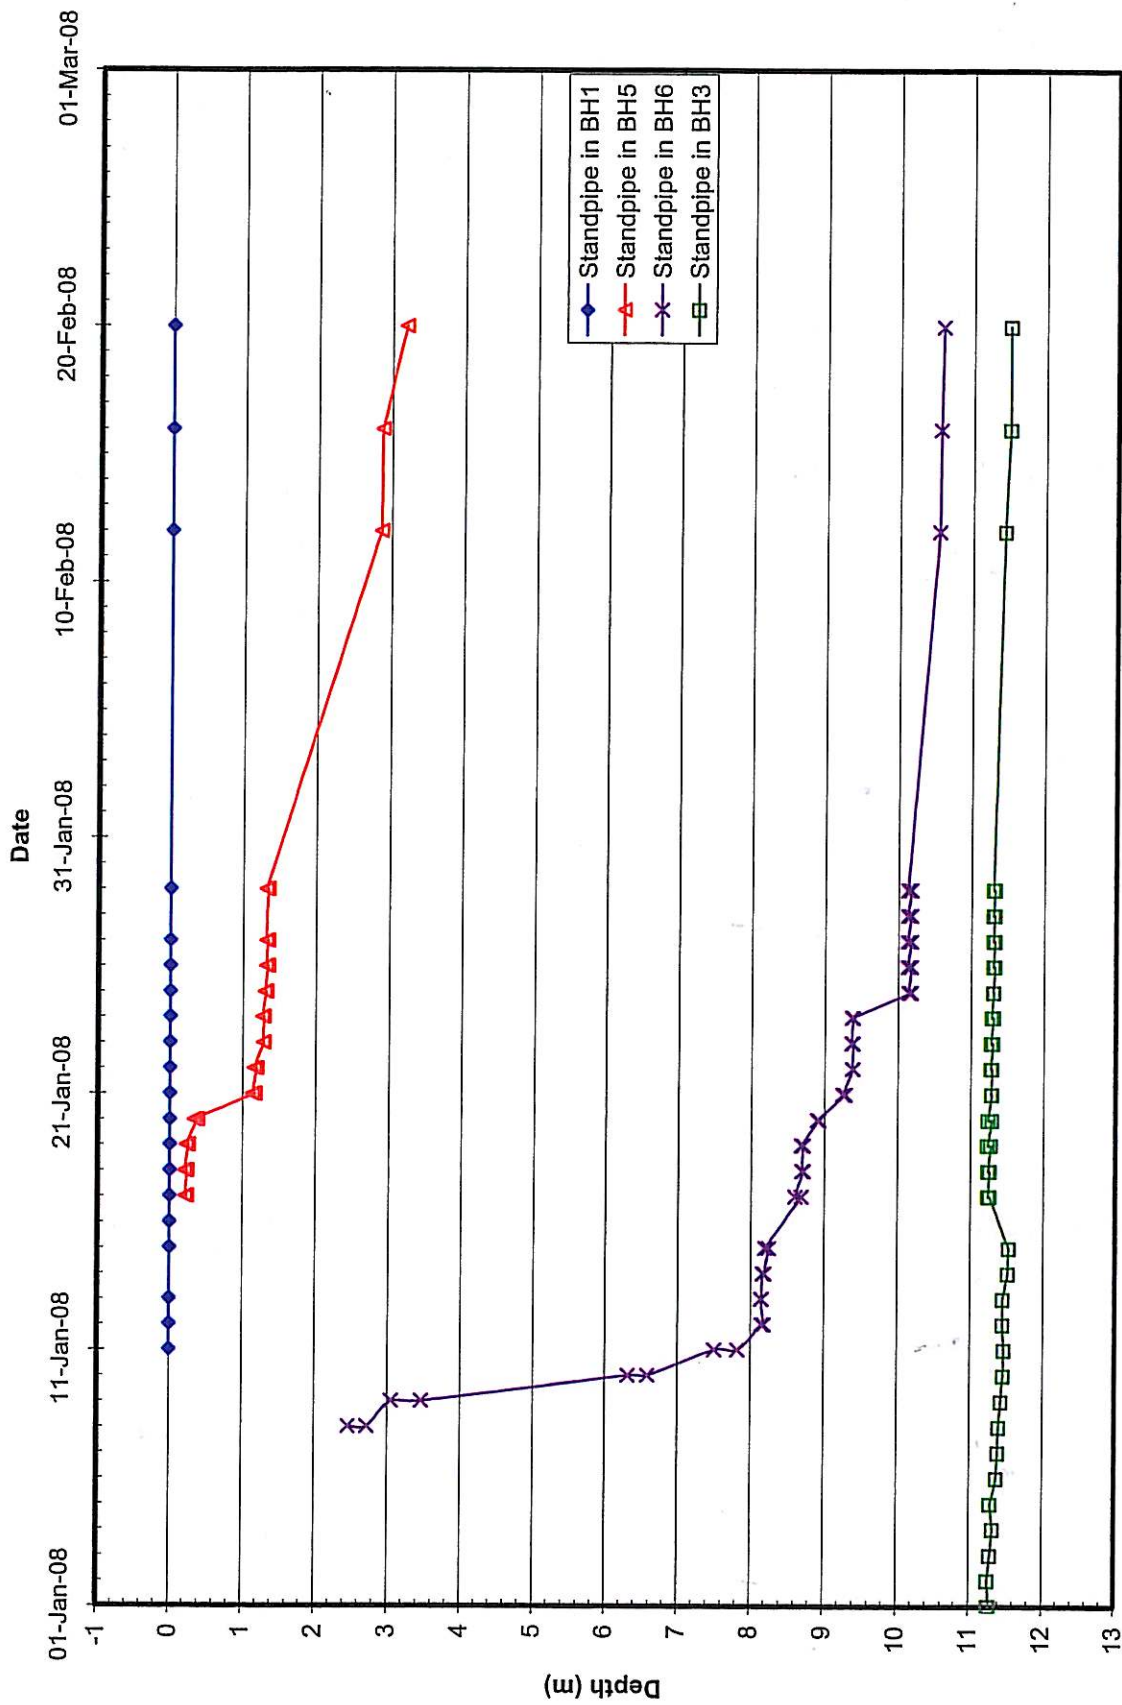
Figure 1.10: Groundwater Monitoring in Standpipes

The groundwater table at the site was monitored from four standpipes since 1st January 2008 to 20th February 2008, as shown in Figure 1.10. The depths of groundwater measured in standpipes vary from 0 to 11.50m.

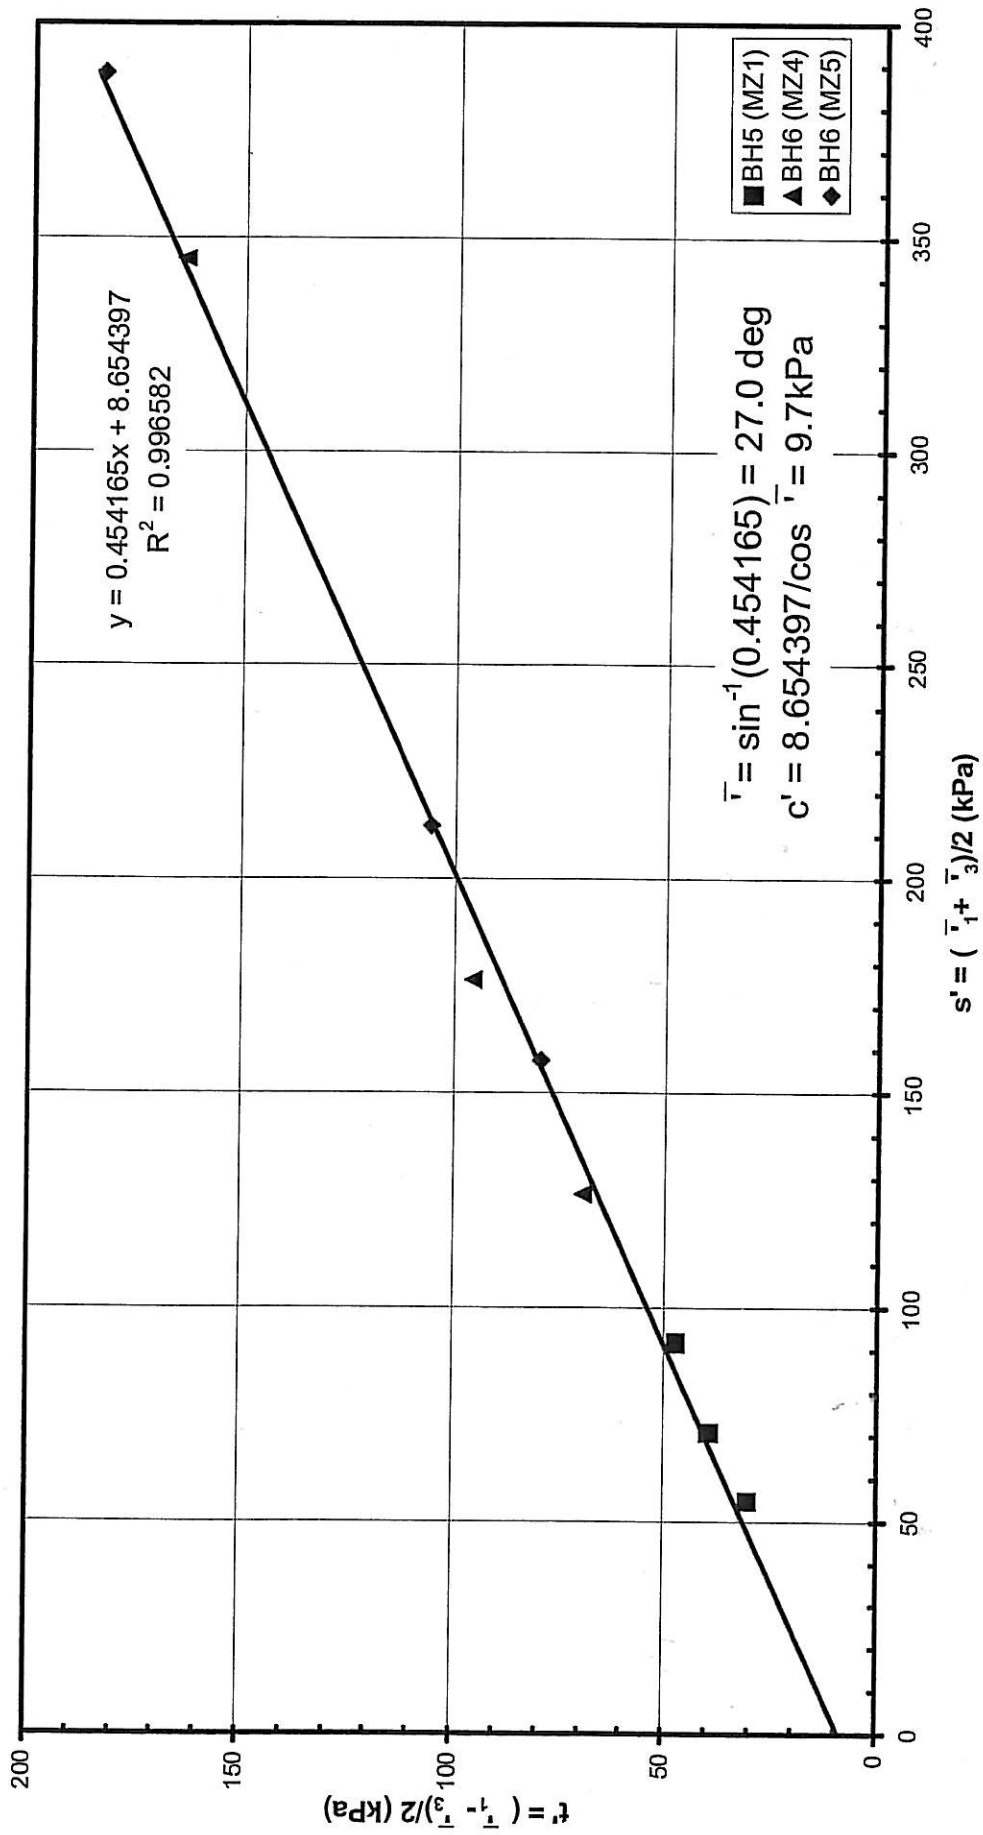
Figure 1.11: CIU Triaxial Test:  $s' - t'$  Plot

The average value of effective shear strength can be obtained by plotting the stress invariant  $s' = (\sigma'_1 + \sigma'_3)/2$  versus stress invariant  $t' = (\sigma'_1 - \sigma'_3)/2$  for all the three samples, as shown in Figure 1.11. The average effective cohesion (C') is 9.7kPa and the average effective angles of friction ( $\phi'$ ) is 27.0°.

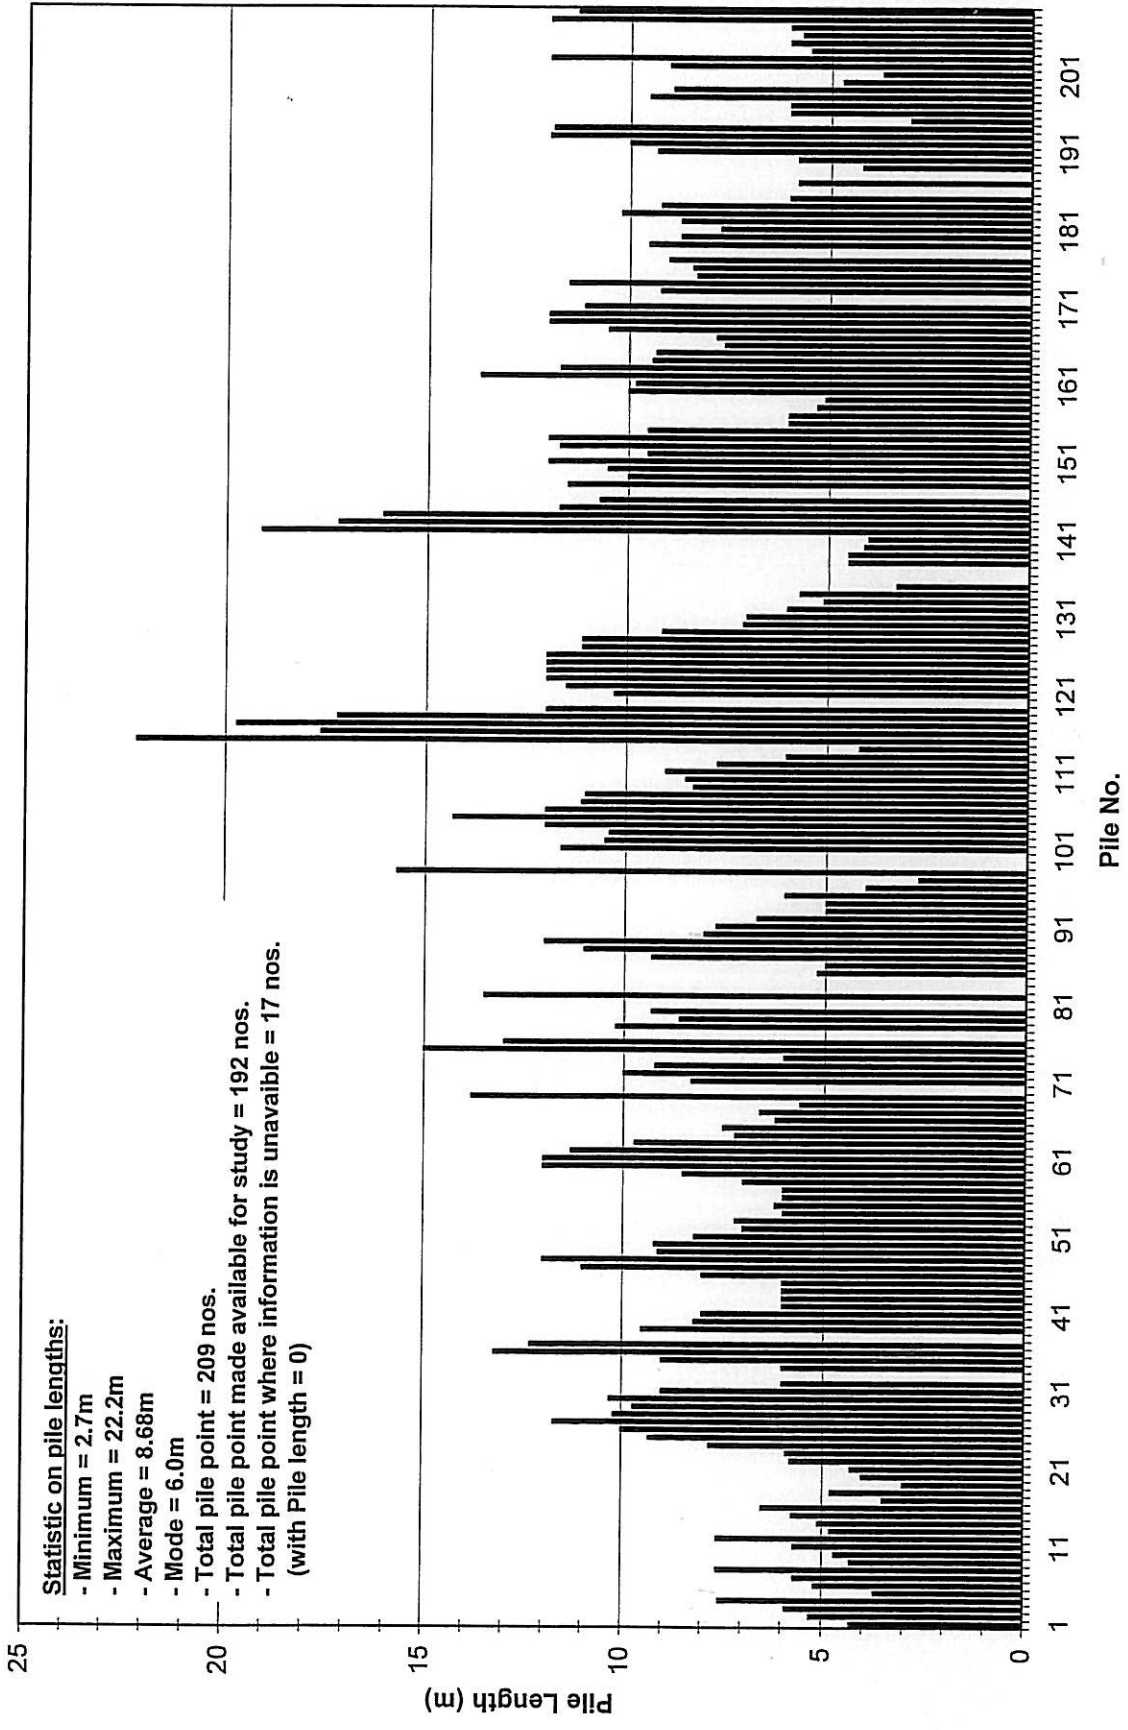
**Figure 1.14: Summary of Pile Lengths**

The pile lengths are summarized and plotted in Figure 1.14. Statistical analyses on pile length show that
