BLACKSPOT (BS)2015 EFFICACY REPORT

EFFECTIVE MONITORING OF TREATMENTS

SITE VISIT FOR LOCATIONS THAT DO NOT REACH > 70% OF THE EFFICACY OF TREATMENT

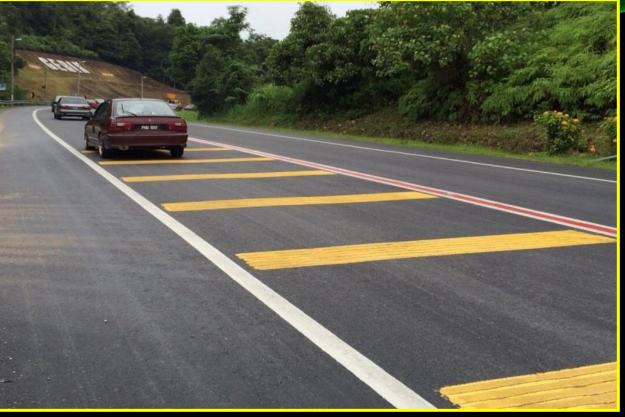
FT076, KM92, JALAN KUALA KANGSAR – GERIK – PENGKALAN HULU, HULU PERAK, PERAK

• There are **2 accidents** that occur after treatment.

- The road marking has faded.
- Road <u>surface has cracked</u>.
- <u>The thickness of the Yellow Transverse Bar (YTB) has been lacking</u> (specification: 3 mm – 7 mm)
- YTB is far more than 100 meters to the intersection/accident area.

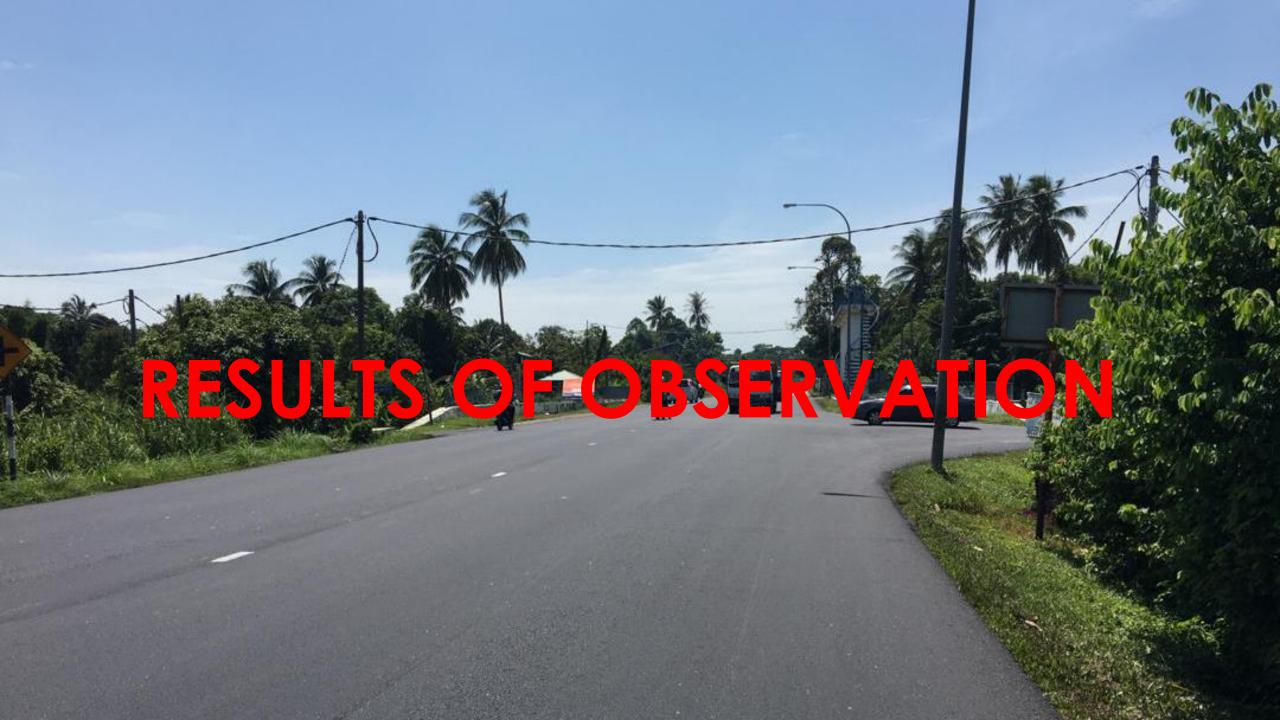
- A frequent accident occurred due to the vehicle making a U turn.
- In addition, accidents are also caused by vehicles crossing lanes to enter the opposite exit.

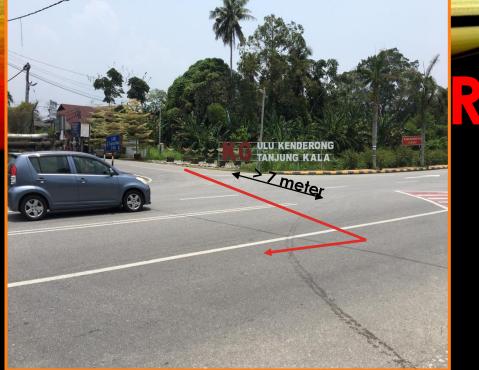
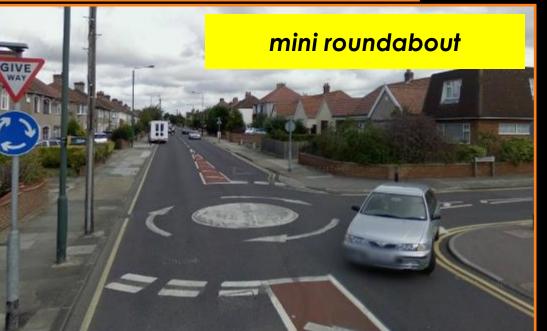
Yellow Tranverse Bar (YTB) is located at a distance that allow the vehicle to speed up again before arriving at the accident prone area.

1. Treatment must be carried out within the radius of the accident prone area.

- 2. Re-study the treatment at the exit/entry that is too wide for the vehicle/motorcyclist to cross out.
- 3. Consider construction of a roundabout at a wide junction to address the problem other than the high-cost signal installation.
