Landslide Types & Processes

IR. DR. MOHD ASBI BIN OTHMAN

Mohd Asbi & Associates

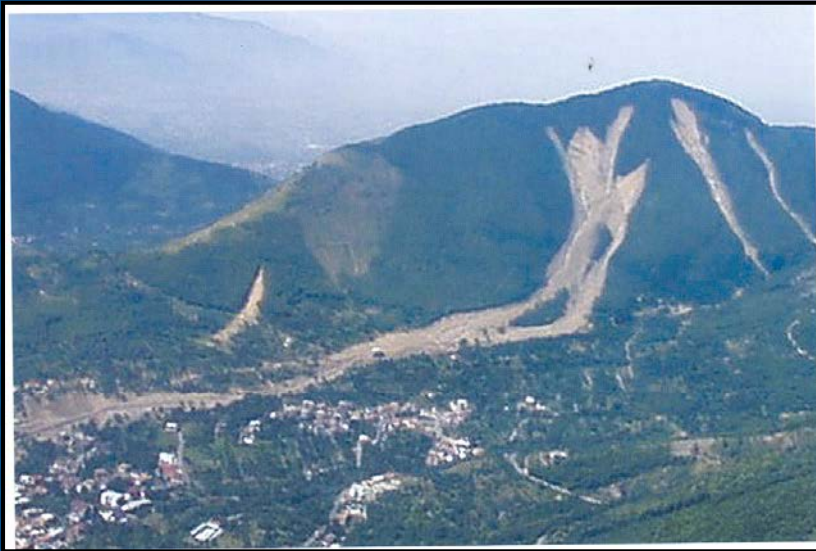
The Sarno landslide southern Italy in May 1998 which resulted in the loss of 244 lives

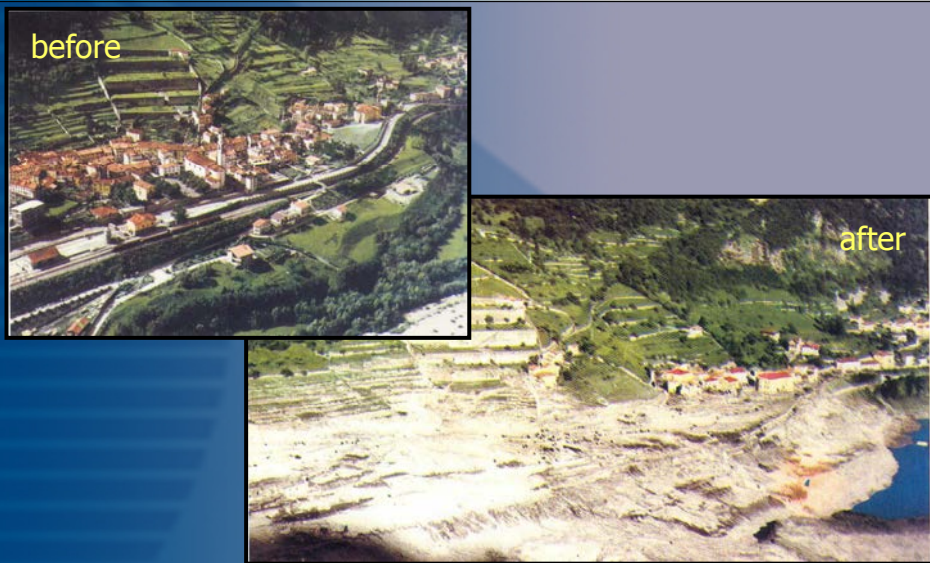
The Vajont landslide in Italy, caused by the collapse of a valley-side into a reservoir.

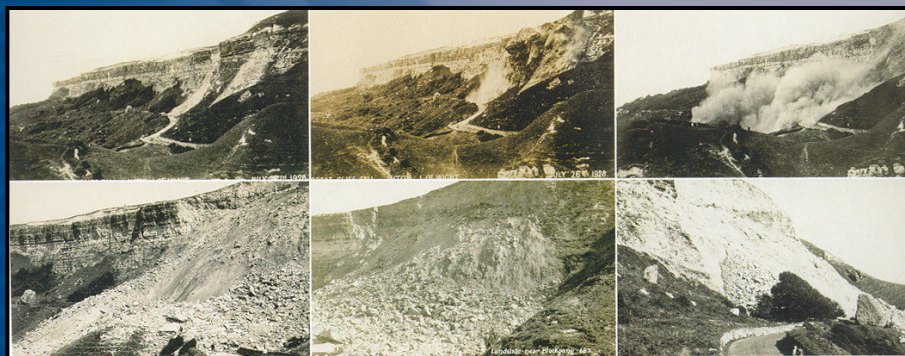
One of the most famous examples of a toppling failure occurred on the 26 July 1928 at Niton Underclift, Isle of Wight

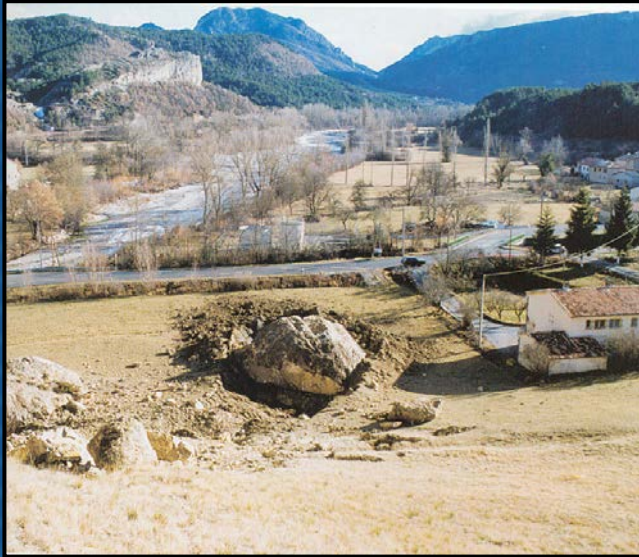
A massive rock fall in the Commune of Sennoz, France with debris impacting close to residential development

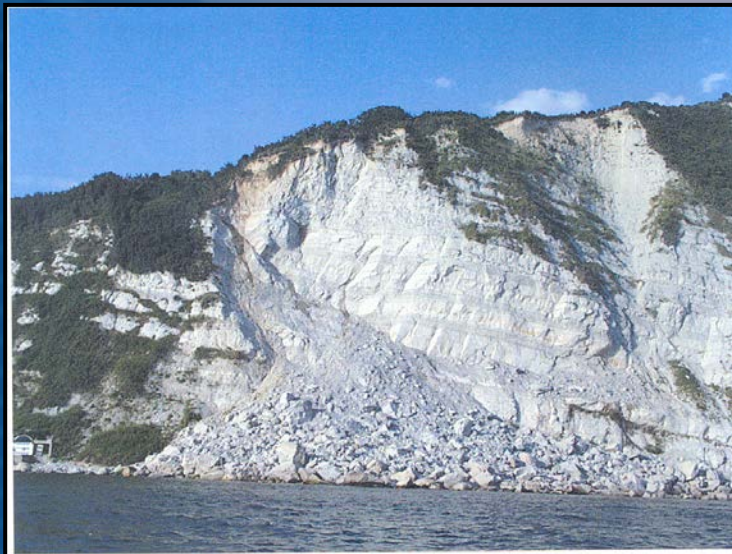
Rock fall at Ancona, Adriatic coast of Italy

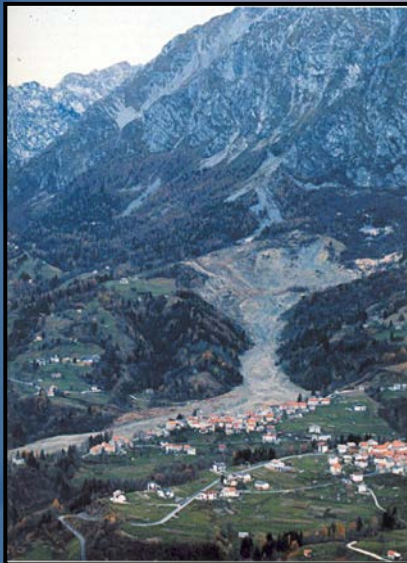
The landslide extends for 2.5km through the southern slopes of Mount Teverone and the major mudslide was activated after intense rainfall in October 1960.

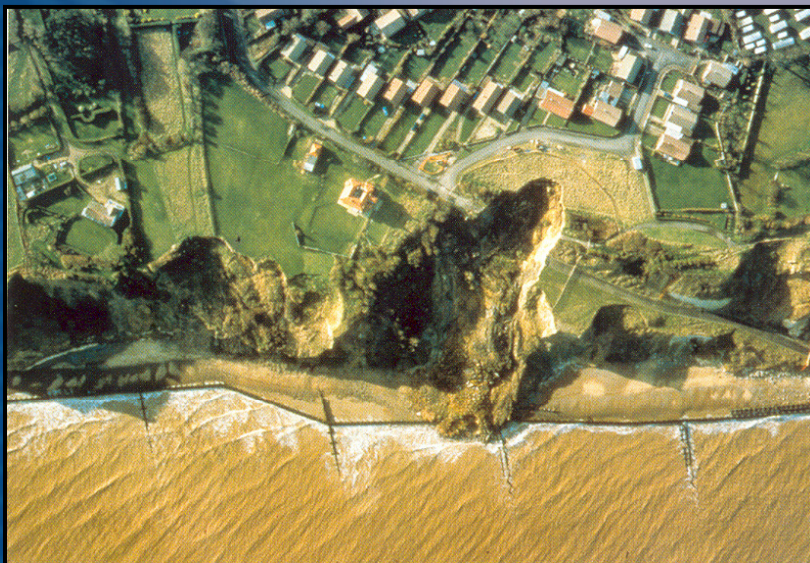
Coastal landsliding at Overstrand, Norfolk , UK – part of this frontage has now been protected.

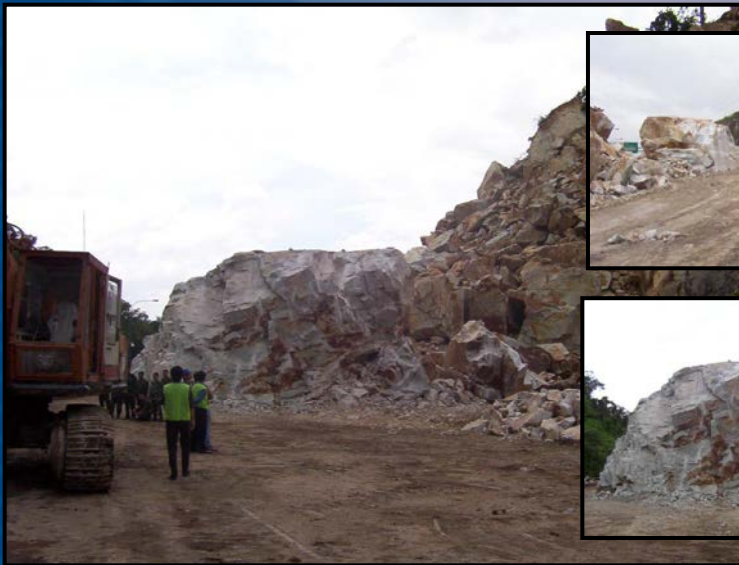
Case Study 1: Bukit Lanjan Rock Slope Failure

- On the 26 November 2003 at about 07:16 a very large rock slope failure occurred at kilometer 21.8 of the Bukit Lanjan Interchange on the New Klang Valley Expressway (NKVE).
- The rock slope failure involved an estimated 35,000 m³ of rock debris, mainly angular blocks of various sizes, which came to rest on the expressway. The failure materials blocked the entire expressway forcing the closure of the road to the public

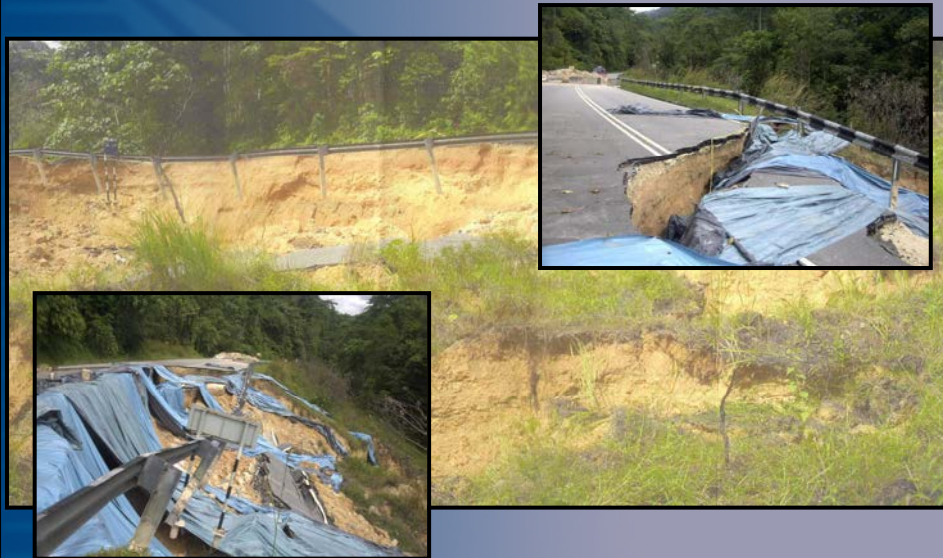
Case Study 2: Embankment Failure at Ulu Yam Road

- A major landslide occurred at KM 12, Jalan Ulu Gombak - Ulu Yam Baru (B23) located in Daerah Gombak on 22 Nov 2002.
- The landslide was triggered by intense and prolonged rainfall brought down tonnes of earth and damaged almost three-quarters of the width of the road. No fatalities were reported in the incident.
- The **rotational landslide** measured approximately 70m wide and 10m high. The crown and surface of rupture were circular.
- The toe of the slope was seen to have heaved indicating a very high pore water pressure build up prior to the failure.
- This is common for areas where large catchment is found upslope.

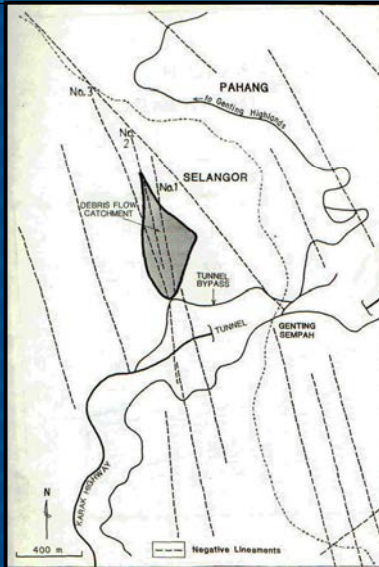
Case Study 3: Debris flow at the tunnel bypass Road, Genting Sempah

- The tragic site is located in Genting Sempah at a curved turning at the tunnel bypass road which is approximately 425 metres from its Junction at the Kuala Lumpur-Karak Highway.

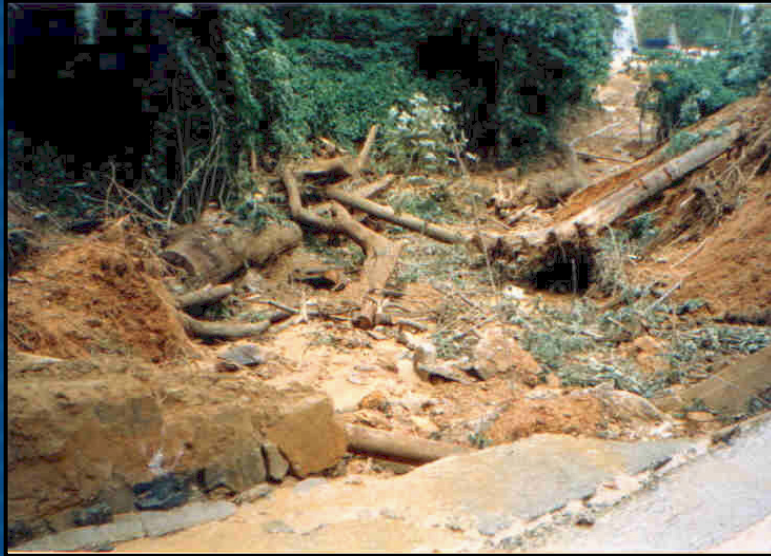
Case Study 3: Debris flow at the tunnel bypass Road, Genting Sempah

- The debris flow tragedy at the tunnel bypass road to the Genting Highlands occurred at about 5.20 p.m. on the 30th June 1995.
- The incident took 21 lives (one body missing) and injured another 22 persons.
- Most of the victims were buried under tonnes of mud, some 200 metres from the point where the debris flow crossed the bypass road

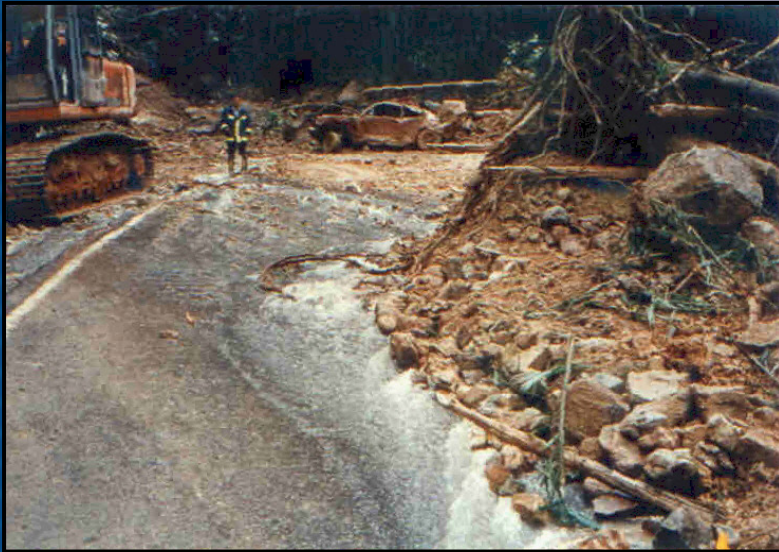
Case Study 3: Debris flow at the tunnel bypass Road, Genting Sempah

- A very intense and heavy rainfall occurred over the Genting Sempah area covering the debris flow catchment from about 3.40 p.m. to about 5.30 p.m. on the 30th June 1995.
- As a consequence, flash floods were reported at the highway tunnel and the surrounding Genting Sempah area resulting in a massive traffic jam in the area.
- The debris flow, consisting essentially of large volume of water carrying mud, stone, cobbles, boulders and tree trunks flowed down a stream course at great velocity and force sweeping across the tunnel bypass road at the curved turning where heavy traffic was lined up.

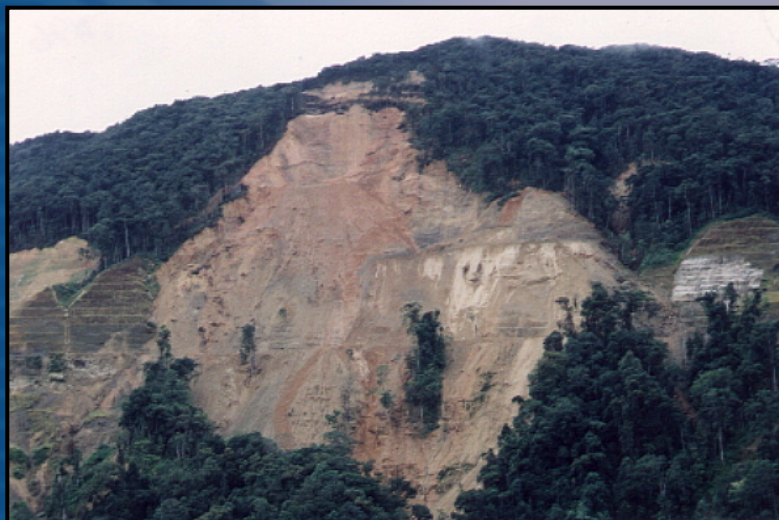
October 2001

After completion of a few berms, the slope started to fail. A series of failures on this slope was first reported in April 2000 after a long period of intense and heavy rainfall which triggered further retrogressive slips in the upper catchment .

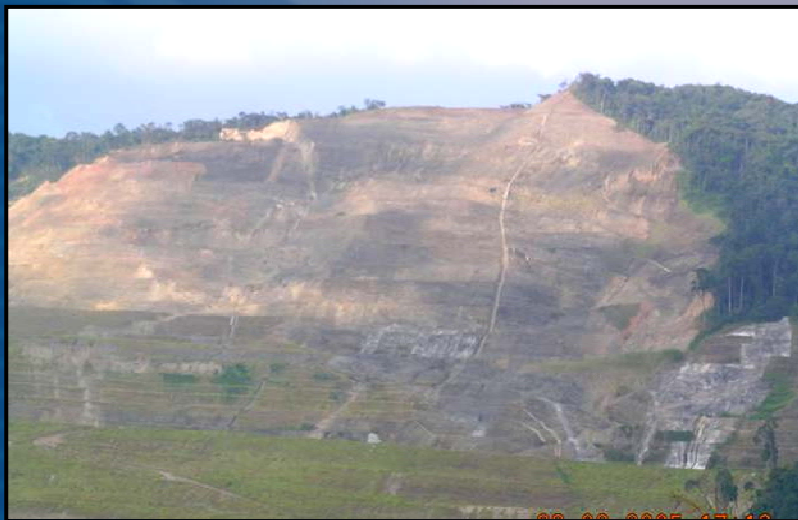
2005

The deep-seated failure mode exhibited by these failures had prohibited the adoption of stabilization measures using active anchors, passive soil nails, sprayed concrete etc. Eventually, the Main Contractor had no alternative but to adopt the rehabilitation scheme involving slope re-profiling.
