Technical Issues Faced on Completed Government Hospital Project

Forensic Findings

Mesyuarat Tahunan Jurutera Mekanikal 2016
Cawangan Kejuruteraan Mekanikal, Ibu Pejabat JKR
5 September 2016

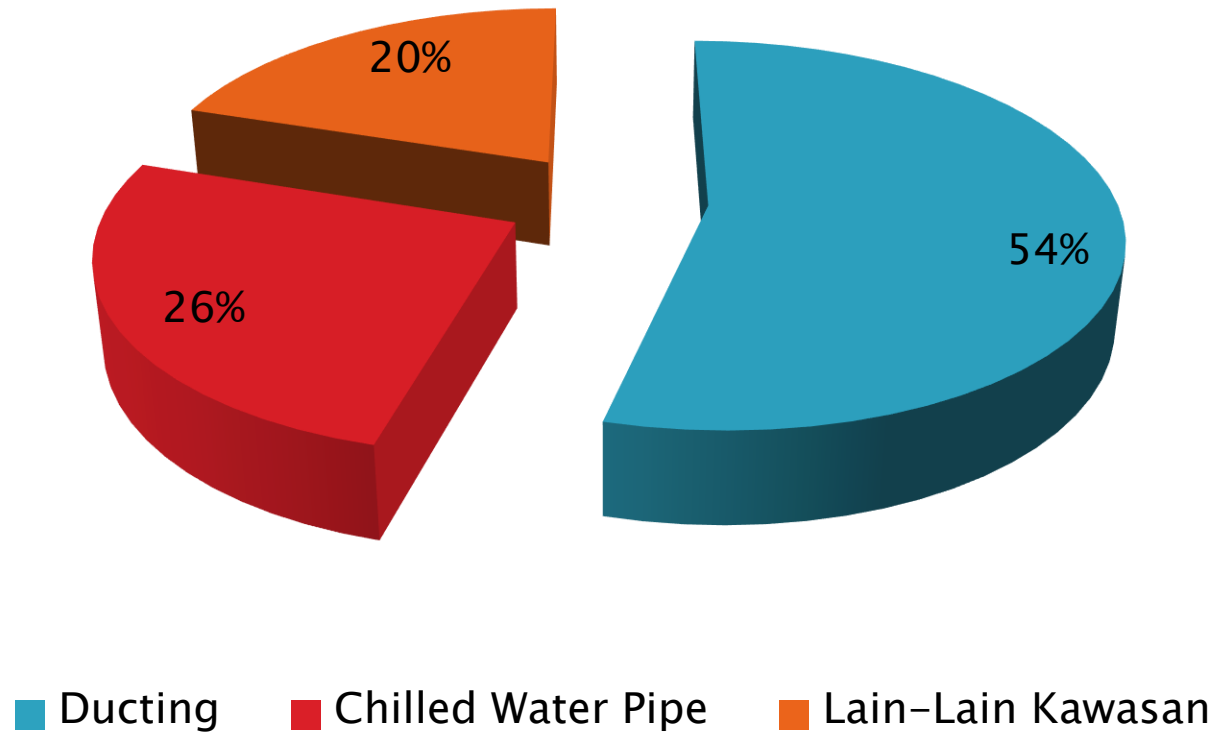
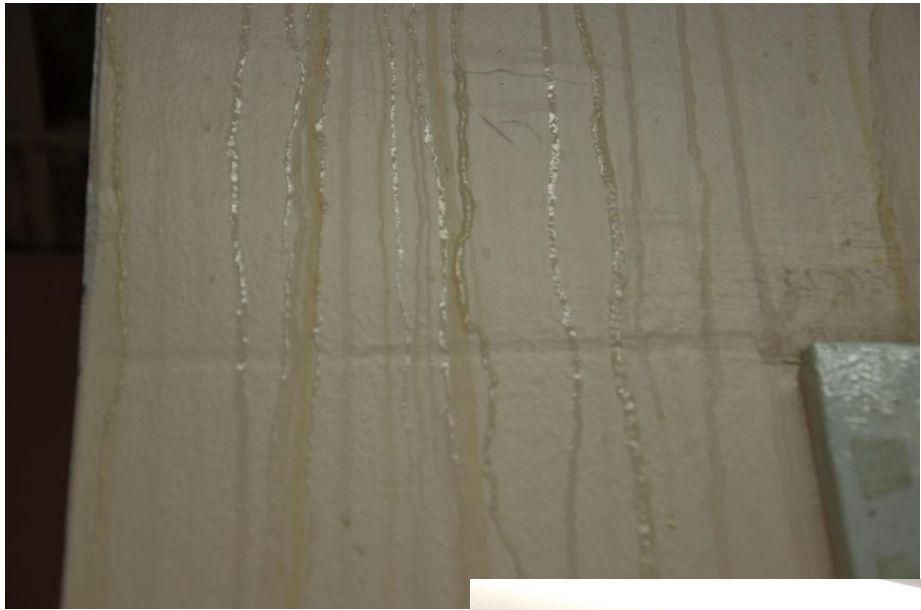
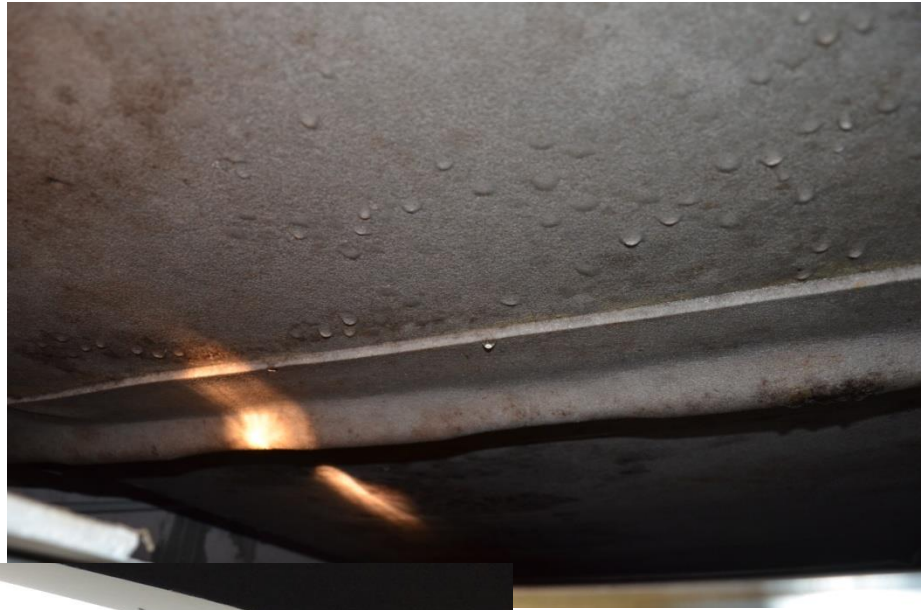
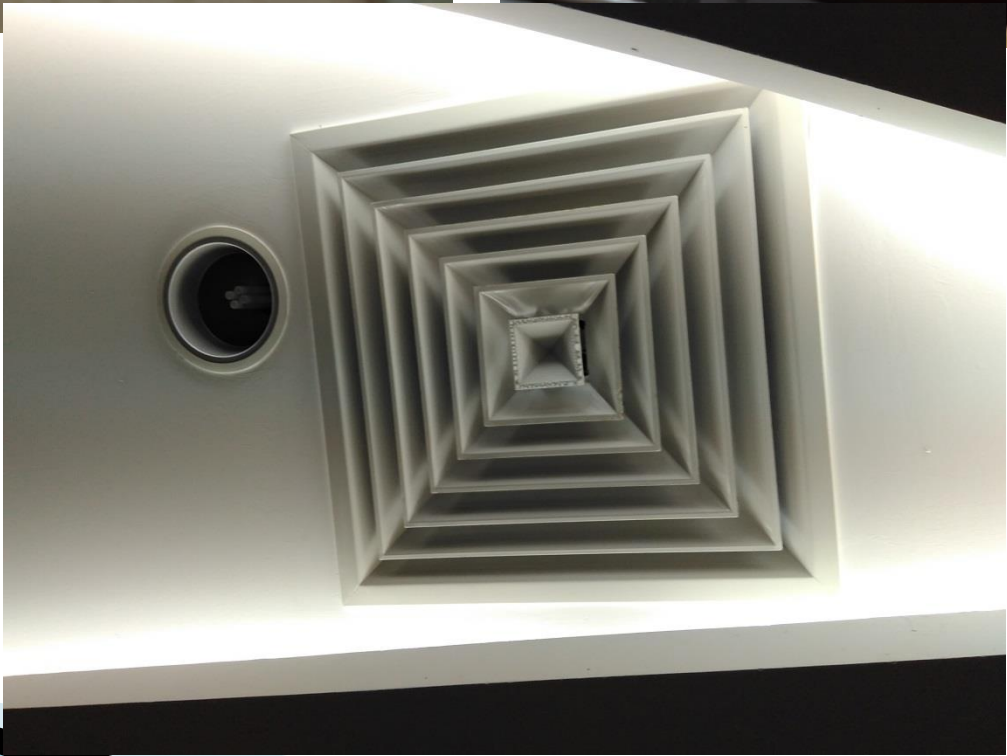
Locations Condensation Happens

Condensation

- ▶ This condition occurs due to reasons as below:
 - Surface Temp Lower Than Dew Point Temp

Dew Point Temp : 18°C

Surface Temp : 17.5°C

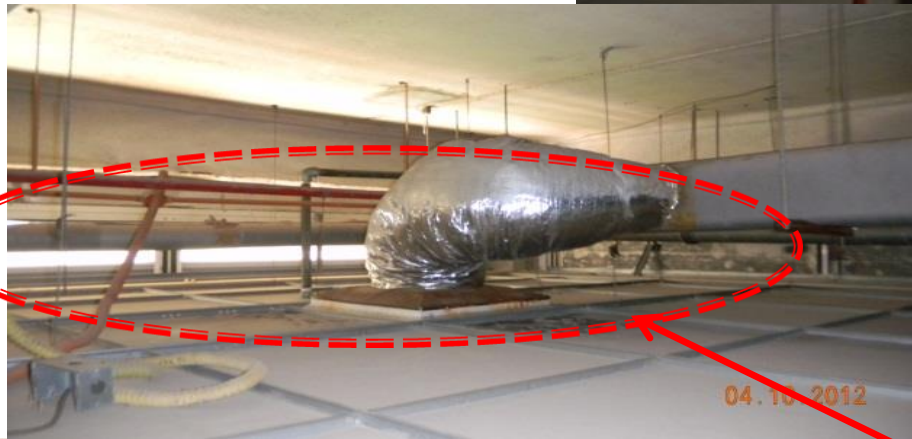
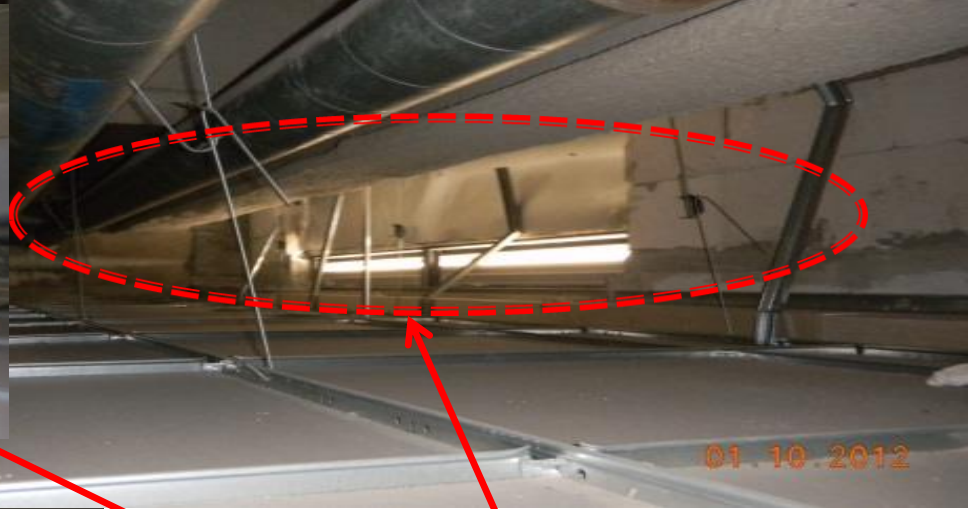
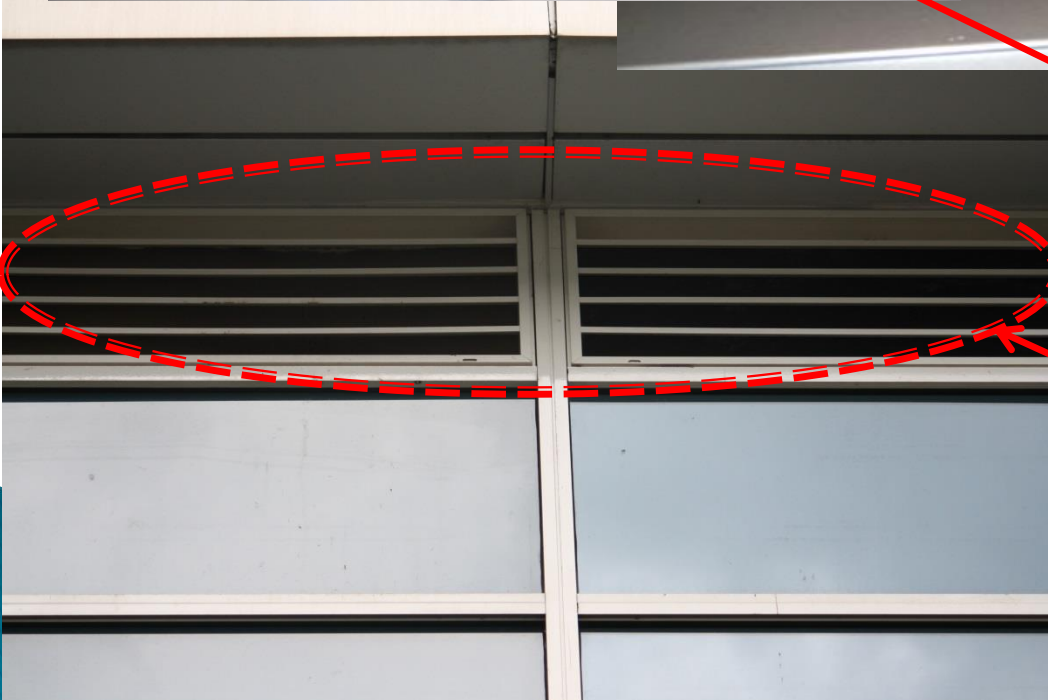
Perimeter Opening (Cross Ventilation)

Louvers Opening

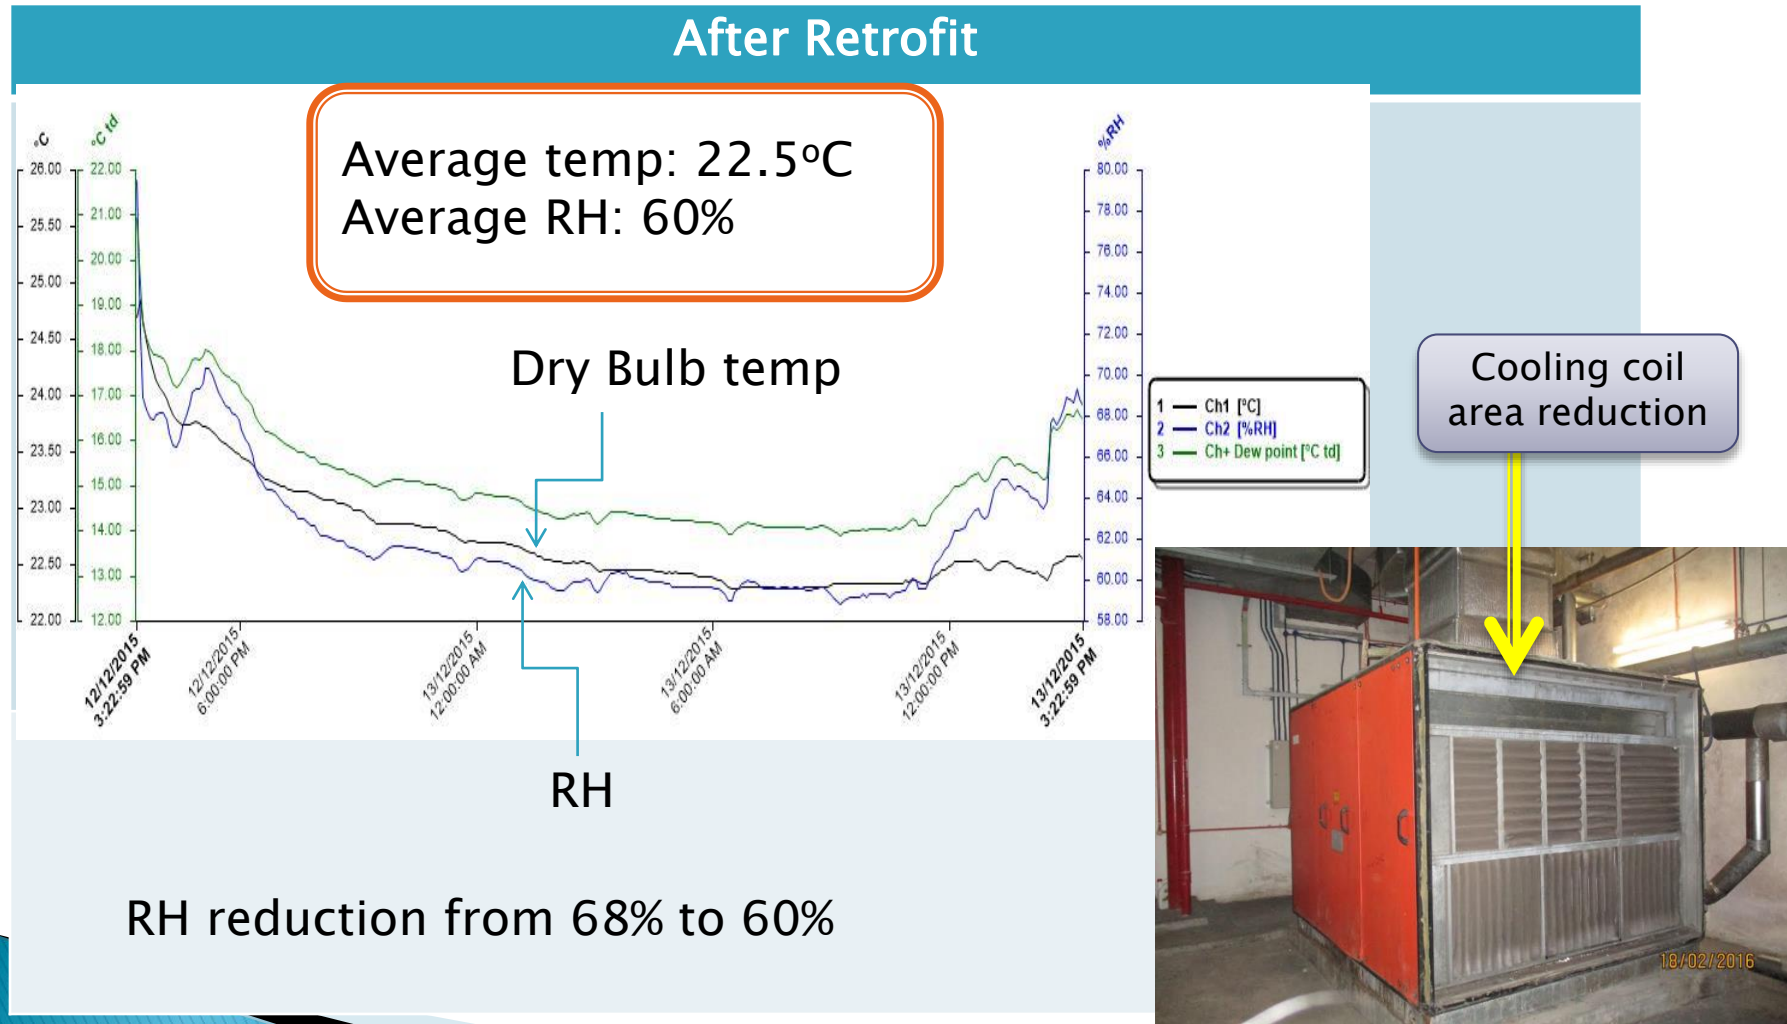
- ▶ This condition occurs due to reasons as below:
 - **Building Load** – Building Load Less Than Design Load
 - **Coil Capacity** – Oversized
 - **System Failure** – The Possibility of System Failure

Average temp: 22°C
Average RH: 68%

Load density: 53 btu/hr.sq.ft

Retrofitting- *Cooling coil area reduction*

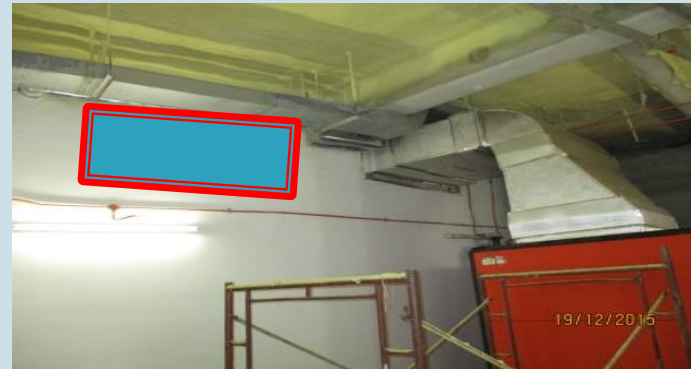
Propose Ducting Wall Penetration

AHU duct outlet for General Medicine zone is at 90 deg relative to flow discharge direction from fan.

Design AirFlow $> 6250 \text{ l/s} \sim 13000 \text{ cfm}$

Measured AirFlow $> 3108 \text{ l/s} \sim 6500 \text{ cfm}$

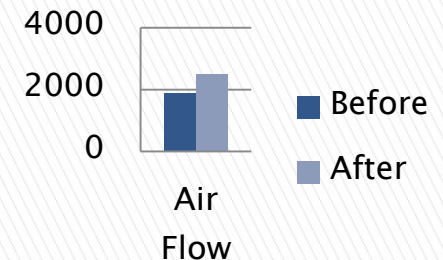
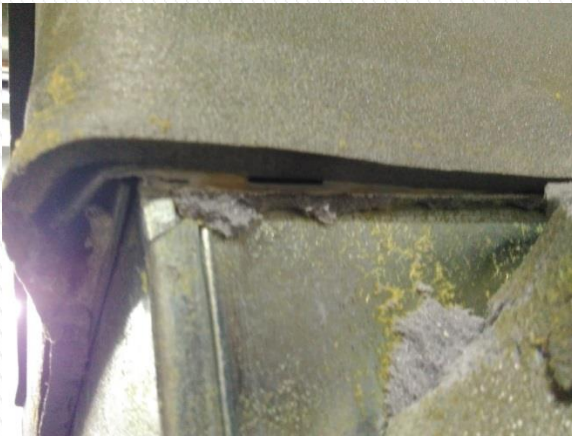
Air flow Improvements

Ref case:
Retrofitting works
After duct reseal, supply air flow rate increases from 1900 cfm to 2500 cfm. An improvement of 32%.

Existing duct seal was applied at duct corner only. New duct seal was applied along all transverse joint perimeter.

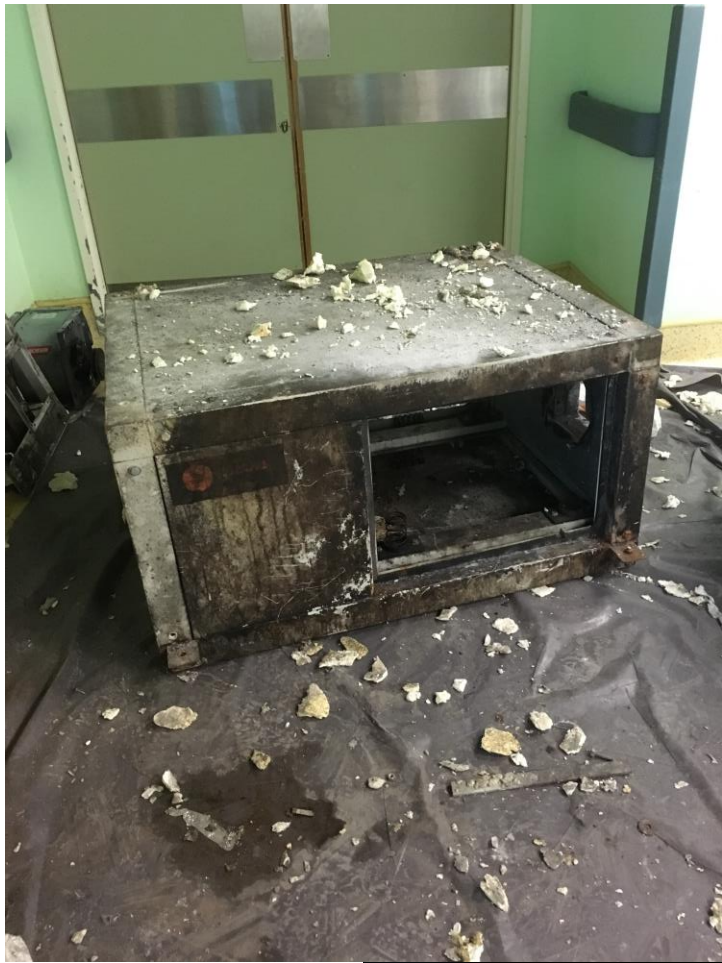
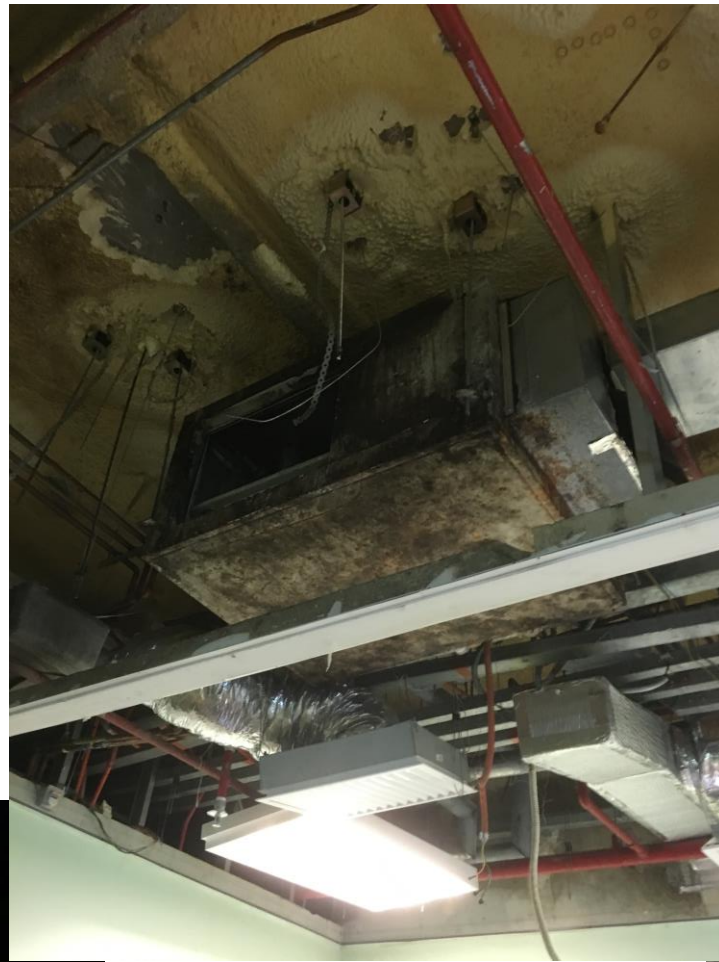
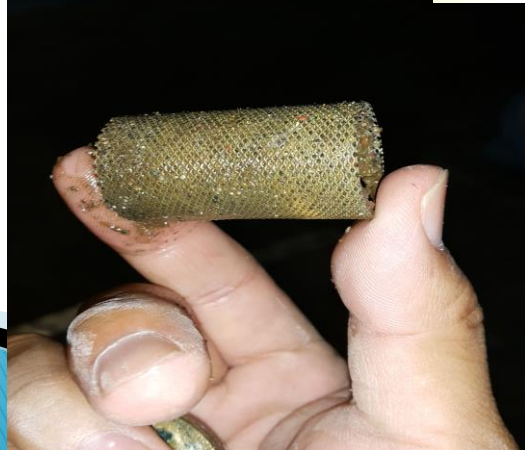
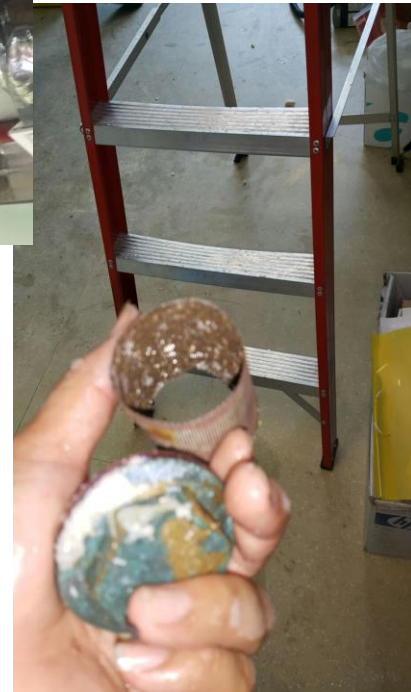
- ▶ Poor maintenance supervisory

DIRTY AIR FILTER

COOLING COIL CHOKE
