ACCESS AUDIT IN THE BUILT ENVIRONMENT 2014

WORKSHOP REPORT

Audited Venue: BANGUNAN KKR2

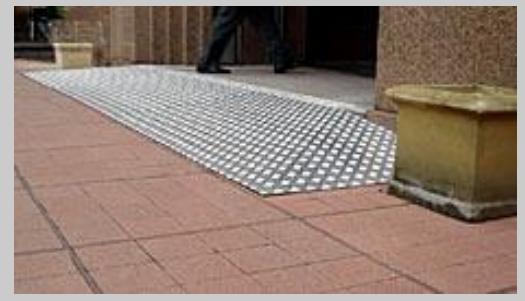
Example of good grating design

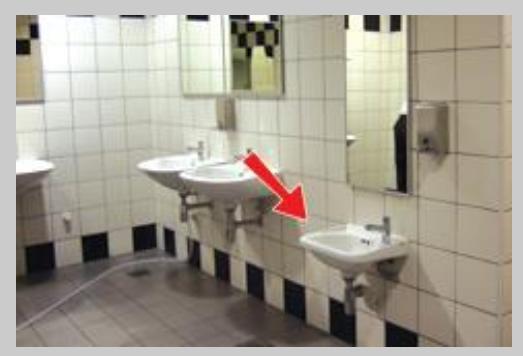
2. No wash hand basin provided for wheelchair users.

Example of good design for disable wash basin

- 1. Should provide ramp.
- 2. Should provide wash hand basin for wheelchair user.
