ACCESS AUDIT IN THE BUILT ENVIRONMENT 2014

WORKSHOP REPORT

Audited Venue: Blok F, JKR

Group No. : 2

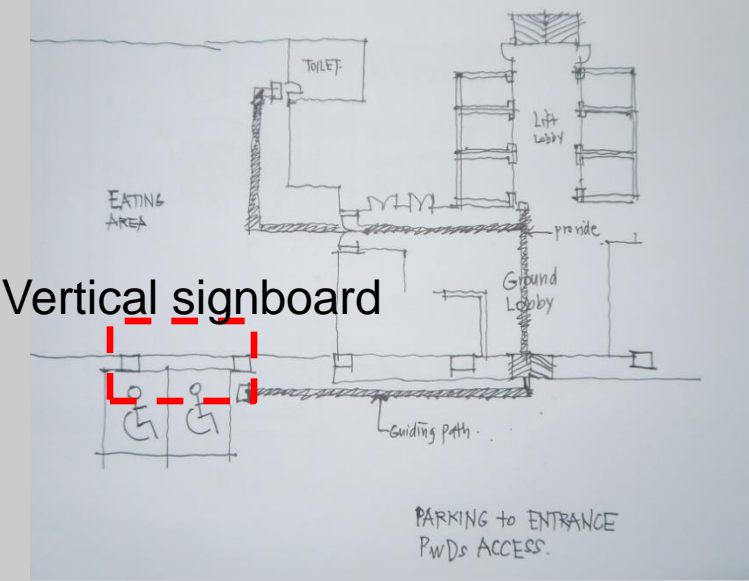
<ol style="list-style-type: none"> Current parking size is 3500 x 5000mm No wheel stopper Imprinted symbol indicated but no vertical signboard OKU parking located more than 3300mm from entrance 	<ul style="list-style-type: none"> - Parking size should be in accordance with MS 1184: 2014 (3600 x 5400mm) - To add wheel stopper - To add vertical signboard

<p>Vertical signboard</p> <p>PARKING to ENTRANCE PwDs ACCESS.</p>

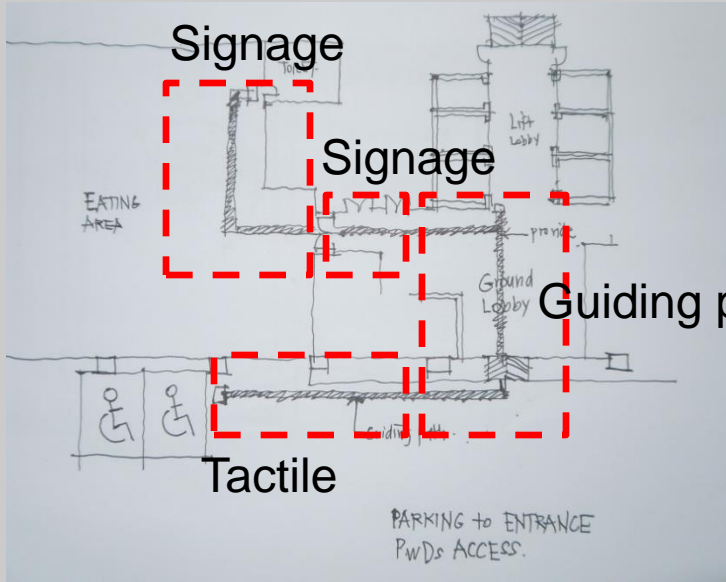
<ol style="list-style-type: none">1. Clear of steps and stairs2. No tactile guiding and warning blocks from parking to entrance	<p>- To provide tactile guiding and warning blocks</p>

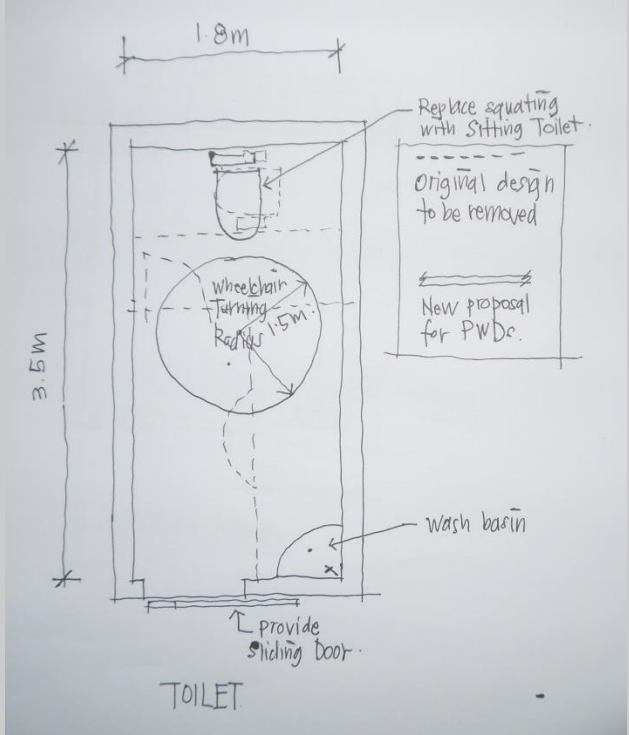
<p>1. No People with Disabilities (PwDs) toilet</p>	<p>- To provide accessible toilet for PwDs with grab bars</p>

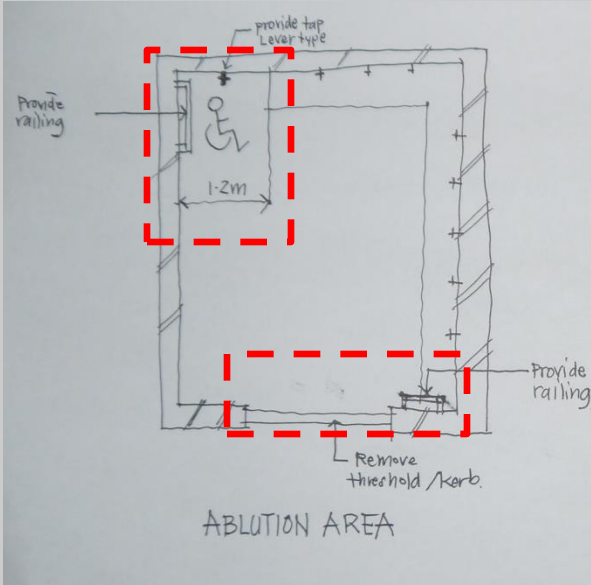
<ol style="list-style-type: none">1. Kerb at the entrance to ablution area2. No railing hook and concrete stool3. Slippery surface at ablution area	<ul style="list-style-type: none">- To remove threshold/ kerb-To provide railing hook and concrete stool

<ul style="list-style-type: none">- To provide rubber matt

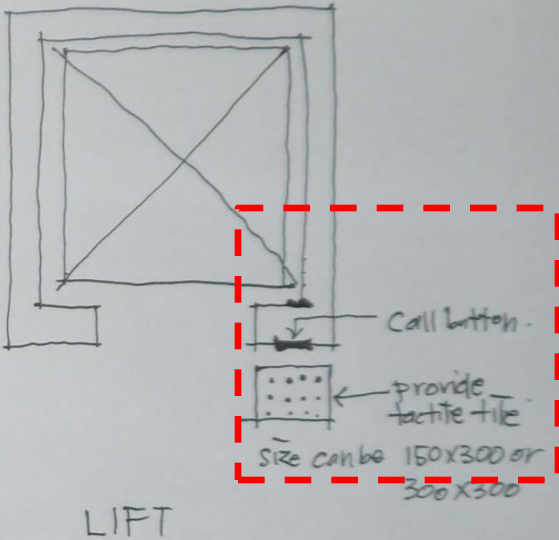
<p>LIFT</p>

<ol style="list-style-type: none">1. Opening width is 1100mm2. No accessible path leading to the lift3. Emergency button not reachable4. Call button more than 1400mm height	<ul style="list-style-type: none">-Tactile to be installed leading to the main entrance.-To provide Audio and Visual installed for safety reasons and guidance.-To provide visual indicator light-To provide mirror wall in the lift car-Provide side button panel
