**FINAL REPORT**

**KAJIAN BAGI MENGGANTIKAN JAMBATAN SULTAN ISKANDAR  
DI FT001/639/90, KUALA KANGSAR, PERAK  
- THE STRUCTURAL ASSESSMENT AND REHABILITATION  
OF JAMBATAN SULTAN ISKANDAR**

**VOLUME 1 OF 4 : MAIN REPORT**

RPT/TC/275/14/40-FinalReport - Vol 1 of 4

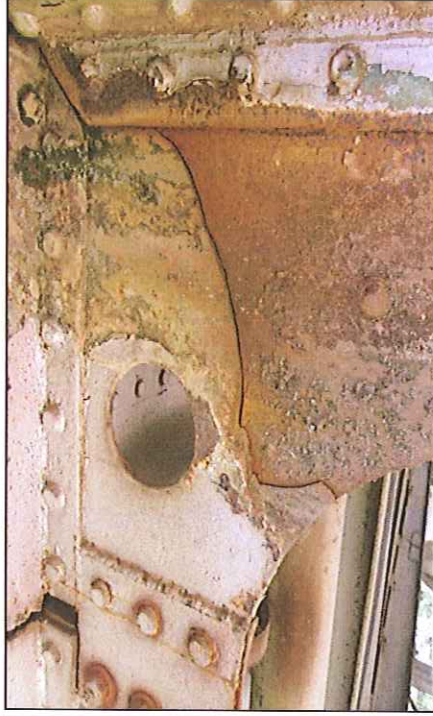
Picture M – S5 – P19 and M – S5 – P20  
Moderate corrosion and crack line on steel plate.

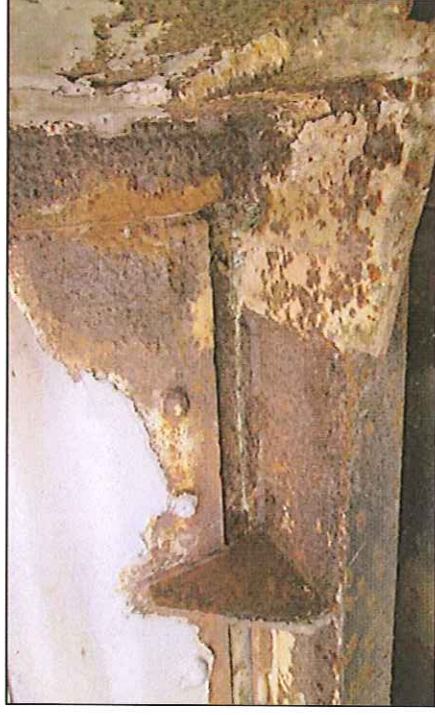
Picture M – S6 – P19 and M – S6 – P20  
Moderate corrosion on steel plate.

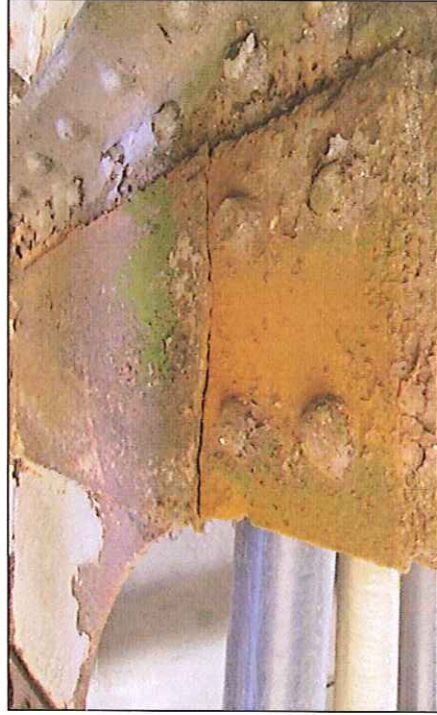
Picture M – S6 – P17 and M – S6 – P18  
Moderate corrosion and crack line on steel plate near expansion joint.

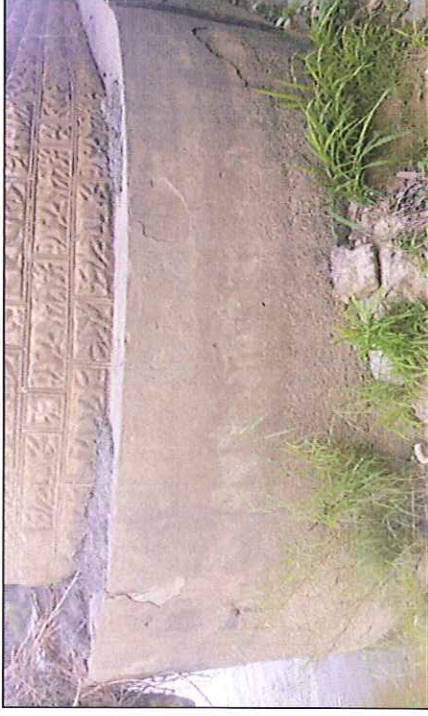
Picture 3 – Pier 1 (toward Sungai Siput)

Minor plaster spalling on the surface of the pier's pile cap.

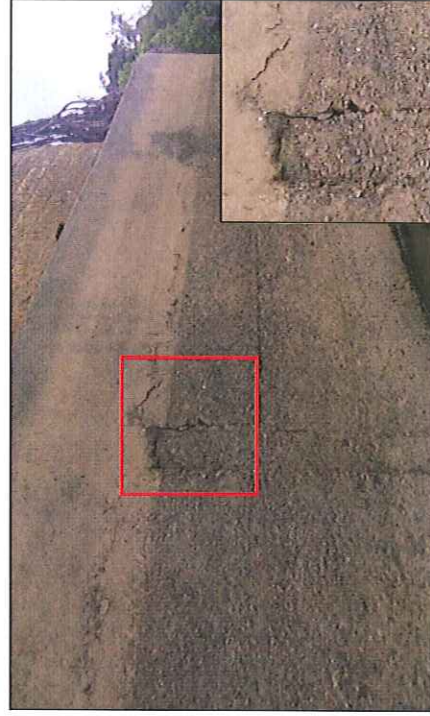
Picture 4 – Pier 1 (toward Kuala Kangsar)

Vertical crack lines on the surface of the pier's pile cap.

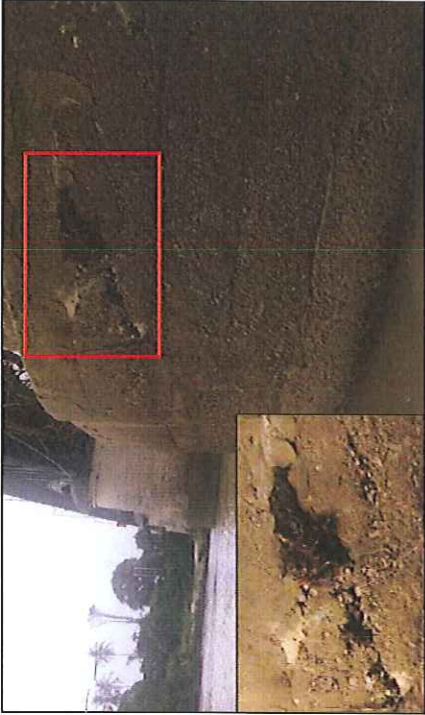
Picture 5 – Pier 2 (toward Sungai Siput)

Minor honeycombed concrete on surface of the pier's pile cap.

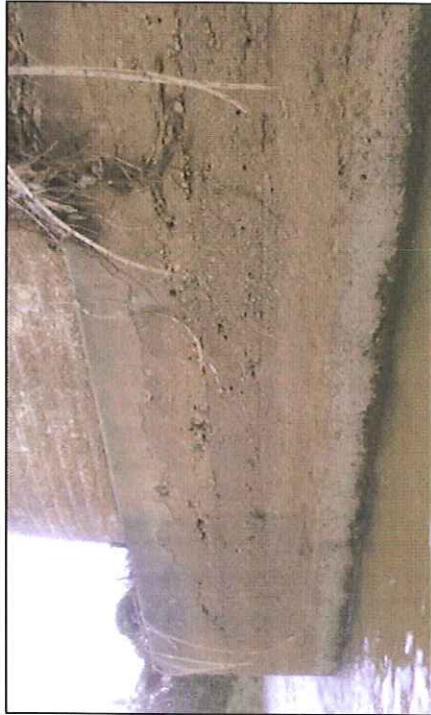
Picture 6 – Pier 2 (toward Kuala Kangsar)

Honeycombed concrete on surface of the pier's pile cap.

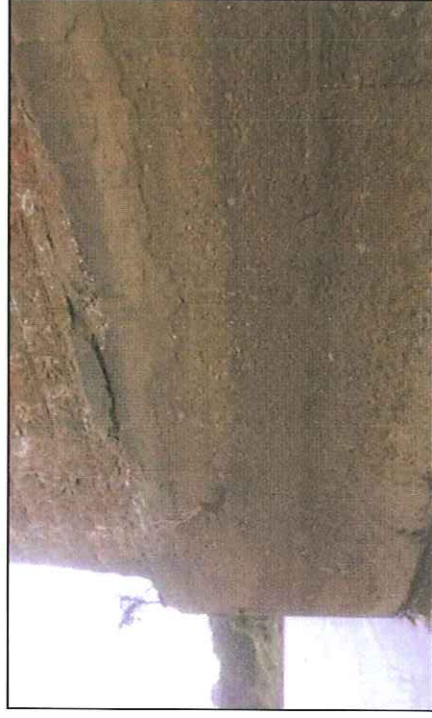
Picture 8 – Pier 3 (toward Kuala Kangsar)

Minor edge spalling and delamination of surface plaster of the pier's pile cap.

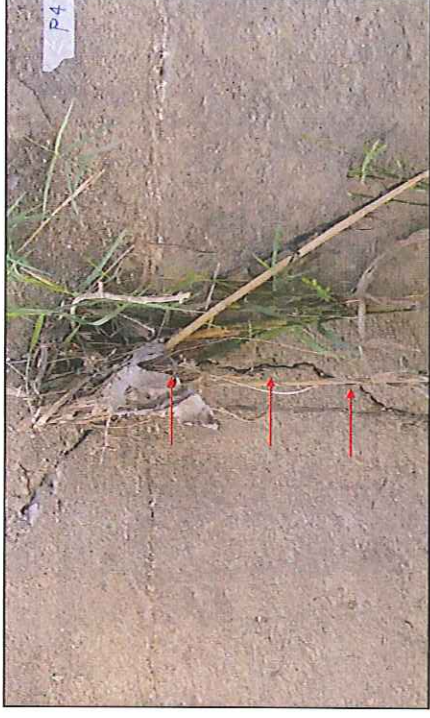
Picture 11 – Pier 4 (toward Kuala Kangsar)

Vertical crack line on the surface of the pier's pile cap.

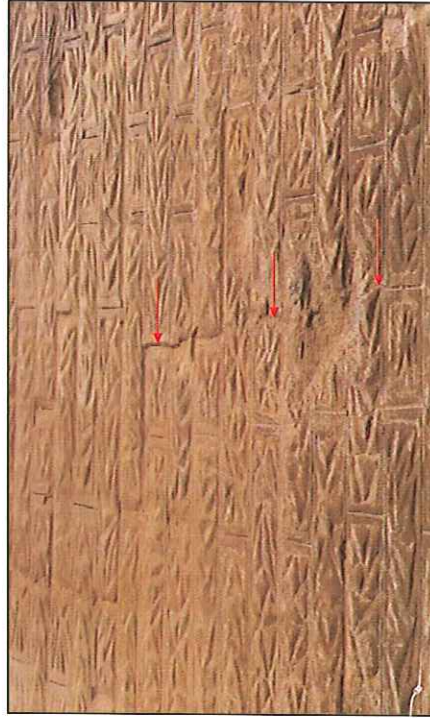
Picture 10 – Pier 4 (toward Sungai Siput)

Vertical crack line on the surface of the pier's wall.

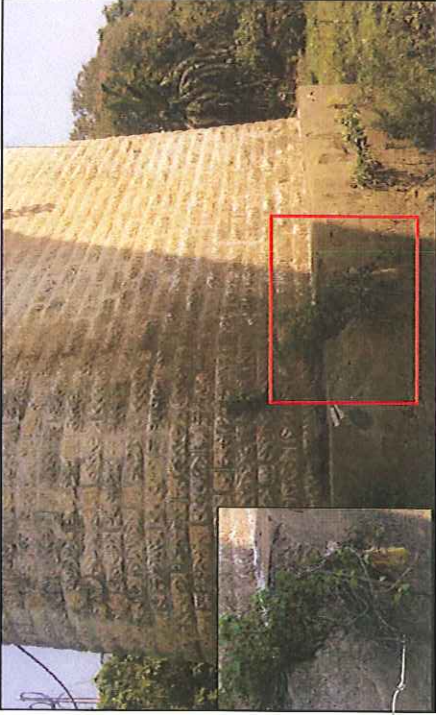
Picture 13 – Pier 5 (toward Sungai Siput)

Minor spalling of pile cap's edge.

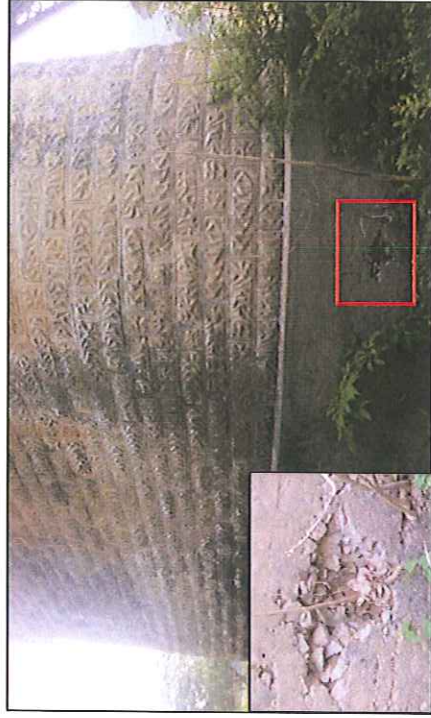
Picture 14 – Pier 5 (toward Kuala Kangsar)

Minor honeycombed concrete on surface of pier's pile cap.

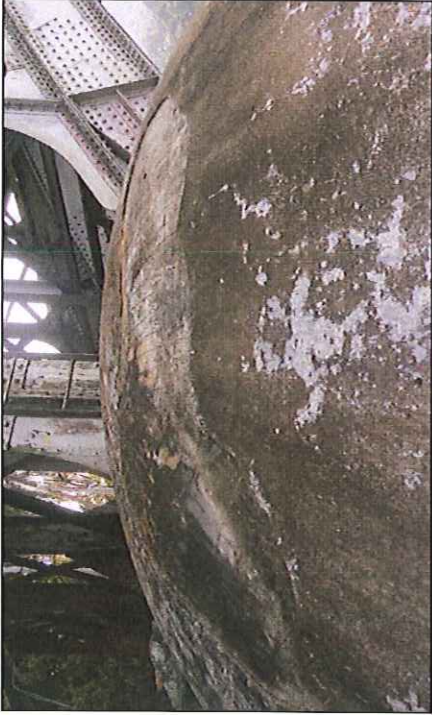
Picture 17 – Pier 6 (toward Kuala Kangsar)

Delamination of the surface plaster.
