Geotechnical Forensic Engineering – Case Histories Ir. Dr. Gue See Sew G&P Geotechnics Sdn Bhd

Contents

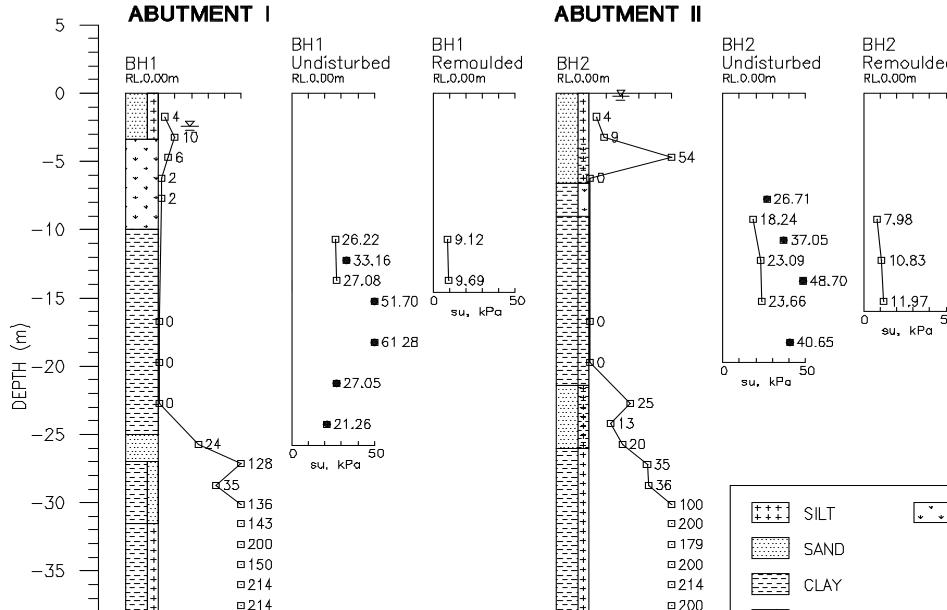
<u>Slip Failure of Embankment</u>

- At Approach Embankment
 25m from Abutment II
- $\mathbf{Fill} = \mathbf{3m}$.
- Abutment II :
 - Tilted 550mm on top.
 - Angular distortion of 1/6
- 300mm gap between bridge decks.

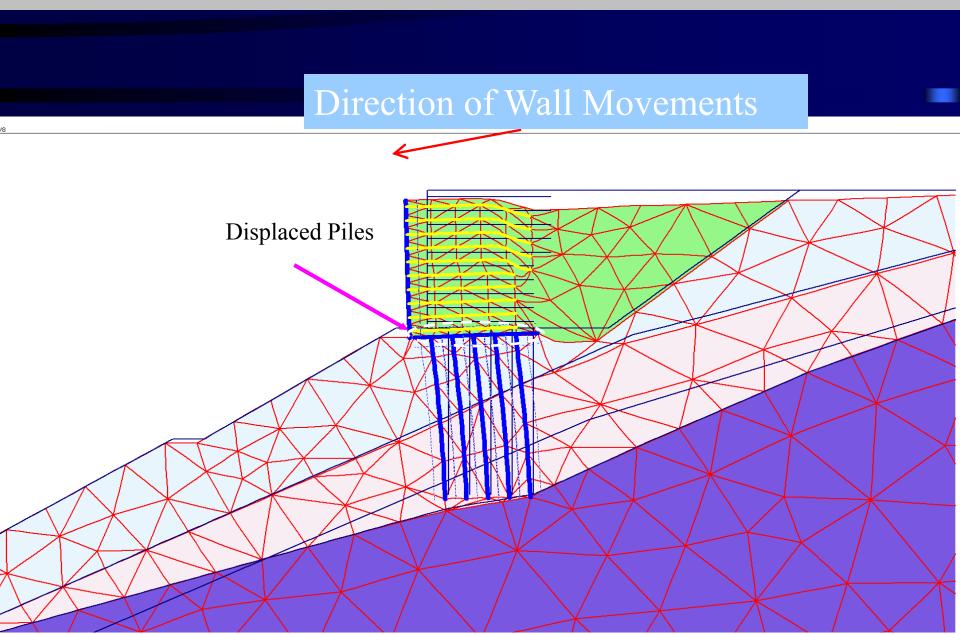
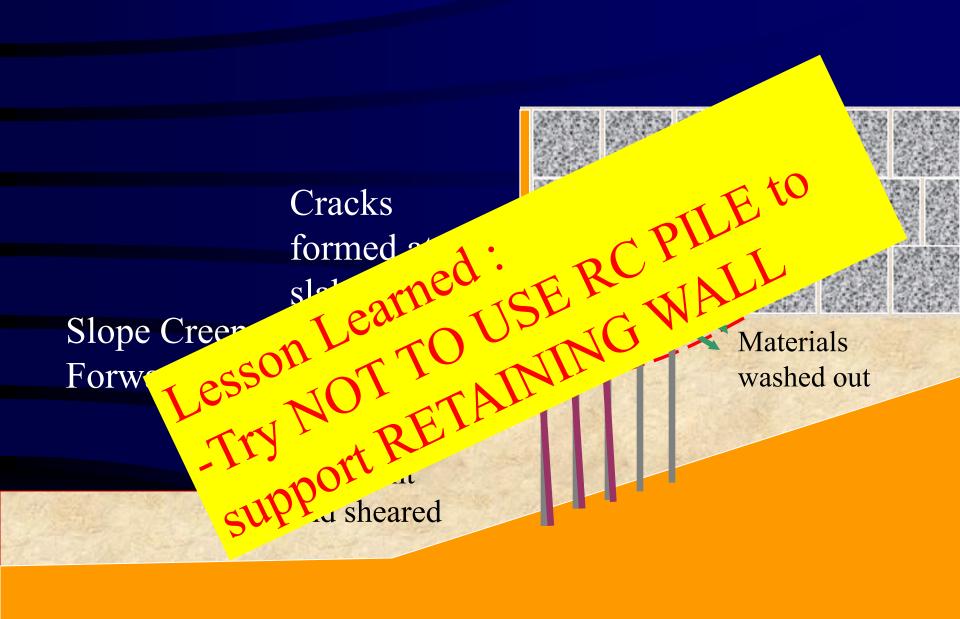
FEM ANALYSES - RESULTS

→Lateral Movement →Foundation Instability

- Inadequate pile lateral resistance
- Inadequate shear and moment resistances of RC piles and slab
- = Slab Cracked + Displaced Forward
