MICRO-SURFACING

(QUALITY CONTROL)

A Guide To Quality Construction

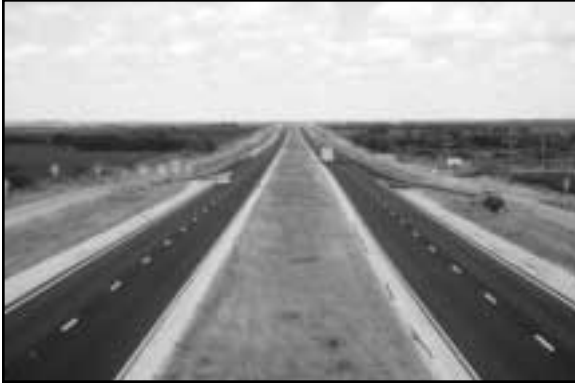
Slide 2 West Texas I-20

Interstate 20 in the West part of Texas that has been resurfaced with Micro-Surfacing. Notice the good cosmetics of the surface, the good edge line, and the lack of any appreciable center line joint. This is what you as a contractor and as a buyer of a Micro-Surfacing project had in mind when you started on the project. This as an example of the type of work this process should give you on a four lane type of highway.

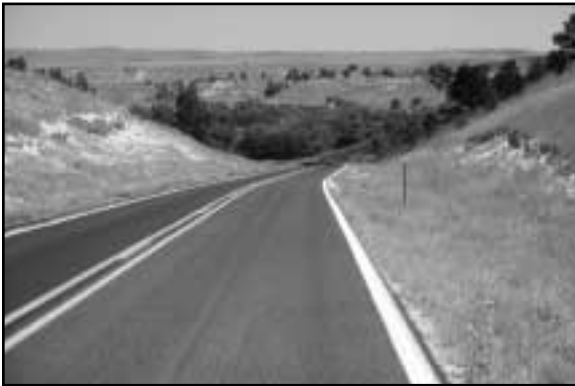
Slide 3 Northwest Nebraska two lane project

A two lane project in the Sand Hills of Nebraska that was resurfaced with Micro-Surfacing material. Again notice the good cosmetics of the surface, the lack of surface imperfections, the straight edge lines, and good center line joint. An example of what you should expect from two lane work with Micro-Surfacing.

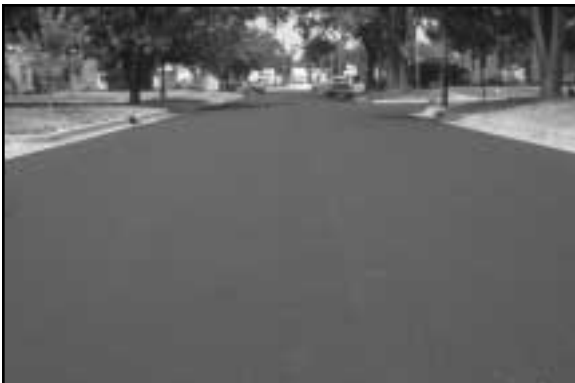
Slide 4 Residential type work

This last slide shows the other type of asphalt resurfacing done with Micro-Surfacing materials. A conventional city residential street resurfaced as a maintenance seal. Notice the good cosmetics, good center line joint, and the lack of any construction related surface defects.

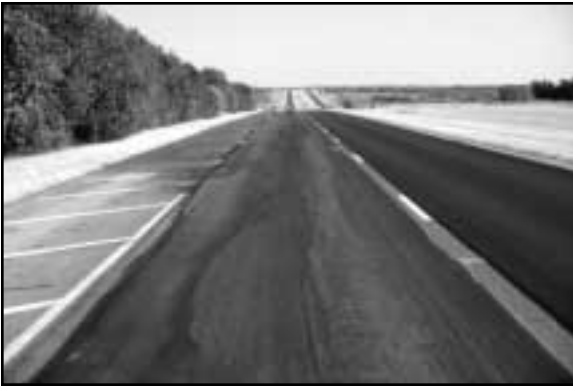
Slide 5 Unacceptable four lane work

Now that you have seen what acceptable Micro-Surfacing looks like, here are some examples of unacceptable work that has been bought by some buyer agencies. This project was laid with the mixture out of control and breaking too fast for the contractor to keep the material in that semi-liquid state as it was being placed on the road. This type of condition will harm the materials ability to bond to the existing road surface as well as being unacceptable cosmetically.

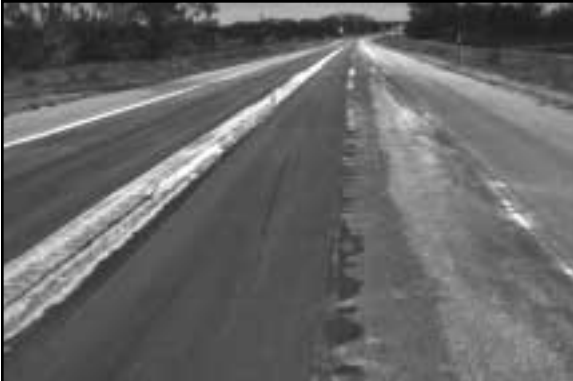
Slide 6 Unacceptable two lane work

Another example of unacceptable work that was bought by a state agency. Here also the mixture was breaking too fast for the contractor to lay the material correctly. In this case the contractor tried to put too much water in the mix to help slow down the chemical breaking process. This flushed the asphalt up to the surface and traffic stripped it off of the aggregate. Micro-Surfacing has a chemical retarding agent that is used to slow down this breaking process that will help stop this problem. Also note the bad edge lines and total disregard for surface aesthetics.

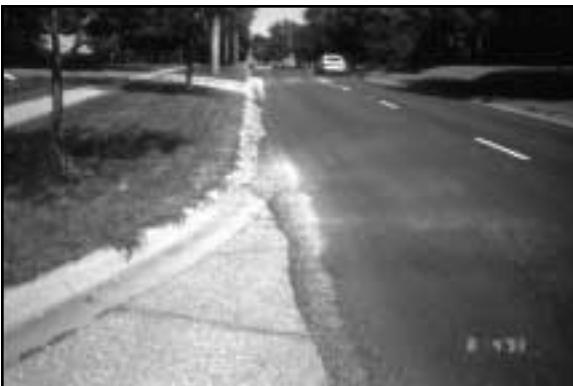
Slide 7 Unacceptable residential work

This is an example of unacceptable residential type work. Notice the drag marks at the outside edge, and the overrun of material in the curb line. This type of edge line and cosmetics of the surface is unacceptable workmanship. As a buyer agency your contract should allow you to receive remedial work from the contractor to correct these types of problems.

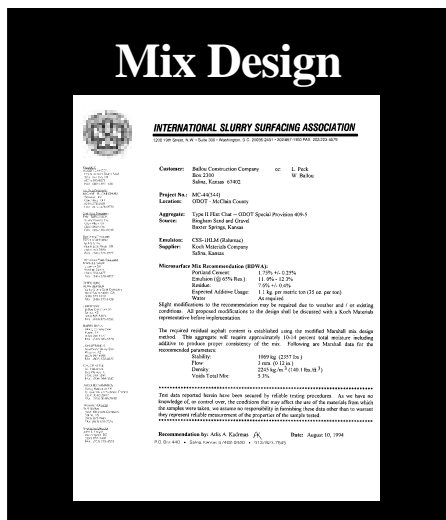
Slide 9 Material Mix Design

After the project is let and before the contractor goes to work a mix design must be submitted to the buyer, showing what the contractor plans on using for materials and in what proportion he will mix them. The mix design will also give the values of each of the materials used, for comparison to the requirements given in the material specifications. Also before construction starts the mixing and lay-down machine must be calibrated, to insure that each of the ingredients used in the mix are in the correct proportions.

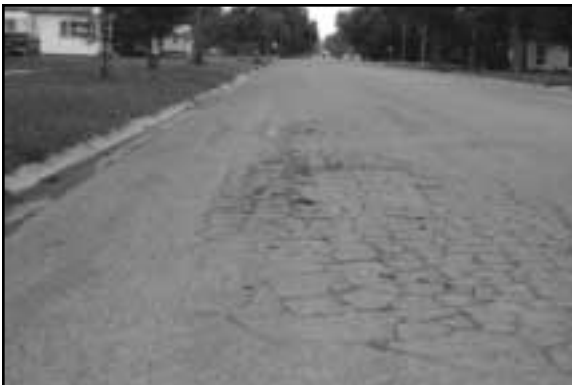
Slide 10 Where not to use Micro-Surfacing

Keep in mind that this is a thin lift of asphalt resurfacing material that will not bridge over or correct failed asphalt areas. These types of failed asphalt must be corrected before you can successfully resurface them.

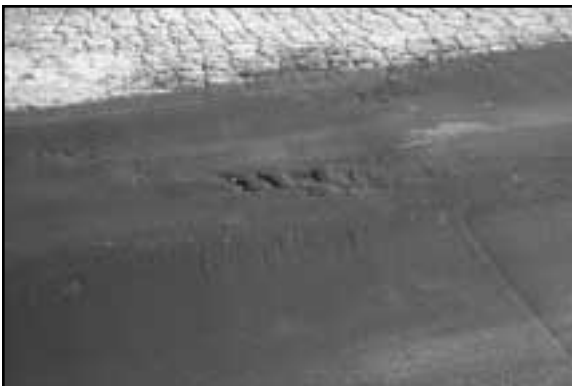
Slide 11 Micro-Surfacing over failed asphalt

As the last slide pointed out, obviously failed areas must be corrected before they can be resurfaced. Here is an example of an area that was not corrected before being resurfaced. Notice where the lay down machine has broken through the bad area and left an unacceptable surface blemish.

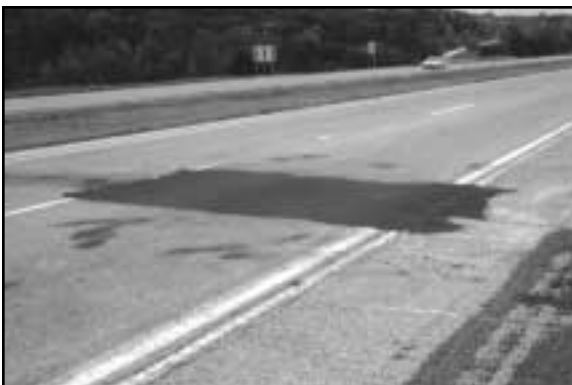
Slide 12 Asphalt patch area

This is an example of a repaired asphalt area that is suitable for resurfacing with Micro-Surfacing material. You already know how to patch asphalt, so we won't spend any time discussing it, but one point needs to be made about patching for Micro-Surfacing. This material does a very good job of filling in depressions in the road surface, which we will talk about later, but it is not very effective at smoothing out a bump or protrusion. Therefore it is preferable to leave any patching areas with a correct profile or a slightly shallow profile rather than a raised profile.

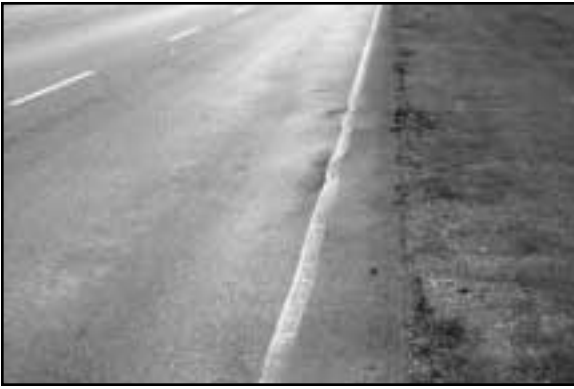
Slide 13 Pushed up edge line

Another area that should be addressed before a Micro-Surfacing application is plastic deformation or pushed up asphalt on the surface. Here is an example where the surface lift has pushed up at the edge line. Once again the Micro-Surfacing material does a good job of filling in any low spots in the surface but it is not very effective when used to correct high areas in the road. The accepted method of correcting this type of problem is to cold mill the high areas of the pavement before you Micro-Surface.

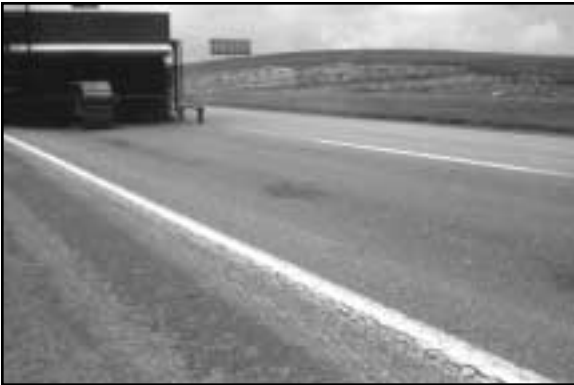
Slide 14 Cold milling the edge line

When this type of corrective action is used it is noteworthy to mention that you do not need to mill inches of material off of the surface. Rather do a skip mill operation where you only remove that portion of pavement that is pushed up and let the Micro-Surface material fill in any low areas in the pavement. Of course the Micro-Surfacing material will not correct the problem in the asphalt surface that caused the movement initially but it will buy you some time on the road.

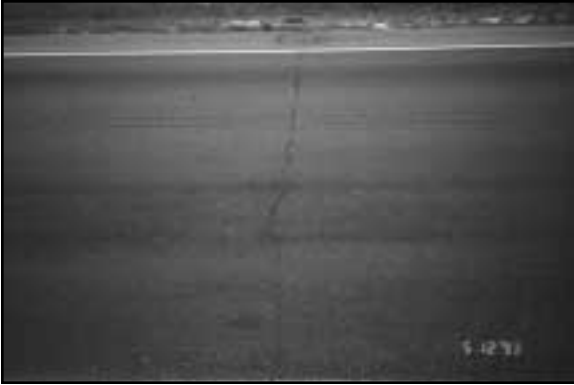
Slide 15 Reflective crack through Micro-Surfacing

As seen here a crack has reappeared through two year old Micro-Surfacing material. Large reflective cracks should always be treated prior to any asphalt resurfacing material being applied. It is recommended that some type of crack sealing material be used before any Micro-Surfacing is applied. It is the buyers decision of what type of crack seal material to use, as there are many types available. You must remember to insure that the crack sealing material is compatible with asphaltic materials.

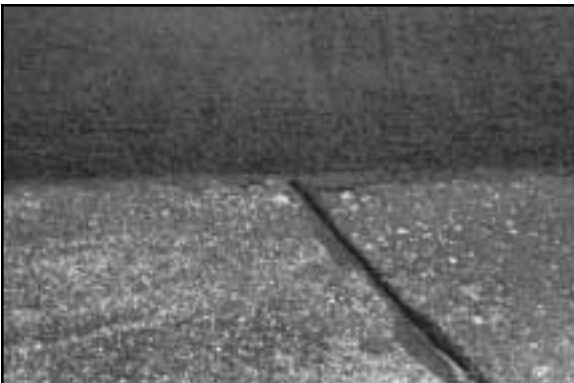
Slide 16 Fresh material over a large crack

Lets go over crack preparation work prior to a Micro-Surfacing. This is an example of a Micro-Surfacing material placed over an unprepared crack. The crack appears to be filled, but even though we have a polymer modification in our asphalt we still can not stop full depth reflective cracks from reappearing. Micro-surfacing is somewhat effective on retarding small oxidation and hairline cracks , but not large reflective cracks.

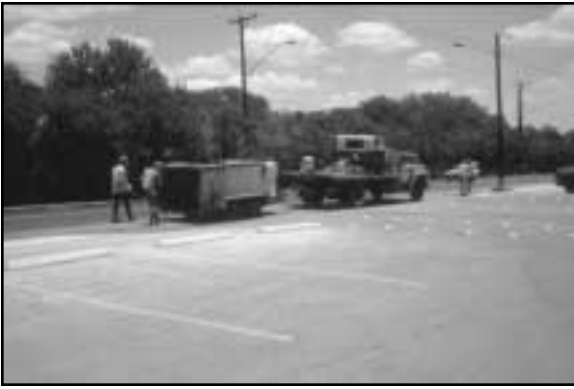
Slide 17 Crack sealing

Large cracks must be sealed with something prior to resurfacing. One method that has gained a lot of acceptance is a polypropylene, or polyester fiber suspended in an AC-10 asphalt and applied hot, through a wand. This slide is an example of this type of crack seal operation. The crack needs to be cleaned with compressed air, then the crack seal material is applied into and over the crack. There are many different types of crack sealers available and we aren't promoting one over the other, but we are promoting that some type of crack work be done.

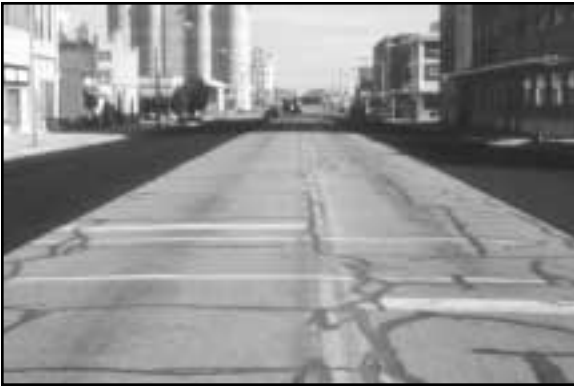
Slide 18 Crack sealed street ready for resurfacing

This is an example of a street that is prepared for Micro-Surfacing, with the crack sealing operation already done. Remember that most Micro-Surfacing applications are applied at a very thin application rate per square yard. Therefore we have found that it works best when the crack sealing operation is done early enough that traffic can run on the seal material and pound it down into the crack or flatten it out on the road surface. This will allow the thin lift of Micro-Surfacing material to cover the crack sealer without leaving a bump in the road.

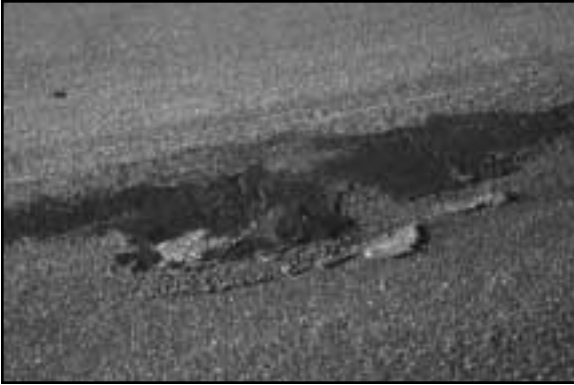
Slide 19 Debonding of Micro-Surfacing due to road contaminates

When preparing a road for resurfacing it is important to insure that you are bonding asphalt to asphalt and not have any contaminates between that bond. Here is an example of a one year old Micro-Surfacing material that has come loose from the original pavement because the road was not sufficiently cleaned ahead of the application. This happens to be an animal carcass that was left on the pavement and surfaced over. The material has come off of the contaminate and left an unsurfaced area.

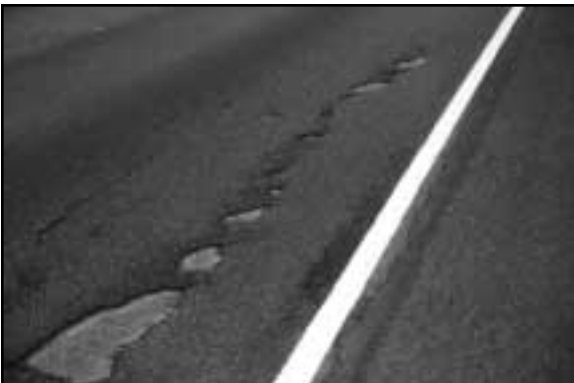
Slide 20 Debonded areas

This is another example of debonding of the surfacing material from the existing pavement surface. This illustrates an area where virgin aggregate from the dump trucks that are feeding the lay down machine have spilled rock on the road and it was then surfaced over. The point that needs to be made clear here, is that good cleaning must be done on the road before any Micro-Surfacing can be applied or it may not stick or bond to the road.

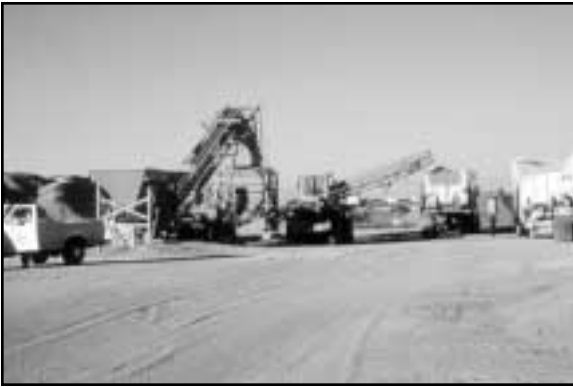
Slide 21 Micro-Surfacing stockpile area

Lets now take a few minutes to go over the stockpile site, the support equipment, and the lay down machine. This first slide shows a stockpile area where the aggregate is screened, weighed, and loaded onto dump trucks for delivery to the lay down machine. We suggest that even though the aggregate is select crushed material, that it be screened to remove any oversize particles and contaminants before it is loaded onto trucks. Also in most areas of the country the aggregate is then weighed and a ticket made that is delivered to the lay down inspector. At the stockpile site the dump trucks are loaded with emulsified asphalt and water while they are being loaded with aggregate.

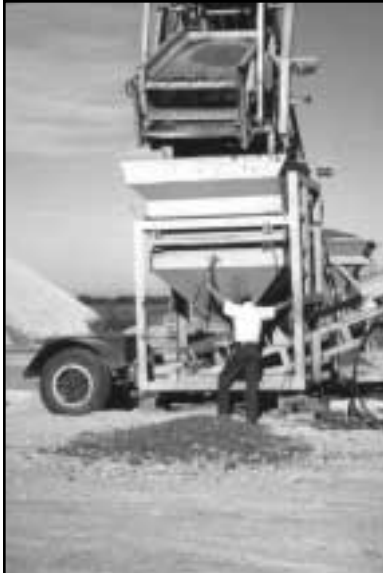
Slide 22 Oversize material at the screening plant

This shows why it is recommended that a screening plant be used to screen the aggregate before it is delivered to the lay down machine. The pile of material that can be seen below the screen is oversize aggregate that was in the material when it was delivered from the quarry. Also there is some dirt and grass that the loader operator got into when he was picking up material to load. Any oversize material or contaminants that you can remove from the aggregate before it gets to the lay down machine will help with surface cosmetics on the road.

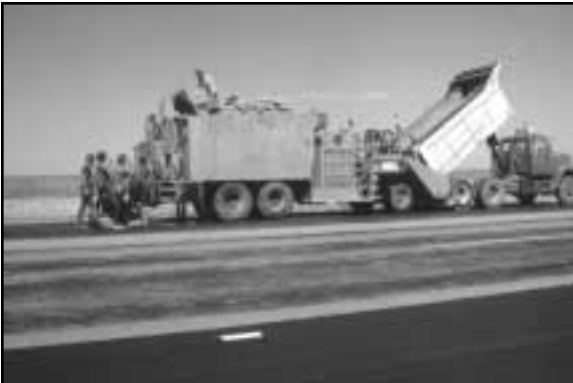
Slide 23 Lift bed dump support

There are basically three methods of delivering the materials to the lay down machine. This is one method where conventional dump trucks have liquid tanks on each side of their dump beds that hold the emulsified asphalt on one side and the water on the other side. They lift their beds to charge the lay down machine with aggregate and fill the machine with the liquids. This method works well enough if the project is out in the open spaces, but does not work well if there are overhead obstructions on the road.

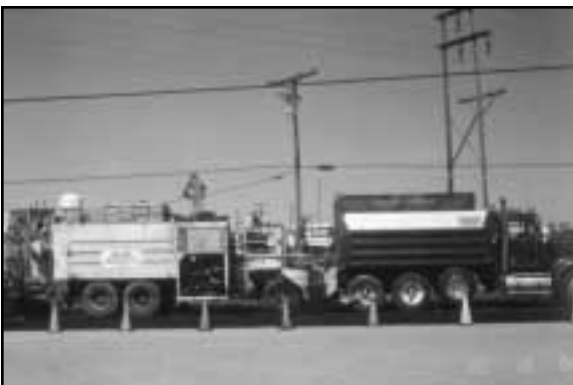
Slide 24 Conveyor belt dump support

As shown here the lift bed dump support method may not work very well when the roadway has overhead obstructions such as power line or heavy tree growth. The method shown here is a conventional dump truck that has been fitted with a slide in support unit that holds the liquids in a tank on each side and has a conveyor to discharge the aggregate without having to lift the truck bed. This method will solve the lifting of the bed problem in obstructed areas that was just discussed.

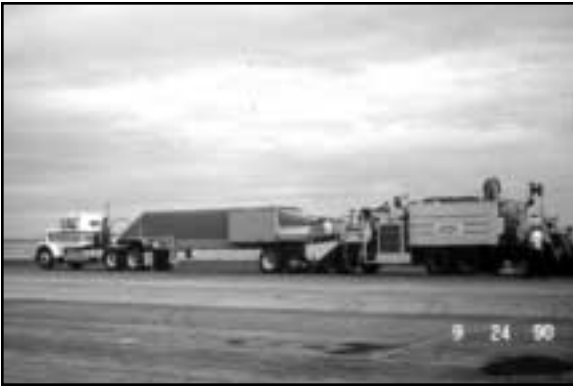
Slide 25 Tractor trailer type support unit

The last material delivery system we'll talk about is a tractor trailer unit as shown here. This method also has storage tanks on each side of the trailer for delivering the liquids to the lay down machine and a conveyor system for delivering the aggregate, without lifting the trailer bed. This method is basically the same as the insert method except that the contractor can haul more material out to the lay down machine.

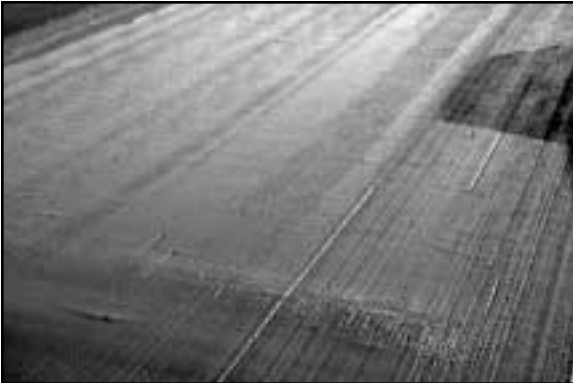
Slide 26 Surface drag marks

We need to talk about one of the common problems associated with this type of work; which is a drag mark. A drag mark is when an oversize particle of rock becomes lodged under the strike off device of the lay down box, and while being pulled along with the machine leaves a furrow in the surface. This problem is the main reason that we are recommending that a screening device be used in the stockpile to remove any oversize material before it gets to the lay down machine. We will discuss how to deal with these marks in a moment.

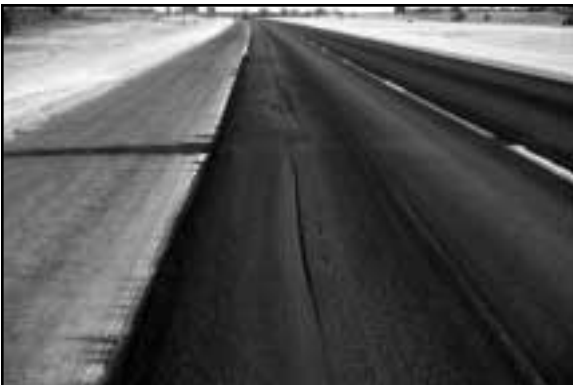
Slide 27 Cold mix and oversize material drag marks

Here we see some more of those oversize material drag marks along with another type of drag mark. The larger mark seen here is caused by a ball of broken Micro-Surfacing mix or cold mix which is caught in the lay down box strike off. This type of problem occurs when the mixture is changing from a semi-liquid flowable material to a cold mix material before it is deposited on the road surface. This mixture is out of control and the lay down process should be stopped while the contractor determines how to slow the breaking process down enough to eliminate this problem.

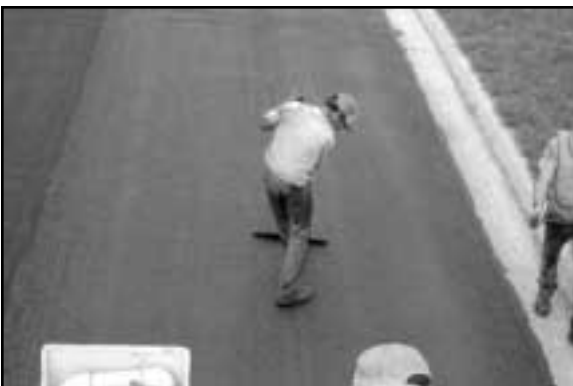
Slide 28 Squeegee removal of drag marks

There are basically two methods of repairing these drag marks once they appear in the road surface. The traditional method is to remove them with a hand tool called a squeegee as shown here. Someone simply walks out into the fresh mix and removes the mark with a hand tool while another person is working with a different tool to remove the obstruction from the lay down box strikeoff plate. This method works well but it requires a well trained person to remove the offending mark and his foot prints without leaving an unsightly appearance in the mix. As mentioned there are two methods of removing these marks and we will talk about the other method in a moment.

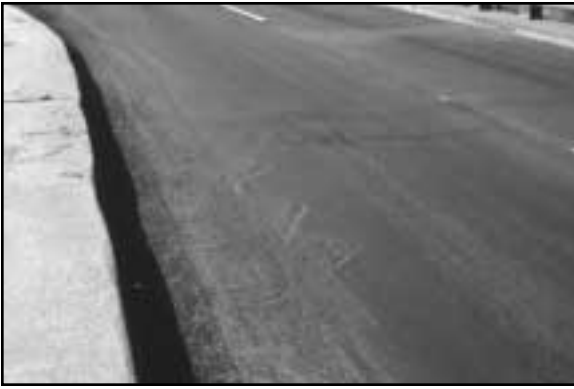
Slide 29 Surface imperfections after hand work

As mentioned earlier the removal of drag marks with a hand tool requires a well trained person, so that the surface cosmetics after the drag mark has been removed is not worse than before the hand work was done. As shown here the hand work has left imperfections in the surface that are not acceptable and probably look worse than the original drag mark did. Contractor personal training is the key here.

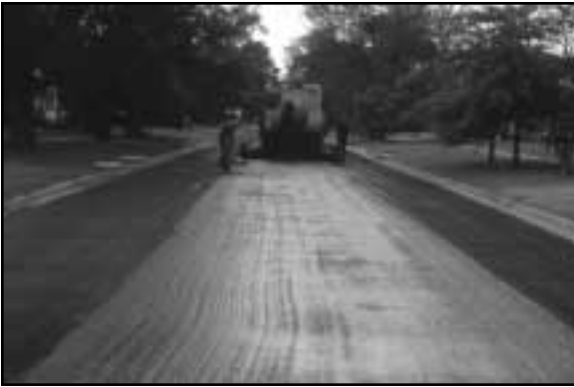
Slide 30 Dirty strike off drags

This as an example of another type of drag mark that can be in a Micro-Surfacing project. This type of mark is much shallower and smaller than those we have just talked about. These imperfections are caused when the lay down box strike off becomes dirty with small particles of aggregate and asphalt, sticking to the final strike off plate causing this indentation in the surface.

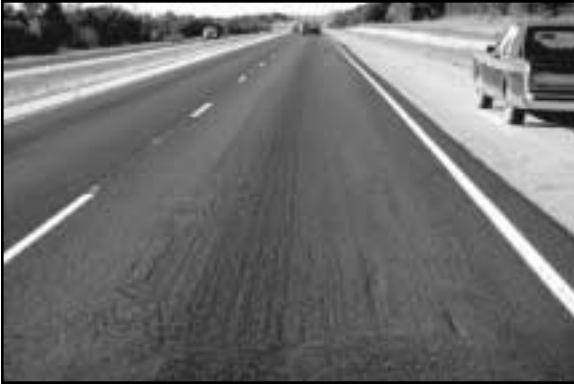
Slide 31 Dirty strike off drag marks

Another example of dirty strike off drag marks in the surface. As shown here this type of problem is most commonly seen when a transverse joint is made. When making a transverse joint the lay down box is lifted off of the road and the asphalt and fine particles have a chance to harden on the strike off plate. The solution to this problem is to physically remove any material that has dried on the strike off every time a transverse joint is made or when this type of surface problem becomes apparent. We will talk about this in greater detail when we are going over how to make a transverse joint.

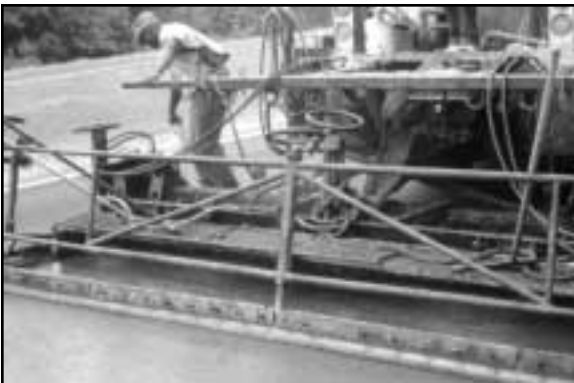
Slide 32 Secondary strike off device

As we said earlier there are two methods of correcting drag marks, so let's discuss the newer method. This device is called a "secondary strike off", it is a surface texturing and surface cosmetic improvement device. The secondary strike off mounts directly behind the lay down box primary strike off and is in contact with the fresh mix. It will remove most surface imperfections without requiring someone to walk in the mix and remove them with a hand tool. This device does not actually remove what is causing the drag mark in the primary strike off, that still must be removed by hand. But this device will correct the imperfections in the surface while you are working to remove the cause.

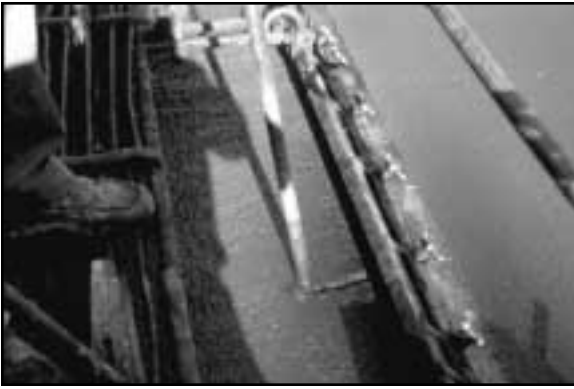
Slide 33 Secondary strike off removing drag mark

An example of the secondary strike off removing a large drag mark. A drag mark is purposely put into the fresh mix here to demonstrate the ability of the strike off, in removing it.

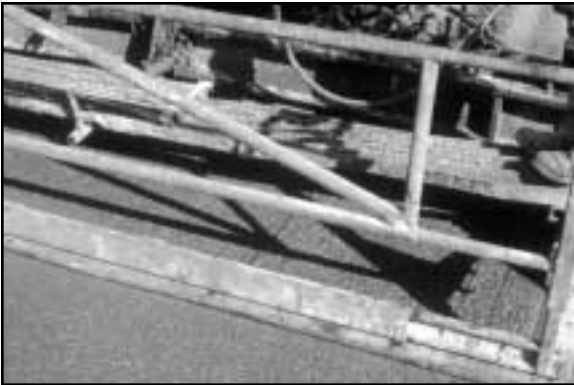
Slide 34 Secondary strike off removing dirty primary strike off marks

This is an example of the secondary strike off removing the serrations in the surface that are associated with the primary strike off being dirty.

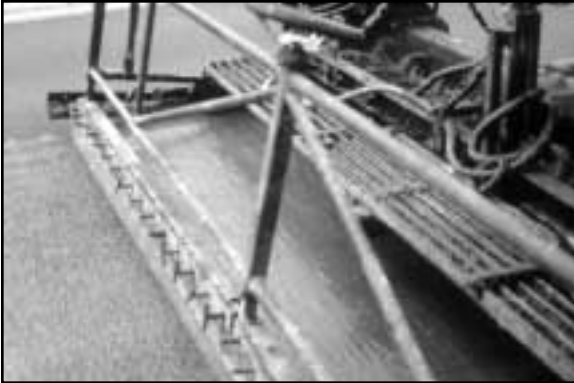
Slide 35 Secondary strike off improving the surface texture

This last example of the secondary strike off shows how it can improve the surface texture and cosmetics as well as correcting drag marks. Here you see a wet shiny surface on the mix between the primary strike off and the secondary strike off, that indicates a mixture that has too much total liquids in it. While the contractor is working to lower the total liquids in the mix the secondary strike off is correcting the surface texture.

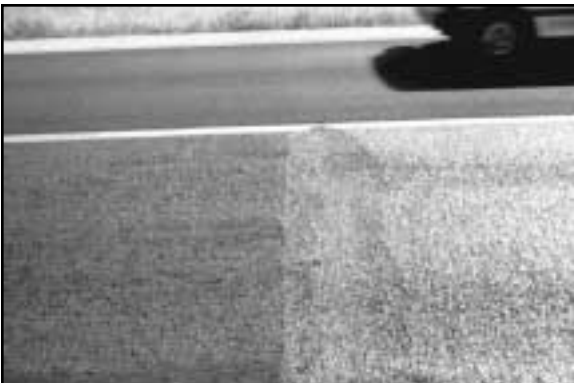
Slide 36 Good transverse joint

This is an example of a good transverse joint in a Micro-Surfacing mix. Making transverse joints with any asphalt material is a difficult process and in this next group of slides we will talk about how to construct those joints when using Micro-Surfacing. The method we will be discussing for constructing a good transverse joint is not the only correct method that may be used, but is one of the methods.

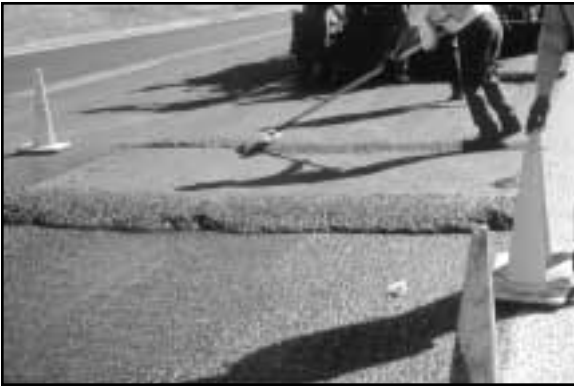
Slide 37 Removal of cold mix

Because of the very quick setting nature of the Micro-Surfacing mix, it is important that the contractor not try to empty the lay down box material when making a construction joint. Once fresh material is no longer being discharged into the lay down box, the material being carried along that is all ready there will quickly change from a semi-liquid state to a cold mix state. This change may occur before the material in the box can be deposited onto the road surface, and if the contractor tries to lay all of the material in the box before making his joint the cold mix material he is depositing may not adhere to the road surface. It is recommended then when making a transverse joint, that when the mixing unit is shut off, that the material that is present in the box be picked up and disposed of.

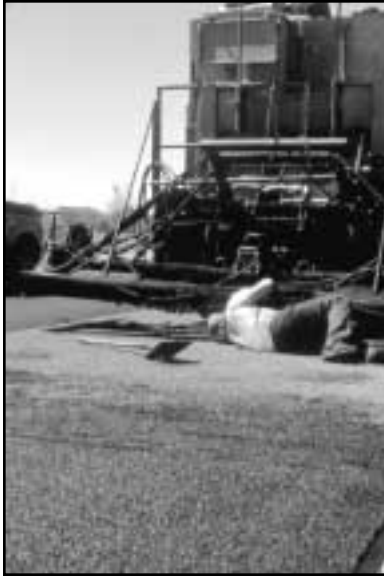
Slide 38 Cleaning the primary strike off

When the lay down machine has stopped it is important to take this time to physically remove the build up of asphalt and fines that are present on the primary strike off. As we discussed previously this build up of material causes drag marks or serrations in the road surface, and it needs to be removed every time the lay down machine stops.

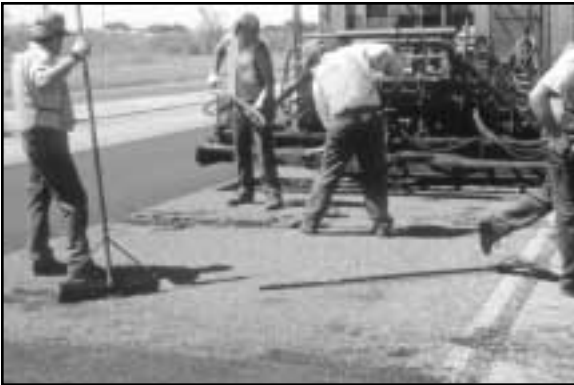
Slide 39 Surface clean up

After the strike off has been cleaned and the machine is ready to start its lay down process again it should be noted that all cold mix material and contaminates on the road surface should be cleaned up. If this clean up process is not done these contaminates will be picked up by the lay down box and may become drag mark particles that will need to be removed while the machine is in motion. It is simpler to remove this material before the machine is moving.

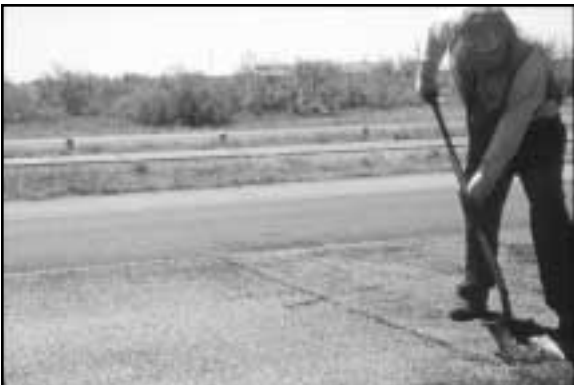
Slide 40 Preparing for a transverse butt joint

Transverse joints with the Micro-Surfacing system need to be butt joints not overlap joints. The recommended method of making a good butt joint is to first cut a straight edge line into the existing mix as demonstrated here. Then the lay down box is placed at this cut out point perpendicular to the road. The lay down box is then charged with fresh material and the lay down process proceeds down the road. A hand tool is then used to dress up the transverse joint.

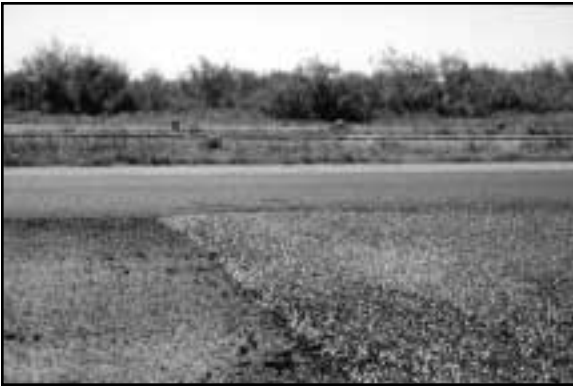
Slide 41 Completed transverse butt joint

This is another example of a good transverse butt joint that was constructed using the method we have just discussed. Notice that the line is perpendicular with the road with good aesthetics. There is not a double thickness of material as would be evident if an overlap joint was used. A joint like this will not be evident in a short period of time, as it will quickly blend into the overall road appearance.

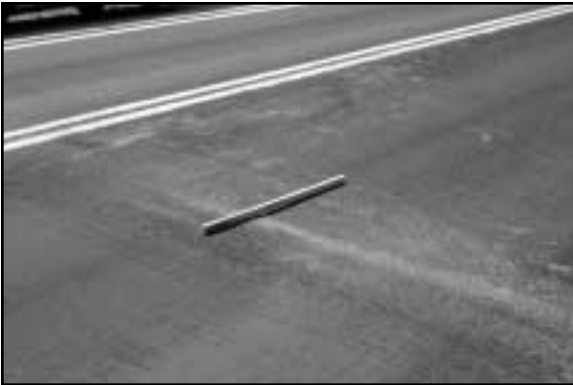
Slide 42 Unacceptable transverse joint

This is an example of a transverse joint that was built as an overlap joint. Notice the gap under the straight edge on the joint, which shows an elevation difference. This gap will cause a bump to be felt when traveling over the joint. Also the discolored material that is evident here is cold mix material that was picked up by the lay down box when it was pulled over the fresh or tender mix at the joint. This bump and discolored area will remain in the road surface long after the project is completed.

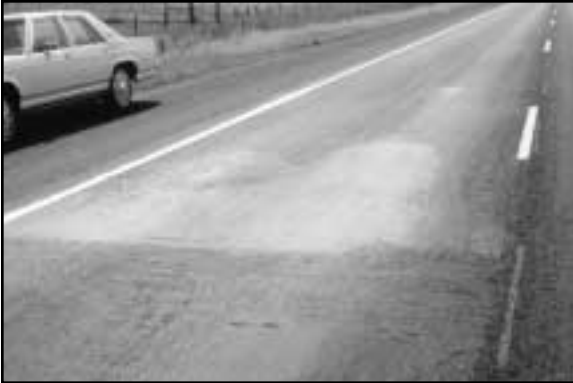
Slide 43 Unacceptable transverse joint

Here is another example of an unacceptable transverse joint. This joint shows an area that has too much total liquids in the Micro-Surfacing material. The texture of the joint should be the same as the rest of the road surface and not be unsightly or flushed as shown here. Also you will notice foot prints and other defects in the joint caused by workers trying to correct the defect at the joint, rather than constructing it correctly the first time.

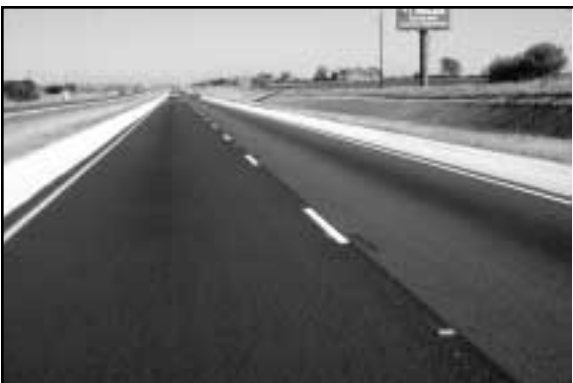
Slide 44 Good longitudinal joint

This slide shows a good longitudinal joint in a four lane section of roadway. Constructing a longitudinal joint on a four lane highway is relatively easy as the normal process of constructing the road will insure that the longitudinal joint application will be placed when the first application of material is well cured and stable. It simply requires the contractor take care to minimize the overlap of material at the joint interface. A maximum overlap at a longitudinal joint should not exceed four inches at a typical joint.

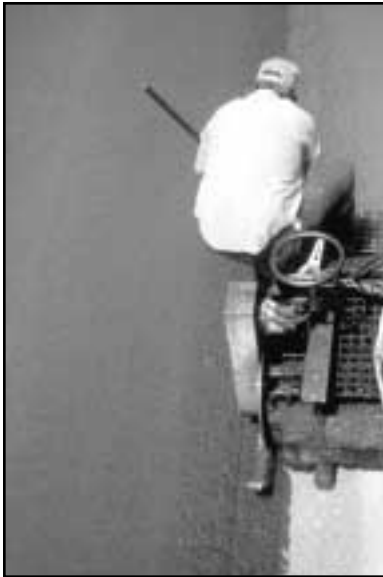
Slide 45 Working the joint overlap down by hand

As we pointed out in the previous slide, an overlap of up to four inches is permissible on a longitudinal joint, but care should be taken to minimize the thickness of the material at this joint. Here a worker is working the second application of material down at the joint with a squeegee to minimize the thickness. This is an acceptable practice to aid in smoothing out the transition and ride when going from one lane to the other.

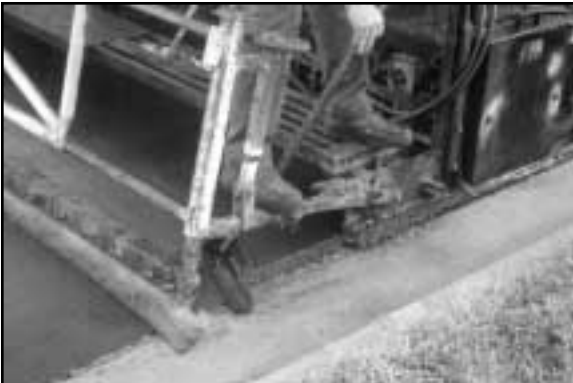
Slide 46 Working the joint overlap down with a squeegee and secondary strike off

Another technique that is being used is to feather or minimize the material at the joint with a hand squeegee placed between the primary and secondary strike offs as shown here.

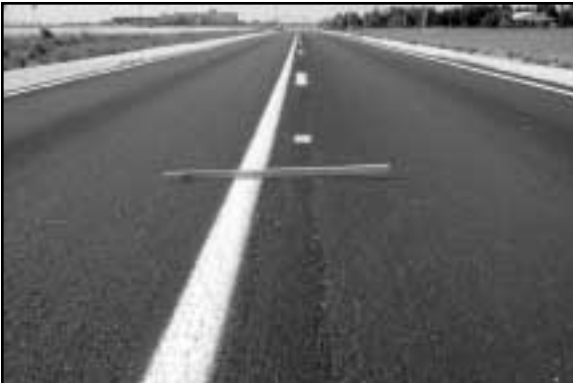
Slide 47 Excessively overlapped transverse joint

When the maximum overlap of four inches is exceeded it is impossible to work the two passes of material down to any acceptable degree. Here we see an overlap of approximately eighteen inches and the associated problem of having a double thickness of material. This excessive overlap will cause an elevation difference in the mix that will cause a bump when transitioning from one lane to the other as is evident by the gap seen under the straight edge.

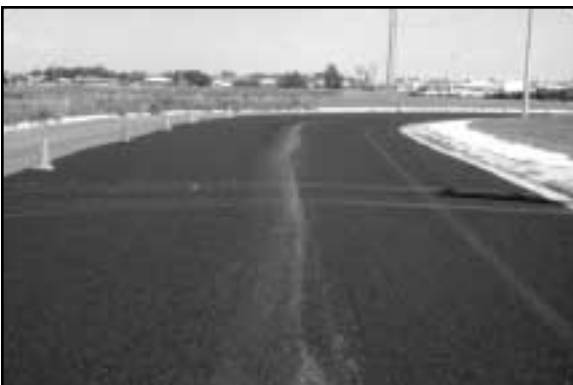
Slide 48 Overlapping fresh mixture at the longitudinal joint

It was pointed out previously that making a longitudinal joint when the second application is placed next to a completely cured first application is simply a matter of minimizing the overlap and working the second application down. When making this longitudinal joint where the first application is still in a tender or fresh state the process is a little harder to do. As shown here the lay down box will tear the fresh mix and create an unsightly appearance.

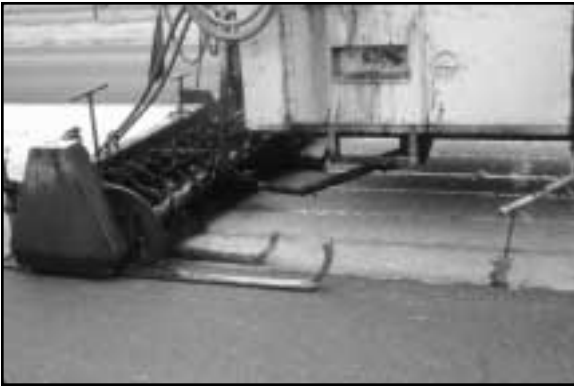
Slide 49 Inside skids on the lay down box

An aid in stopping this tearing of the fresh mix when making a longitudinal joint is to use what is called an inside skid on the lay down box. The lay down box is pulled along the road surface with its weight being carried on long runners or skids, and this skid riding on the fresh mixture is the cause of the tearing we are discussing. The corrective procedure is to mount another skid on the inside of the lay down box. This allows the outside skid that is in contact with the fresh mixture to be raised up so that it does not tear the mix. The weight of the lay down box is now being carried on the inside skid which is in contact with the unsurfaced portion of the road.

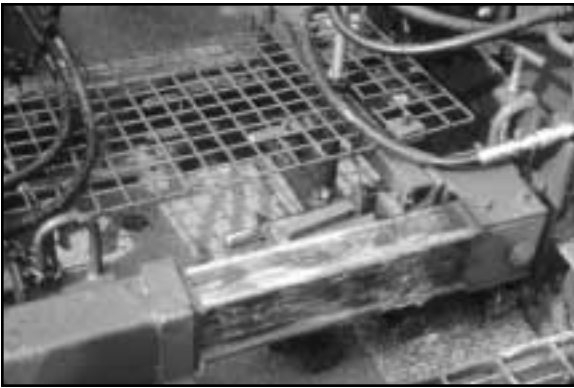
Slide 50 Hydraulically adjustable lay down boxes

Another device that is helpful in stopping this tearing of the fresh mixture is a hydraulic box that will allow the contractor to quickly change the width of his lay down box. With the introduction of these hydraulically adjustable boxes the contractor can change the width of the box in approximately ten minutes. Also these boxes are fitted with inside skids at the factory which further helps the problem as we discussed previously.

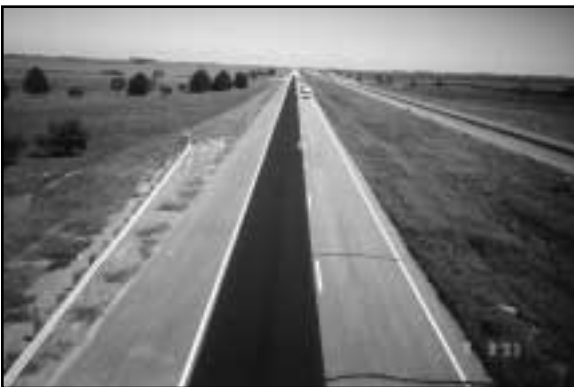
Slide 51 Longitudinal alignment

This is an example of the type of longitudinal alignment that can be achieved with the Micro-Surfacing system. This is an Interstate project in Nebraska where the outside lane was rut filled then surfaced. Notice the straight edge lines which were placed inside of the existing paint line.

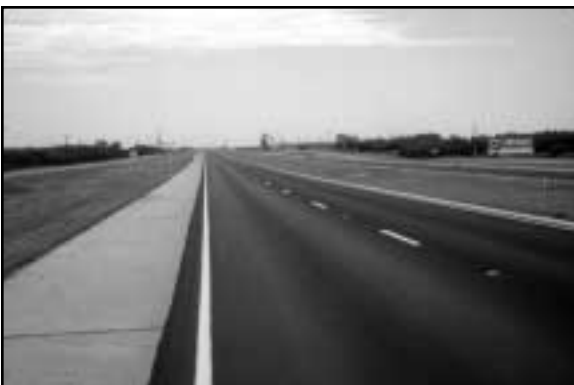
Slide 52 Acceptable edge lines

Another example of an acceptable edge line or longitudinal line on a four lane roadway. Notice that this system can produce a very straight and clean edge line.

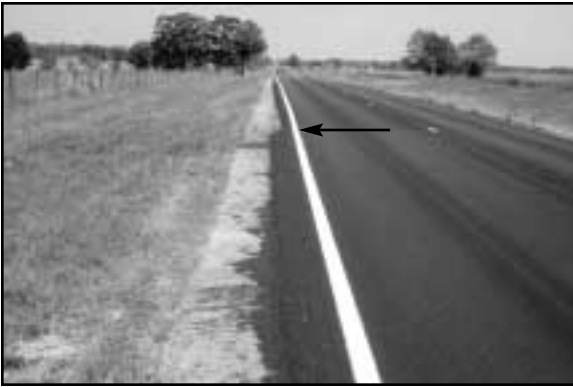
Slide 53 Unacceptable longitudinal alignment

This is an example of an edge line that should not have happened or been accepted by the buyer agency. As seen here the mixture had too much total liquids in the system, which ran off onto the shoulder. The mixture should have had some of the liquids removed which would have stopped the free liquid run off. Also the operator of the lay down machine has a side shift device that was used to over correct the alignment at the location shown.

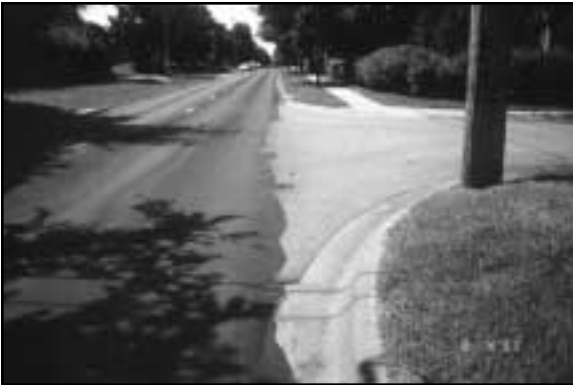
Slide 54 Another example of a bad edge line

This residential location also has a problem with the longitudinal alignment that should not have happened. This problem is also associated with the mixture being laid in too wet of a condition, allowing the mixture to flow past the end of the box. A properly designed and applied Micro-Surfacing material should not have excess liquids free in the mix. Also the driver of the lay down machine was not following a straight line when he was steering the machine.

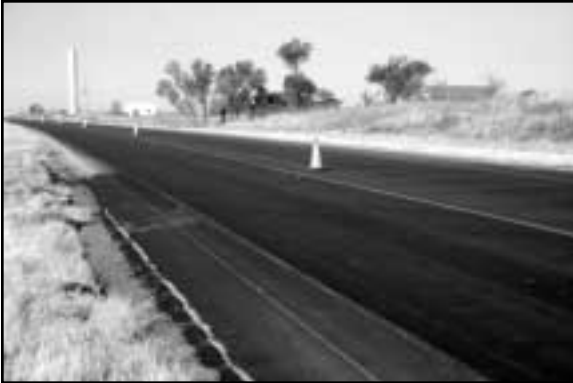
Slide 55 String line edge lines?

If the contractor has difficulty in achieving a straight edge line, one thing that may help this is to require him to put down a string line to use as his guide mark for alignment. We are not recommending that all projects require a string line. Normally the existing paint line at the edge of the road is adequate for the contractor to use as his guide mark, but if he is not able to achieve the alignment that is desired, then a string line guide mark will normally improve the alignment.

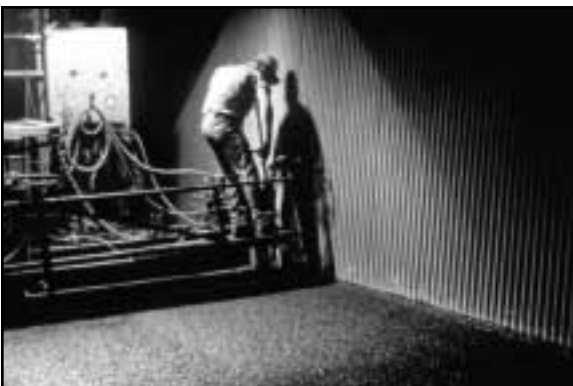
Slide 56 Vertical abutment alignment

As can be seen here the lay down machines are designed to allow the contractor the ability to maintain a very straight edge line if the contractor so desires. When pulling the lay down box next to a vertical wall it requires very good machine control and the ability to maintain that control. Straight edge lines are possible.

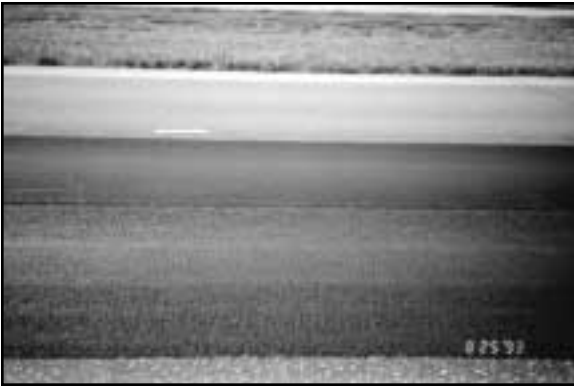
Slide 57 Six foot rut box work

This industry currently has only two sizes of rut boxes available. This slide shows the six foot rut box typical application. Note that when both ruts in a lane are filled with this box, twelve feet of the road is surfaced which requires the two passes make a longitudinal joint. The design and operation of a rut box is such that the outside edge is able to be laid with less material than the center part of the box. This allows what is called feathering of the rut box edge where very little material is applied. This promotes very good longitudinal joints with a rut box.

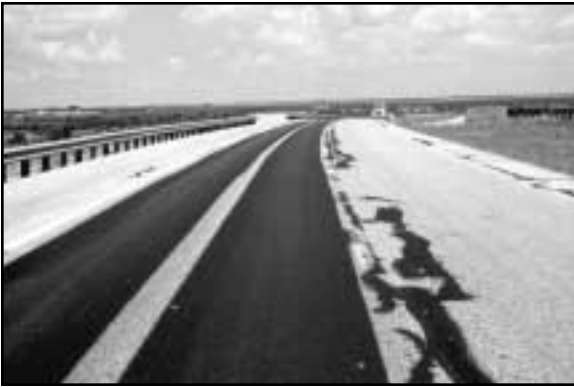
Slide 58 Five foot rut box work

Seen here are two passes of rut box work with a five foot rut box. The five foot box will leave a gap between the applications, and will normally be followed with a surface application on top of the rut work. Notice again that the five foot rut box will feather the outside edge material down so that the edge of the rut work is as thin as possible.

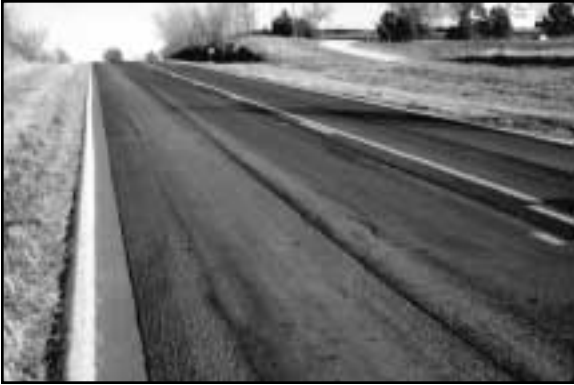
Slide 59 Unacceptable rut work

Here is a project done with rut box work only, where the contractor overran the project by sixty five percent simply because he did not try to feather the outside part of the mix down as the design of the box promotes. This excess material was not needed to re-profile the rutted section and should not have been accepted.

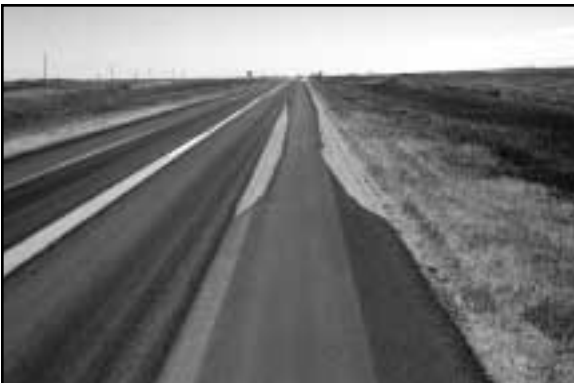
Slide 60 Under filled rut work application

This slide illustrates a rut application where the rut was under filled with material. The design and intent of rut work is to completely fill each individual rut with enough material to correct the roads profile. In this slide, that has not be accomplished. When the surface application is applied over the rut work, the under filled area will not have the same cross section as the rest of the surface.

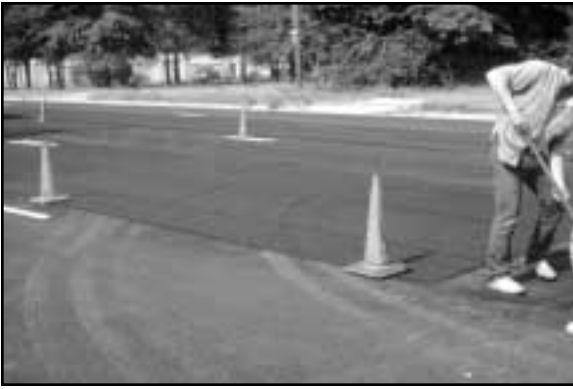
Slide 61 Correct patching procedure

On most projects there will be some areas that the contractor and buyer will want to correct with another application of material, or patch. This slide shows such an area, where a patch has been done correctly. It is normally accepted that when a patch is required, the patched area should have the same surface cosmetics as the rest of the road. This is accomplished by requiring that all patching be done with the same lay down box that was originally used to surface the road.

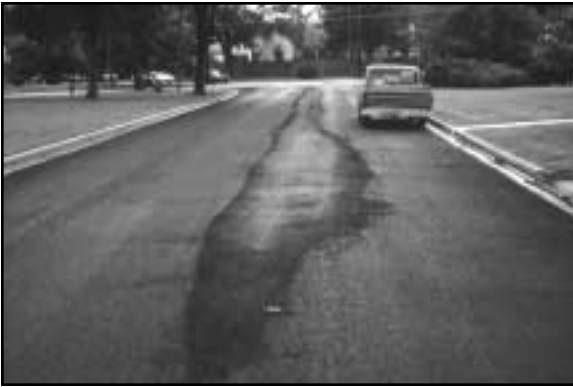
Slide 62 Unacceptable patch work

This is an example of an area that was patched without using the accepted lay down box method we just discussed. Here the contractor discharged material directly onto the road surface and hand tooled the patch in. As can be seen here this method leaves a completely different texture and appearance than the rest of the road, and should be ruled an unacceptable patching process. As pointed out earlier it is recommended that if an area requires a patch it should be patched with the same process and equipment that originally surfaced that area.

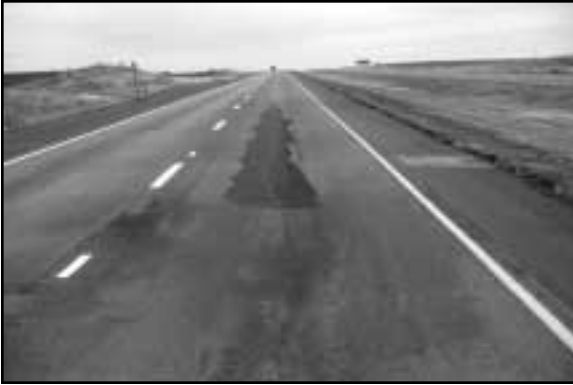
Slide 63 Unacceptable patching

Another example of an unacceptable patch area. Once again the contractor elected to do the patching by simply hand working some mix into the problem area with a hand tool. Remember that if an area requires a patch it should be done with the same device that originally laid the material in that area.

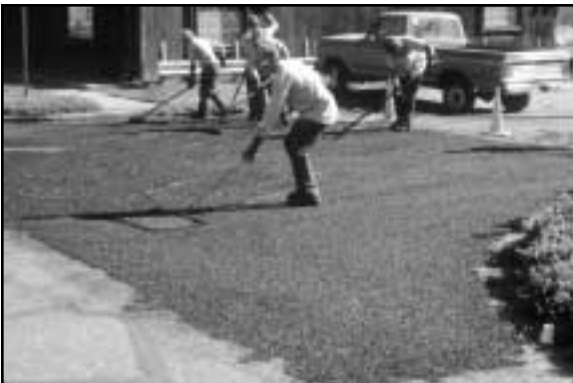
Slide 64 Hand work areas

There are times that the lay down machine will not be able to reach or maneuver into an area to lay the material. In these cases it becomes necessary to hand work the mixture over these areas. This is an example of hand working an intersection approach. It is important to remember that the material is designed to cure very quickly and it will be necessary for the contractor to have extra people available to assist in the hand work process. The mixture must be spread and smoothed before it changes from a semi-liquid state to a cold mix state.
