MICRO-SURFACING

(QUALITY CONTROL)

A Guide To Quality Construction

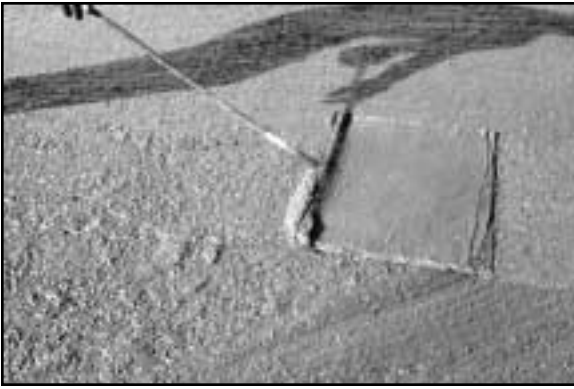
Slide 65 Burlap drag on a hand applied area

After the mixture is applied with hand tools it will need to be smoothed up with a burlap drag as shown here. The hand tools will leave ridges and valleys in the mixture as you can see in this slide. It is necessary to go over all hand work areas with a drag mop to remove these surface imperfections. This is the only time that a burlap drag mop is used on a Micro-Surfacing project.

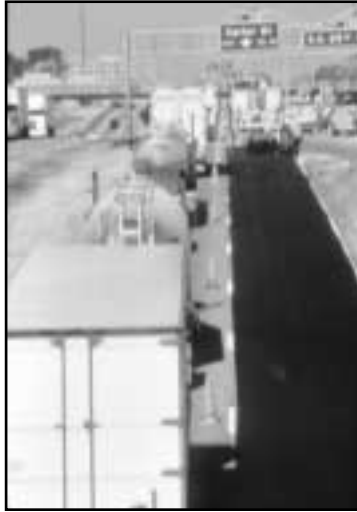
Slide 66 In town traffic conditions

This slide is an in town high traffic area that has been Micro-Surfaced successfully, without excessive traffic damage. When working in town it becomes important for the contractor to devise methods to protect his fresh material from damage caused by traffic getting onto the mix before it has had a chance to cure sufficiently.

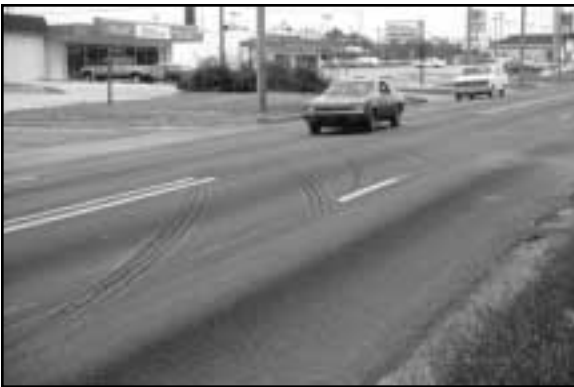
Slide 67 Damaged area from early traffic crossing

This is an example of the damage that traffic can cause when it crosses the mixture before it is sufficiently cured. These wheel marks will remain in the road surface if they are not patched. It is the contractors responsibility to eliminate this type of problem as he should have been aware of the traffic problems before he bid the project.

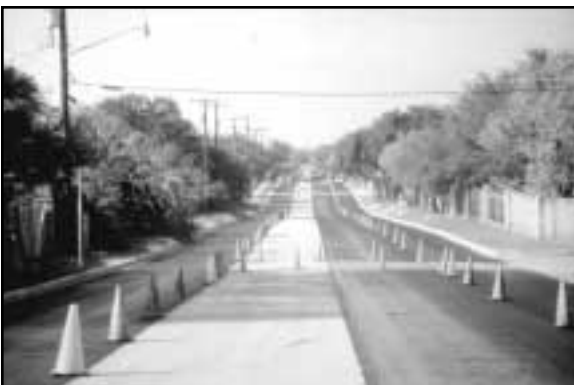
Slide 68 Extra traffic control cones

Perhaps the best method to keep traffic from driving on your material before you want them too, is to use additional cones to channel the traffic out of the areas that are not ready for them. Here we see where cones are spaced much closer together than is normally required, but by doing this vehicles are not as likely to cross over the fresh material and cause the damage we looked at on the previous slide.

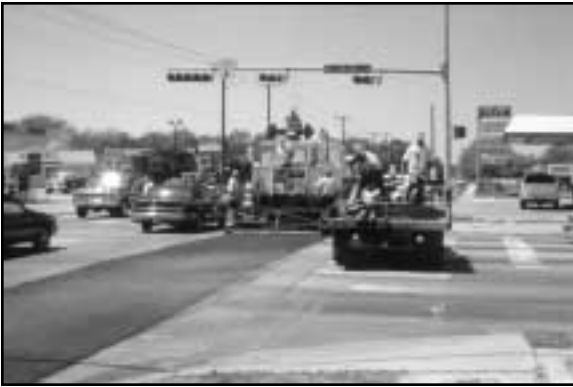
Slide 69 Dusting at an intersection

There are times when a contractor must allow traffic across the fresh mixture before he would like too, normally at an intersection where crossing traffic is not diverted. In this instance the industry has a method to minimize the damage this crossing traffic will cause. This method is called “dusting”, and it is accomplished by spreading some of the virgin mix aggregate over the fresh material to act as a barrier to not allow vehicle tires to sink down into the mixture.

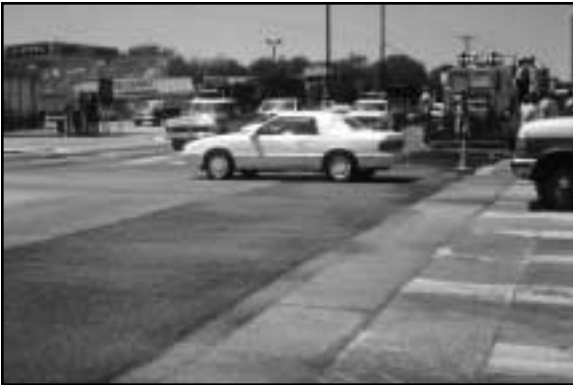
Slide 70 Crossing a dusted area

We can see here where a vehicle is crossing the fresh mixture on a dusted area without indenting the Micro-Surface and leaving a wheel print. It should be noted that even when an area is dusted the early crossing of the mixture will still leave some surface blemishes and the road will have a temporary aggregate dust stain at the dusted location. The dusting procedure is not a perfect control of the traffic blemish problem but it is better than doing nothing at those locations where you must allow traffic to cross the material early.

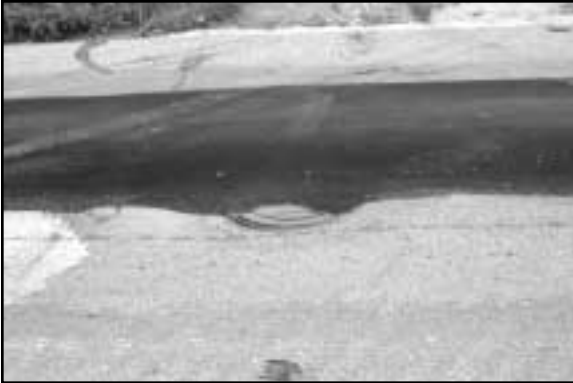
Slide 71 Manhole protection

Manholes and utility covers must be protected from the Micro-Surfacing material to insure that they are serviceable after the application of material. Here we see a manhole cover that is being covered by material without any protection. The Micro-Surfacing material will stick to the metal of these covers so tightly that removal of it later will be very difficult.

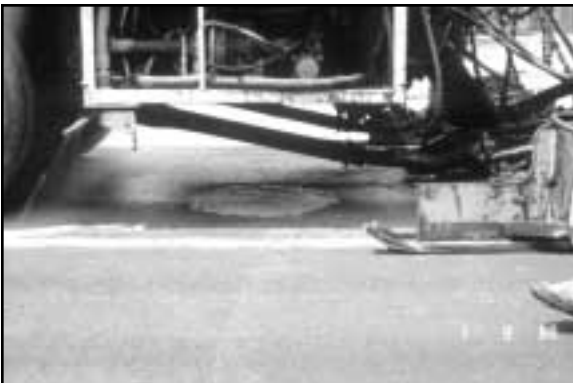
Slide 72 Protected Manhole

The accepted procedure is to cover the utility covers with a plastic material before surfacing over them and then removing the plastic when the road is opened. This allows for easy removal of the material from the cover and puts the utility entrance back into service.

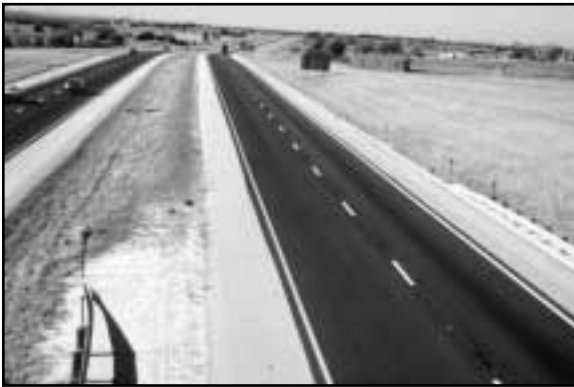
Slide 74 Successful construction

When the specifications are written correctly, the plans spell out what is expected of the contractor, the road is correctly prepared, the contractor has a good mix design and quality control system, this is what you as a buyer agency should get from a Micro-Surfacing project. A quality asphalt resurfacing operation and a resurfaced road that you can be proud of, which will last for many years.
