FORENSIC SITE INVESTIGATION & INSTRUMENTATION

Ir. Dr. M. Farid Ahmad
DFY Consult & CSL Soil Centralab

CAUSE, EFFECT OF FAILURE AND RESULTS OF INVESTIGATION

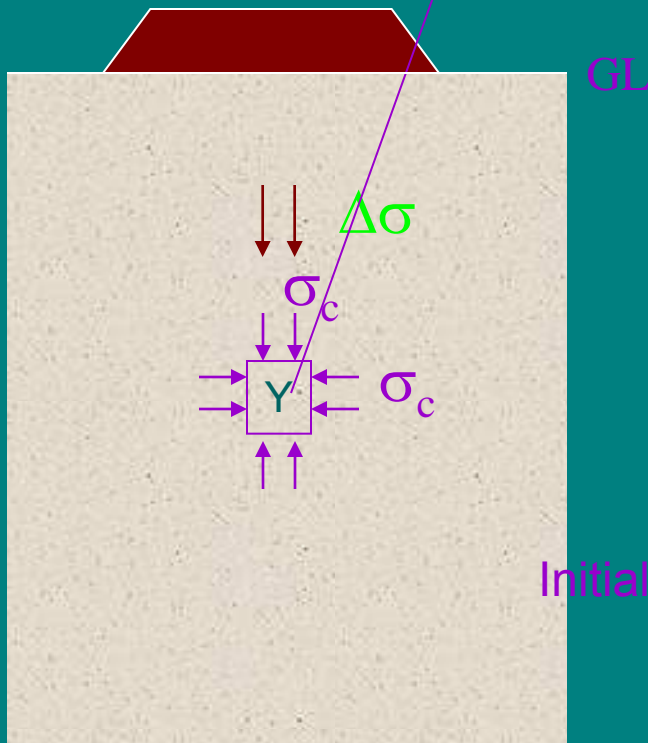
Mohr Circles & Failure Envelope

The soil element does not fail if the Mohr circle is contained within the envelope

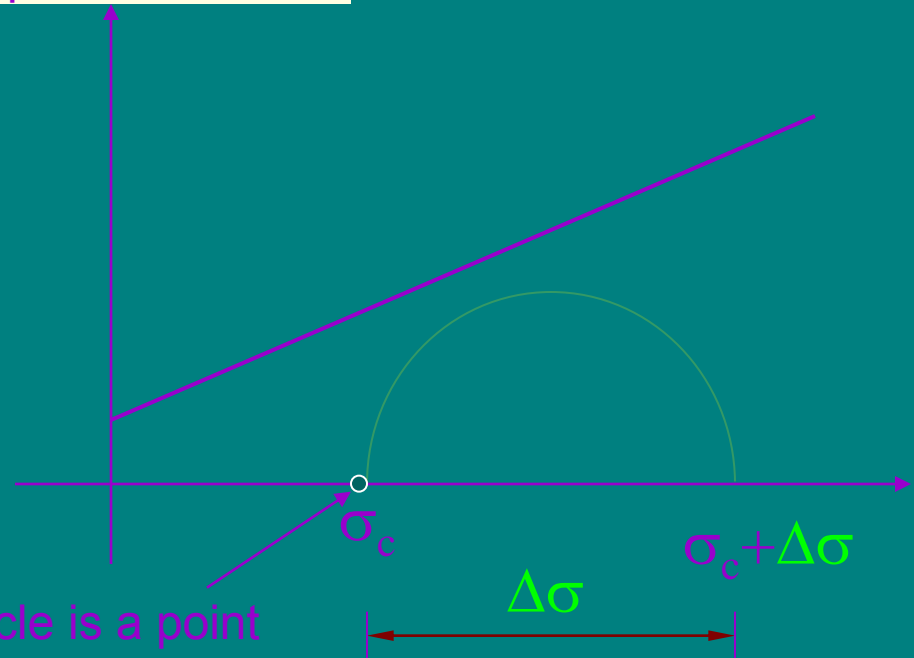
Initially, Mohr circle is a point

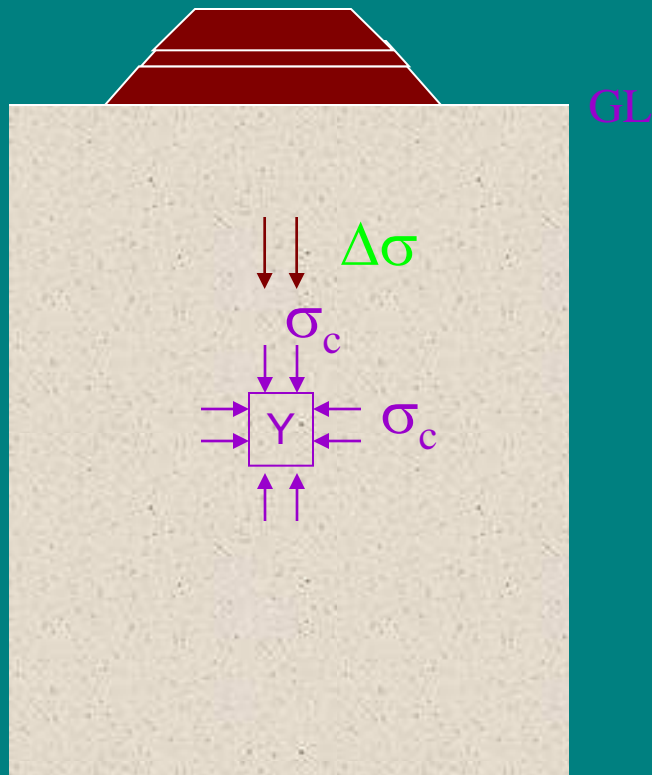
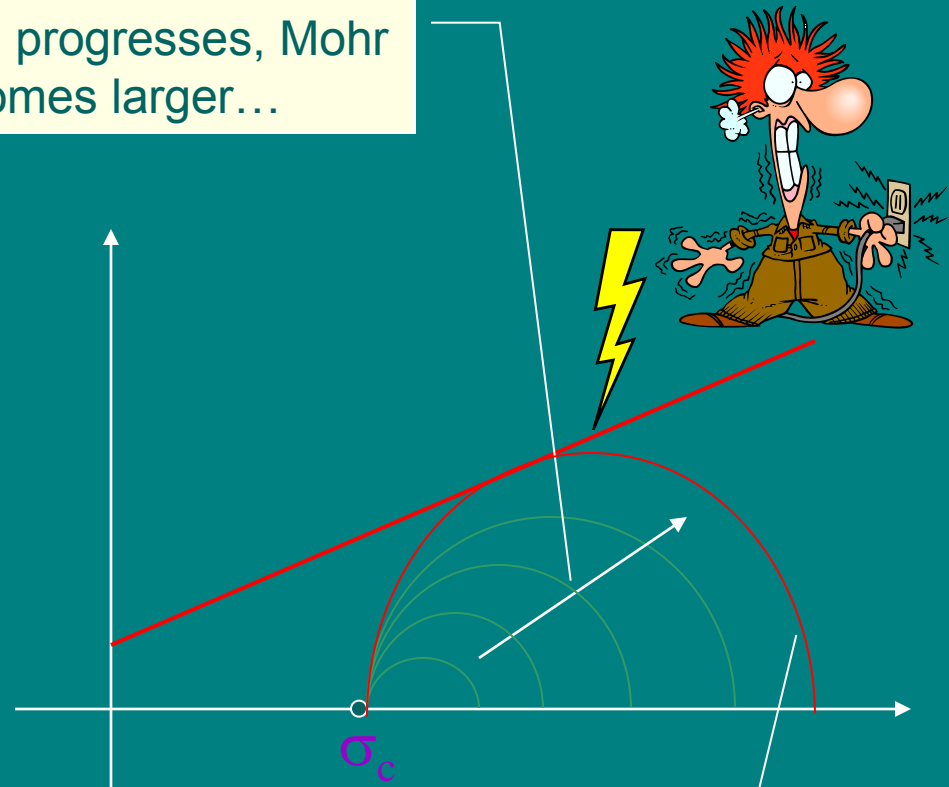
Mohr Circles & Failure Envelope

As loading progresses, Mohr circle becomes larger...

.. and finally failure occurs when Mohr circle touches the envelope

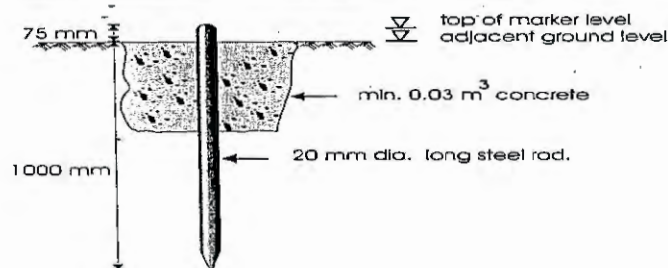
TYPICAL INSTALLATION DETAILS

marker reference no	location		date installed	top of marker level (m)	adjacent ground level (m)	remarks
	chainage (m)	offset (m)				
G1	CH 199.06		15.1.2002	13.891 m		
G2	CH 199.02		15.1.2002	16.080		
G3	CH 198.98		15.1.2002	19.098		
G4	CH 198.94		17.01.2002	19.017		
G5	CH 198.90		15.1.2002	17.854		
G6	CH 198.86		"	14.865		
G7	CH 198.82		"	11.053		
G8	CH 198.84		"	12.587		
G9	CH 198.88		"	13.706		
G10	CH 198.92		"	13.977		
G11	CH 198.96		"	14.066		
G12	CH 198.00		"	14.343		
G13	CH 199.06		"	8.513		
G14	CH 199.02		"	8.245 m		
G15	CH 198.98		"	7.973 m		
G16	CH 198.94		"	7.705		
G17	CH 198.90		15.1.2002	7.865		
markers installed by			HAKIM	level taken by	HAKIM

SETTLEMENT HEAVE MARKER

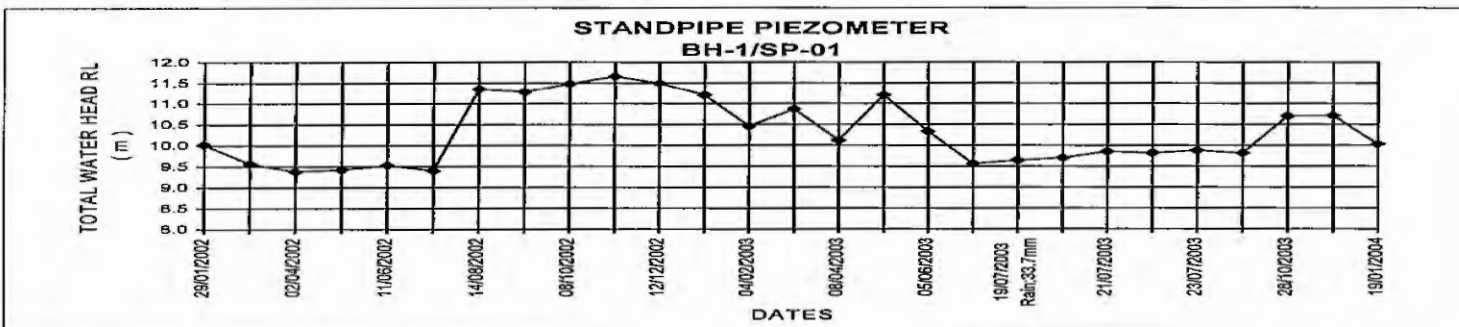
STANDPIPE PIEZOMETER

DATE INSTALLED		16/01/2002		RL OF TOP OF STANDPIPE AS INSTALLED (m)		19.177	
LEVEL OF STANDPIPE AS INSTALLED (m)		8.677		RL OF GROUND ADJACENT TO STANDPIPE AT INSTALLATION (m)		18.746	
TOTAL LENGTH OF STANDPIPE INSTALLED (m)		10.50		TOTAL HEAD BASE READING (m)		10.017	
DATE	DAY NO	TIME	DIPMETER READING (m)	STANDPIPE TOP RL (m)	ADJACENT GROUND RL (m)	TOTAL WATER HEAD RL (m)	WATER HEAD RELATIVE TO BASE READING (m)
29/01/2002	1	15:15	9.160	19.177	18.746	10.017	0.000
19/02/2002	22	17:02	9.620	19.177	18.746	9.557	0.460
02/04/2002	64	12:35	9.800	19.177	18.746	9.377	0.640
23/04/2002	85	11:42	9.760	19.177	18.746	9.417	0.600
11/06/2002	134	13:38	9.650	19.177	18.746	9.527	0.490
09/07/2002	162	10:59	9.780	19.177	18.746	9.397	0.620
14/08/2002	198	11:10	7.830	19.177	18.746	11.347	-1.330
10/09/2002	225	11:16	7.900	19.177	18.746	11.277	-1.260
08/10/2002	253	10:51	7.700	19.177	18.746	11.477	-1.460
12/11/2002	288	10:35	7.520	19.177	18.746	11.657	-1.640

INSTRUMENTATION WORKS AT KM 199 (N/B), DURIAN TUNGGAL

BH-1/SP-01

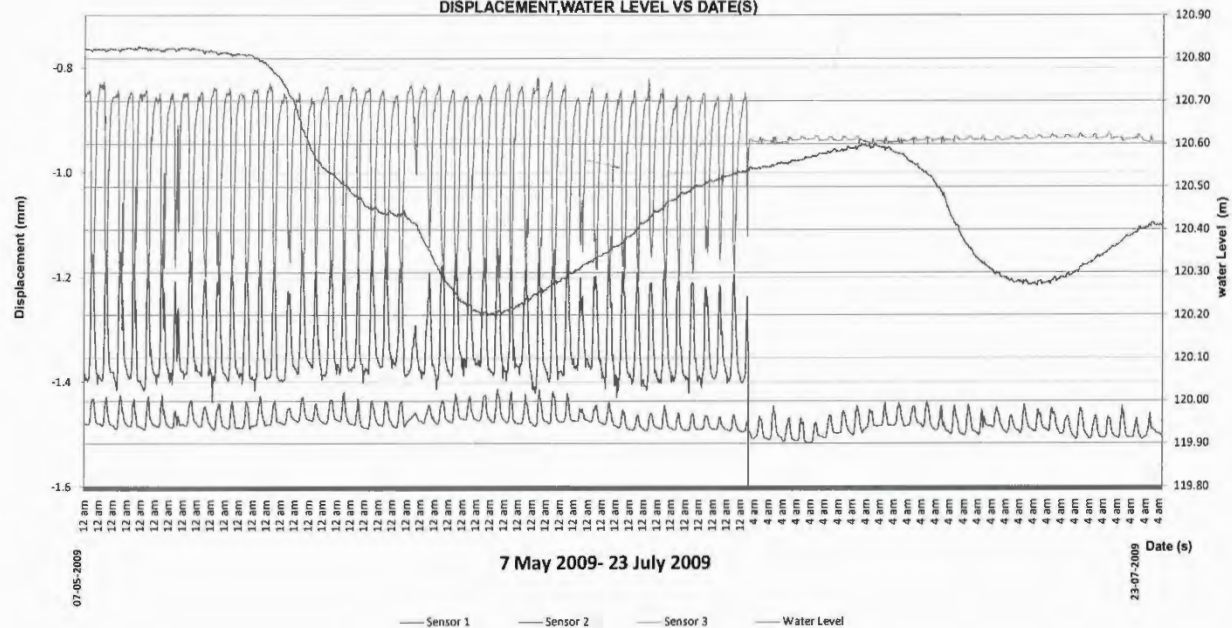
IPI 2 & VWP 4

DISPLACEMENT, WATER LEVEL VS DATE(S)

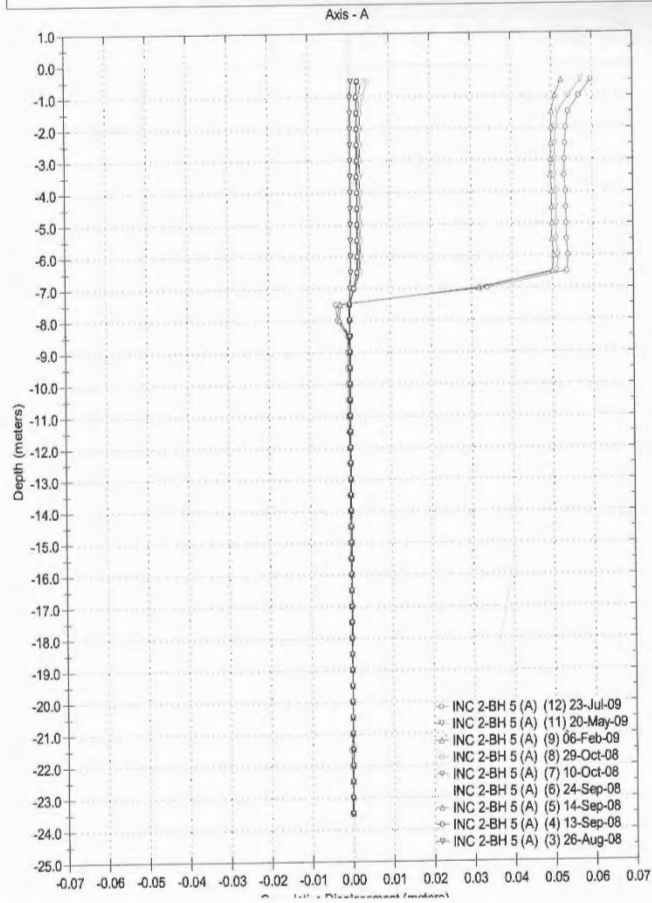
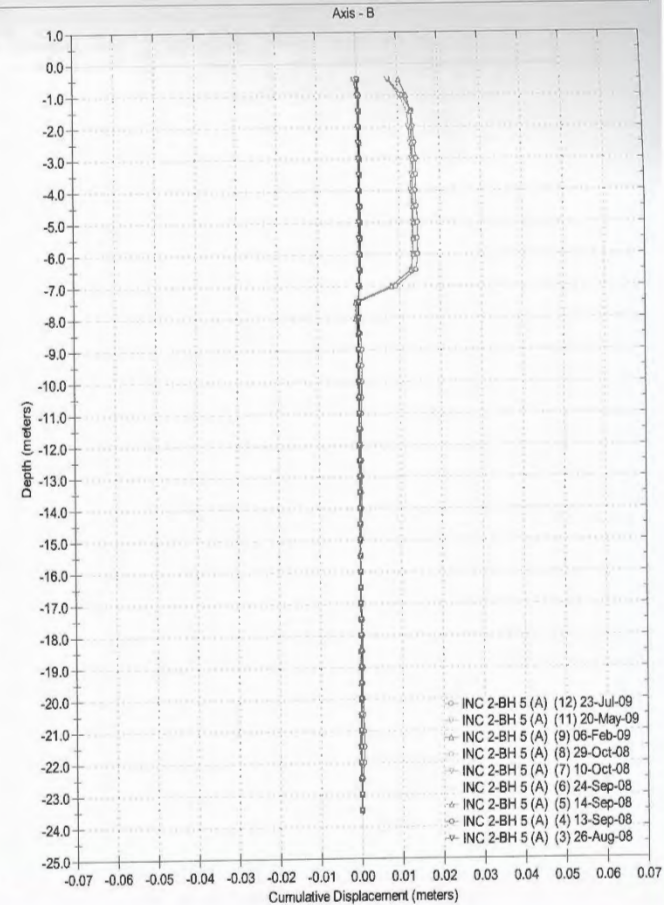
CUMULATIVE DISPLACEMENT

Borehole : INC 3 - BH 5 (A)
Project : JELAWANG - GUA MUSANG
Location :
Northing :
Easting :

Spiral Correction : N/A
Collar Elevation :
Borehole Total Depth : 23.5 meters
North Groove Azimuth :
Base Reading : 2008 Aug 23 13:38

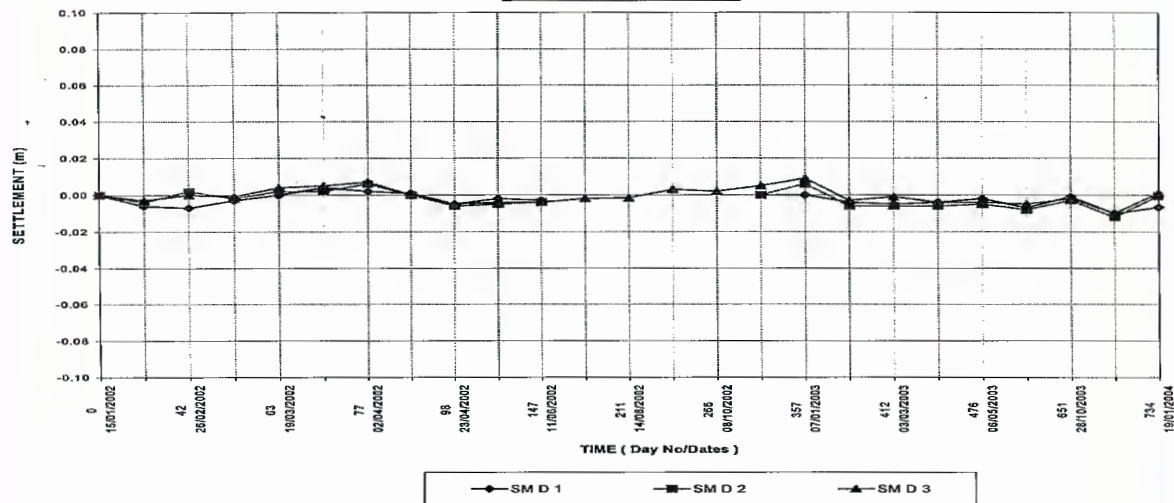
**INSTRUMENTATION WORKS AT KM 199 (NB),
DURIAN TUNGGAL
(SURFACE SETTLEMENT MARKER)
SETTLEMENT VS TIME**

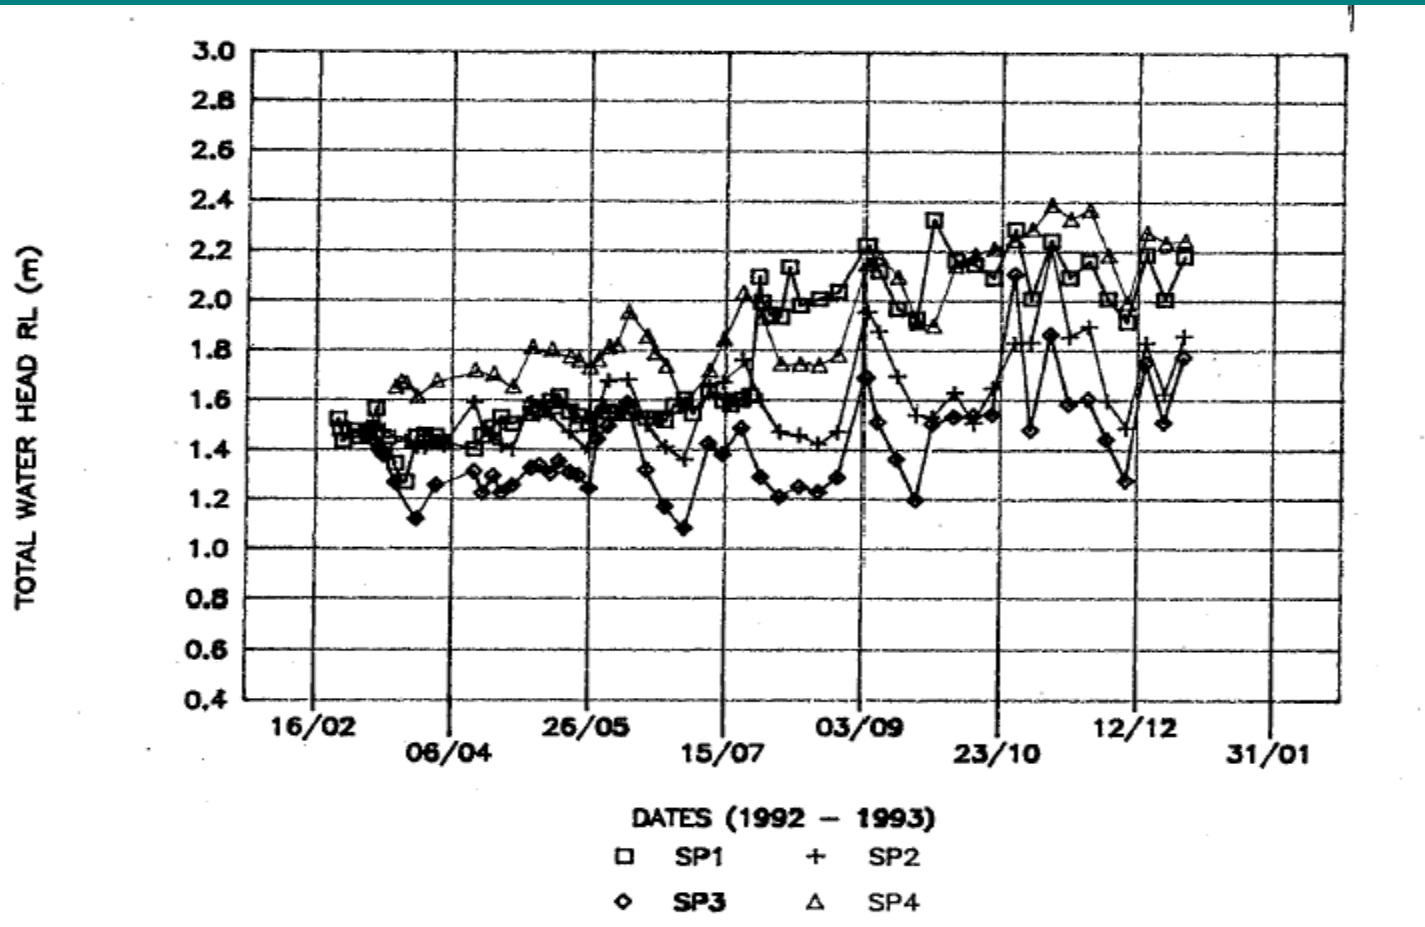
Standpipe Piezometer

Data collection, processing and presentation

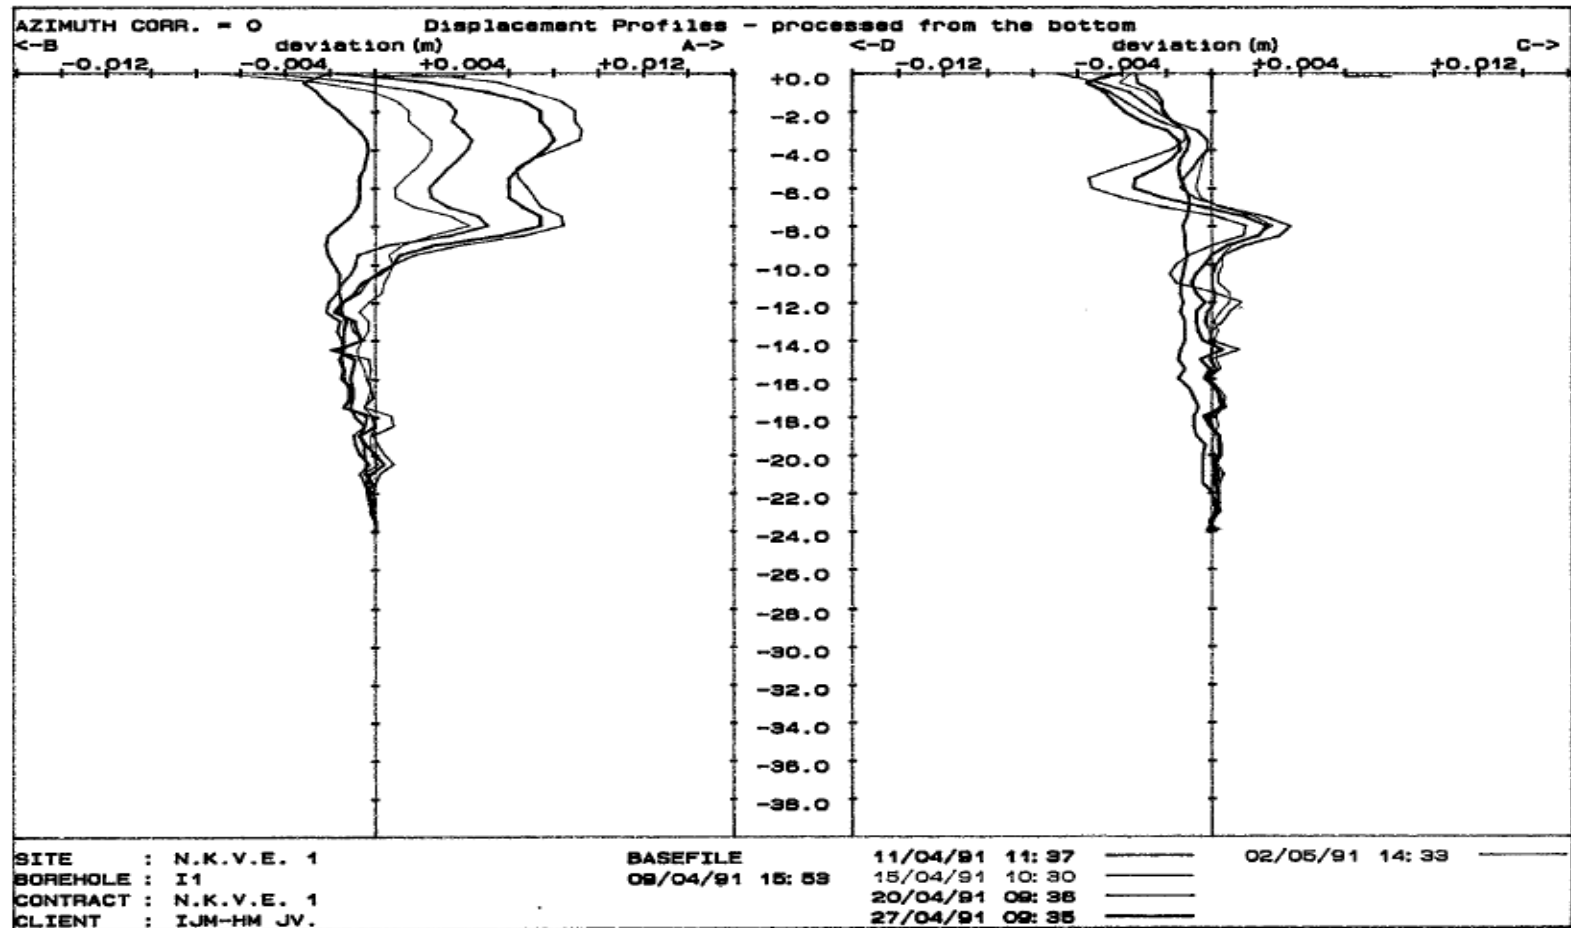
Inclinometer

Data collection, processing and presentation
