Jabatan Kerja Raya Malaysia

# Penyeliaan, Pengujian & Pertaualiahan Kerja Pembetulan

Bahagian Kejuruteraan Awam (Kesihatan &  
Pendidikan, Caw. Kej. Awam & Struktur

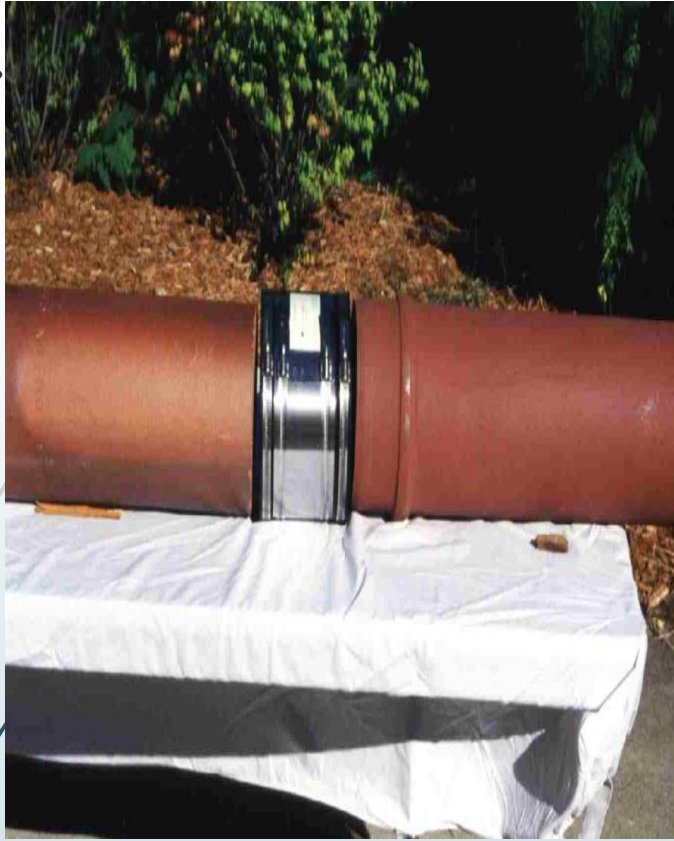
COUPLING

Kaedah 'Coupling'

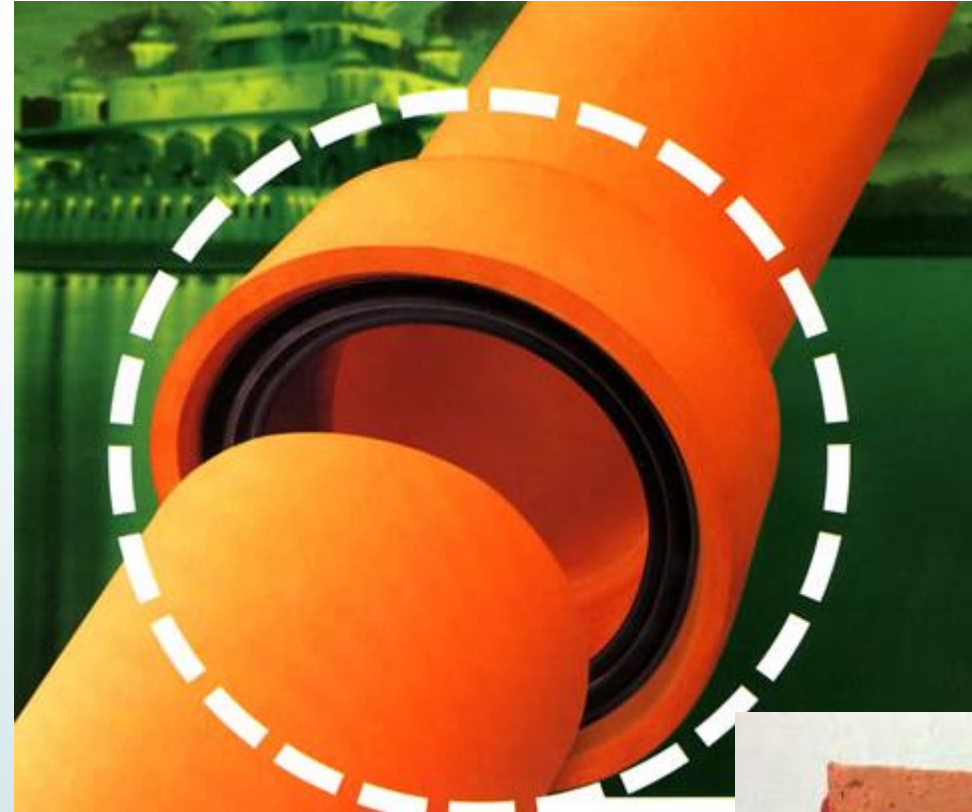
SOCKET & SPIGOT

Spigot & Socket perlu  
dibersihkan sebelum  
dibuat  
penyambungan

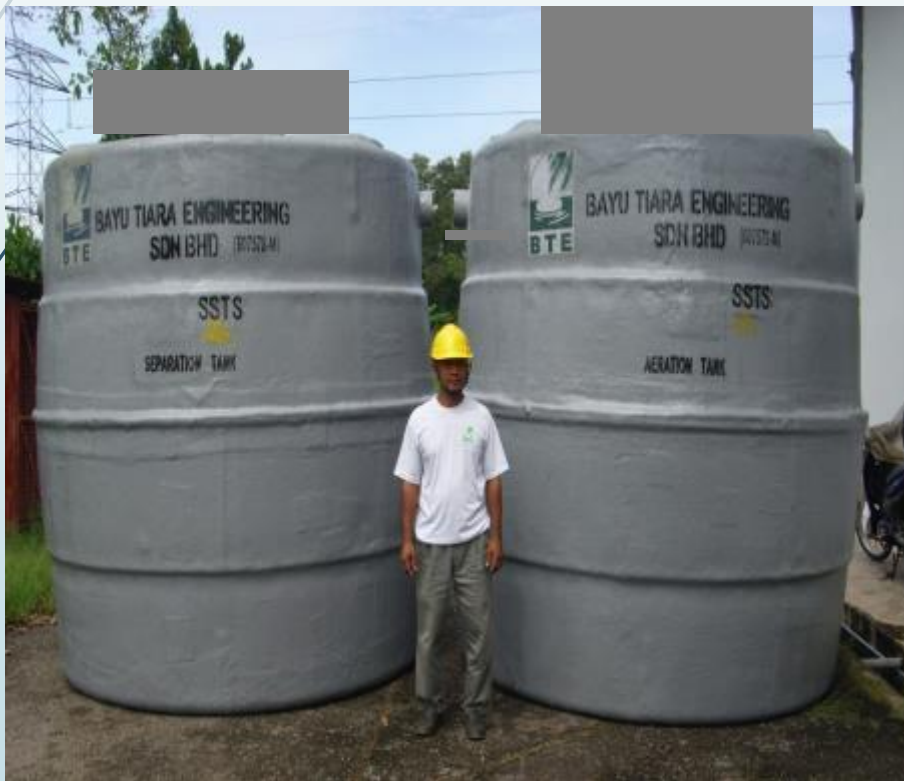
LAYOUT

Aeration  
Tank

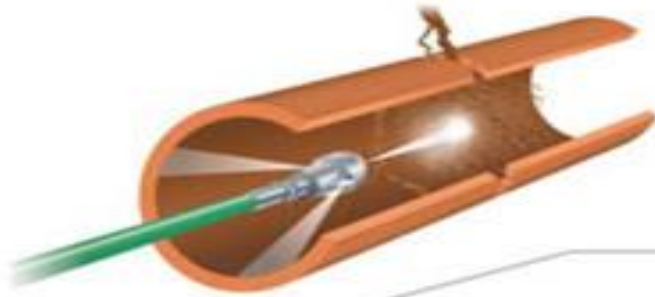
### 1 Unblock

Remove and clean the blockage from the damaged pipe using a high pressure jet blaster.

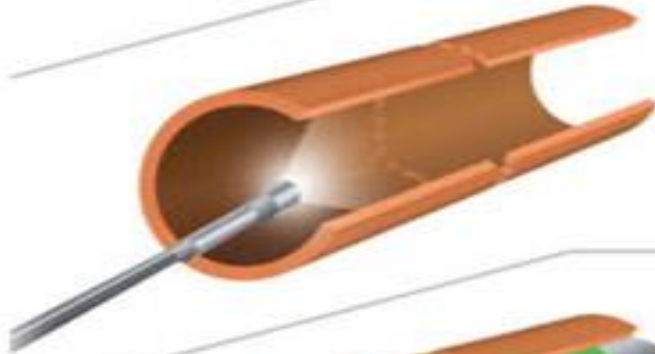
### 2 Inspect

Inspect and mark damaged section of pipe using CCTV Camera.

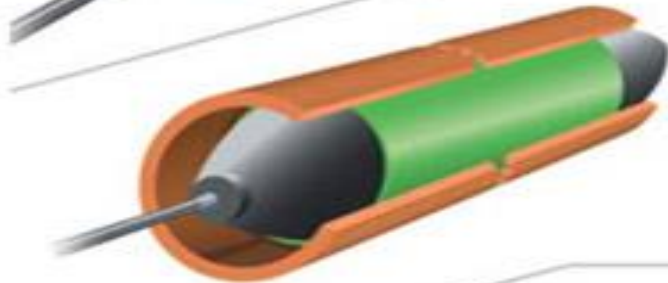
### 3 Insert

Insert the patch into the pipe.

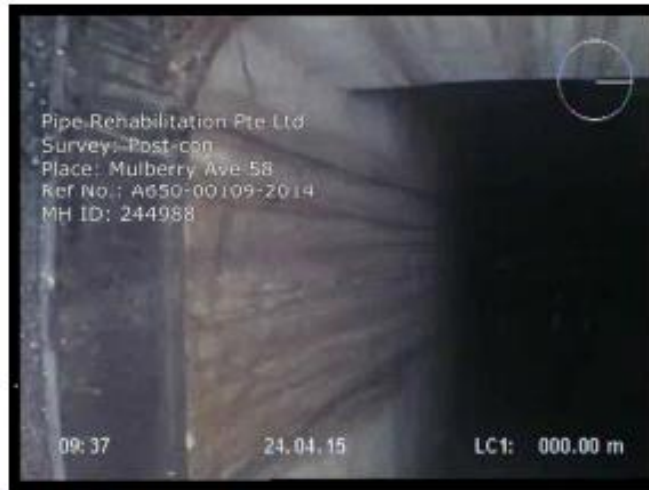
Photo: 244988-042415-M4.JPG  
General photograph, shaft wall (detail)

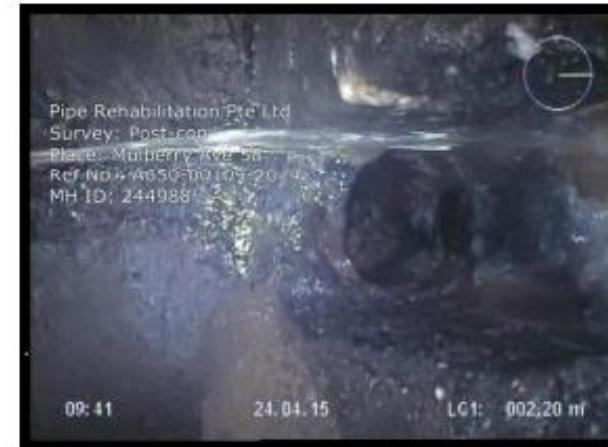
Photo: 244988-042415-M10.JPG  
General photograph, incoming pipe 1

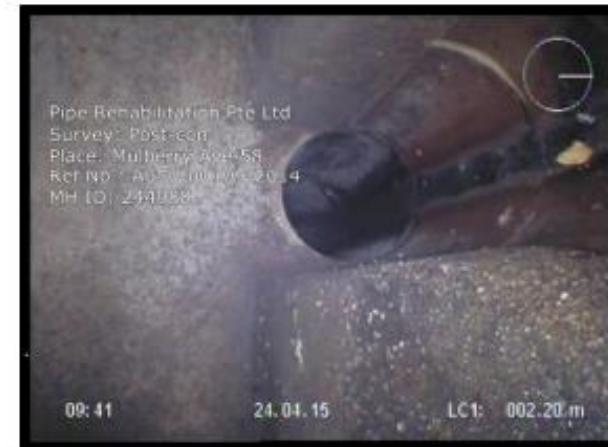
Photo: 244988-042415-M11.JPG  
General photograph, incoming pipe 2
