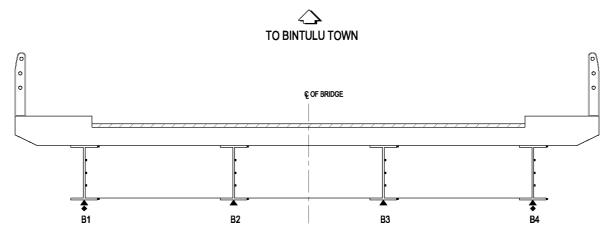
FIRGURE 5: POSITION OF STRAIN GAUGES, LVDT AND PRECISE LEVEL IN BEAM AT MID SPAN

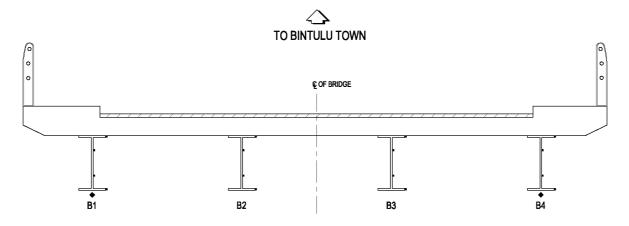
FIGURE 6: POSITION OF STRAIN GAUGES AND PRECISE LEVEL AT PIER 2

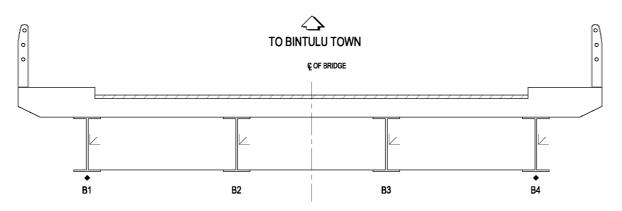
FIRGURE 7: POSITION OF ROSETTE AND PRECISE LEVEL AT ABUTMENT B
