Reference No. : CKASJ/BFSJ.G/2010/02

# DO'S & DON'TS

## *In Building Construction*

BAHAGIAN FORENSIK (STRUKTUR & JAMBATAN)  
CAWANGAN KEJURUTERAAN AWAM, STRUKTUR & JAMBATAN  
IBU PEJABAT JKR MALAYSIA

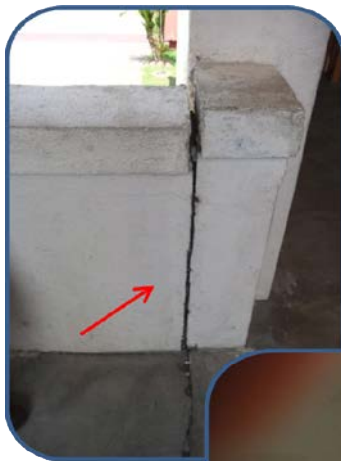
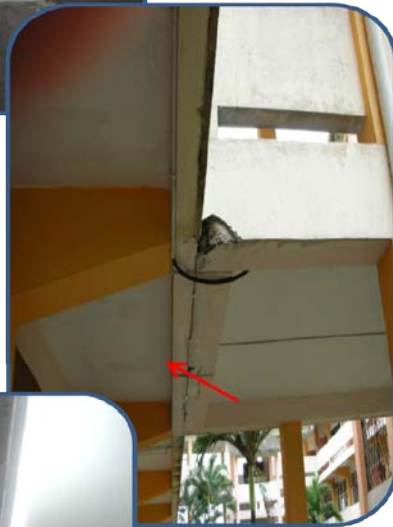
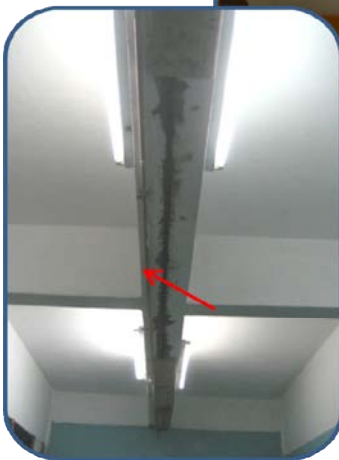
## Defects at Building Joint (Expansion Joint)

Commonly happens at joints between staircase/connecting corridor and classroom block where no proper expansion joint is constructed.

- a) Provide proper expansion joint, e.g. joint filler and sealant between staircase and main block.
- b) Design staircase and main block as a monolithic structure.

- a) Do not plaster over expansion joint.

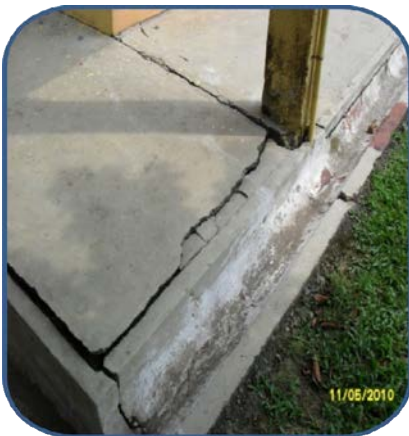
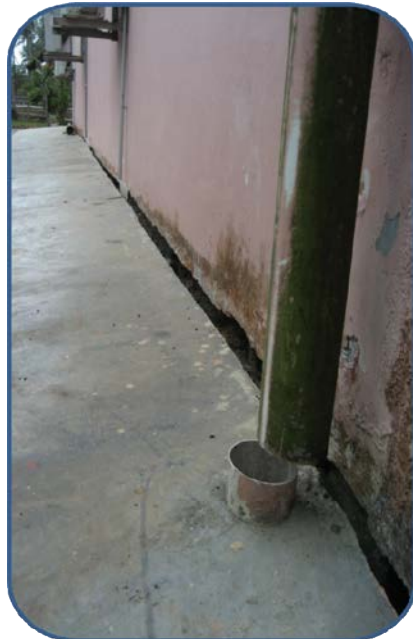
## Apron Settlement & Cracks

Cracks and settlement in apron occur when there is differential settlement due to insufficient compaction and/or ground movement

- a) Compact fill material and hardcore properly according to specifications.
- b) Provide expansion joint for every 6m on non-suspended apron.
- c) Design apron as a suspended slab for weak subgrade.

- a) Do not put any structure e.g. brick wall, brick box-up for column on non-suspended apron.

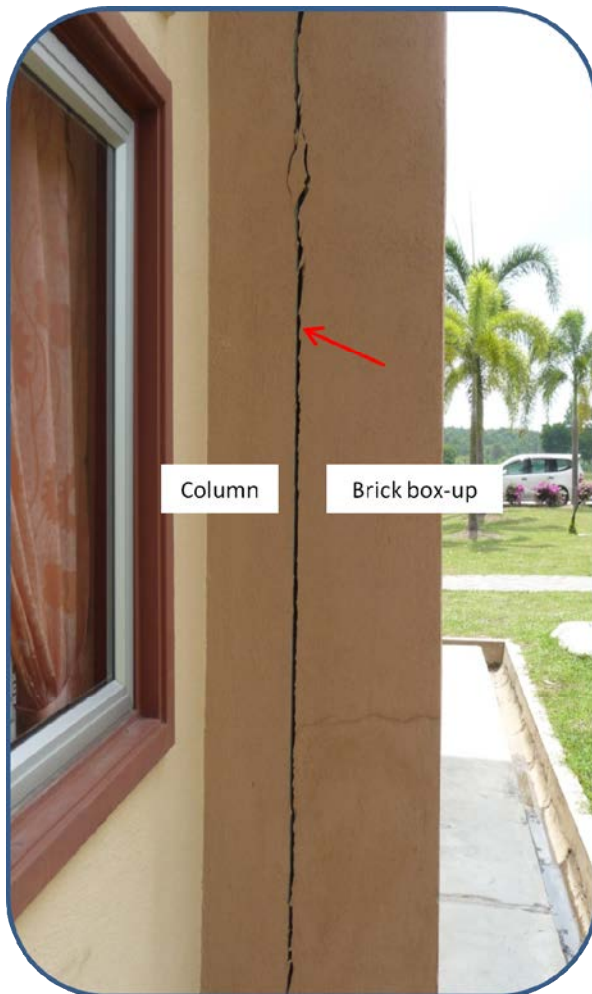
## Plaster Cracks at External Column

Where RWDP is concealed in brick boxed up, plaster cracks occur because of different base / foundation types.

- a) Provide wall ties of dowel or fish tail with exmet at every 4 courses for brick wall.

- a) Do not lay brick box-up column on non-suspended apron.

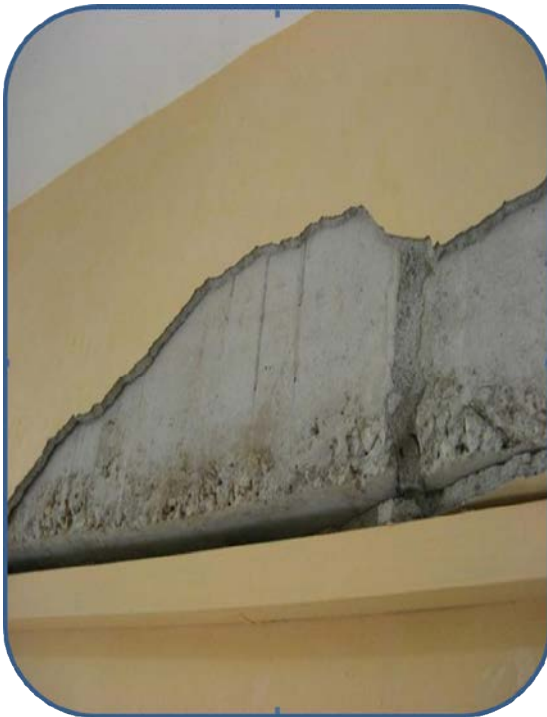
## Plaster Cracks on Beam

Plaster cracks on concrete elements due to use of materials or / and applications not according to specifications.

- a) Warrant materials and workmanship according to specifications
- b) Ensure proper site supervision for plastering work.

- a) Avoid having plaster thickness of more than 16mm for brick wall and 12mm for smooth surface.

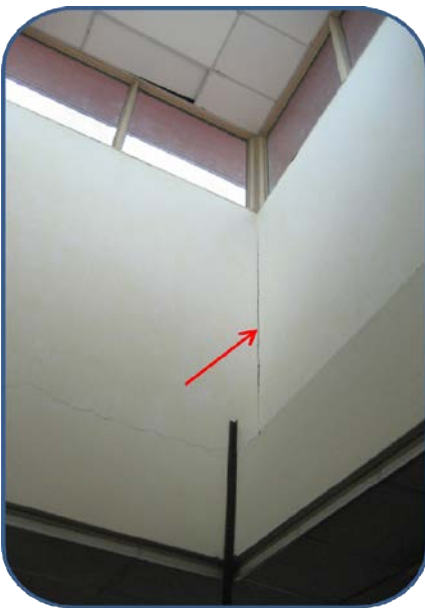
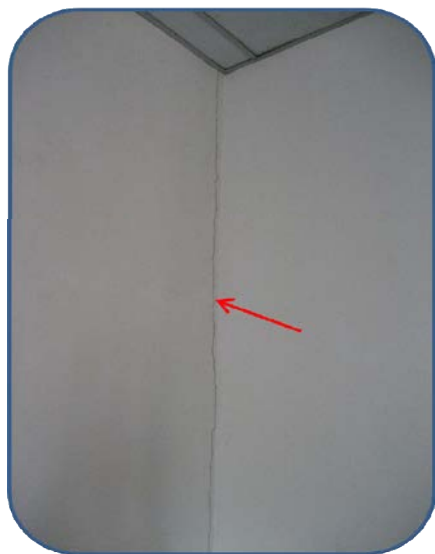
## Plaster Cracks at Wall Intersection

Plaster cracks at wall intersection is caused by improper bonding.

- a) Provide proper bond at all intersections of brick walls.

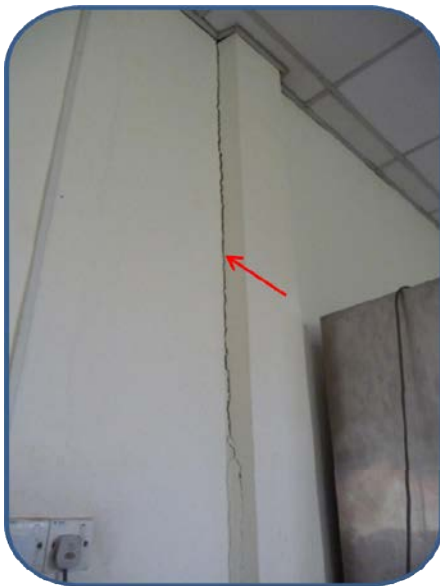
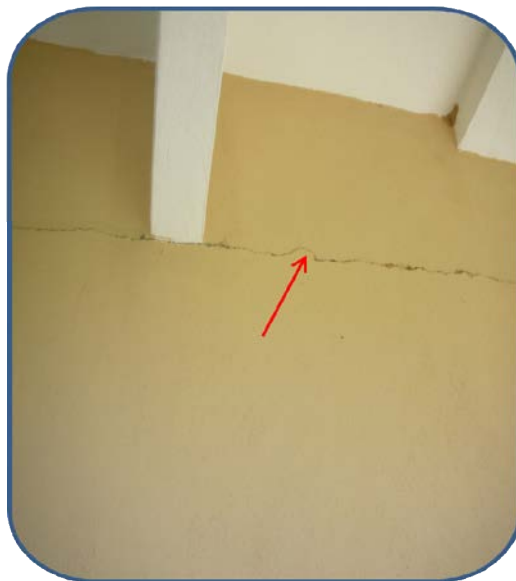
## Plaster Cracks at Joint Between Brick Wall & Concrete Structures

Cracks occur due to insufficient or improper position of wall ties / exmet at intersection.

- a) Provide wall ties of dowel or fish tail with exmet at every 4 courses for brick wall for column-wall connection.
- b) Provide exmet for beam-wall connection.

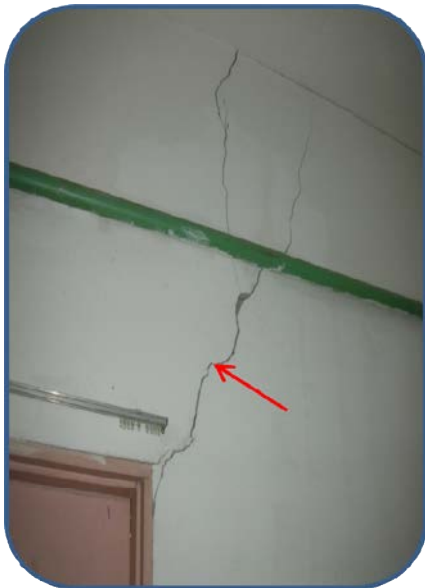
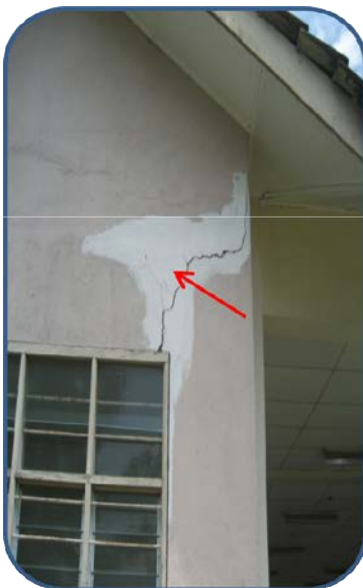
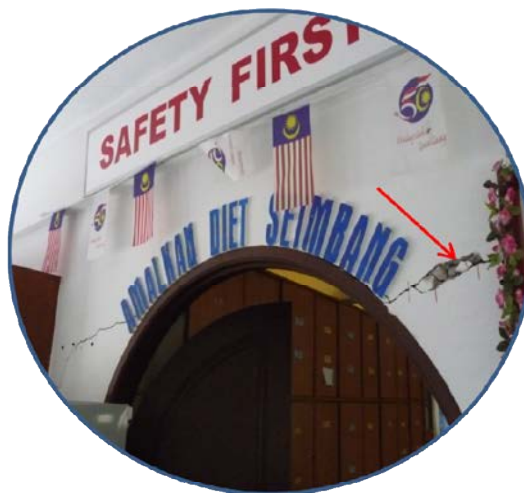
## Cracks at Wall Edge of Window & Door Frame / Wall Opening

Cracks occur due to lack or no proper support for brick walls above openings.

- a) Provide RC lintol for large opening.

- a) Do not place bricks on window or door frame for support.

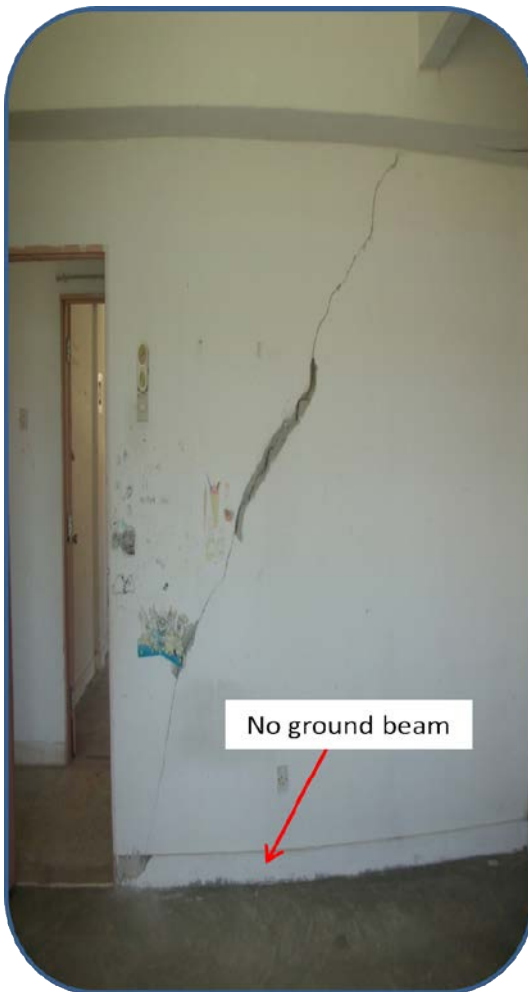
## Cracks on Internal Wall or Partition Wall

Improper support for internal / partition walls.

- a) Provide beam to support line load from the brick wall.
- b) Use lightweight material or cemboard wall as internal wall or partition wall.
- c) Design for adequate slab capacity to take wall load.

- a) Do not construct internal/ partition walls on non-suspended slab.

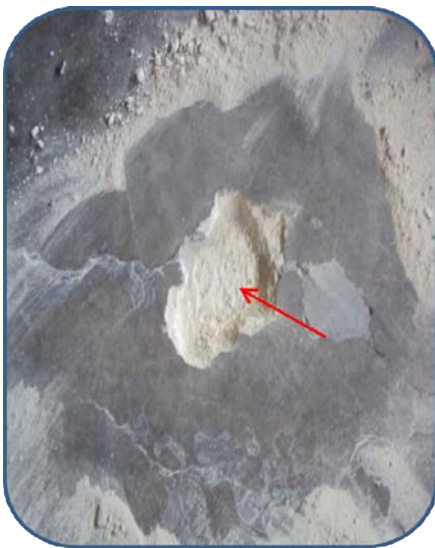
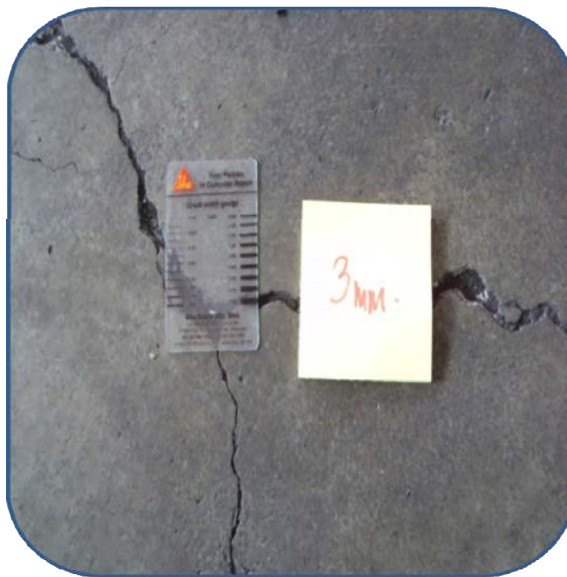
## Damage to Cement Screed

Damage to cement screed at floor and staircase due to poor workmanship and / or improper mixture.

- a) Ensure proper materials and method of applications for screeding according to specifications.
- b) Do proper site supervisions for screeding works.

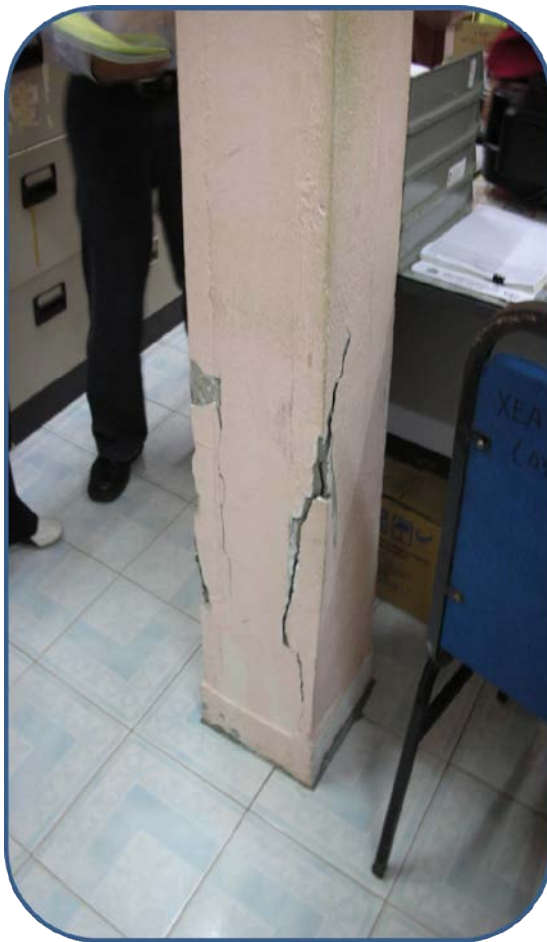
## Concrete Spalling at Base of Column

Improper method of concrete construction.

- a) Practice good concreting with proper method of placing, vibrating and curing.
- b) Pour cement slurry before concreting column.

- a) Do not drop the fresh concrete from a height exceeding 1.5 metre.

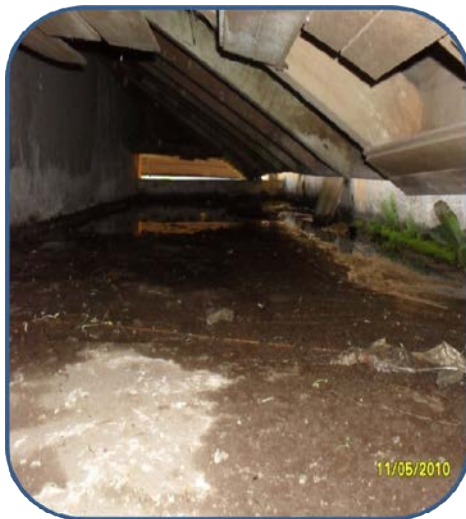
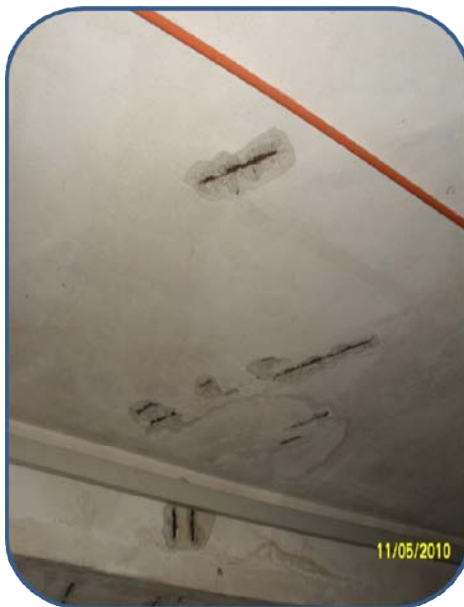
## Concrete Spalling & Corrosion of Reinforcement at Slab Soffit

Corrosion of rebar and concrete spalling due to water leakage in toilet areas and flat roof.

- a) Ensure waterproofing works are supervised according to the specifications.
- b) Do water ponding test after waterproofing works have been done.
- c) Ensure all tiling works in toilet area do not damage any water proofing layer.

- a) Do not make any construction joint or cold joint during concreting at toilet area.
- b) Do not punch for piping or M&E purpose any waterproofing system that has already been constructed.

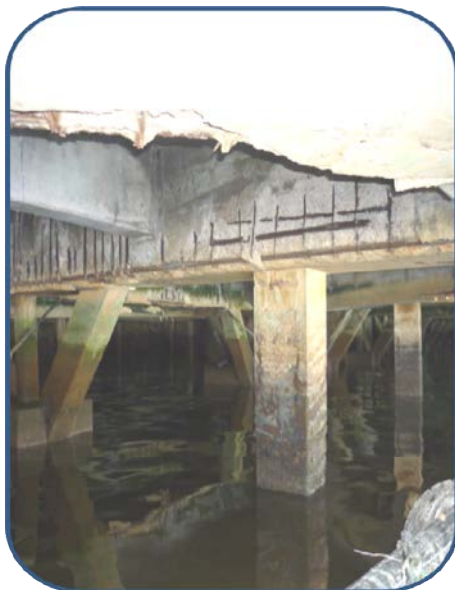
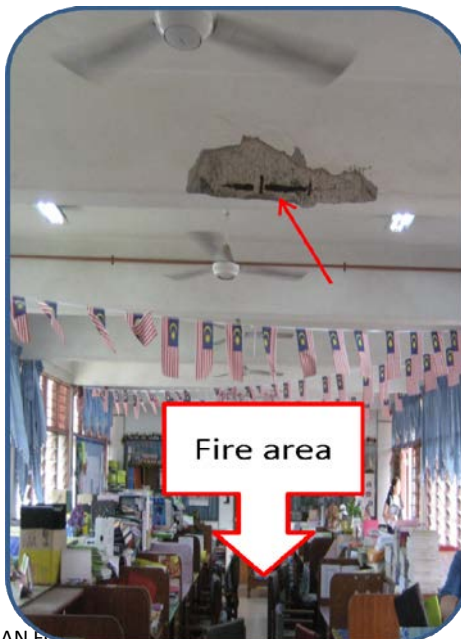
## Corrosion of Reinforcement in Aggressive Environment

Corrosion likely to occur in areas exposed to aggressive environment. (For example areas with high chloride ions, ASR attack & exposure to fire)

- a) Ensure concreting is done according to the design and specifications.
- b) Check the cover of concrete elements according to drawings and specifications.
- c) Do regular maintenance.

- a) Do not use sub-standard quality spacer blocks.

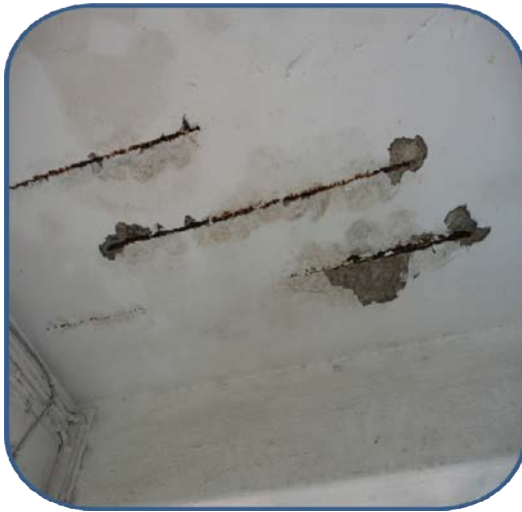
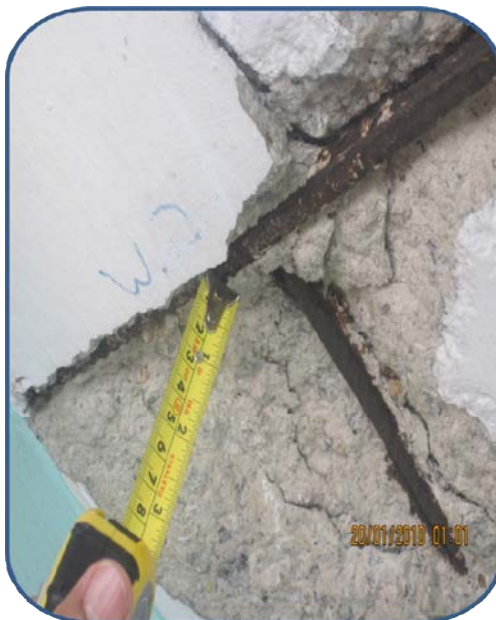
## Concrete Spalling & Corrosion of Reinforcement at Slab Soffit

Inadequate cover in concrete structure.

- a) Ensure cover for slab is adequate according to specifications and drawings.
- b) Develop and promote the use of performance-based specification for in-situ cover monitoring and control.

- a) Do not use sub-standard quality spacer blocks.

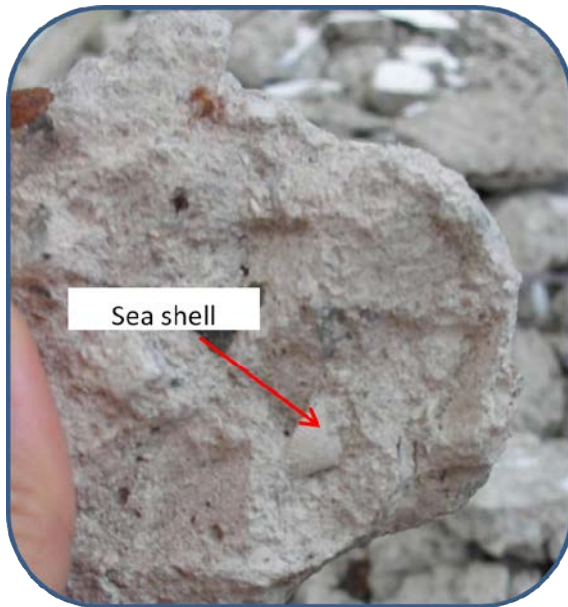
## Corrosion of Reinforcement Due to Internal Factors

Corrosion due to chloride content in concrete mix.

- a) Use high grade concrete accordingly, e.g. Grade 30 or higher
- b) Do stringent check on quality of fresh concrete during concreting work.

- a) Do not use untreated sea sand.

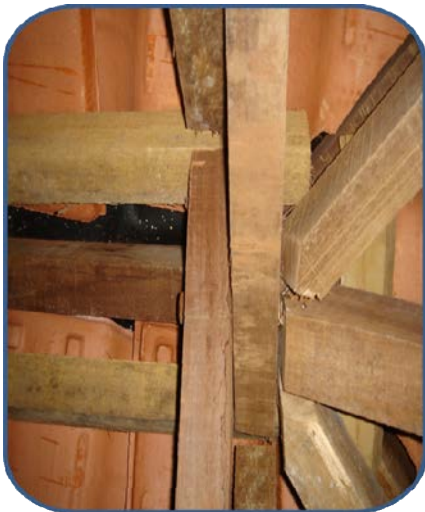
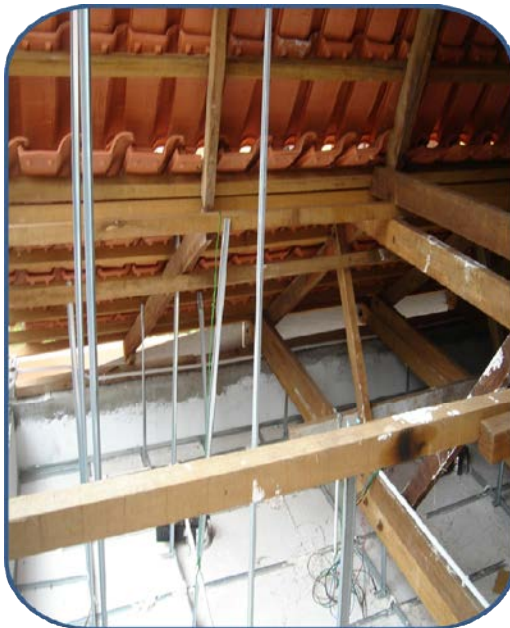
## Roof Failure

Roof truss failure due to materials & handling.

- a) Do stringent check on quality of material as specified in specifications.
- b) Warrant materials, system used and workmanship accordingly.

- a) Do not construct without approved drawing & specifications.

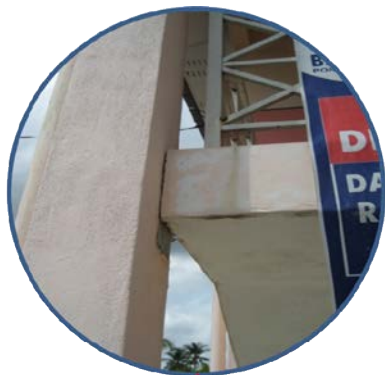
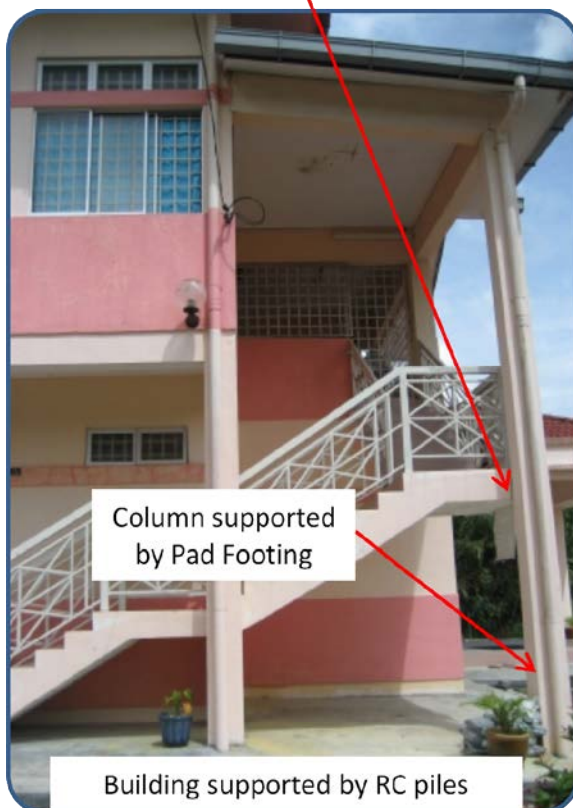
## Differential Settlement Structural Cracks

Cracks occur at connection of different components supported by different types of foundations.

- a) Design foundations according to code requirements.
- b) Construct foundations according to specifications and drawings.

- a) Do not change types of foundation on site without proper consultation.
