**FINAL REPORT**

**KAJIAN BAGI MENGGANTIKAN JAMBATAN SULTAN ISKANDAR  
DI FT001/639/90, KUALA KANGSAR, PERAK  
- THE STRUCTURAL ASSESSMENT AND REHABILITATION  
OF JAMBATAN SULTAN ISKANDAR**

**VOLUME 1 OF 4 : MAIN REPORT**

RPT/TC/275/14/40-FinalReport - Vol 1 of 4

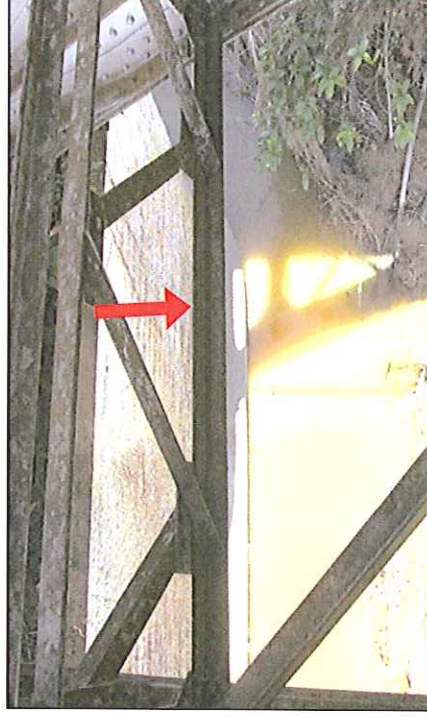
Picture M-S1-P3

Minor corrosion on inclined cross bracing.

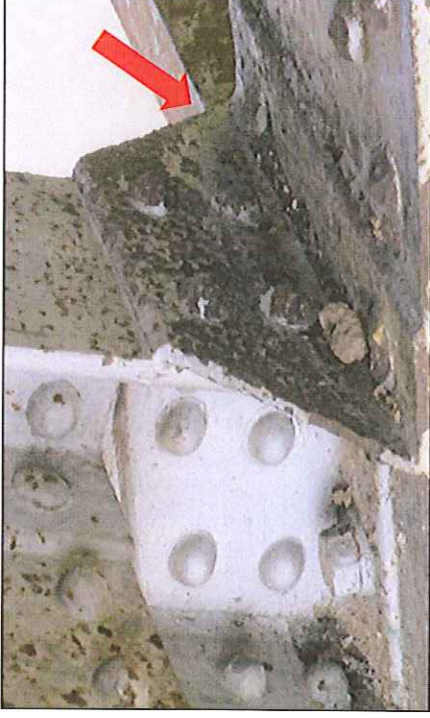
Picture M—S1—P6

Minor corrosion on vertical bracing joint of arch beam.

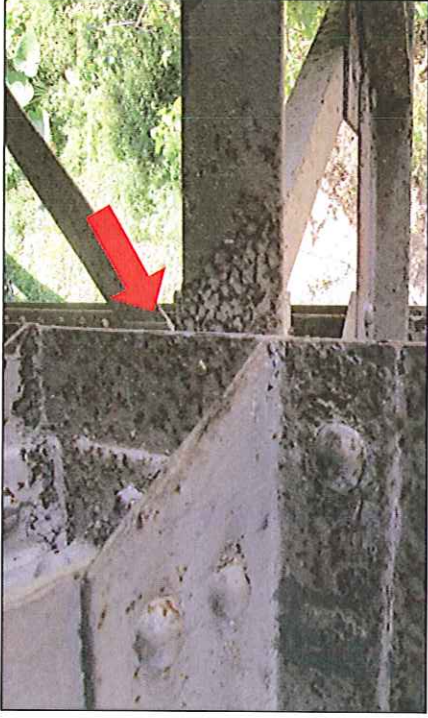
Picture M—S1—P8

Minor corrosion on top flange of arch beam.

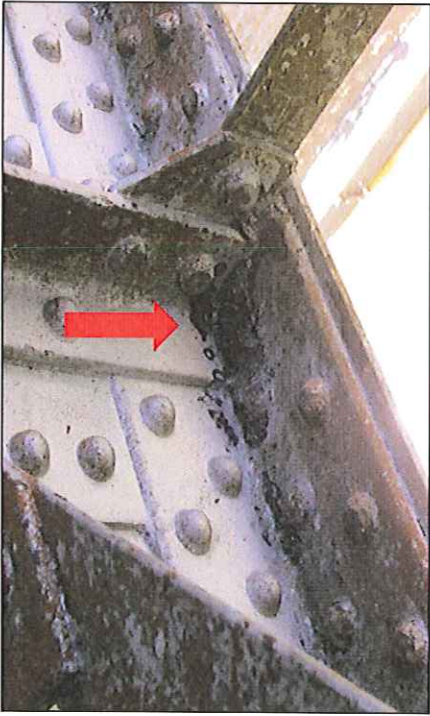
Picture M – S1 – P12

Minor corrosion on vertical bracing joint of arch beam.

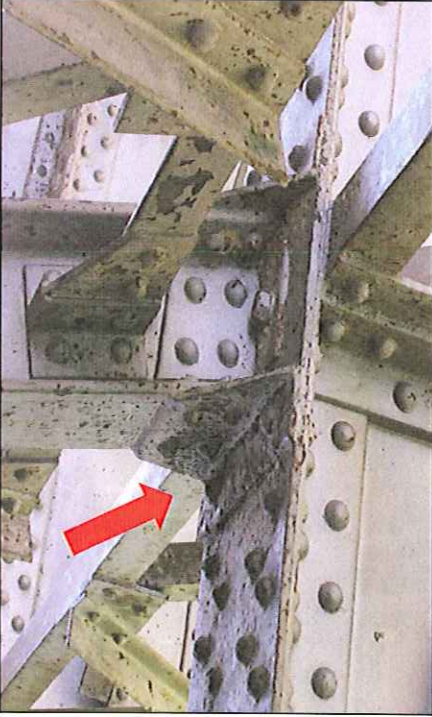
Picture M – S4 – P10

Minor corrosion on inclined cross bracing.

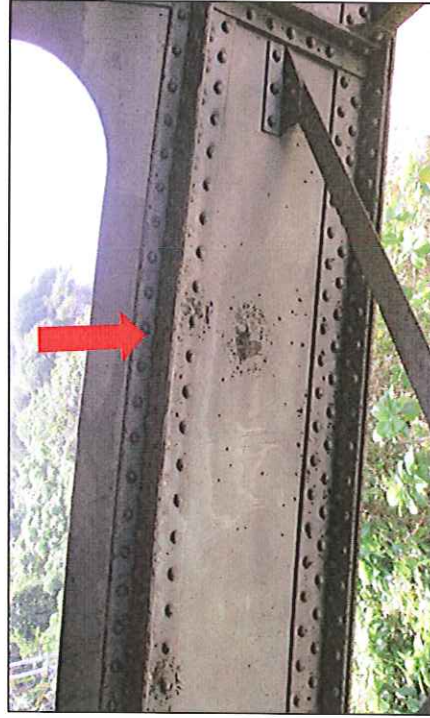
Picture M-S1-P13

Minor corrosion on vertical bracing joint of arch beam.

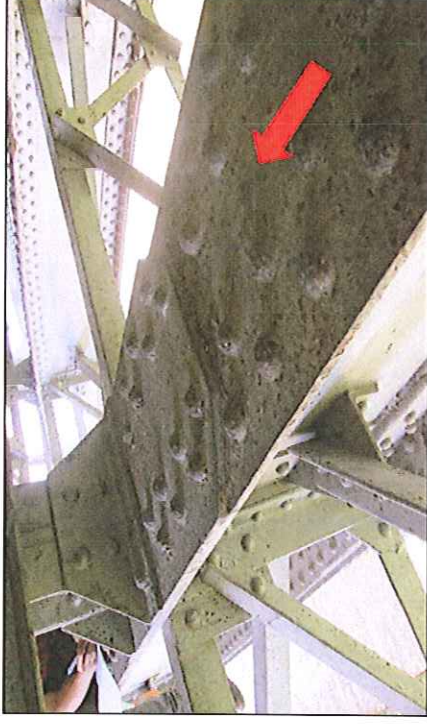
Picture M-S1-P14

Minor corrosion on vertical bracing joint of arch beam.

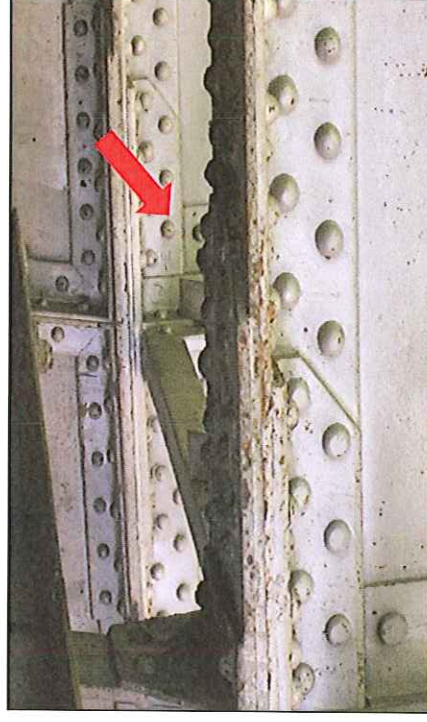
Picture M-S1-P15

Minor corrosion on top flange of arch beam.

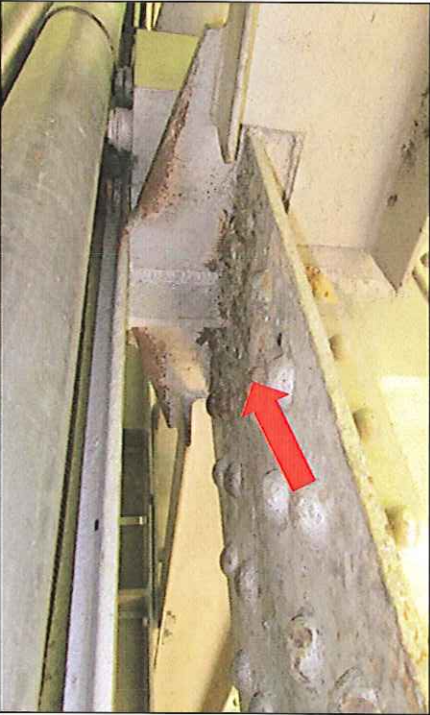
Picture M-S1-P16

Minor corrosion on top flange of arch beam.

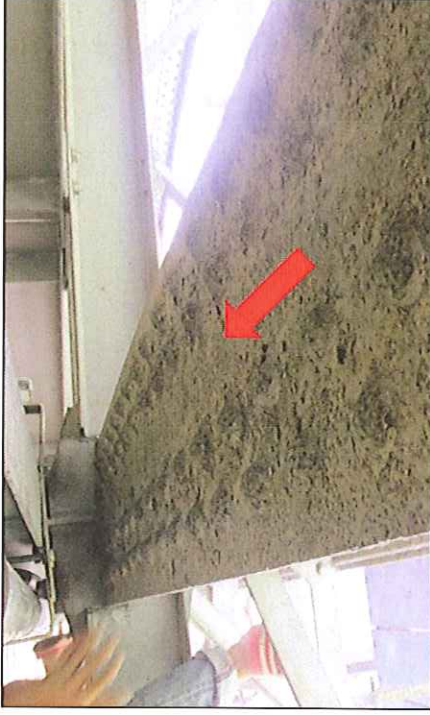
Picture M-S1-P18

Minor corrosion on top flange of arch beam.

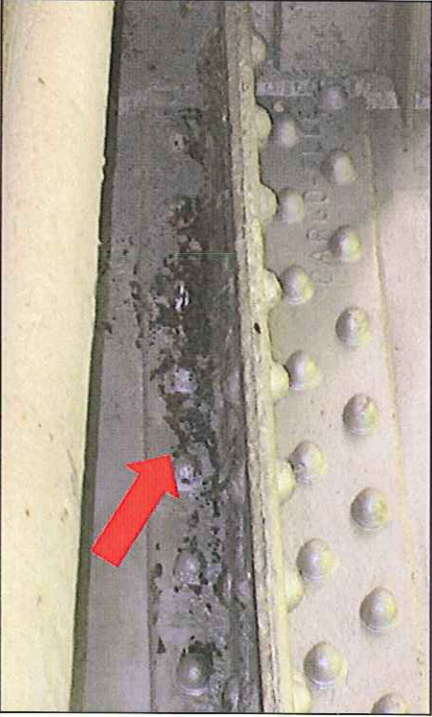
Picture M-S1-P20

Minor corrosion on top flange of arch beam.

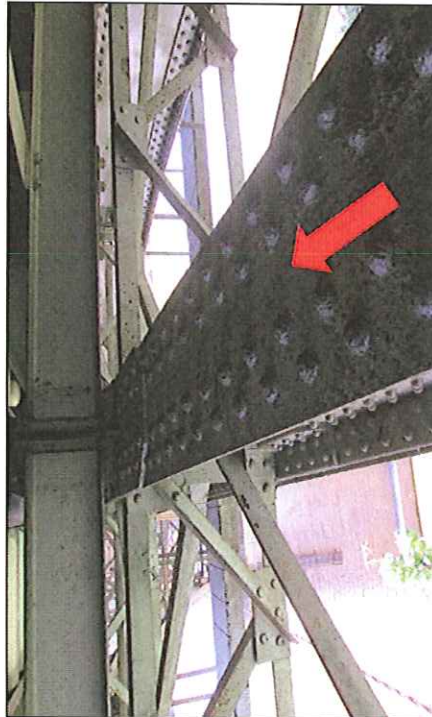
Picture M-S1-P21

Minor corrosion on top flange of arch beam.

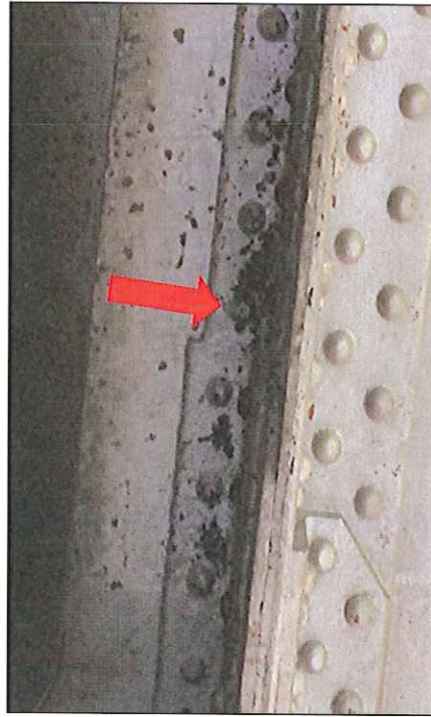
Picture M-S1-P23

Minor corrosion on top flange of arch beam.

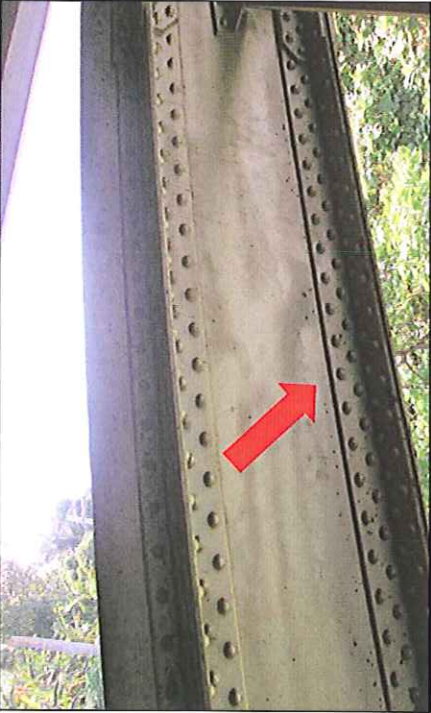
Picture M-S1-P24

Minor corrosion on top flange of arch beam.

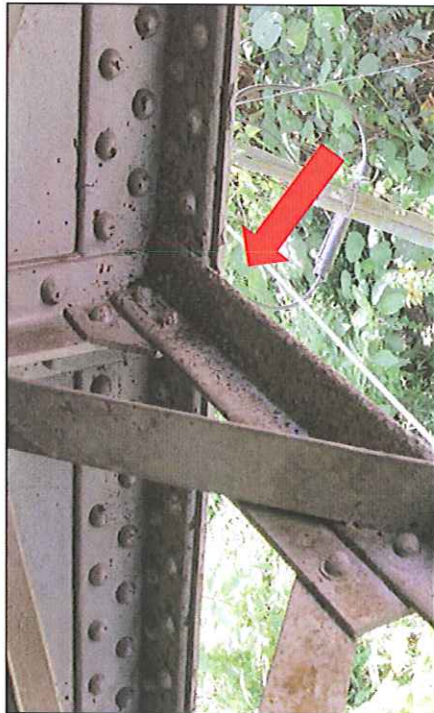
Picture M-S1-P25

Minor corrosion on bottom flange of arch beam.

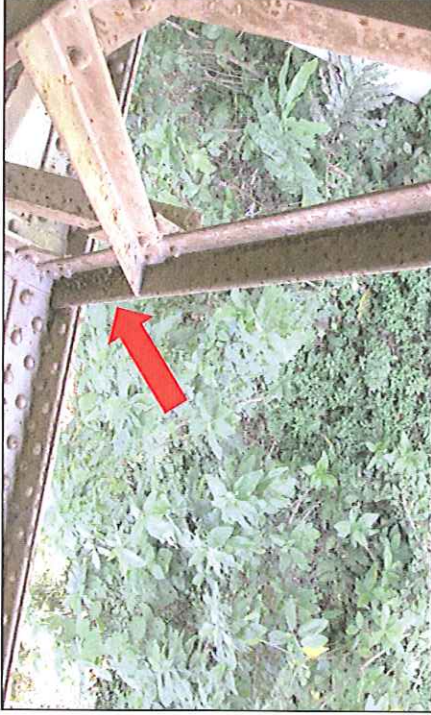
Picture M-S1-P26

Minor corrosion on inclined cross bracing.

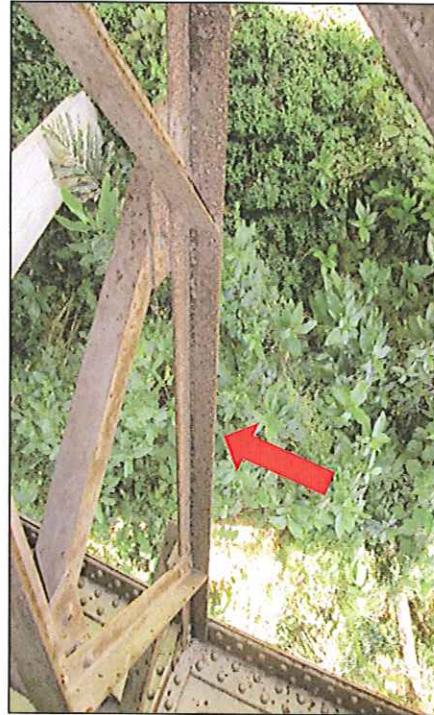
Picture M-S1-P27

Minor corrosion on inclined cross bracing.

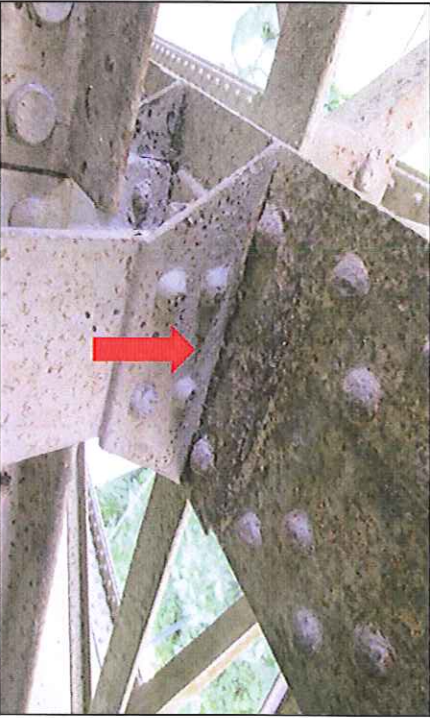
Picture M-S1-P28

Minor corrosion on inclined cross bracing.

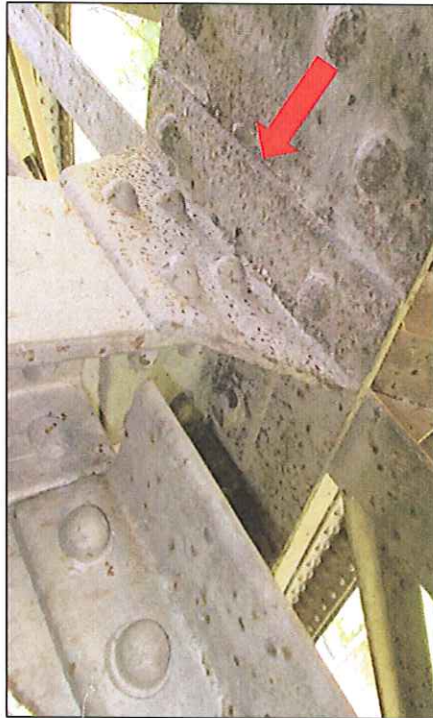
Picture M – S1 – P29

Minor corrosion on vertical bracing joint of arch beam.

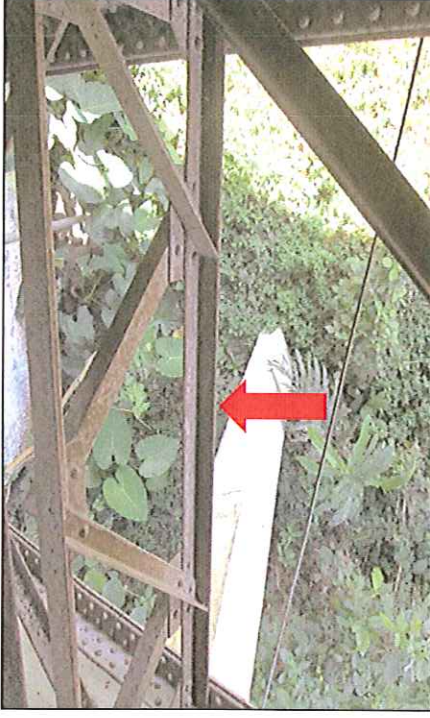
Picture M – S1 – P30

Minor corrosion on vertical bracing joint of arch beam.

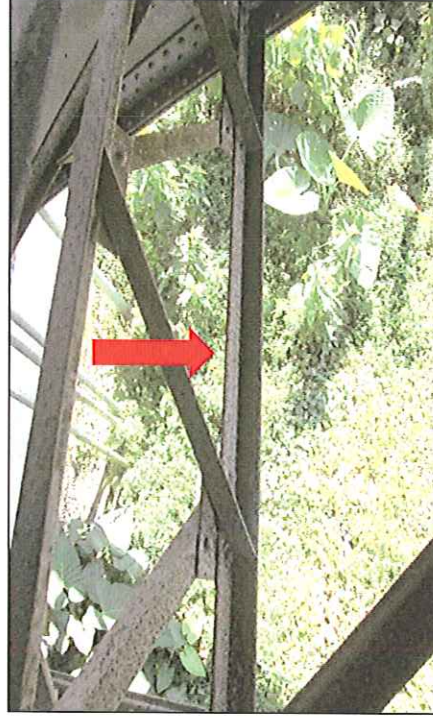
Picture M – S1 – P31

Minor corrosion on inclined cross bracing.

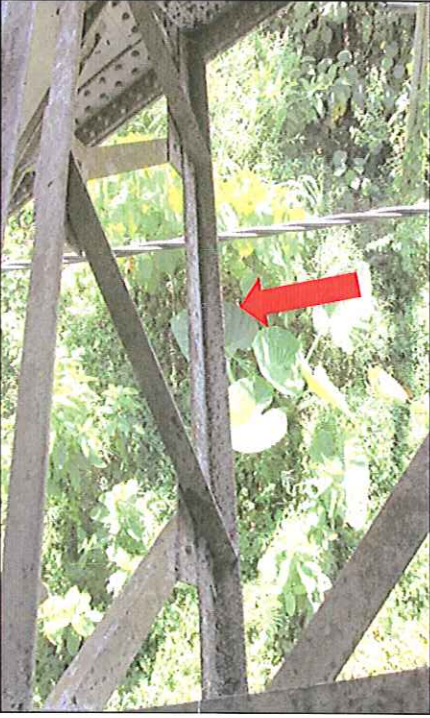
Picture M – S1 – P32

Minor corrosion on inclined cross bracing.

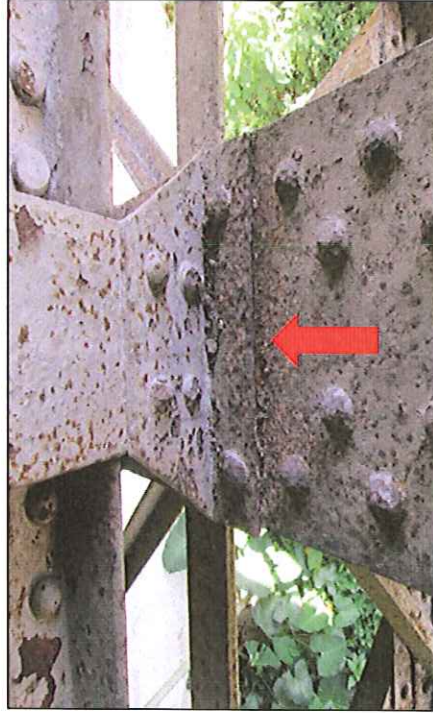
Picture M – S1 – P33

Minor corrosion on inclined cross bracing.

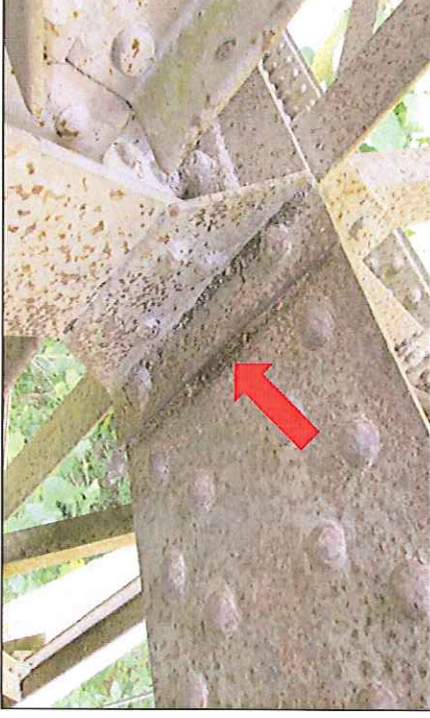
Picture M – S1 – P34

Minor corrosion on vertical bracing joint of arch beam.

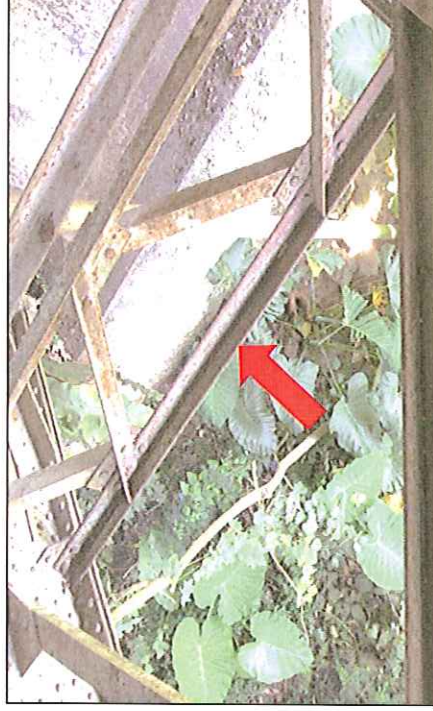
Picture M – S1 – P35

Minor corrosion on vertical bracing joint of arch beam.

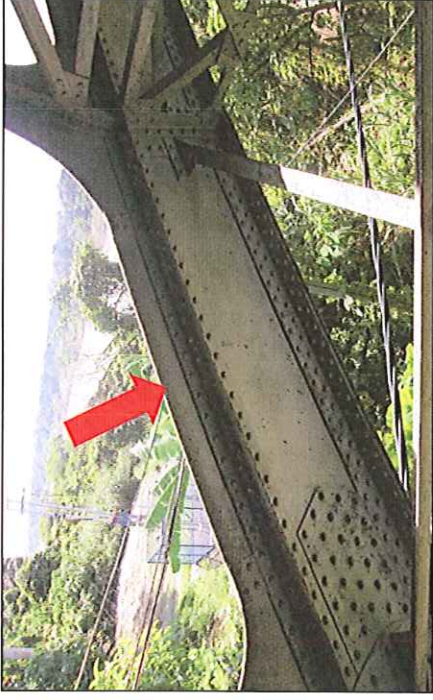
Picture M – S1 – P36

Minor corrosion on inclined cross bracing.

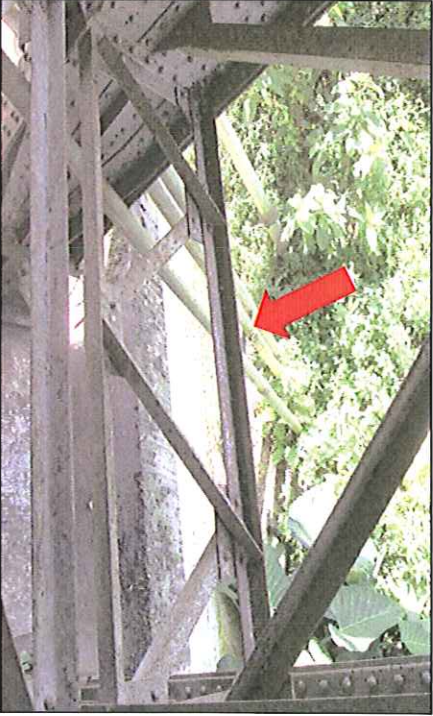
Picture M – S1 – P40

Minor corrosion on top flange of arch beam.

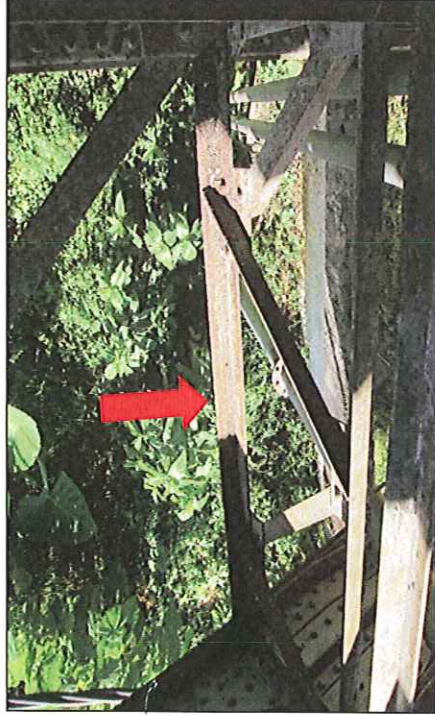
Picture M – S1 – P37

Minor corrosion on inclined cross bracing.

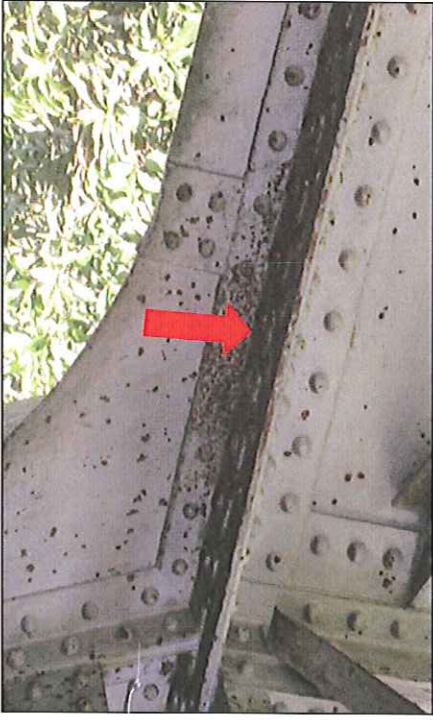
Picture M – S1 – P38

Minor corrosion on inclined cross bracing.

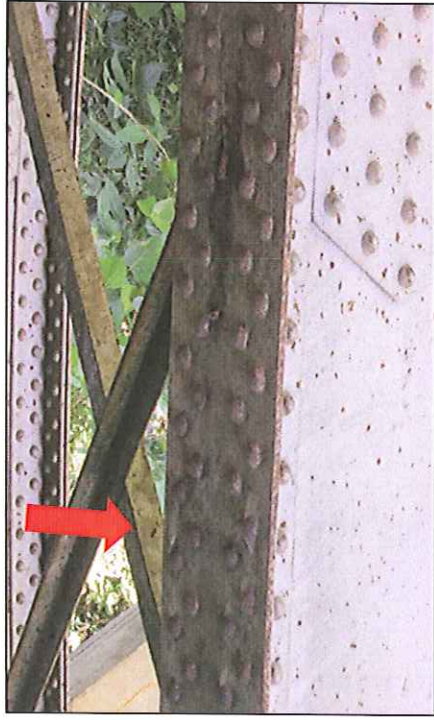
Picture M – S1 – P41

Minor corrosion on top flange of arch beam.

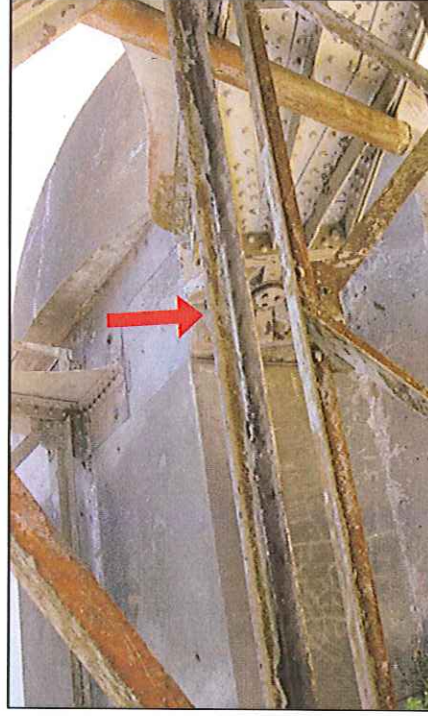
Picture M – S2 – P4

Minor corrosion on vertical cross bracing.

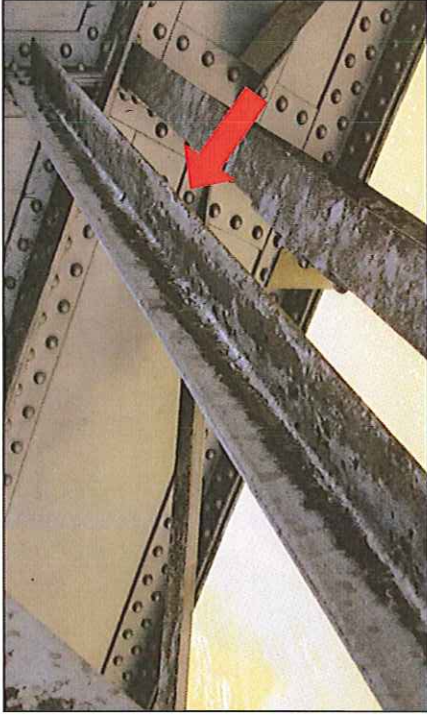
Picture M-S2-P11

Minor corrosion on vertical cross bracing.

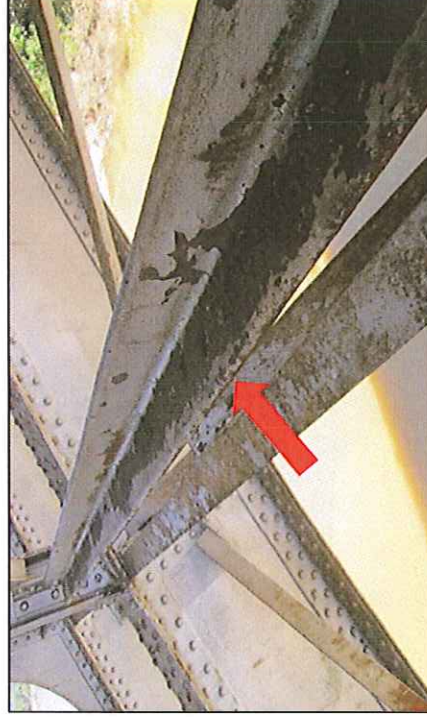
Picture M-S2-P12

Minor corrosion on vertical cross bracing.

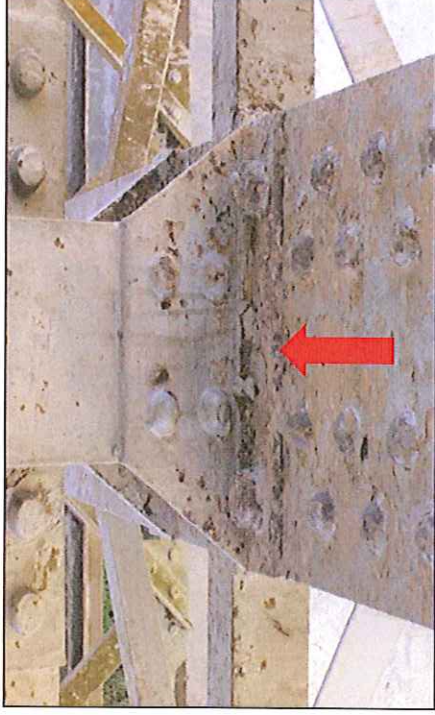
Picture M – S2 – P19

Minor corrosion on vertical bracing joint of arch beam.

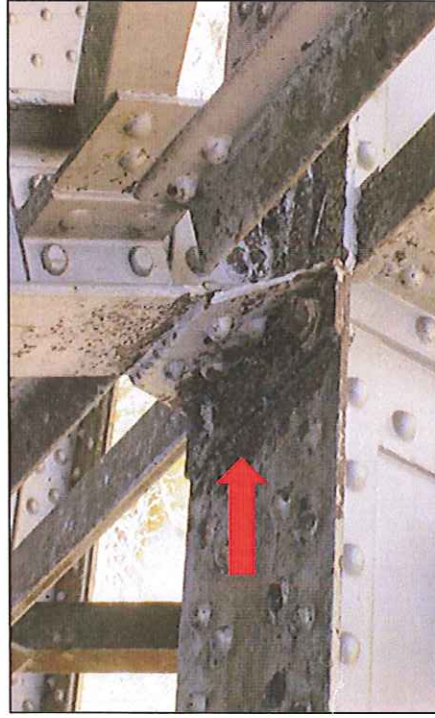
Picture M-S2-P34

Minor corrosion on vertical cross bracing joint of arch beam.

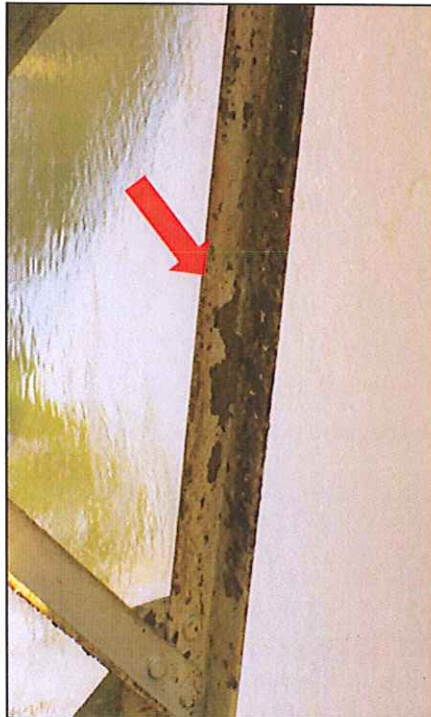
Picture M-S3-P2

Minor corrosion on inclined cross bracing.

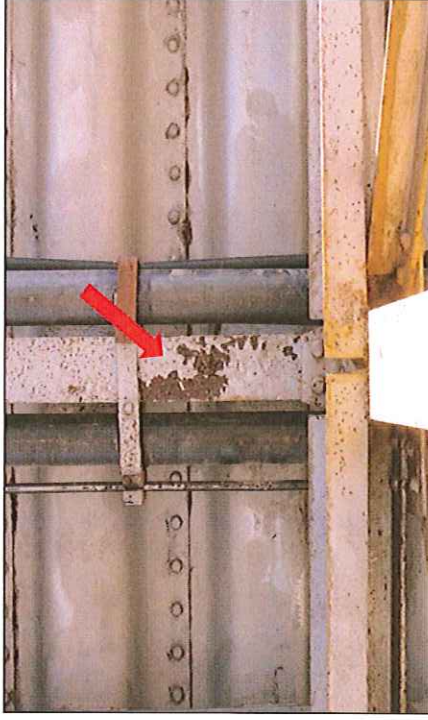
Picture M-S3-P3

Minor corrosion on I-beam.

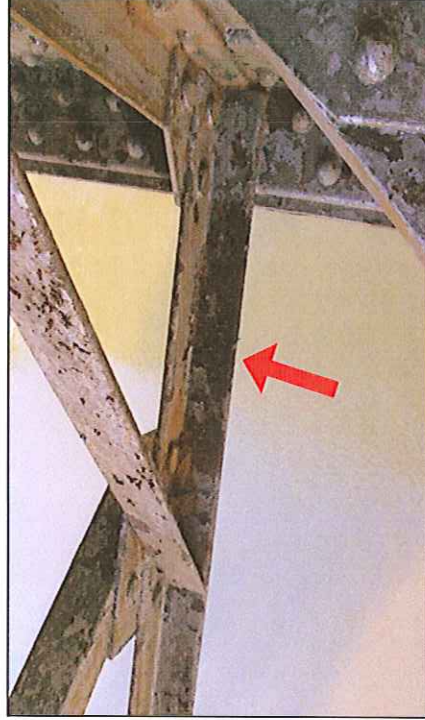
Picture M-S3-P4

Minor corrosion on inclined cross bracing.

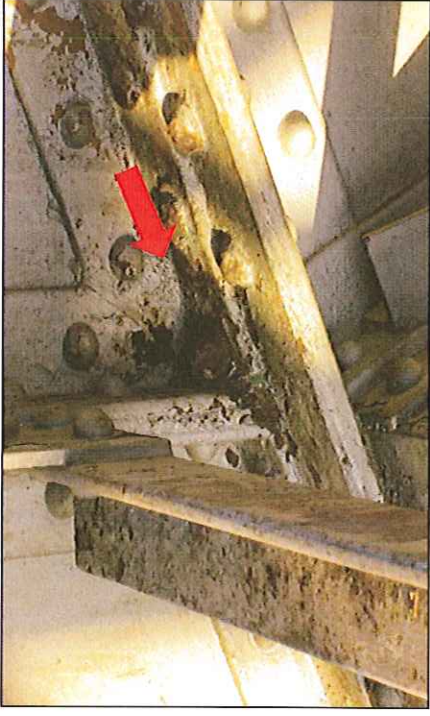
Picture M – S3 – P7

Minor corrosion on top flange of arch beam.

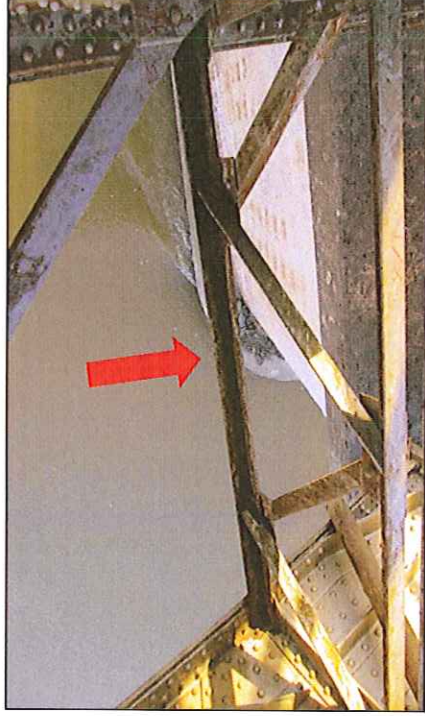
Picture M – S3 – P8

Moderate corrosion on inclined cross bracing.

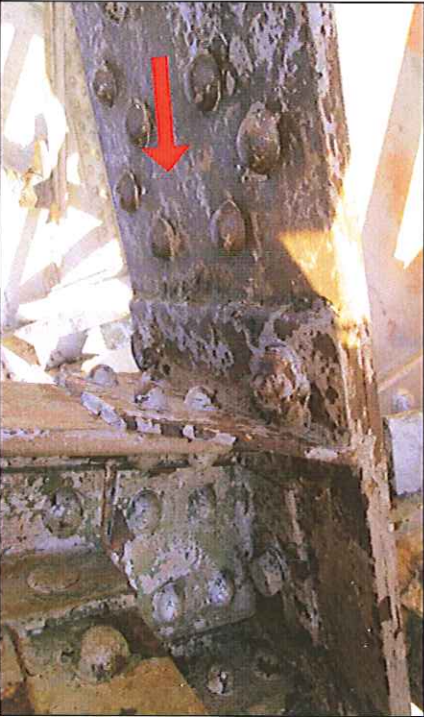
Picture M – S3 – P5

Minor corrosion on vertical bracing of arch beam.

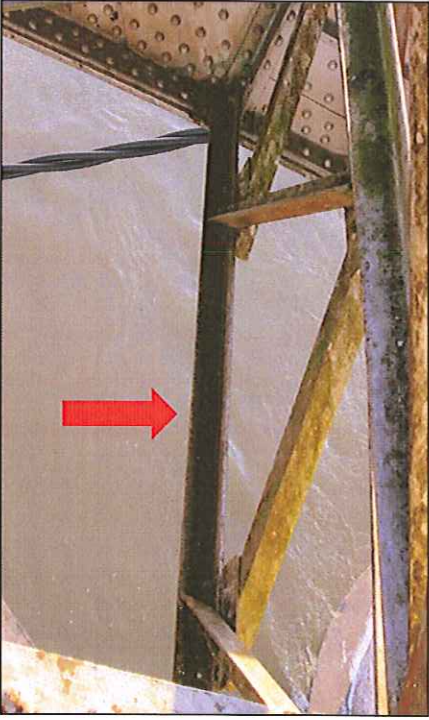
Picture M – S3 – P9

Moderate corrosion on inclined cross bracing.

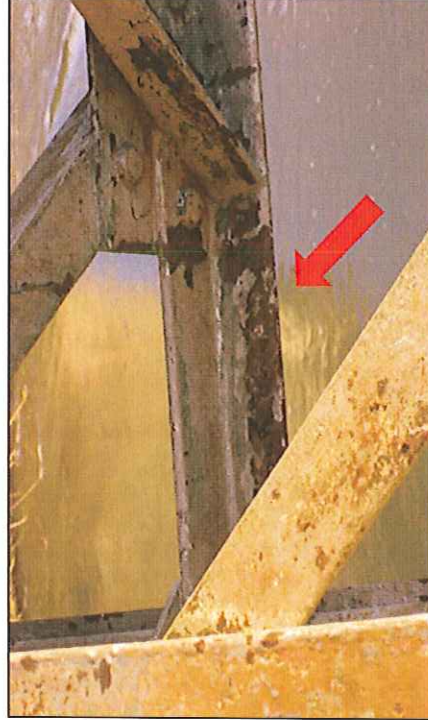
Picture M – S3 – P10

Minor corrosion on inclined cross bracing.

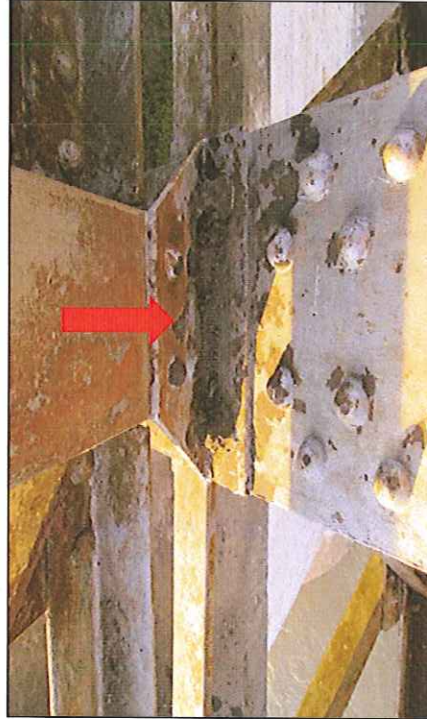
Picture M – S3 – P12

Moderate corrosion on vertical joint bracing of arch beam.

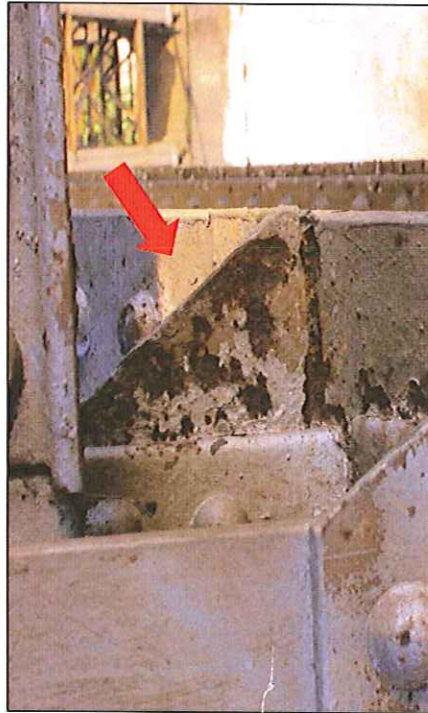
Picture M – S3 – P14

Minor corrosion on vertical bracing joint of arch beam.

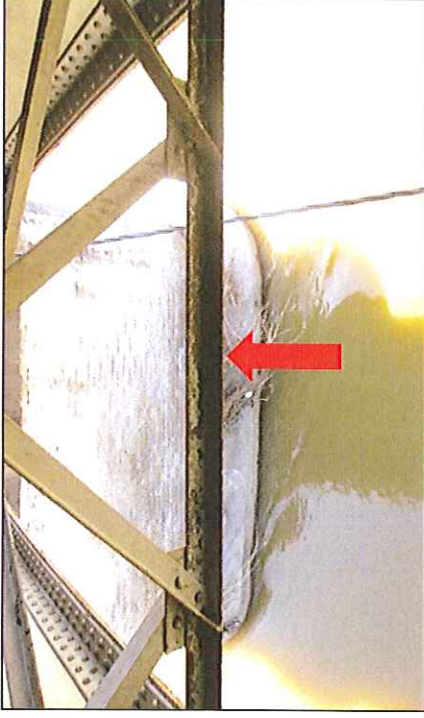
Picture M – S3 – P15

Moderate corrosion on inclined cross bracing.

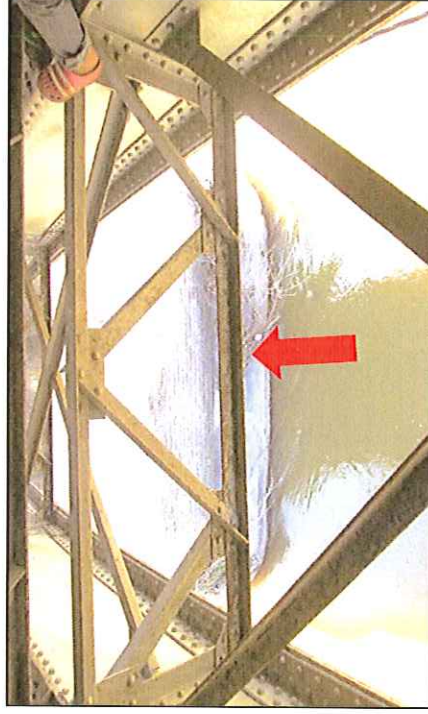
Picture M – S3 – P16

Minor corrosion on inclined cross bracing.

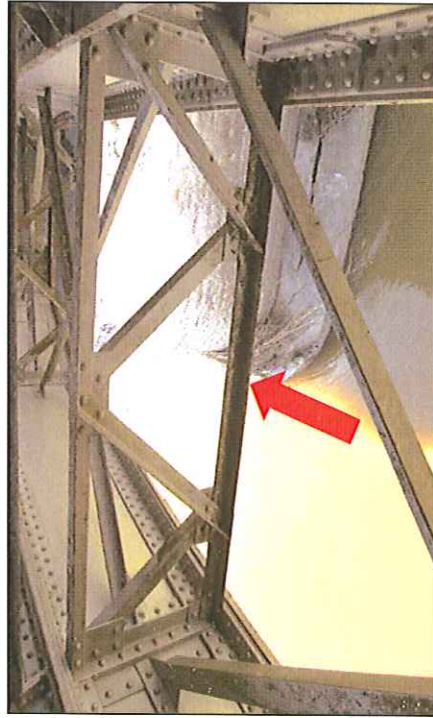
Picture M – S3 – P18

Minor corrosion on inclined cross bracing.

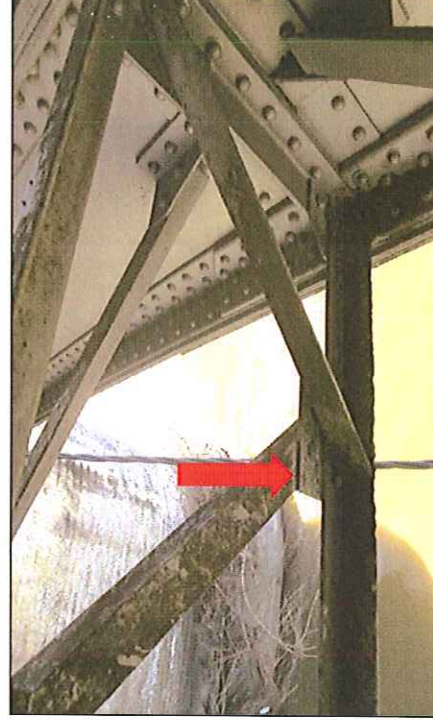
Picture M – S3 – P20

Moderate corrosion on inclined cross bracing.

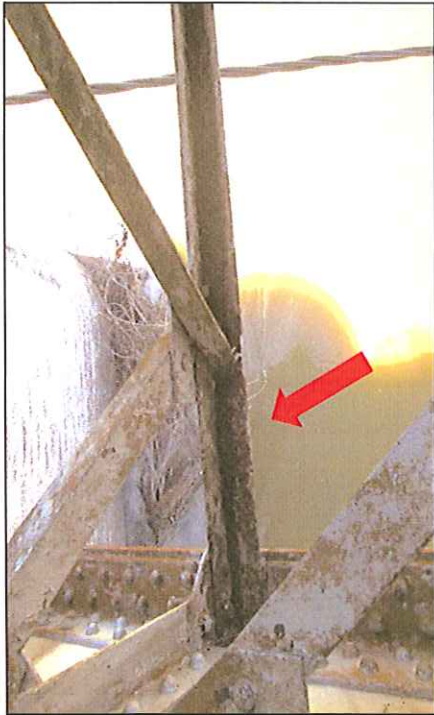
Picture M-S3-P21

Minor corrosion on inclined cross bracing.

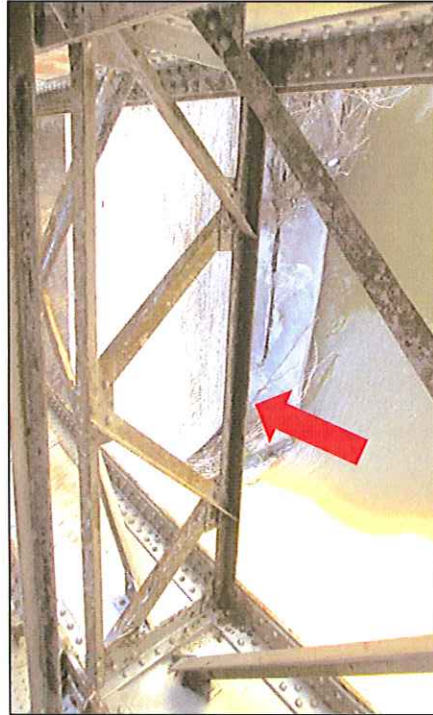
Picture M-S3-P22

Minor corrosion on inclined cross bracing.

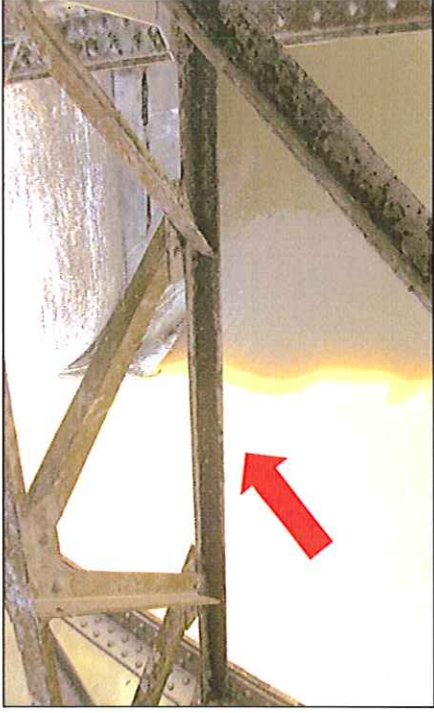
Picture M-S3-P23

Minor corrosion on inclined cross bracing.

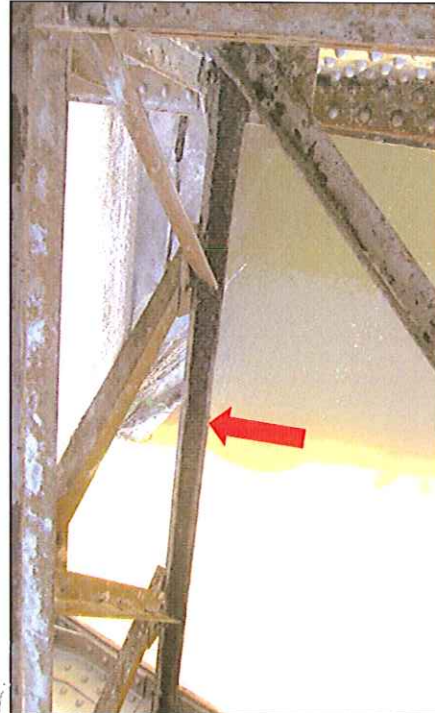
Picture M – S3 – P25

Minor corrosion on inclined cross bracing.

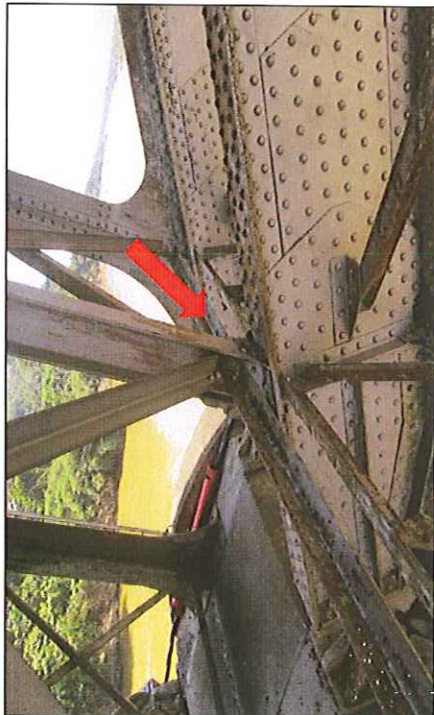
Picture M – S3 – P29

Minor corrosion on vertical bracing joint of arch beam.

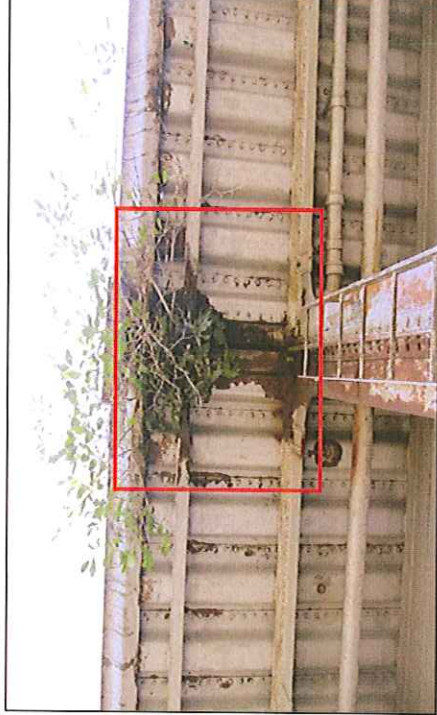
Picture M – S3 – P31

Minor corrosion and missing rivet on bottom flange of arch beam.

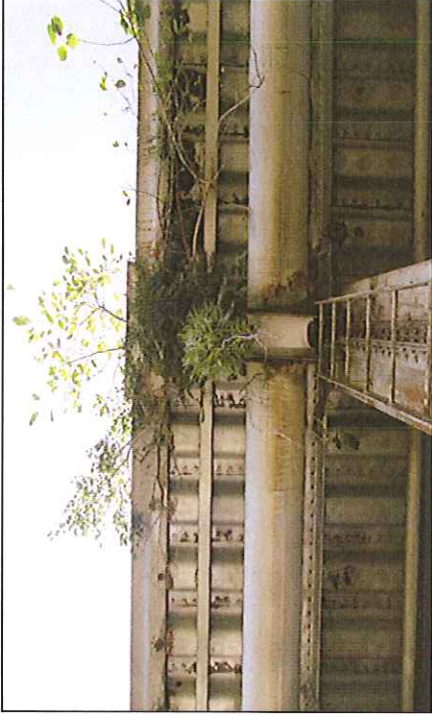
Picture M – S3 – P32

Moderate corrosion on steel frame.

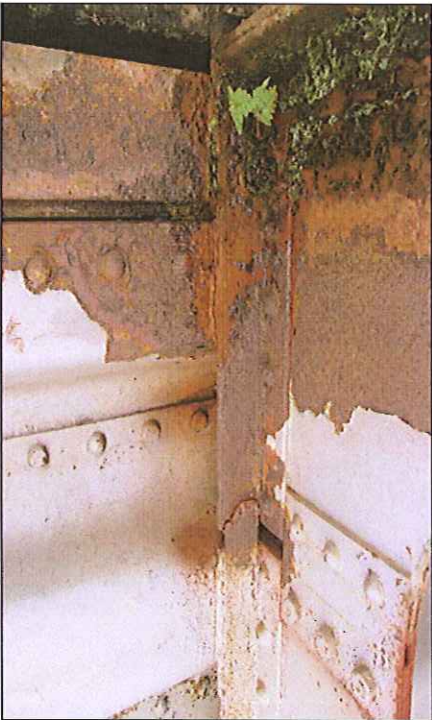
Picture M – S3 – P33 and M – S3 – P34  
Moderate corrosion on steel frame.

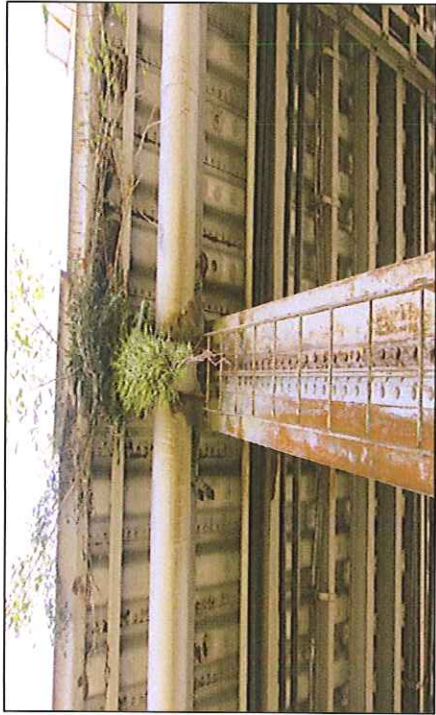
Picture M-S3-P39

Minor corrosion on overall middle frame.

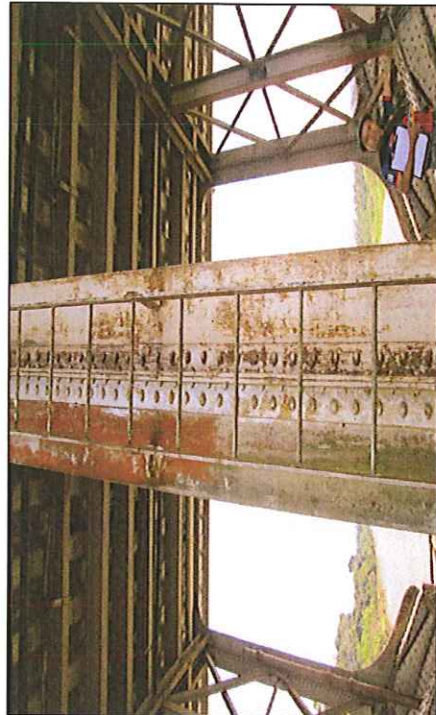
Picture M-S3-P40

Minor corrosion on overall middle frame.

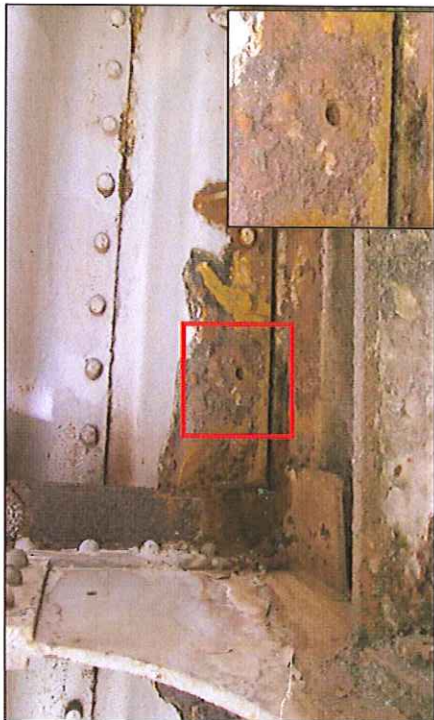
Picture M-S3-P37 and M-S3-P38.

Moderate corrosion and missing bolt on steel plate.

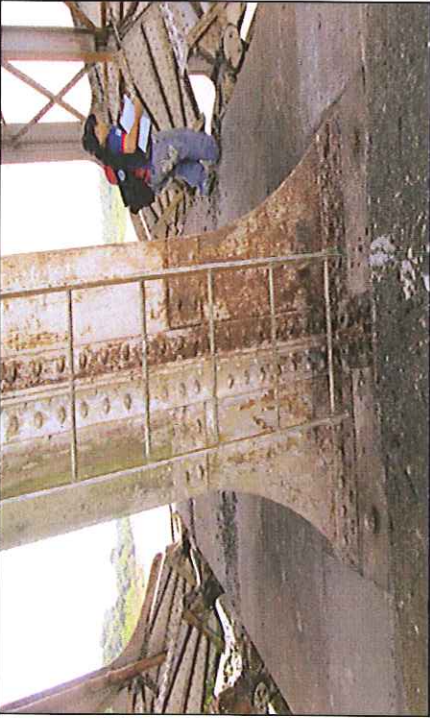
Picture M – S3 – P41

Minor corrosion on overall middle frame.

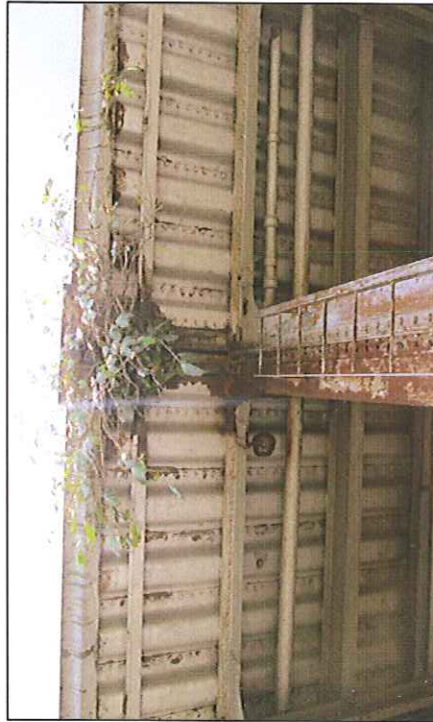
Picture M – S3 – P50

Moderate corrosion on overall middle frame.

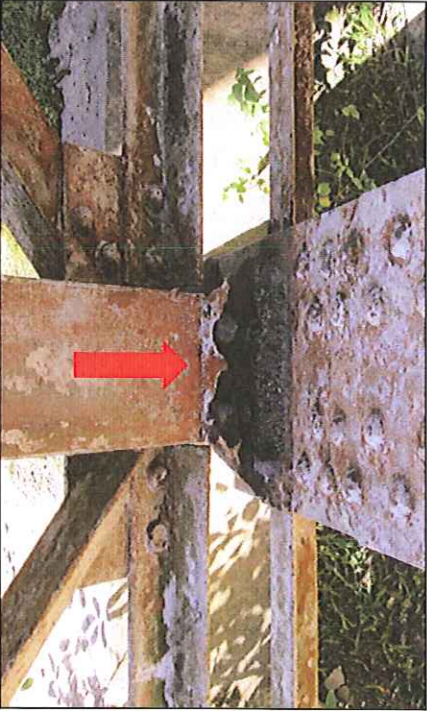
Picture M – S4 – P1

Moderate corrosion on vertical bracing of arch beam.

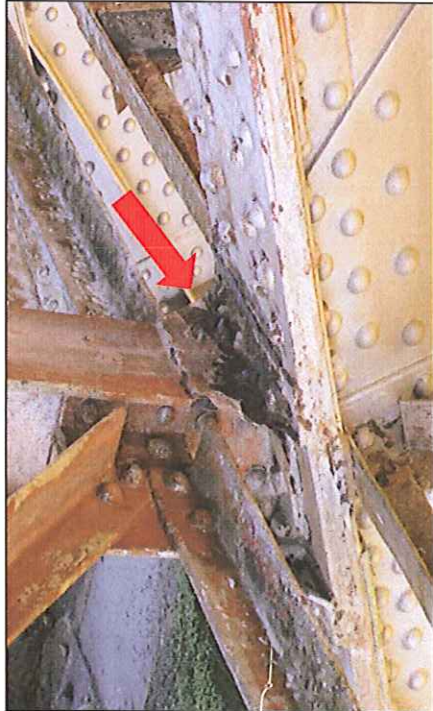
Picture M – S4 – P2

Moderate corrosion on vertical bracing of arch beam.

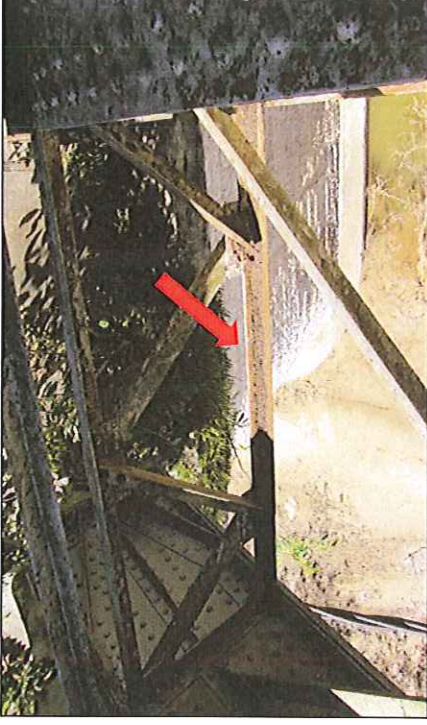
Picture M – S4 – P3

Minor corrosion on inclined cross bracing.

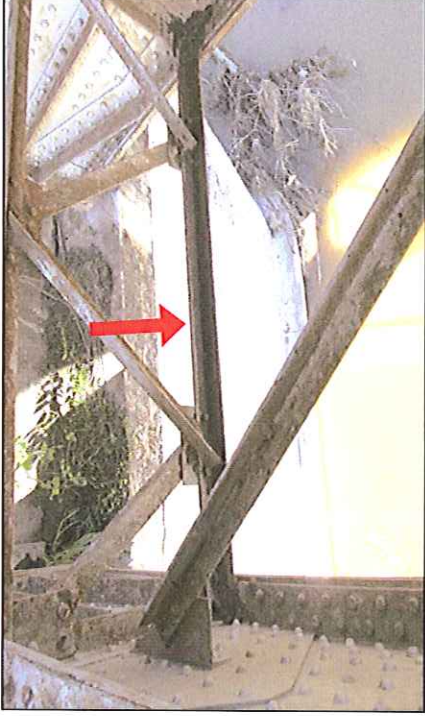
Picture M – S4 – P4

Minor corrosion on inclined cross bracing.

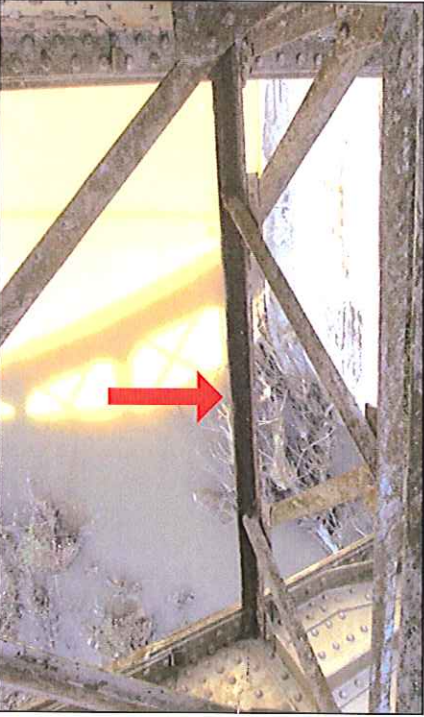
Picture M – S4 – P5

Minor corrosion on inclined cross bracing.

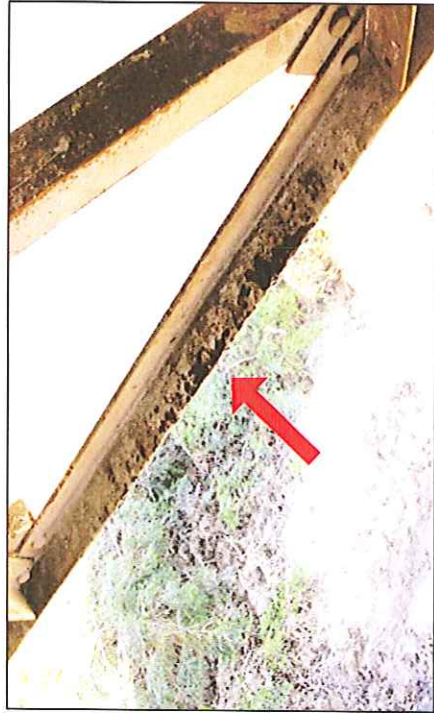
Picture M – S4 – P6

Minor corrosion on inclined cross bracing.

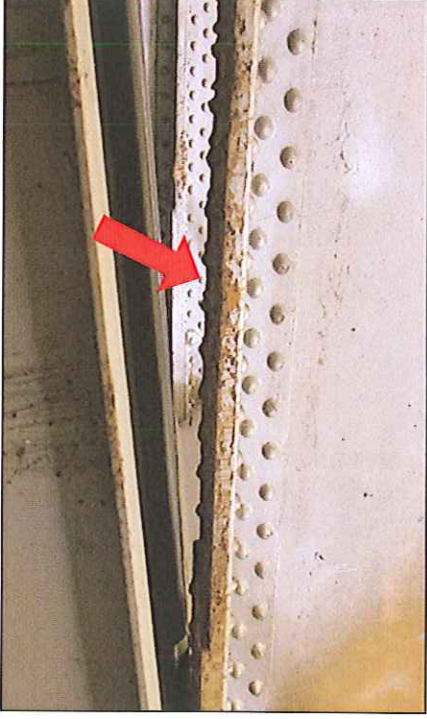
Picture M - S4 - P11

Minor corrosion on top flange of arch beam.

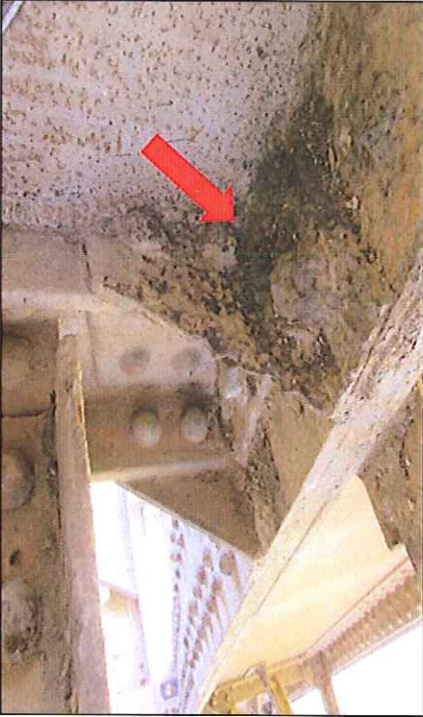
Picture M – S4 – P13

Minor corrosion on vertical bracing joint of arch beam.

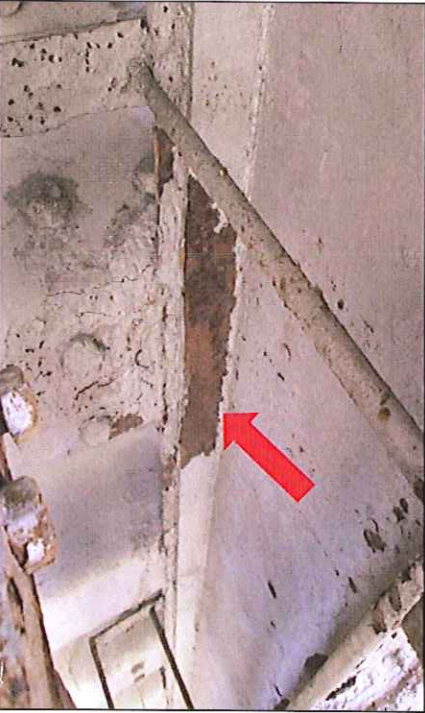
Picture M – S4 – P16

Minor corrosion on inclined cross bracing.
